BALLARD BUNDER GATEHOUSE

CONSERVATION REPORT

DOCUMENTATION, ANALYSIS & PROCESS

K.UNWALLA ARCHITECTS, MAY 2005

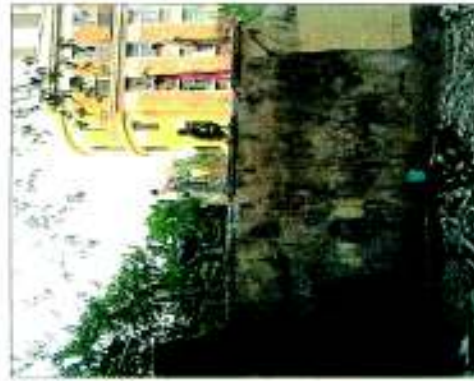
Layers of loose filling material revealed after removal of tar felt.

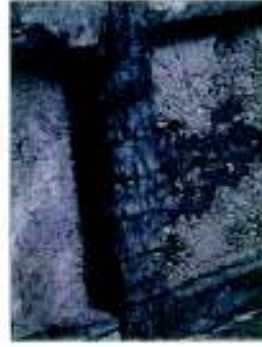
Application of Polymer modified plaster after introduction of additional reinforcement and new stirrups

Bulging of cover / loose cover at some locations indicating cracking of the cover, leakage stains indicating ingress of water, rusting / scaling of reinforcement. The reinforcement of an adequate design.

- Loose, disintegrated and cracked concrete broken and removed using chipping hammer and / or light chisel upto sound core concrete.
- Loose rust from reinforcement removed by light tapping, chipping, hammering and scrubbing

- Brush application of Rusticide to rusted steel
- Additional reinforcement placed at the bottom and secured to the new stirrups
- New stirrups provided by drilling holes and anchoring the same into the rib of existing RC beam with epoxy putty.

- Application of 2 coats of Polyalk Fixoprime and cement slurry
- Application of Polyalk EP + cement slurry as Bonding coat after 45 hours to entire broken surface

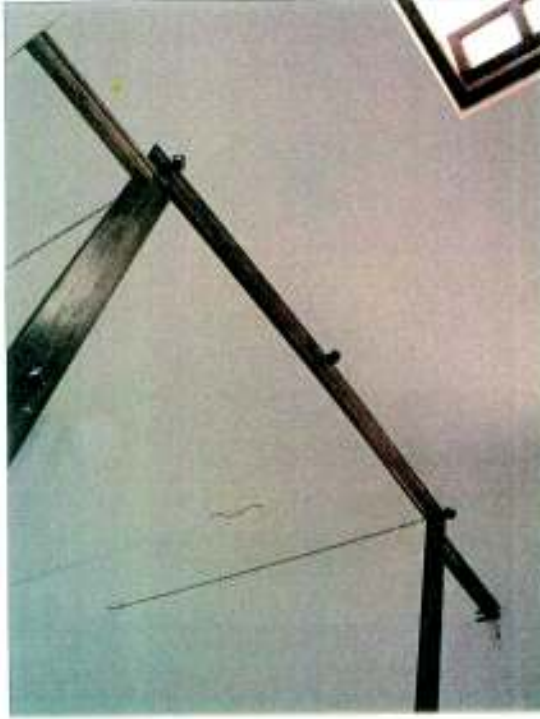
SLAB SOFFIT IN ROOMS BEFORE RESTORATION

Bulging of cover / loose cover at some locations indicating cracking of the cover, leakage stains indicating ingress of water, rusting / scaling of reinforcement. The reinforcement of an inadequate depth.

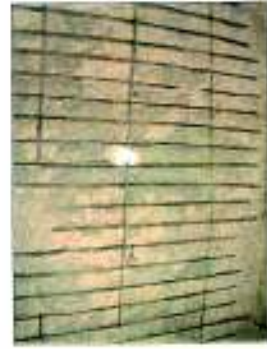
Reinforcement of slab exposed after removal of loose concrete cover

- Loose, disintegrated and cracked concrete broken and removed using chipping hammer and / or light chisel upto sound core concrete.
- Loose rust from reinforcement removed by light tapping, chipping, hammering and scrubbing

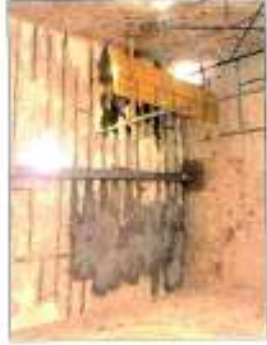
ISMB 250 introduced to strengthen the existing slab and prevent further sagging.

- Brush application of Rusticide to rusted steel
- ISMB 250 introduced spanning across the length of the room to reduce the effective span of existing RC slab. Secured to the stone walls by special ("Hilti" make) bolts insertion of steel wedges between the steel beam and the slab.

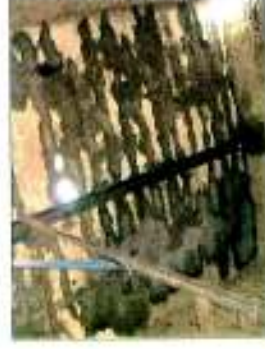
Application of Polymer modified mortar after the application of rusticide treatment

- Application of 2 coats of Polyalk Fixoprime and cement slurry
- Application of Polyalk EP + cement slurry as Bonding coat after 46 hours to entire broken surface

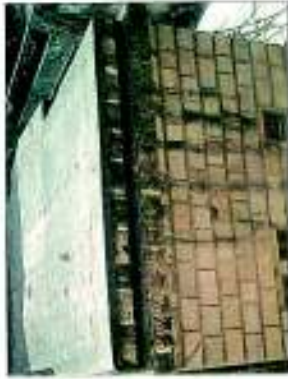
FACADE SOILED WITH STAINS (DUE TO WEATHERING AND TAR FROM THE TAR FELT ROOF PROTECTION) BEFORE RESTORATION

- Staining of stone surface due to water ingress from the roof and rising damp from the foundations is evident.
- Staining of stone surface due to weathering.
- Stains of tar on western facade.
- Stains associated to adjoining filling / dump / P.C.C.
- Stains due to rusting of nails driven in the wall
- Paint stains due to surfaces used as a backing while painting other objects/materials - evident mainly in the plinth surfaces.

- Removal of soiling by gentle mist spray and controlled pressure water jets.
- manual - light tapping / scrubbing / water application / Steam application
- Tar stains removed by Steam / diluted Petrol
- Careful removal of Nails / wooden blocks etc and sealing the holes / depressions with lime mortar

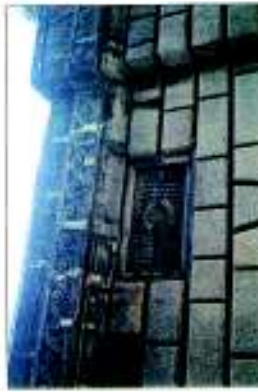
Ficus growth - a marginal problem, treated with a mixture of Hing, Jagni and unslaked lime

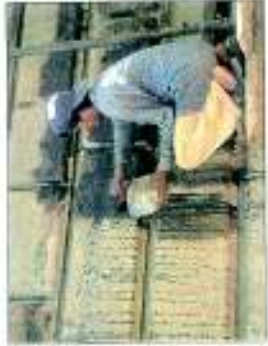
Application of petrol for removal of tar stains

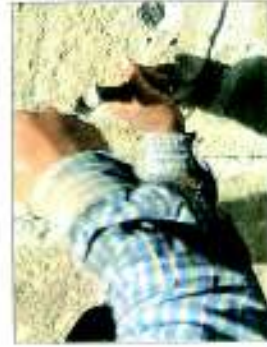
Careful removal of nails embedded in the stone surfaces

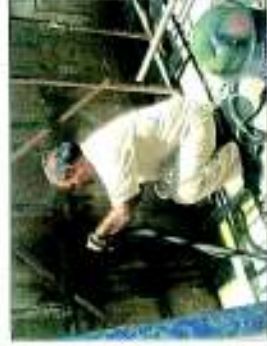
An attempt at use of pressurised steam to remove stubborn tar stains from the stone surface did not prove effective.

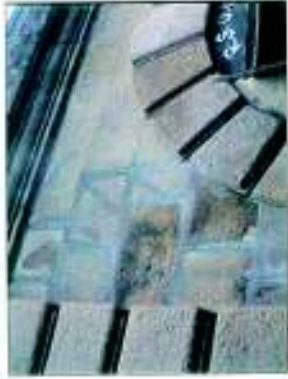
JOINTS AND CRACKS IN ASHLAR MASONRY SEALED WITH CEMENT

- Randomly located fine superficial cracks in the body of the stones
- The wide, depressed border profiles of the stones having been mistaken as wide open joints had been completely sealed.
- A complete fill of open joint profiles in the masonry

- Cement Pointing of joints carefully removed manually by light tapping and use of fine chisels.
- Stubborn cement application removed optimally by tapping and light abrasive hammering. At a few locations the attempt was abandoned for reasons of causing undue damage to the body parent stone.
- Rejointing and pointing in lime mortar.
- Sealing Joints between Door / window frames and stone surface with Lime mortar
- Plastic Repairs using lime mortar in locations where part stones had spalled.

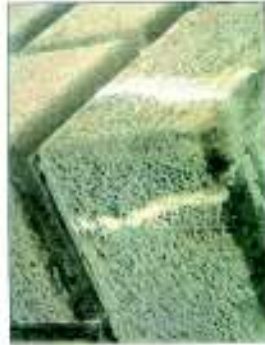
Damaged corner stone restored by stitching with SS pins and lime mortar jointing.

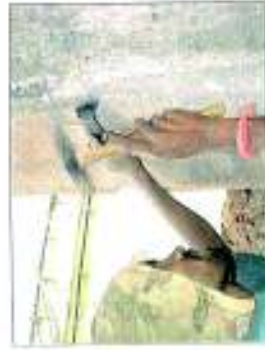
Removal of cement pointing / accretions by tapping.

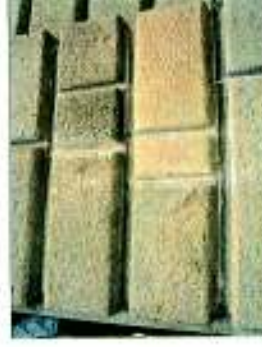
Stone masonry after removal of cement accretions and cleaning.

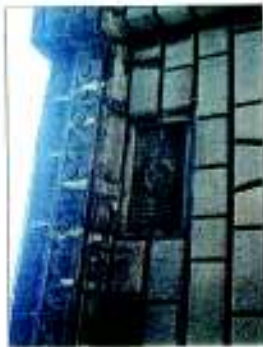
Decorative façade features demystified by soiling / tar stains and cement application (before restoration)

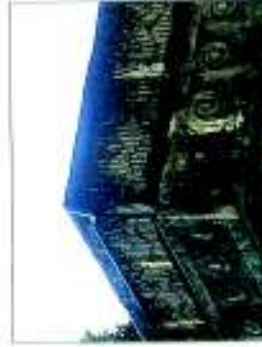
Cornice and frieze bands soiled by tar stains and weathering

- Weathering stains
- Stains due to water flow
- General atmospheric soiling
- Tar

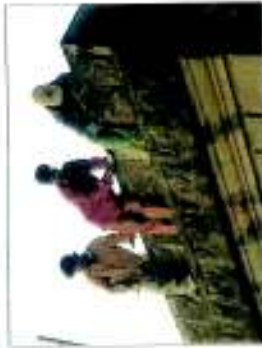
Decorative frieze band being cleaned by scrubbing.

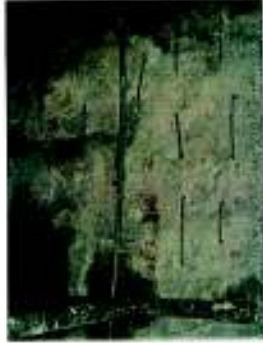
- Cause: Ceiling fans hung on steel angles, "L" shaped & jointed back to back, forming a beam spanning across the Hall, supported at the intrados base of the "Bulls Eye" opening in the partition wall. The off-centre support, induced pin pointed, rotational action in the masonry, and a resultant vertical through crack, travelling the full height of the walls - both partition walls.

Vertical structural crack in the masonry wall between the central hall and the rooms stitched with SS pins.

- Treatment: The crack along its run is stretched using SS pins, grouted correctly into the parent wall structure and covered in lime plaster in the rooms.

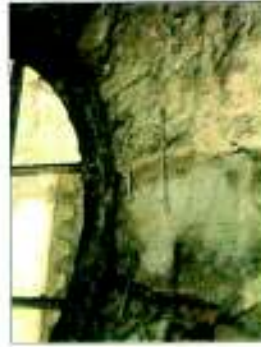
SS pins placed across opened joints of voussoirs of the ox-eye window.

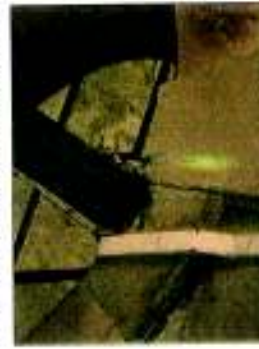
Inclusion of 45 degree angle through the Ox eye window caused damage to the voussoirs and lead to vertical structural cracks.

Voussoirs of the Ox eye window restored with lime mortar. The structural cracks were slotted with SS pins.

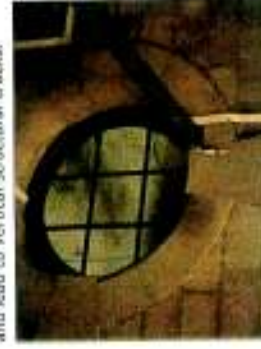
Ox eye window damaged by incompatible interventions.

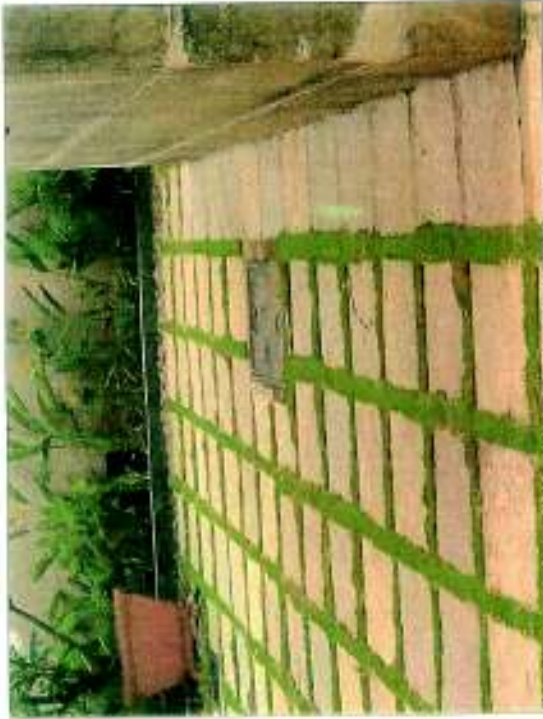
NETWORK OF SERVICES AROUND THE STRUCTURE LACKED ORGANISATION - BEFORE RESTORATION

SERVICE CHAMBERS INTEGRATED INTO LANDSCAPE SCHEME - AFTER RESTORATION
