**RESTORATION WORKS AT CHHATRAPATI SHIVAJI MAHARAJ VASTU SANGRAHALAYA**  
**Completion Report for Phase I Exterior Restoration Works**

**Abha Narain Lambah Associates: Conservation Architects & Historic Building Consultants**  
**Structural Rehab Consultant**

December 2008

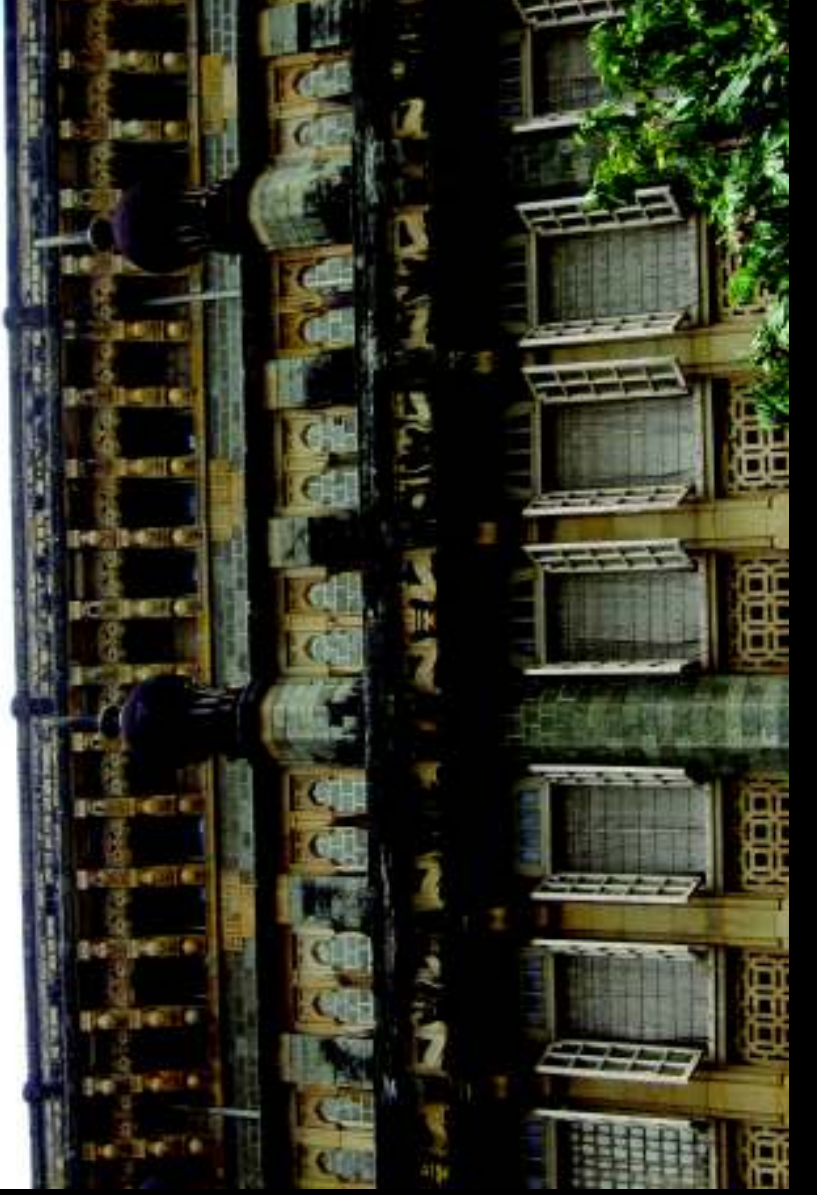
Right Above: Photograph showing the front façade of the museum that is prone to sulphate encrustations, soiling and flaking

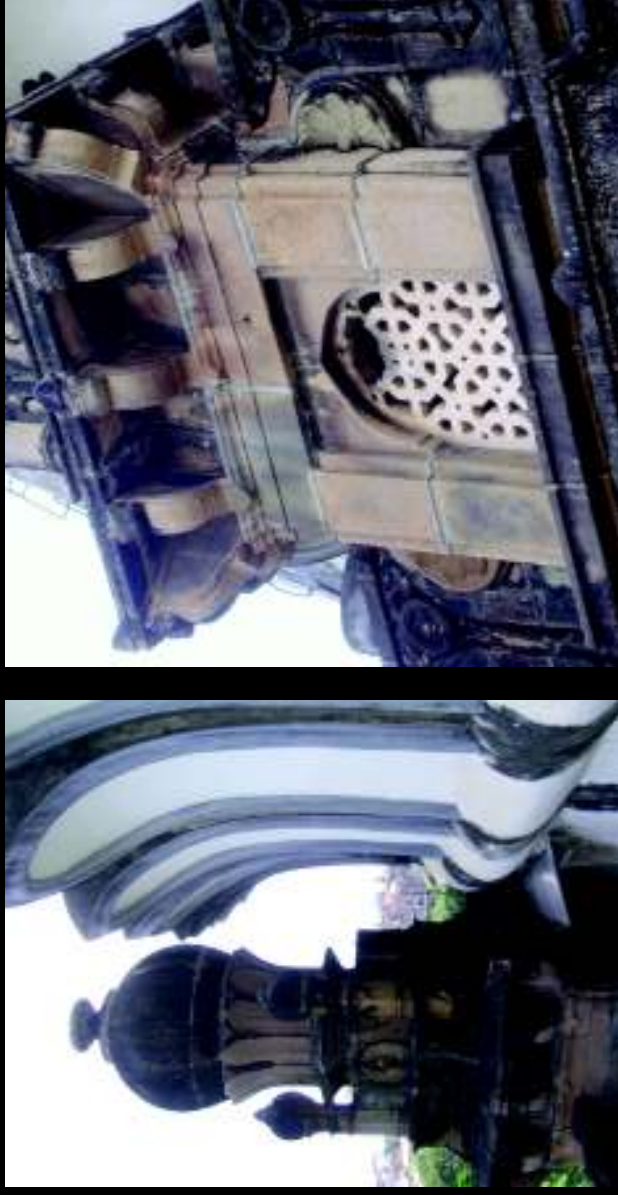
Right Below: Photographs showing a missing stone finial of a roof level *guldasta* in stone and the broken detail of the *jaali*

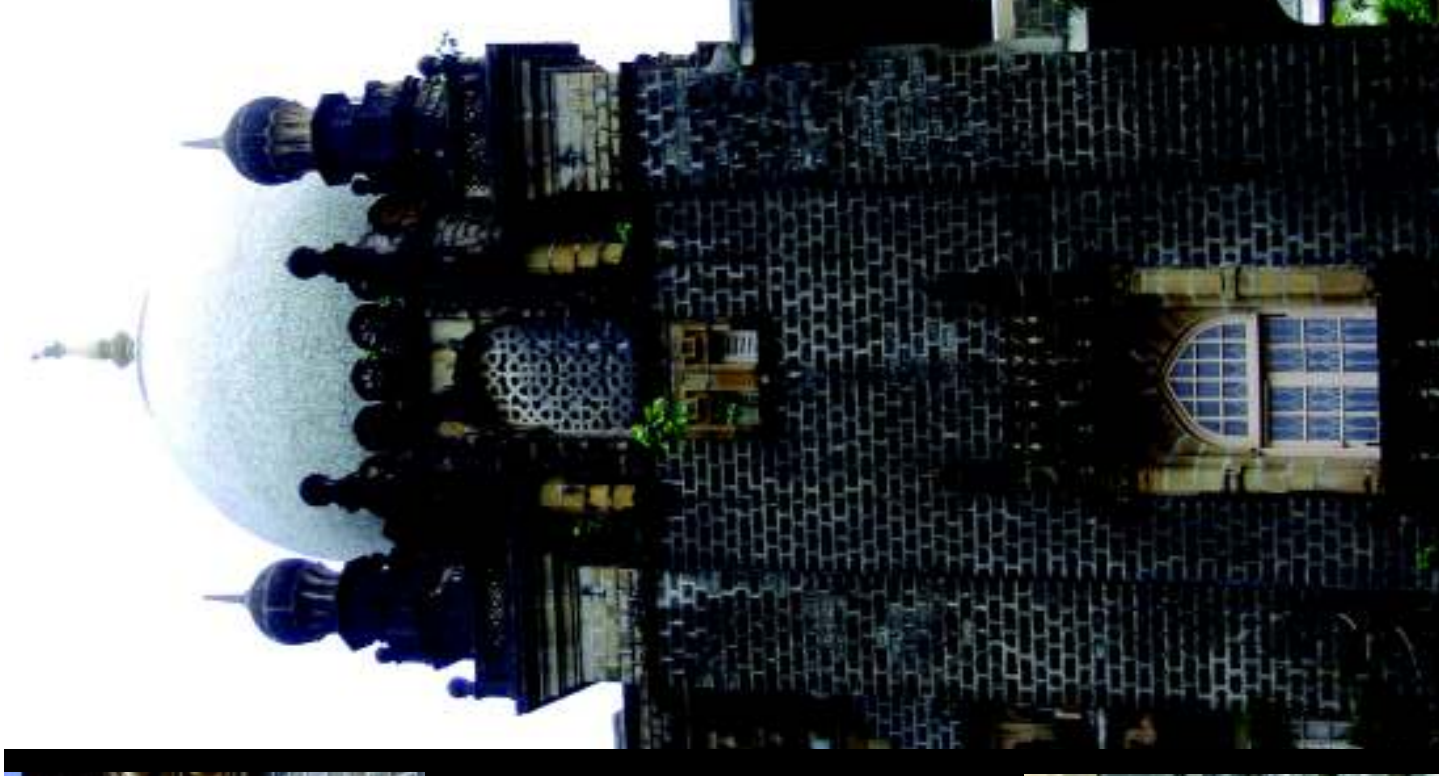
Top to Bottom: Photographs showing hard ribbon pointing in cement, partially removed hard ribbon pointing to expose the finer joints and plinth level masonry with deteriorated pointing that needs to be repointed in lime mortar.

Far Right: Ugly hard pointing that requires removal

The original stone joints were very fine joints and ensured the breathability of the masonry, allowing trapped moisture to evaporate. Hard pointing in cement introduced at a later stage in the building, in fact competed with the strength of the stone masonry. As a result, it caused the moisture to evaporate from the stone surface, stressing the stone masonry and causing deposition of salts and consequently stone delamination. Removal of Hard pointing and re doing the same in fine lime pointing.

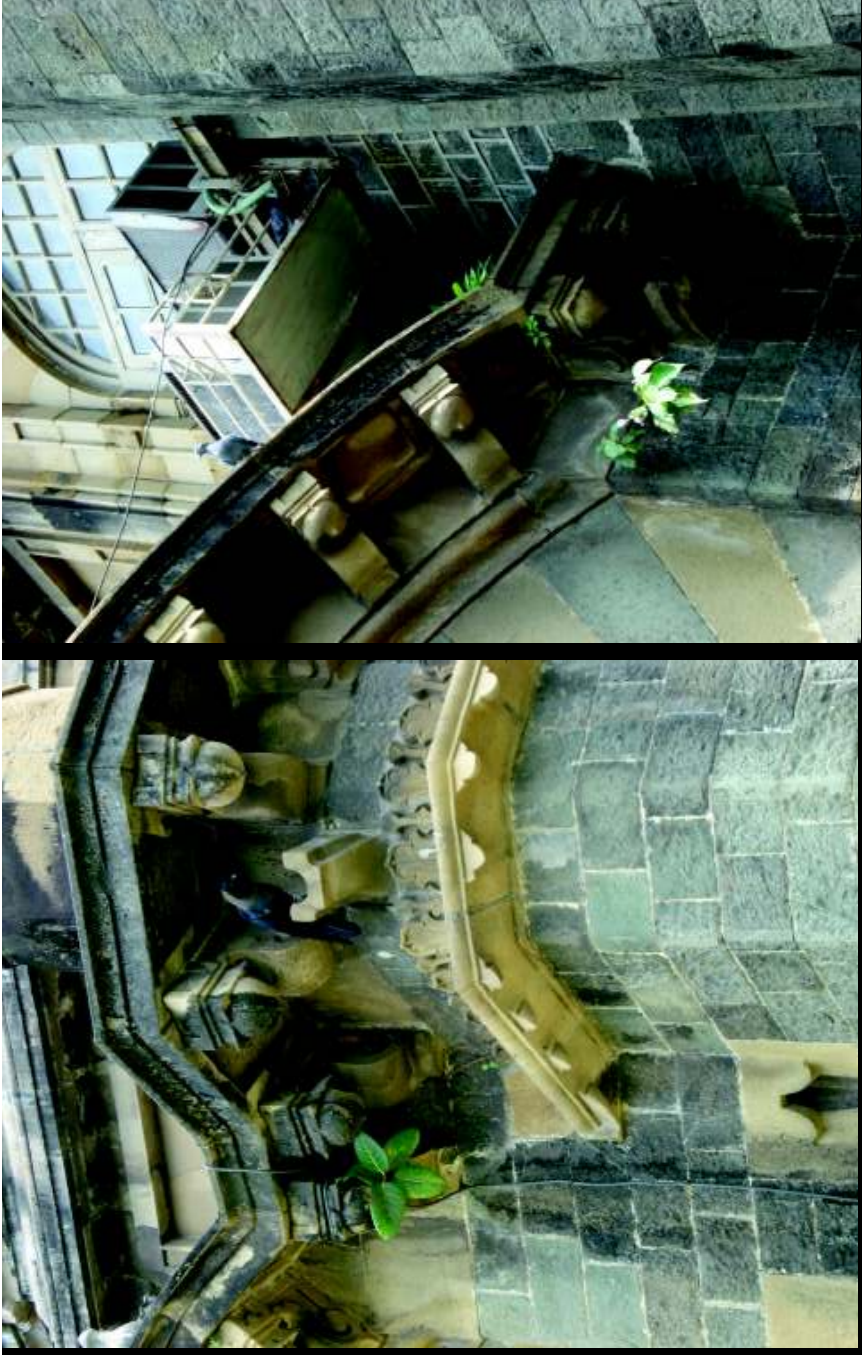
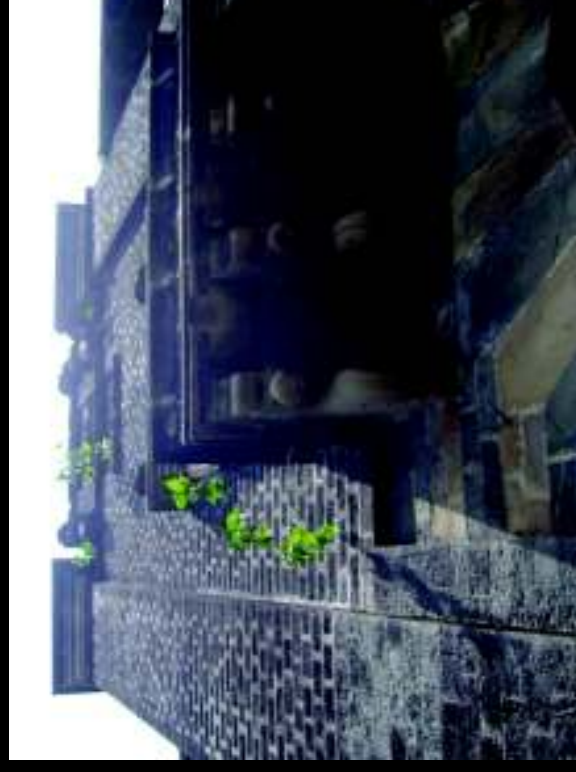
Especially prone areas were the higher reaches of turrets and minarets not easily accessible to regular maintenance and also areas of choked waterspouts that trap moisture and particulate matter, creating a thriving ground for biological growth.

The biological growth could lead to widening of stone cracks, develop stains and discolouration of stone masonry and damage the walls, thus they needed to be removed immediately.

Photographs showing Peepal plants growing out of masonry joints along sections of deteriorated pointing, specially where there is a source of water leakage close by as a result of choked drainage outlets, leaking rain water down takes or air conditioner units

Areas along rainwater down takes were prone to ficus growth as the constantly wet masonry harboured such plant growth. In the case of smaller ficus (peepal /banyan) plants growing out of the stone joints, the methodology adopted was that of pulling out the plant and using a syringe to inject the ammoniacal biocide into the root system. In case of larger plants, a length of the main stem was cut out at a convenient height above the stone surface. The plant was then sprayed over with biocides and the parent stem, after cutting was cut into a frill girdle, and coated with a paste made from Ammonium sulphamate crystals. This is a better system than using acids, but in cases of extremely stubborn growth, when the above measures are not effective, and the masonry is not a soft limestone, only then can the option of injecting acid be adopted, and that too after ensuring that no surface overflowing of the solution takes place.

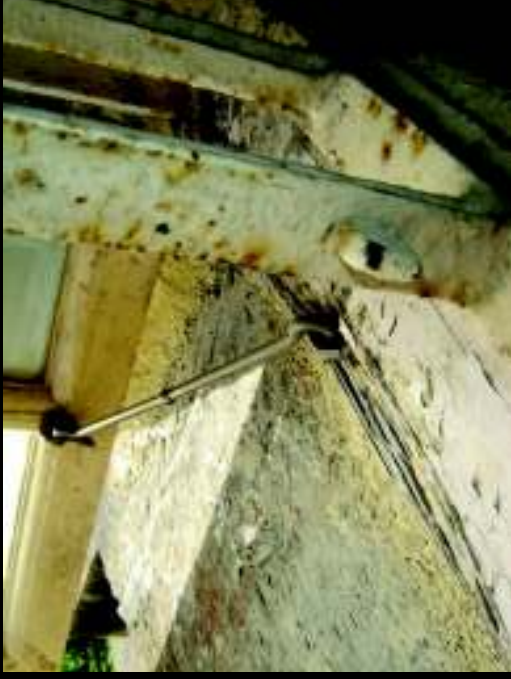
Photograph showing the Deterioration of the window frames  
Right: Photograph showing a window air conditioner unit mounted on the sill  
Below: Photograph showing the original window design with a glass fanlight and glazed shutters.

The window restoration work included making of new shutters and frames where they were damaged beyond reasonable repair, restoration of window shutters and frames where they were damaged to a lesser extent and for those windows which were sound, only scraping of old paint layers and repainting.

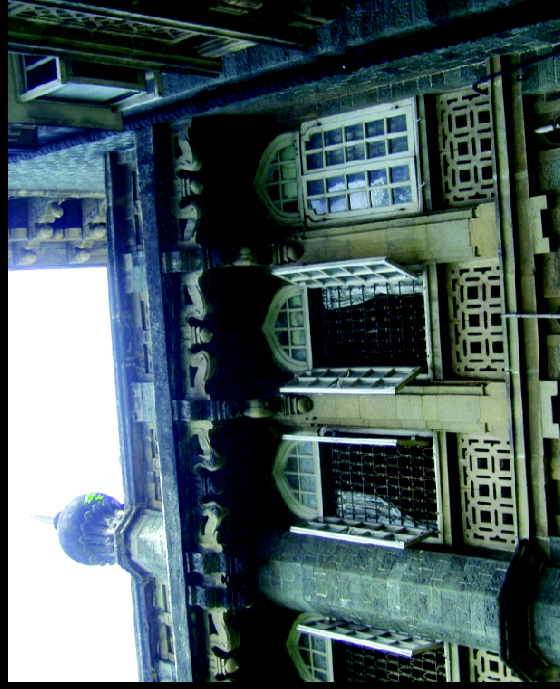
- Hampered the visual integrity
- Leakage from these units led to dampness and microbiological growth
- Altered the original look of the design and detail of the building.

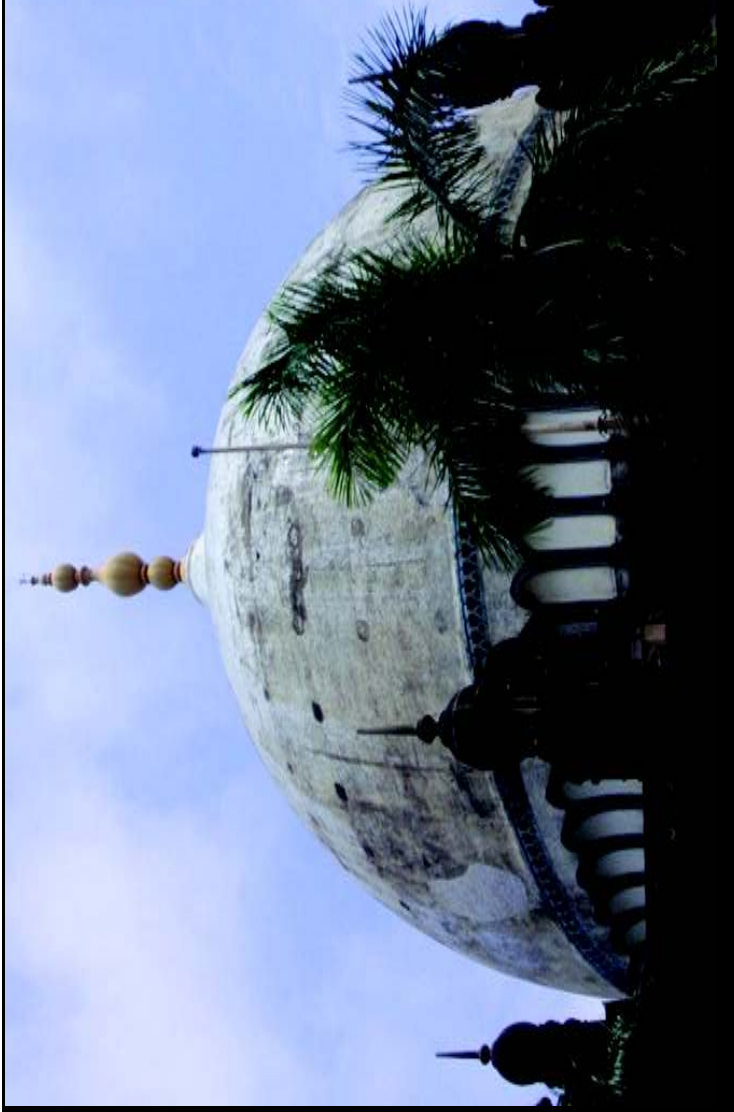
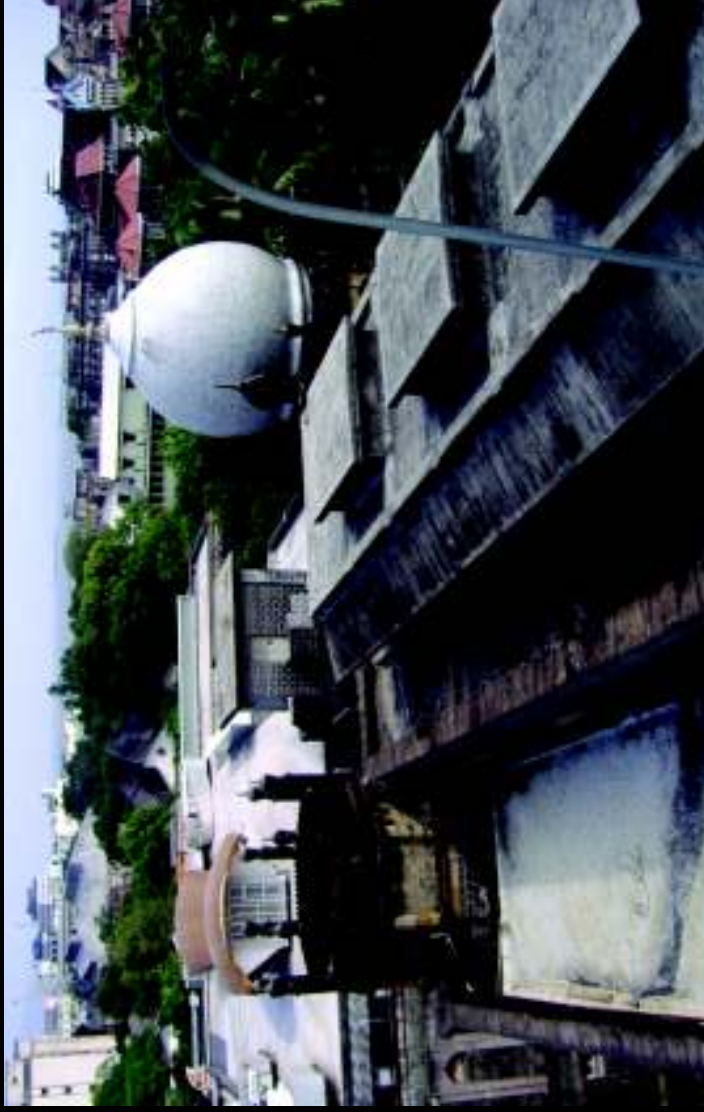
Left and Right Above: Photographs showing the domes surfaces that indicate past grouts as well as patchwork plastering over the surface. Any exercise to undertake major roof repair of the domes should be preceded by thorough non destructive testing and structural investigations.

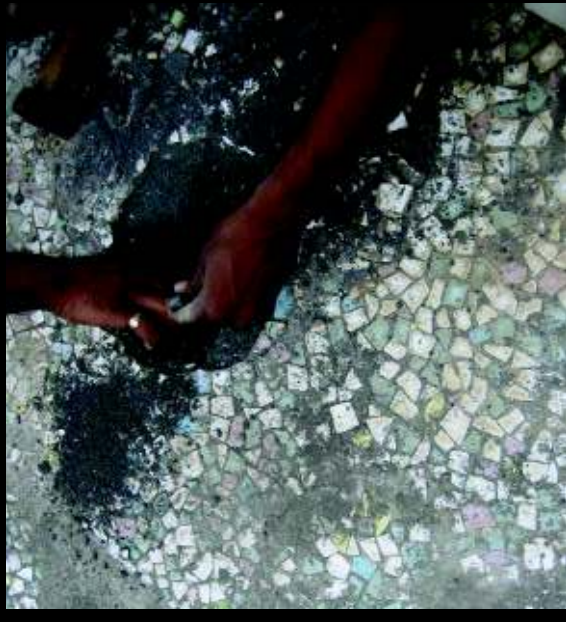
The Consultants have inspected sections of the terrace waterproofing that had been cracked and after opening out sections of hollow and cracked terrace waterproofing the team jointly decided that redoing the China Mosaic waterproofing would be a more effective treatment for addressing the waterproofing as the underlying layer of screed was very friable and had an extremely low cement content.
