RESTORATION OF DAVID SASSOON LIBRARY AND READING ROOM 2005 - 2006

RESTORATION OF DAVID SASSOON LIBRARY AND READING ROOM
Consultants: BOMBAY COLLABORATIVE URBAN DESIGN AND CONSERVATION PVT. LTD.

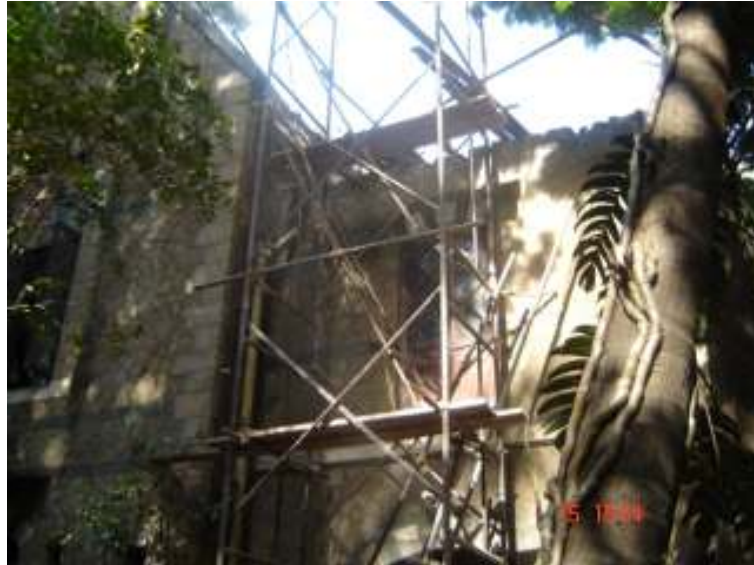
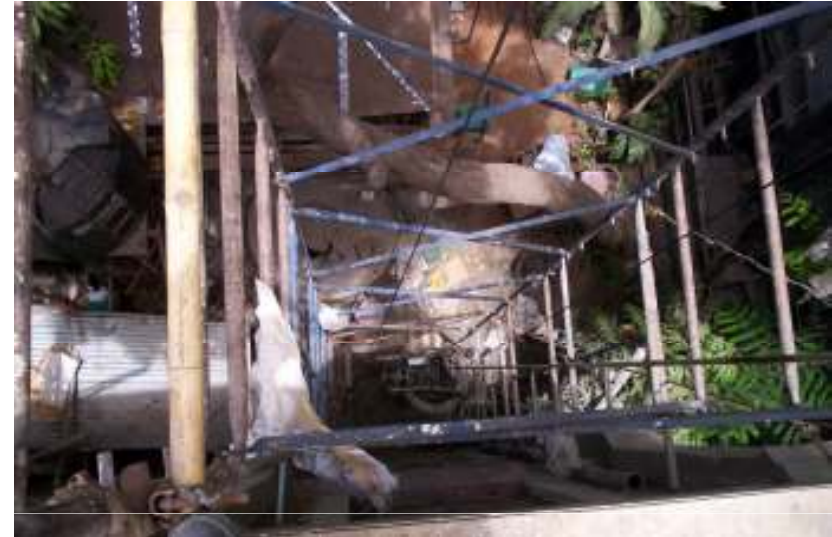
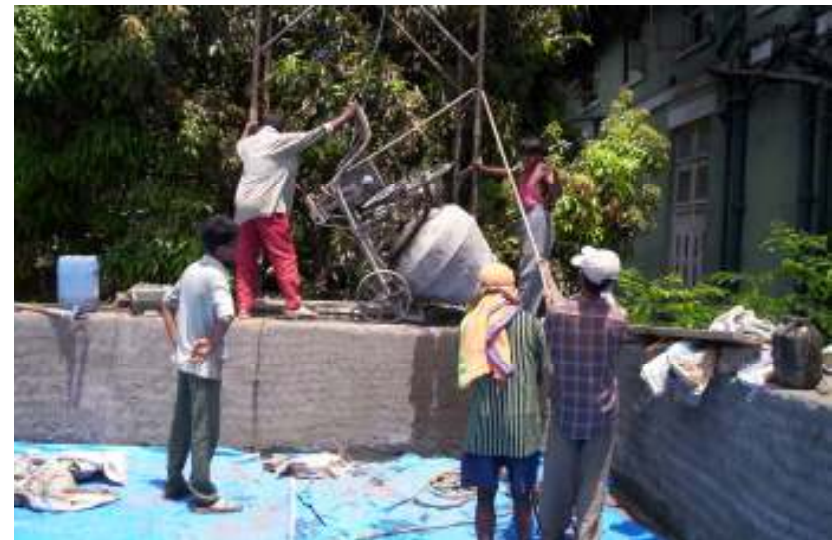
1.1 Enabling Works

The enabling works include erecting scaffolding on the external of the facades and all around the clock tower for roof repair works and façade restoration works. It also includes erecting scaffolding on the interior of the staircase lobby and administration room to facilitate work for the roof repair of the respective areas.

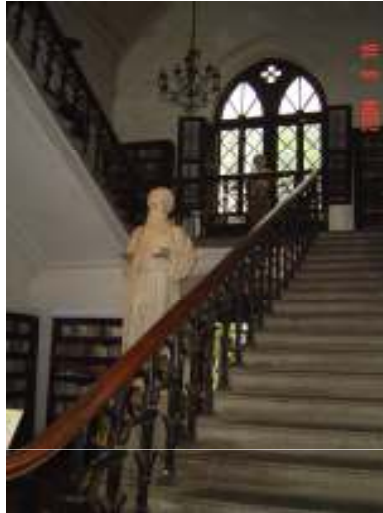
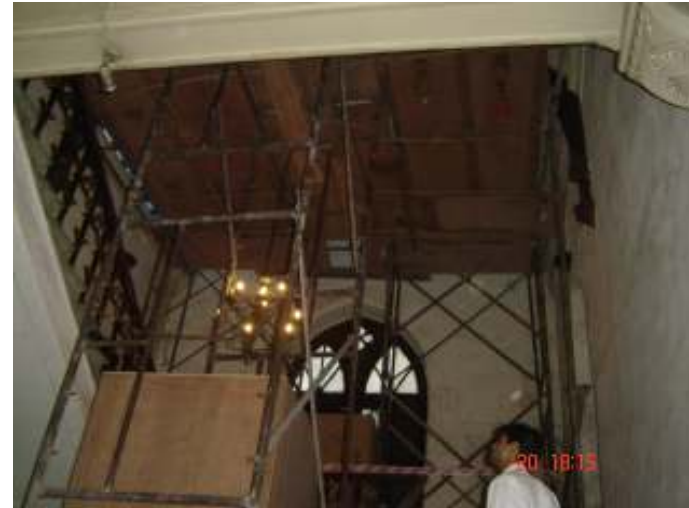
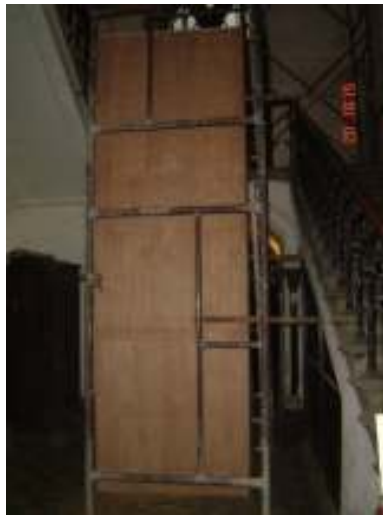
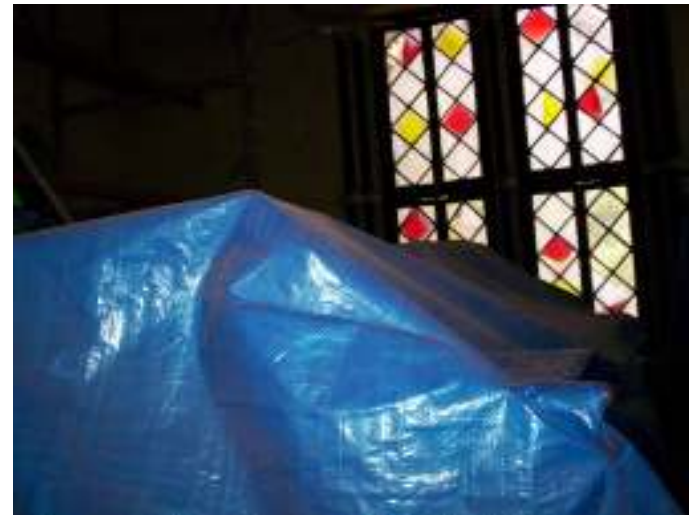
1.2 Protection Works

Protection works for the statue of David Sassoon and one at the mid-landing level

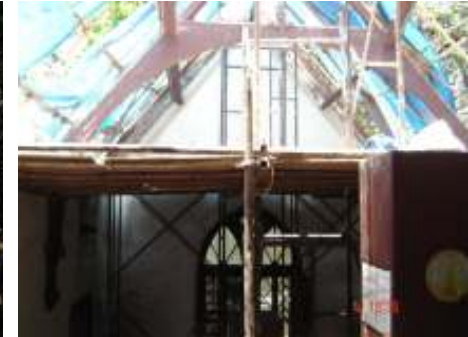
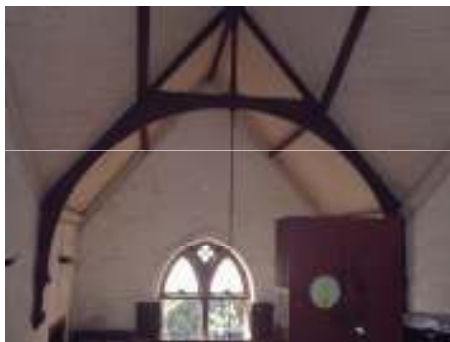
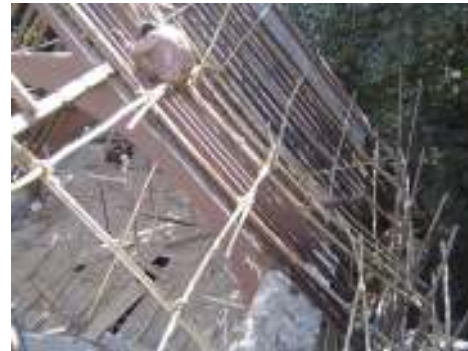
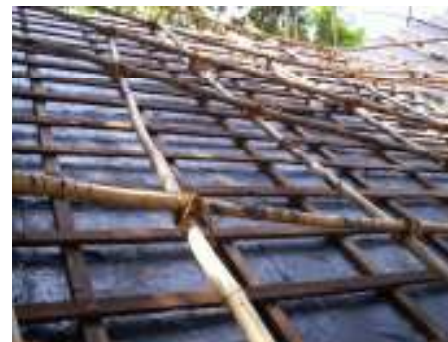
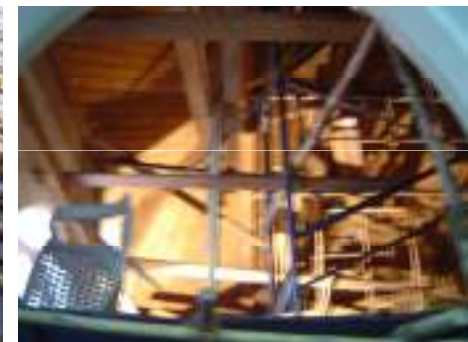
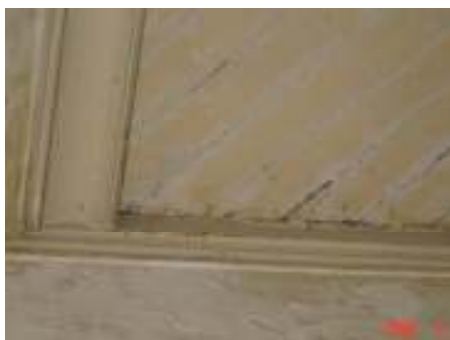
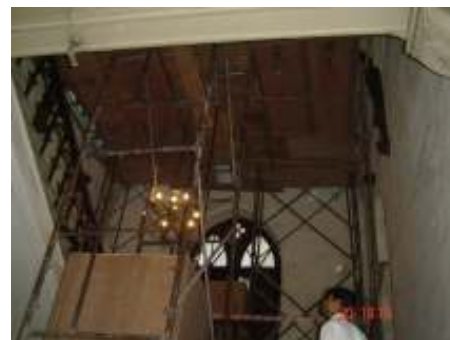
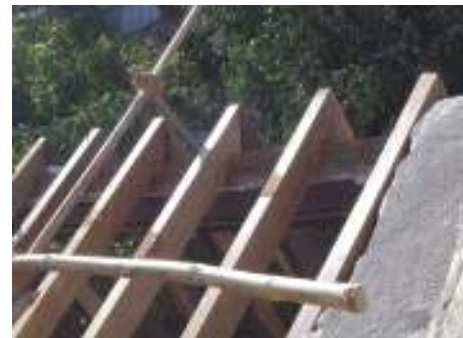
Staircase Roof

Initially it was decided to open up only 25% of the entire roof, as the ends showed deterioration and damp condition. The assumption of deterioration before opening up the 25% was 50% of all rafters, 50% of all battens, 50% of all wall plates, 50% of boarding, purlins and ridge rafters.

After opening up, as there was extensive termite infestation and the entire roof had to be opened to check on extent of repair.

The junctions at the parapet wall were largely the source of water leakage. Additionally, the wood boarding of the angular pitch was badly warped and had resulted in a sagging of the roof. This required extensive replacement of the old wooden boarding with new wooden members.

The boarding is made in 19mm Marine Ply

Repair to Rafters in Old BTC

Replacement of Rafters done in old BTC

Battens completely replaced in Malaysian Salwood

Ridge Rafter replaced in Old BTC

False Ceiling on the underside of the roof repaired and replaced in old BTC

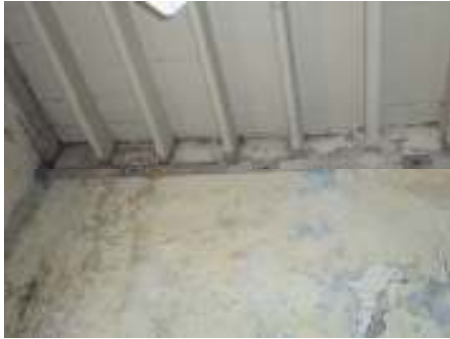
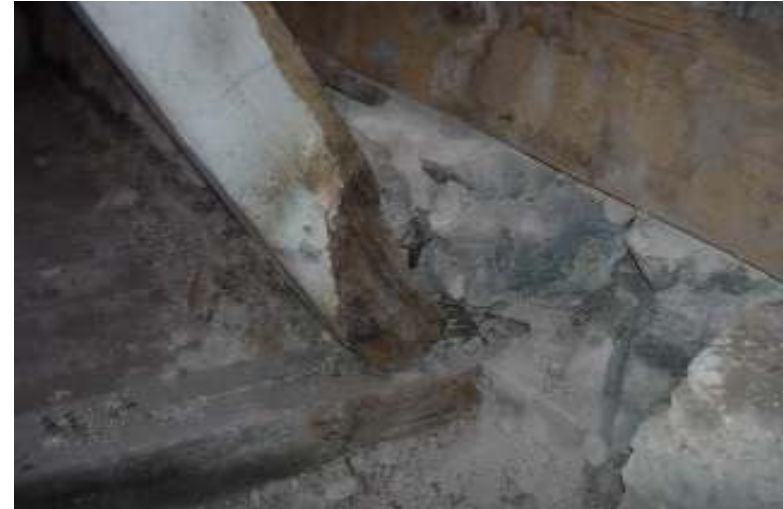
Deteriorated end condition of timber truss

The truss member was in an extremely deteriorated condition. Hence it was decided to strengthen the main truss members by supporting it with U-steel plates and brackets at the ends. Also, the flat roof jack arched needed attention.

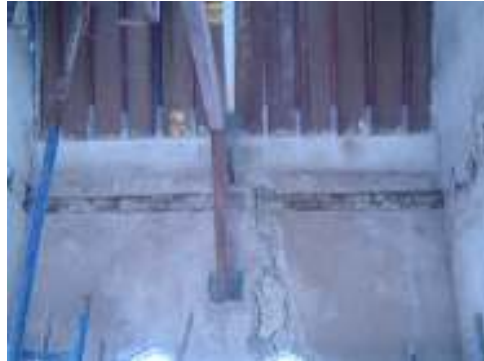
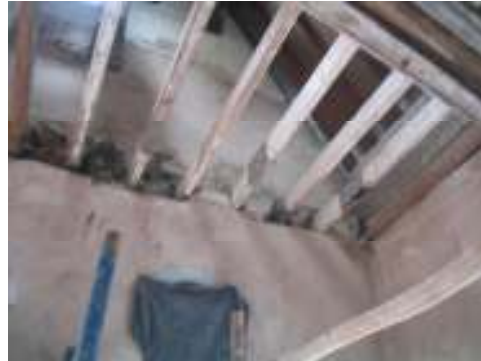
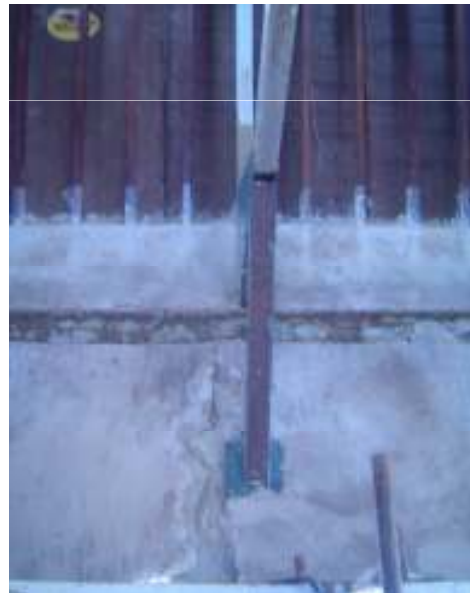
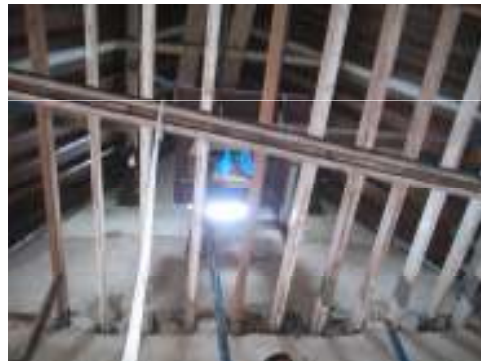
Clock Tower Structural Repair work

The truss member was in an extremely deteriorated condition. Hence it was decided to strengthen the main truss members by supporting it with U-steel plates and brackets at the ends.

Alternate ends of the timber joists were replaced and joint with 150 x 175 x 6 thick plates on both sides and at bottom.

The tie - truss also required strengthening. New timber member and S.S. plate was introduced and firmly anchor fastened to the wall.

Repair to ends of timber joists.

Strengthening of the truss member

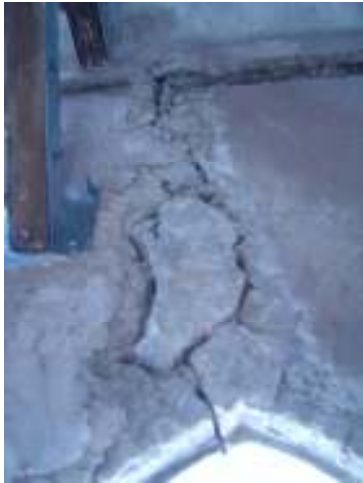
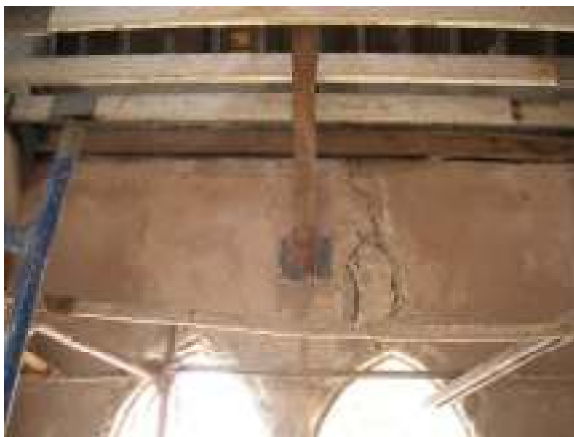
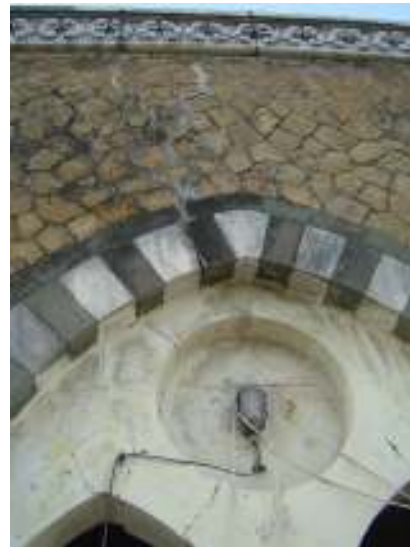
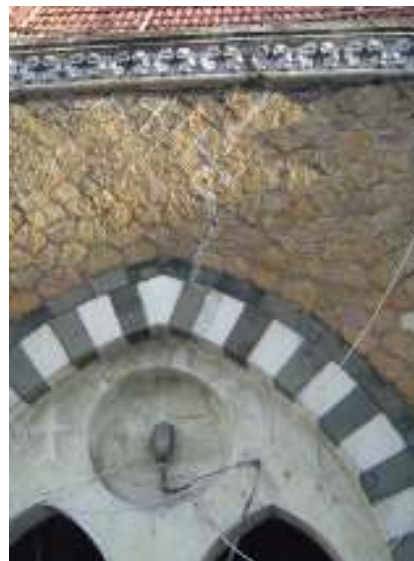
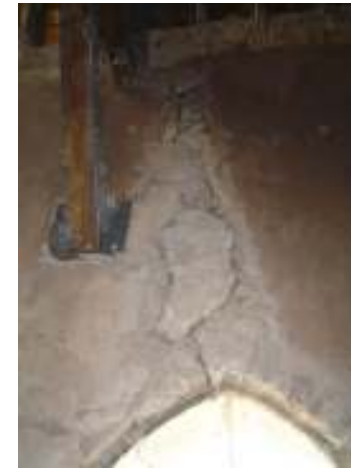
Large cracks running from the arched doors up to the ceiling were stitched in an unobtrusive manner using non - corrosive pins.

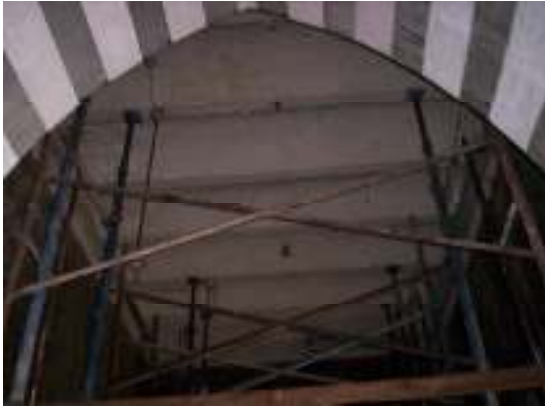
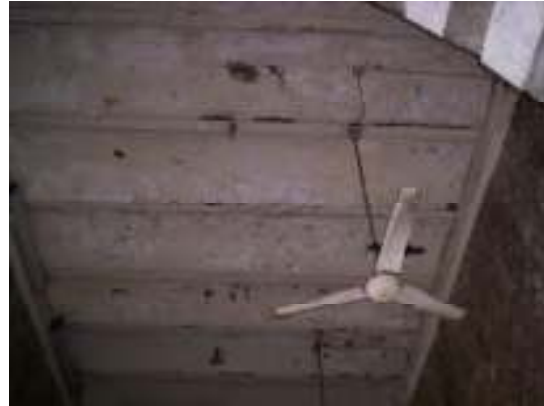
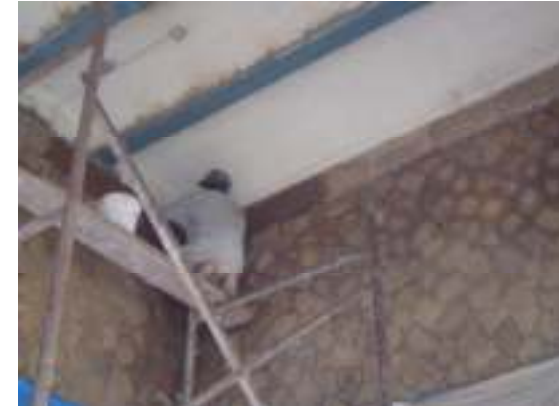
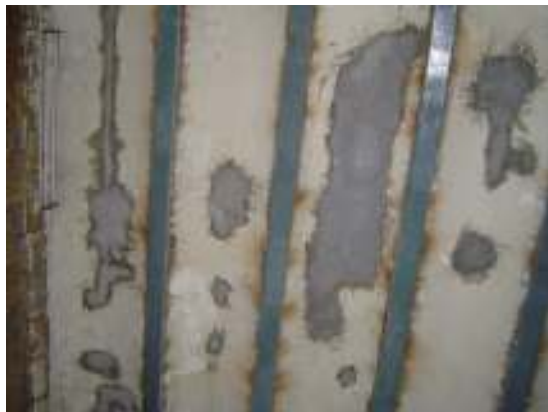
Repair of Jack Arch below flat terrace – First Floor Verandah

The terrace surface has cracked with evidence of water seepage on the ceiling below - within the reading room and veranda. Hence it was necessary to repair the bitumen layer and re-lay a waterproofing membrane. Due to shortage of space, the terrace is used actively for the library activities and functions. Hence tiling it with appropriate tiles will help in the long run.

When the waterproofing of the flat terrace was dismantled, structural cracks were visible in the slab, which was then attended to, and measures were taken to stitch the cracks. The work is complete with laying of texa

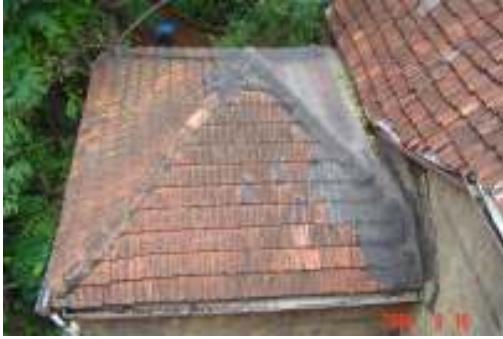
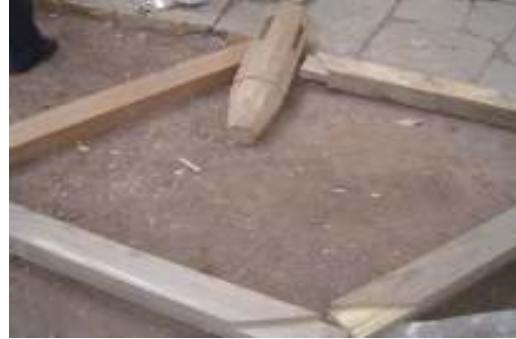
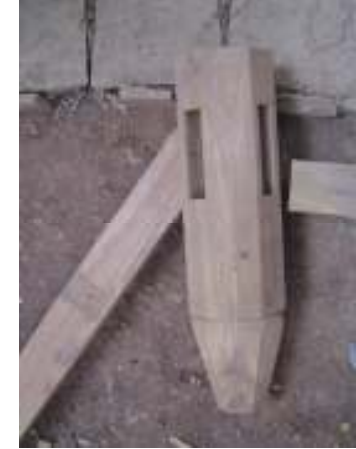
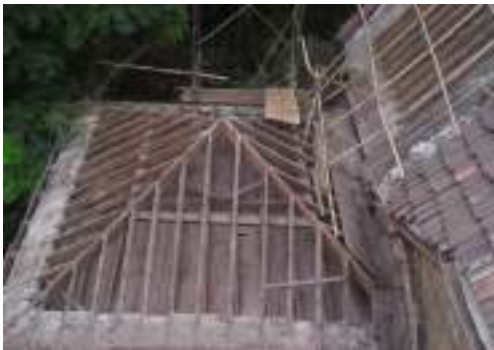
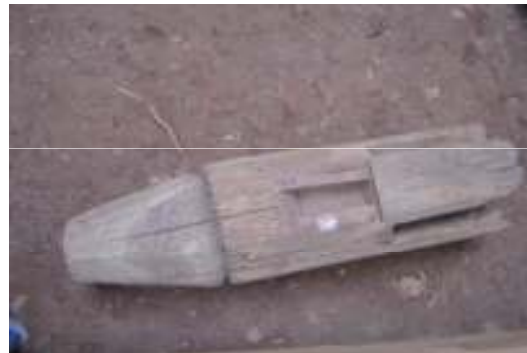
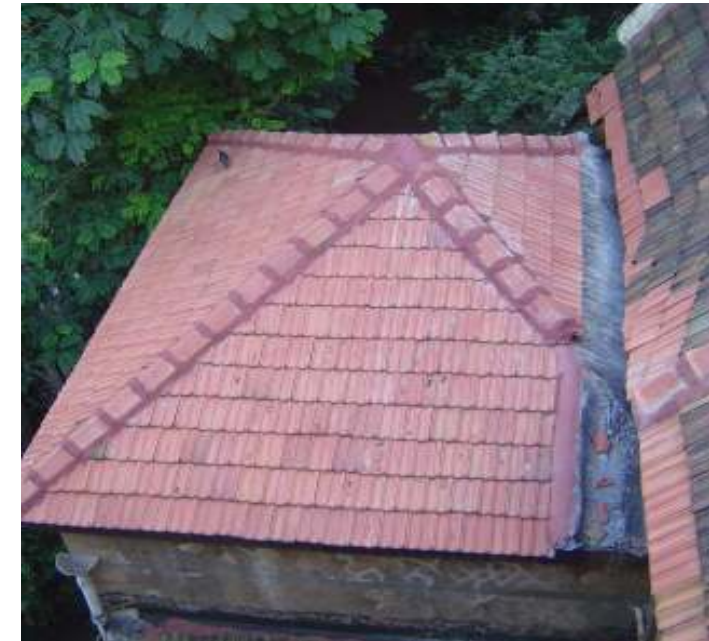
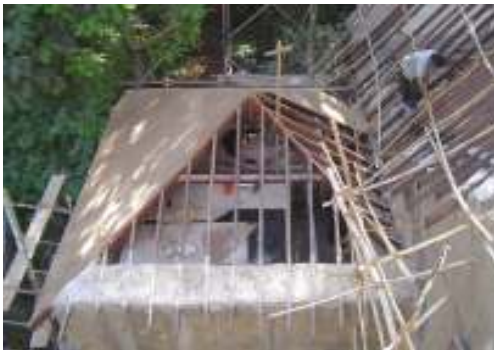
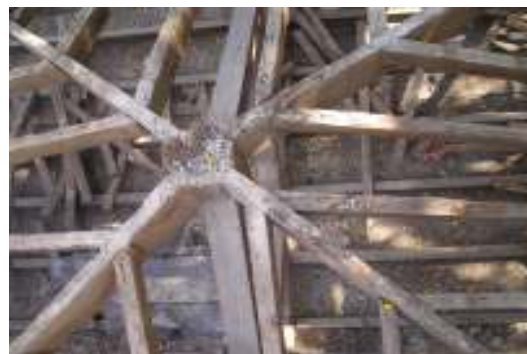
Committee Room Roof

The work in the committee room mainly comprised of replacing all deteriorated wooden members.

All Boarding made in 19mm Marine Ply

False Ceiling made in Malaysian Sal Wood

Floor boards and joists replaced in Malaysian Sal Wood

Repairs and Replacement of Rafters in Malaysian Sal Wood

Battens completely replaced in Malaysian Sal Wood

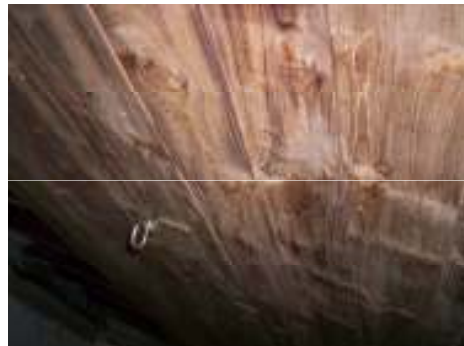
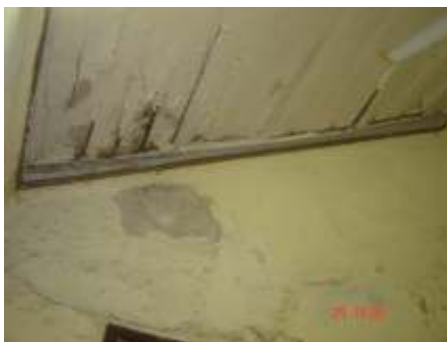
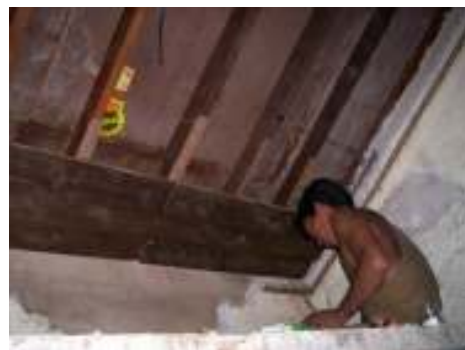
Secretary Room Roof

Assumptions for Deterioration: 100% of all Rafters, 100% of all Battens, 100% of all wall plates, 100% of boarding.

Boarding in 19mm Marine Ply

False Ceiling made in Malaysian Sal Wood

Repairs and Replacement of Rafters in Malaysian Sal Wood

Battens completely replaced in Malaysian Sal Wood

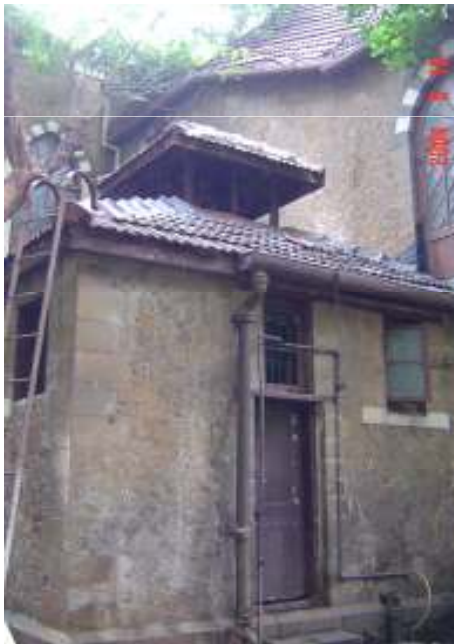
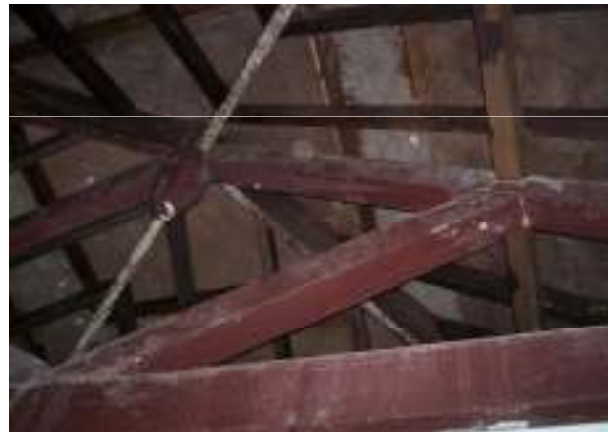
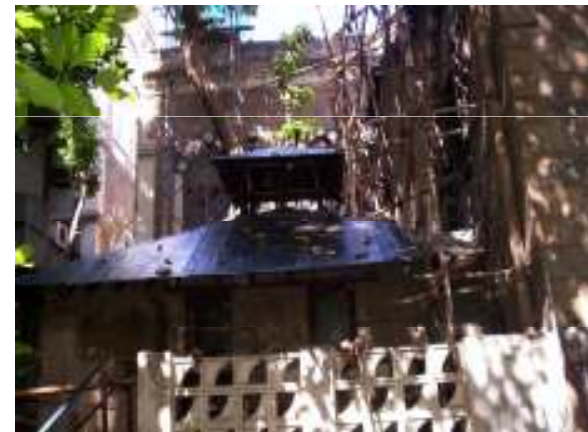
Toilet Roof

Assumptions of deterioration – 100% of all rafters, 100% of all battens, 100% of the Post.
Lower Roof: 50% of all Rafters, 50% of battens, 50% of wall plates, Ridge Rafter, Purlins.

Boarding made in 19mm Marine Ply

Repair to Rafters in old BTC

Replacement of Rafters in Malaysian Sal Wood

Battens completely replaced in Malaysian Sal Wood

Ridge Rafter replaced in Malaysian Sal Wood

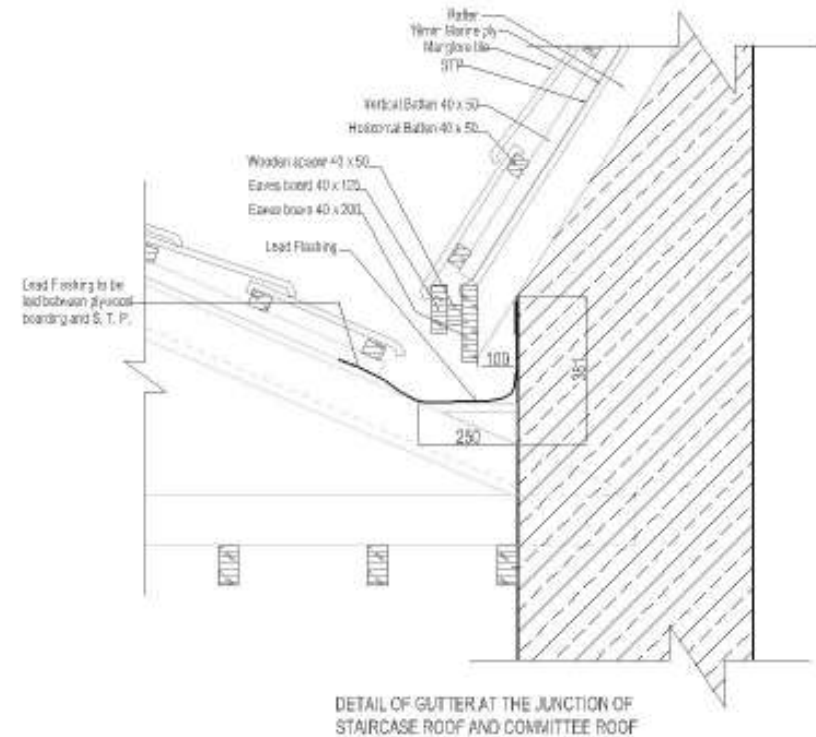
2.6 Plumbing Works

The gutters of the pitched roof had deteriorated completely. As the roofs are high, it is difficult to access the gutter to remove the dirt and leaves lodging at their junctions that cause water penetration through the walls. Additionally poor plumbing connections had also caused water leakage. Gutters needed to be removed and retained only wherever essential and where they can be accessed easily. Instead of gutters, roof overhangs need to be extended to allow the water to flow over without splashing on the wall.

The plumbing job is to replace all corroded pipes with PVC pipes along with removal of old gutters and providing with new GI gutters.

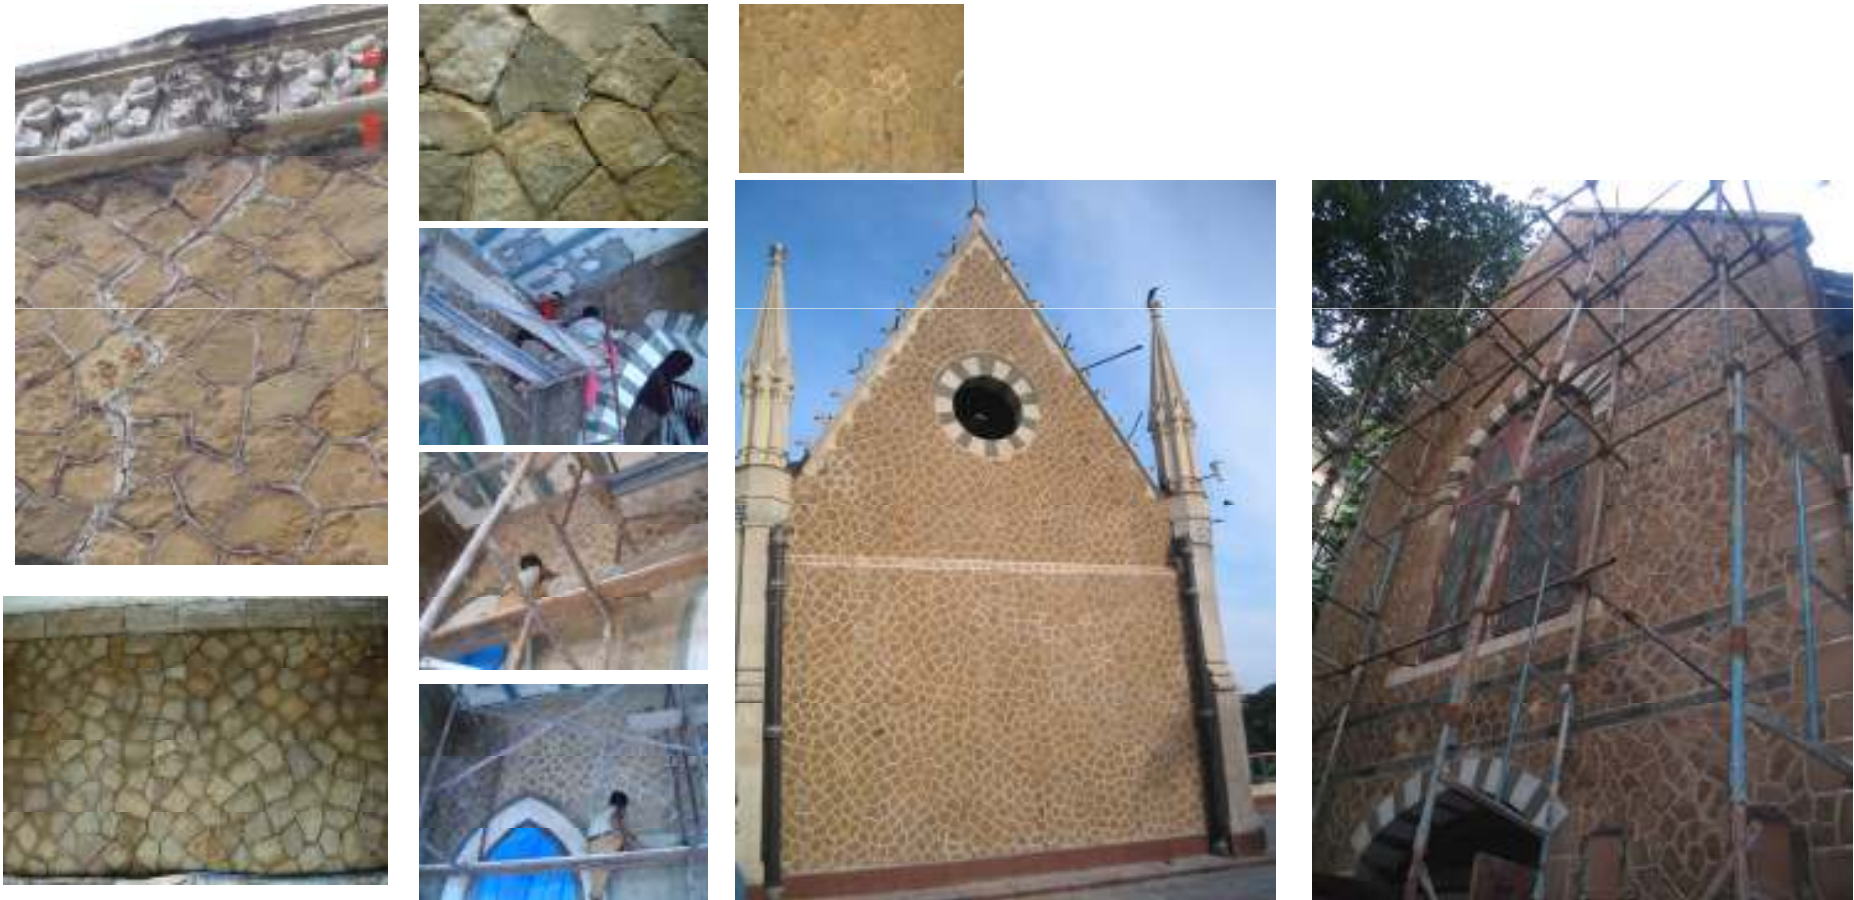
3.1(a) Re-pointing in Lime

The original lime mortar has been replaced with a hard cement or epoxy mortar. The hard pointing material's composition has resulted in stress on the stone and eventual cracking and spalling has been noticed in a number of places. The existing pointing was carefully removed and replaced with softer lime mortar. This was a specialised job but extremely essential to improve the longevity of the structure.

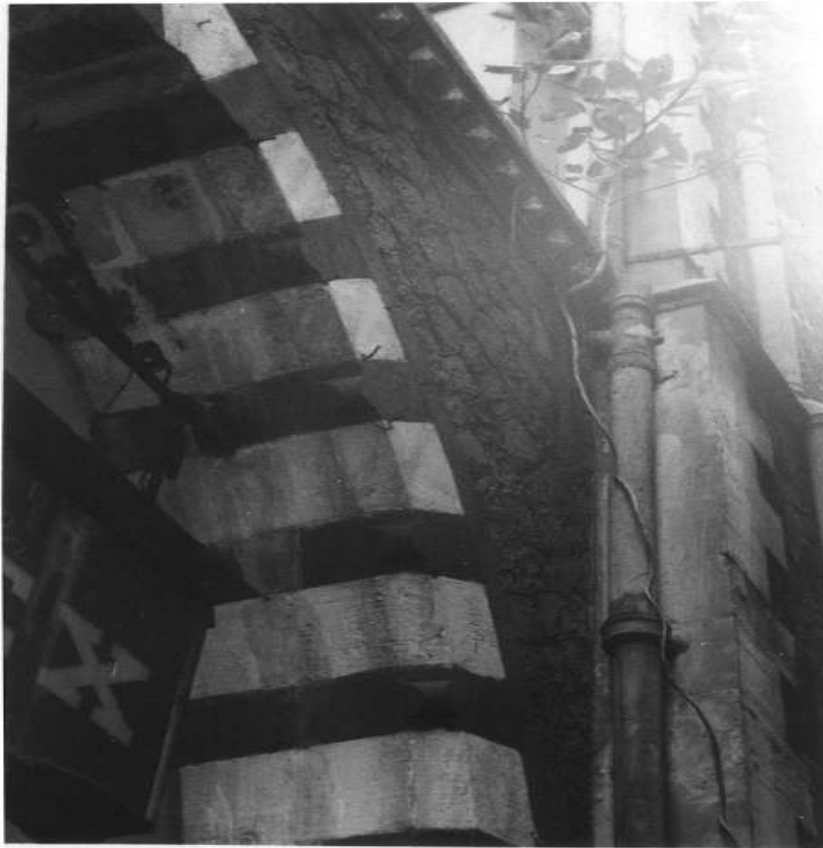
3.6 Restoration of Extended Cornice

The corner cornice stone on the NW side of the Reading room has dislodged and broken off. Also, at most of the corners the corner stones of the external cornice band, have open mortar joints indicating eventual dislodgement. To prevent breakage these need to be refitted with stitching.

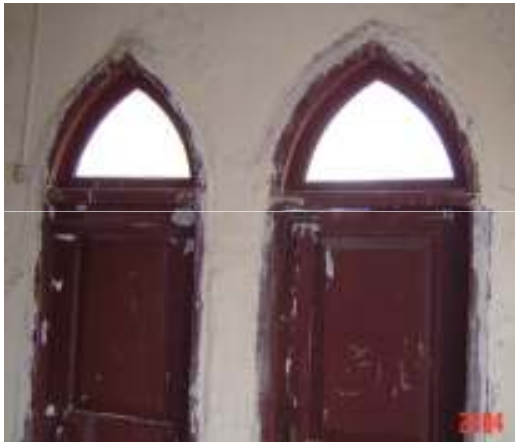
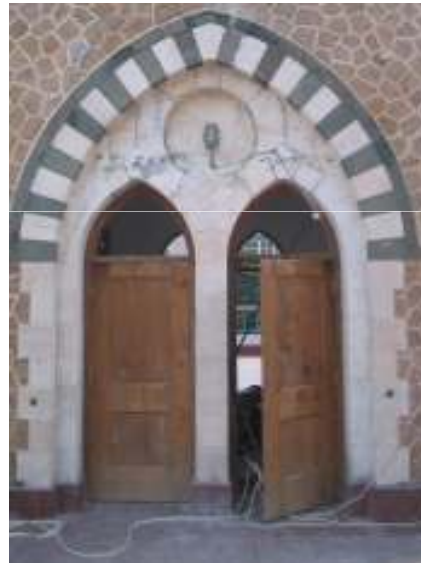
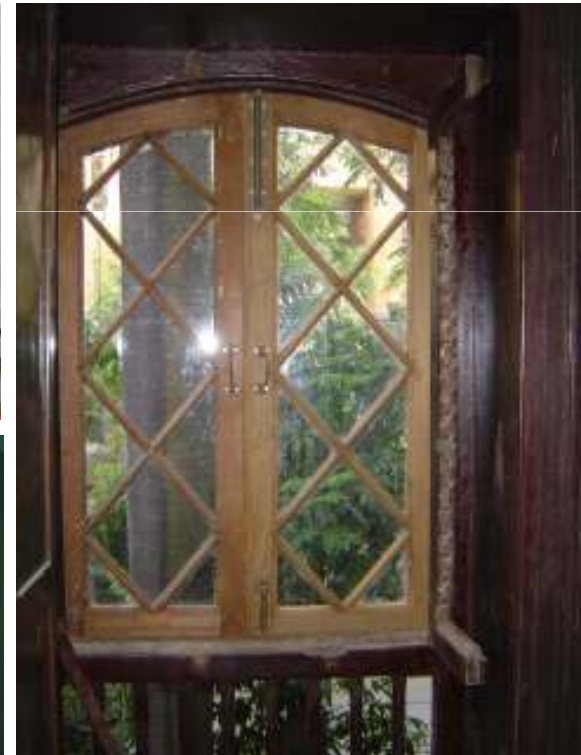
4.2 Making New Doors and Windows

The doors and windows are mostly original and have weathered over the years. Most of the frames are largely intact. However the woodwork of openings facing the west and south sides have deteriorated considerably due to the direct effect of the rains and needed to be replaced. Some windows require glazing replacement and refitting of the mullions. Additionally the beading which hold the mullions need to be replaced for practically all the windows. Along with all the wooden joinery, the hardware and hinges for all the windows needed to be refixed wherever essential.
