Mumbai University Convocation Hall

Scheme for Restoration

Abha Narain Lambah Associates – Conservation Architects & Historic Building Consultants

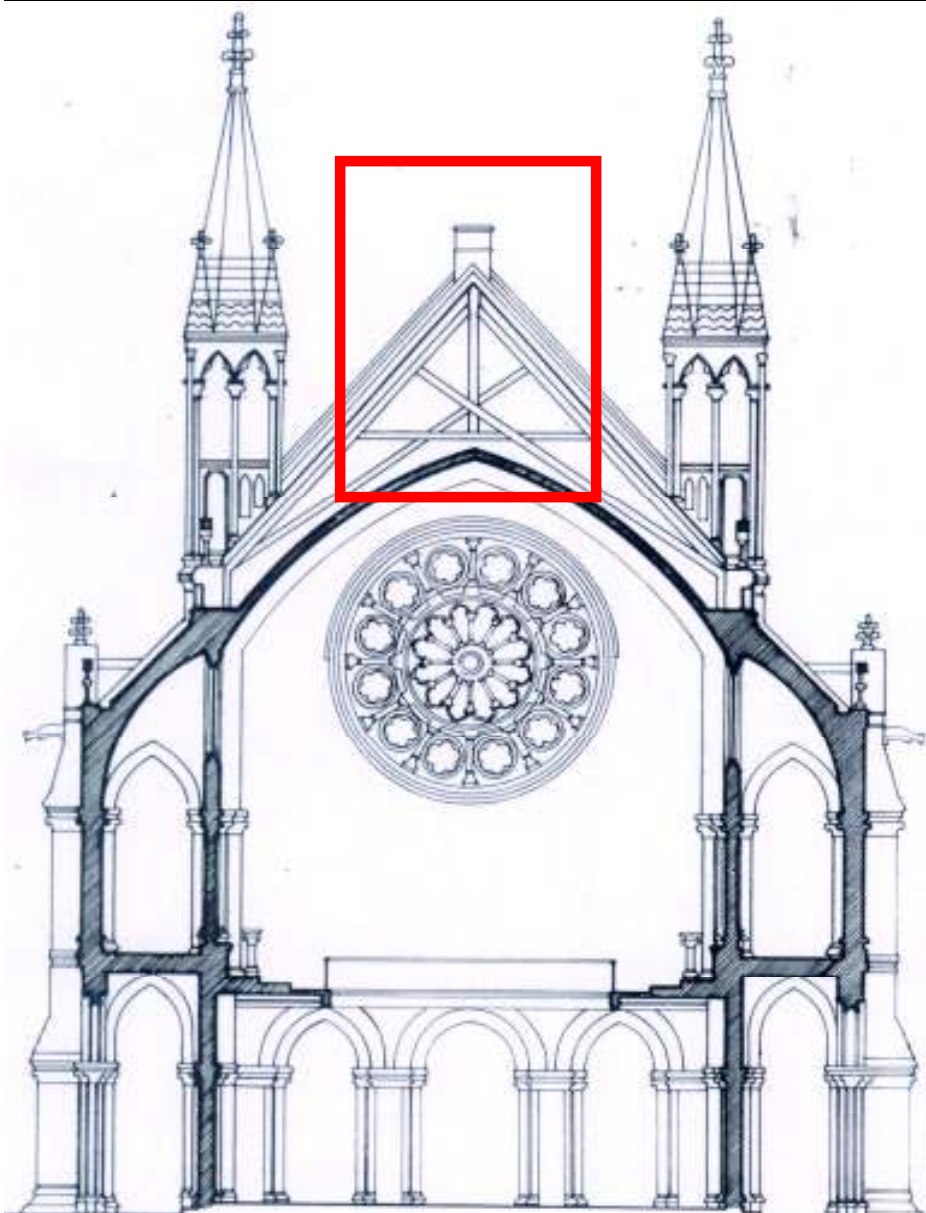
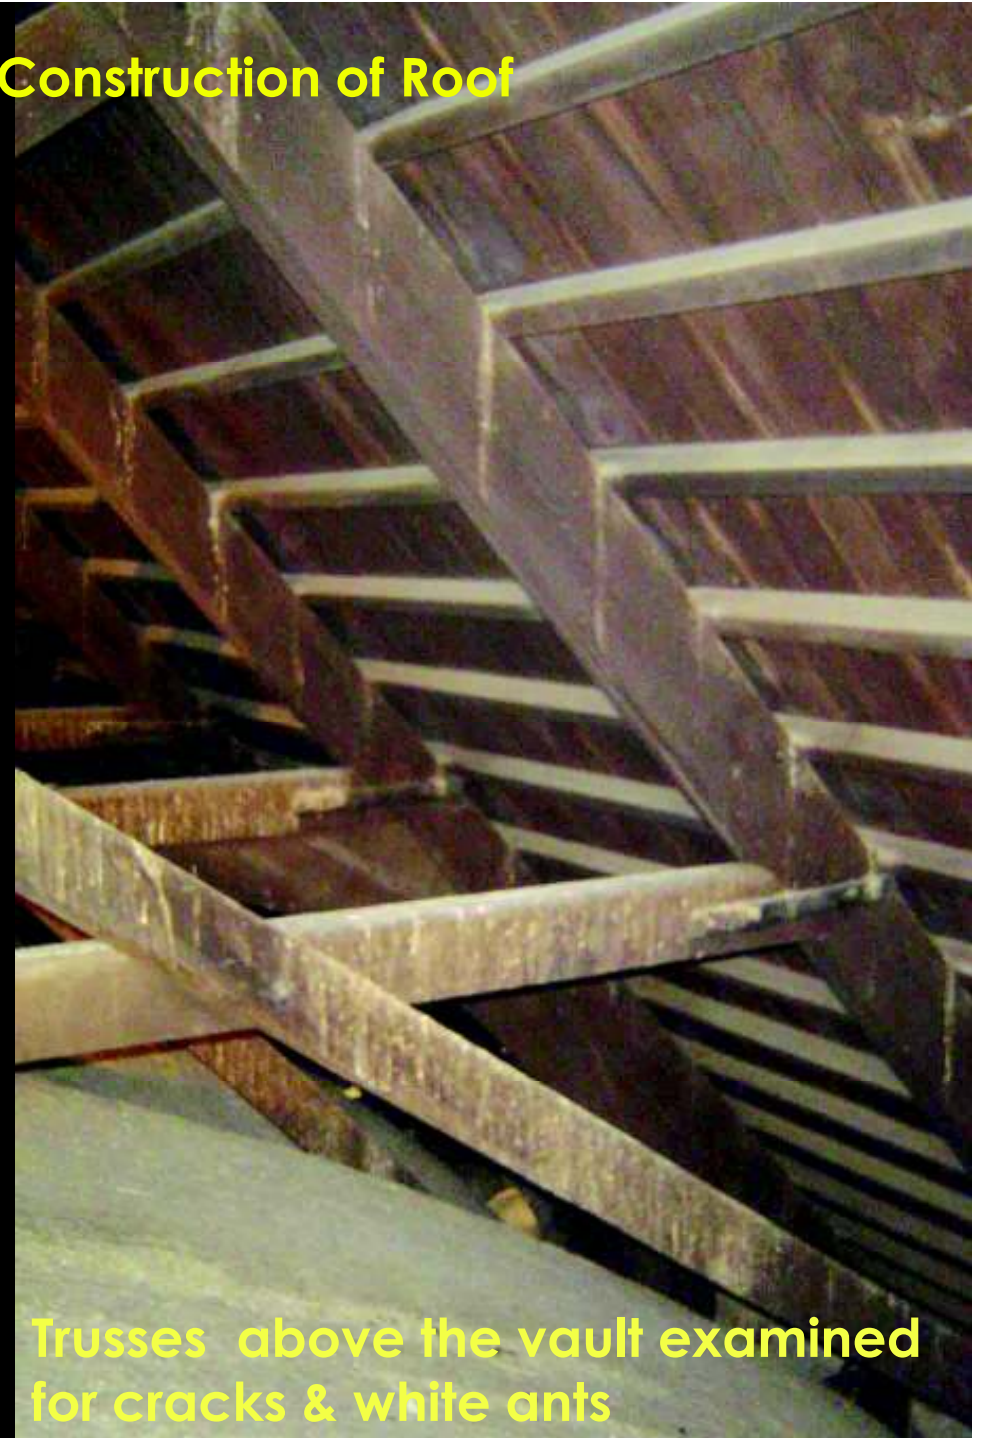
Trusses above the vault examined for cracks & white ants

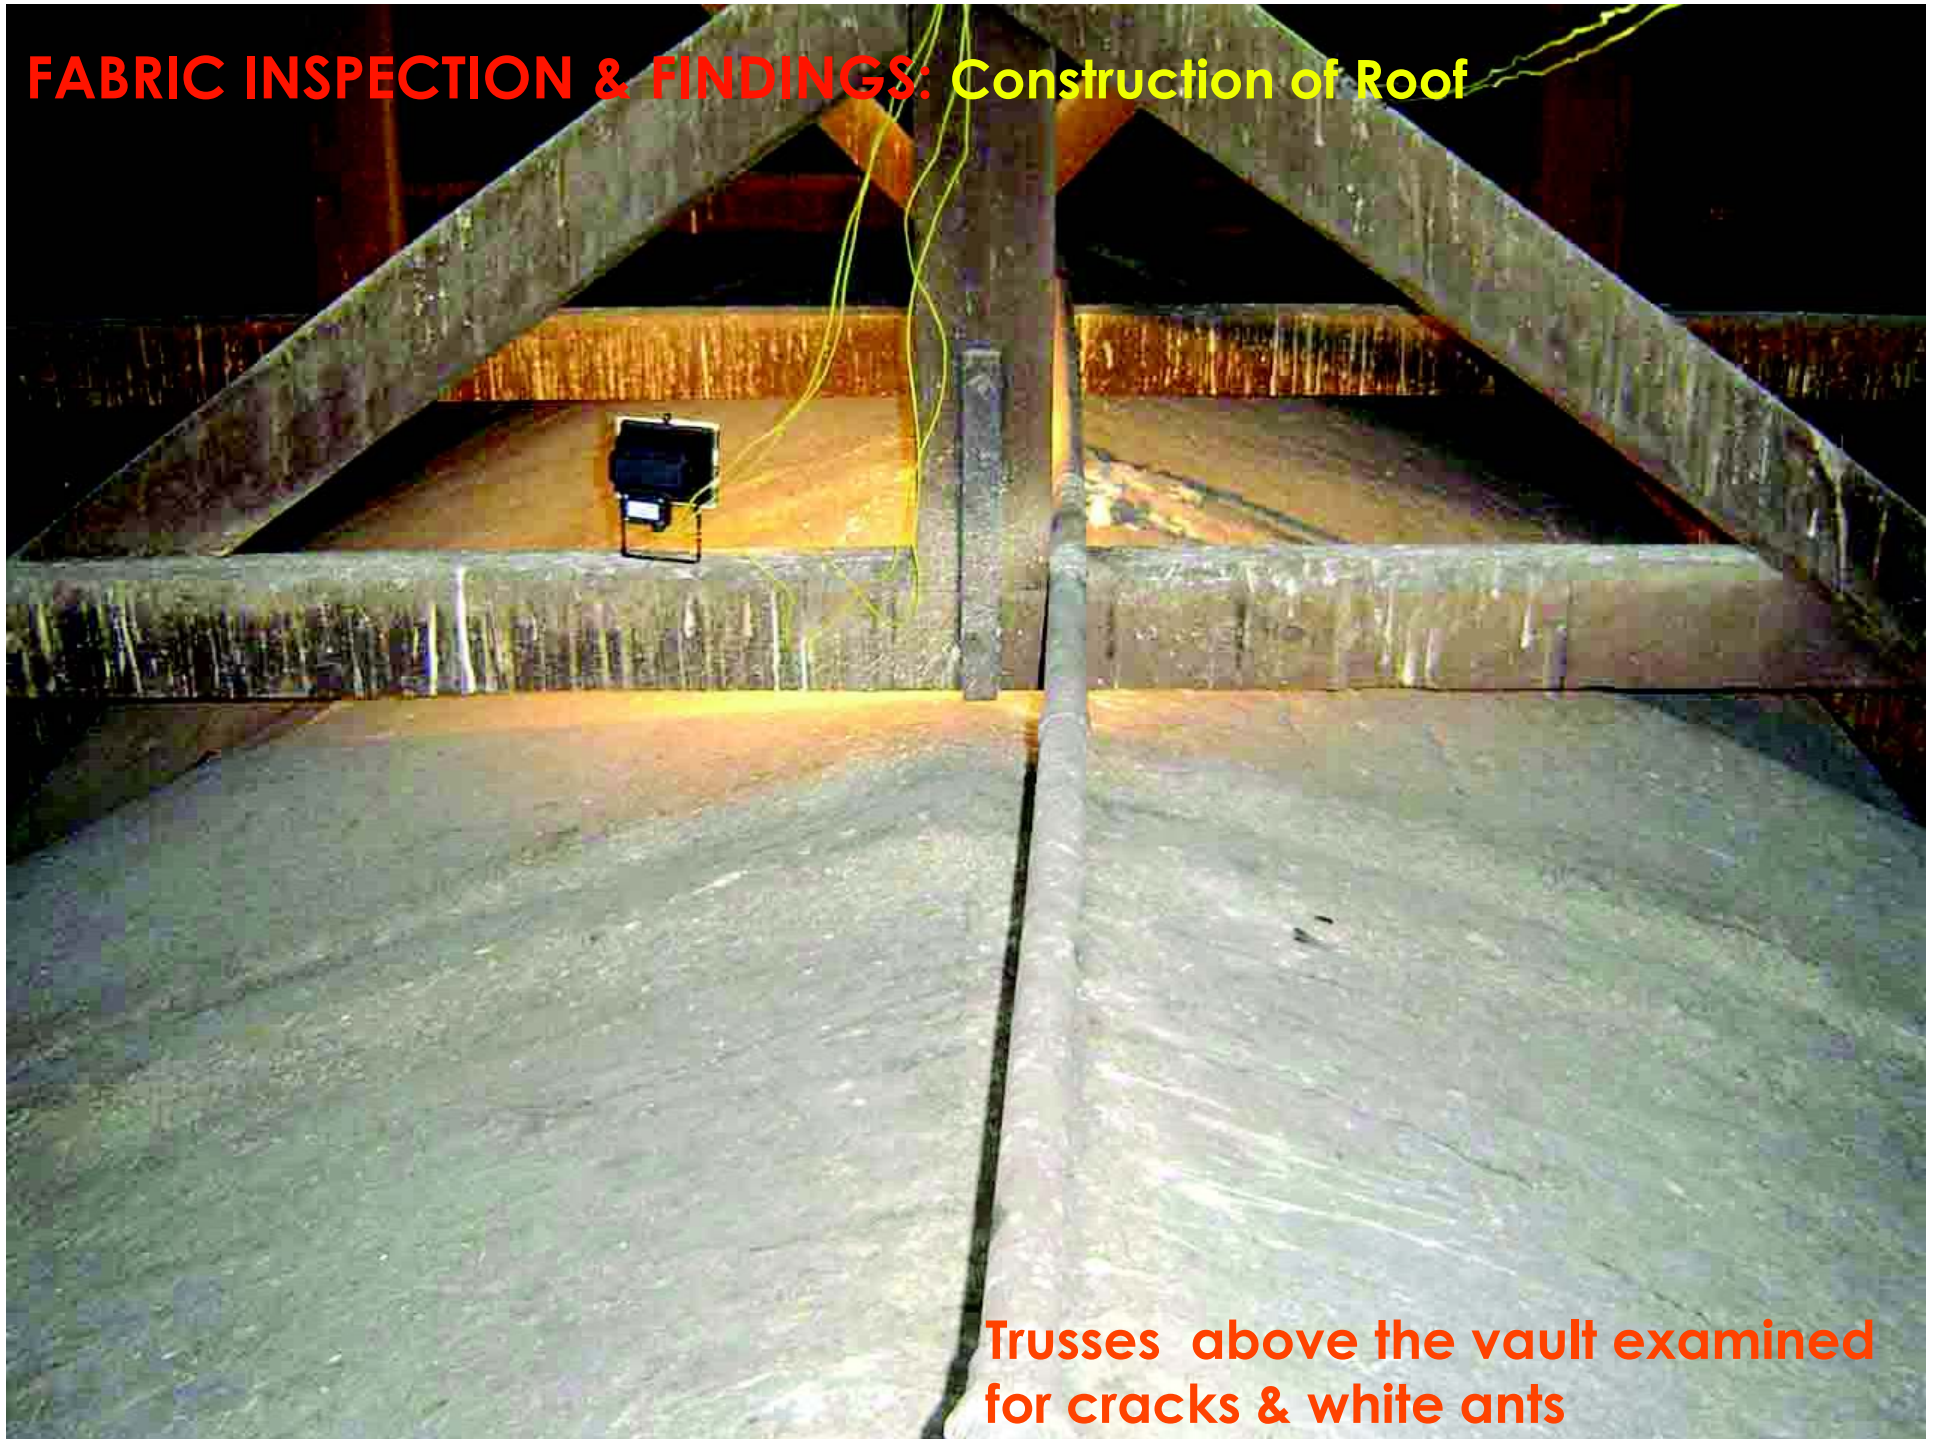
Trusses above the vault examined for cracks & white ants

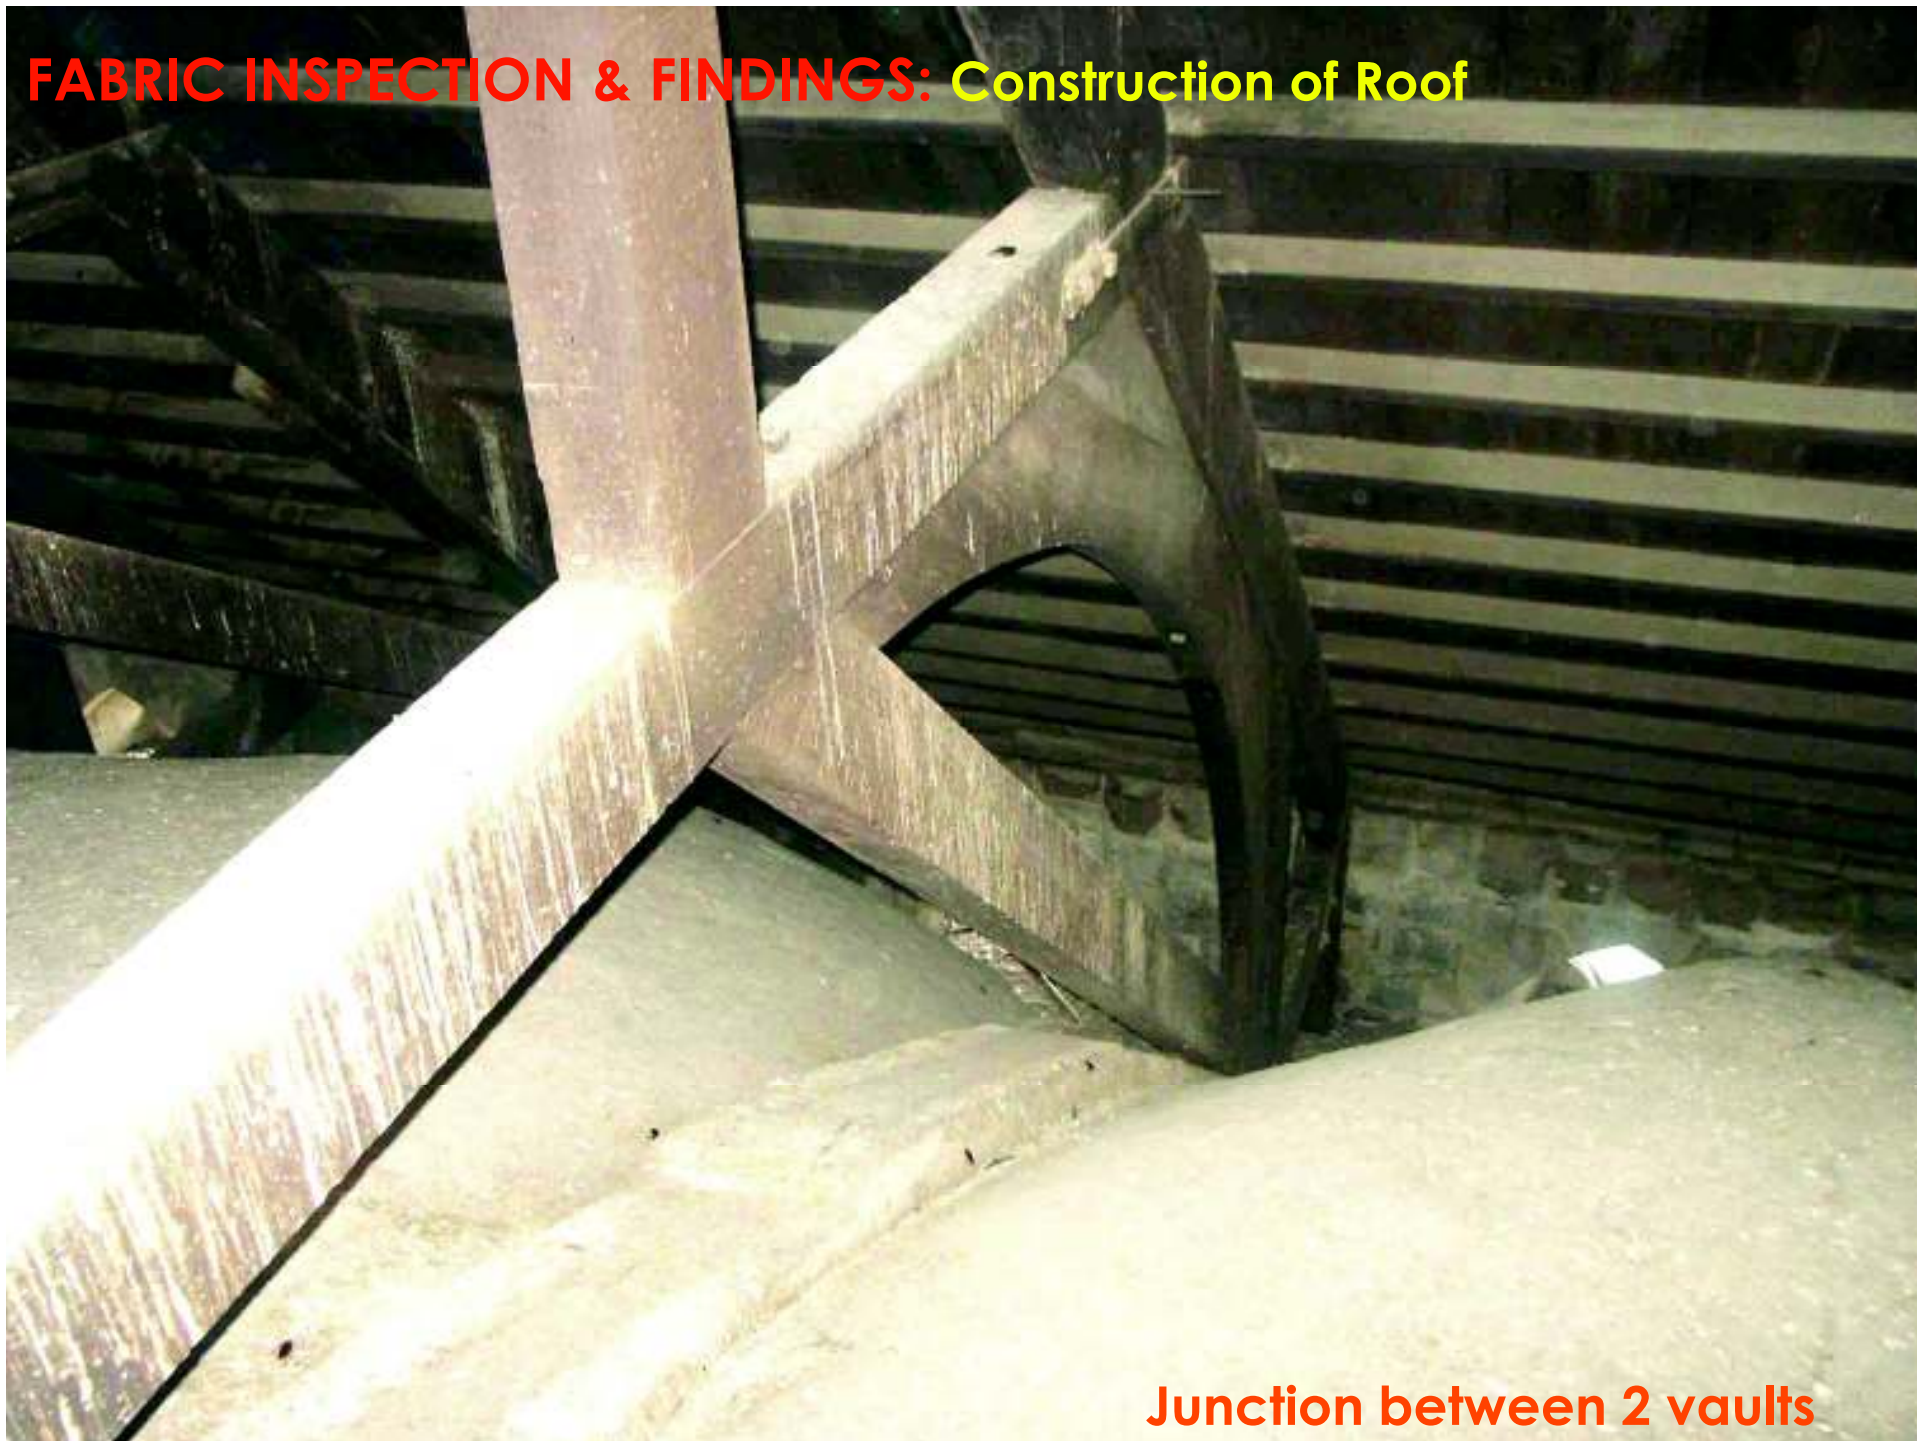
Junction between 2 vaults

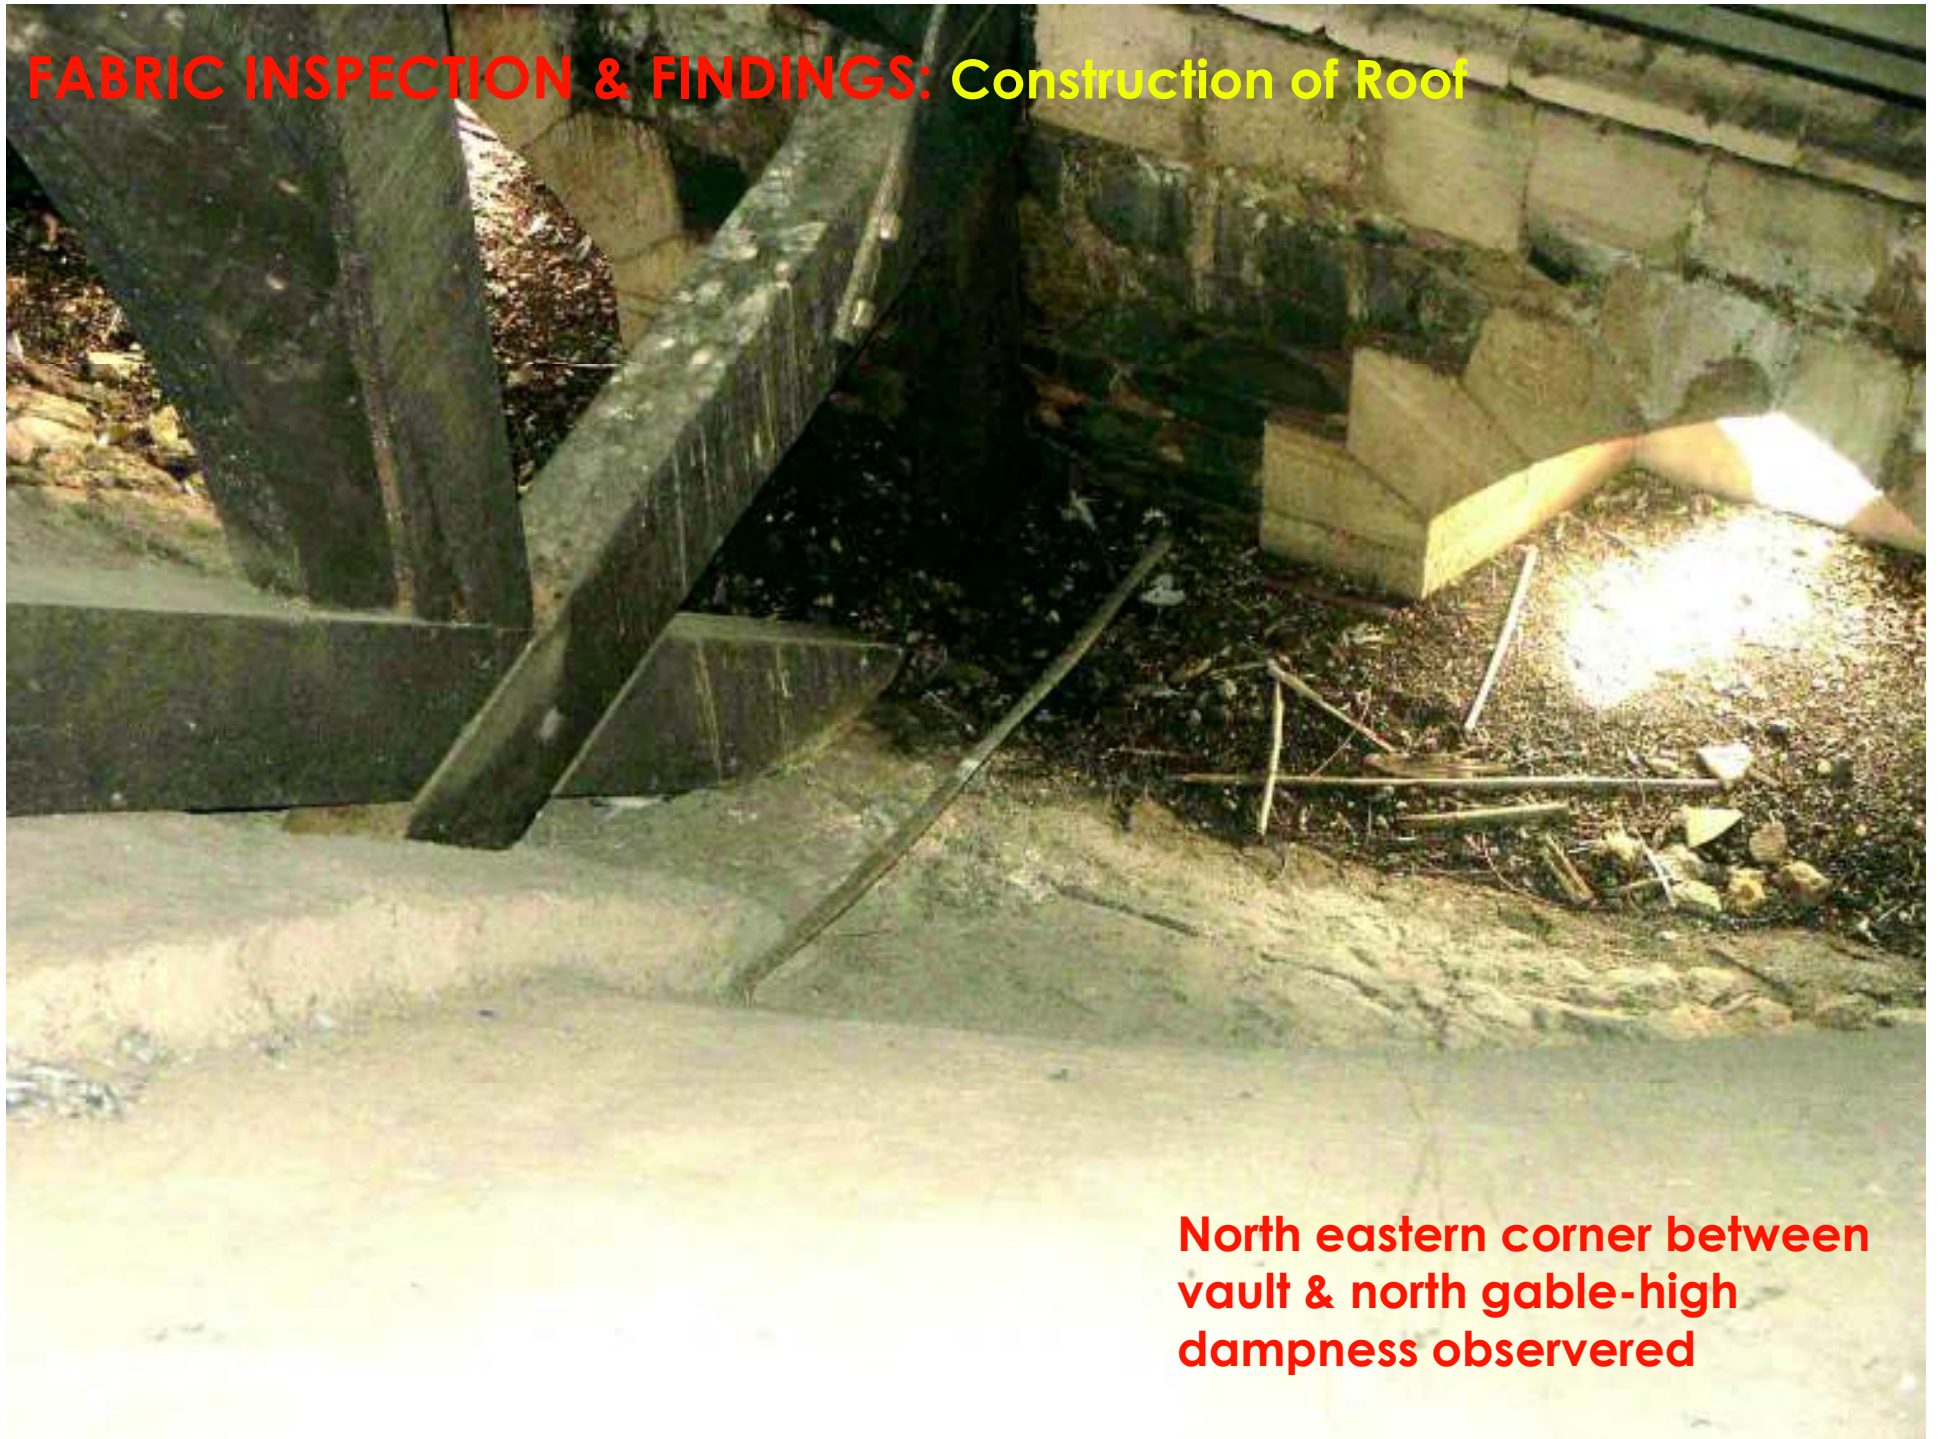
**North eastern corner between
vault & north gable-high
dampness observed**

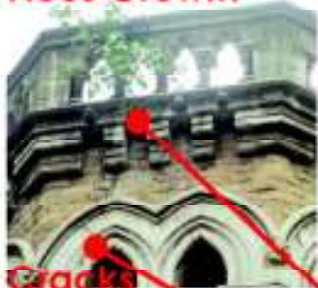
Ficus Growth

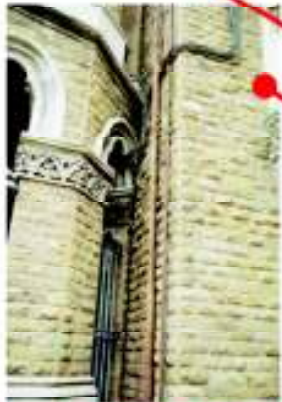
Cracks

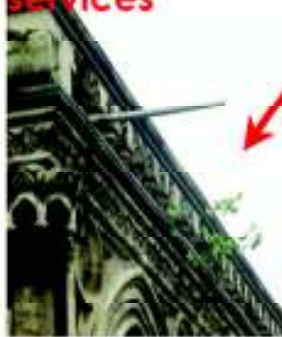
Insensitive routing of services

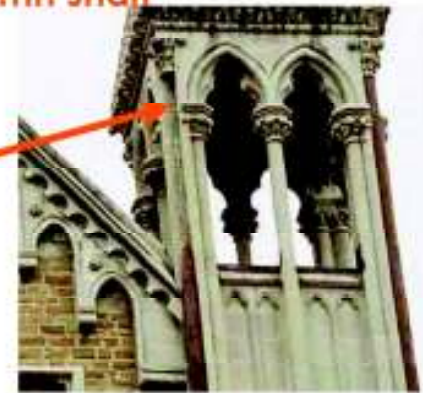
Missing Sandstone column shaft

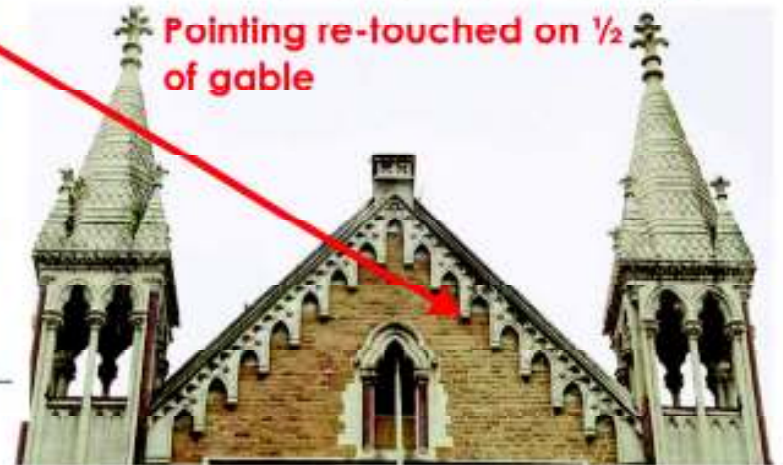
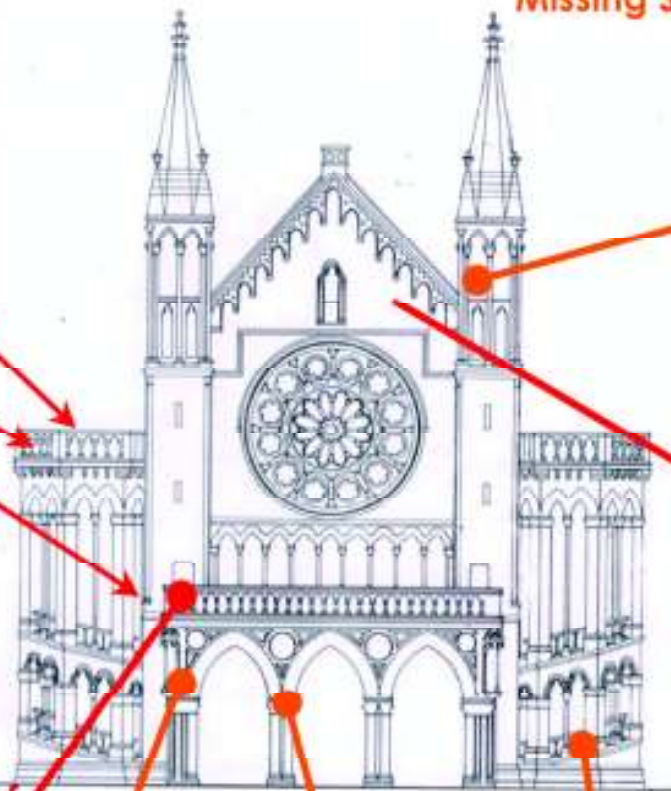
Pointing re-touched on 1/2 of gable

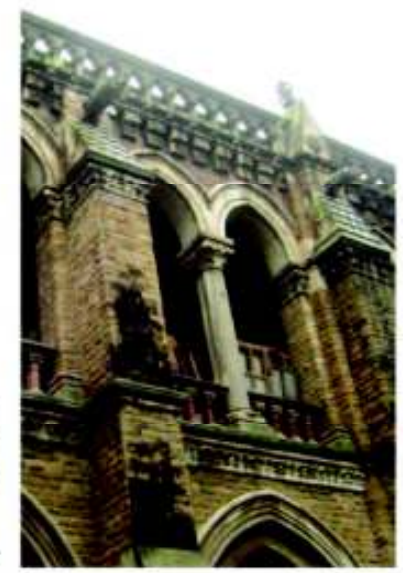
5 Peepal Tree too close to historic plinth

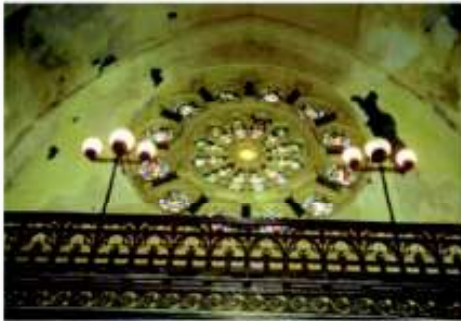
6 Staining of Stone masonry

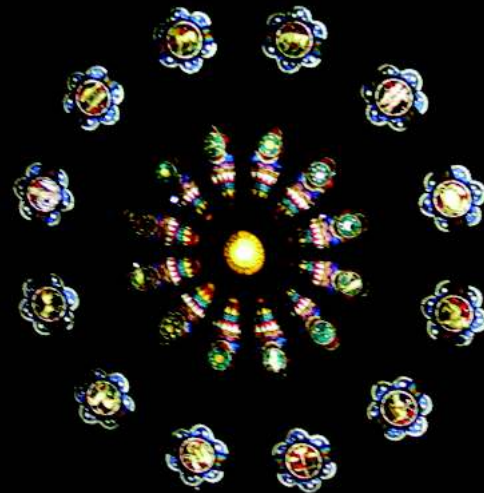
TYPE II: NORTH WALL – THE WHEEL WINDOW.

The condition of all steel frames/rings seems alright. Needs to be inspected after removal of glass.

All the panels inside the spokes are fixed from the outside into masonry. All panels in fairly stable (single cracks in glass) or paint loss.

Buckling is observed in some.

Each Panel is protected with wire-guards on the outside. Condition of guards ranging from average to poor. Missing in some areas.

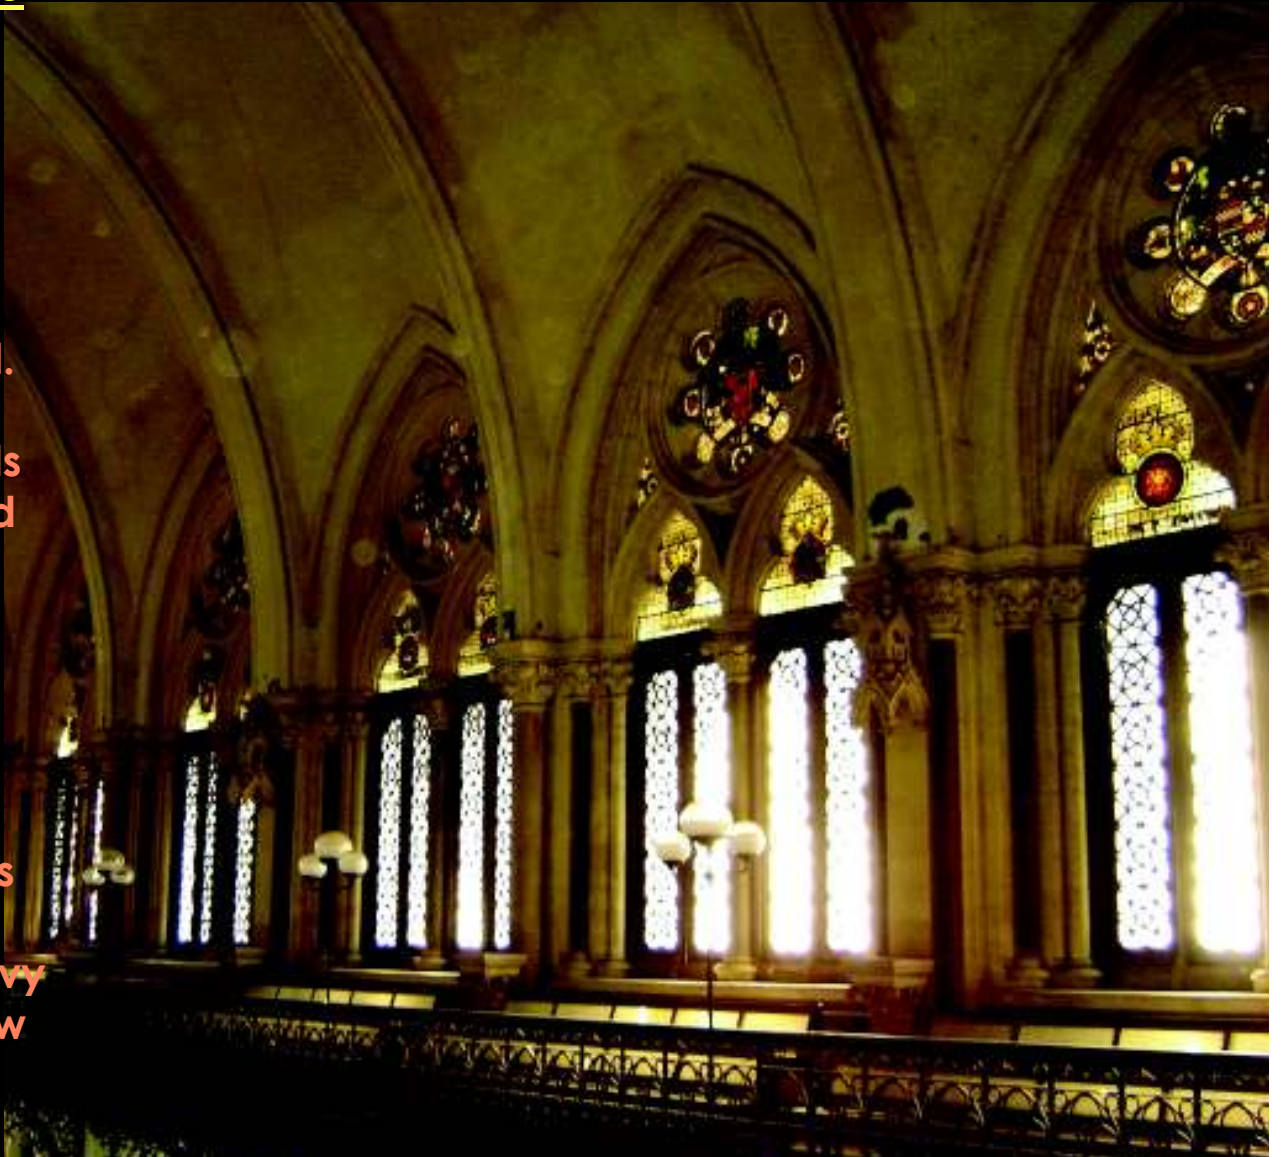
TYPE III: HEAD-TO-LIGHTS

Extremely dirty with heavy tar deposits that mars lead and glass. Defects Range from Buckling, to dirt deposits and staining of glass. In some cases foils are entirely missing, badly damaged or boarded up. Heavy inward buckling is seen in a few panels where stone Cusps are damaged.

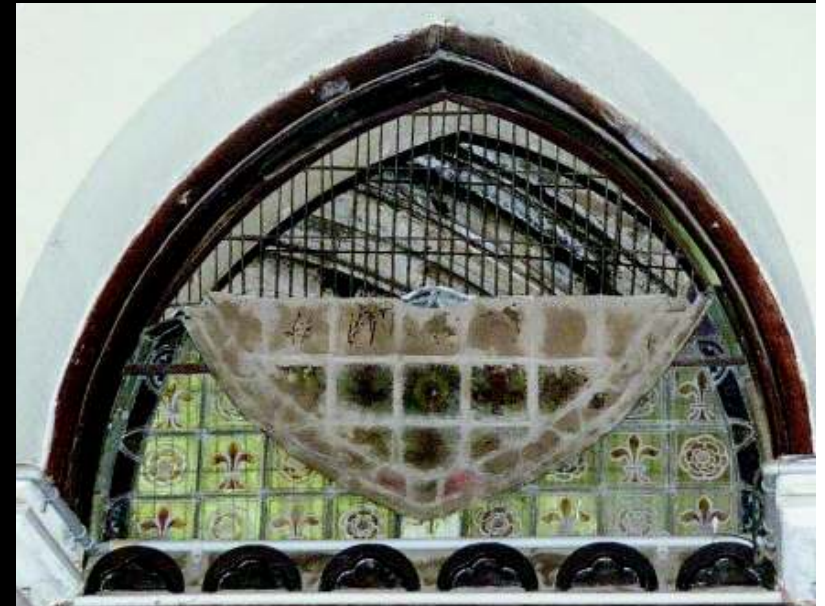
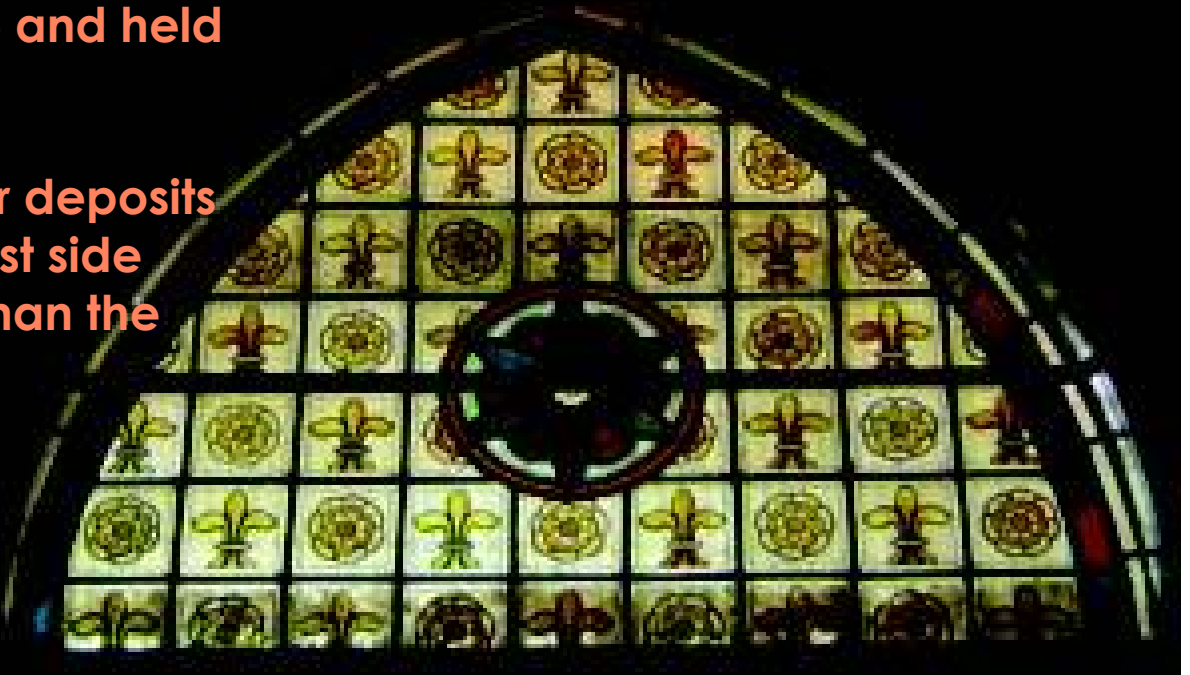
TYPE IV: HEAD-TO-LIGHTS between bays on Ground Floor.

Extremely dirty with heavy tar deposits that mars lead and glass. West side panels are more damaged than the east side ones.

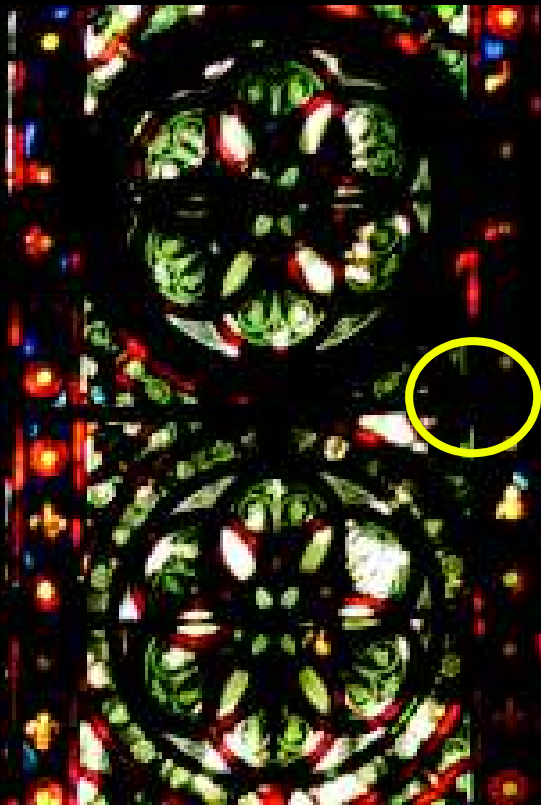
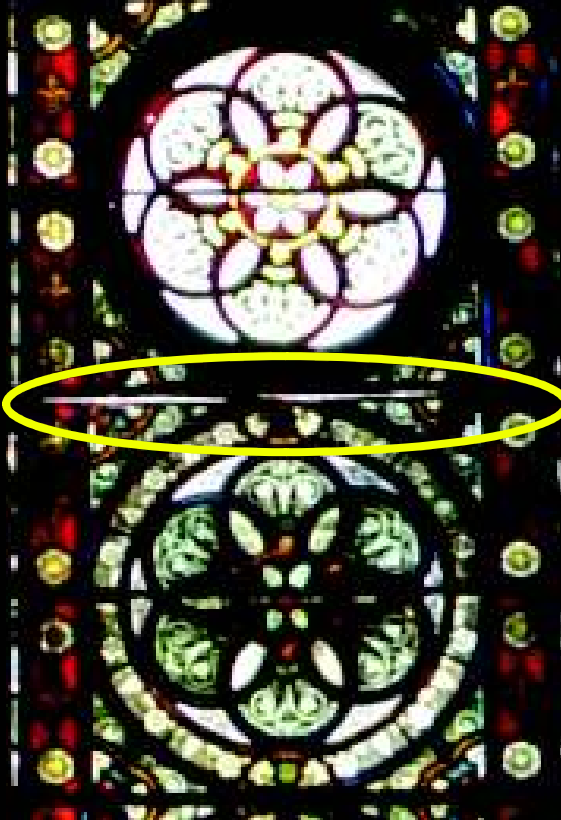
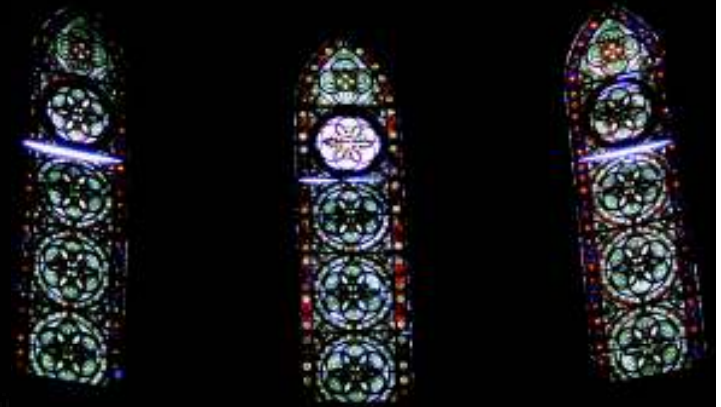
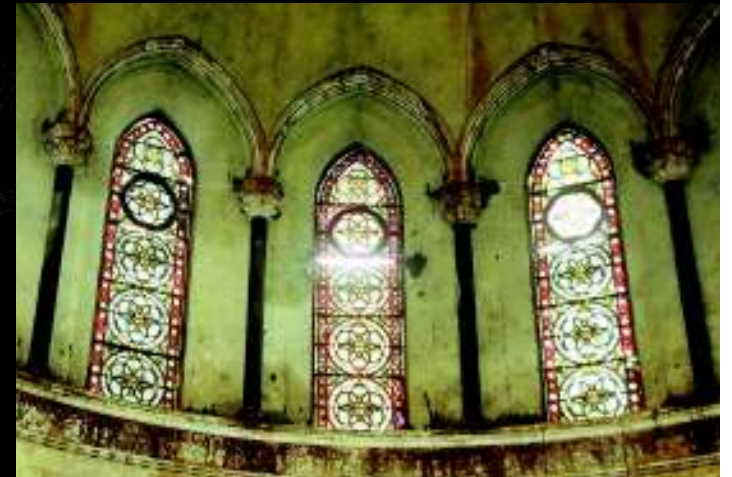
Damage due to weathering and age of glass

Damage due to corrosion of the steel pivotal frame

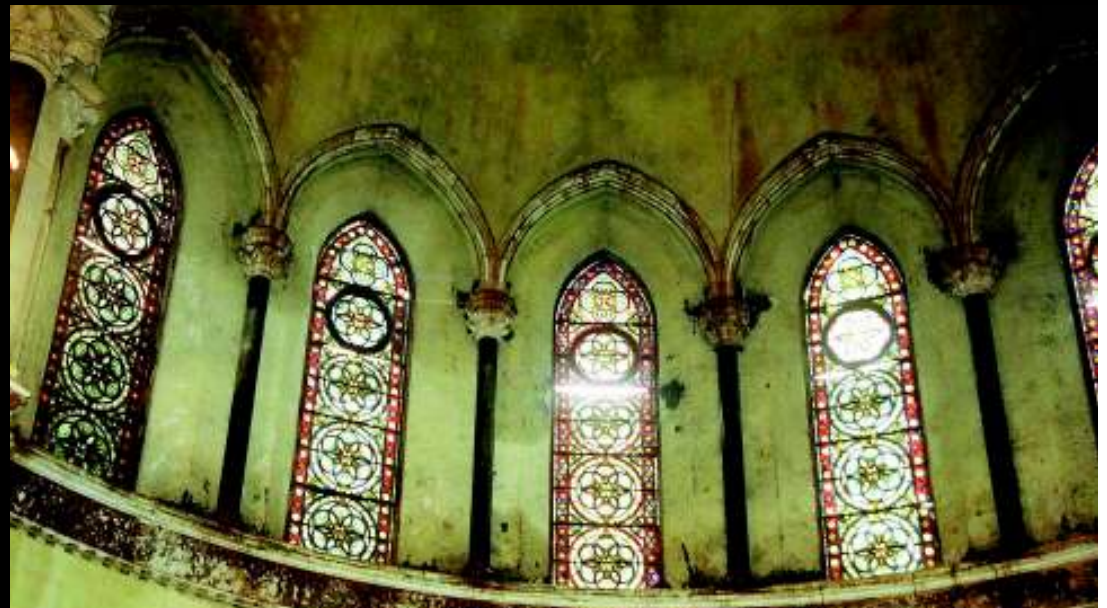
TYPE I: SOUTH WALL LANCET LIGHTS

- a) Fragile, with the panels come loose of the framework along the second panel = apparent from ground level.
- b) Paint loss in all the Lancets.
- c) Tar residue and foliage trapped between glass and wire-guard.

Condition of surrounding materials: Steel (MS) frames to locate lancets, with pivots in the upper sections. Horizontal steel (MS) Tie-bars to support the panels from inside. Need to be inspected once windows are dismantled. Evidence of rust and warp on the windows.
