DOCUMENTATION AND PREPARATION OF CONSERVATION GUIDELINES
for
HERITAGE BUILDINGS AND PRECINCTS IN VASAI - VIRAR SUB - REGION
VOLUME IV: HERITAGE ASSETS IN THE GREEN ZONE

Final Report of the
DOCUMENTATION AND PREPARATION OF CONSERVATION GUIDELINES
for
HERITAGE BUILDINGS AND PRECINCTS IN VASAI – VIRAR SUB – REGION

VOLUME IV: APPENDICES
LIST OF HERITAGE ASSETS IN THE GREEN ZONE

December 2008

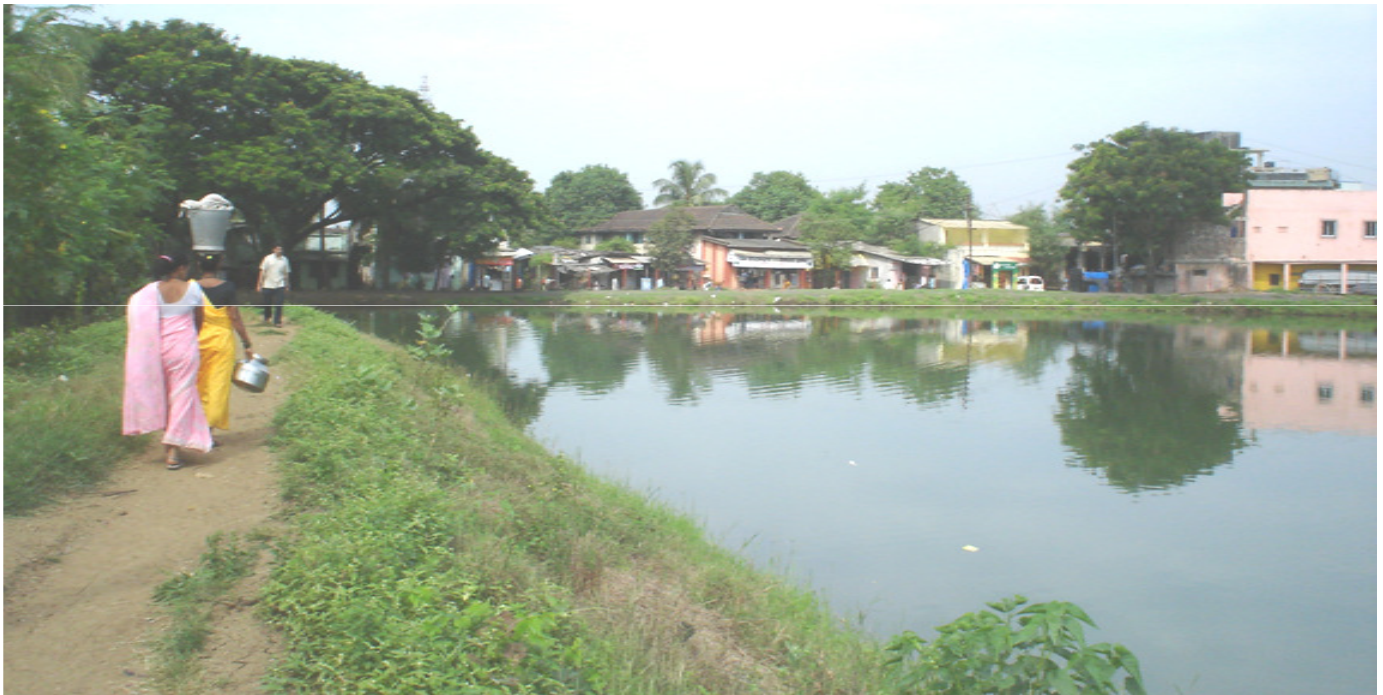
Path along the internal edge of the talav

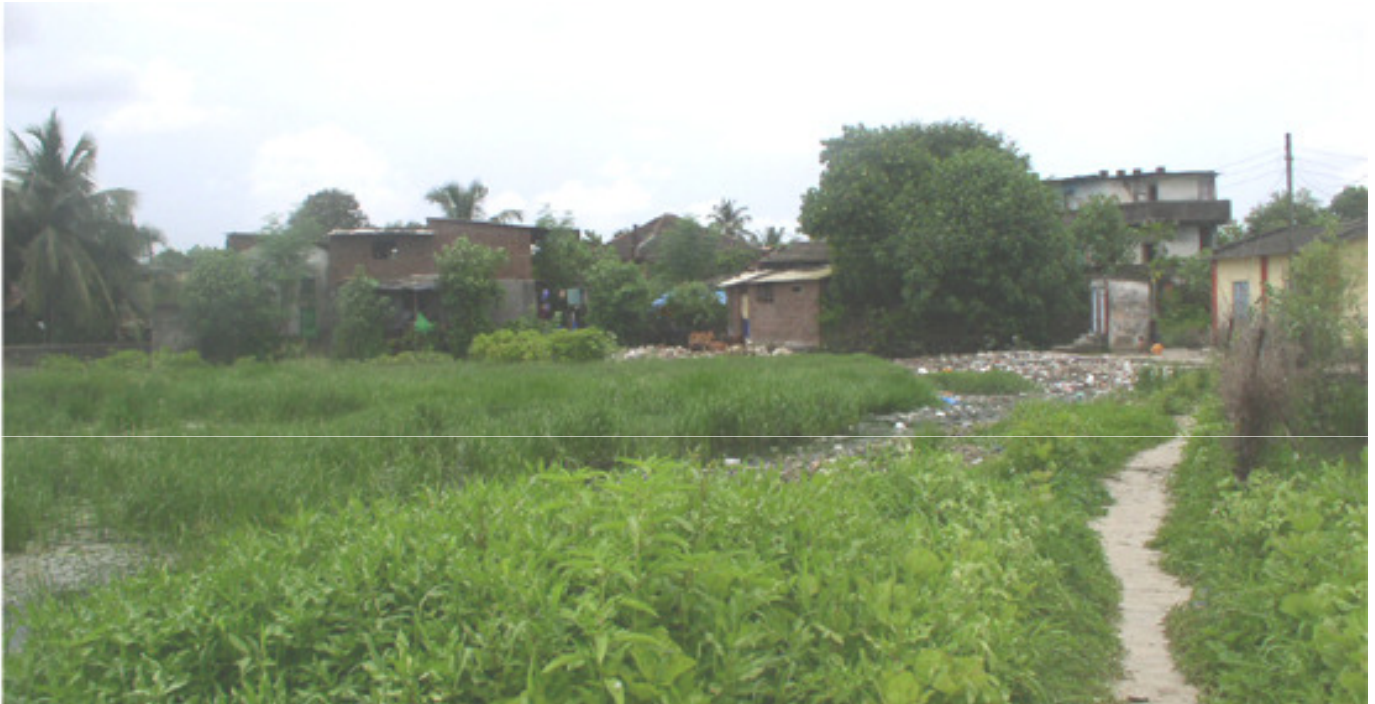
5.2	Physical Infrastructure						Assessment	
Lighting: No street lights have been provided						Non Existent		
Sanitation: Strewn garbage and open defecation are observed on the edge where the talav can be accessed.						Poor		
Storm Water Drainage: Presently no storm water drainage system is provided around the Talav.						Non Existent		
Public Facilities: Inadequate and badly designed gathering space for washing and cleaning purposes.						Poor

5.4	Overall Condition Assessment (based on 5.1, 5.2 and 5.3): The structure of the talav is in a fair condition. The physical infrastructure around the talav is poor and the talav remains neglected because the capacities of the Grampanchayat to undertake maintainence and repair works are poor.	POOR

Garbage and open defecation along the path leading to the talav

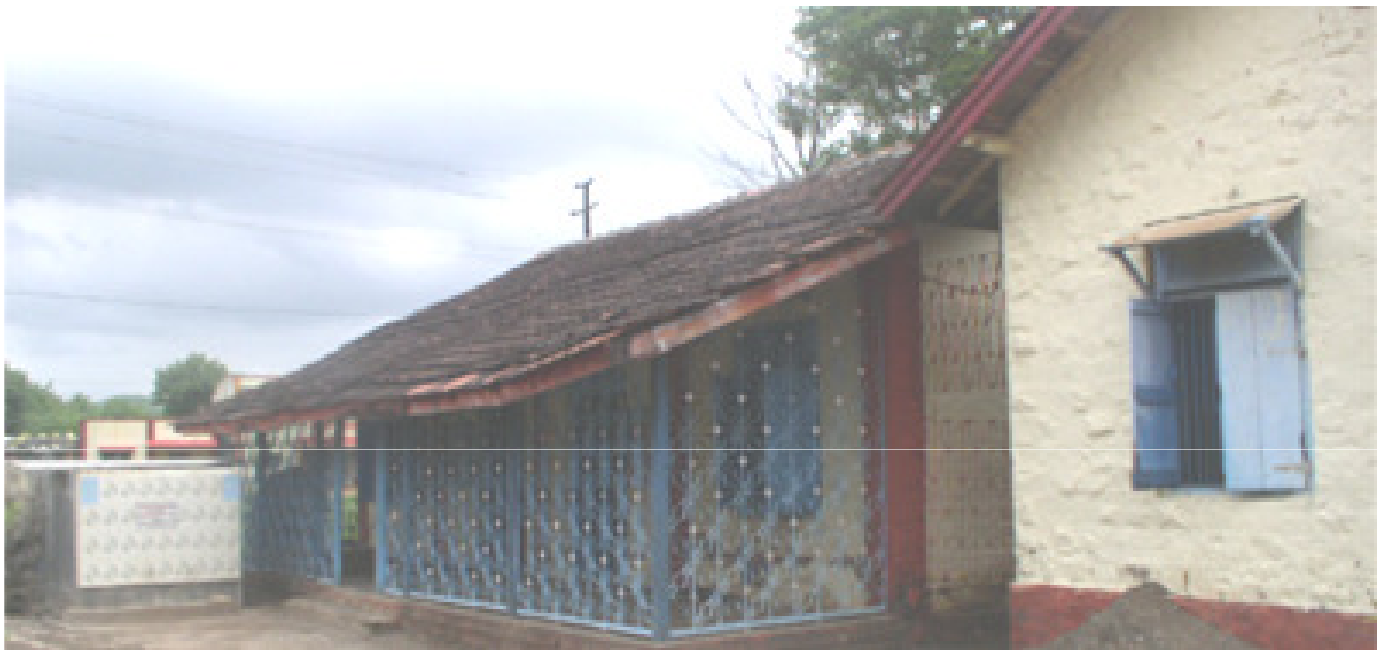
5.4	Overall Condition Assessment (based on 5.1, 5.2 and 5.3): Apart from the roofing, the building is in a structurally fair condition. The infrastructure necessary for the school is inadequate and in a poor condition. The Zilla Parishad does not have the financial capacity to for maintenance, repairs and extensions that are required.	POOR

The school building with the verandah and the mangalore tile roof forms a background to the courtyard

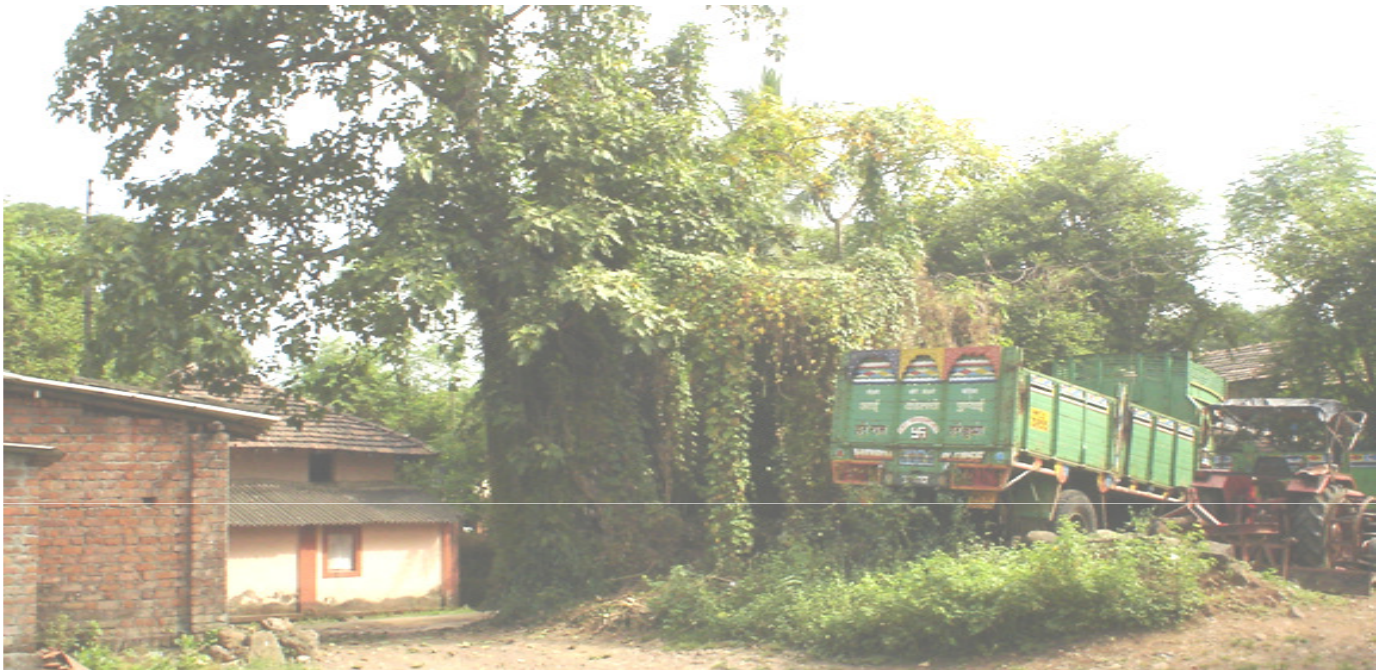
5.4	Overall Condition Assessment (based on 5.1, 5.2 and 5.3): This structure is in complete ruin.	RUIN
	0: RUIN / NON EXISTENT 1: POOR 2: FAIR 3: GOOD	
6	FUTURE RELEVANCE

Hambara lies in the open space amidst the houses in the goathan

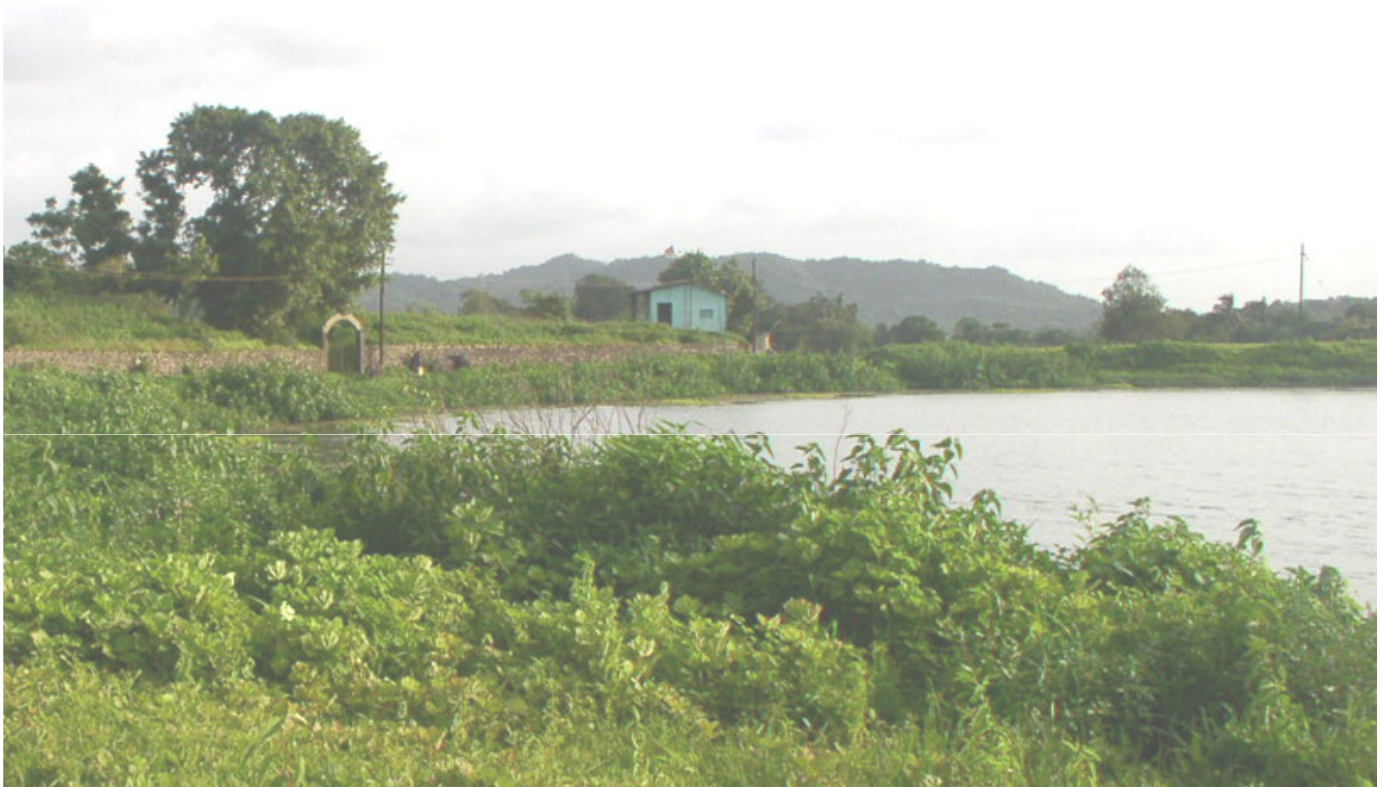
The small blue building of the dargah seen in the background

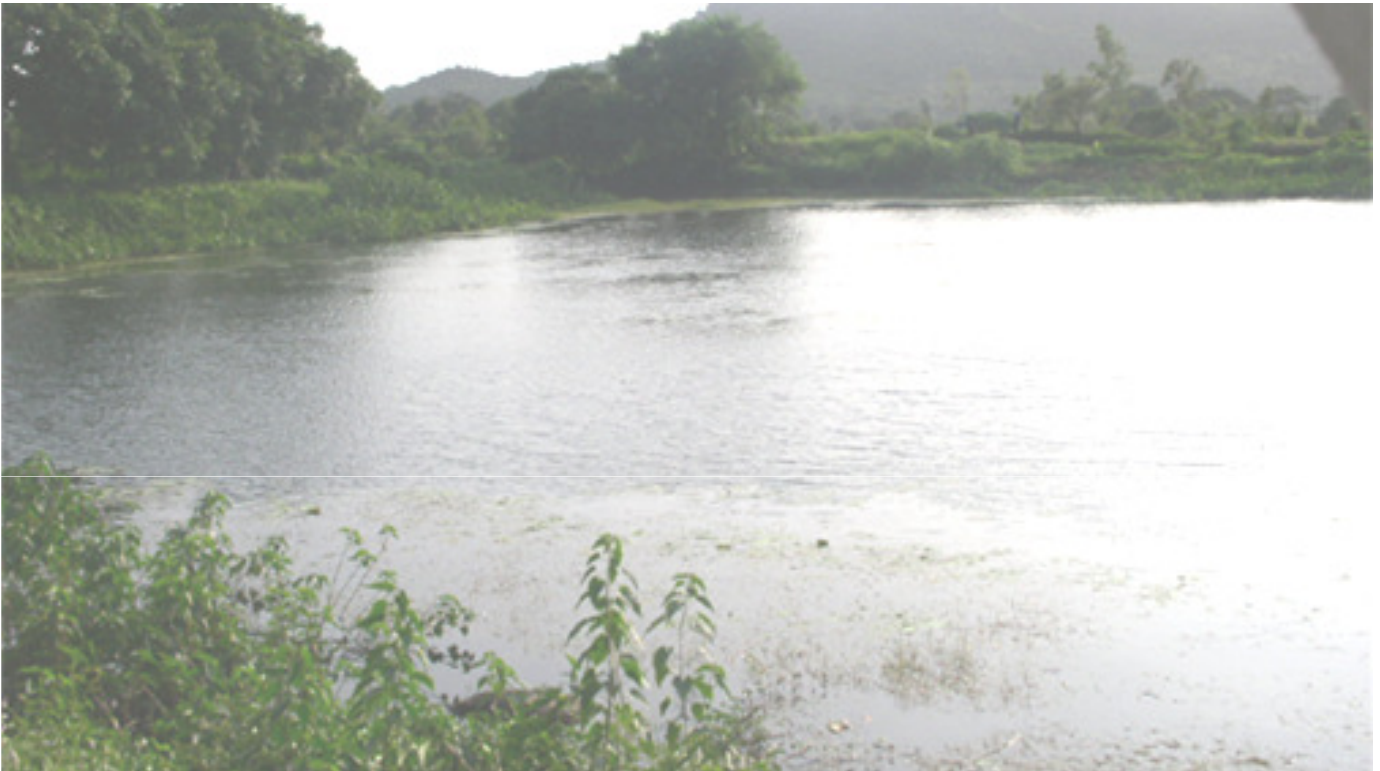
Ambe talav after the monsoon

Low water retention capacity of the rock leads to the drying up of the talav during summer

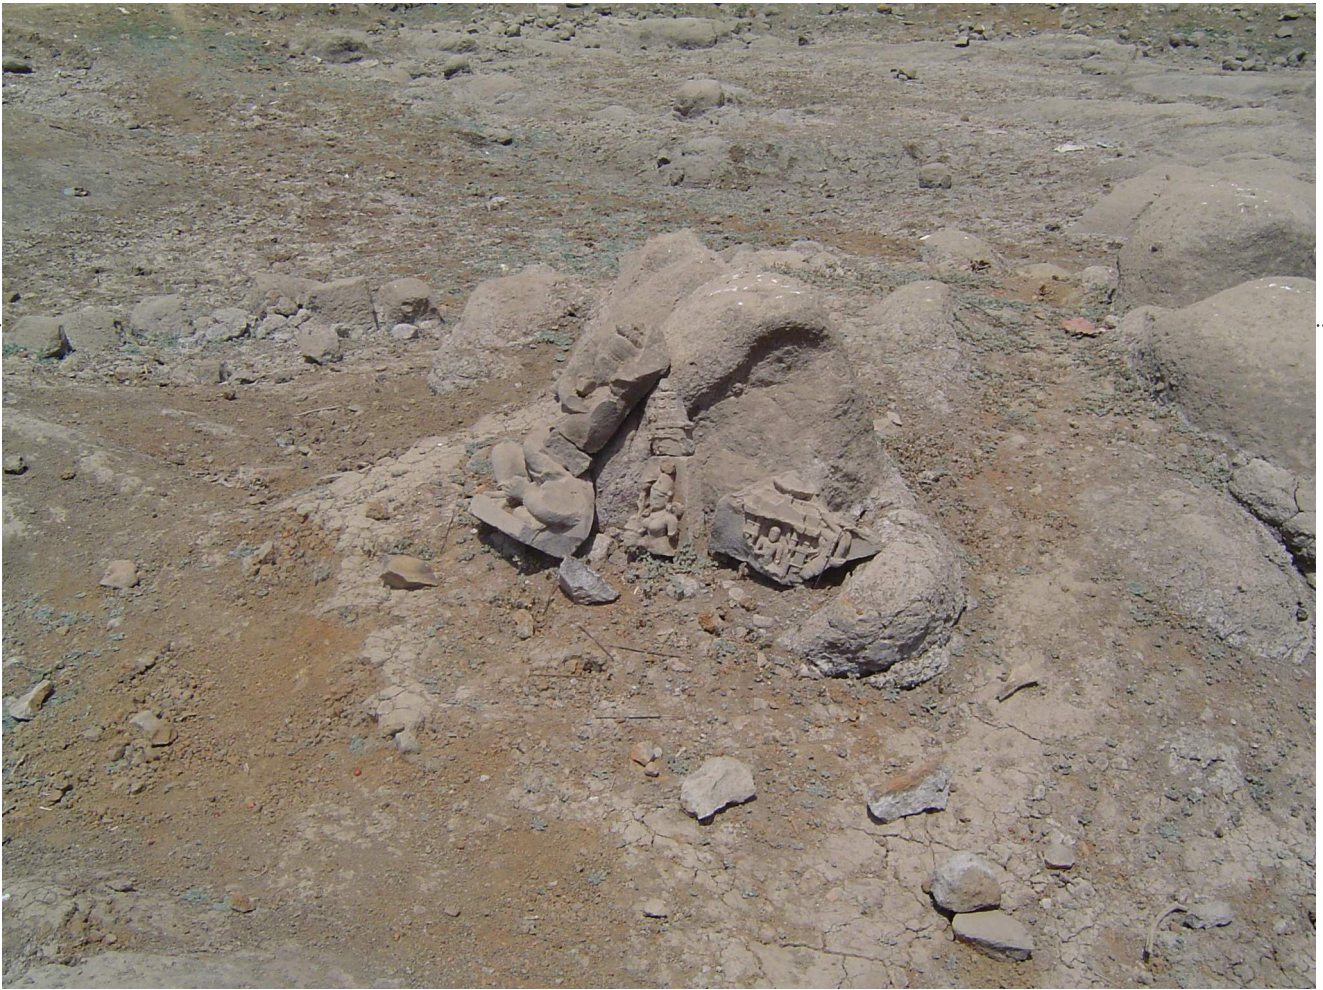
A group of broken statues lying in the talav

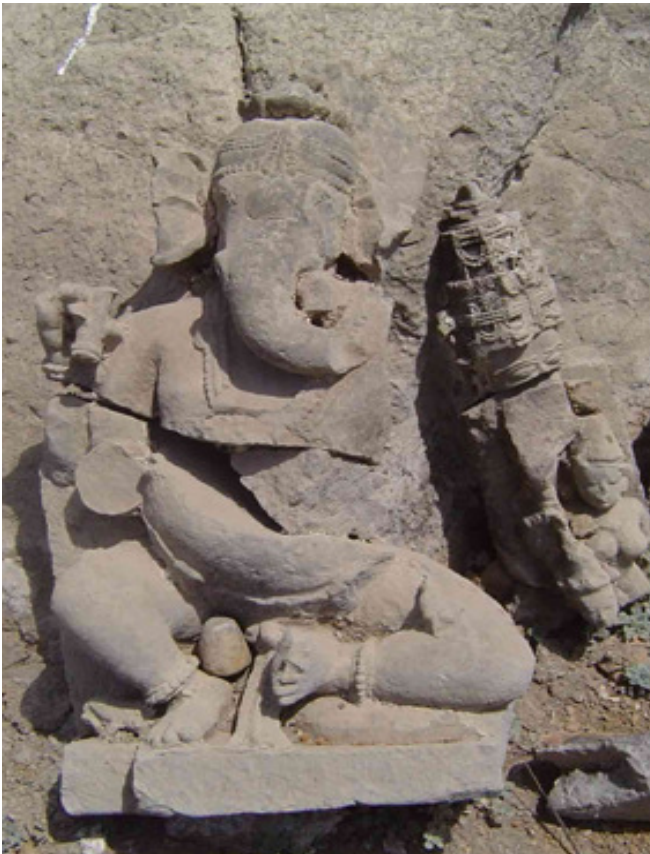
Ganesha statue in the talav

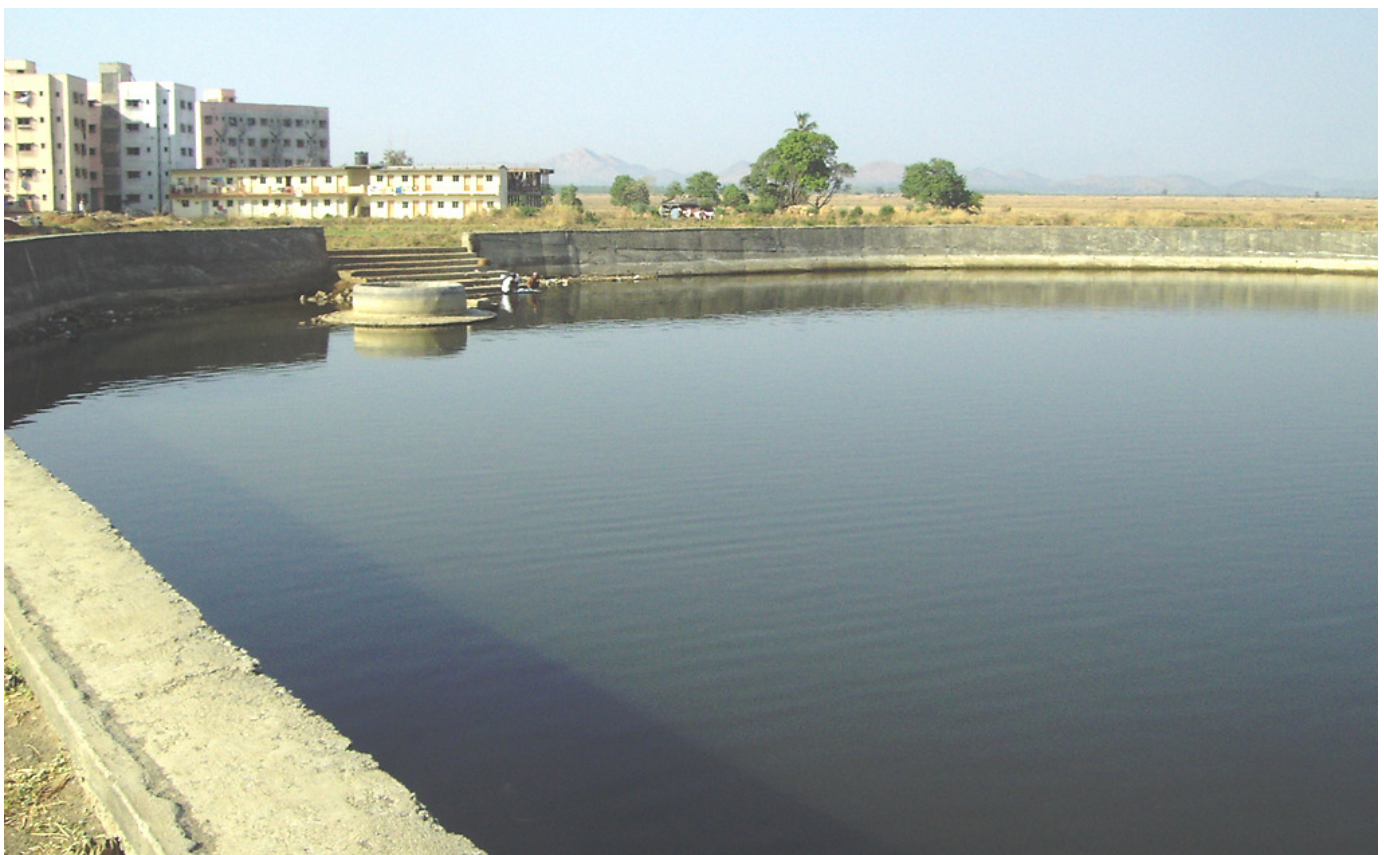
Recently constructed retaining wall in the foreground and new apartment buildings and transit camps in the background

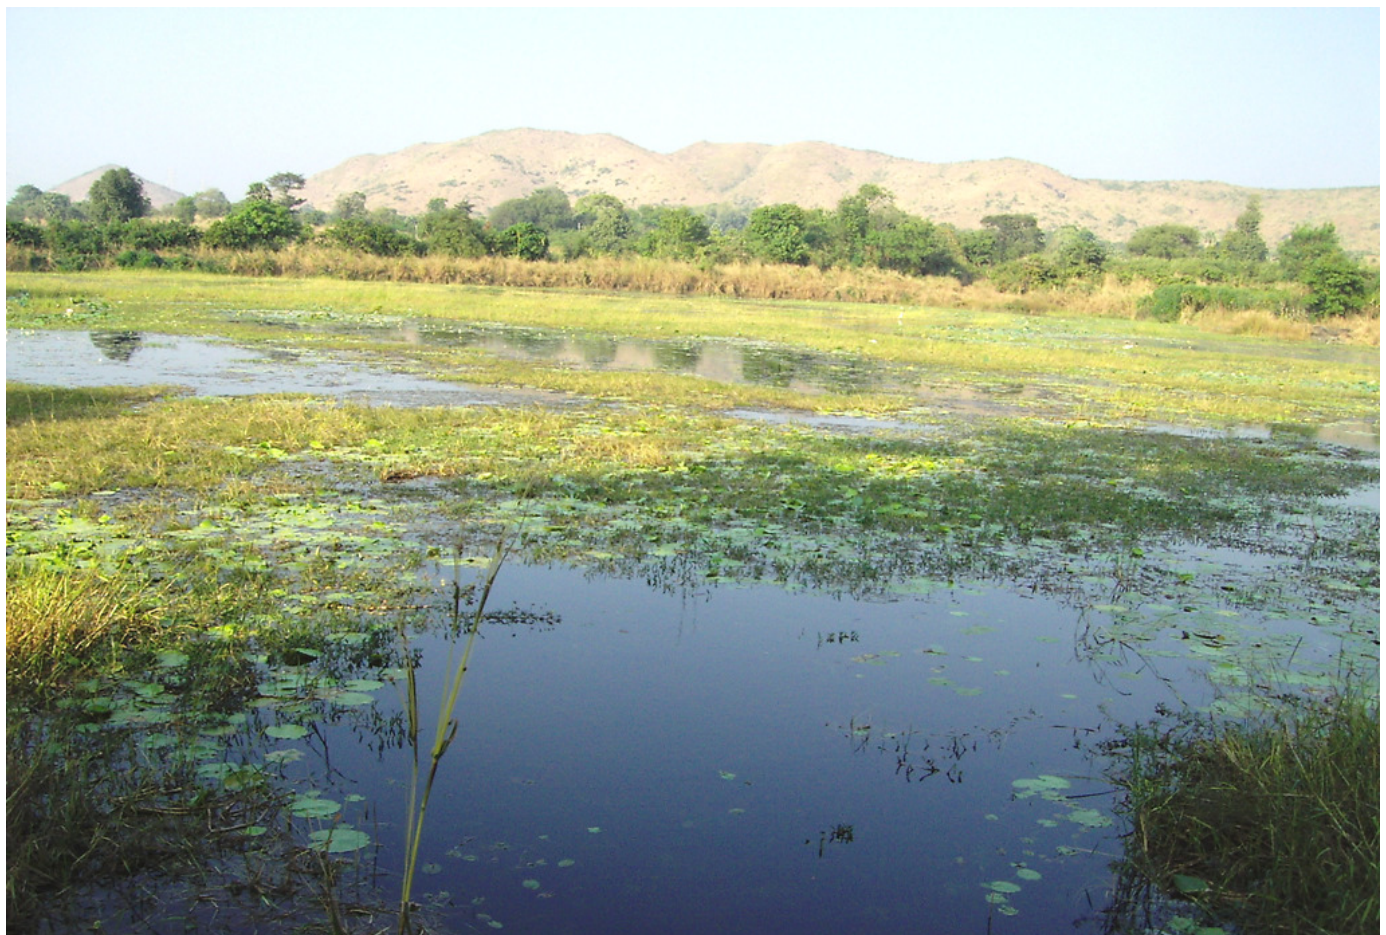
Soft landscape around the talav and the growth of water plants

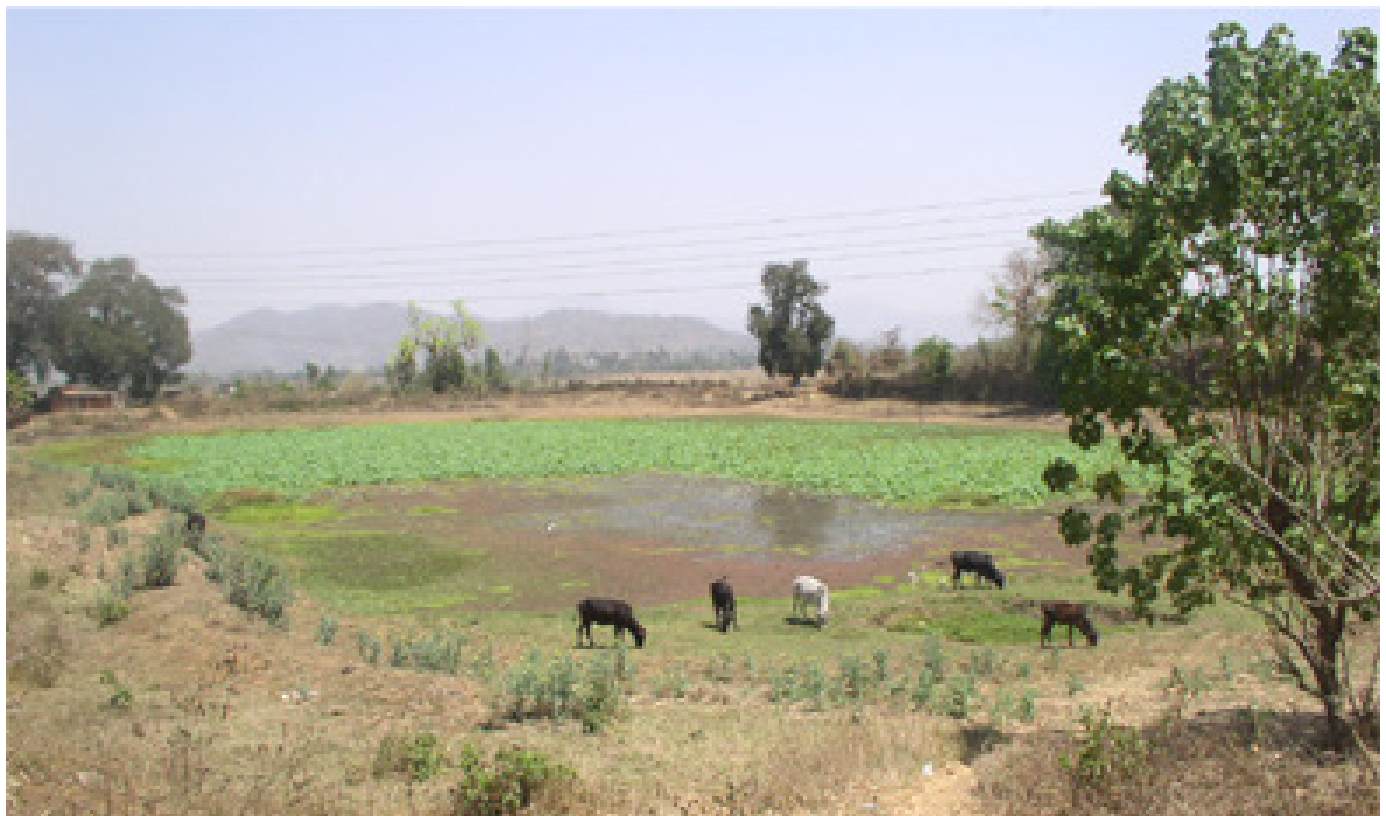
The talav dried up during the summer months with vegetative growth

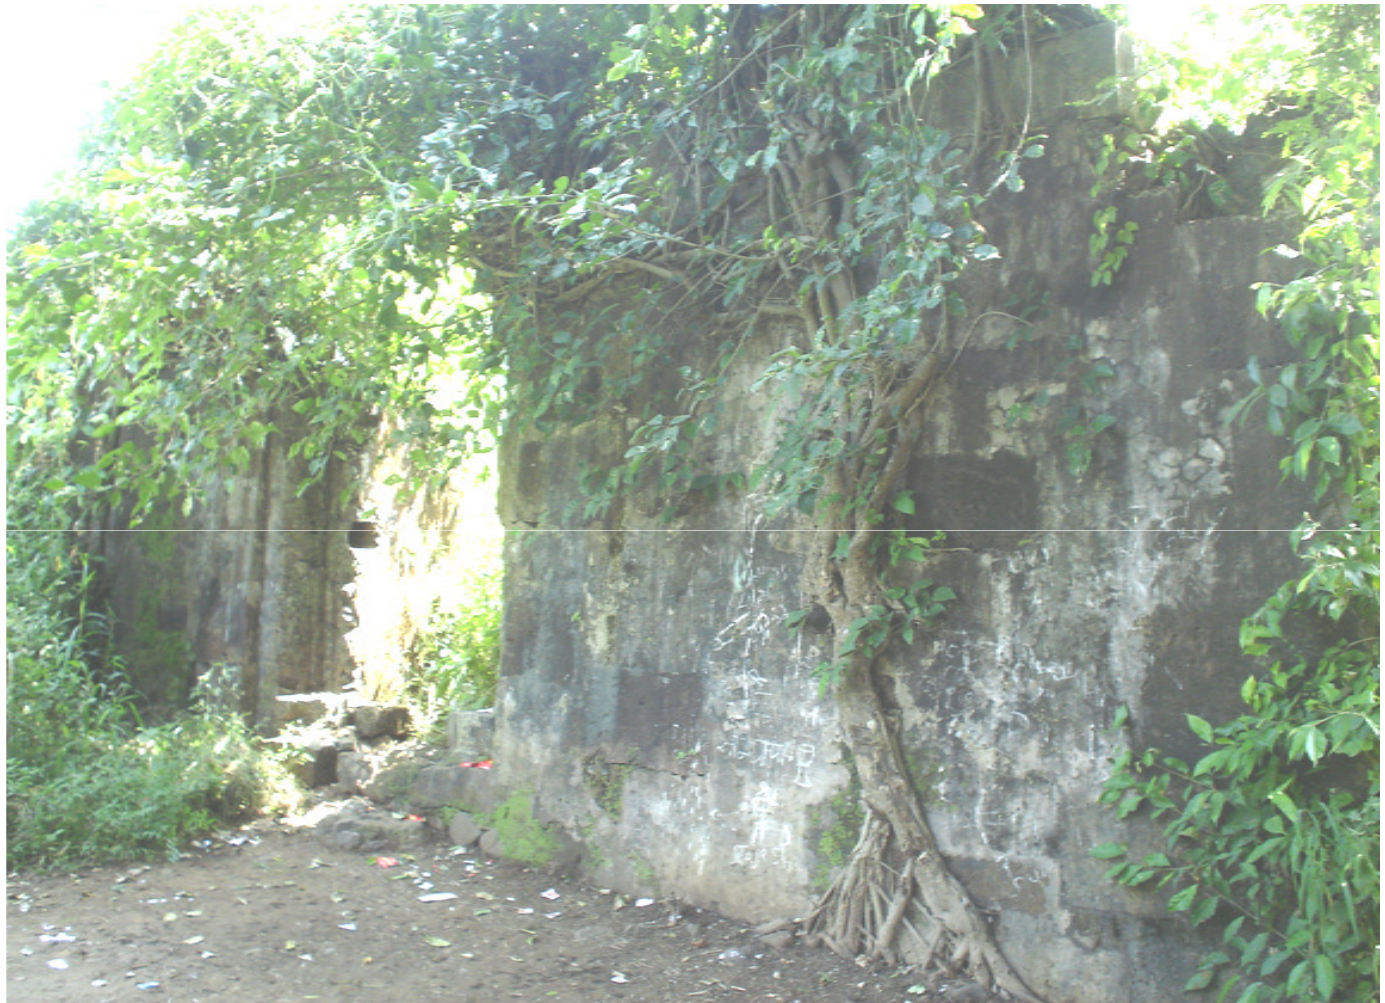
Fort wall with growth of vegetation

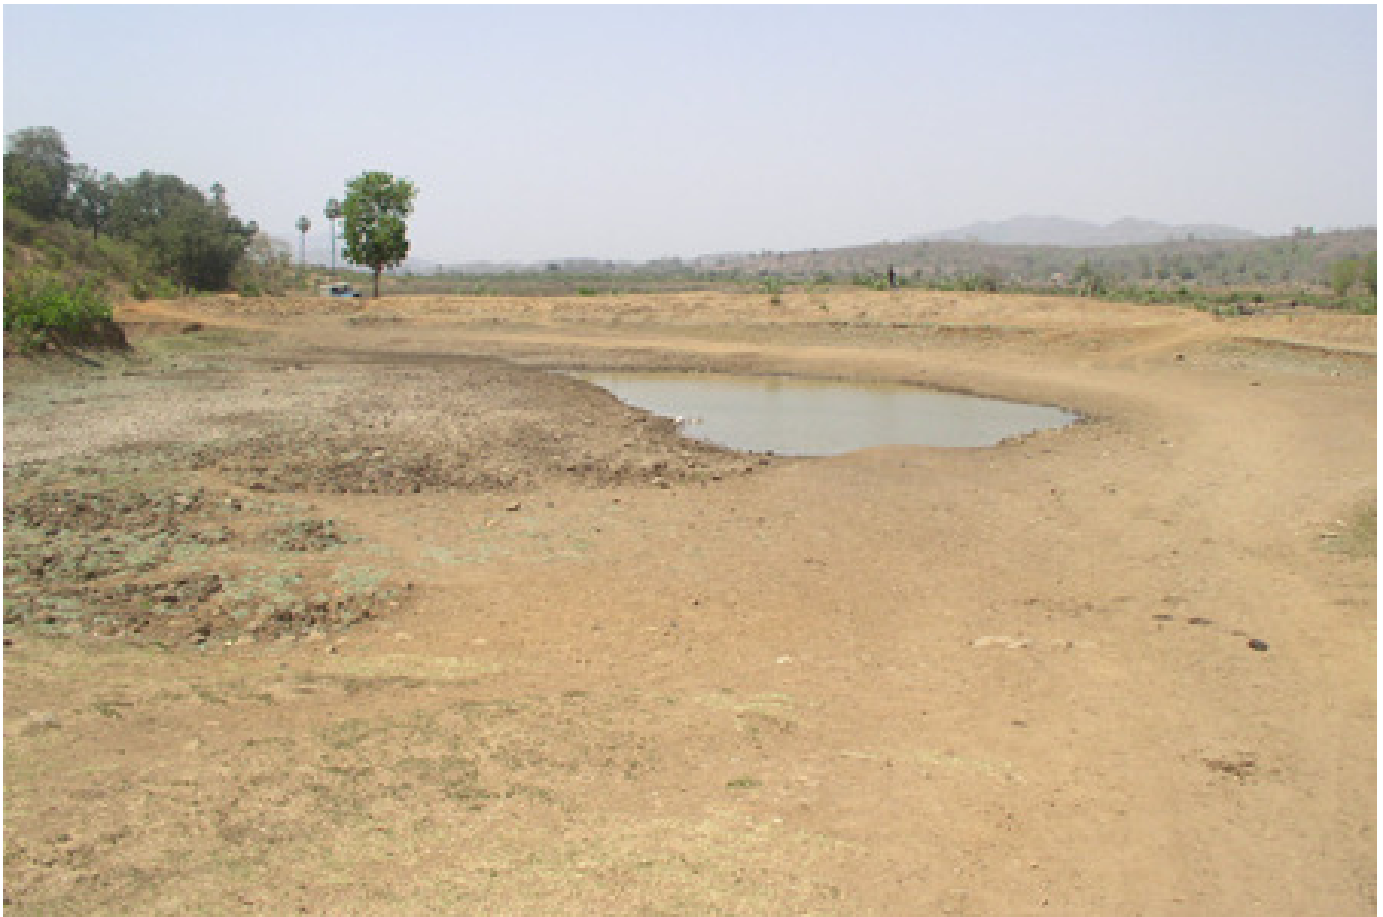
The talav dried up during summer
