# Navi Mumbai (Raigad) Heritage Project

## Stage II Report

## Area B- Panvel

by  
the Pillais College of Architecture Research Cell  
New Panvel

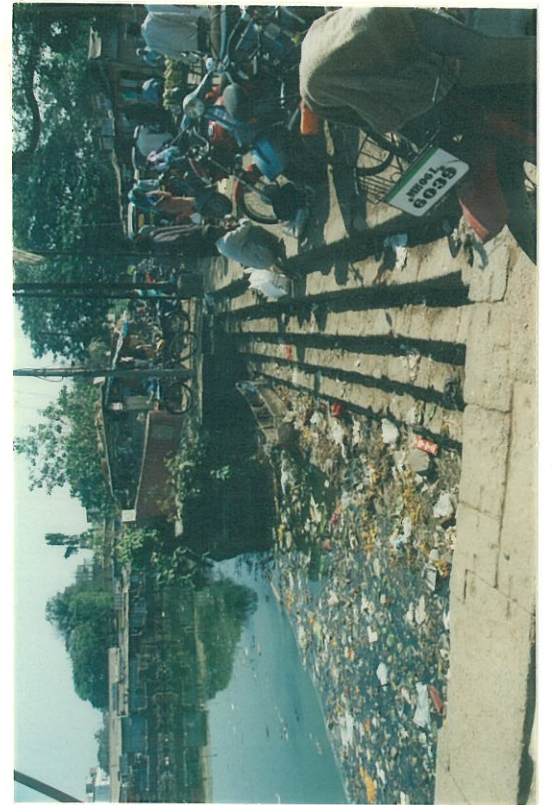
Condition of the steps leading to water level

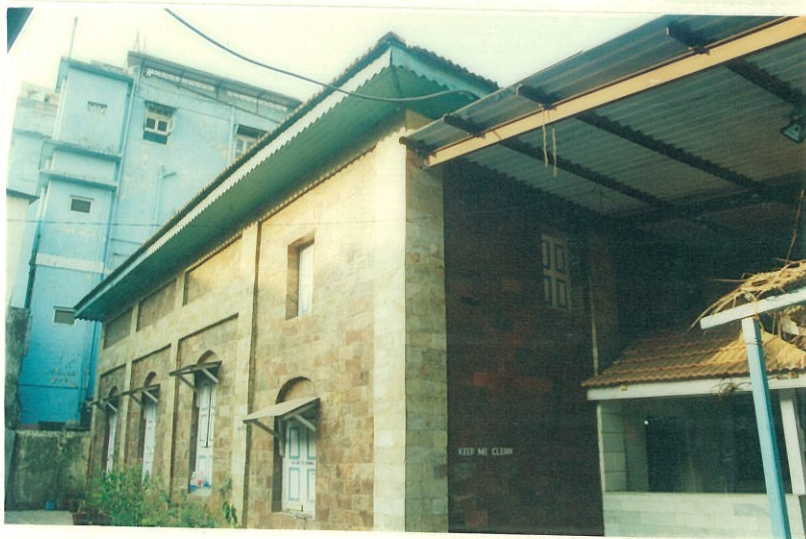
Courtyard side view of the building with the original porch seen below the temporary roof cover
