Navi Mumbai (Raigad) Heritage Project

Stage II Report

Area C- Uran

List Cards No: 75 to 118

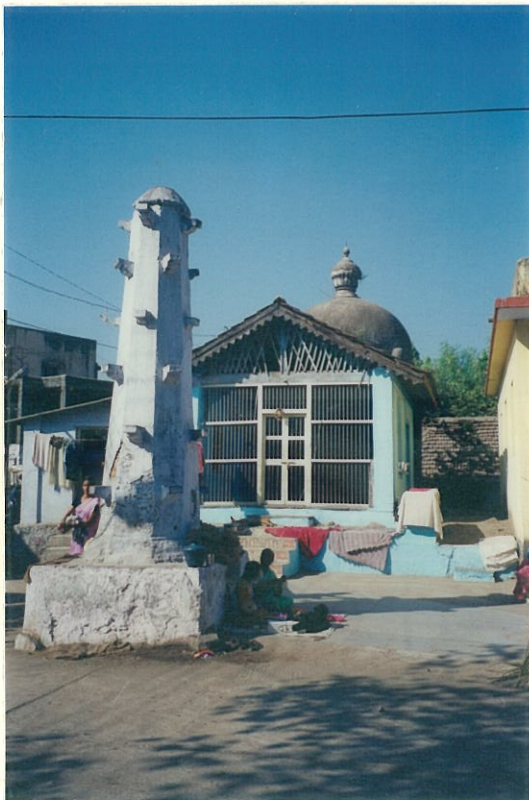
9.6 Roofing	The timber frames on the front facade of the roof truss is weathered in few places, but generally sound. The Eave boards are in good condition. The dome is infested with vegetative growth on the top.

Front elevation of Temple with Deepasthamba in the front

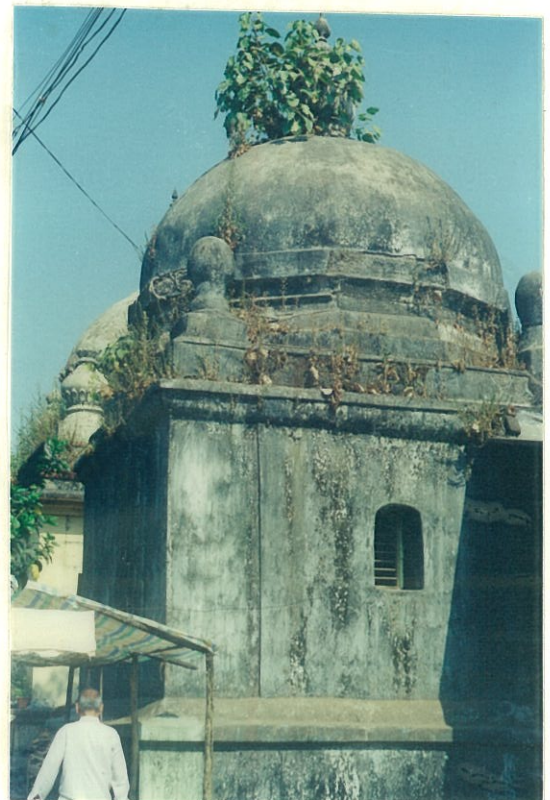
View of the Garbhagriha and the Dome from South

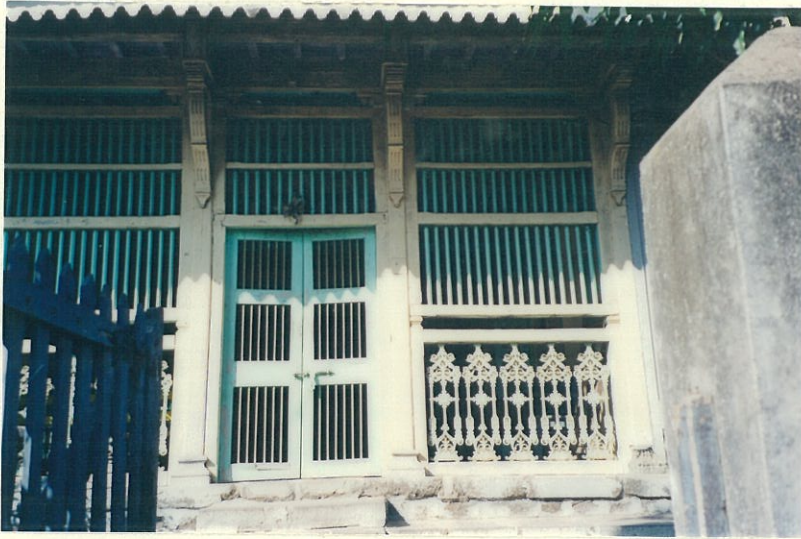
Common Reference No.	UN4
Card No.	78
Name of Property	Vitthal Rakhumai Mandir Deulwadi

View of entrance to Vitthal Rakhumai Mandir showing typical Konkan style temple front projected plinth stones

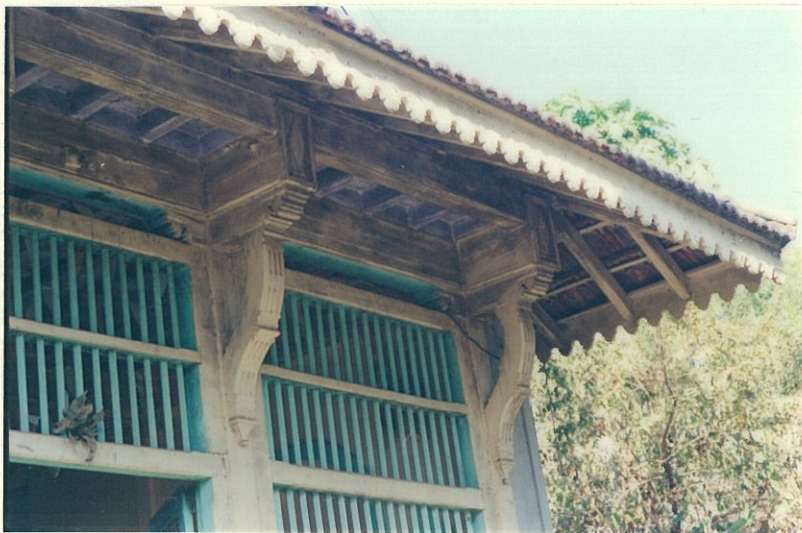
View of ornated timber brackets supporting hipped roof beams and decorative eaves boards in timber with projected Mangalore roof tiles

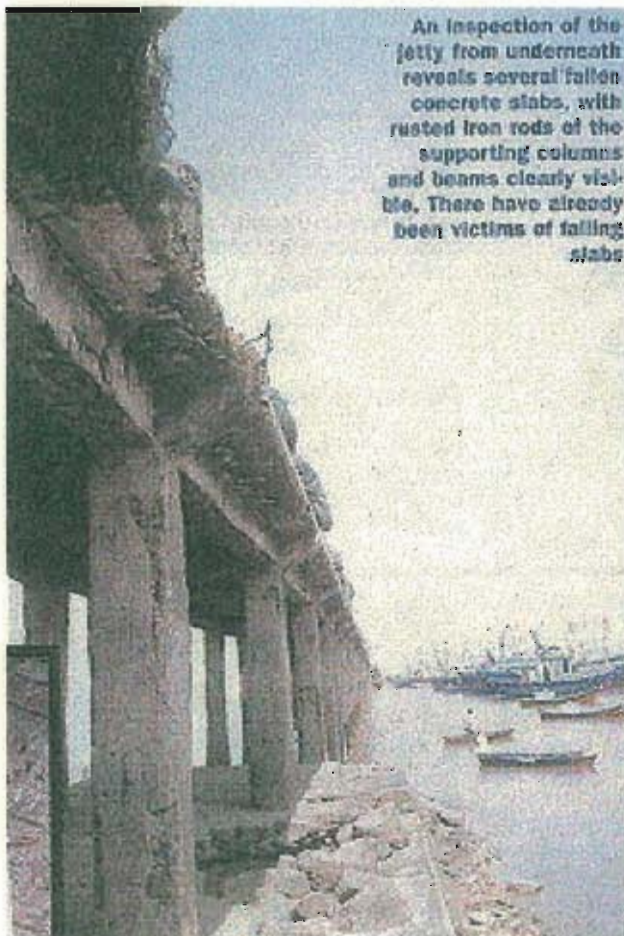
Scanned image from the photograph showing the condition of the present jetty at Mora.
