BALLARD BUNDER GATEHOUSE

CONSERVATION REPORT

DOCUMENTATION, ANALYSIS & PROCESS

K.UNWALLA ARCHITECTS, MAY 2005

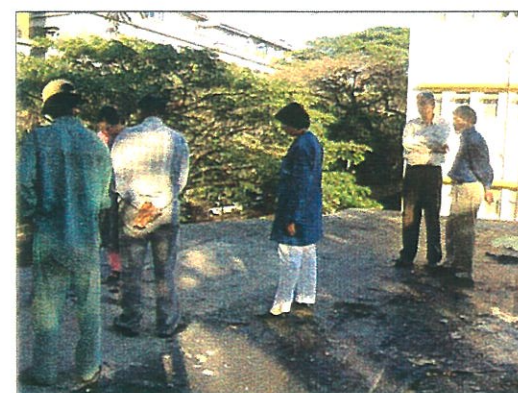
Layers of loose filling material revealed after removal of tar felt.

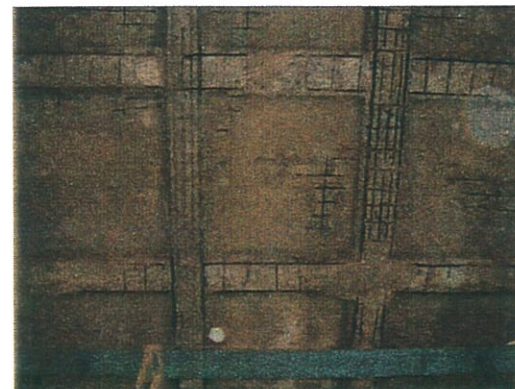
*Reinforcement of coffered slab exposed
after removal of Loose concrete cover.*

Bulging of cover / loose cover at some locations inducing cracking of the cover, leakage stains indicating ingress of water, rusting / scaling of reinforcement. The reinforcement of an adequate design.

- Loose, disintegrated and cracked concrete broken and removed using chipping hammer and / or light chisel upto sound core concrete.
- Loose rust from reinforcement removed by light tapping, chipping, hammering and scrubbing

- Brush application of Rusticide to rusted steel
- Additional reinforcement placed at the bottom and secured to the new stirrups
- New stirrups provided by drilling holes and anchoring the same into the rib of existing RC beam with epoxy putty.

- Application of 2 coats of Polyalk Fixoprime and cement slurry
- Application of Polyalk EP + cement slurry as Bonding coat after 46 hours to entire broken surface

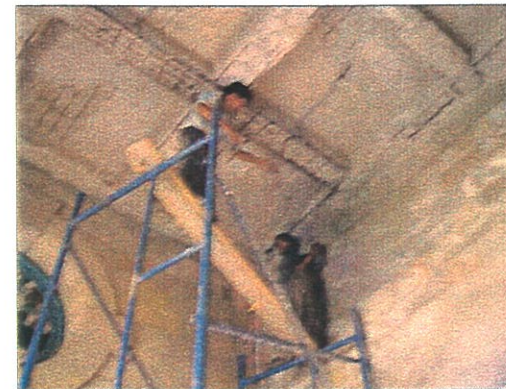
*Laying of electric cables prior to Polymer
treatment to coffered slab.*

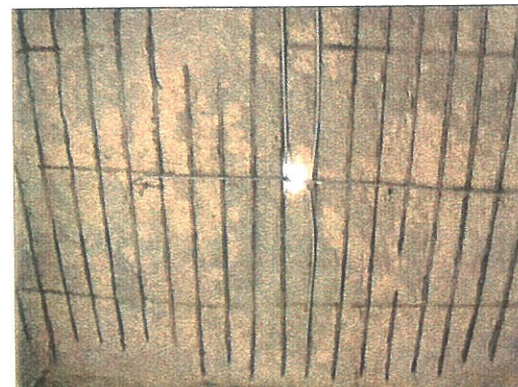
Reinforcement of slab exposed after removal of loose concrete cover

Bulging of cover / loose cover at some locations inducing cracking of the cover, leakage stains indicating ingress of water, rusting / scaling of reinforcement. The reinforcement of an inadequate design.

- Loose, disintegrated and cracked concrete broken and removed using chipping hammer and / or light chisel upto sound core concrete.
- Loose rust from reinforcement removed by light tapping, chipping, hammering and scrubbing

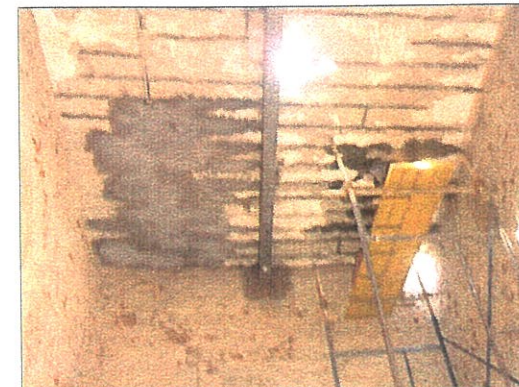
ISMB 250 introduced to strengthen the existing slab and prevent further sagging.

- Brush application of Rusticide to rusted steel
- ISMB 250 introduced spanning across the length of the room to reduce the effective span of existing RC slab. Secured to the stone walls by special ('Hilti' make) bolts. Insertion of steel wedges between the steel beam and the slab.

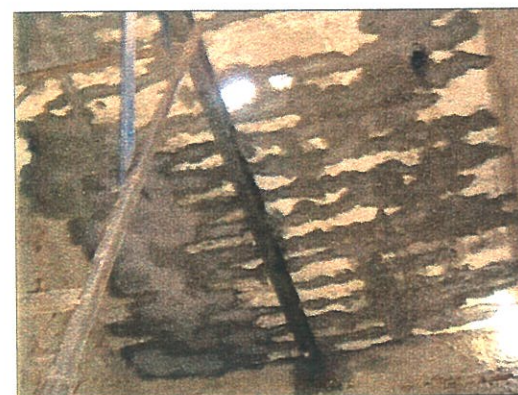
Application of Polymer modified mortar after the application of rusticide treatment

- Application of 2 coats of Polyalk Fixoprime and cement slurry
- Application of Polyalk EP + cement slurry as Bonding coat after 46 hours to entire broken surface

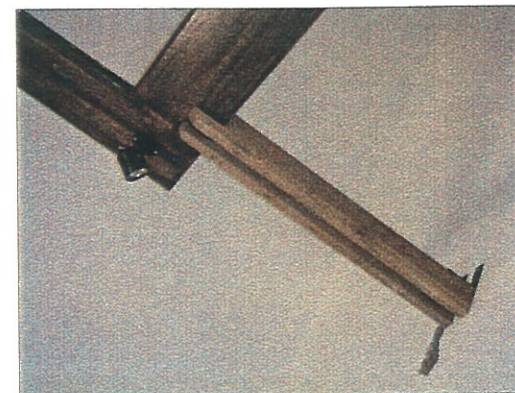
Wooden frame suspended from slab with GI link chains to install light fixtures

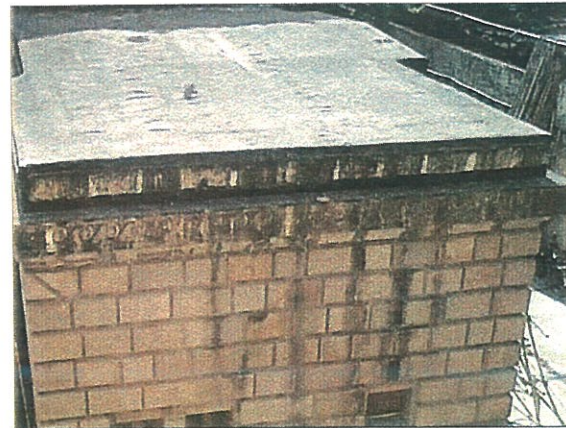
FACADE SOILED WITH STAINS (DUE TO WEATHERING AND TAR FROM THE TAR FELT ROOF PROTECTION) BEFORE RESTORATION

- Staining of stone surface due to water ingress from the roof and rising damp from the foundations is evident.
- Staining of stone surface due to weathering.
- Stains of tar on western façade.
- Stains associated to adjoining filling / dump / P.C.C.
- Stains due to rusting of nails driven in the wall
- Paint stains due to surfaces used as a backing while painting other objects/materials - evident mainly in the plinth surfaces.

- Removal of soiling by gentle mist spray and controlled pressure water jets.
- manual - light tapping / scrubbing / water application / Steam
- Tar stains removed by Steam / diluted Petrol
- Careful removal of Nails / wooden blocks etc and sealing the holes / depressions with lime mortar

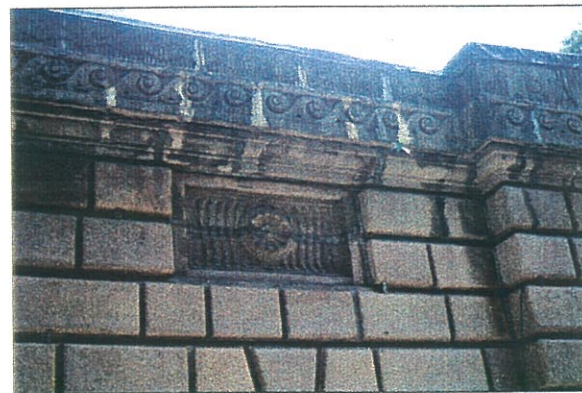
Ficus growth - a marginal problem, treated with a mixture of Hing, Jagri and unslaked lime.

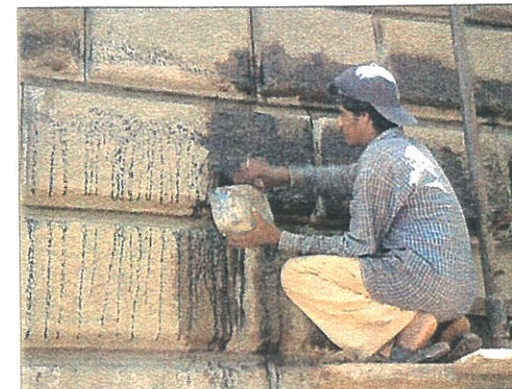
Application of petrol for removal of tar stains

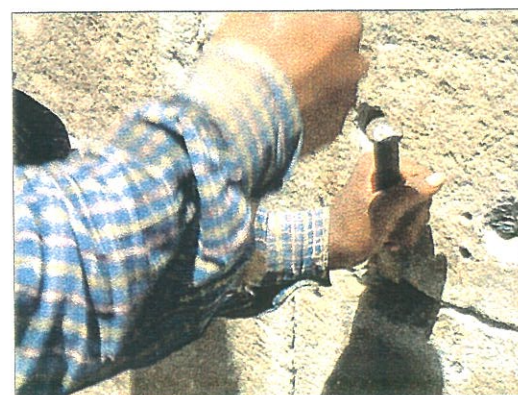
Careful removal of nails embedded in the stone surfaces.

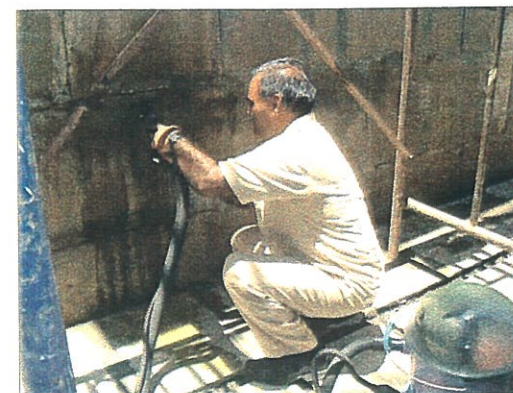
An attempt at use of pressurized steam to remove stubborn tar stains from the stone surface did not prove effective.

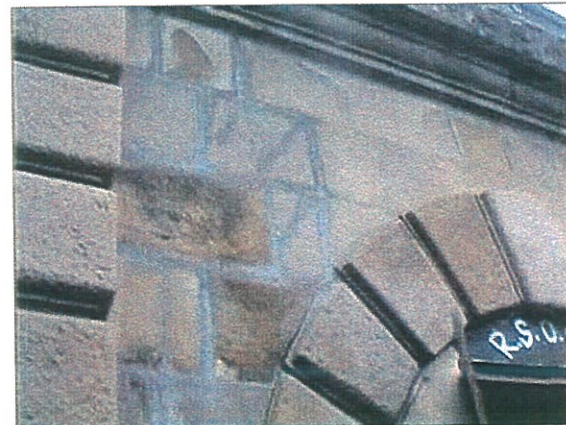
JOINTS AND CRACKS IN ASHLAR MASONRY SEALED WITH CEMENT

- Randomly located fine superficial cracks in the body of the stones
- The wide, depressed border profiles of the stones having been mistaken as wide open joints had been completely sealed,
- A complete fill of open joint profiles in the masonry

- Stubborn cement application removed optimally by tapping and light abrasive hammering. At a few locations the attempt was abandoned for reasons of causing undue damage to the body parent stone.

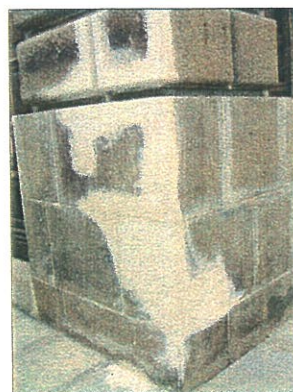
Plastic Repairs using lime mortar in locations where part stones had spalled

- Plastic Repairs using lime mortar in locations where part stones had spalled.

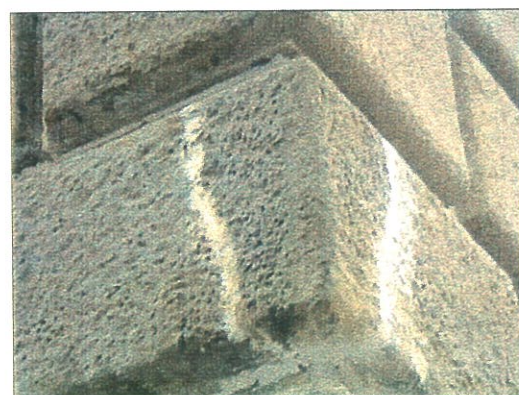
Damaged corner stone restored by stitching with SS pins and lime mortar jointing.

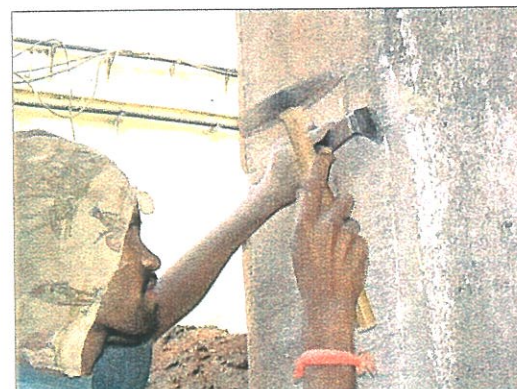
Removal of cement pointing / accretions by tapping.

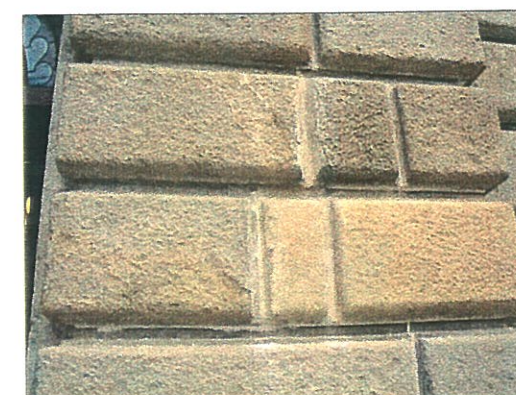
Stone masonry after removal of cement accretions and cleaning.

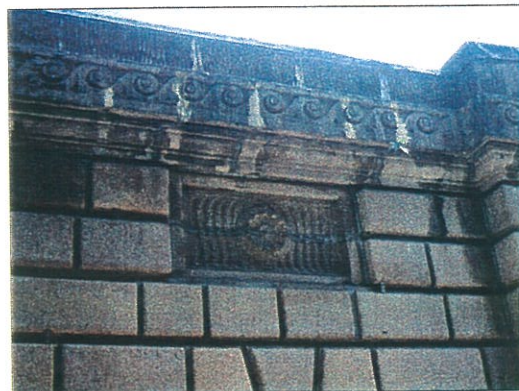
Decorative façade features damaged by soiling / tar stains and cement application (before restoration)

- Weathering stains
- Stains due to water flow
- General atmospheric soiling
- Tar

- Attempt to fill cracks / repair damaged portions with cement mortar
- Recessed band, an integral component of façade design along the top of the pediment filled with cement mortar

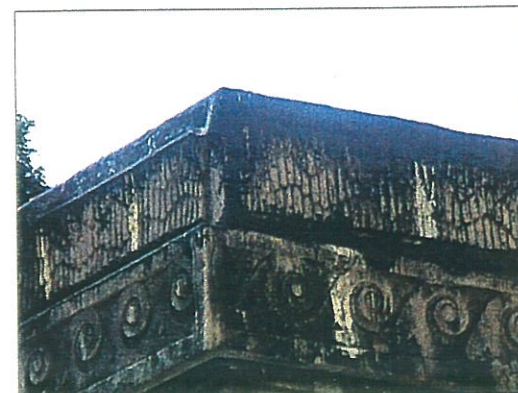
Cornice and frieze bands soiled by tar stains and weathering

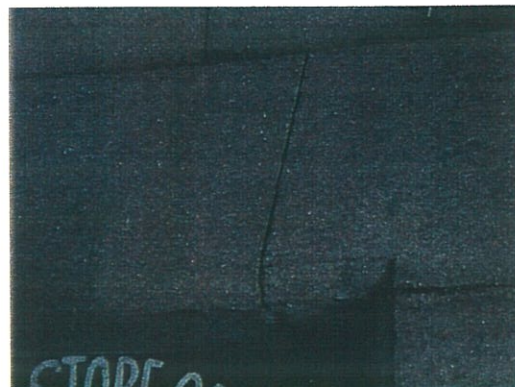
Structural crack in partition wall between the hall and the rooms caused due to insertion of steel beam. Note the disintegration of the stone voussoir at the beam.

Cause: Ceiling fans hung on steel angles, "L" shaped & Jointed back to back, forming a beam spanning across the Hall, supported at the intrados base of the "Bulls Eye" opening in the partition wall. The off-centre support, induced pin pointed, rotational action in the masonry, and a resultant vertical through crack, traveling the full height of the walls - both partition walls.

Treatment: The crack along its run is stitched using SS pins, grouted correctly into the parent wall structure and covered in lime plaster in the rooms.

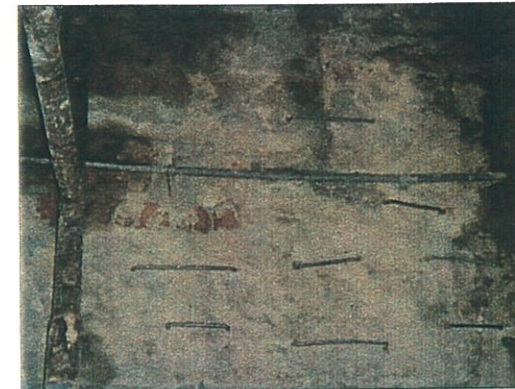
Vertical structural crack in the partition wall between the central hall and the rooms stitched with SS pins.

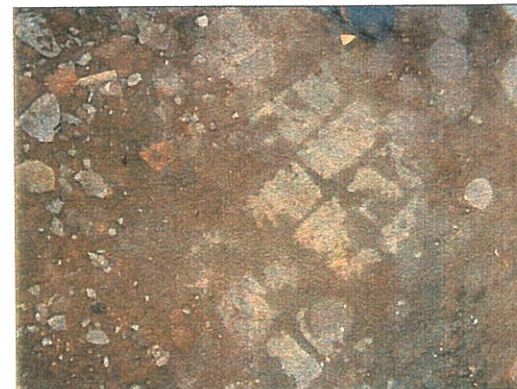
Removal of filling material and debris revealed the original cobbled floor in excellent condition.

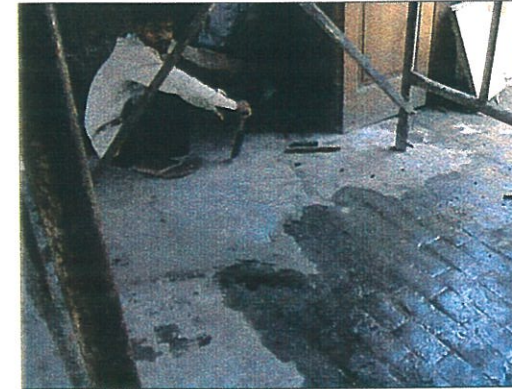
Cleaning the cementitious layers off the cobbled floor was a painstaking task.

- Scrubbing / tapping to remove dirt, cement accretions from cobbles
- Replacement of damaged cobbles (by cobbles obtained elsewhere on site)
- Pointing in Lime
- Kotah stone slabs, size 33 cm x 33 cm laid in diagonal pattern
- Skirting of Kotah stone (half tile)

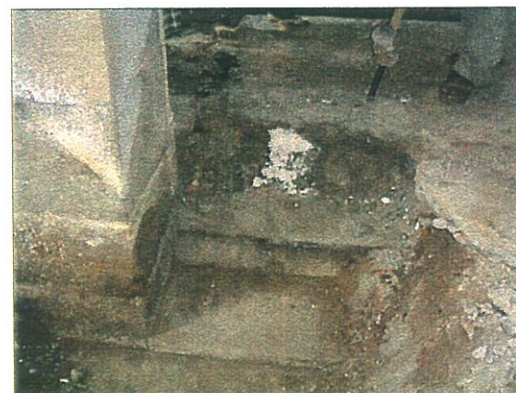
Dressed stone steps between the central hall and the rooms found during excavation.

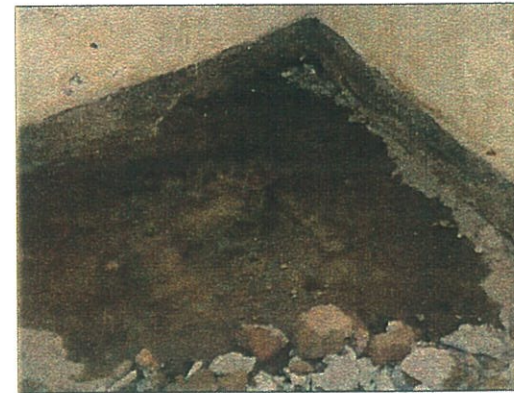
Shahbad stone flooring explored in the rooms was fairly damaged and uneven.

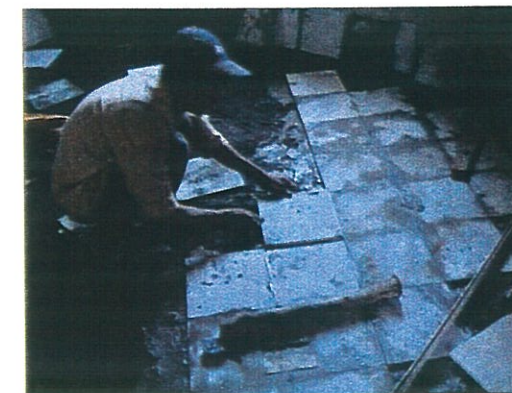
Laying of Kotah stone flooring in diagonal pattern (in the rooms).

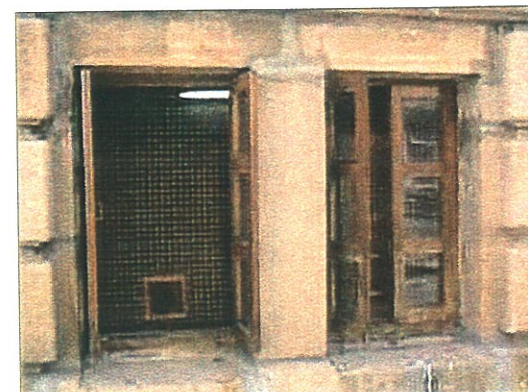
*Rectangular openings in the rooms before
restoration.*

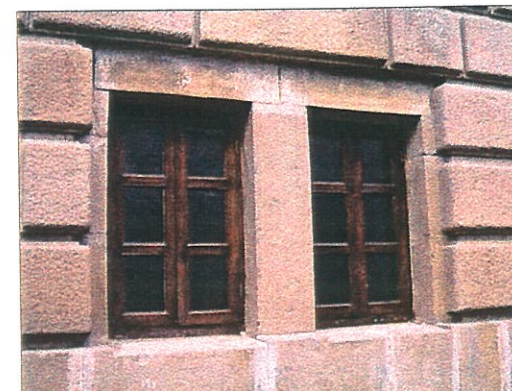
*Original window frames and shutters
replaced by new windows.*

- All windows are replaced by timber windows of new design retaining the original direction of shutter opening.
- The semi-circular arched opening relates in design to the arched doors including the use of stained glass.
- Simple mouldings
- 6 mm clear glass for shutters
- Finish in melamine polish
- Removal of cement pointing and repointing of stone joints in the jambs, cracks and window surrounds with Lime mortar.
- Introduction of internal Kotah stone sill.

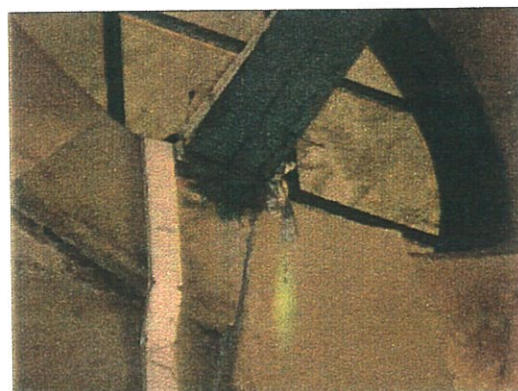
Insertion of MS angle through the ox eye window caused damage to the voussoirs and lead to vertical structural cracks.

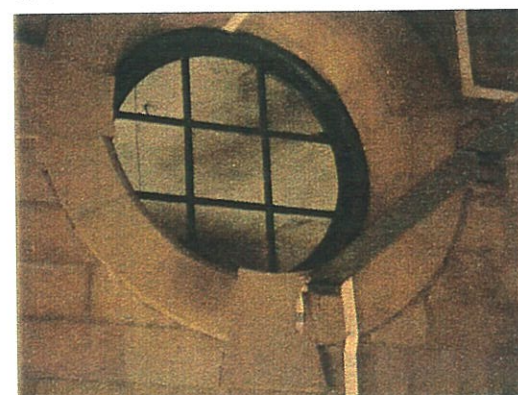
Ox eye window damaged by incompatible interventions.

- Plastic repairs for damaged portion of the Bull's eye window.

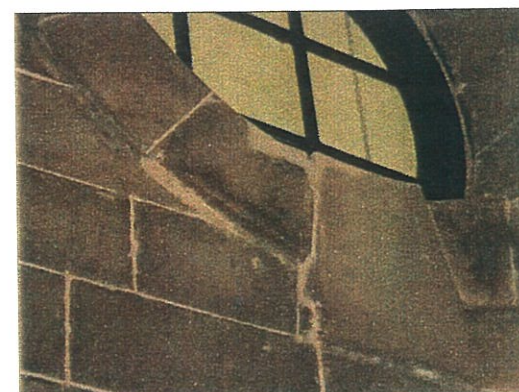
Voussoirs of the ox eye window restored with lime mortar. The structural cracks were stitched with SS pins.

- Stitching of crack with SS pins, sealing the crack with lime mortar.

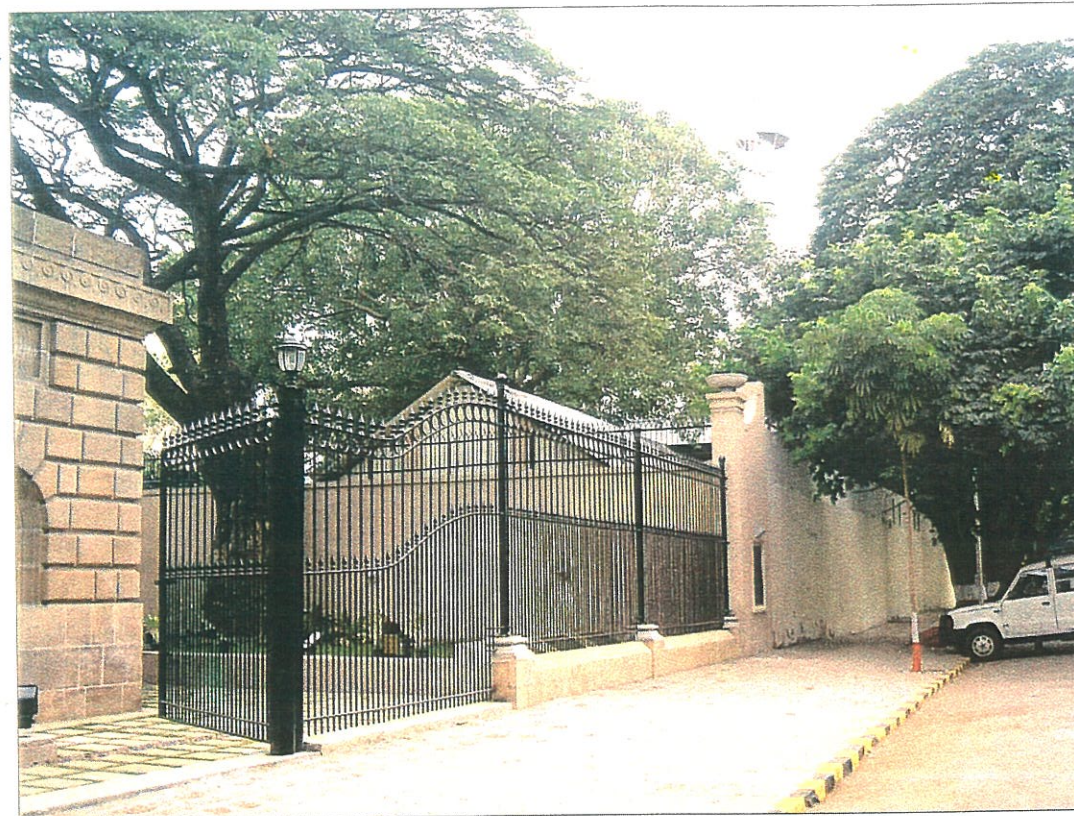
HIGH SECURITY WALL OBSTRUCTING VIEW OF THE GATEHOUSE – BEFORE RESTORATION

ACTION: IT IS PROPOSED TO BRING DOWN THE WALL AND REPLACE IT WITH GRILLS AND FENCING OF A DESIGN APPROPRIATE WITHIN THE NEO-CLASSICAL SETTING. THE SECURITY ASPECT OF THE NAVAL DOCKYARD WHICH IS DIMINISHED IN THE ABOVE ACTION IS PROPOSED TO BE RESTRICTED BY TURNING AROUND THE WALL AT THE AT THE REAR OF THE STRUCTURE. THE PROCESS AFFORDS A PROPER SETTING TO THE GATEHOUSE BY CREATION OF A PROPER PLOT AREA WITH OPEN SPACES. ALSO IT IS PROPOSED TO LOWER AND DIRECT THE CABLES INTO THE SUBSOIL ALONG THE LENGTH OF THE WALL.
