**University of Mumbai**  
Restoration of the Convocation Hall

Restoration of the Convocation Hall: The History

## Restoration of the Convocation Hall: Fabric Inspection

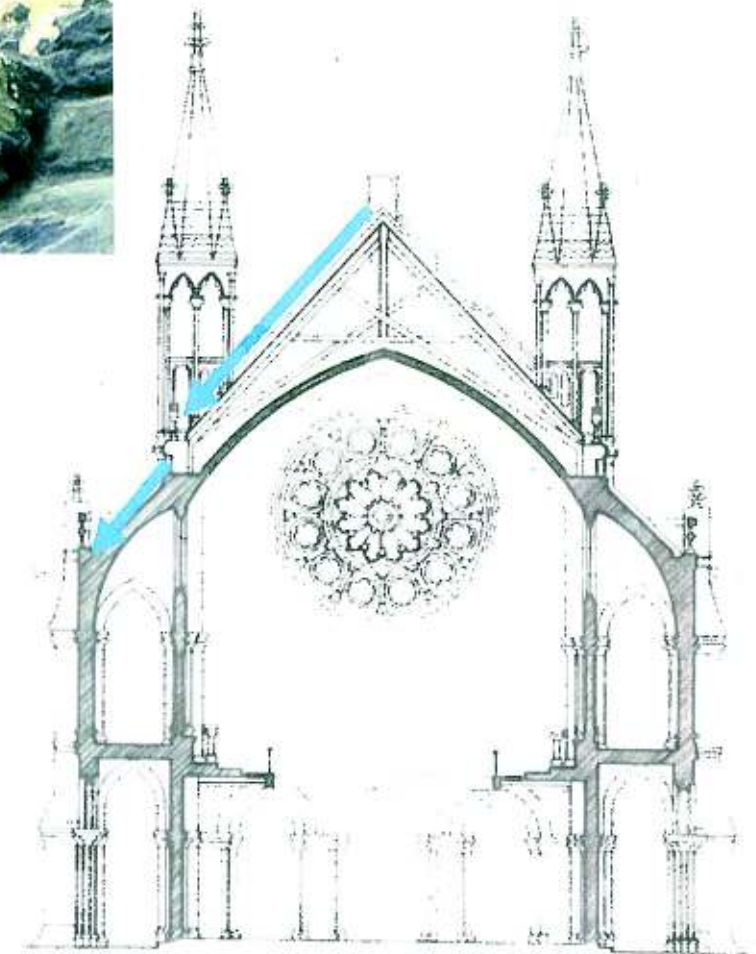
As the roof was layered with bitumen felt each year after the monsoons to prevent water ingress without properly addressing the roof, the layers of bitumen clogged the gargoyles, thus choking the drainage outlets. This caused water to collect at the roof levels, finally percolating through the vaults into the building and showing up as extensive peeling off of the internal plaster and paint in the interiors.

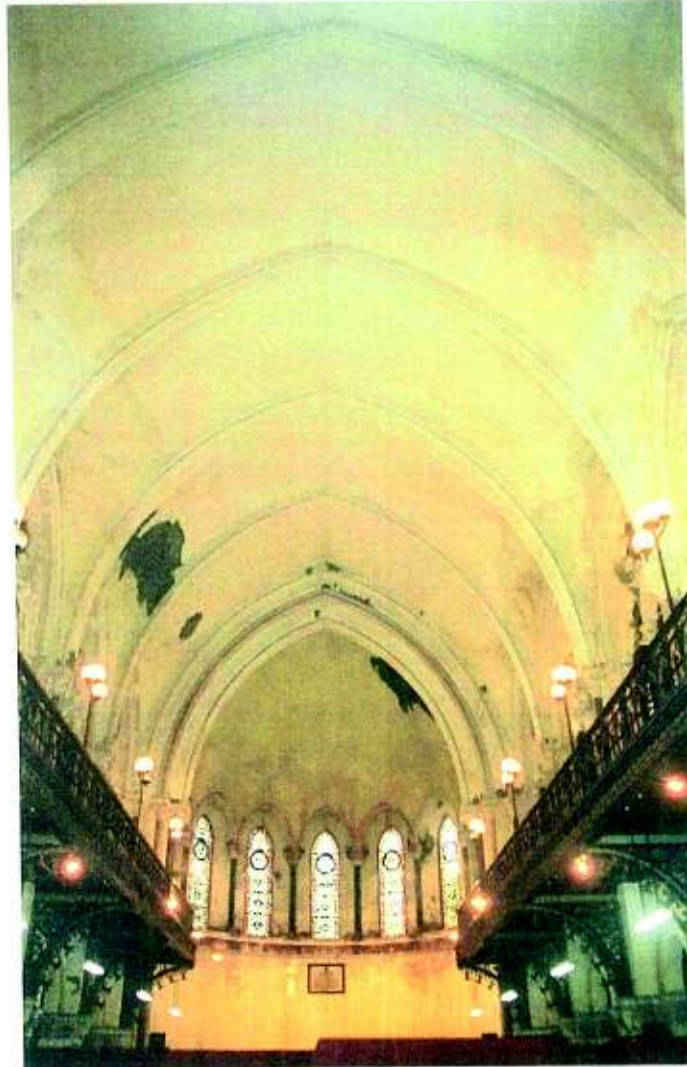
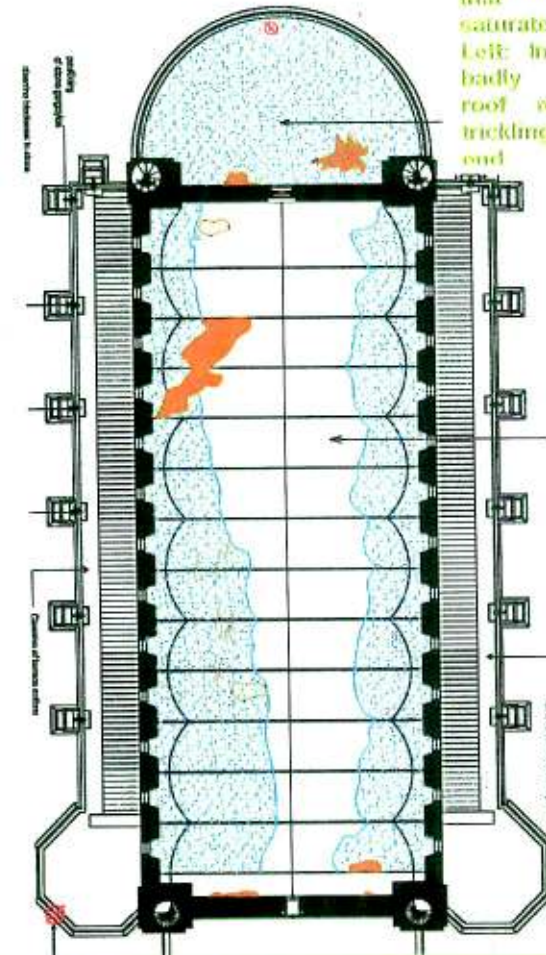
Moisture meter tests conducted during the assessment indicated that nearly 2/3<sup>rd</sup> of the roof vault was saturated with water during the monsoons. This caused serious concerns about its structural safety as chemical analysis of lime mortar samples in the vault showed that the ratio of lime to sand in the lower reaches of the vault had

Below: Fabric inspection drawing indicating the sections of the vaulted roof that were completely saturated with moisture. Left: Images showing the badly deteriorated apse roof resulting in water trickling down the apse end.

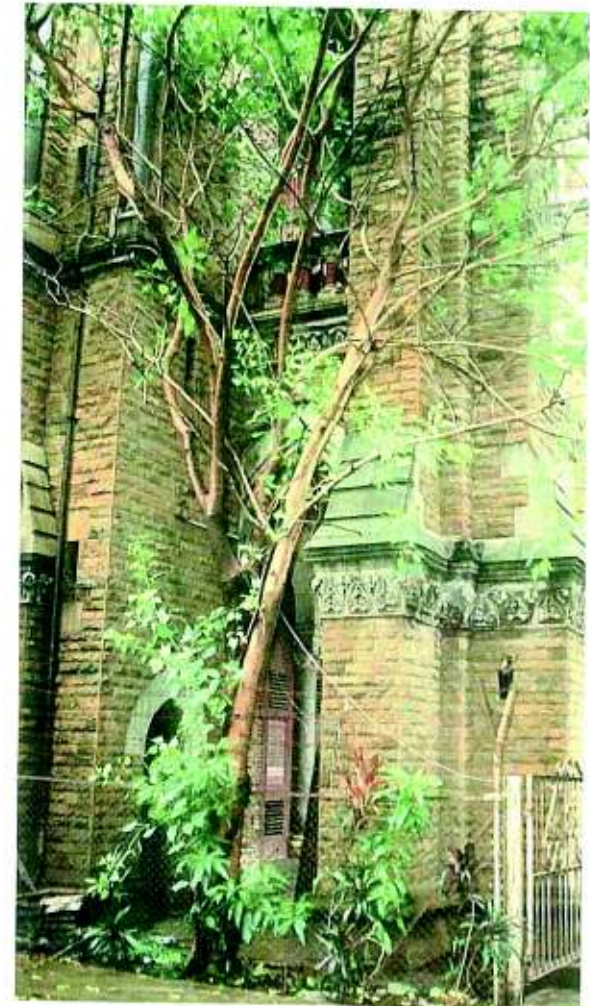
At the north east terrace level, there was a substantial crack along the masonry, with visible dislodging of the stone parapet. This was also true of the northern porch that had a similar problem. This was the result of a large *peepal* plant growing at the terrace level, with its root system embedded into the masonry down to a depth of over three meters. The solution to this was to

cut the ficus plant, pull out the root system and carefully dismantle and re-set the parapet level stones to restore the original level and line. Similar but much larger growths of full grown ficus trees was seen in the south east and south west ends where the root system was too close to the foundations, threatening settlement and cracks.

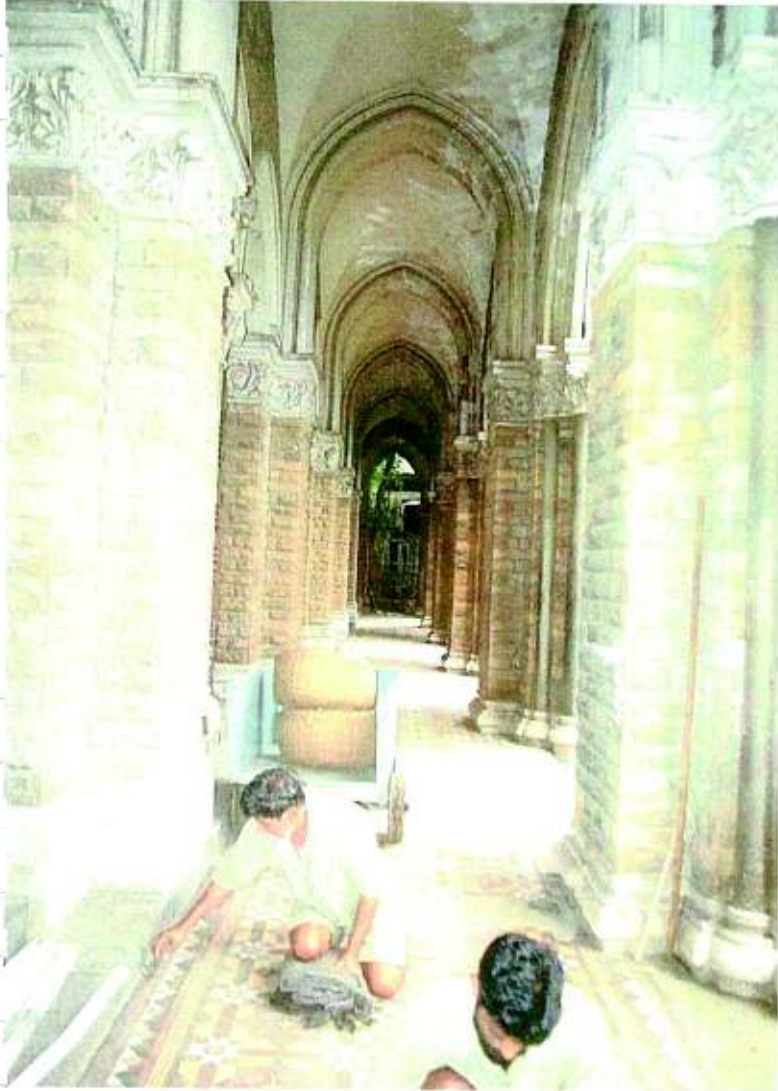
The many rich patterns of Minton tile floor imported from Minton Tile Co. in England, had been damaged at places, with bulged sections or entirely missing sections of tilework infilled with cement patchwork repairs.

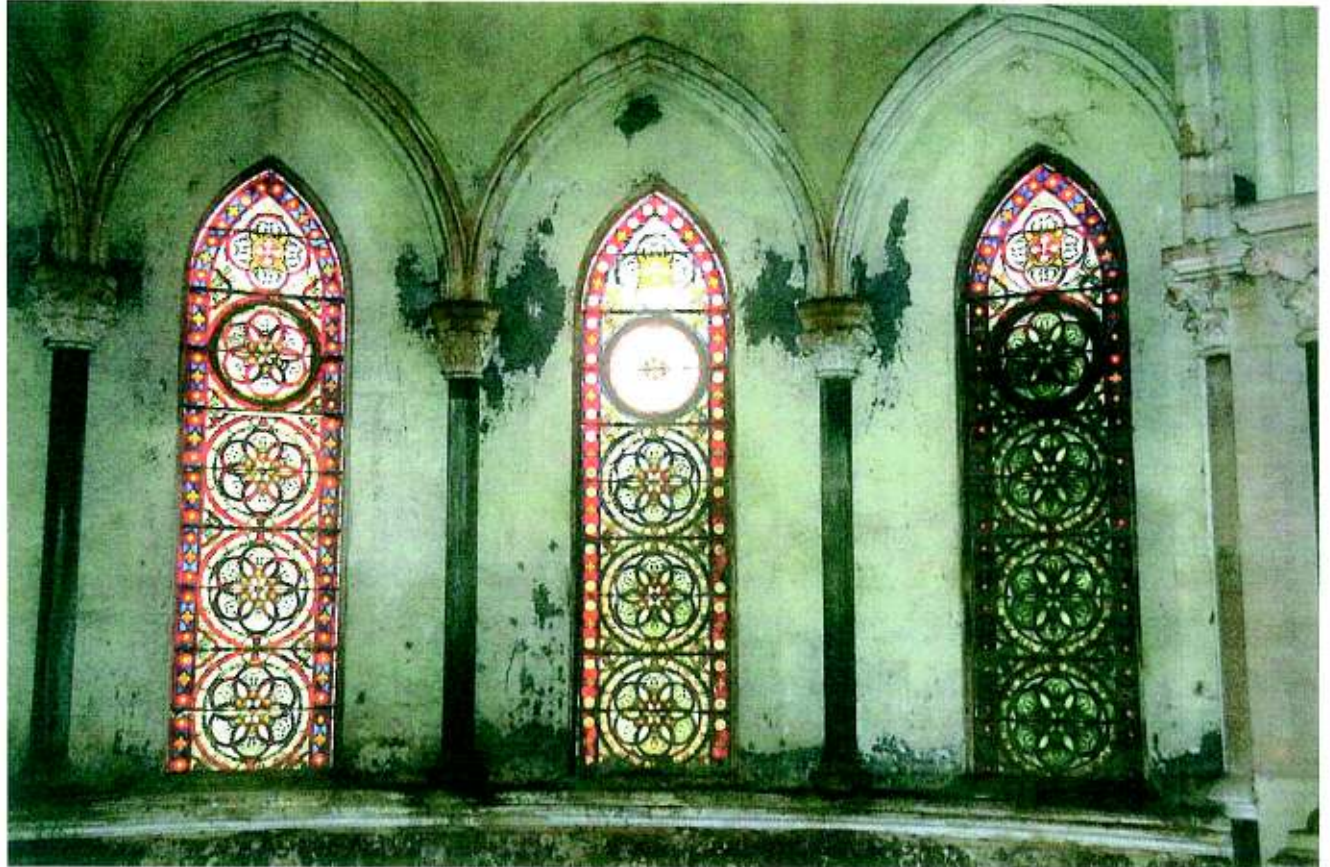
Over the decades, the fine stained glass panels too had developed issues ranging from soot deposition and loss of paint to more severe issues of cracks and shattering of glass, damage to the leading, visible cases of bulging or entirely missing sections. All this required specialized restoration by trained conservators.

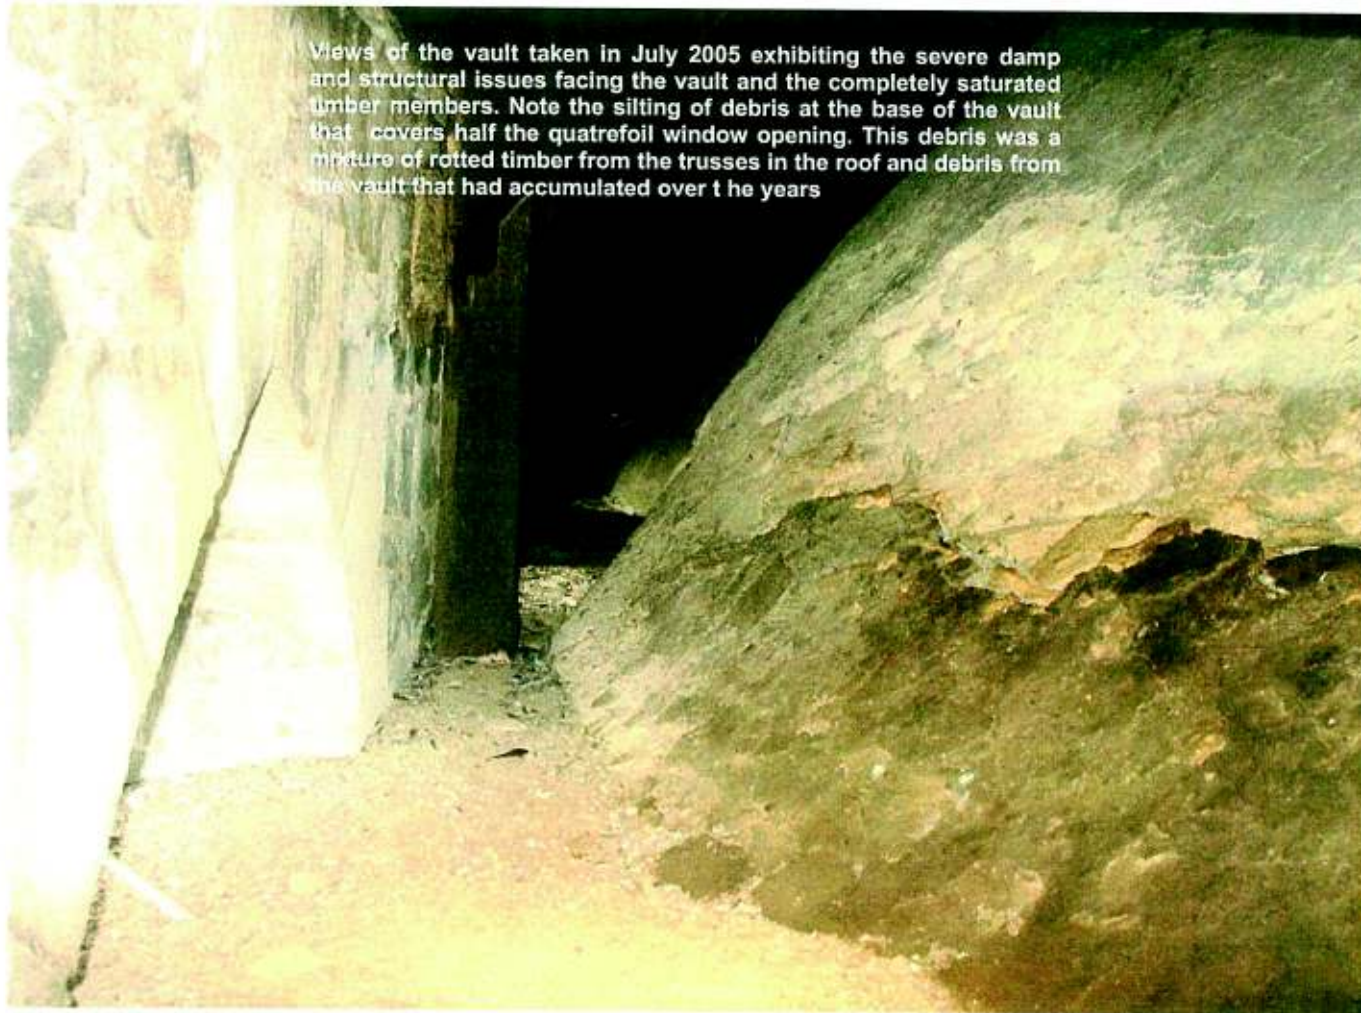
The vault was one of the biggest structural challenges in the building as it was constructed with rubble stone and lime concrete. This was subject to a great amount of leakage over the years since the roof above had been leaking. The constant leakage from the roof had leached away at the lime binders holding up the stone vault and water had so saturated the vault that even the acoustic lining below the wall was peeling off as it was heavy with water. Investigations into the lime content and endoscopic examinations had revealed that the lime content had greatly reduced in the vault, threatening its structural stability. The vaulted roof thus required considerable structural investigation and analysis.

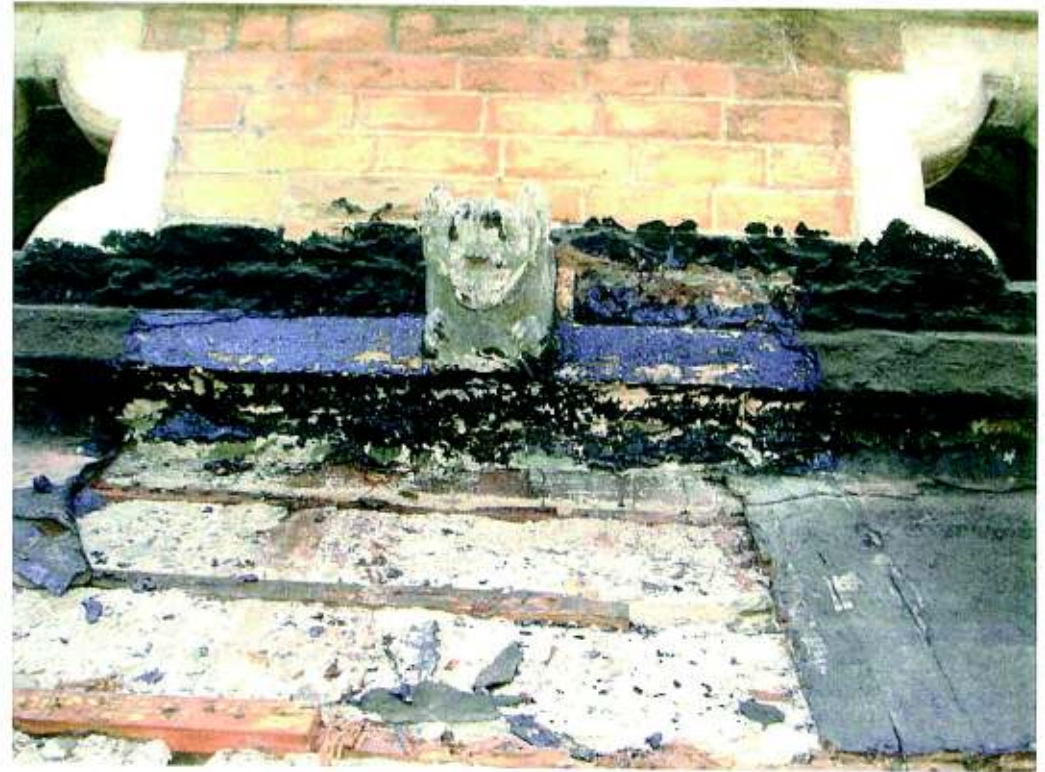
As the lower section of roof was opened out, it revealed a construction of a lime concrete base in which were set timber reapers, over which a tiled roof was laid. As the lime concrete was saturated with moisture, the timber inset in it, rotted and the entire roofing became loose.

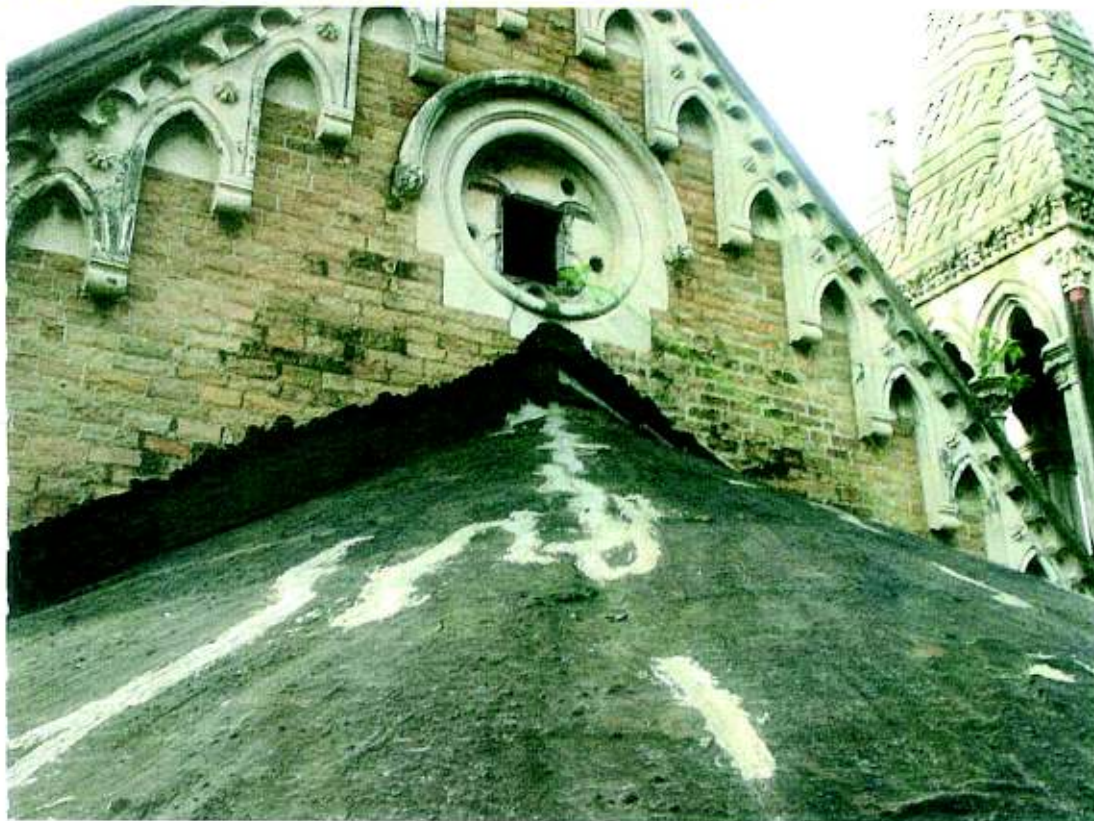
A major point of leakage was the southern apse roof that had been reduced to a layer of bitumen tar felt over timber planking, wholly inadequate for the monsoons. This tar felt too had greatly deteriorated, resulting in the apse roof leaking badly during the rain.

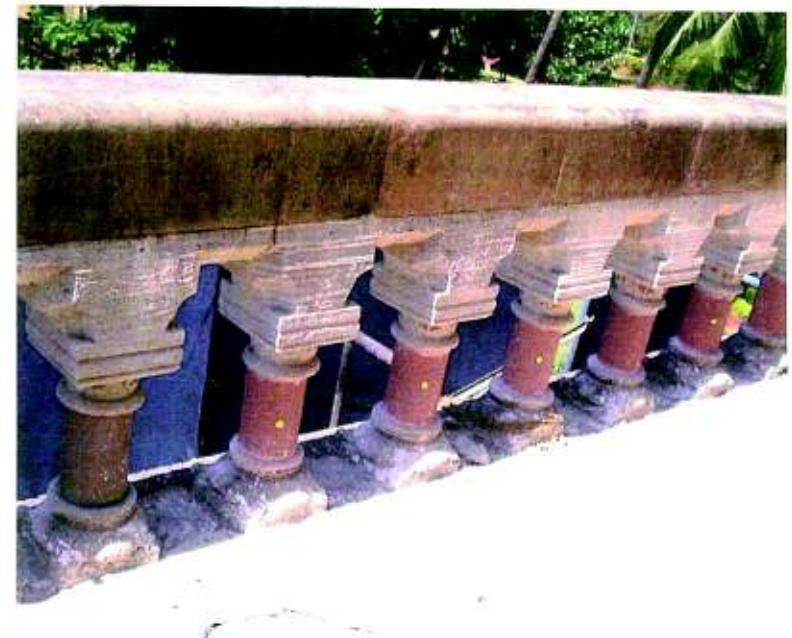
Stone parapets along the northern façade, especially along the front porch and upper terrace were dislodged at places. This was found to be the result of ficus plants growing into the masonry, with their root systems exerting pressure on the stone crevices, eventually leading to dislodged parapets. The tree growths were pulled out and completely removed from the roots by carefully dismantling the stone balustrade, pouring hot lime and the stone work carefully pieced together, correcting the levels.

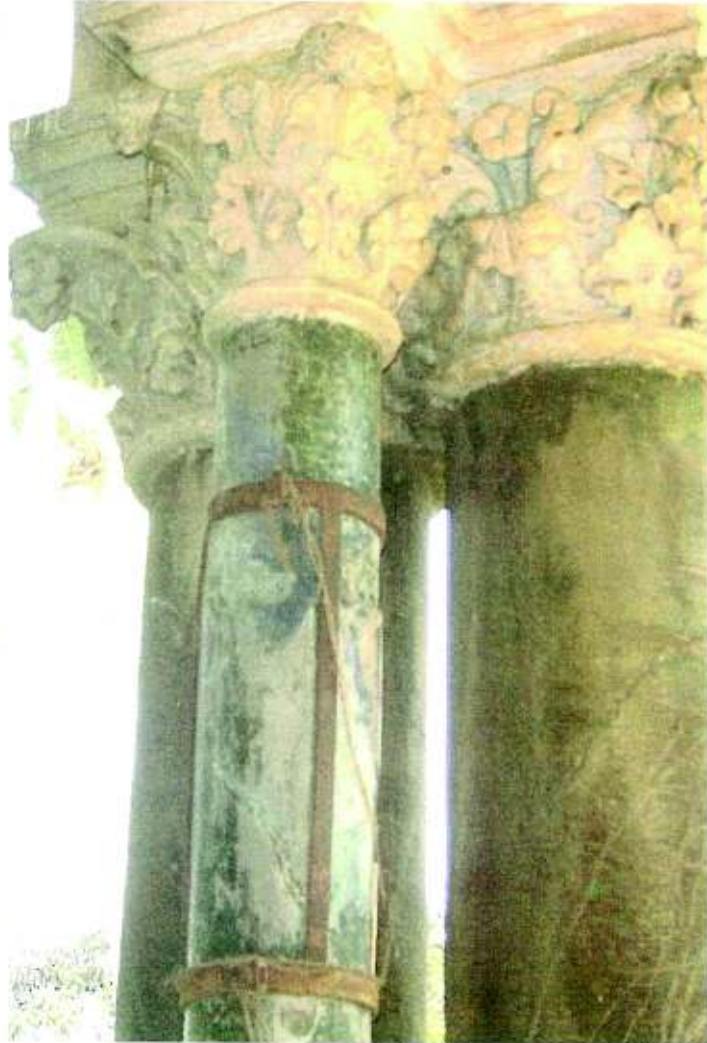
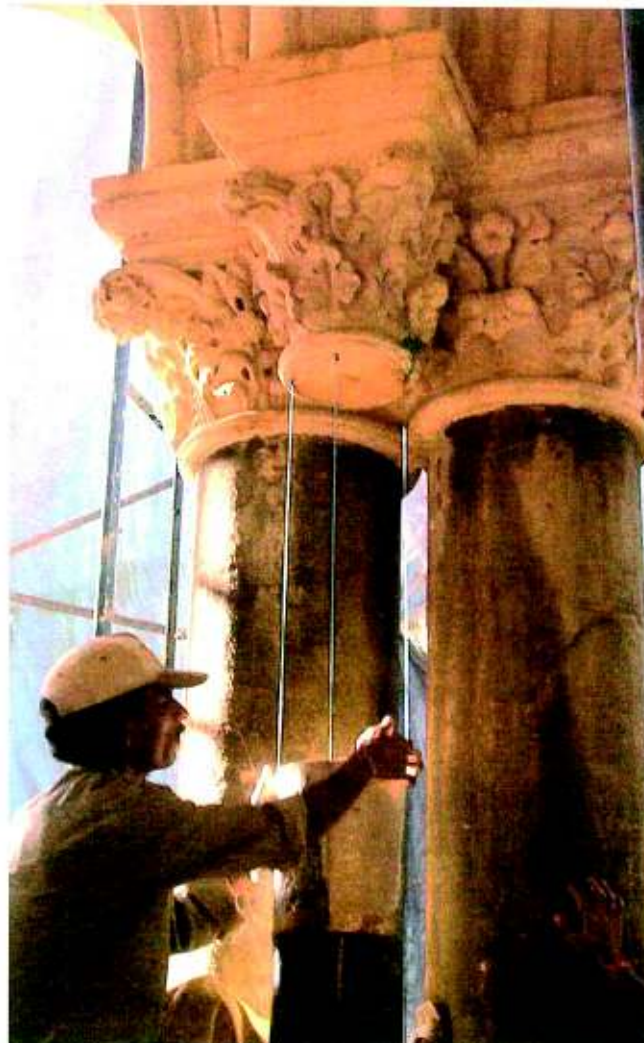
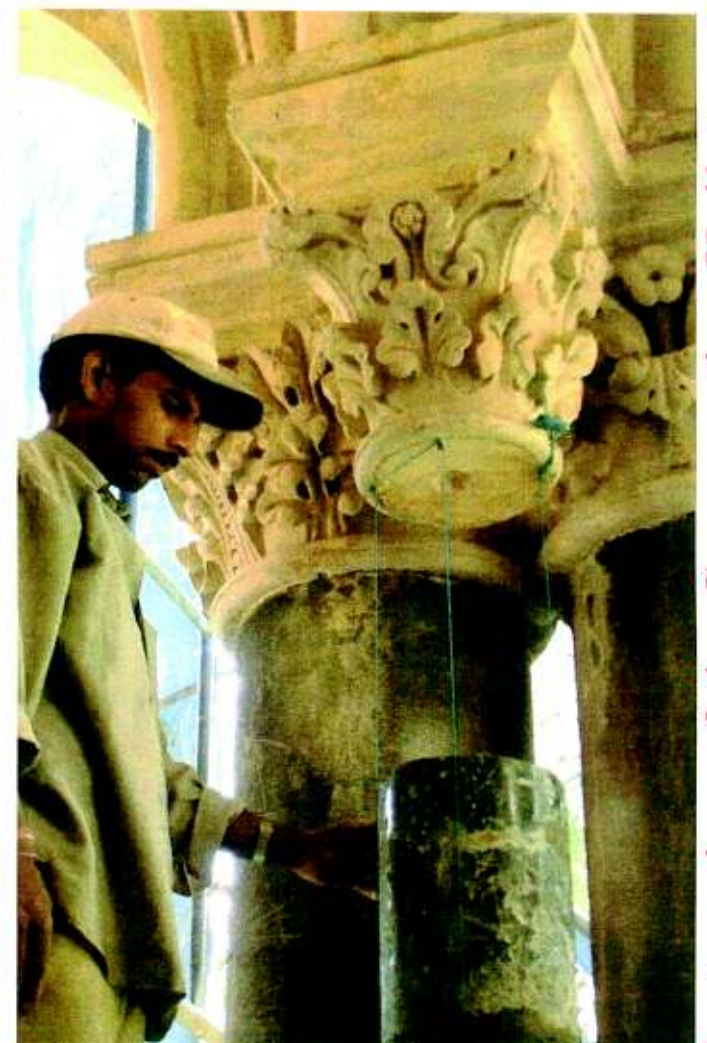
The greenish stone resembling Purbeck marble seen in many of England's cathedral visible in the porch was found to be a serpentine from Karnataka. This had severely deteriorated, and had been strapped with metal in the past. The matching stone was found and cut and traditional stone craftsmen from Gujarat were employed to carefully replace the damaged stone pillars with the new stone.

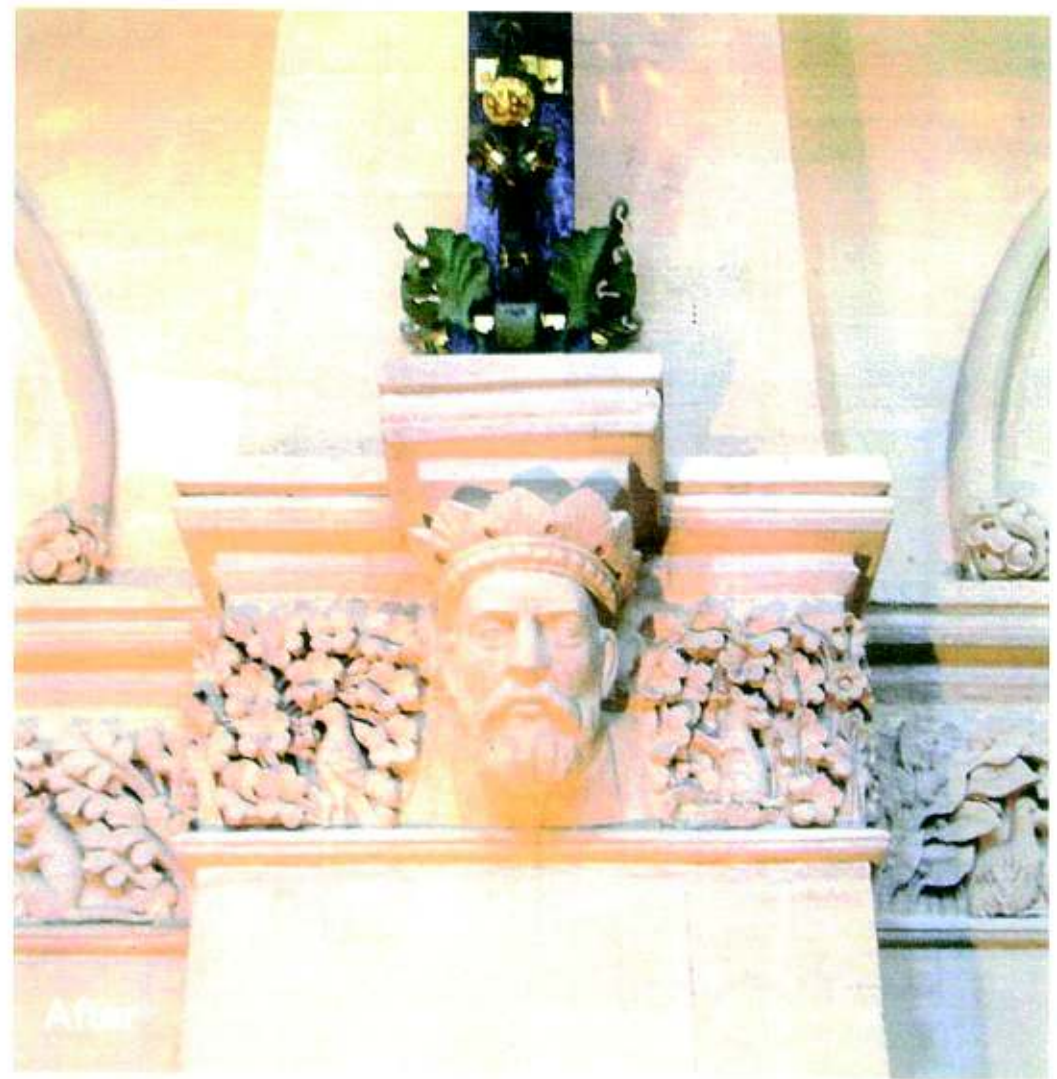
While the paint was being removed, in the case of 2 male heads, the base was found to be made of cast cement, with a steel armature. This was quite a surprise to the team as all the other figures were crafted out of limestone. This would have been a past intervention, possibly as a stone figure head was damaged. It was decided to retain this as a layering of past intervention and the head was given a surface covering of lime plastic repair to match it with the surrounding stone.

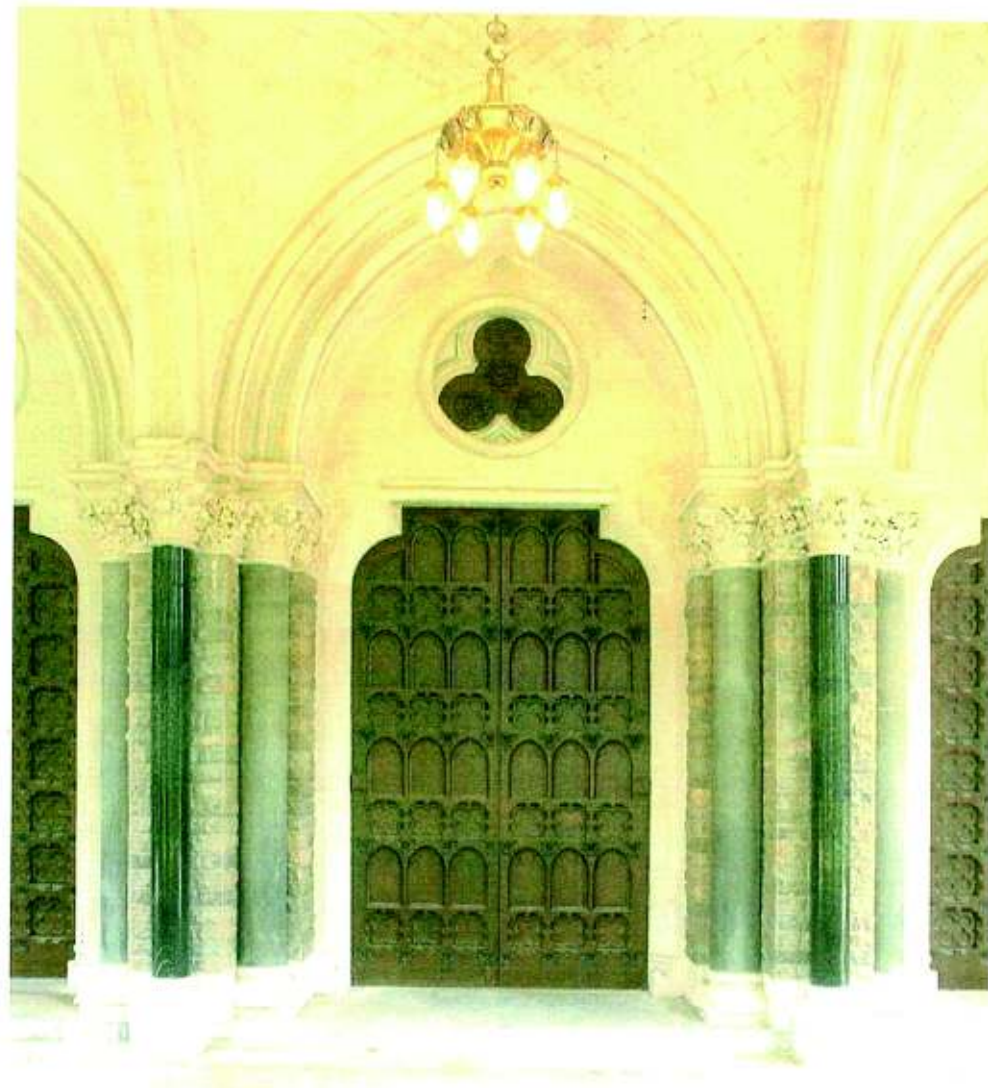
Below: Before and after images of the central entrance door on the north porch that had its trefoil fanlight boarded up with plywood. The other was covered with layers of oil paint. The plywood panels were removed and a missing pentafol pattern refixed in teak fretwork by replicating the surviving piece on the other door.

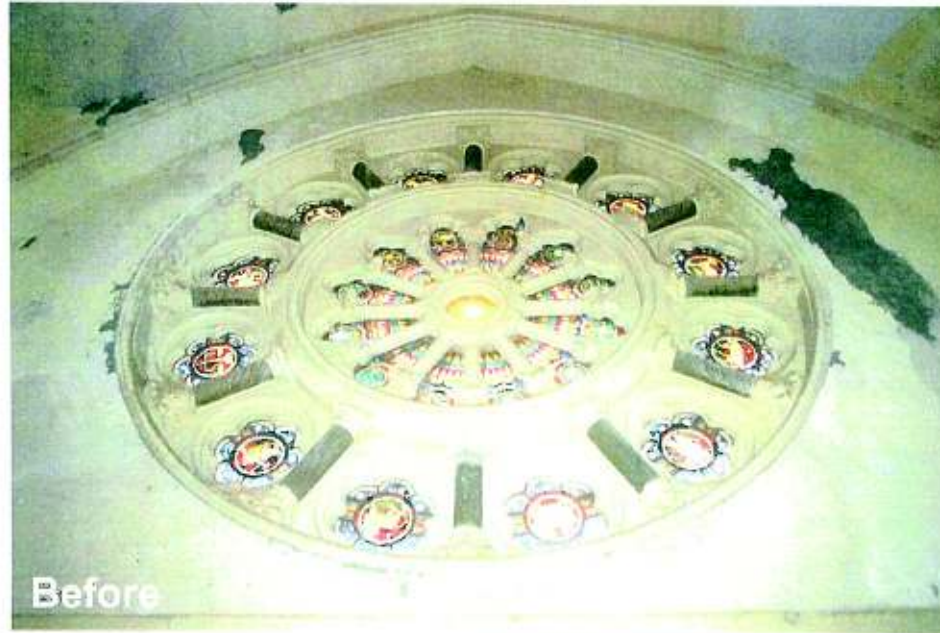
**2. The Wheel Window / Type II:** Here, twelve panels (50% of the window) were found to be buckled and damaged removed. However, as the surrounding material (stone and ferramenta) were found to be good condition, it was decided to repair the panels in-situ. This included stop-repairs to the cracks, re-enforcement of weak lead-joints and re-cementing of the panels on both sides. De-stressing in some panels was also conducted in-situ by loosening the copper-ties and lime-mortar. These time-consuming and complex activities were carried on by Mr Arethna and his team on the scaffolding in the most painstaking manner. Only panels that had paint and glass loss were removed for bench-repair.
