LISTING & GRADING OF HERITAGE BUILDINGS & PRECINCTS IN MUMBAI
TASK II: Review of Sr. No. 317 to 632 of the Heritage Regulations

317 ZAOBA HOUSE		
 	Common Ref no:	2005/GII/317
	Card No.:	1
	Ward (Part):	C Ward
	CS No.	1963
	Plot Area:	318.63 sq m
	Date:	7 th February 05
	Record by:	Sheetal Gandhi
	Review by:	Aishwarya Tipnis
	Int: SG Ext: SG	
	Photo Ref:	317a

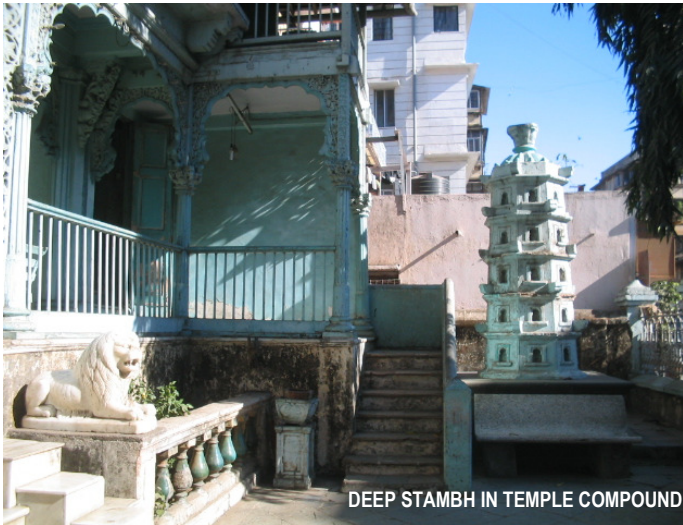
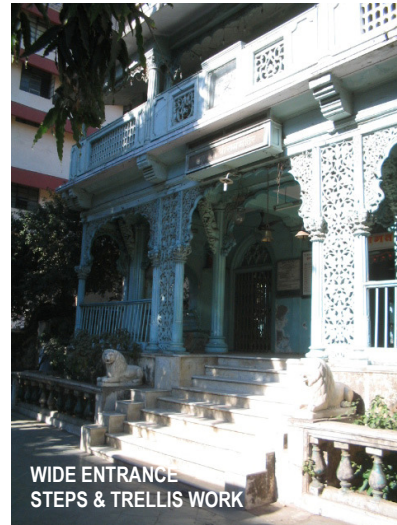
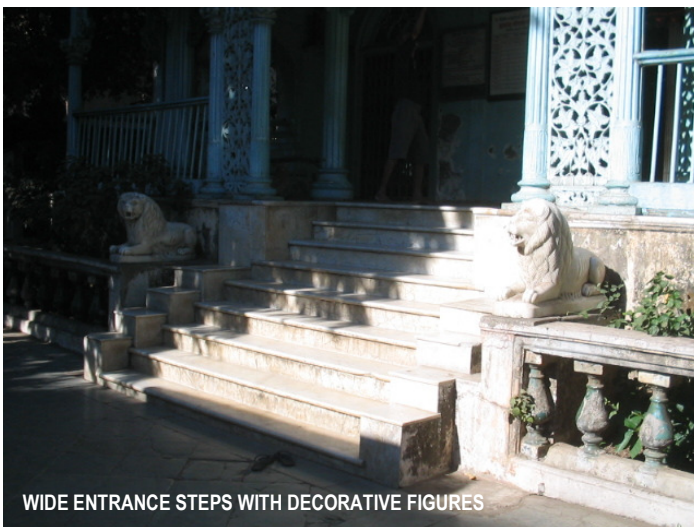
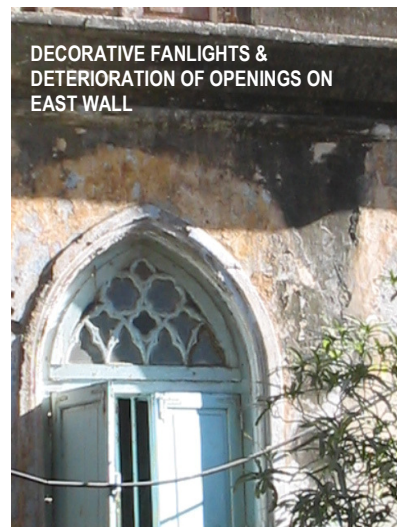
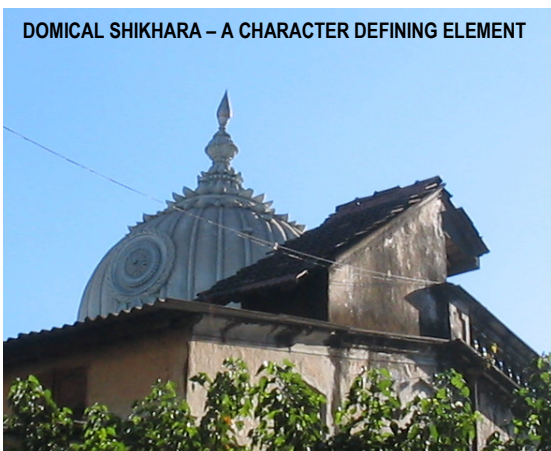
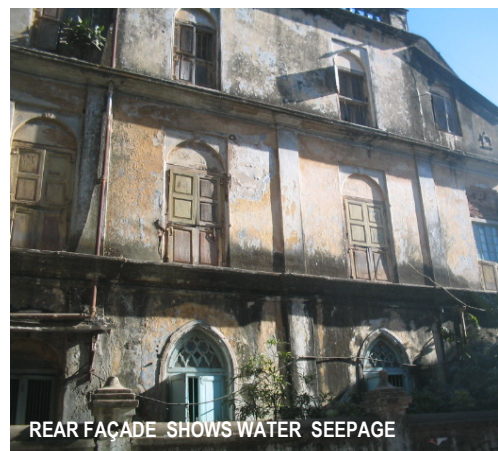
318 ZAOPA RAM MANDIR

9.0		CONDITION
9.1	Plinth	Rising damp observed in front verandah
9.2	Walls	The east, west and south side walls are affected by seepage and water. Seepage from roof on all gable walls and in verandahs on the first floor. Due to the constant damp condition of the wall, there is presence of biological growth in the form of ficus and moss. The paint and plaster has peeled off exposing the brickwork. The walls also show large cracks extending from the openings to the roof.

318	ZAOBA RAM MANDIR	
		structural timber members are free from any cracks and warping or sagging. The end condition of the members also appears to be dry. The windows and doors however, on the east side elevation are in a dilapidated state. This is mainly due to it being unoccupied and in a state of disuse. All wooden frames and shutters are rotting due to constant contact with water dripping from the roof and pipes. Also majority of the openings are in filled with brick or blocked using wooden members or ply.
	Roofing	The fascia boards and gutters are missing from the pitched roof. Also, the end tiles are broken, missing or displaced. The ridge tiles are absent causing the roof to be in a state of total disrepair. The Shikar (onion shaped domical roof over the main temple) is free from any seepage on the inside. The outside also appears to be intact without cracks and fissures.
	Articulation & Finishes	The articulation in the main temple is in the original state and shows no signs of deterioration. The rear residential part of the building is in a dilapidated state and all articulation including fanlights and door / window frames and shutters are decaying.

Services	The downtake and sanitation pipes are in a state of disrepair. They are rusted and have cracks through which water leaks. All gutters are broken and further increase the dripping of water from the roof edge.
.9	Outbuildings	There are no outbuildings within the plot.

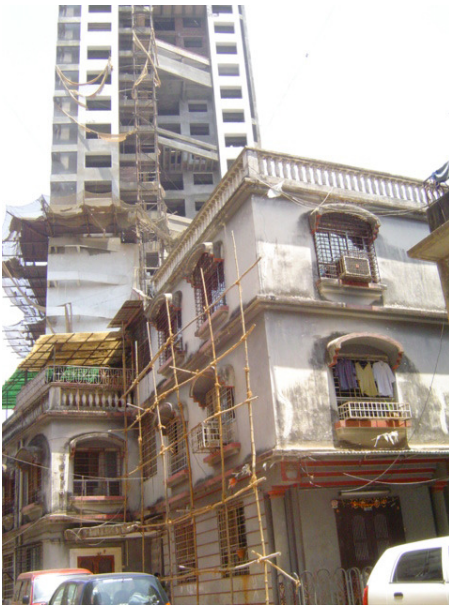
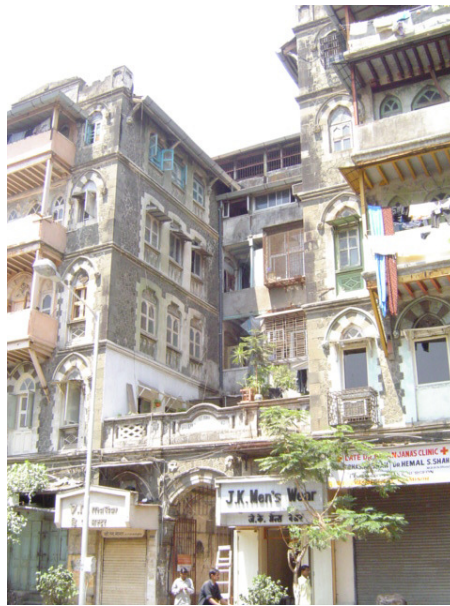
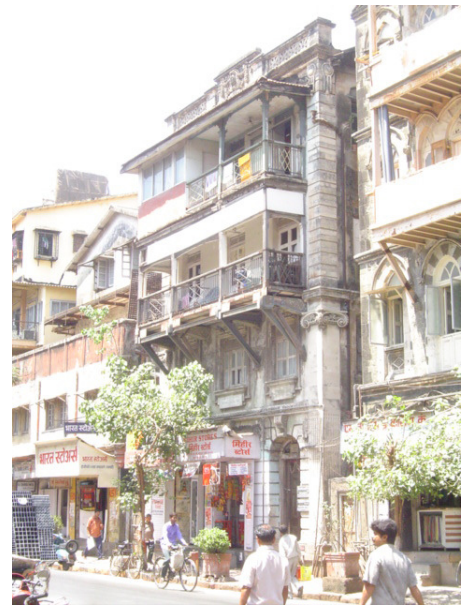
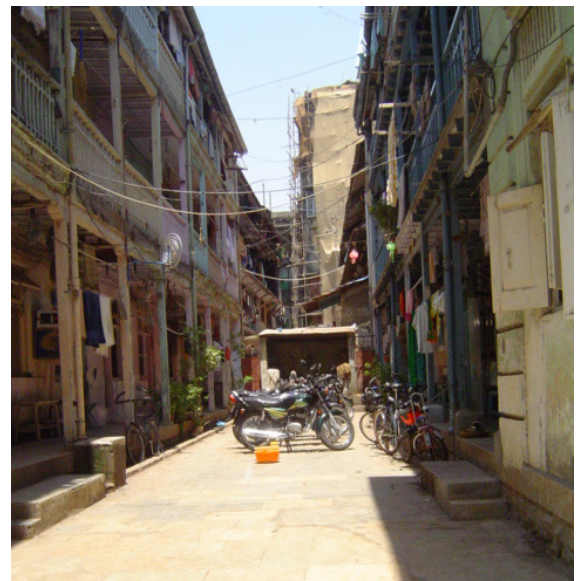
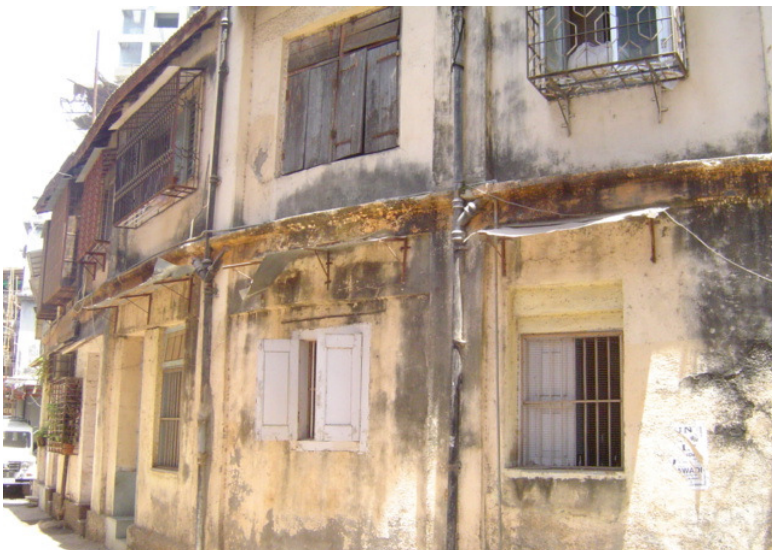
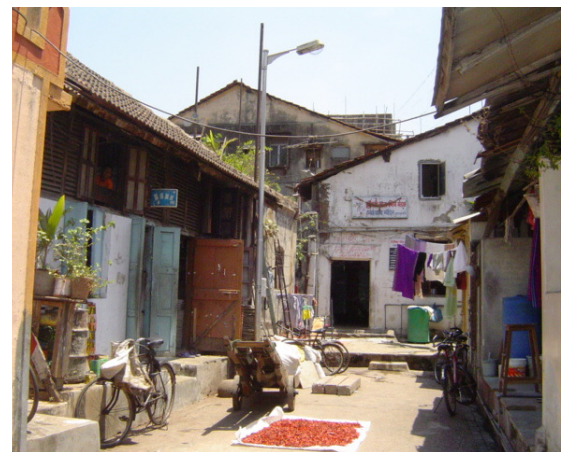
319 ZAOPA WADI PRECINCT

10.0		TRANSFORMATION
10.1	Form	The precinct has completely altered in terms of the features, on account of replacement of original details with contemporary materials, as well as the scale has been totally distorted due to the ongoing construction in the heart of the precinct. The neighbourhood quality of the chawl housing and vernacular dwellings still survives but the housing stock is of poor quality.

10.2	Structure	Timber frame structures have given way to steel stanchions and original buildings have made way for high rises.
10.3	Articulation & Finishes	Original timber brackets have been replaced with steel angles and balusters have been blocked with masonry infills.

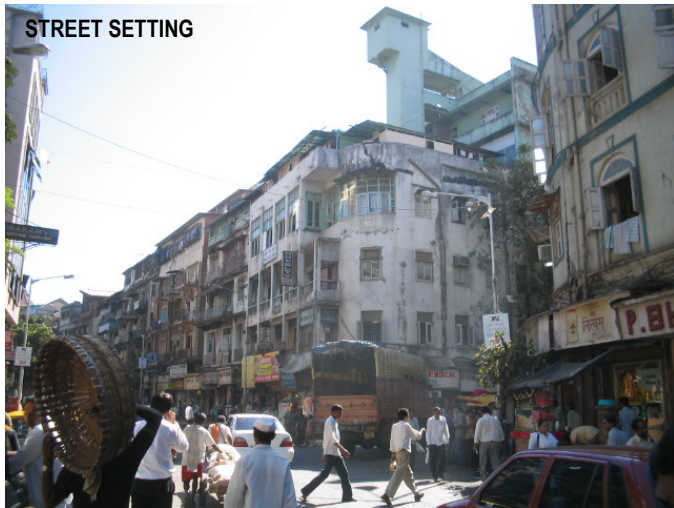
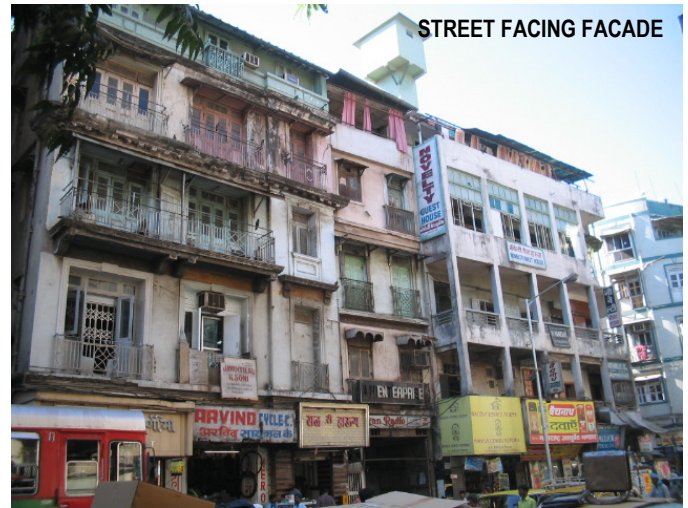
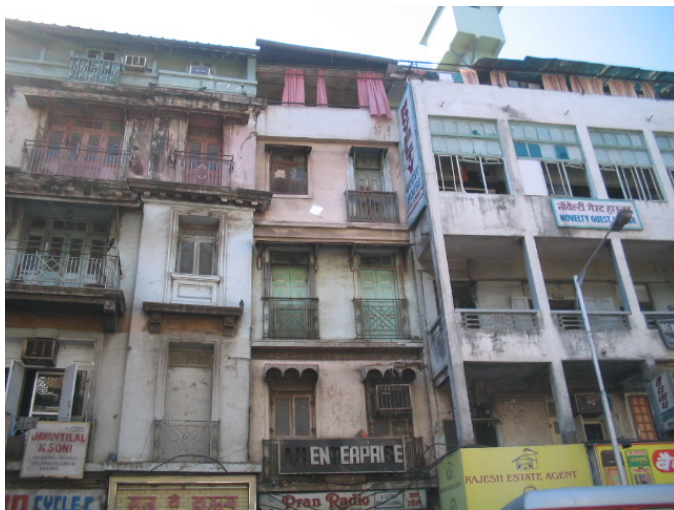
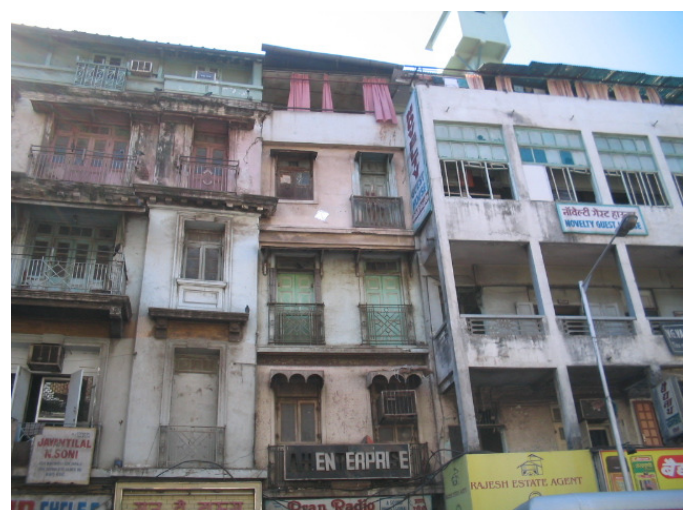
322 KANJI GOKULDAS BUILDING

9.0		CONDITION
9.1	Plinth	No plinth observed as commercial establishments are on the ground level
9.2	Walls	The walls show structural cracks where the renovation has taken place since it has not being done properly, along with it few areas have plastered cracks. Dampness is observed around the areas where drainage pipes run along the façade

INSENSITIVE RECONSTRUCTION HAS LED TO LOSS OF DETAILS
