LISTING & GRADING OF HERITAGE BUILDINGS & PRECINCTS IN MUMBAI  
 TASK II: Review of Sr. No. 317 to 632 of the Heritage Regulations

470 SWAMI PREMPURI ASHRAM TRUST BUILDING

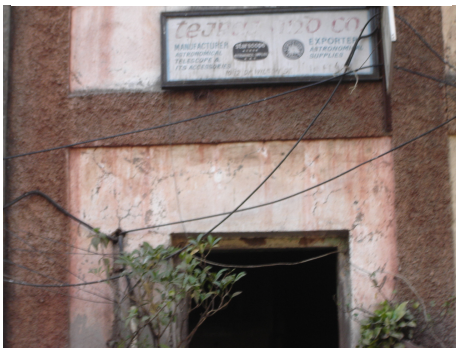
DETERIORATED ARTICULATIONS

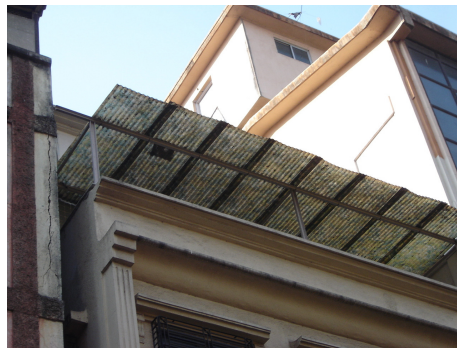
CONDITION OF WALLS
