Final Report of the

DOCUMENTATION AND PREPARATION OF CONSERVATION GUIDELINES for

HERITAGE BUILDINGS AND PRECINCTS IN VASAI - VIRAR SUB - REGION

VOLUME II: APPENDICES LIST OF HERITAGE ASSETS IN THE MUNICIPAL COUNCILS

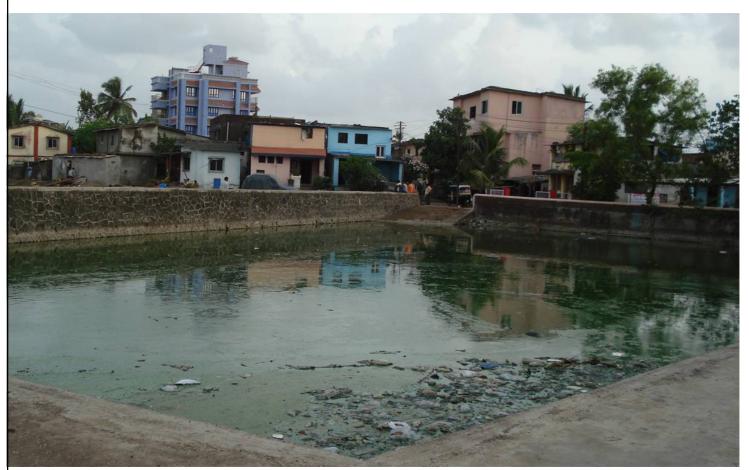
Sanitation: Presently garbage is thrown into the Talav. One of the sides is used for open defecation. Urbanization of the area has led to the mixing of sewer water with that of the talav leading to its degradation. Storm Water Drainage: The storm water from the surroundings flows into the talav. Public Facilities: Inadequate public gathering space, no seating areas. Poor Public toilets that exist on one end remain unused.				have beer	n provided arou	nd the talav.			
used for open defecation. Urbanization of the area has led to the mixing of sewer water with that of the talav leading to its degradation. Storm Water Drainage: The storm water from the surroundings flows into the talav. Public Facilities: Inadequate public gathering space, no seating areas. Poor Public toilets that exist on one end remain unused.									
Storm Water Drainage: The storm water from the surroundings flows into the talav. Public Facilities: Inadequate public gathering space, no seating areas. Poor Public toilets that exist on one end remain unused.		used for open defecation. Urbanization of the area has led to the mixing of

Mixing of sewer water from the new developments in the surroundings with that of the talav leading to its degradation

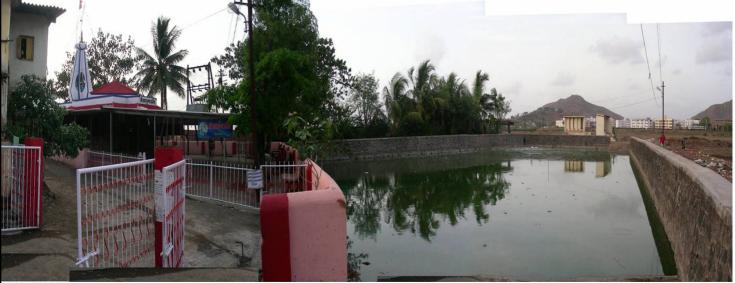
Temple on the left edge and a low level parapet wall on all the other edges

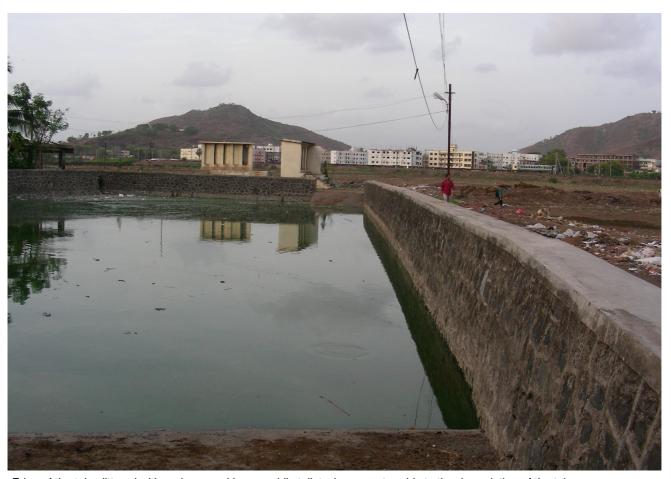
5.2 Physical Infrastructure Lighting: No street lights have been provided around the talav. Sanitation: Presently garbage is thrown into the Talav. One of the sides is used for open defecation. Urbanization of the area has led to the mixing of sewer water with that of the talav leading to its degradation. Storm Water Drainage: The storm water from the surroundings flows into the talav. Public Facilities: Inadequate public gathering space, no seating areas. Poor			nd / Fence / G	ate: A sto	one masonary	retaining wa	II around its	Fair	
Lighting: No street lights have been provided around the talav. Sanitation: Presently garbage is thrown into the Talav. One of the sides is used for open defecation. Urbanization of the area has led to the mixing of sewer water with that of the talav leading to its degradation. Storm Water Drainage: The storm water from the surroundings flows into the talav. Public Facilities: Inadequate public gathering space, no seating areas. Poor	5.2		Infrastructure					Assessment

Edge of the talav littered with garbage and has a public toilet whose waste adds to the degradation of the talav

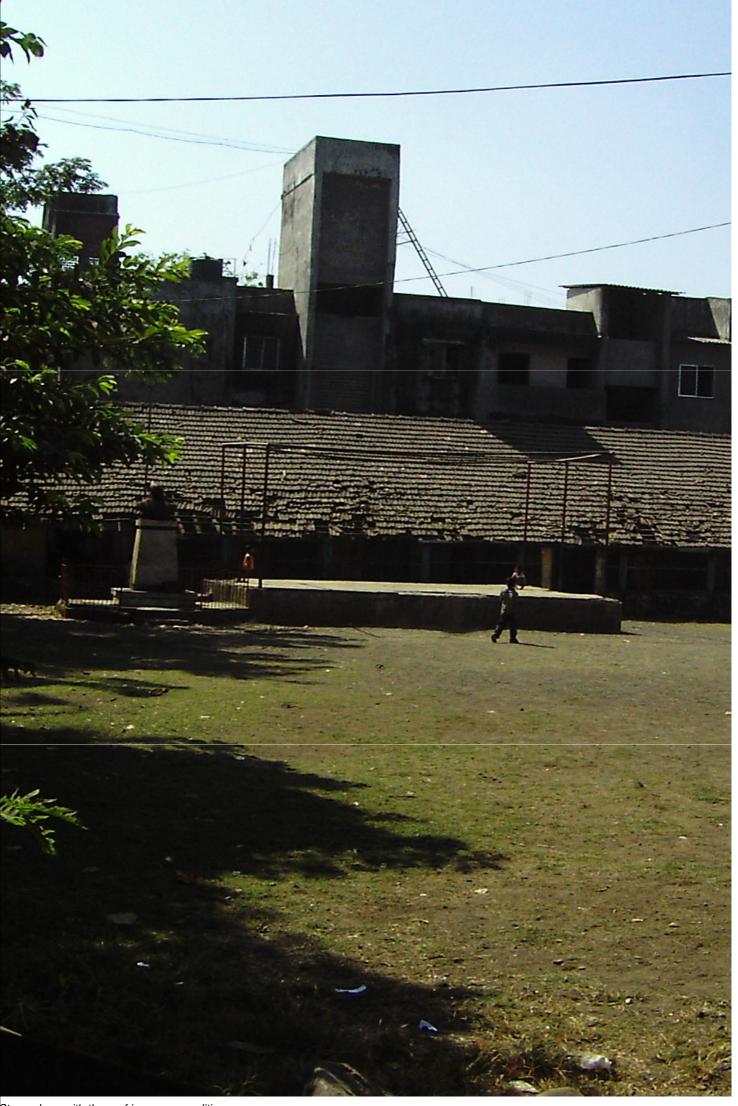
Stage along with the roof in a poor condition

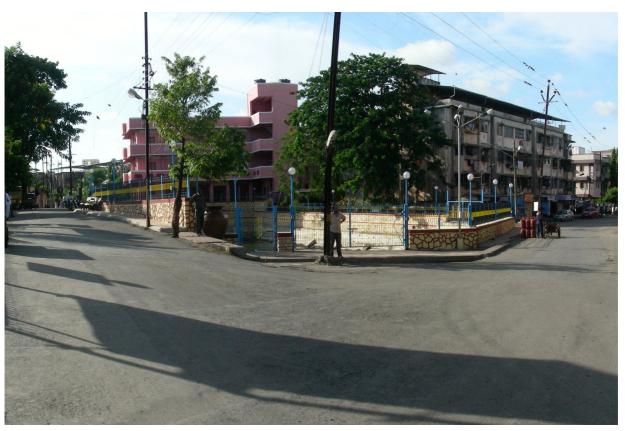
Edge condition of the talav - narrow pavements of approximately one meter width

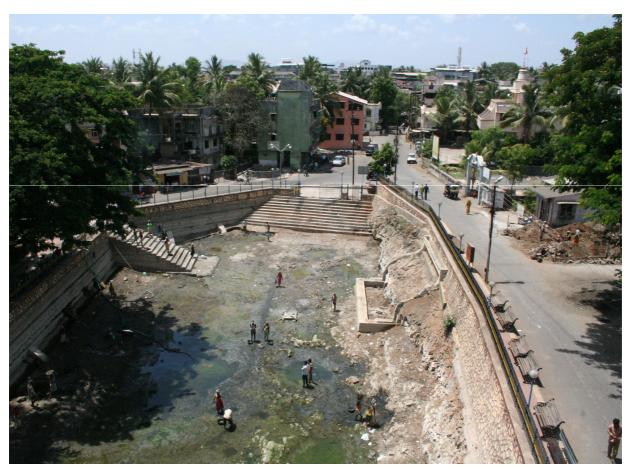
Pitching work being undertaken in the talav; benches for seating along the narrow pavement

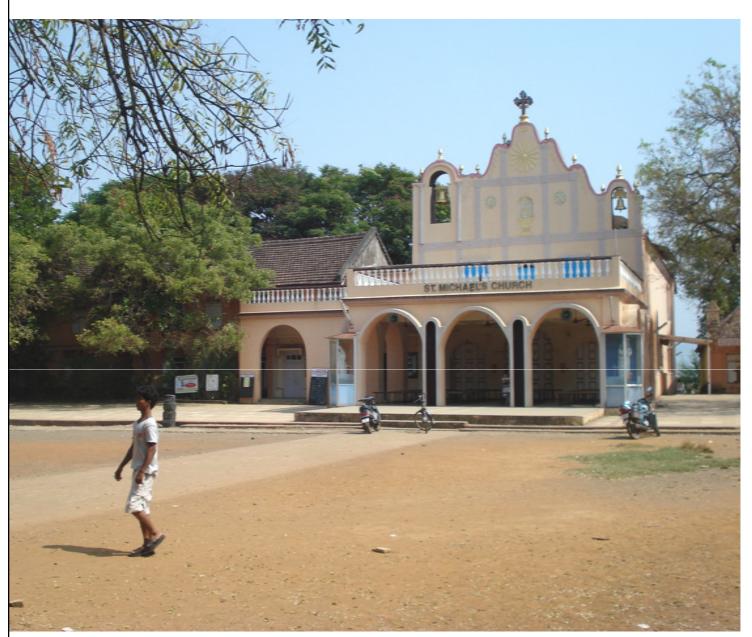
"False" front façade of the church – similar to Portuguese churches in Goa; recent extension of the porch over the front facade

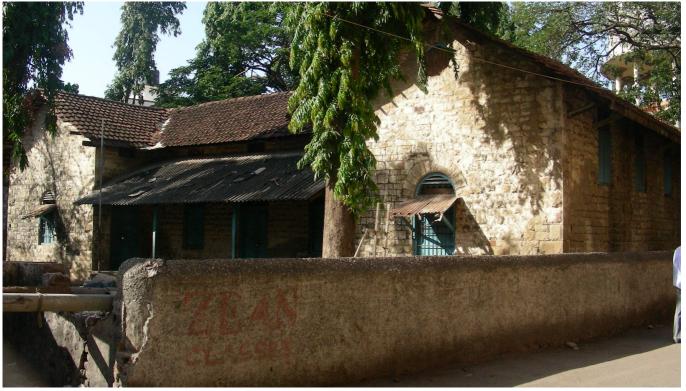
Load bearing structure with Mangalore tile roof which is in a poor condition

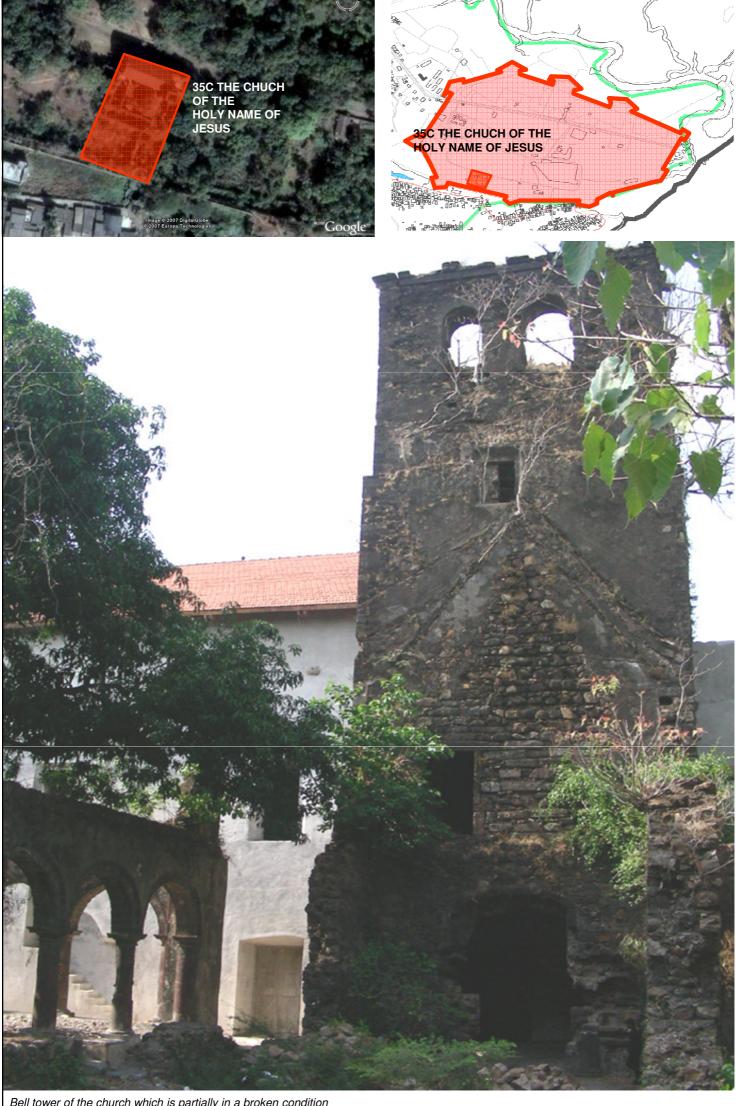
Bell tower of the church which is partially in a broken condition

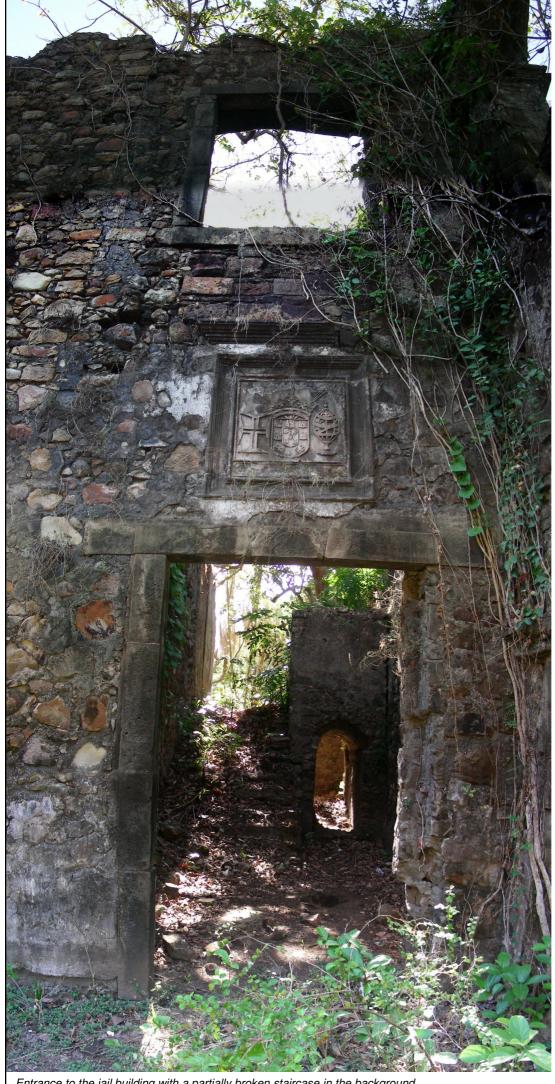
Entrance to the jail building with a partially broken staircase in the background
