HERITAGE SITES IDENTIFIED IN THE STUDY AREA

MUMBAI METROPOLITAN REGION HERITAGE CONSERVATION SOCIETY

Record Details for Hazrat Alishah Darbar

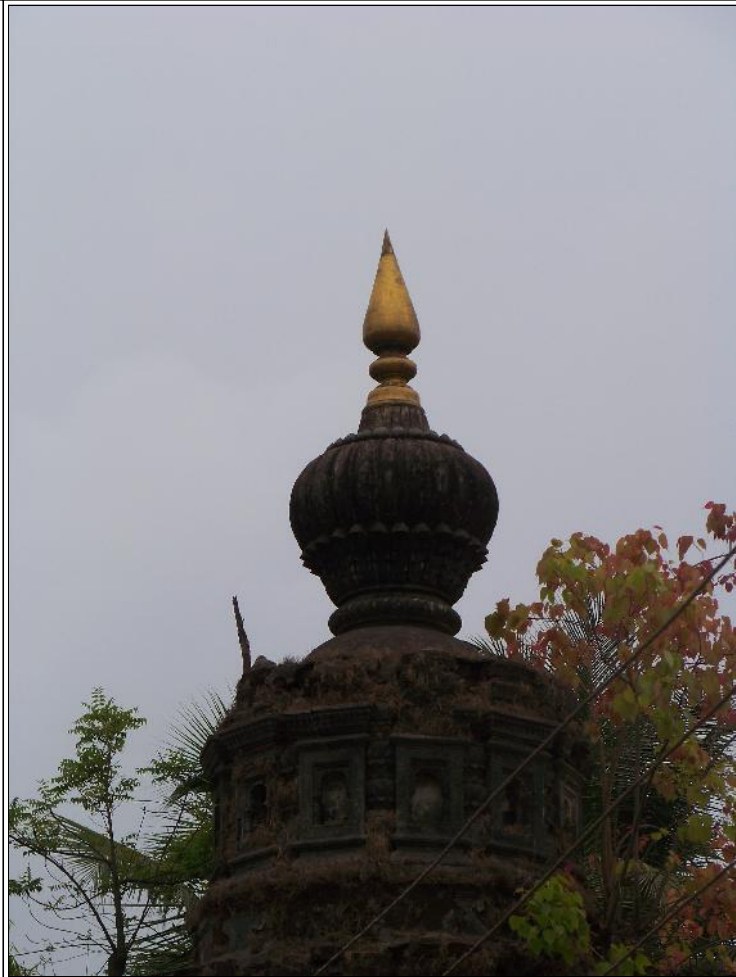
Image Title: Biwalkar Shiv Mandir
 Image Type: Front-View
 Reference: Dilapidated condition of the Shikhara Evidences of good craftsmanship still clearly evident

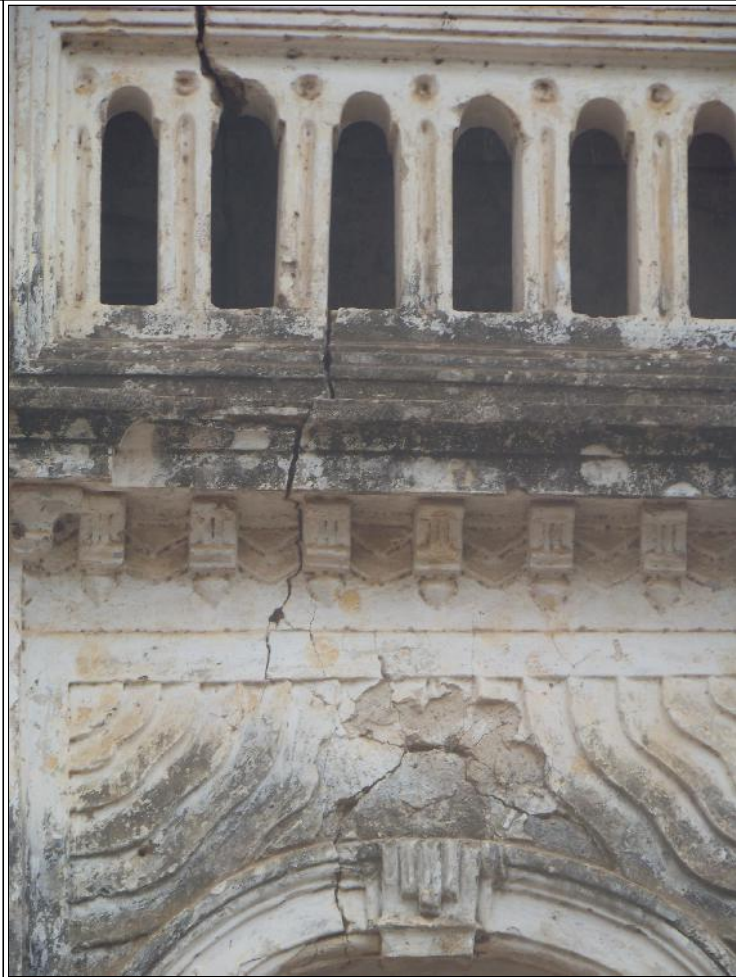
Image Title: Raigad Jilha Macchimar Sangha Ltd.
 Image Type: Front-View
 Reference: Detail view of plinth crack indicating possible differential brittleness

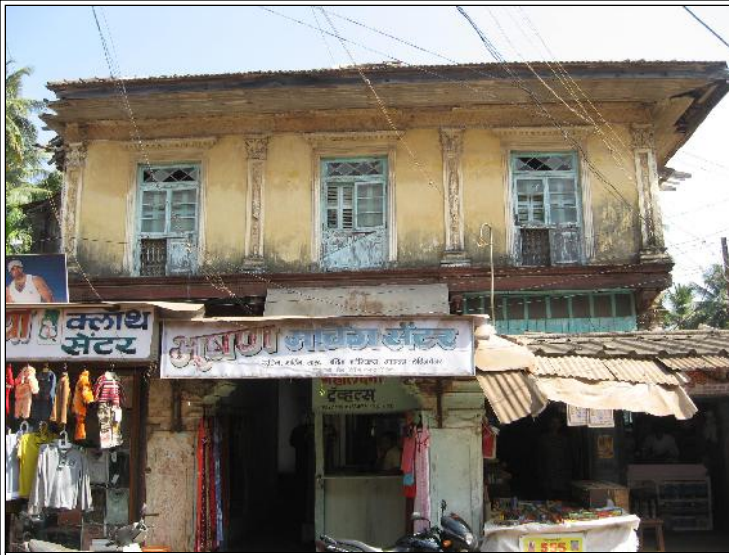
Image Title: Gurjar House
Image Type: Front-View
Reference: View of the sides showing plaster work and the damage caused by water

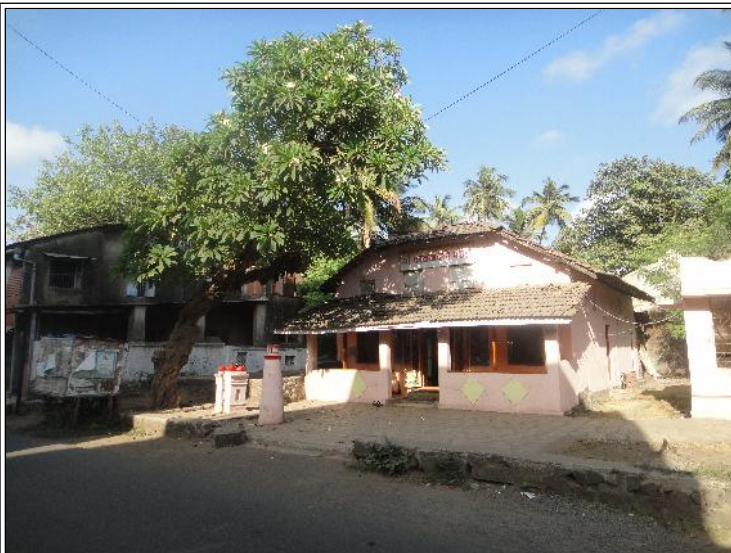
Image Title: Kalambika Mandir
 Image Type: Top-View
 Reference: Woodwork of the temple in need of repairs

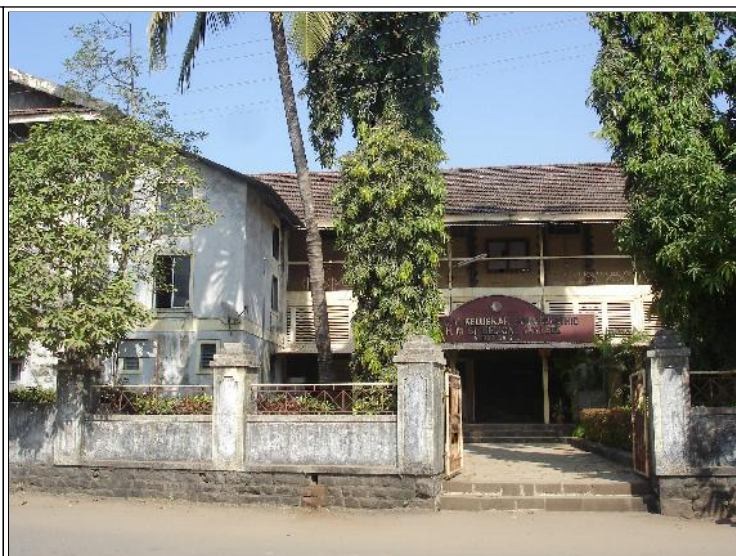
Image Title: Keluskar College
Image Type: Side-View1
Reference: Corner view showing adhoc changes / repairs to the facade

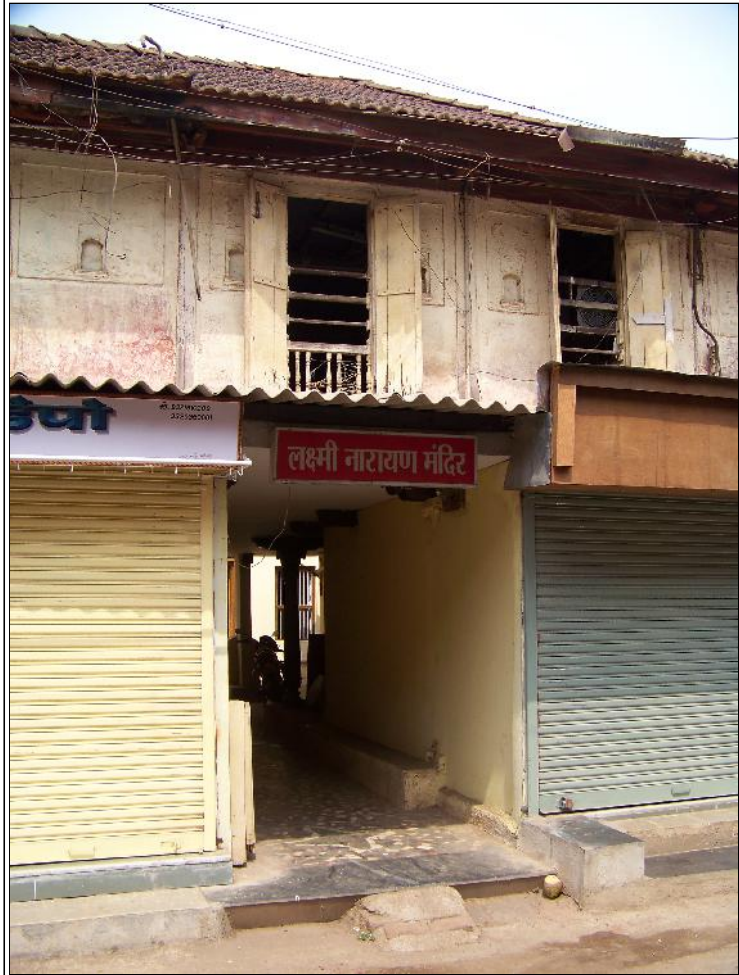
Image Title: Laxmi Narayan Mandir
 Image Type: Top-View
 Reference: Neglected part of the roof in need of repairs

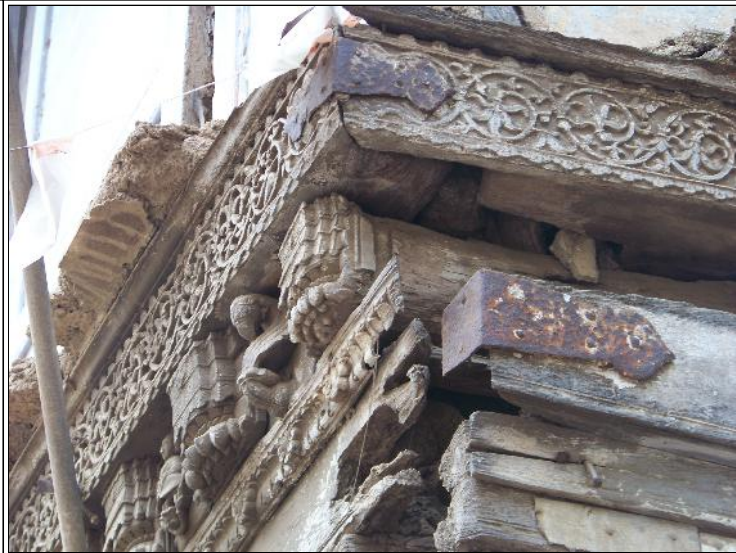
Image Title: Modi Wada
 Image Type: Rear-View
 Reference: Rear elevation showing damage to facade

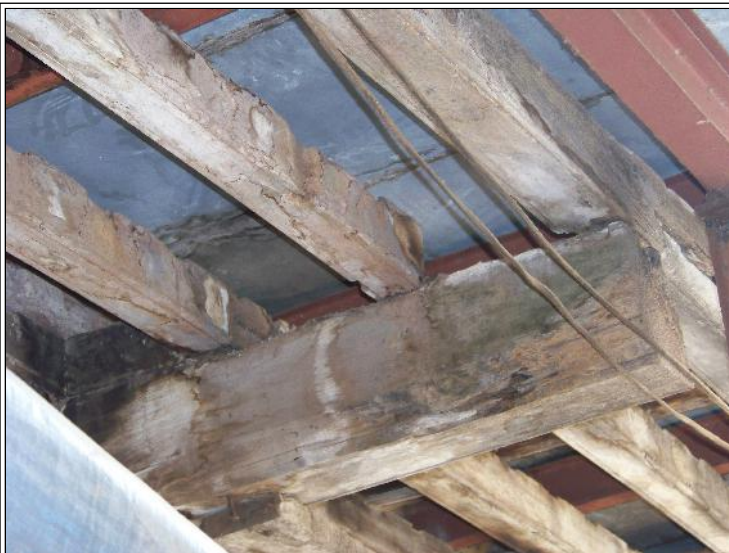
Image Title: Modi Wada
Image Type: Front-View
Reference: Part of wall damaged due to water
