Heritage Sites in Pen	
Ref. No.	Name of property
P - 01	Ahilya Mandal
P - 02	Ambika Mandir
P - 03	Asha Niwas
P - 04	Beth Haelohim Synagogue
P - 05	Bhagwat Wada
P - 06	Bridge
P - 07	Datar Ganpati Mandir
P - 08	Datar Wada
P - 09	Deodhar Wada
P - 10	Despande Wada (Ziral Ali)
P - 11	Dharkar Wada
P - 12	Ganpati Mandir - Chavadinaka
P - 13	Ghangrekar Wada
P - 14	Gosavi Datta Mandir
P - 15	Goteswar Mandir
P - 16	Hanuman Mandir
P - 17	Hazare Wada
P - 18	Patil House
P - 19	Jari Mari Aai Mandir
P - 20	Patwardhan House
P - 21	Karmarkar Wada
P - 22	Kasar Tale
P - 23	Kelkar Wada
P - 24	Kolhatkar Wada
P - 25	Kumbhar Tale
P - 26	Kaundal Tale
P - 27	Limaye Wada
P - 28	Londhe Wada
P - 29	Mandlik Wada
P - 30	Manohar Chawl
P - 31	More Wada
P - 32	Motiram Talav
P - 33	Parmar Wada
P - 34	Tilak Wada 1
P - 35	Tilak Wada 2
P - 36	Tilak Wada 3
P - 37	Vishweshwar Mandir
P - 38	Ziral Ali Ganpati Mandir
P - 39	Tipecha Maruti Mandir
P - 40	Rameshwar Mandir
P - 41	Mahakali Mandir

MUMBAI METROPOLITAN REGION HERITAGE CONSERVATION SOCIETY

Record Details for Ahilya Mandal

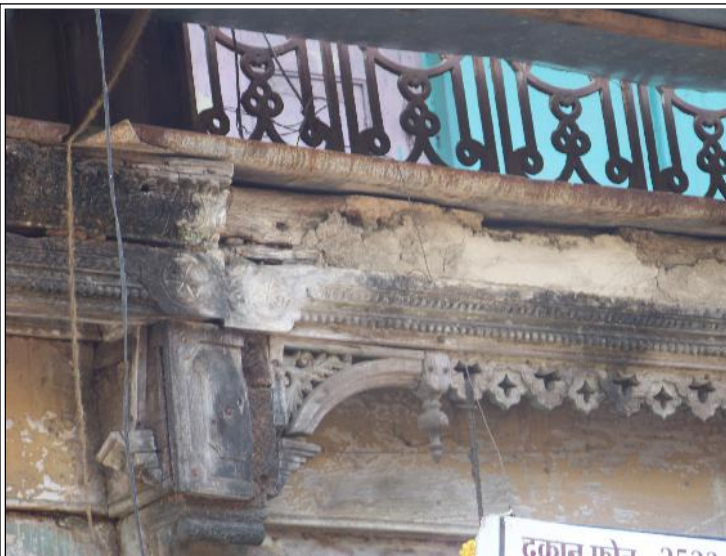
Image Title: Asha Niwas
Image Type: Front-View
Reference: Wooden louvered panels of the first floor balcony form a prominent character giving feature of the building. These how are not in a good shape and require urgent repairs

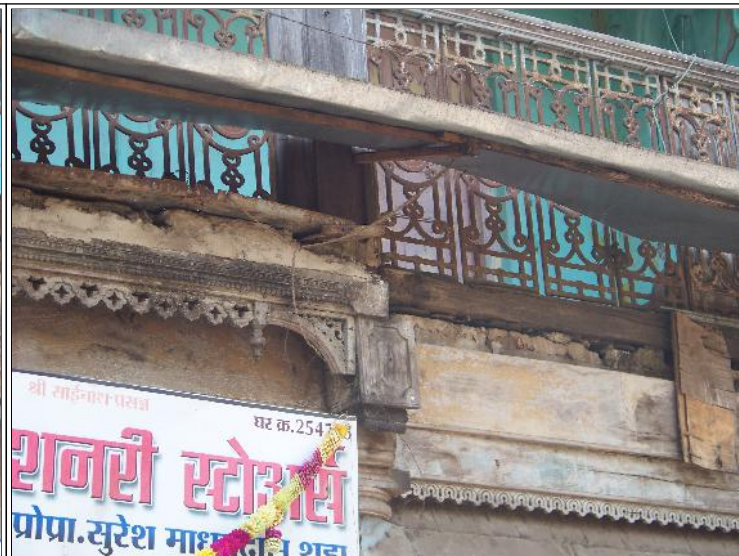
Image Title: Asha Niwas
Image Type: Front-View
Reference: A Deterioration of wooden elements of the building

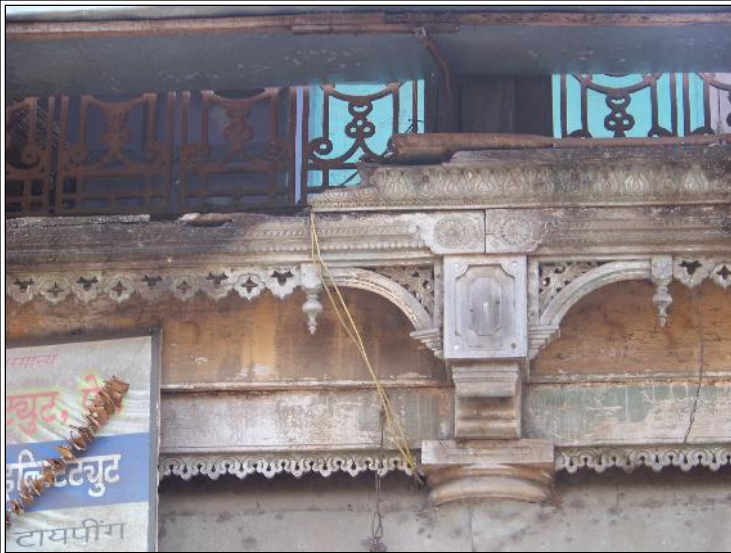
Image Title: Asha Niwas
Image Type: Front-View
Reference: Damaged wooden elements of the front facade of the building

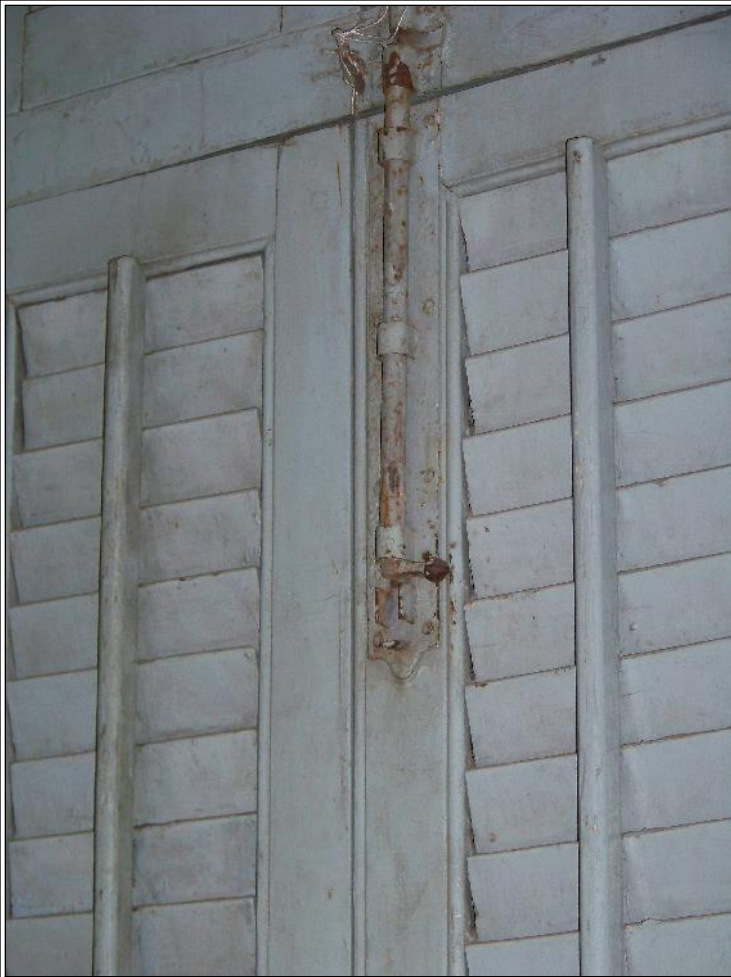
Image Title: Beth Haelohim Synagogue
Image Type: Front-View
Reference: Deterioration of the store on the exterior of the building

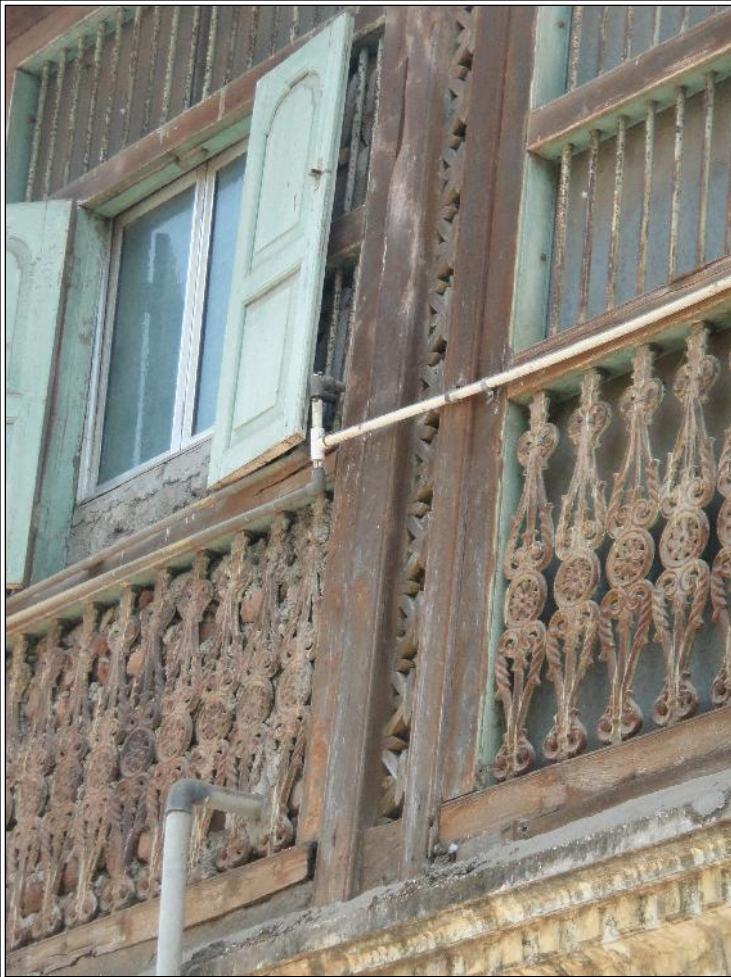
Image Title: Bhagwat Wada
Image Type: Front-View
Reference: One end of the house in a badly damaged condition

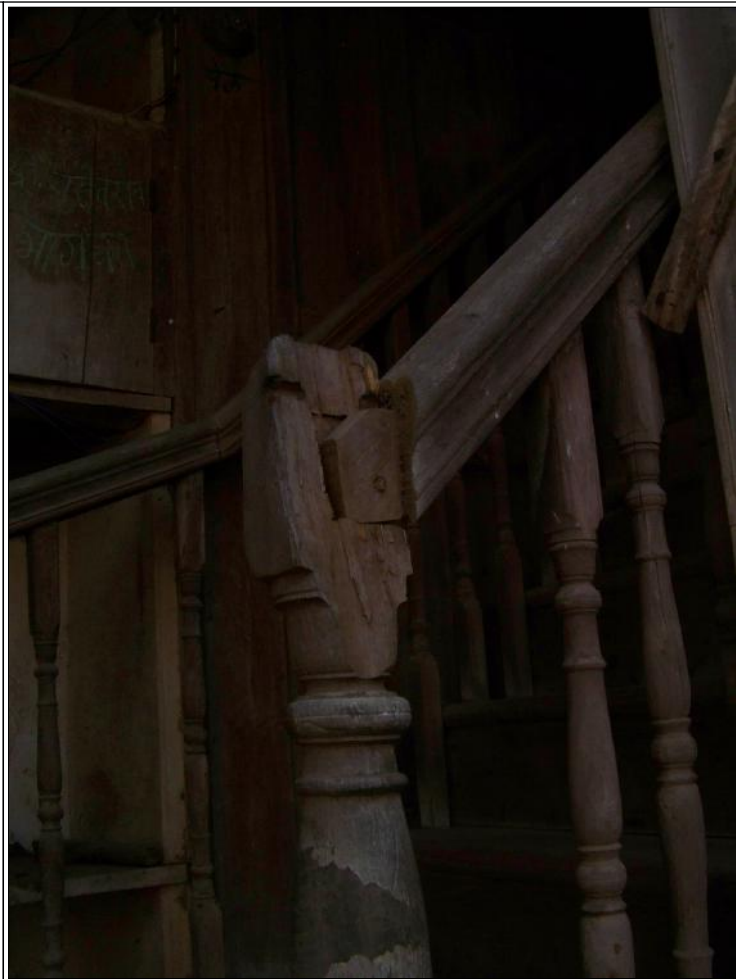
Image Title: Bhagwat Wada
Image Type: Front-View
Reference: Badly damaged corner of the house

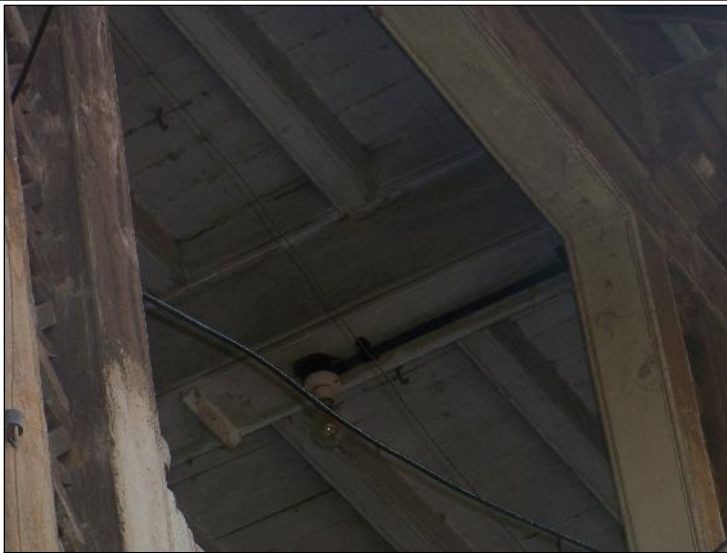
Image Title: Bhagwat Wada
Image Type: Front-View
Reference: Deterioration of wood work

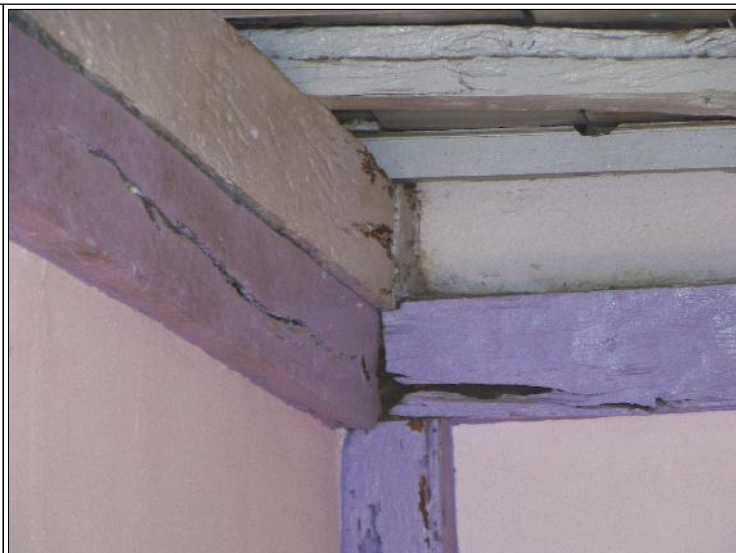
Image Title: Datar Ganpati Mandir
Image Type: Top-View
Reference: Deteriorating wooden ceiling of the temple

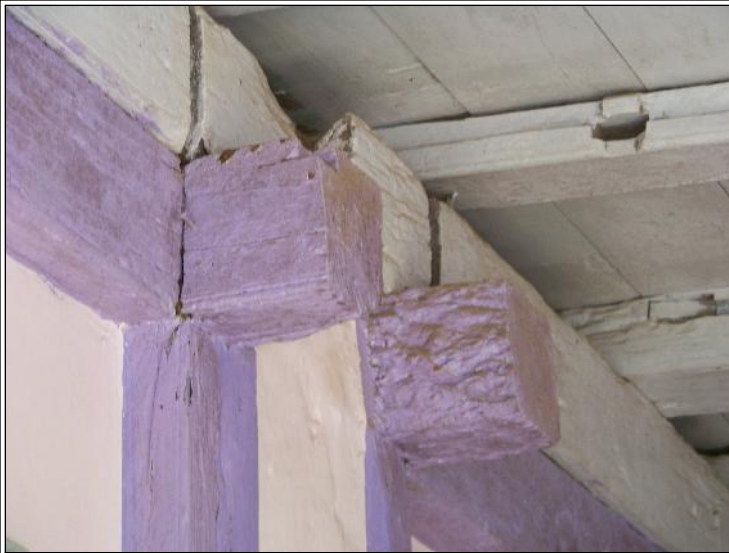
Image Title: Datar Ganpati Mandir
Image Type: Top-View
Reference: Deterioration of the woodwork

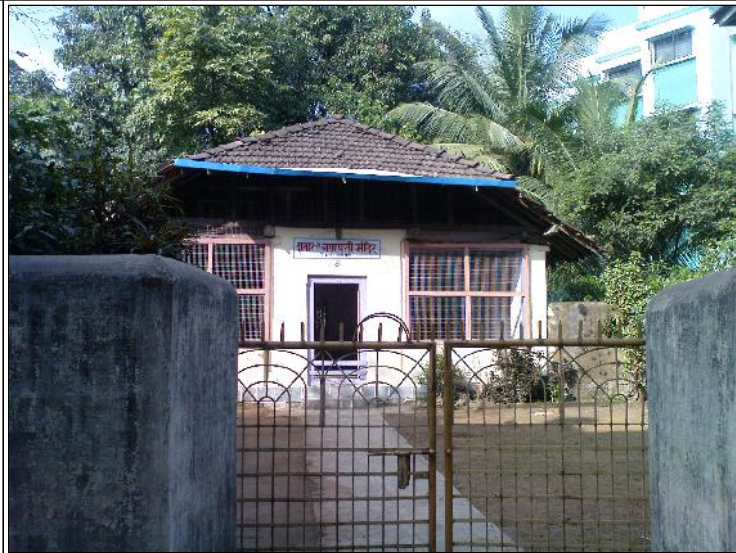
Image Title: Datar Ganpati Mandir
Image Type: Top-View
Reference: Deterioration as structural woodwork

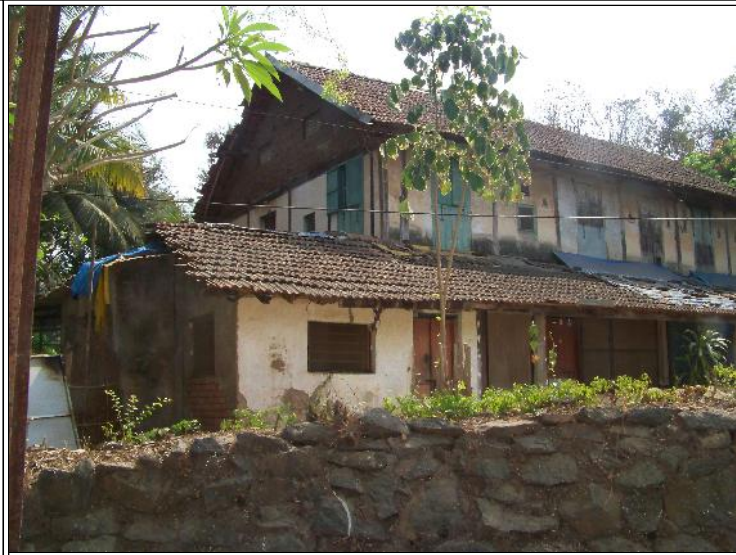
Image Title: Ghangrekar Wada
Image Type: Front-View
Reference: Detail of cracking of the wall on the front side

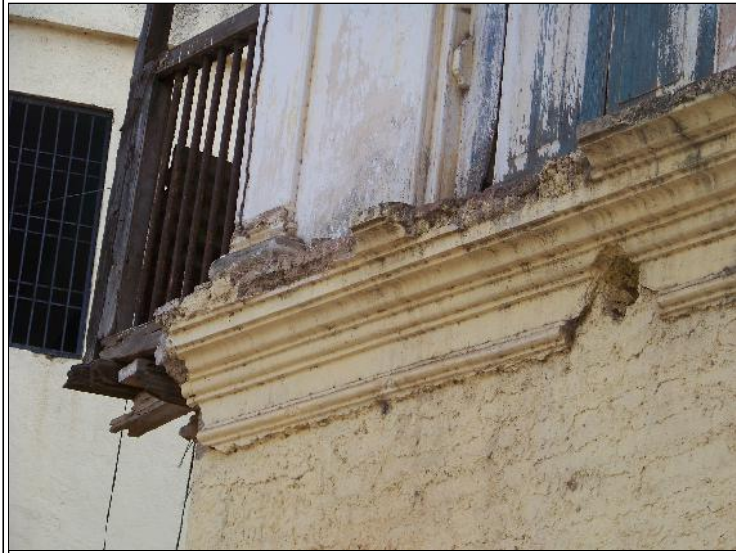
Image Title: Patil House
Image Type: Front-View
Reference: Damaged lime mortar cornice on the exterior of the building. Also seen is the damaged timber of the balcony

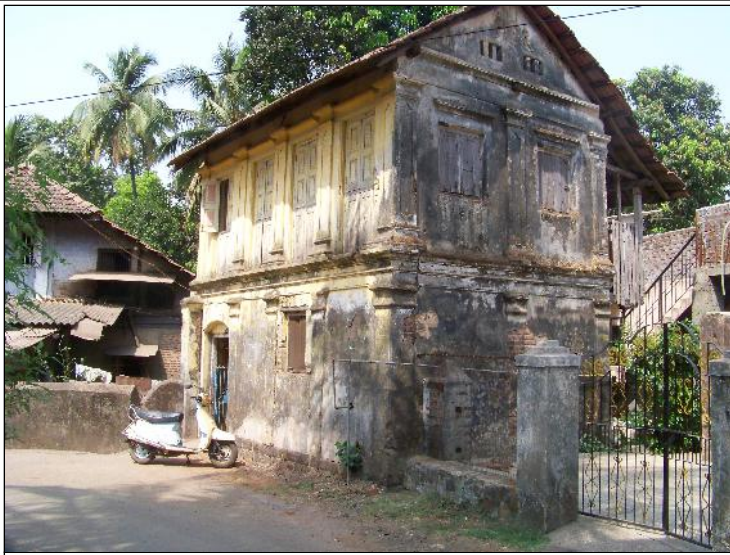
Image Title: Kelkar Wada
Image Type: Side-View1
Reference: Moss growth on plaster cracking and peeling off of the plaster is apparant or the external surface

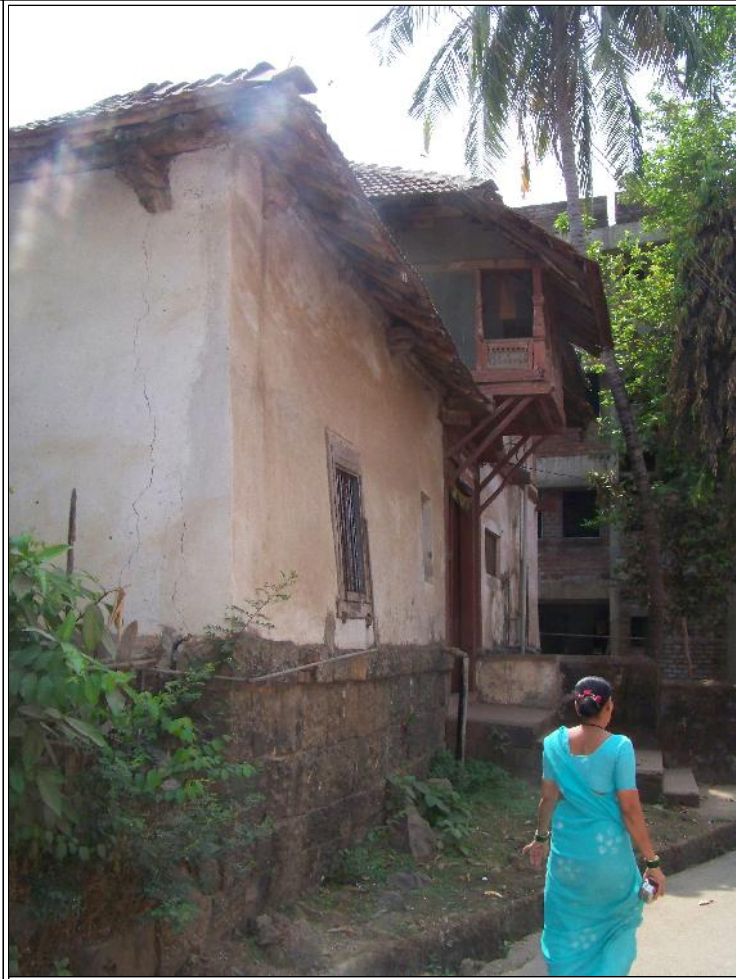
Image Title: Limaye Wada
 Image Type: Front-View
 Reference: Window detail showing the deterioration and ageing of the timber

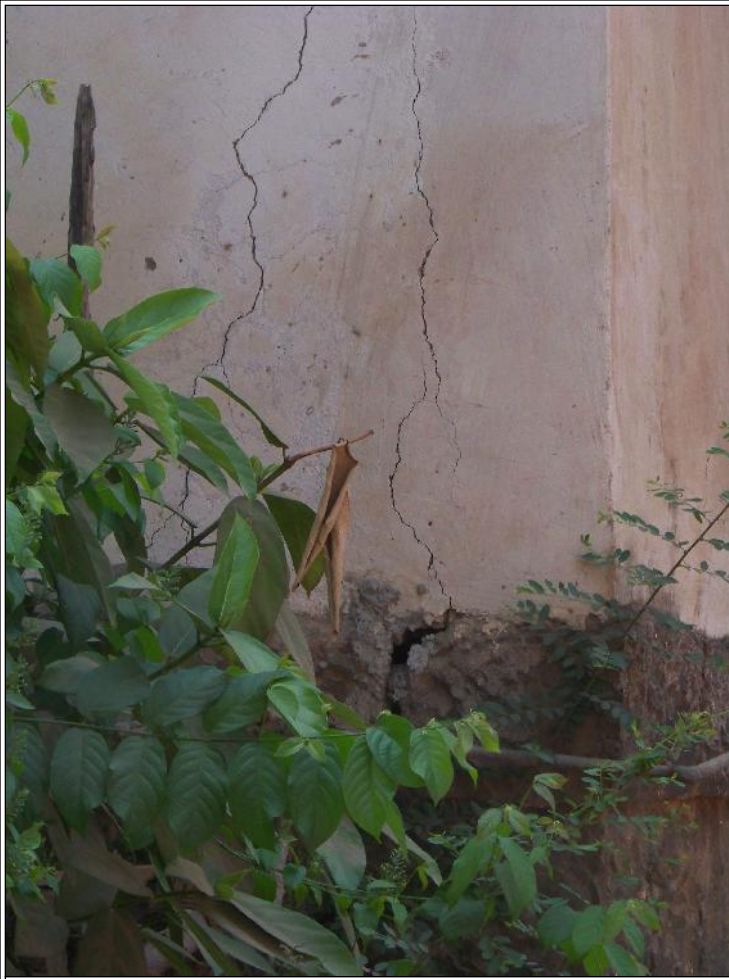
Image Title: Limaye Wada
 Image Type: Side-View1
 Reference: View showing the lots of plumb of the old wall

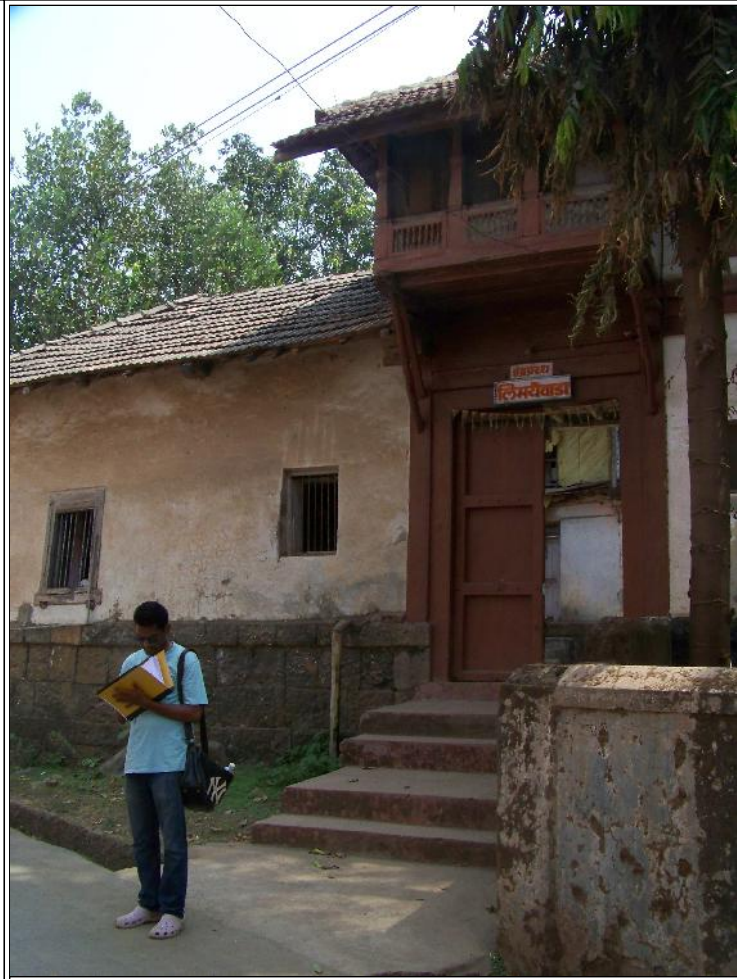
Image Title: Limaye Wada
Image Type: Front-View
Reference: Cracking of plaster on the exterior

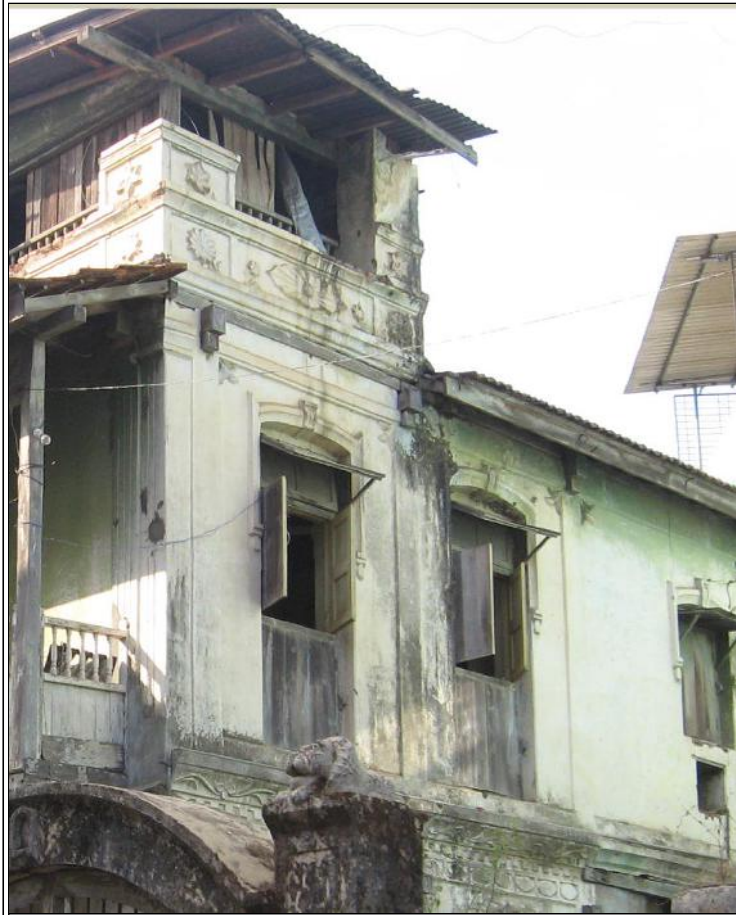
Image Title: Londhe Wada
Image Type: Front-View
Reference: Deterioration of the stucco work

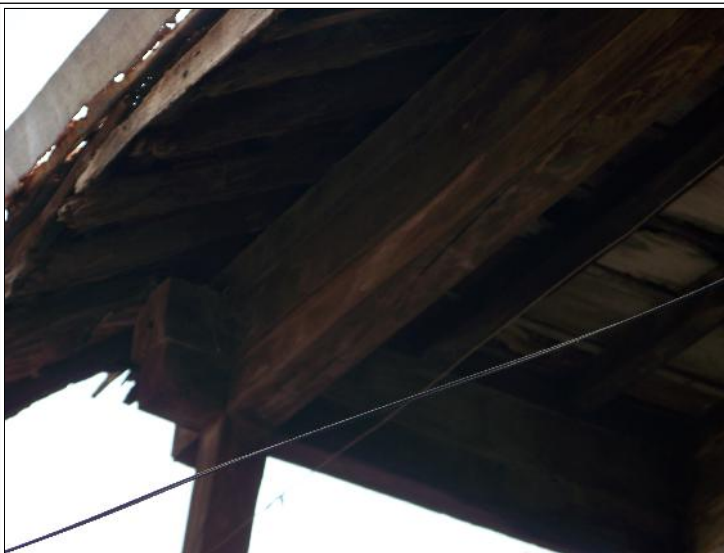
Image Title: Mandlik Wada
Image Type: Top-View
Reference: Water leakage in the wooden ceiling

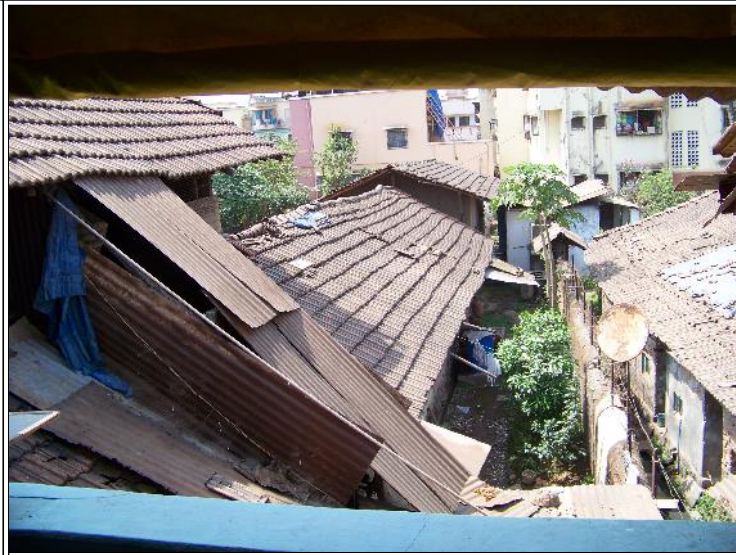
Image Title: Manohar Chawl
Image Type: Front-View
Reference: Deteriorating walls of timber work

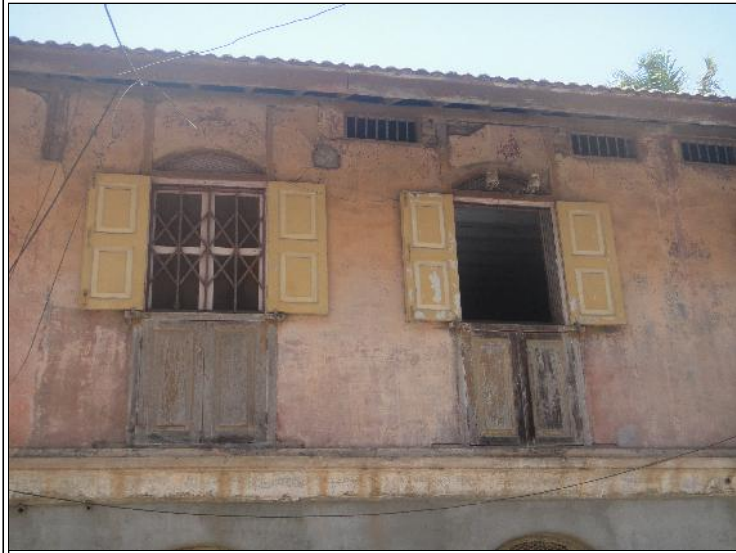
Image Title: Manohar Chawl
Image Type: Top-View
Reference: Deteriorating timber work

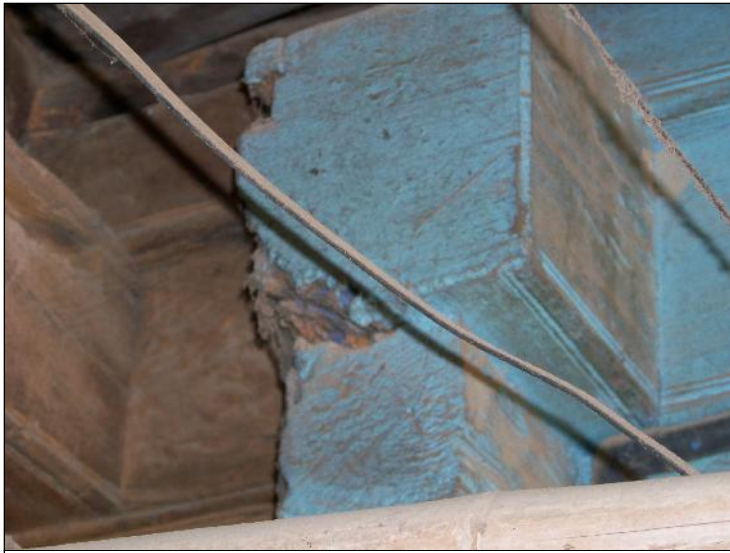
Image Title: More Wada
Image Type: Front-View
Reference: Deteriorating timber work on First Floor

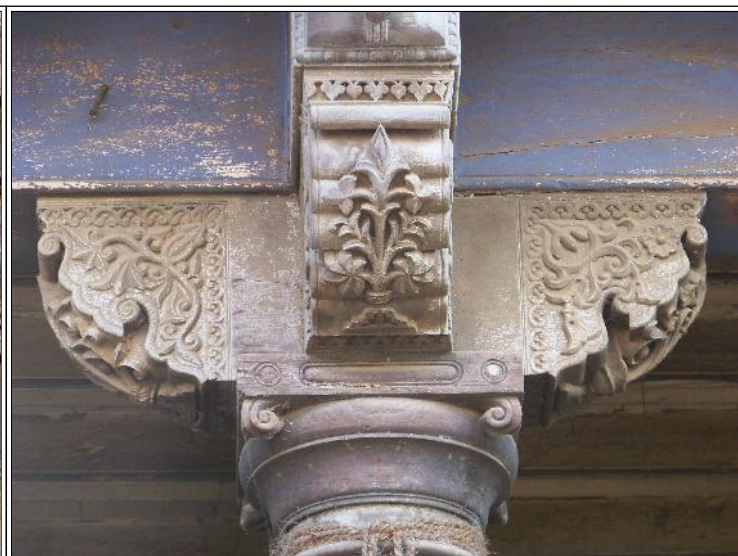
Image Title: Tilak Wada
Image Type: Top-View
Reference: Deteriorating woodwork

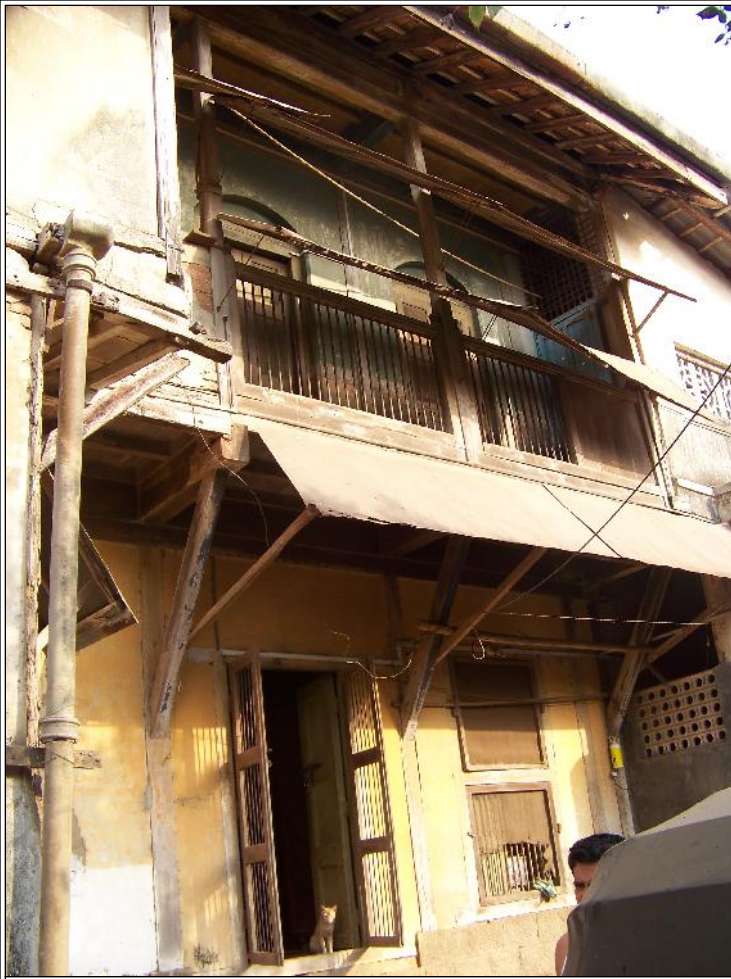
Image Title: Tilak Wada
Image Type: Front-View
Reference: Deteriorating woodwork

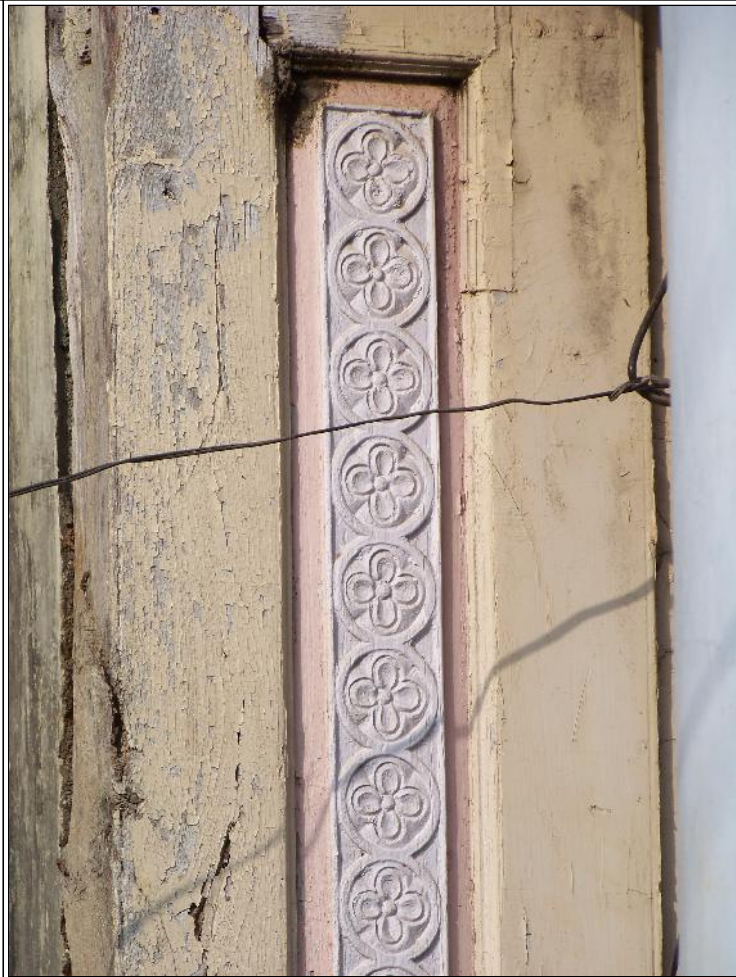
Image Title: Tilak Wada
Image Type: Front-View
Reference: Deterioration due to water seepage

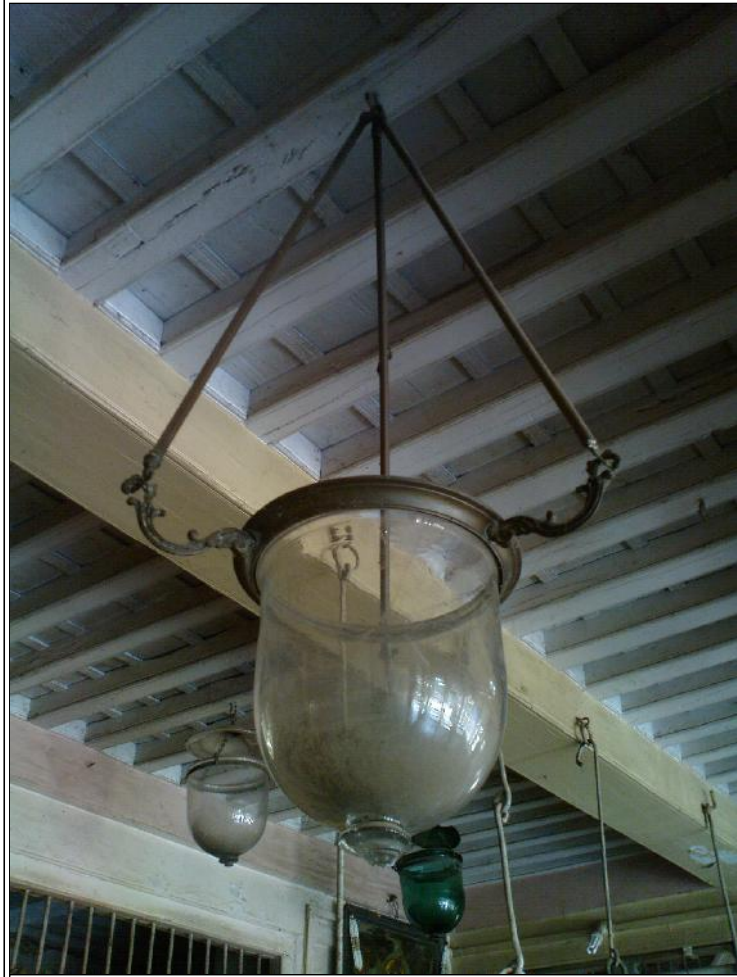
Image Title: Mahakali Mandir
Image Type: Front-View
Reference: Deteriorating Wood work

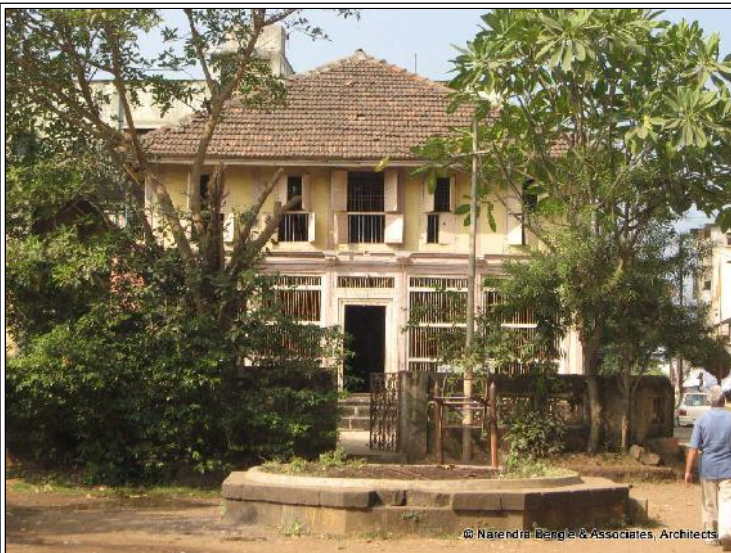
Image Title: Mahakali Mandir
Image Type: Front-View
Reference: Deteriorating Wood work
