Heritage Sites in Karjat	
Ref. No.	Name of property
KA – 01	Bafna House
KA – 02	Datta Mandir
KA – 03	Kale House
KA – 04	Railway Station
KA – 05	Shiva Mandir
KA – 06	Vaidya House

MUMBAI METROPOLITAN REGION HERITAGE CONSERVATION SOCIETY

Record Details for Medhi House

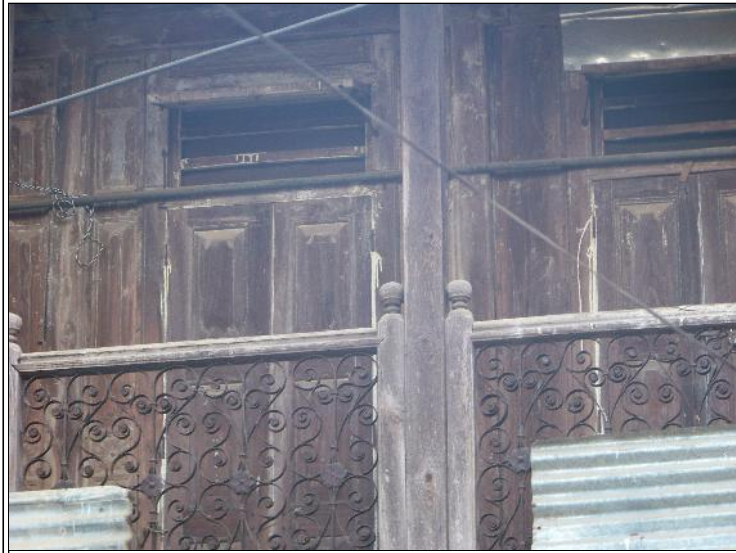
Image Title: Medhi House
Image Type: Front-View
Reference: deteriorating timber work

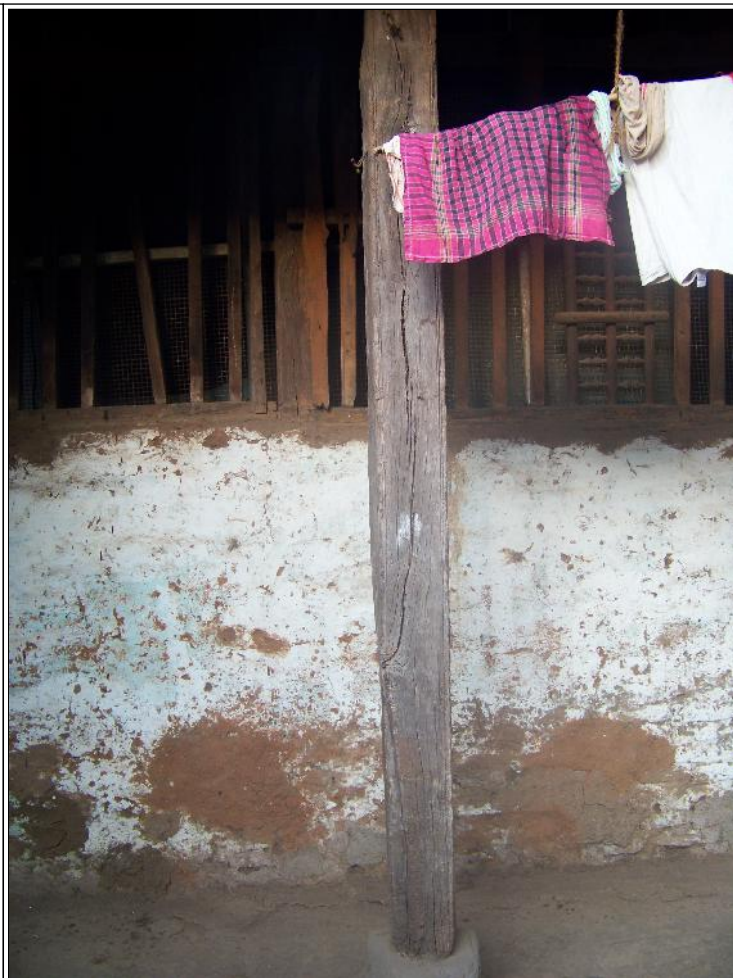
Image Title: Pimputkar Wada
Image Type: Front-View
Reference: Deterioration of timber

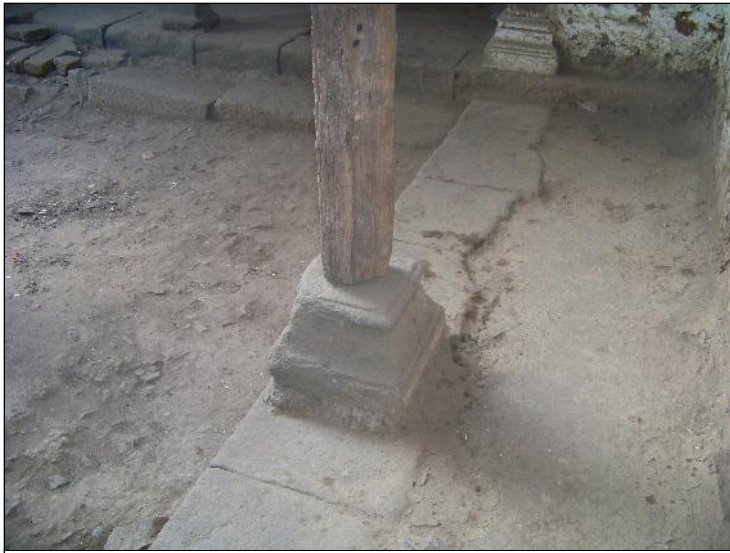
4.01	D P Remarks	Landuse - Residential The street abuts the Pimputkar Wada Premises on the East.
4.02	Overall Problems & Threats	The structure is very old and has undergone a lot of deterioration and also part demolition. In the current state, it will not survive for long and therefore calls for urgent action.

Reference: Precarious support due to severe deterioration of many structural elements

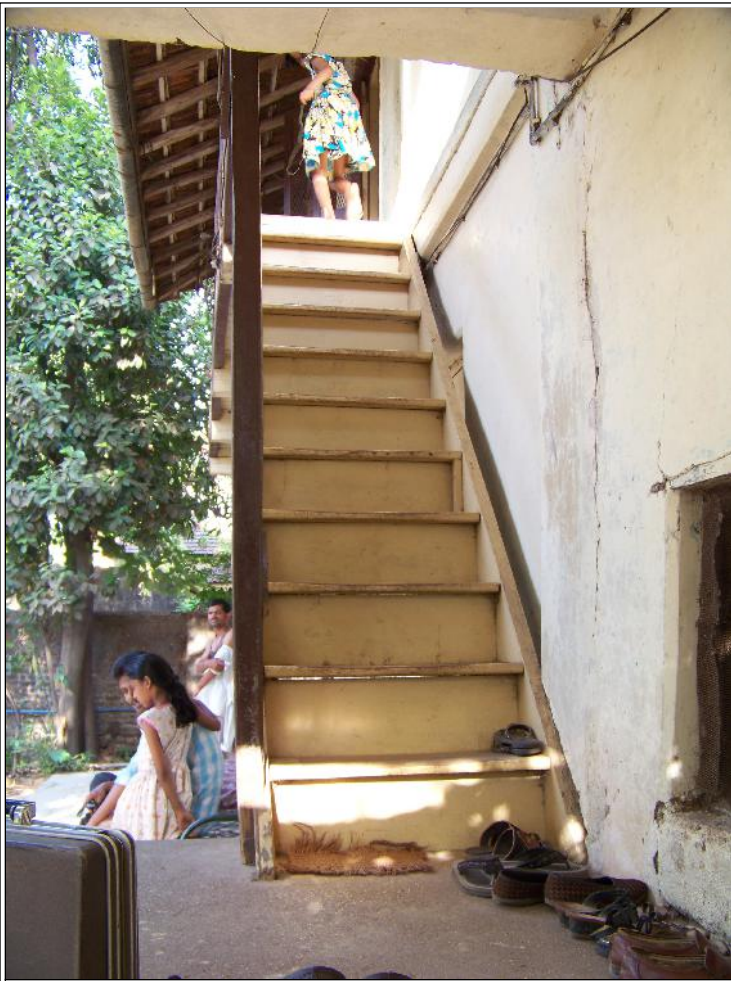
3.06	Floors	Timber floor beams and joists support the first floor. Timber roof with Mangalore tiles.	no major problems	Minor Repair
3.07	Stairs	Timber stairs tied with MS bolt rods.	Loosening of joinery	Minor Repair

Image Title: Salaye House
Image Type: Front-View
Reference: Timber Stairs leading to the first floor apartments

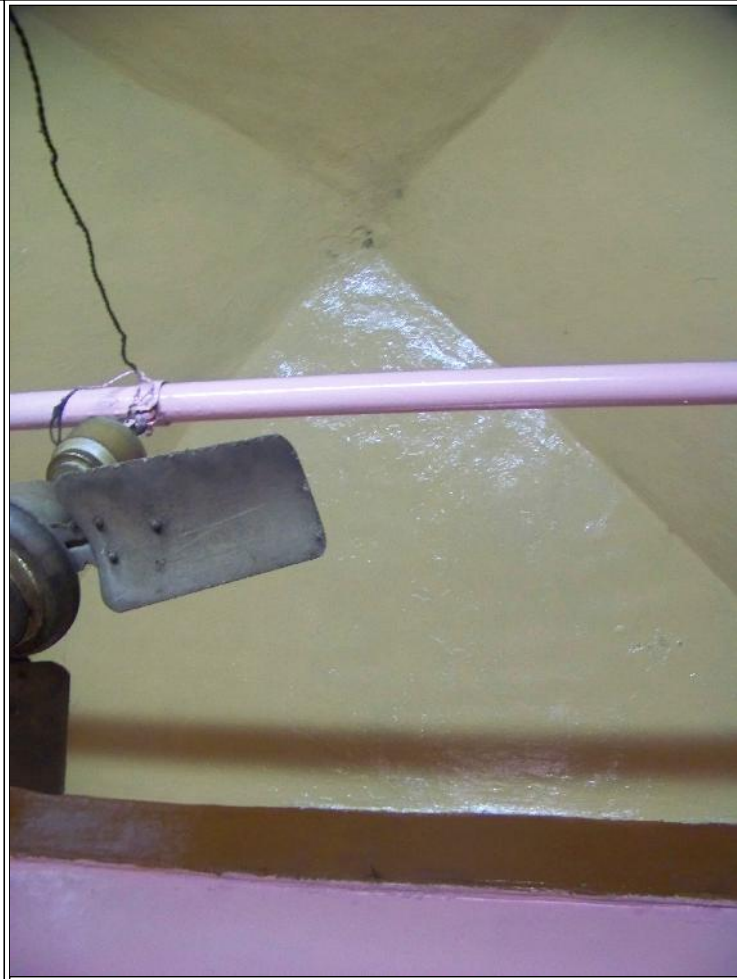
Image Title: Datta Mandir
Image Type: Top-View
Reference: Incongruent addition of the electrical fan inside the temple

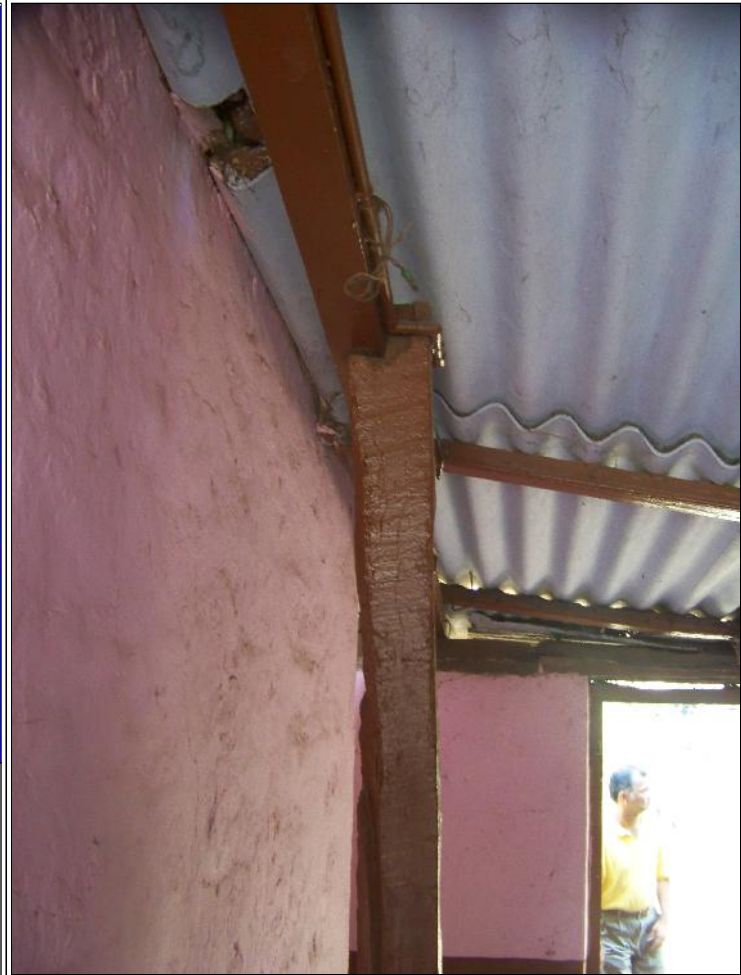
Image Title: Datta Mandir
Image Type: Top-View
Reference: Shed added later

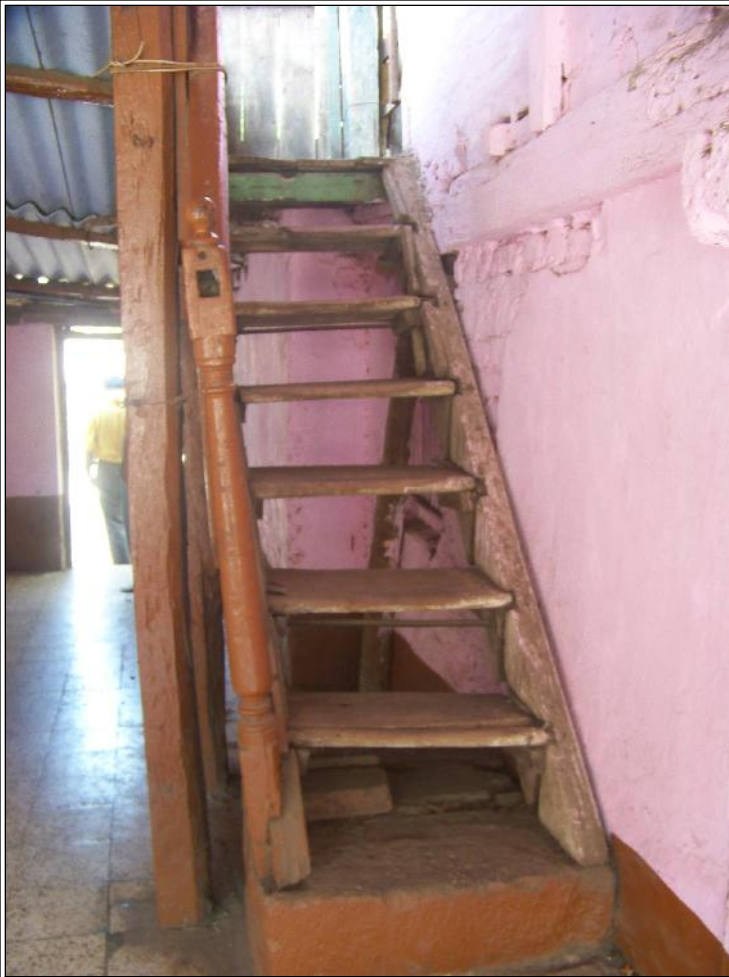
Image Title: Datta Mandir
Image Type: Front-View
Reference: Make-shift Stairs

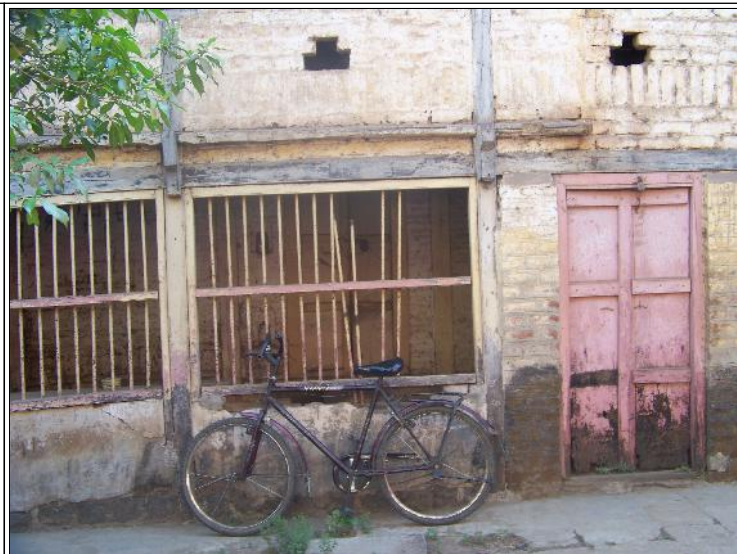
Image Title: Vaidya House
Image Type: Front-View
Reference: Broken grills on the ground floor
