Heritage Sites in Khopoli	
Ref. No.	Name of property
KH – 01	Mulekar House
KH – 02	Samadhi
KH – 03	Tilak Wada 1
KH – 04	Tilak Wada 2
Ref. No.	Precincts
KH P 1	Vireshwar Mandir and Tank near Mandir

MUMBAI METROPOLITAN REGION HERITAGE CONSERVATION SOCIETY

Record Details for Adv. Mulekar House

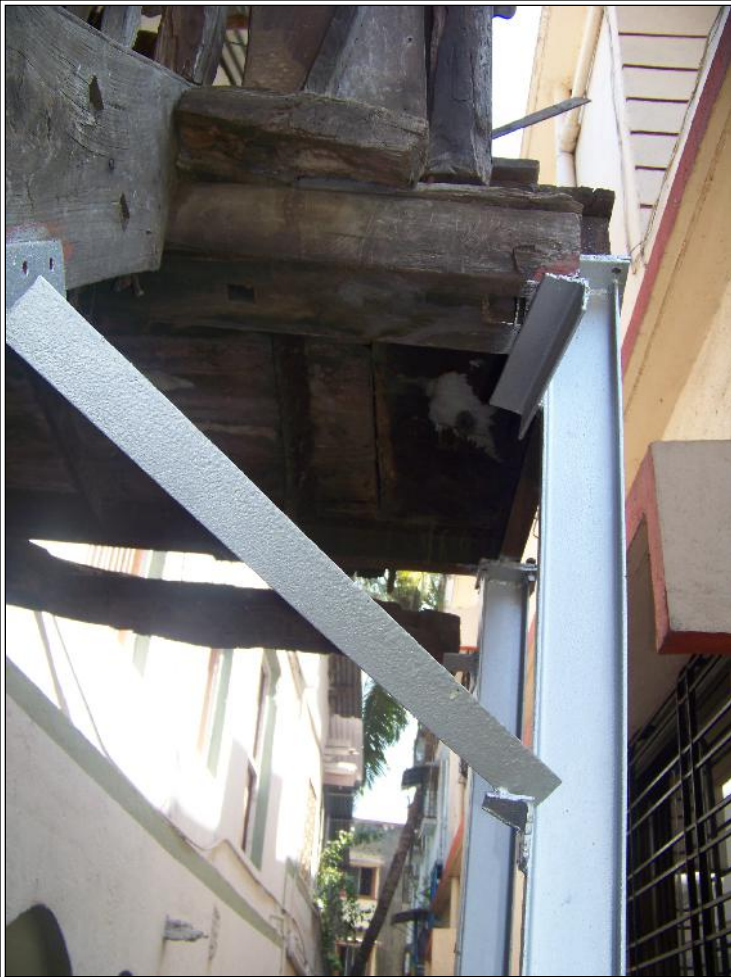
3.19	Plumbing & Drainage	Municipal corporation	NA	-
3.20	Other(Fire protection, HVAC, Security etc)	None	NA	-
3.21	Incongruent Transformation	Front verandah has been walled in, structural repairs have been done using mild steel supports

Image Title: Adv. Mulekar House
Image Type: Front-View
Reference: MS Bracket stays added to strengthen canti

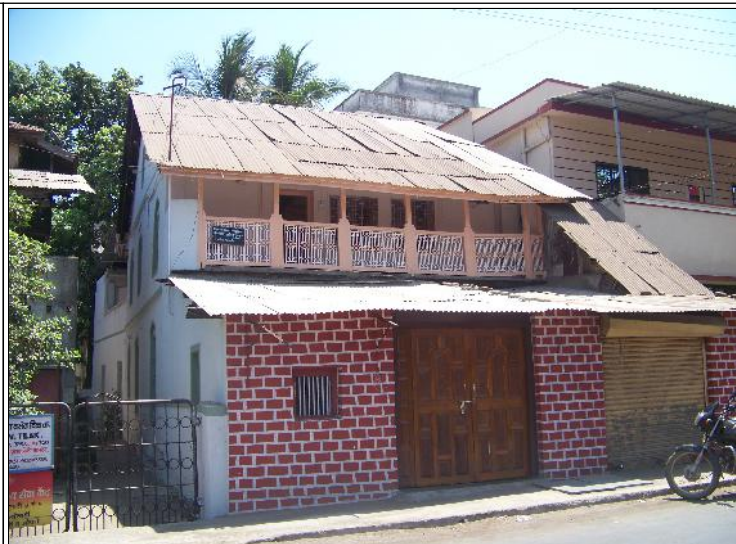
Image Title: Adv. Mulekar House
Image Type: Front-View
Reference: View from main road showing recently enclosed ground floor verandah

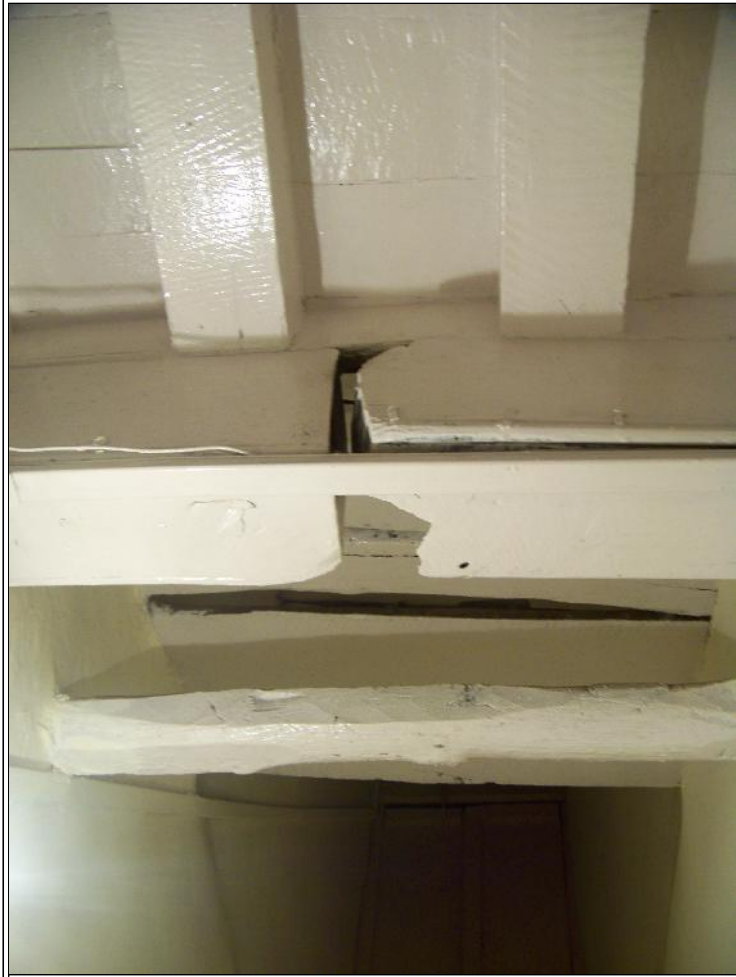
Image Title: Adv. Mulekar House
Image Type: Front-View
Reference: One of the roof beams showing signs of distress

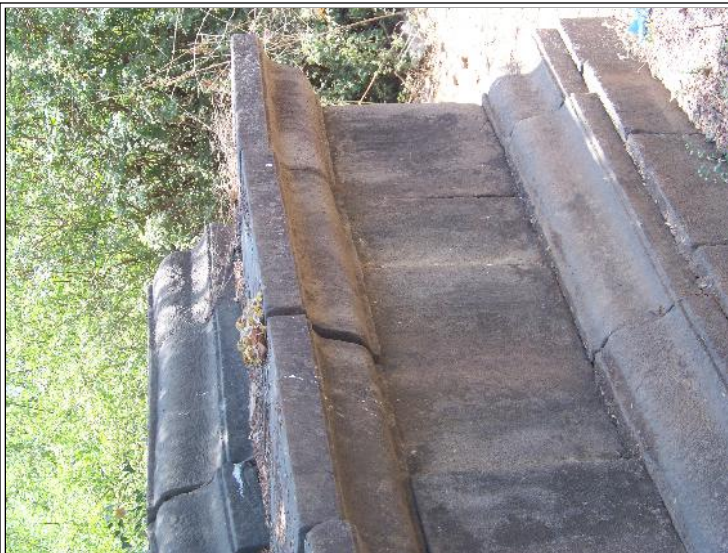
3.01	Height	NA		
3.02	No. of Floors	Ground		
		Description	Problem/Threat	Condition
3.03	Structural System	dressed Stone masonry with rubble core	Large Structural Cracks in joints with dislocation of stones	Major Repair

3.04	Plinth	dressed Stone masonry with rubble core	Large Structural Cracks in joints with dislocation of stones	Major Repair
3.05	Walls	Basalt dressed masonry, mouldings at top and bottom	Large Structural Cracks in joints with dislocation of stones	Major Repair

Image Title: Samadhi
Image Type: Front-View
Reference: Loosening of corner stones from top to bottom due to differential settlement

3.06	Floors	NA	NA	-
3.07	Stairs	NA	NA	-
3.08	Openings	NA	NA	-
3.09	Roof	NA	NA	-
3.10	Articulation	Moulded Plinth and top edge	the stones need to be reset	Minor Repair

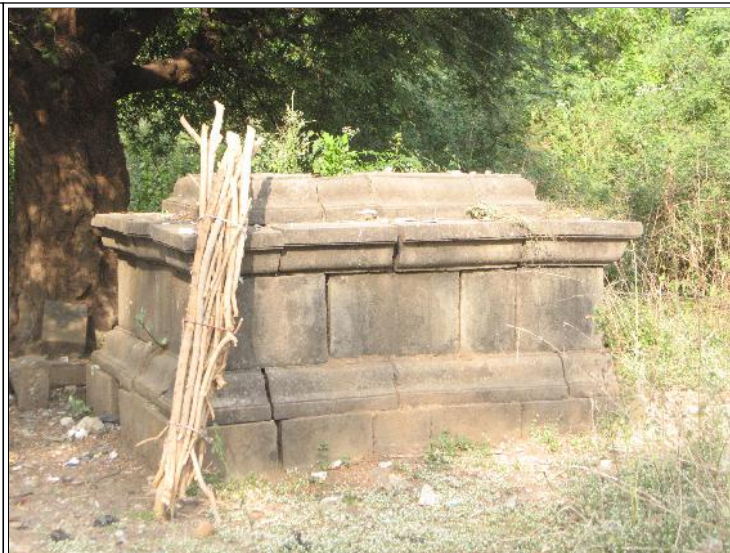
Image Title: Samadhi
Image Type: Front-View
Reference: Loosening of corner stones from top to bottom due to differential settlement

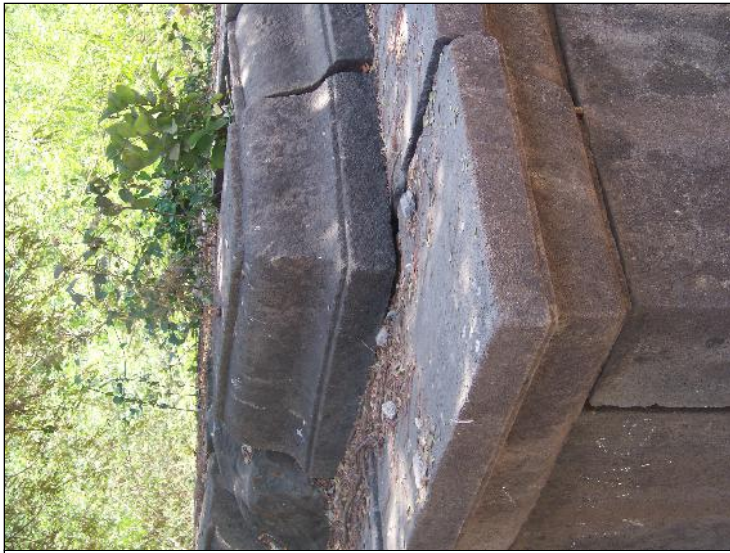
Image Title: Samadhi
Image Type: Top-View
Reference: Loosening of corner stones from top to bottom due to differential settlement

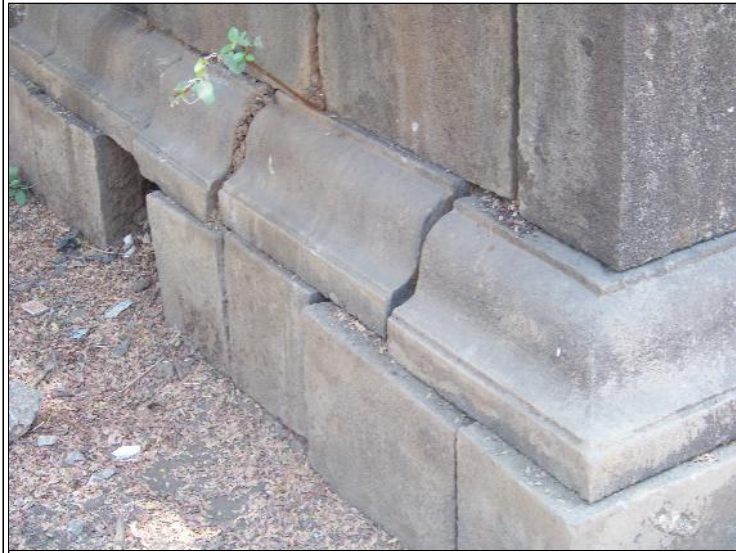
Image Title: Samadhi
Image Type: Front-View
Reference: Loosening of corner stones from top to bottom due to differential settlement

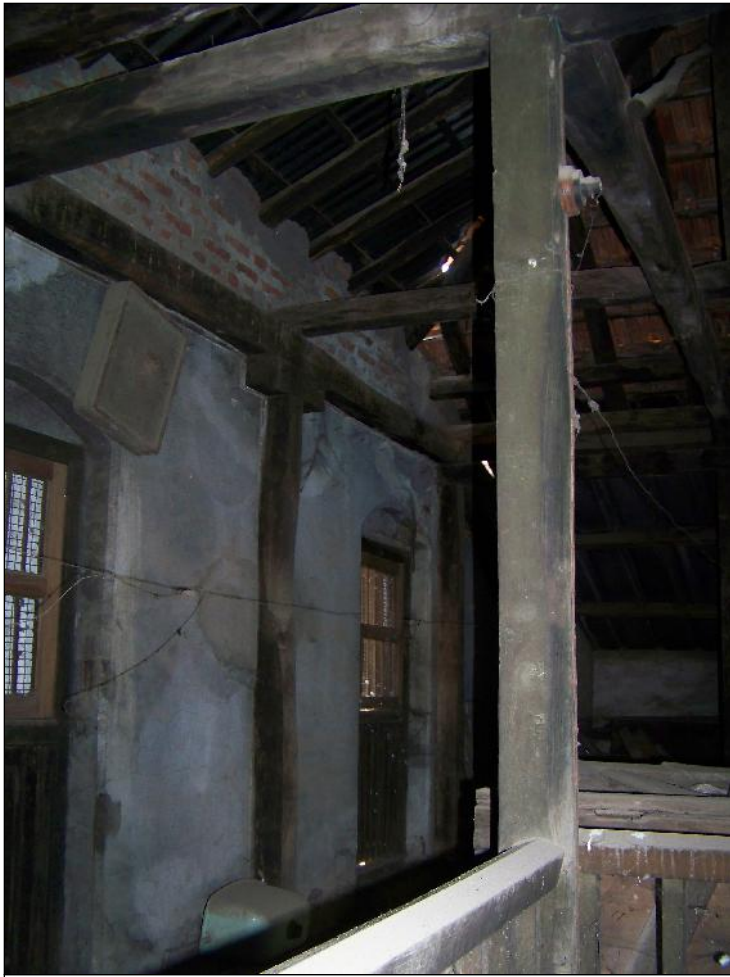
Image Title: Tilak Wada
Image Type: Front-View
Reference: Illmaintained first floor plaster peeling off
unmaintained wood work

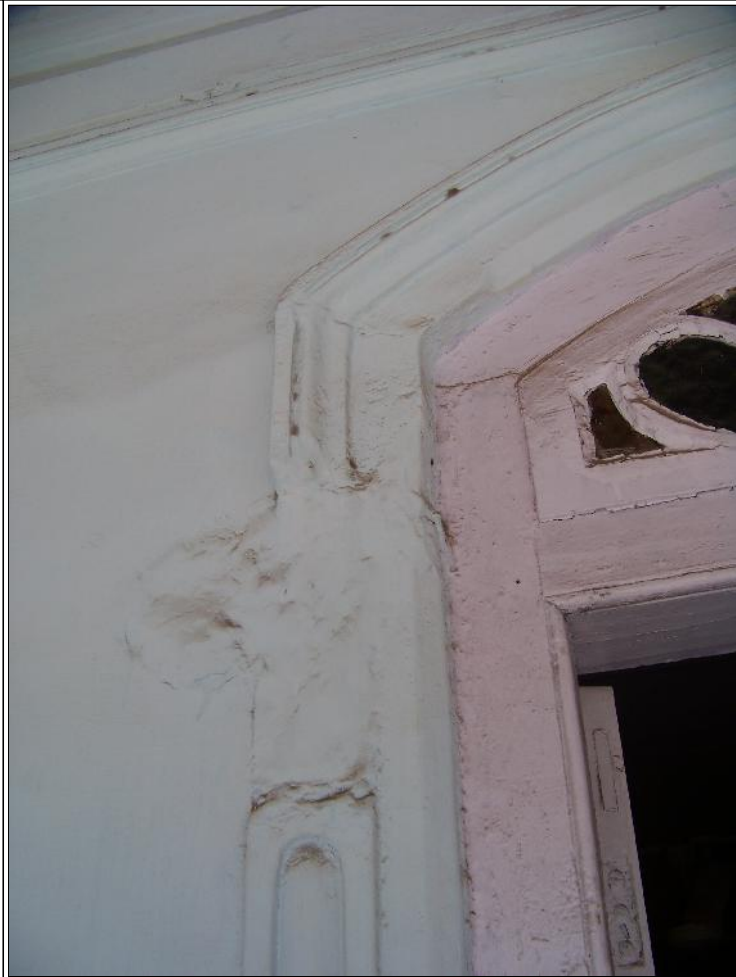
Image Title: Tilak Wada
Image Type: Front-View
Reference: Moulding around the openings obscured due to coats of paint

3.07	Stairs	Timber stairs	Flaking of timber supports and cracks	Minor Repair
3.08	Openings	Timber framed doors and windows with infill wooden panels.	oil paint needs to be removed	Minor Repair

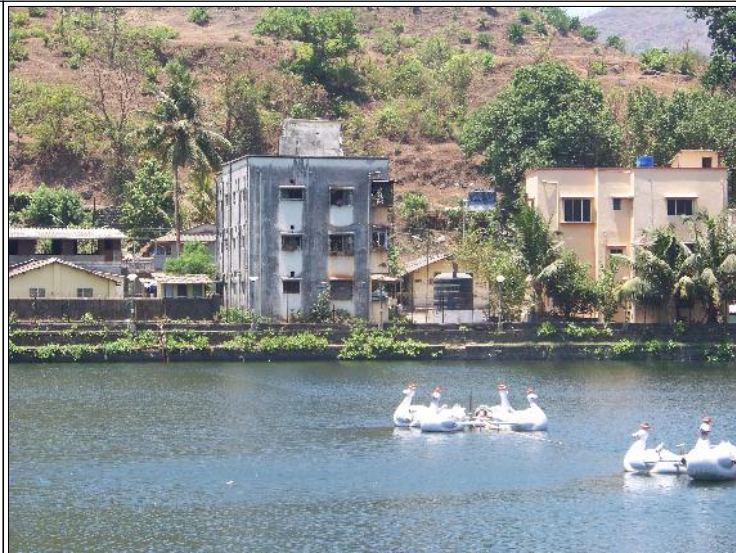
4.01	D P Remarks	Landuse - Waterbody, The street abuts the Vireshwar Mandir and Tank Premises on the East.
4.02	Overall Problems & Threats	Adhoc changes to the lake (such as putting in fibre glass swans), and to the Mandir (such as colouring the stone with grey colour) need to be rectified.

Image Title: Vireshwar Mandir and Vireshwar Tank
Image Type: Front-View
Reference: Out of scale development on the lakeside
