# GUIDELINES FOR SHIVAJI PARK HERITAGE PRECINCT

for  
MMR-Heritage Conservation Society

Final Report  
April 2014

Consultants

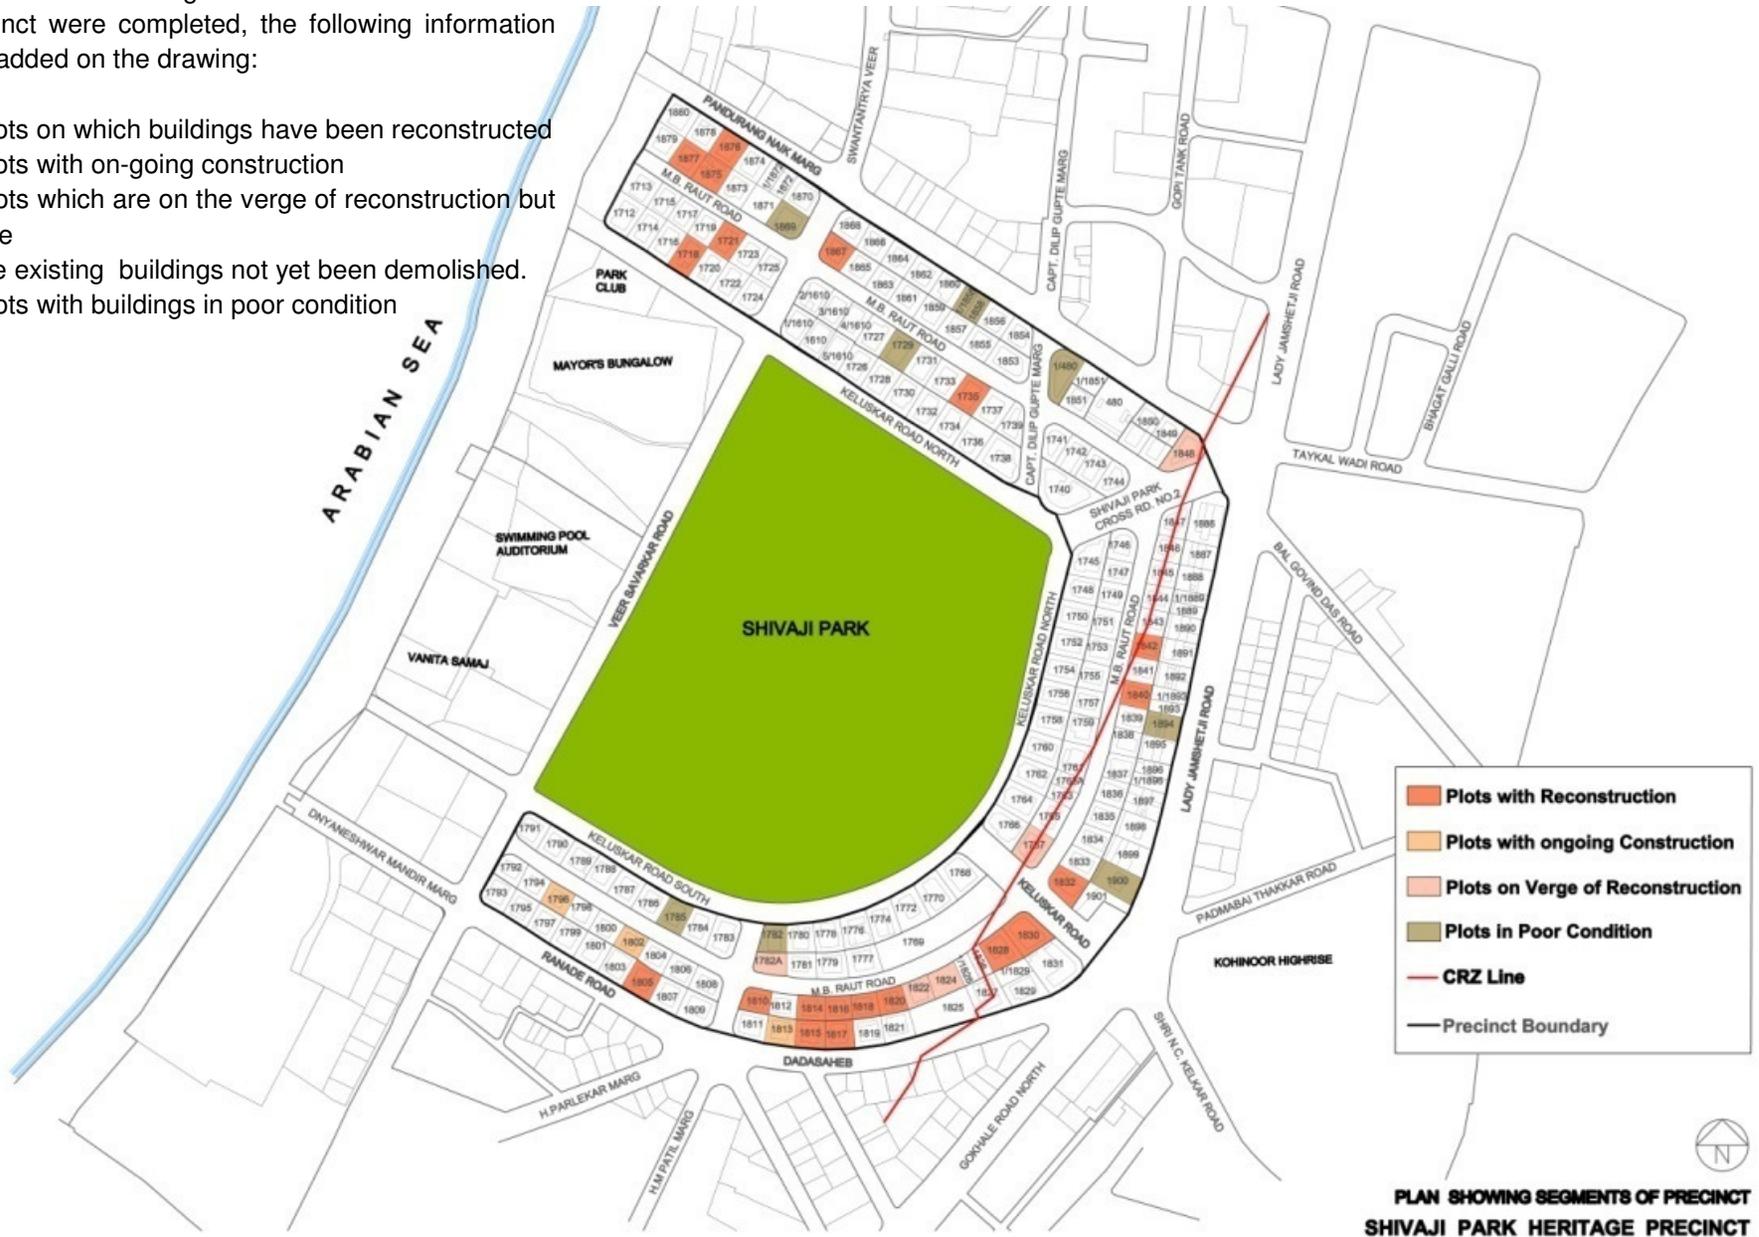
1. Plots on which buildings have been reconstructed
2. Plots with on-going construction
3. Plots which are on the verge of reconstruction but where the existing buildings not yet been demolished.
4. Plots with buildings in poor condition

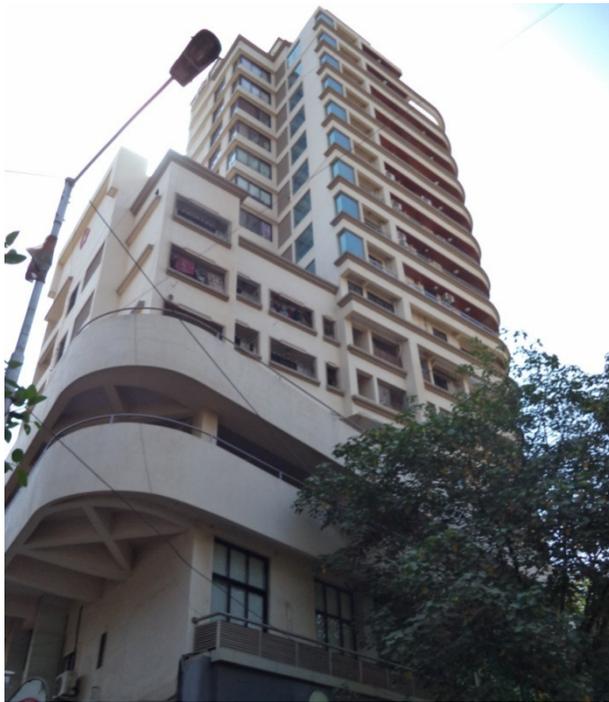
**Reconstruction**

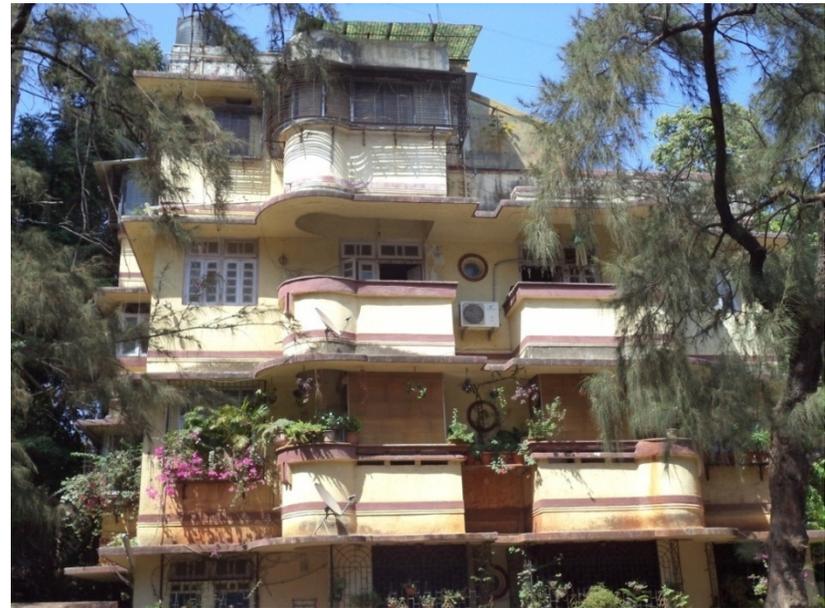
**Additions**  
One floor added with setback

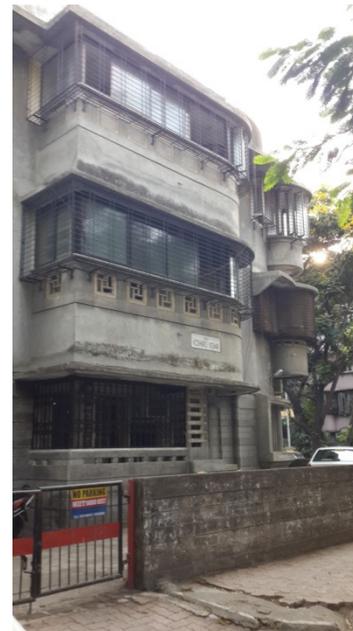
**Modifications**  
Balcony Enclosed

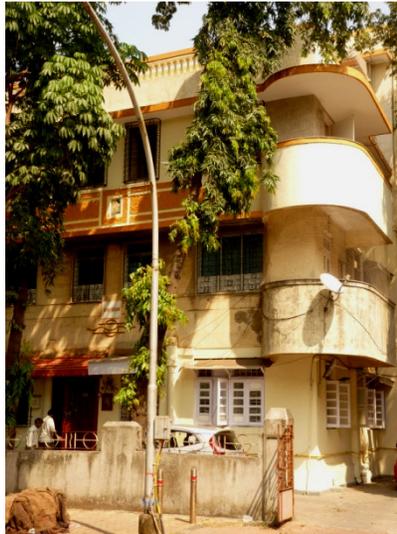
A building which does not display cracks in masonry / structural members, does not display exposed reinforcement or other signs of disrepair, which does not show leakages or seepages and generally appears to be maintained in a good manner and especially appears to be externally painted in the recent past is considered to be in good condition.

Good condition

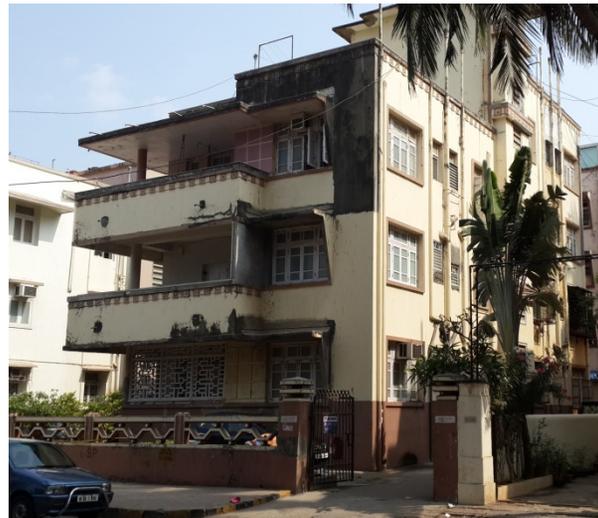
A building which does not significantly display cracks in structural members but shows minor cracks in masonry, displays exposed reinforcement (loss of concrete cover) in small patches or shows other signs of disrepair such as chipped and broken corners of chajjas and other members but which does not show significant leakages or seepages and generally appears to be maintained is considered to be in fair condition.

Fair condition

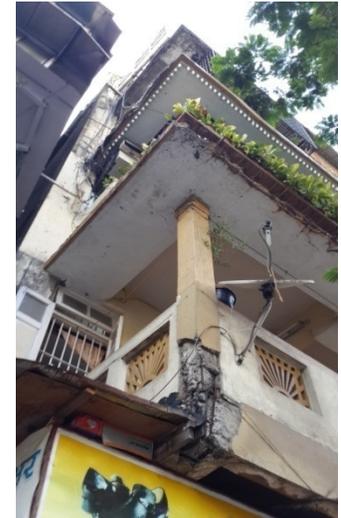
A building which displays significant cracks in structural members and / or significant cracks in masonry, displays exposed reinforcement (loss of concrete cover) or other signs of **extensive disrepair** such as chipped and broken corners of chajjas and other members, which shows significant leakages or seepages and generally appears to be poorly maintained is considered to be in poor condition.

Poor condition

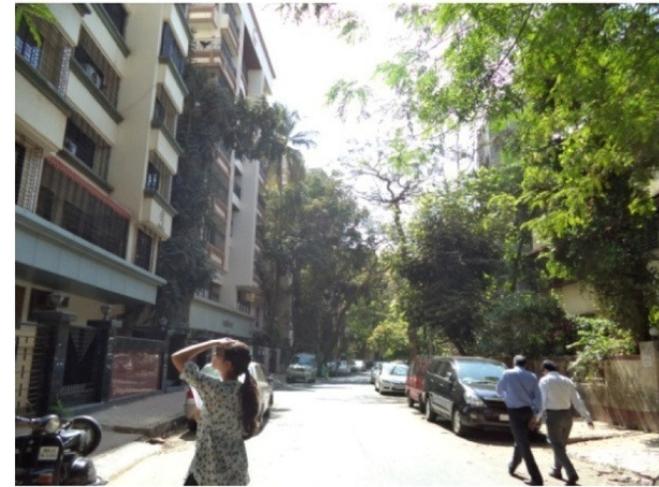
Loss of greenery is evident in stretches which have newly constructed buildings.
