Card No.: F/n-1

Ward (Part): F north-VI

Date: May, 2005

**Photo** T-III-Fn:\Ward F north\ **Ref.:** N. C. Nariealvala Fire

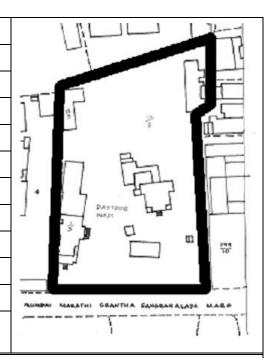
Ref.: Dastoor House

10.1	Form	No transformation		
10.0	Transformation			
9.10	Overall condition	Fair Maintenance level Fair		
9.9	Outbuildings	Good		
9.8	Services	Fair (Recently replastered)

9.7	Articulation & Finishes	Fair (Plaster chapped off at some places )		
9.6	Roofing	Fair (Mangalore tiles and fascia need repairs)		
9.5	Openings	Fair (Wooden members need maintenance)

9.3 9.4	Stairs	Good (Well maintained)		
9.2 9.3	Floor	Fair (Sagging observed at some places)		
9.1 9.2	Walls	Good (No settlement or cracks observed)  Good (No dampness or cracks observed)		
	<b>Condition</b> Plinth	Good (No sattlement or cracks observed)

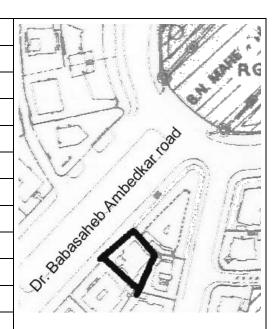
**Photo** T-III-Fn:\Ward F north\ **Ref.:** 541, Gajjar Niwas

9.0	Condition					
9.1	Plinth	Good (No settlement or cracks observed)				
9.2	Walls	Good (No dampness or cracks observed)				
9.3	Floor	Good (No sagging observed)

9.4	Stairs	Good (Well maintained)				
9.5	Openings	Good (Wooden members in sound state)				
9.6	Roofing	Good (No sagging or leakage observed)				
9.7	Articulation & Finishes	Good (Need to be re-paint, cracks in brackets )

9.8	Services	Fair				
9.9	Outbuildings	Good				
9.10	Overall condition	Good Maintenance level Good				
10.0	Transformation					
10.1	Form	No transformation

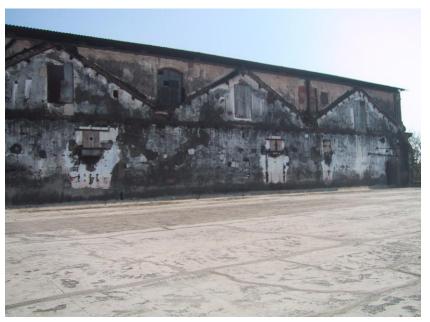
Part of the demolished floor - Carding and Spinning unit
