Mahatma Education Society's
PILLAIS' COLLEGE OF ARCHITECTURE Research Cell
10, Sector 16, New Panvel (e) 410206
Telephones: (022) 27456100, 27451700
e-mail: picapanvel@hotmail.com

Contents

Volume II

Area A- Villages

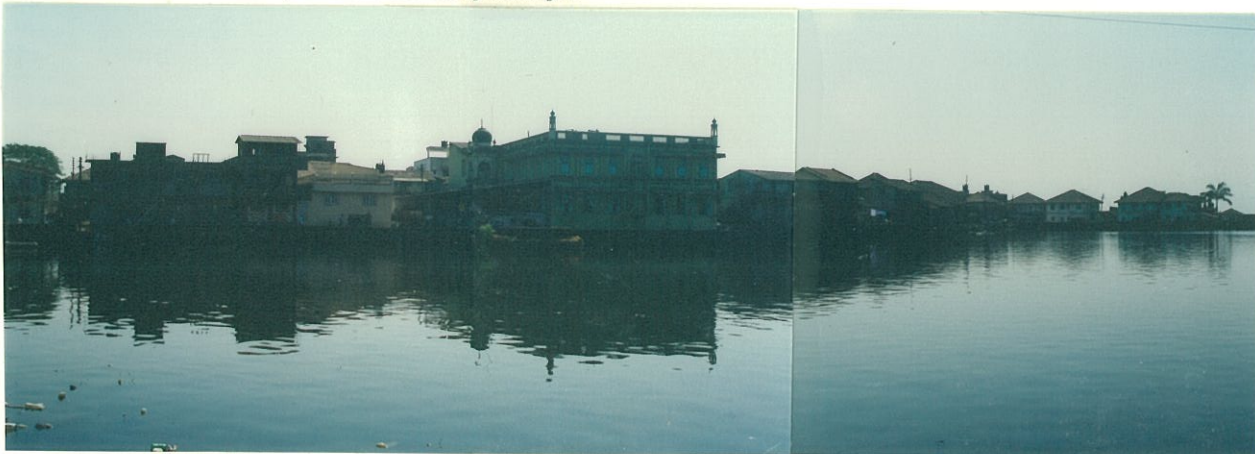
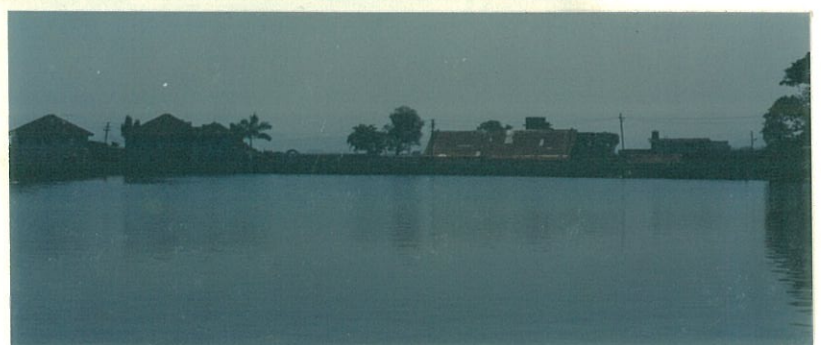
9.5	Openings	NA	
9.6	Roofing	NA	
9.7	Articulation & Finishes	NA	
9.8	Services	NA	
9.9	Outbuildings	NA	
9.10	Overall condition	The water of the Talav needs cleaning. The retaining wall is broken in many places and poorly built. Currently the steps to the water are used for washing clothes. The surroundings are unkempt and the pavement along the periphery is blocked in a few places due to the accumulation of garbage. Most significantly the Mosque, temple and houses have severed their connection with the Talav.	Maintenance level Poor

Panoramic view of Talav, centred on Taloja Masjid

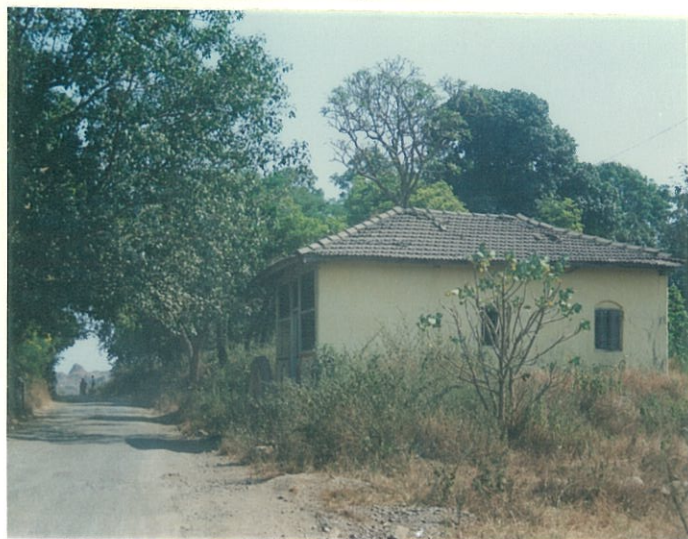
9.1	Plinth	The plinth is in fair condition, some plinth steps are broken	
9.2	Walls	This is a crudely built temple. The plaster in the mandapa walls is uneven, and has come off in many places

9.3	Floor	Flooring has cracked in many places	
9.4	Stairs	NA	
9.5	Openings	The TW framing of the front grilles is completely broken on one side. The rods have been removed. The frames of the other openings have weathered. A few windows are broken.

9.6	Roofing	Roof is in poor shape. The parts of the trusses have opened up. The ties are damaged. The roof has begun to sag.	
9.7	Articulation & Finishes	The plaster is uneven and cracked near pilasters. The paint is patchy

Temple with the Targhar village road

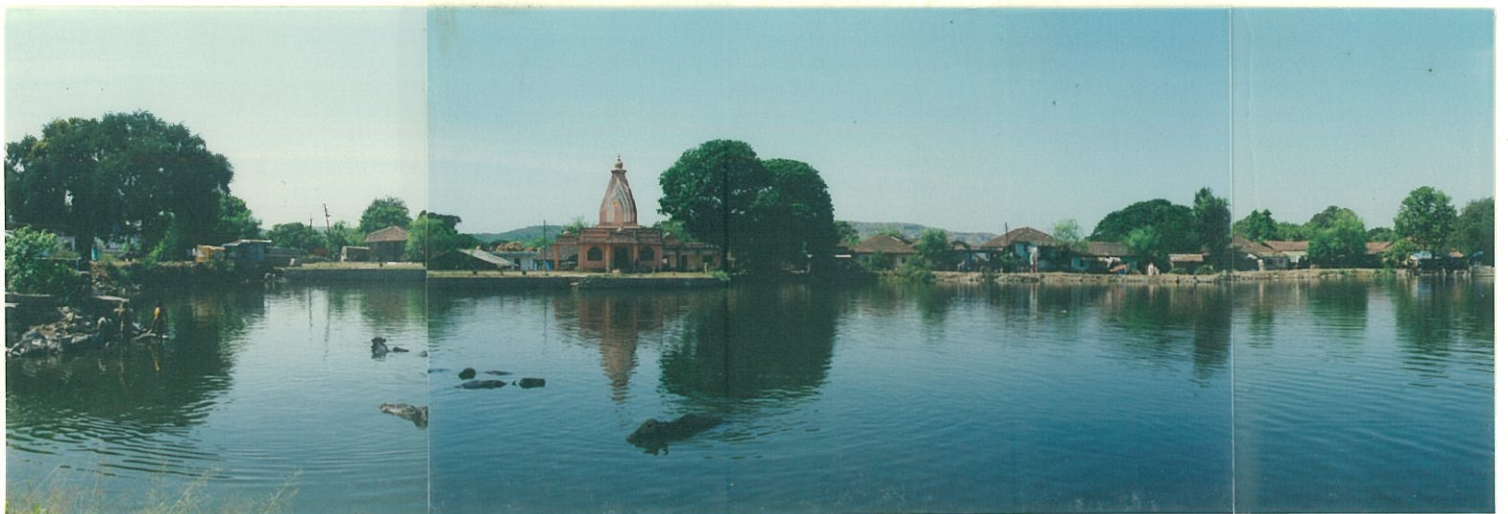
9.10	Overall condition	The water of the Talav needs cleaning. Currently one edge to the water is used for washing clothes. Cattle bathe freely in the water.
		Maintenance level Fair

Panoramic view of Talav centred on Maruti Mandir
