Intational Ga	allery of Modern Art (Sir Cowasji Jeha	angir Public Hall) 15
		Common Ref No: 156
		Card No: 214
		Ward (Part): A (Part III)
		Ward (Part): A (Part III) CS No: Indeterminable
		Plot Area: Indeterminable
	राष्ट्रीयडायुतिक कला मध्रतलय मुंबई सर कावसजी जहाँयोर पज्लिक हॉल	
	State Man on Annu and	B U Area: -
A DECEMBER		Date: 10/11/2004
		Recorded by: Zankhana Prajapati
		Reviewed by:
	NG	Int: Arun Wadhwa, Zankhana Prajapati
		Ext: Arun Wadhwa, Zankhana Prajapati
		Photo Ref.: 156_Cowasji Jehangir Hall
		WITT BE STATE
		Location Plan

1.0		Denomination
1.1	Name of Premises	National Gallery of Modern Art
1.2	Earlier Name	Sir Cowasji Jehangir Public Hall
1.2	Built in:	Foundation stone laid in 1911, completion in 1917 Extension Date: -
		opened in 1920 during World War I
<u> </u>

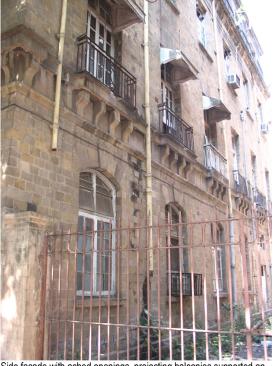
Side façade with ached openings, projecting balconies supported on brackets, sloping chajjas, modified openings to take in services

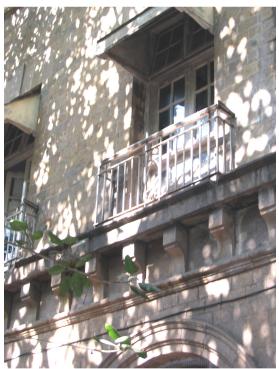
Balcony supported on stone brackets, bands

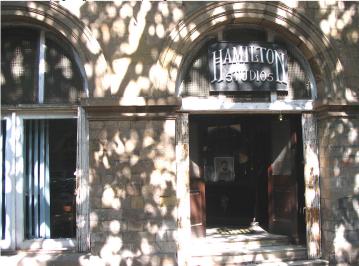
Main entrance façade with arched openings with bands

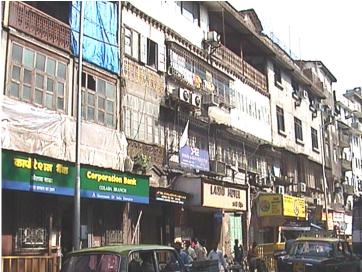
9.9	Out Buildings	Poor	
9.10	Overall Conditions	Poor Maintenance level Poor	
10.0		Transformation	
	Form		
	Structure	Completely transformed building.	
	Articulation & Finishes

Newly constructed building with no trace of the old building
