RESTORATION WORKS AT CHHATRAPATI SHIVAJI MAHARAJ VASTU SANGRAHALAYA Completion Report for Phase I Exterior Restoration Works

> Architects Abha Narain Lambah Associates: Conservation Architects & Historic Building Consultants Structural Rehab Consultant Mr. Arup Sarbadhikary Contractors

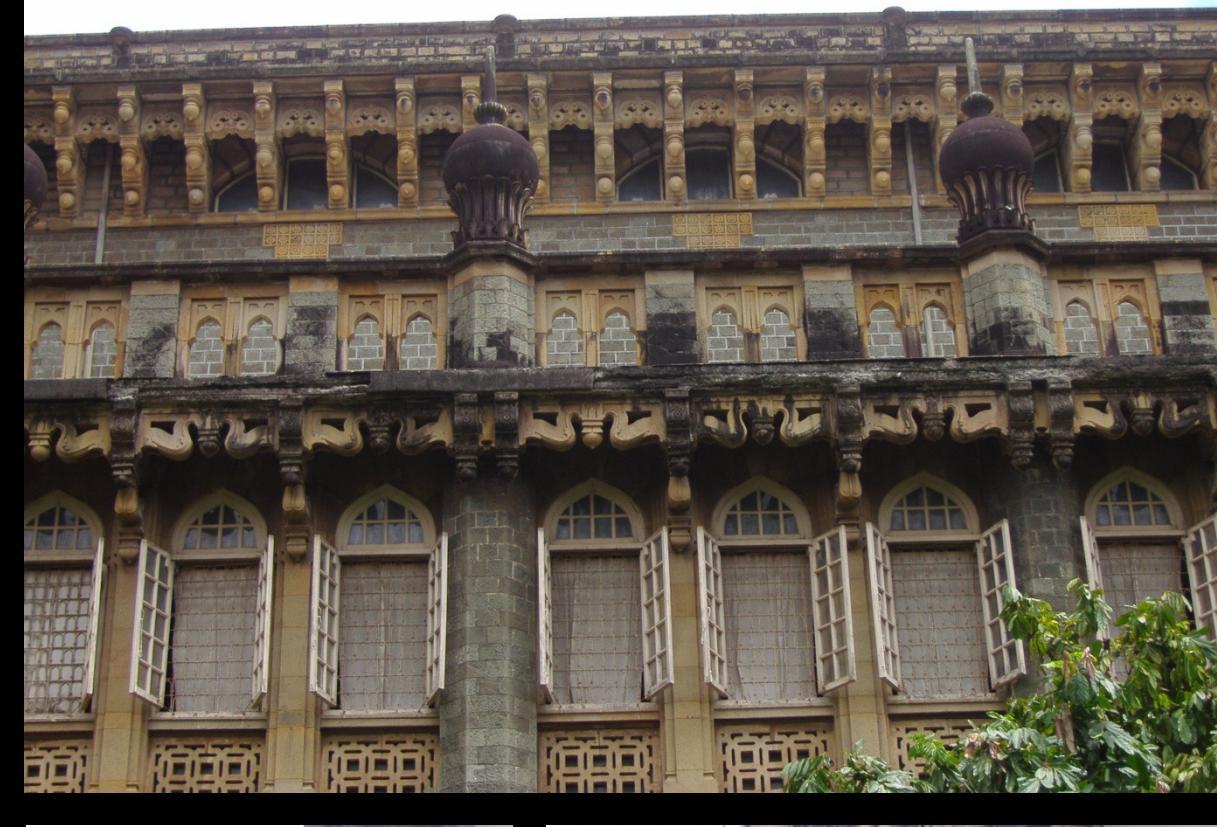
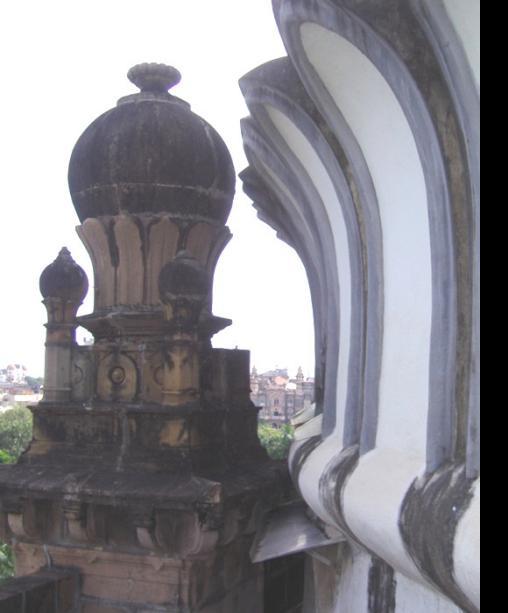
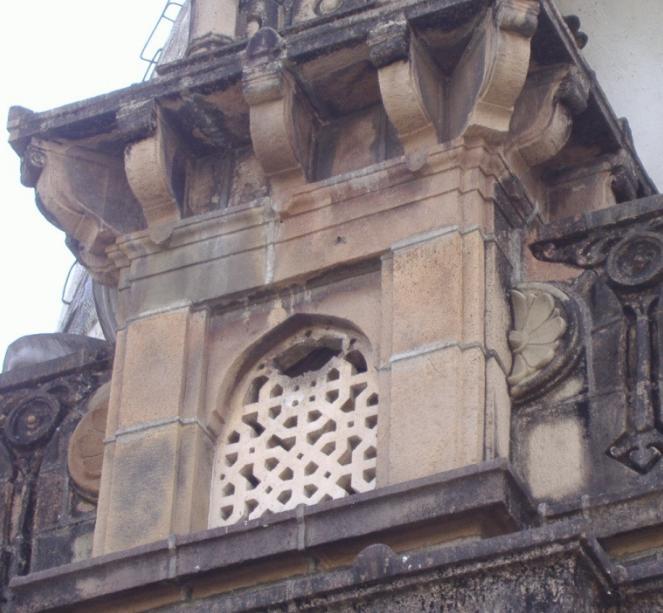
Right Below: Photographs showing a missing stone finial of a roof level guldasta in stone and the broken detail of the jaali

Various samples for Malad stone were shown and after having taken the approval from the architect, the contractors crafted new stone finials for Dutchman repair and fixed the new finials in position with non corrosive pins and dowels as seen in the photographs.

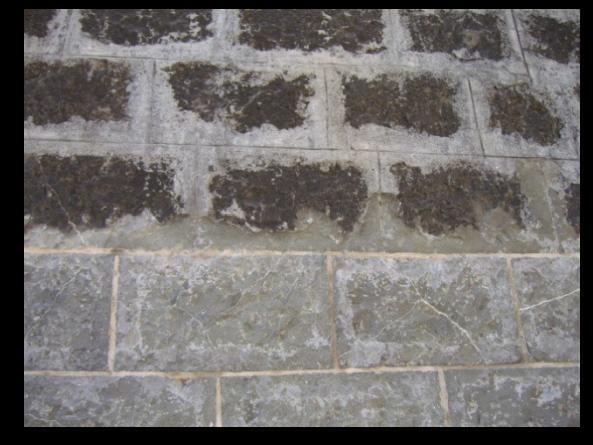
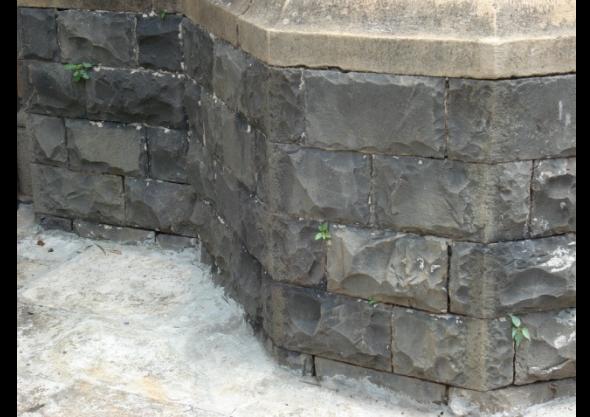
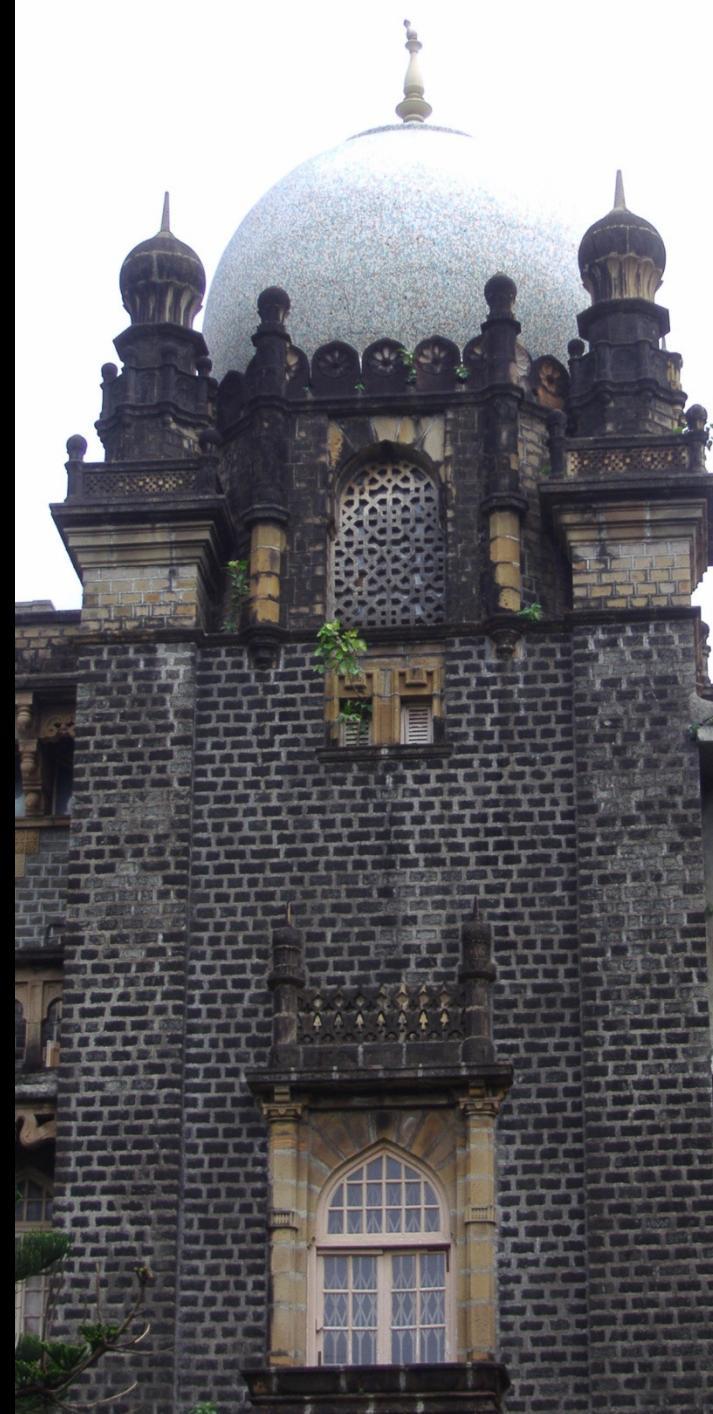
Top to Bottom: Photographs showing hard ribbon pointing in cement, partially removed hard ribbon pointing to expose the finer joints and plinth level masonry with deteriorated pointing that needs to be repointed in lime mortar.

Far Right: Ugly hard pointing that requires removal

This pointing exercise was undertaken in the 1970's and the pointing mix was not compatible with the original softer lime pointing. Almost the entire façade of the North West and the south east protruding block has been re-pointed in cement. Ribbon pointing juts out from the surface of the masonry, is much wider than the original joint and different from the original texture of pointing, therefore altering the visual aesthetics of the stone. The careful removal of this hard ribbon pointing was undertaken as a first step in the restoration process.

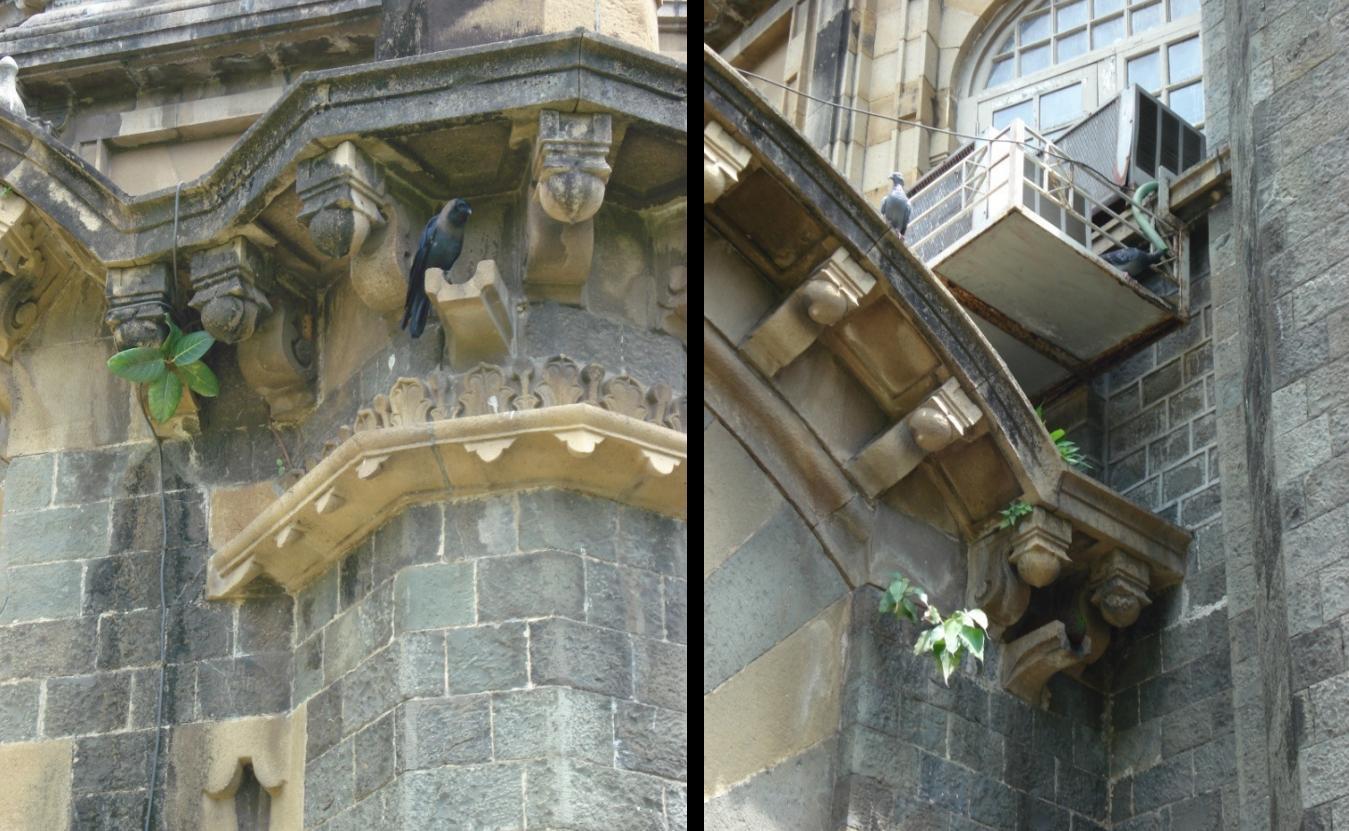
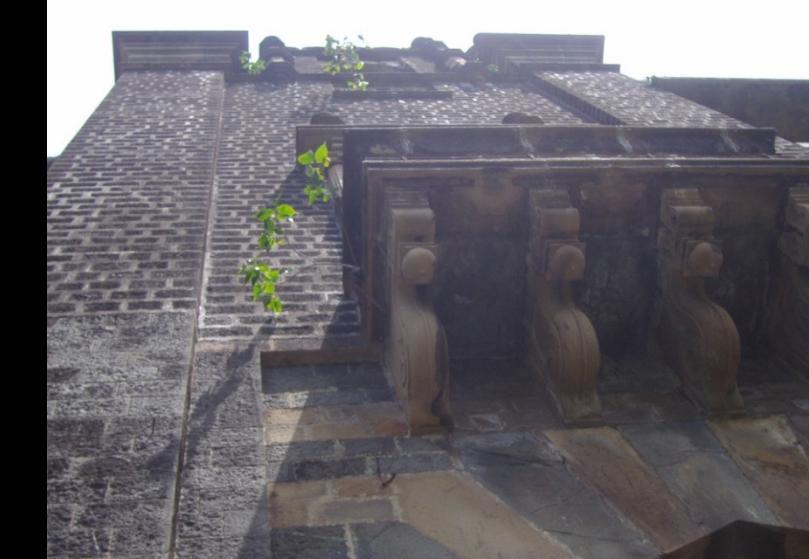
Photographs showing *Peepal* plants growing out of masonry joints along sections of deteriorated pointing, specially where there is a source of water leakage close by as a result of choked drainage outlets, leaking rain water down takes or air conditioner units

Areas along rainwater down takes were prone to ficus growth as the constantly wet masonry harboured such plant growth. In the case of smaller ficus (peepal /banyan) plants growing out of the stone joints, the methodology adopted was that of pulling out the plant and using a syringe to inject the ammoniacal biocide into the root system. In case of larger plants, a length of the main stem was cut out at a convenient height above the stone surface. The plant was then sprayed over with biocides and the parent stem, after cutting was cut into a frill girdle, and coated with a paste made from Ammonium sulphamate crystals. This is a better system than using acids, but in cases of extremely stubborn growth, when the above measures are not effective, and the masonry is not a soft limestone, only then can the option of injecting acid be adopted, and that too after ensuring that no surface overflowing of the solution takes place.

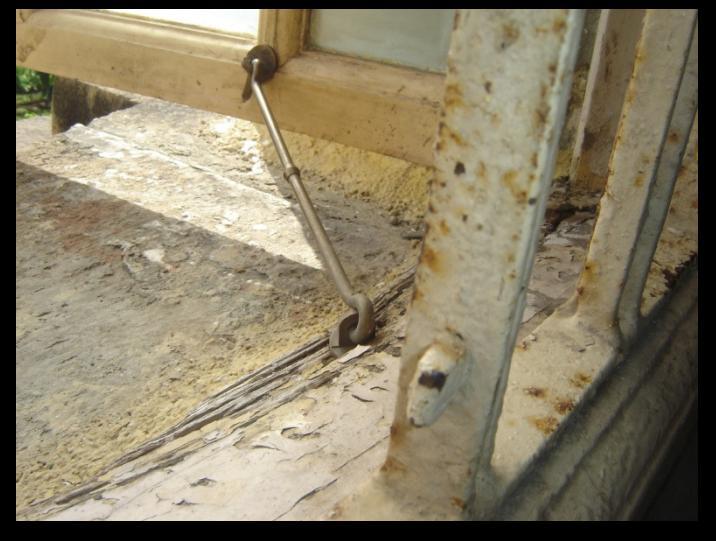
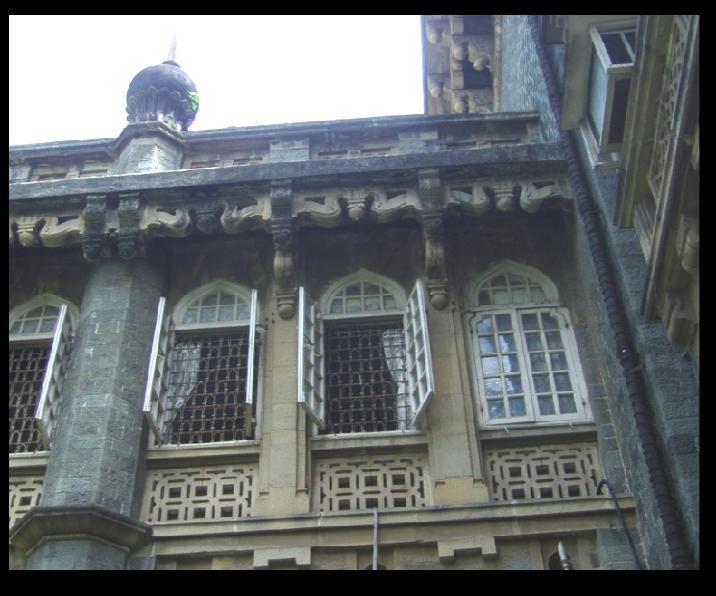
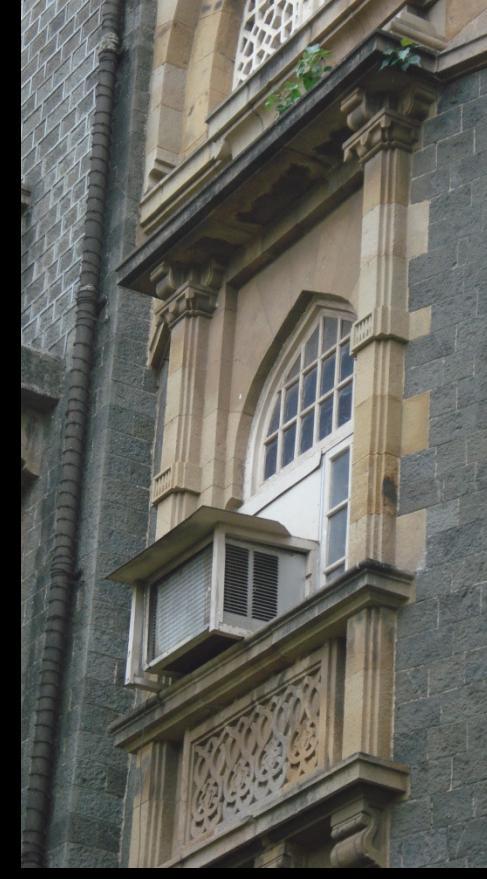
Photograph showing the Deterioration of the window frames Right: Photograph showing a window air conditioner unit mounted on the sill Below: Photograph showing the original window design with a glass fanlight and glazed shutters.

The window restoration work included making of new shutters and frames where they were damaged beyond reasonable repair, restoration of window shutters and frames where they were damaged to a lesser extent and for those windows which were sound, only scraping of old paint layers and repainting.

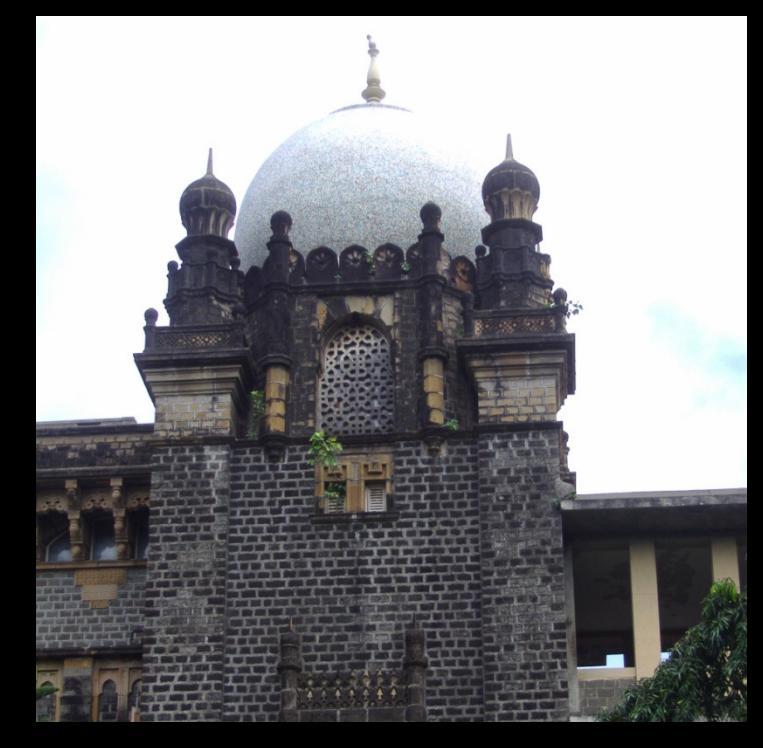
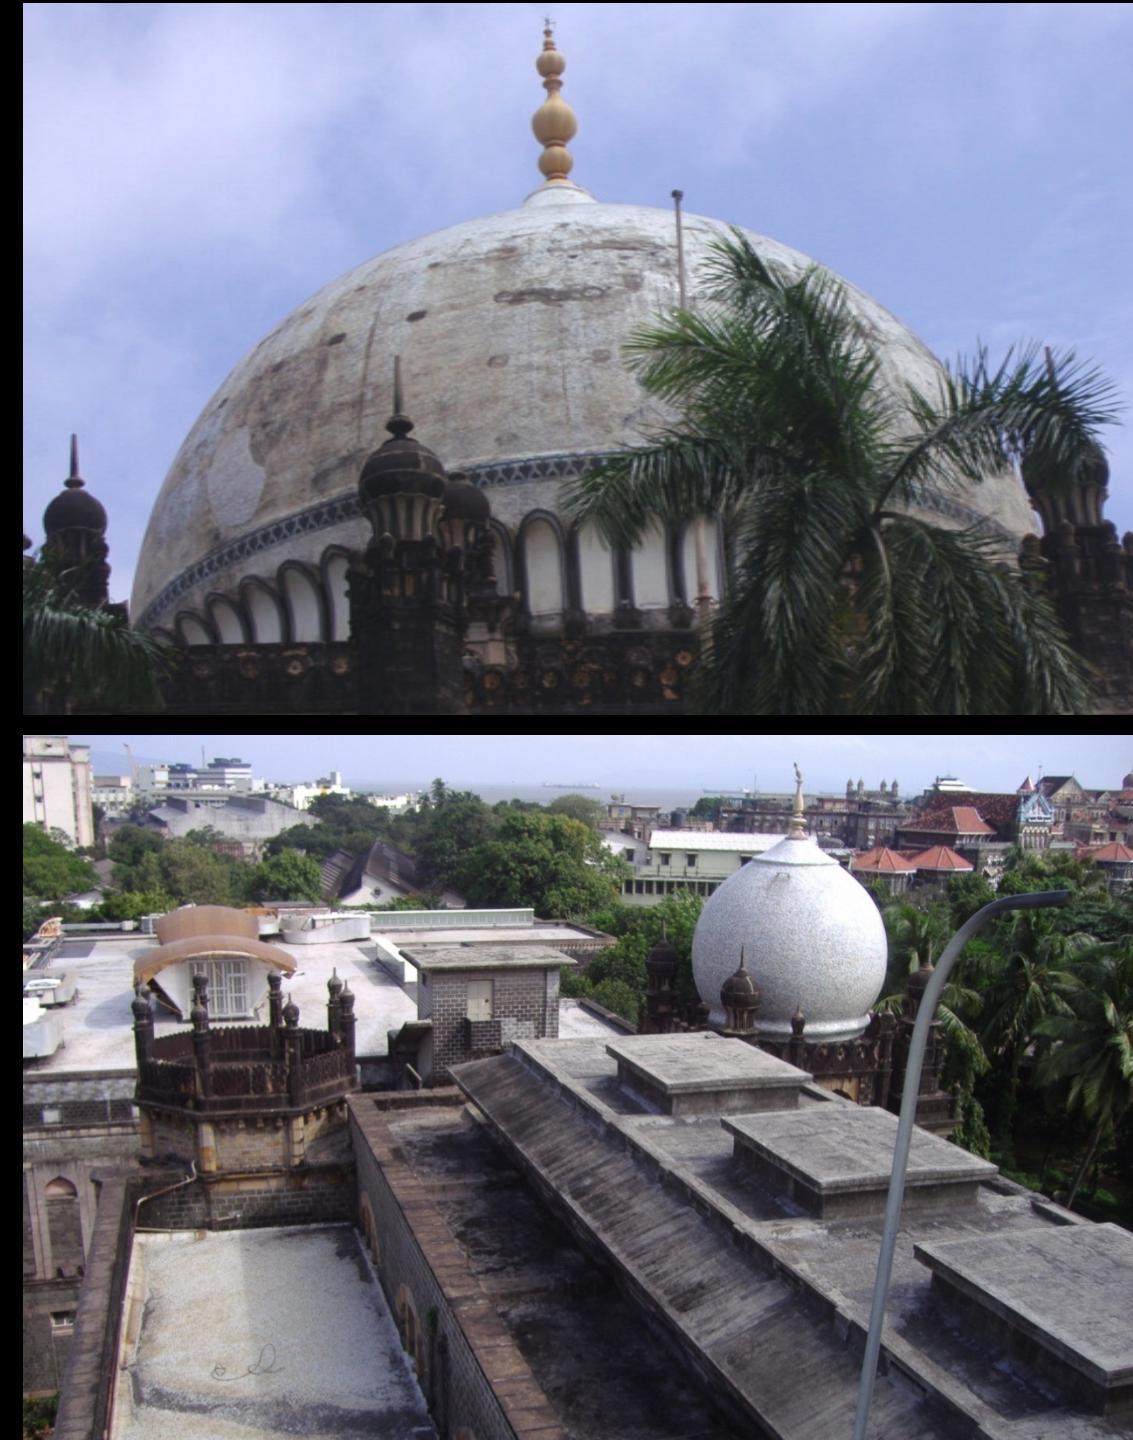
Left and Right Above: Photographs showing the domes surfaces that indicate past grouts as well as patchwork plastering over the surface. Any exercise to undertake major roof repair of the domes should be preceded by thorough non destructive testing and structural investigations. Right Below: Photograph of the terrace

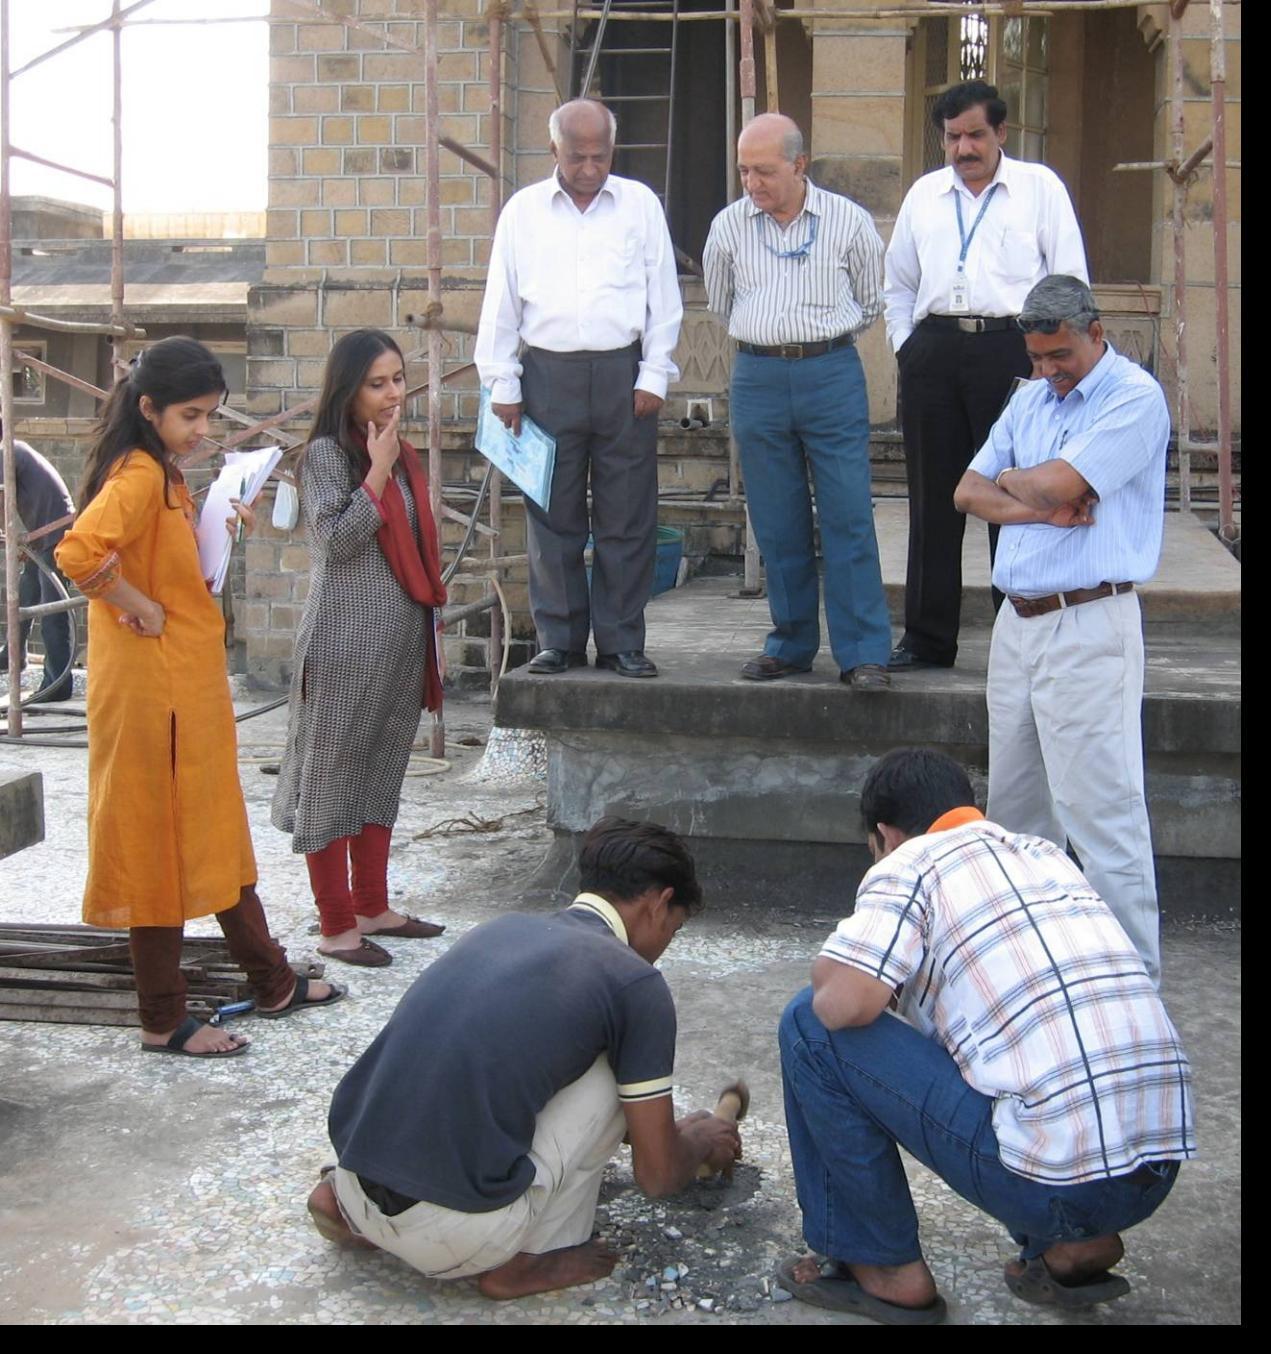
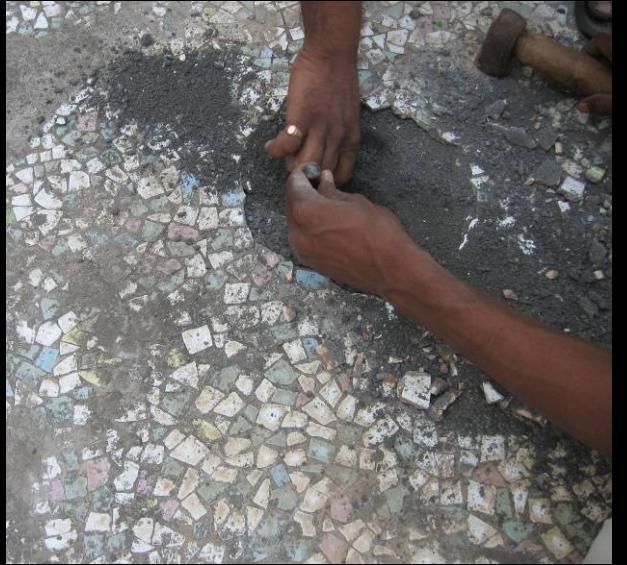
The Consultants have inspected sections of the terrace waterproofing that had been cracked and after opening out sections of hollow and cracked terrace waterproofing the team jointly decided that redoing the China Mosaic waterproofing would be a more effective treatment for addressing the waterproofing as the underlying layer of screed was very friable and had an extremely low cement content.
