CONSERVATION OF BOMBAY CASTLE

NAVAL DOCKYARD, MUMBAI

FINAL REPORT – PHASE I

K. Unwalla Architects, December 2005

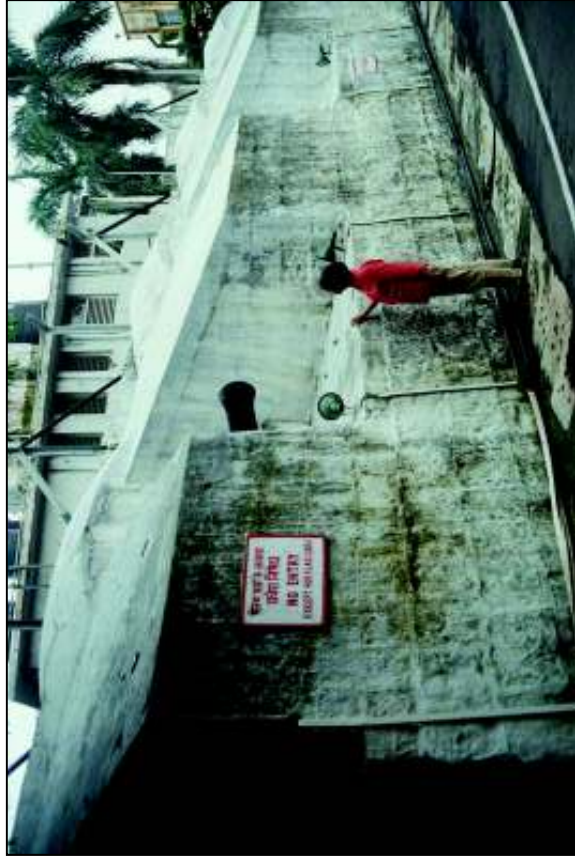
Security fencing in steel angles & mesh was mounted onto the Fort wall directly. This has been cleared and the walls restored.

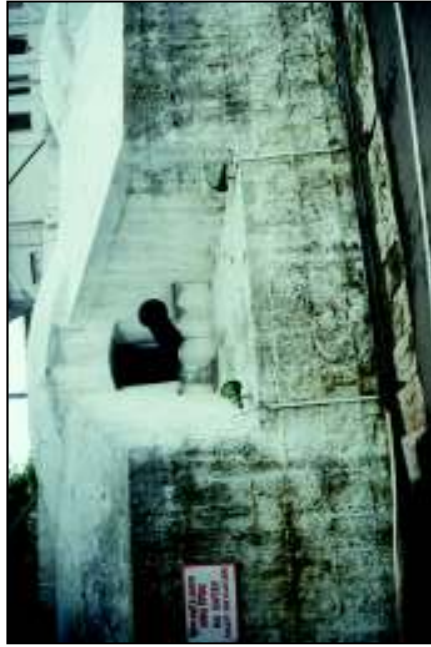
Condition prior restoration – accretions of cement paint

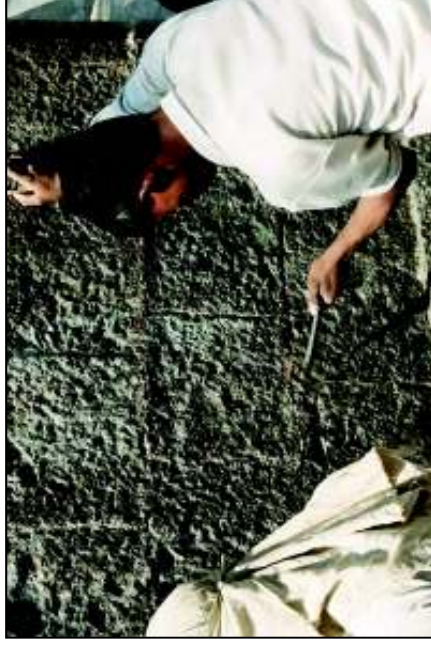
Removal of cementitious accretions by gentle tapping & soft brushing of pre-wetted stone surfaces

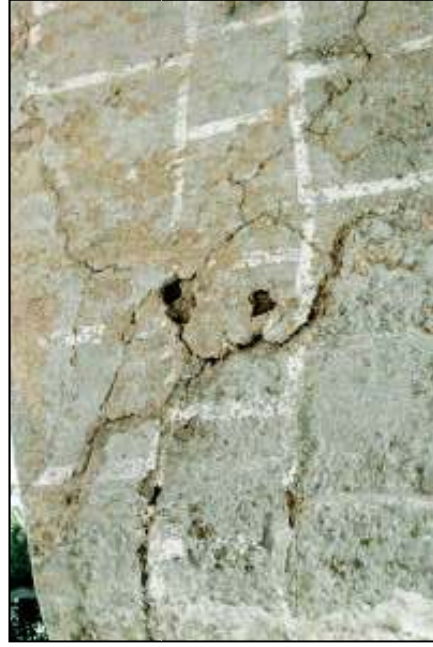
Condition prior restoration – accretions of cement plaster

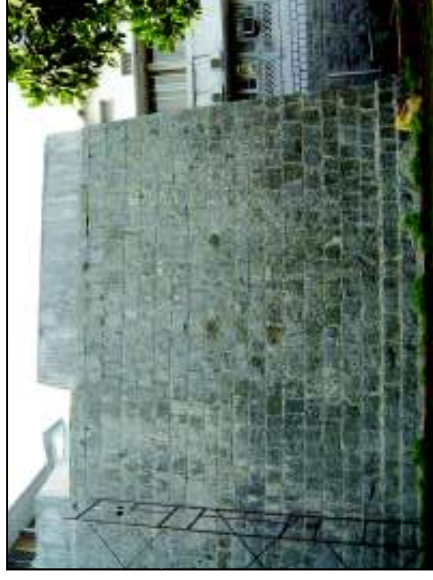
Bastion 3 after initial removal of paint

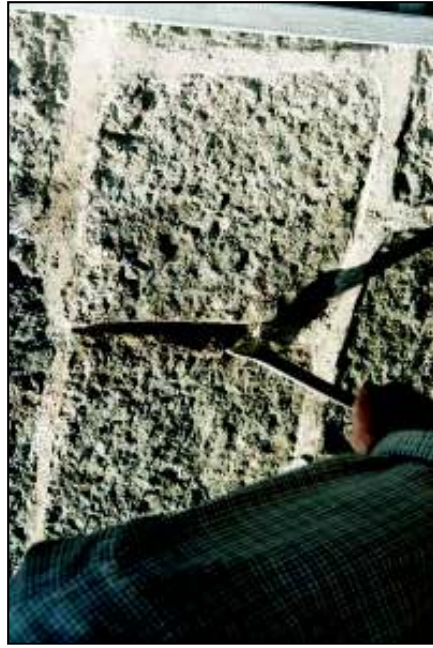
Raking out weakened jointing mortar and flushing out loose mortar

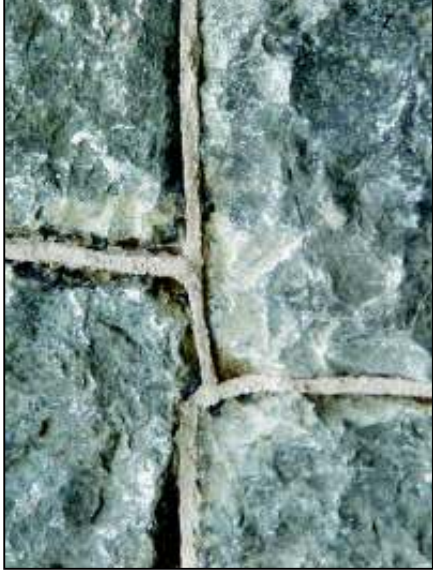
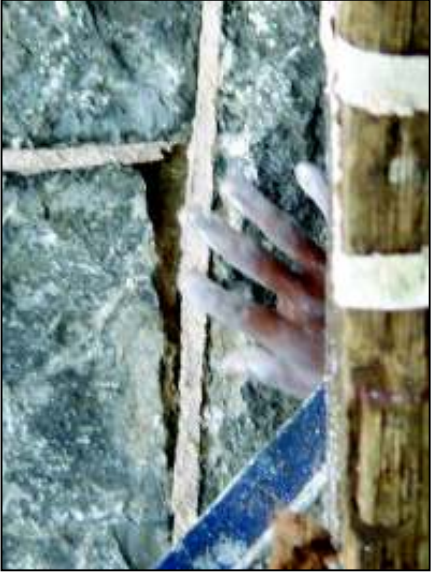
Re-jointing and re-pointing with lime mortar

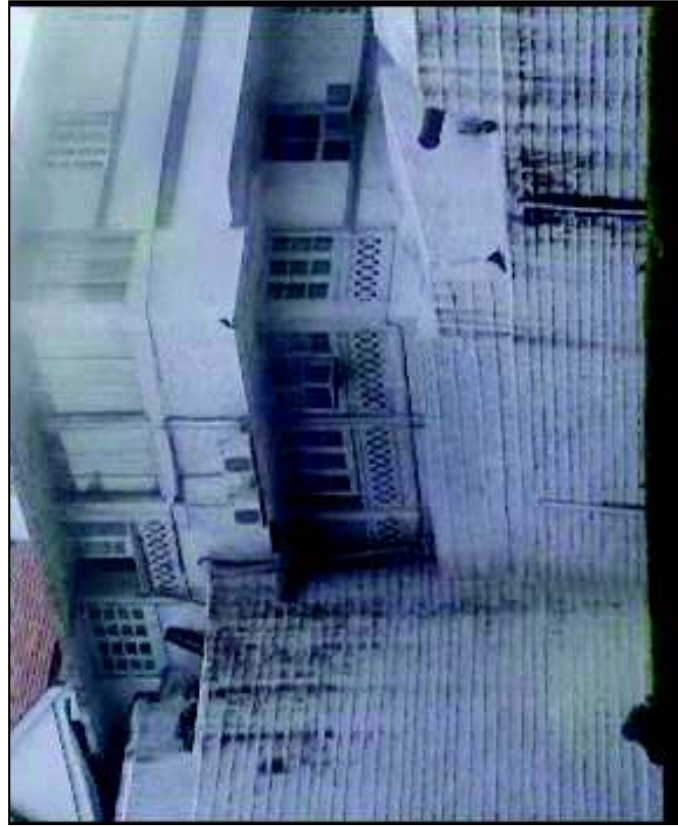
Condition prior to restoration

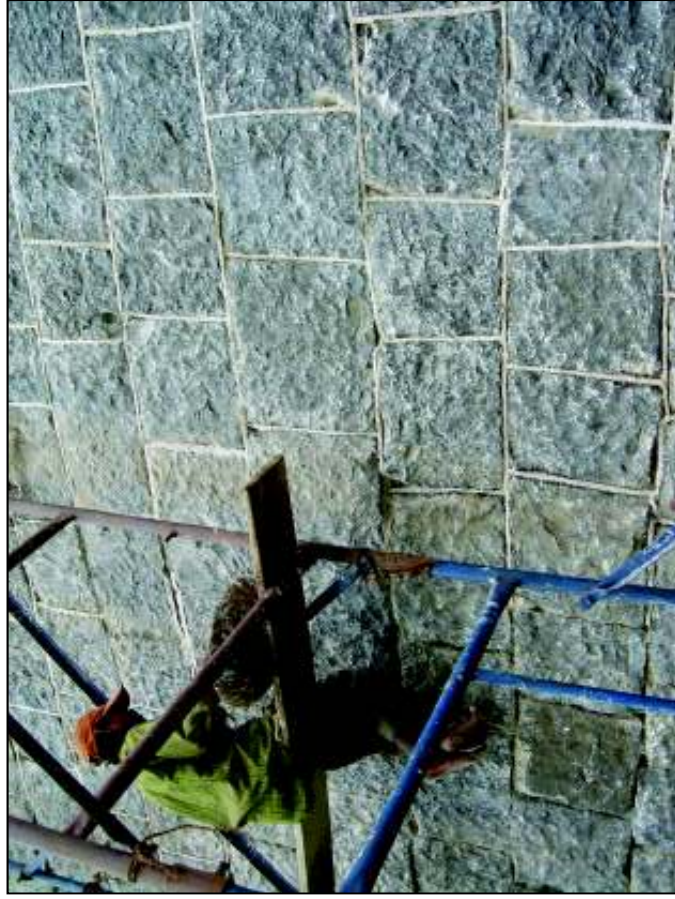
Part pointing complete.

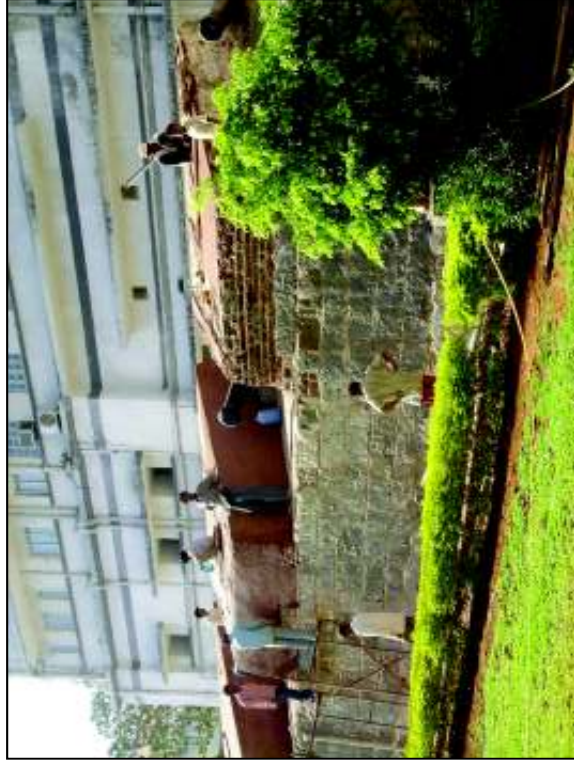
The battlements in this section of the curtain wall while beginning with a single layer of grey basalt stone, its final form is completed with brick masonry, unlike the battlements of the Fort Wall. Topped with mass cement concrete, it was replaced with brick bat coba in lime mortar and lime plaster finish.

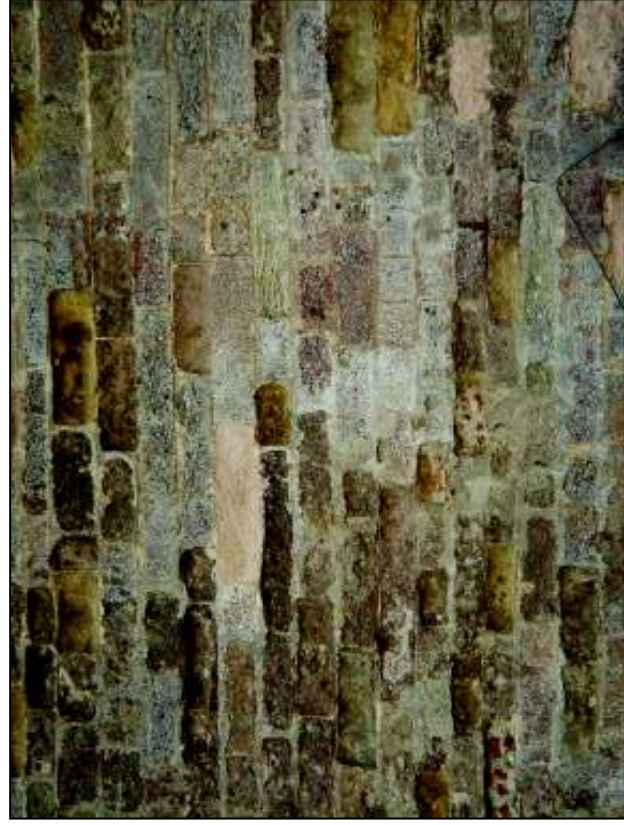
Condition of Laterite stones exposed after removal of paint & cement plaster

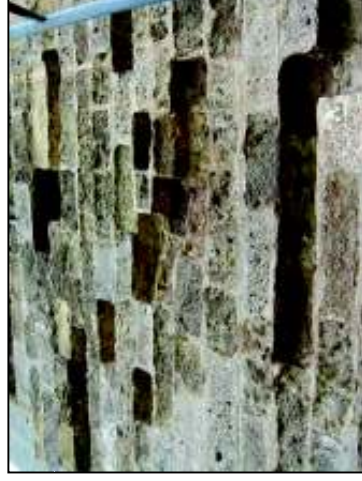
Stone replacement in process

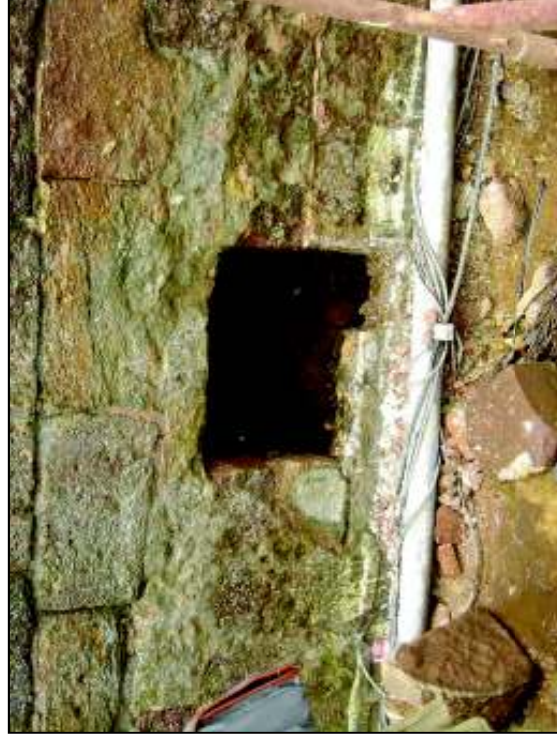
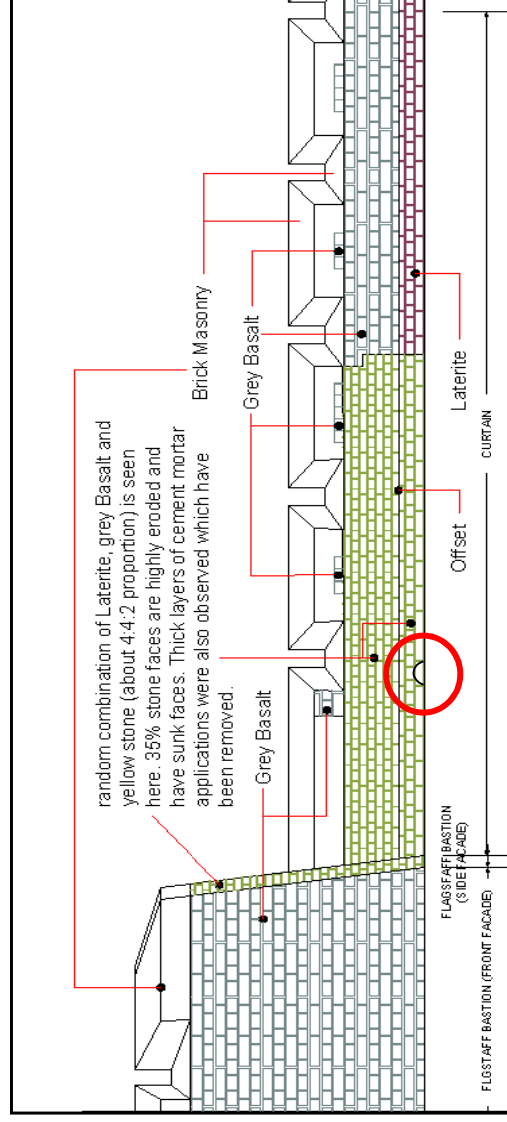
Unearthed Feature – Passage Tunnel in Curtain B

Location of Passage tunnel at Curtain B. this wall originally would have been fronting the shore line of the eastern coast.

During carrying out the process of stone replacement in Curtain B, this passage tunnel (1.5m wide & 1.2m tall) has been unearthed. It has been decided to undertake further research subsequent to which further excavation and restoration work may be carried out.

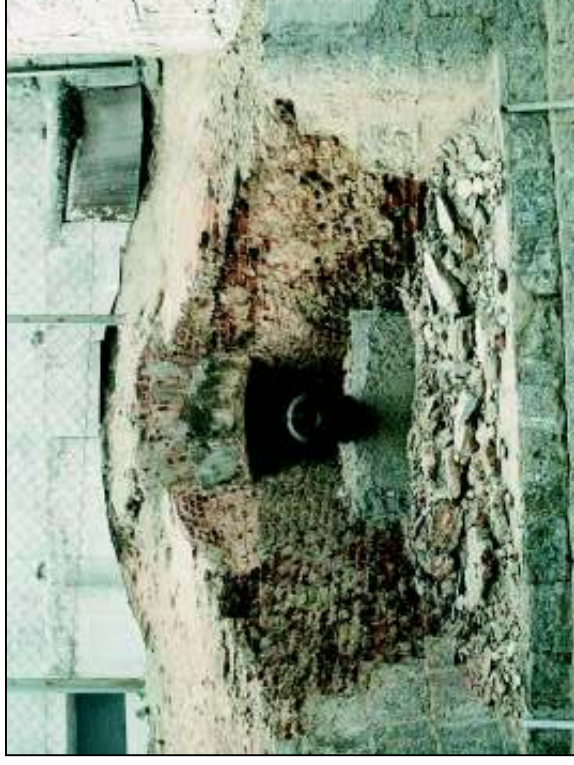
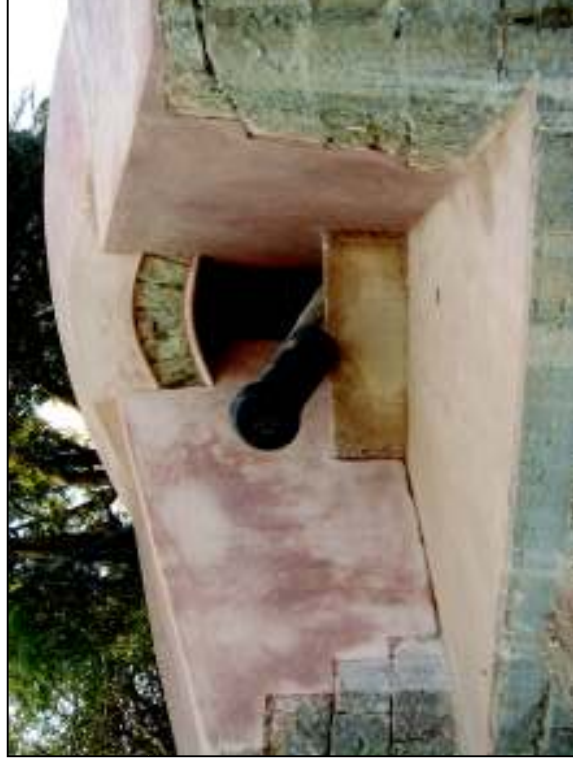
The restoration process while removing the obtrusive application of cement plaster exposed the original stone arches. The arches have now been restored and maintained in an exposed state.

The guns with the constructed pedestal are of recent intervention and have been maintained as such.
