A COMPREHENSIVE LISTING OF HERITAGE VALUES IN THANE

PART II

FOREWORD

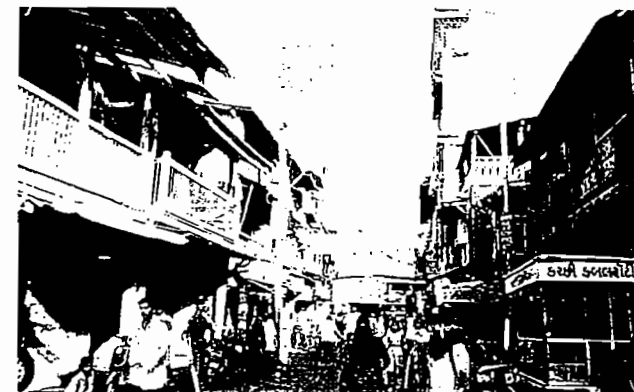
KHARKAR ALI

Kharkar Ali on the other hand has become a flourishing wholesale market with all the old and new structures being used as storage spaces and godowns. The old structures in Kharkar Ali are in a poor condition and have undergone tremendous additions and

alterations to suit the purpose of the commercial activity there.

As a result, the originality of these old structures is not visible in entirety so as to document them for the purpose of this study. As for the other two areas of Panchpakhadi and Ghantali all old structures are fast disappearing and only new development is visible.

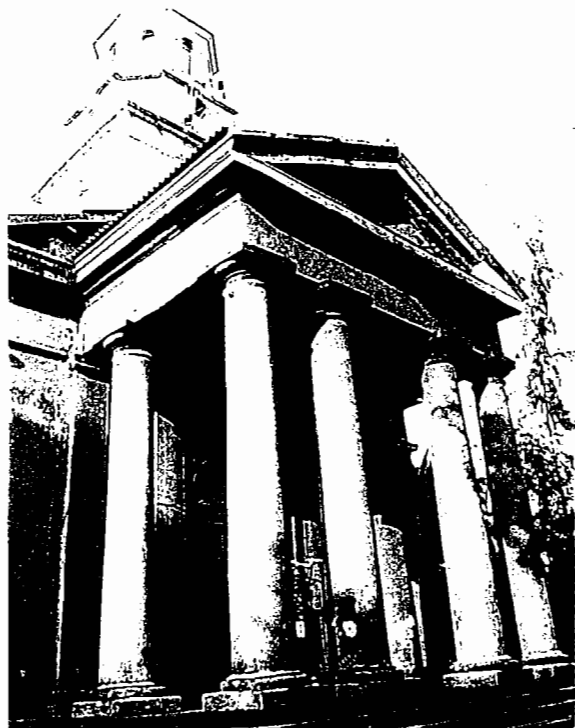
ST. JAMES CHURCH

Inside the church, different dates are found inscribed on the tablets, which adorn the walls, which may convey that the construction of the church was done over a period of time.

It is said that the fort i.e. the Central Jail was linked to the church by means of an underground tunnel. This tunnel ceases to exist today and no person can pinpoint the exact whereabouts of it.

Name of Building	: St. James Church
Location	: Near Head Post Office, Opp. Castle Tank
Plot / Survey No.	: Not available
Landuse	: Amenity
Ownership Status	: Under the Trust
Name of Owner	: Not available
Date of Construction	: 1825
Present Use	: Place of Worship

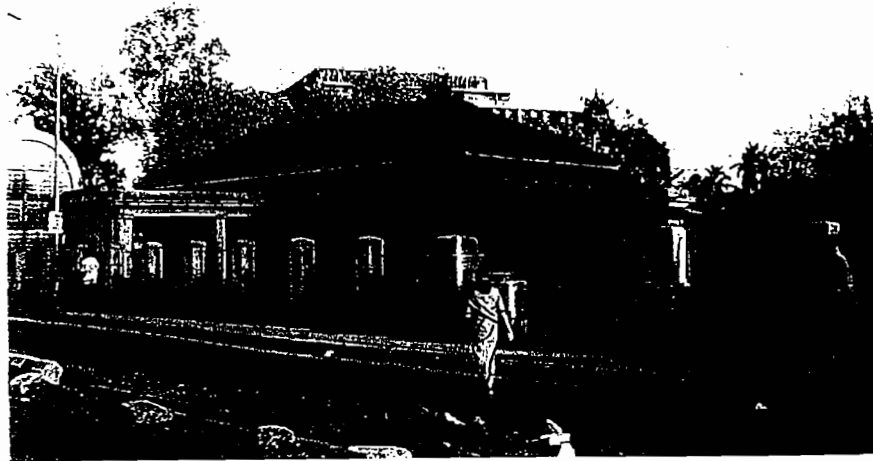
The structure is very simple but has a strong historical relevance for the city of Thane.

Height of Structure	: G
Notable Features	: Nil
Architectural Style	: Unidentifiable
Ornamentation	: Nil
Additions & Alterations	: Verandah added later on.
Remarks	: Nil
State of Preservation	: Fair
Proposed grade	: III (Type 2) B

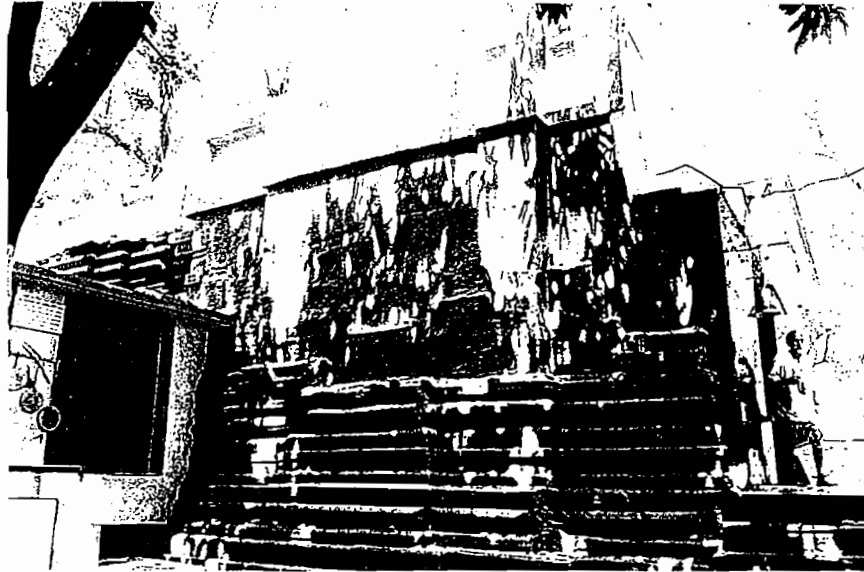
KHIDKALESHWAR TEMPLE

Name of Building	: Khidkaleshwar Mandir
Location	: Khidkali, Kalyan Highway
Plot / Survey No.	: Not available
Landuse	: Amenity (Temple)
Ownership Status	: Under the Trust
Name of Owner	: Khidkaleshwar Mandir Trust
Date of Construction	: 8 th Cent. AD.
Present Use	: Place of Worship

Present Use	: Place of Worship.
Past Use	: Place of Worship.
Height of Structure	: G + 1
Notable Features	: Stucco work. Entrance portico. Double framed window. Shikhar of the garbhagriha is enclosed in the sabhamandapa. Glazed tiles used in the sabhamandapa were brought from England and are still in good condition.

Additions & Alterations : Temple was entirely renovated in 1921.
Pillars in the central area replaced with iron.
Some of the flooring tiles replaced with ceramic ones.

State of Preservation : Fair

Proposed grade : III (Type 2) A

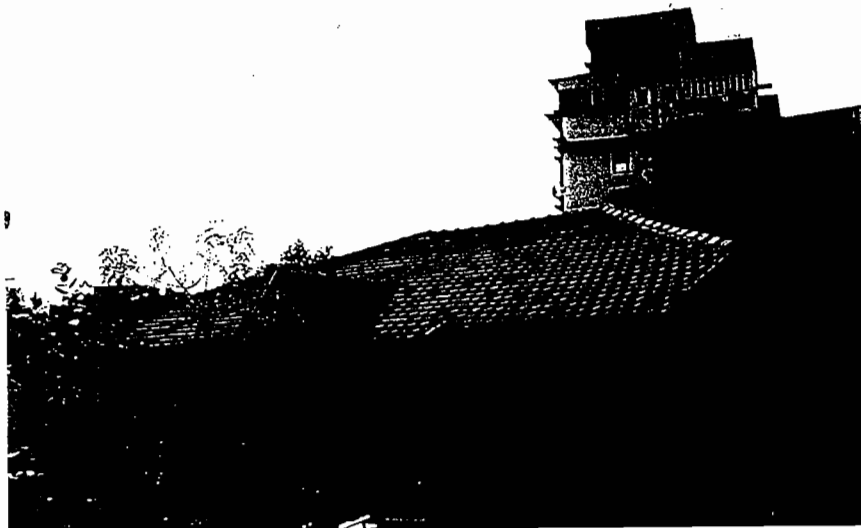
MANI BAUG

Name of Building	: Mani Baug
Location	: Near Hariniwas.
Plot / Survey No.	: Not available
Landuse	: Residential
Ownership Status	: Private
Name of Owner	: Mr. Thanawalla
Date of Construction	: 1918
Present Use	: Residential and commercial
Past Use	: Residential.

Height of Structure	: G
Notable Features	: Verandah. Cast iron railings. Fascia. House form.
Architectural Style	: Vernacular
Ornamentation	: Decorative Fascia. Decorative cast iron railings.
Additions & Alterations	: In 1975, on the rear side a master bedroom was added (G + 1) made in R.C.C. One of the rooms was extended on the verandah side. Bedroom was extended on the rear side. False ceiling was added for the living room.
Remarks	: Owner intends to maintain the house in the best possible way.
State of Preservation	: Good.
Proposed grade	: III (Type 2) B

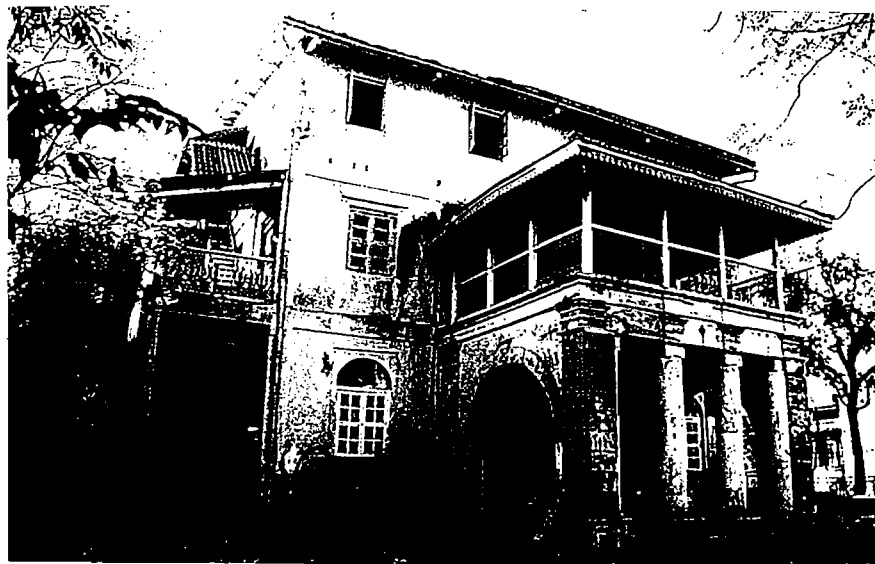
THAKUR BUNGALOW

Name of Building	: Thakur Bungalow
Location	: Gokhale road
Plot / Survey No.	: Not available
Landuse	: Residential
Ownership Status	: Private
Name of Owner	: Mr. Thakur
Date of Construction	: Not available
Present Use	: Residence

Past Use : Residential (Police Headquarters for a short period.)

Height of Structure : G + 2

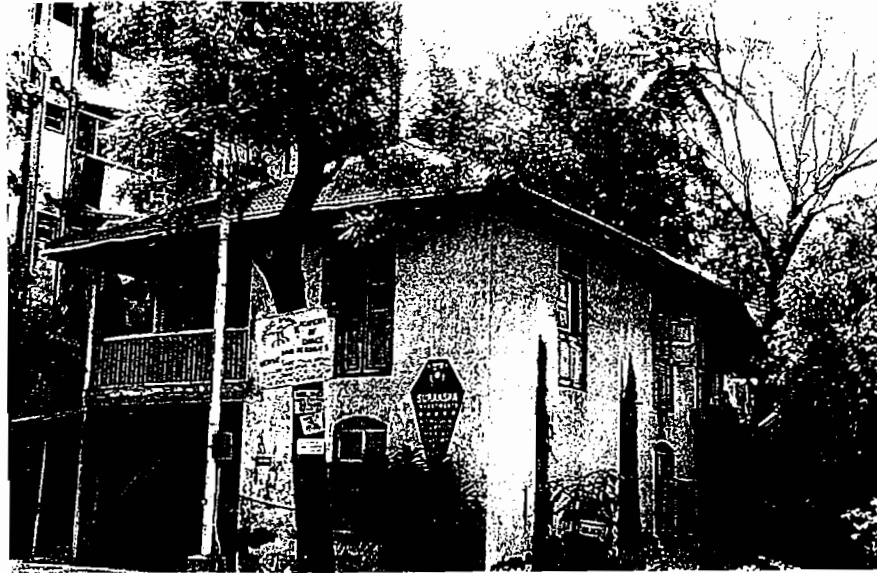
Name of Building	: Gandhi Building
Location	: Near Police Lines, Kharkar Ali.
Plot / Survey No.	: Not available
Landuse	: Residential
Ownership Status	: Tenanted. Owner stays in the same premises.
Name of Owner	: Not available
Date of Construction	: Not available

Past Use	: Residence
Height of Structure	: G + 1
Notable Features	: Wooden railing
Architectural Style	: Vernacular
Ornamentation	: Ornamental newel post
Additions & Alterations	: Nil
Remarks	: Nil
State of Preservation	: Fair
Proposed grade	: III (Type 2) B

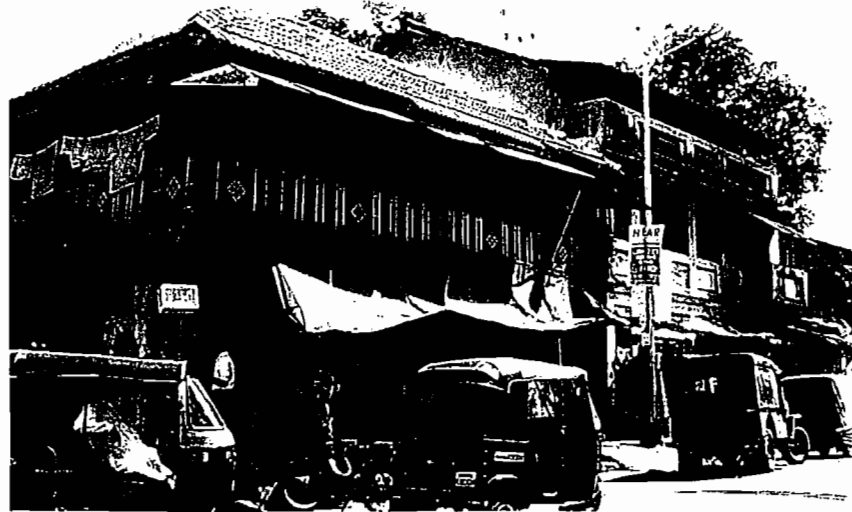
RAM MARUTI ROAD

Name of Building	: Ramchandra Niwas
Location	: Ram Maruti Road
Plot / Survey No.	: Not available
Landuse	: Residential
Ownership Status	: Tenanted
Name of Owner	: Not available
Date of Construction	: Not available
Present Use	: Residence

Present Use	: Residence and Commercial
Past Use	: Residential
Height of Structure	: G + 1
Notable Features	: Wooden railing
Architectural Style	: Vernacular
Ornamentation	: Nil
Additions & Alterations	: Alterations done on the rear side
Remarks	: Intention to demolish the present structure for new development

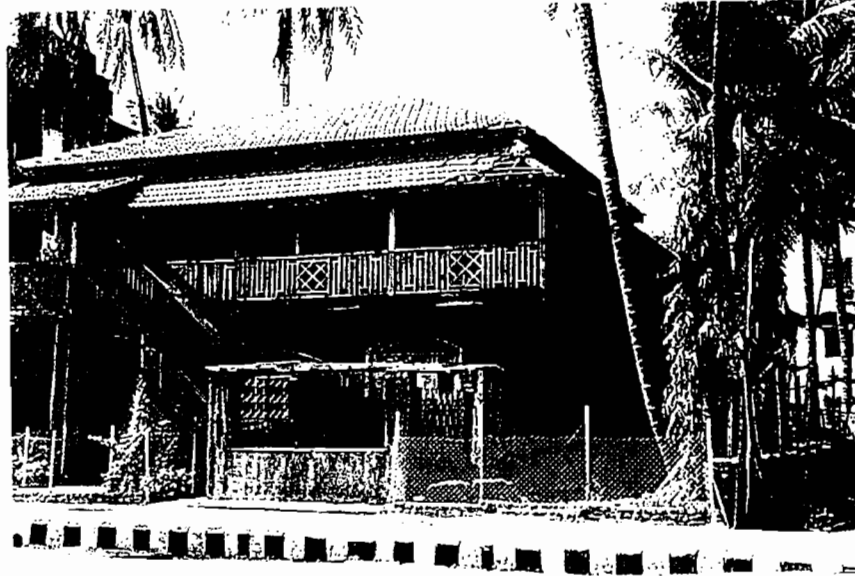
RAM MARUTI ROAD

Name of Building	: Durve building
Location	: Ram Maruti road
Plot / Survey No.	: Not available
Landuse	: Residential
Ownership Status	: Private
Name of Owner	: Mr. Durve
Date of Construction	: 1944
Present Use	: Residence and Shops .

Present Use	: Residence and shops.
Past Use	: Residential and shops.
Height of Structure	: G + 1
Notable Features	: Roof line. Cast iron railings. Balcony on the first floor, Fascia
Architectural Style	: Vernacular
Ornamentation	: Decorative cast iron railings. Decorative wooden fascia.

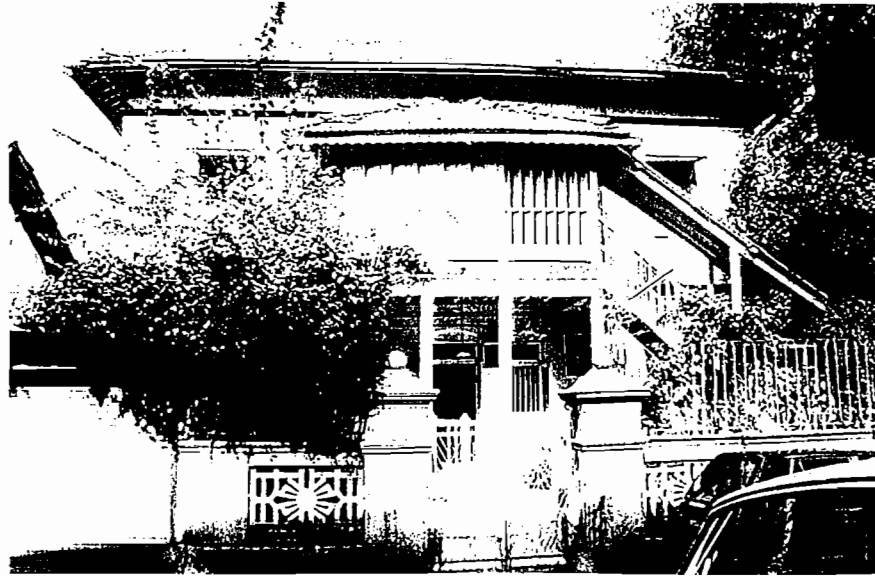
1 CHARAI

Ornamentation : Decorative cast iron railings
Stain glass
Decorative fascia

Remarks : Structure is in good condition and is sound in terms of maintenance

Proposed grade : III (*Type 1*) A

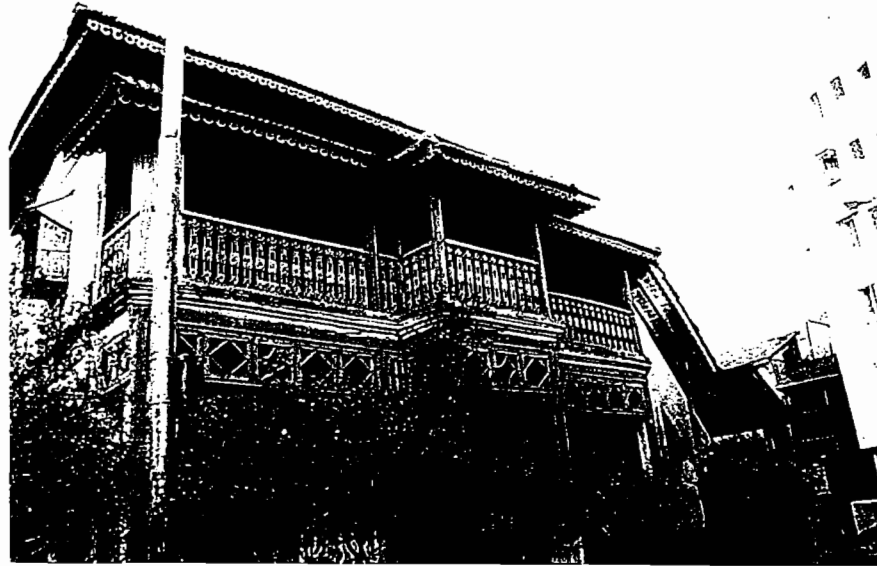
2 CHARAI

Name of building	: Pimenta House
Location	: B. P. Road, off Edulji Road, Charai
Plot / Survey No.	: / 385
Landuse	: Residential
Ownership Status	: Private
Name of Owner	: Mr. Joseph p. Pimenta
Date of Construction	: 1930
Present Use	: Residence

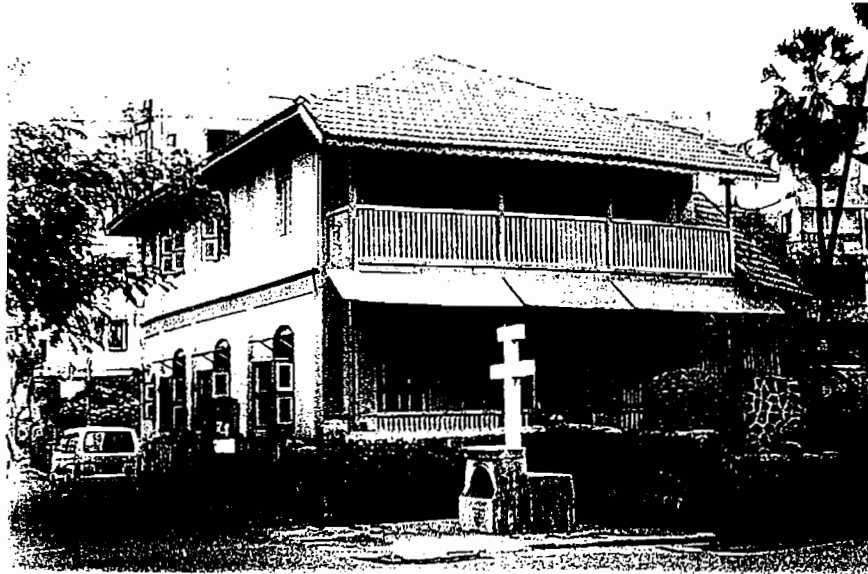
3 CHARAI

Present Use	: Residence and Nursery school
Past Use	: Residential
Height of Structure	: G + 1 (having attic)
Notable Features	: House form. Verandah on ground floor. Balcony on first floor. Timber staircase from the verandah. Fascia.
Architectural Style	: Vernacular
Ornamentation	: Decorative wooden fascia.
Additions & Alterations	: Nil
Remarks	: Structure is in good condition and is sound in terms of maintenance
State of Preservation	: Good
Proposed grade	: III (<i>Type 1</i>) A

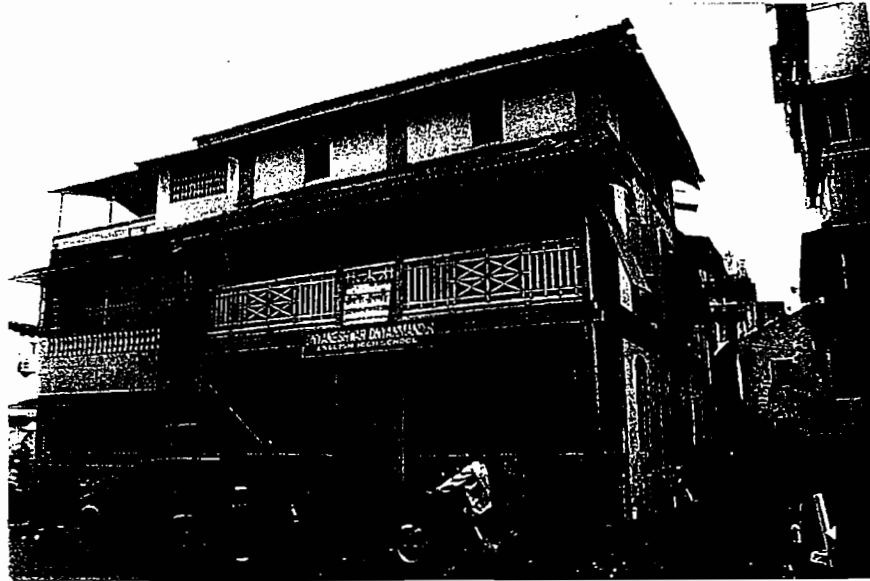
4 CHARAI

Date of Construction	: 1922
Present Use	: School
Past Use	: Residential
Height of Structure	: G + 1 (Having attic)
Notable Features	: Wooden Railings
Architectural Style	: Vernacular
Ornamentation	: Wooden Railings
Additions & Alterations	: RCC Support given to the external staircase. Plastering work carried out by Ramon and Demn.
Remarks	: Staircase on the rear side demolished due to security reasons.
State of Preservation	: Good
Proposed grade	: III (Type 1) A

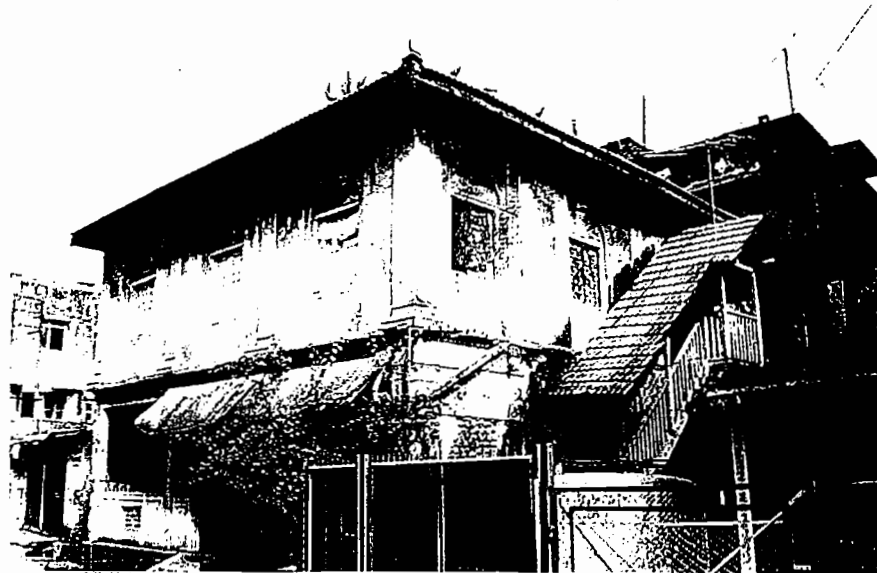
5 CHARAI

Present Use : Residence
Past Use : Residence
Height of Structure : G + 1
Notable Features : External timber staircase.
Projecting balcony.
Stucco work on façade.
Double framed windows.
Architectural Style : Vernacular
Ornamentation : Stucco work on facade
Additions & Alterations : nil
Remarks : External staircase in poor
condition
State of Preservation : Fair
Proposed grade : III (*Type1*) B

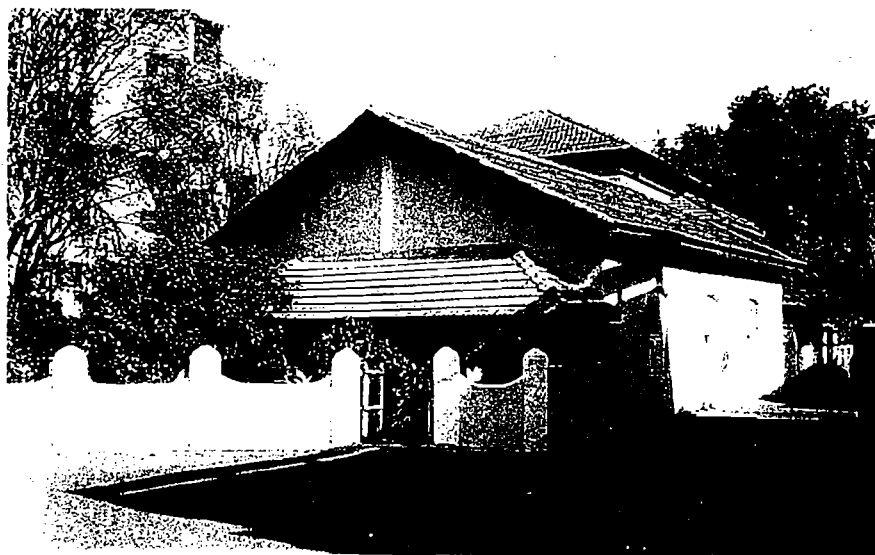
6 CHARAI

Proposed grade : III (*Type 1*) B

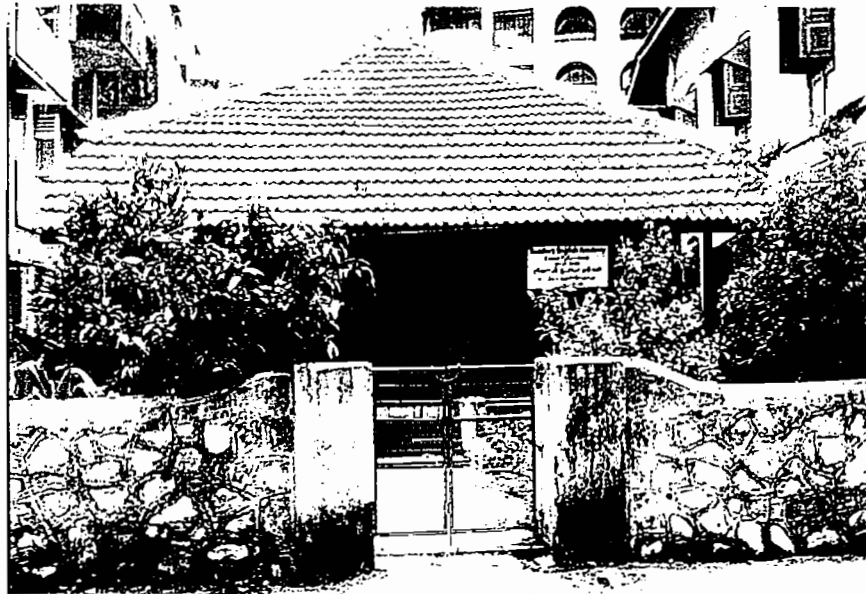
7 CHARAI

Past Use	: Residential
Height of Structure	: G (having attic)
Notable Features	: Verandah on ground floor. Cast-iron railing. Fascia.
Architectural Style	: Vernacular
Ornamentation	: Decorative cast iron railings Stain glass Decorative fascia
Additions & Alterations	: Nil
Remarks	: Structure is in good condition and is sound in terms of maintenance
State of Preservation	: Good
Proposed grade	: III (Type 1) B

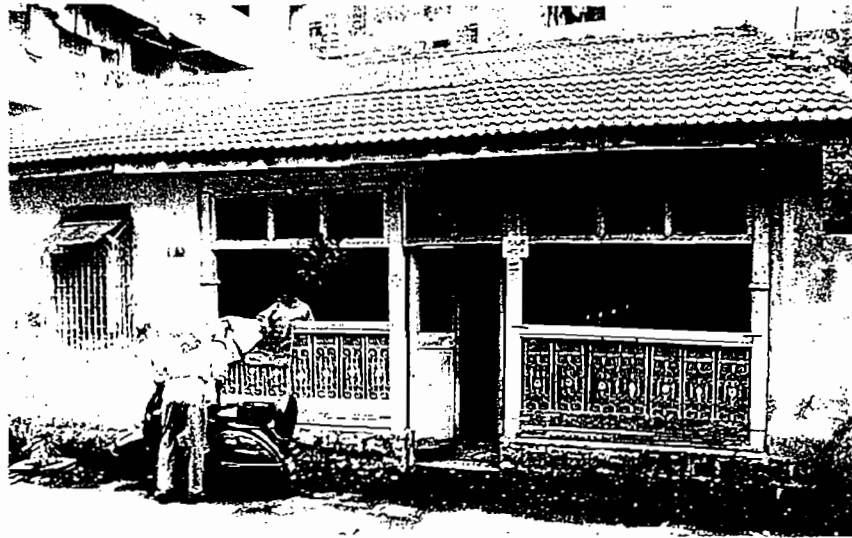
8 CHARAI

Present Use : Residential
Past Use : Residential
Height of Structure : G (Having attic)
Notable Features : Cast iron railings
Architectural Style : Vernacular
Ornamentation : Cast iron railings
Additions & Alterations : Internal plastering and tiling done to prevent seepage.
Remarks : Internal photography not allowed
State of Preservation : Fair
Proposed grade : III (Type 1) B

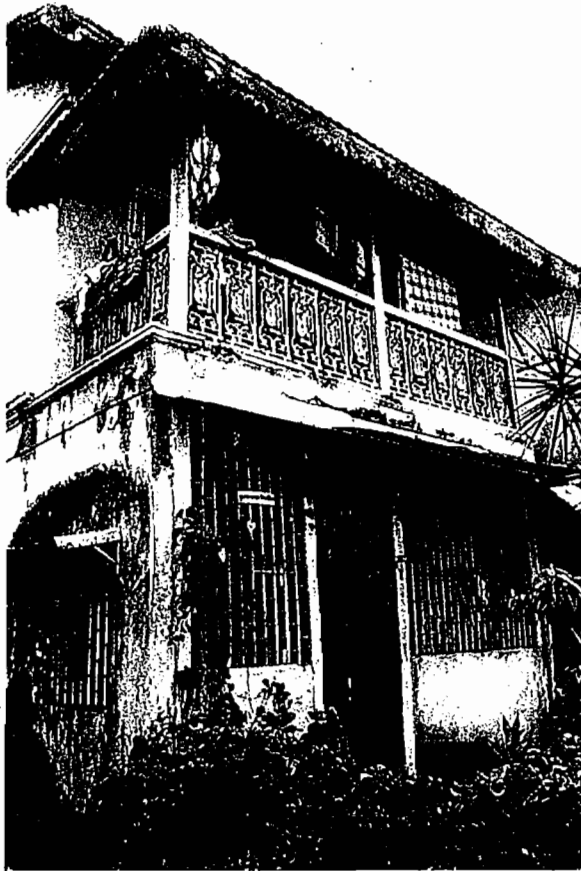
9 CHARAI

Present Use : Residential
Past Use : Residential
Height of Structure : G + 1
Notable Features : Cast iron Railings
 Stucco work above the doors and windows
Architectural Style : Vernacular
Ornamentation : Cast iron railings
 Stucco work above the doors and windows.
Additions & Alterations : MS grilles added to the ground floor for security reasons.
Remarks : Internal photography not allowed.
State of Preservation : Fair.
Proposed grade : III (*Type 1*) B

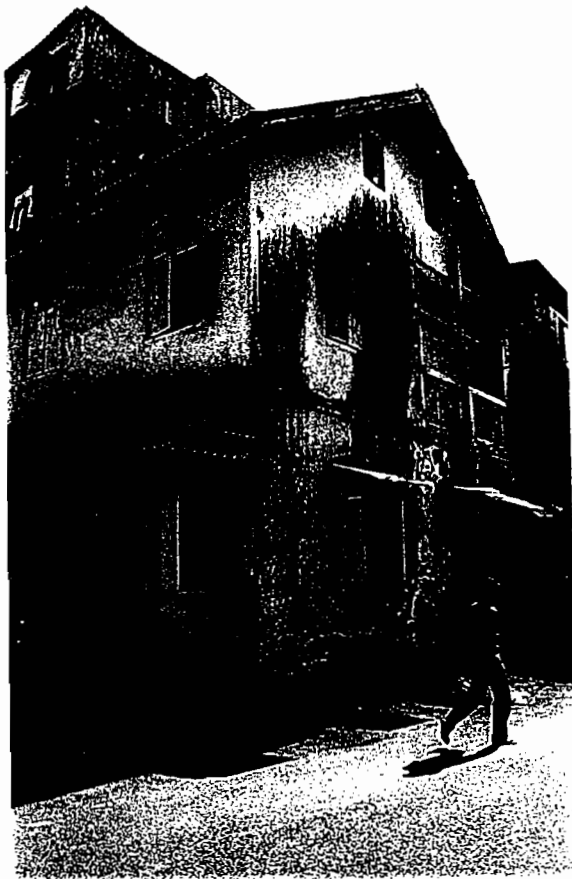
10 CHARAI

Past Use	: Residential
Height of Structure	: G + 1 (having attic)
Notable Features	: Cast iron railings
Architectural Style	: Vernacular
Ornamentation	: Cast iron railings
Additions & Alterations	: Nil
Remarks	: Structure is in a dilapidated condition, declared as a dangerous building.
State of Preservation	: Very poor
Proposed grade	: III (<i>Type 1</i>) B

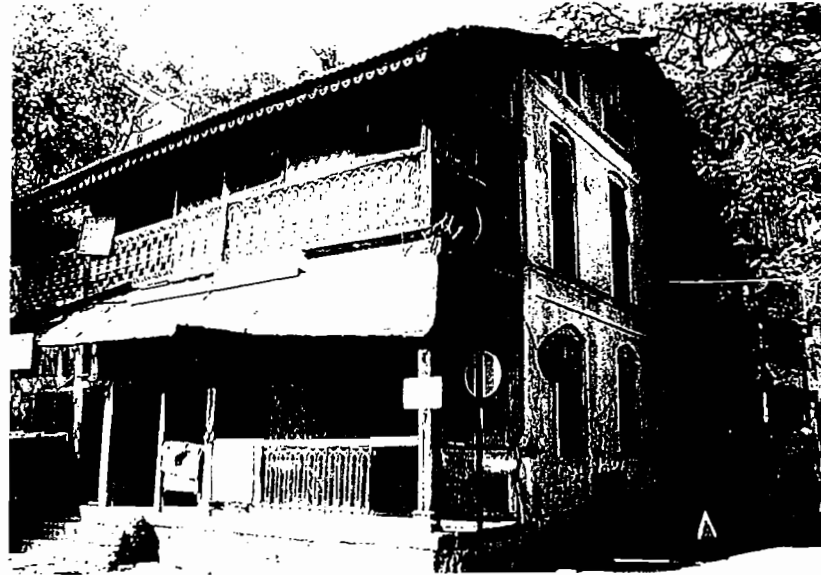
11 CHARAI

Name of Building	: Murkute building
Location	: Lokmanya Ali, Charai
Plot / Survey No.	: Not available.
Landuse	: Residential
Ownership Status	: Tenanted
Name of Owner	: Mr. Pise
Date of Construction	: 1925
Present Use	: Residential

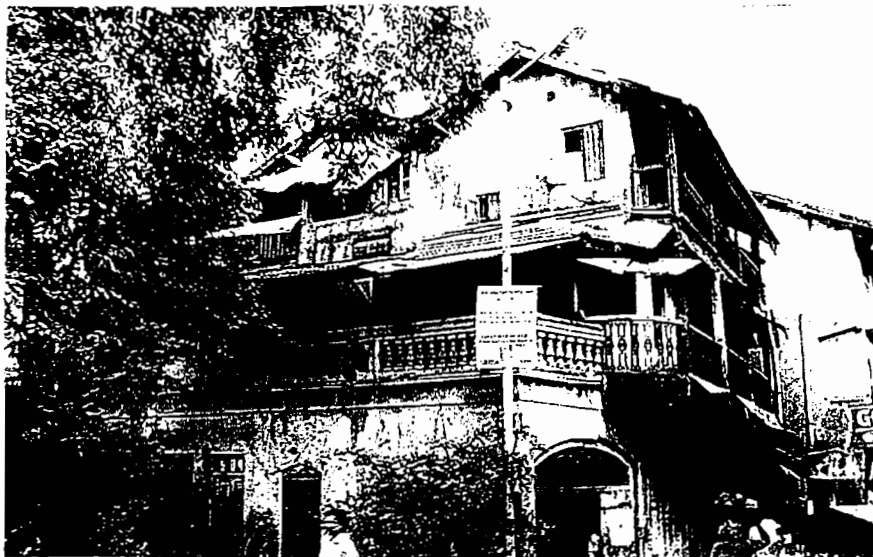
12 CHARAI

Additions & Alterations	: Nil
Remarks	: Poorly Maintained
State of Preservation	: Very poor
Proposed grade	: III (Type 1) B

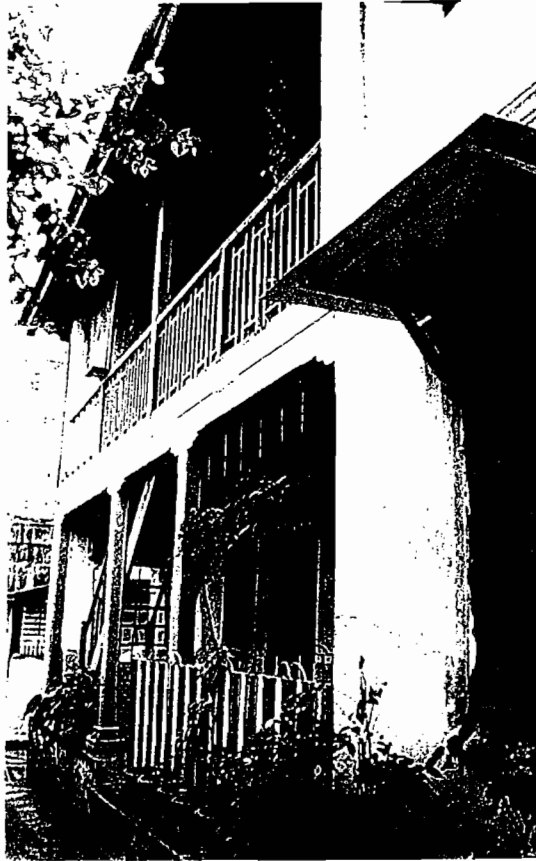
15 CHARAI

Name of Building : Shah House
Location : Charai
Plot / Survey No. : Not Available
Landuse : Residential
Ownership Status : Joint Ownership
Name of Owner : Ms. Anuradha
 Ukirde and Mr.
 Shah
Date of Construction : 1940
Present Use : Residential

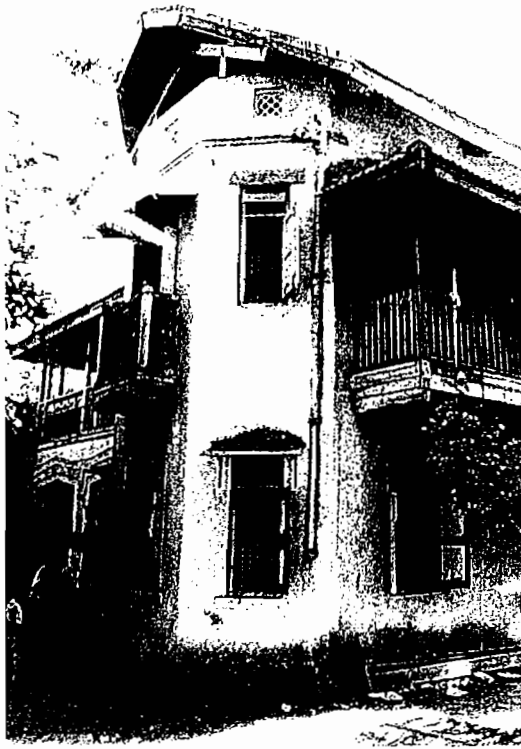
1 BRAHMAN SOCIETY

Name of Building : Hariniwas

Remarks : Leakage in roof

State of Preservation : Fair

Proposed grade : III (Type 1) A

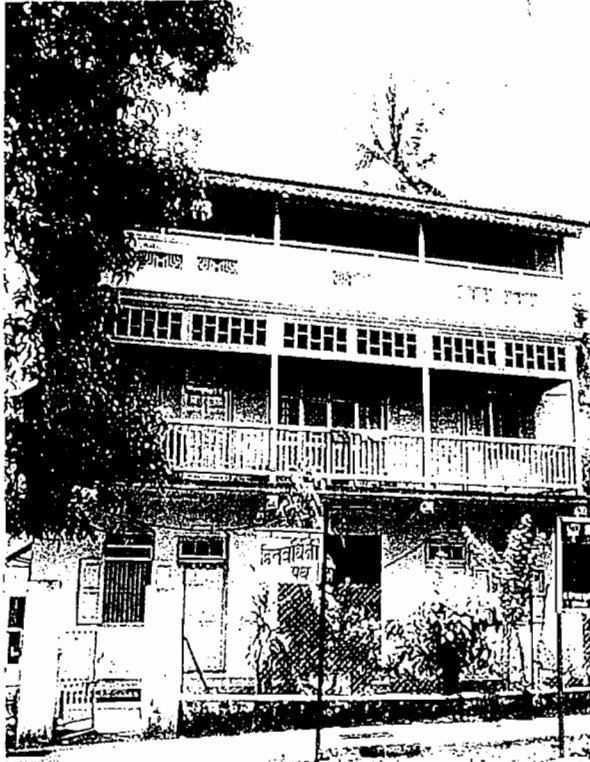
2 BRAHMAN SOCIETY

Name of Building	: Janaki Niwas
Location	: Hindu Colony, Brahman Society
Plot / Survey No.	: 106
Landuse	: Residential
Ownership Status	: Tenanted. Owner stays in the same premises.
Name of Owner	: Ms. Janaki Mulay
Date of Construction	: 1944

Present Use	: Residential and hospital.
Past Use	: Residential.
Height of Structure	: G + 2
Notable Features	: Stain glass panels. Wooden railings. Fascia.
Architectural Style	: Vernacular
Ornamentation	: Decorative wooden fascia.
Additions & Alterations	: Terrace enclosed to form an entire floor. Part of the residential area converted into an hospital.
Remarks	: Nil
State of Preservation	: Good
Proposed grade	: III (Type 1) A

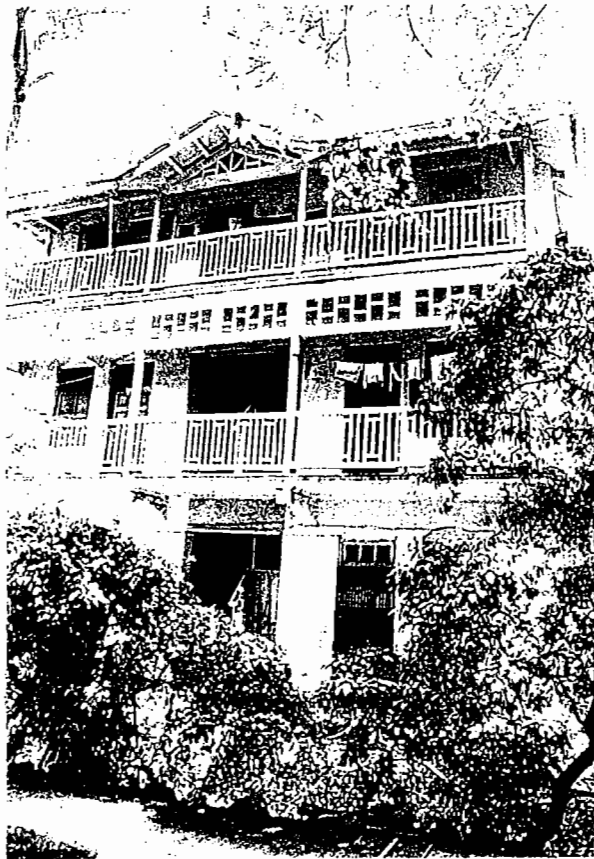
3 BRAHMAN SOCIETY

Past Use : Residential
Height of Structure : G + 2 (Having attic)
Notable Features : House form.
 Stain glass paneling.
 Staircase made in stone and wood
 Fascia
Architectural Style : Vernacular
Ornamentation : Stain glass.
 Decorative Fascia.
Additions & Alterations : Nil
Remarks : Information denied by owner
State of Preservation : Good
Proposed grade : III (Type 1) A

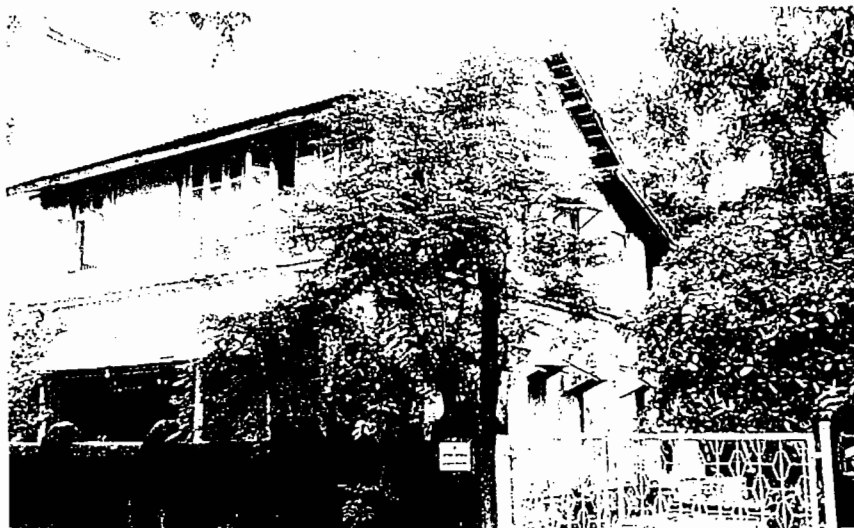
4 BRAHMAN SOCIETY

Past Use	: Residence
Height of Structure	: G + 1
Notable Features	: Stucco work. Cast iron railing.
Architectural Style	: Vernacular
Ornamentation	: Decorative doors and windows. Cast iron railing. Stucco work.
Additions & Alterations	: Extension done on rear side. External toilets taken within the main structure.
Remarks	: Plastering done on external walls in 1966.
State of Preservation	: Fair
Proposed grade	: III (Type 1) A

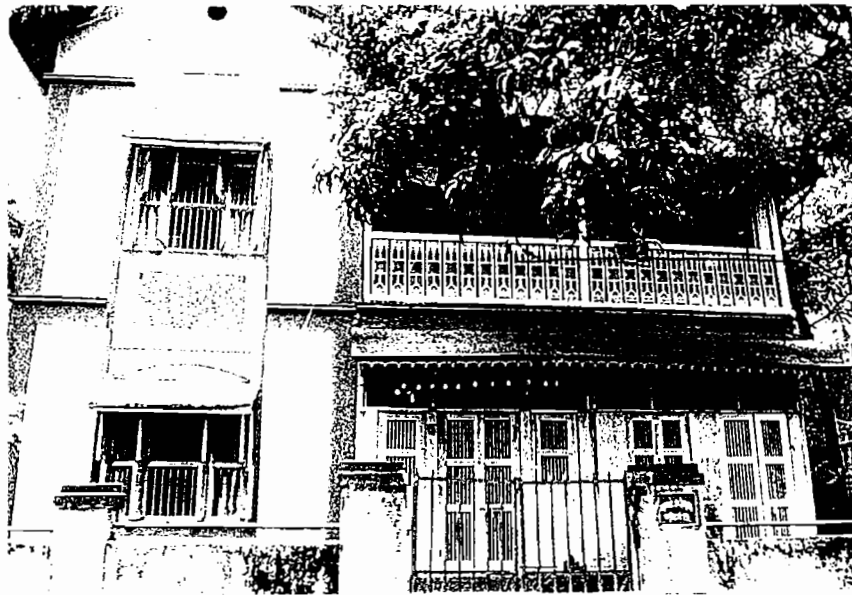
5 BRAHMAN SOCIETY

Name of Building	: Mayadeo building
Location	: Brahman society
Plot / Survey No.	: 15
Landuse	: Residential
Ownership Status	: Private
Name of Owner	: Mr. Mayadeo
Date of Construction	: 1930
Present Use	: Residence

Past Use	: Residence
Height of Structure	: G + 1
Notable Features	: External timber staircase. Cast iron balustrade. Timber flooring.
Architectural Style	: Vernacular
Ornamentation	: Stucco work Decorative cast iron balustrade
Additions & Alterations	: External toilets taken inside
Remarks	: Nil
State of Preservation	: Good
Proposed grade	: III (Type 1) A

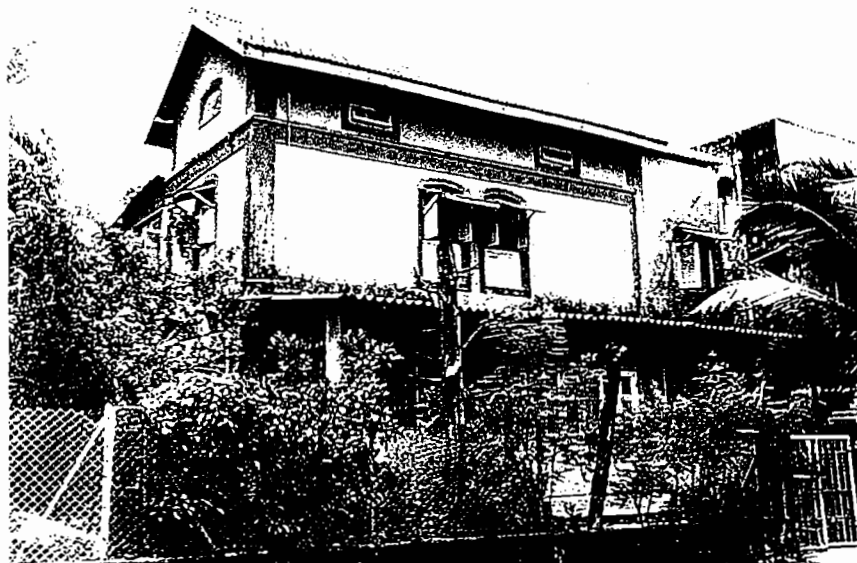
6 BRAHMAN SOCIETY

Height of Structure	: G + 2
Notable Features	: Double framed window.
Architectural Style	: Vernacular
Ornamentation	: Nil
Additions & Alterations	: Nil
Remarks	: Nil
State of Preservation	: Fair
Proposed grade	: III (<i>Type 1</i>) B

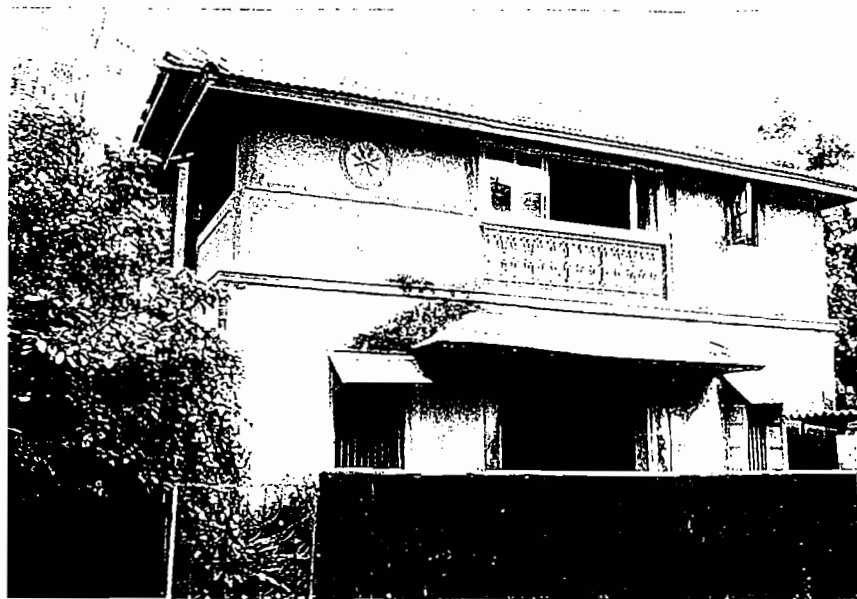
8 BRAHMAN SOCIETY

Past Use	: Residence
Height of Structure	: G + 1
Notable Features	: Rough cast plaster used for external walls. Timber balusters. Timber staircase. Double framed windows.
Architectural Style	: Vernacular
Ornamentation	: Decorative timber balusters. Stucco work.
Additions & Alterations	: Toilets brought inside the main structure. Masonry wall added above the handrail of railing of verandah.
Remarks	: Nil
State of Preservation	: Good
Proposed grade	: III (<i>Type 1</i>) B

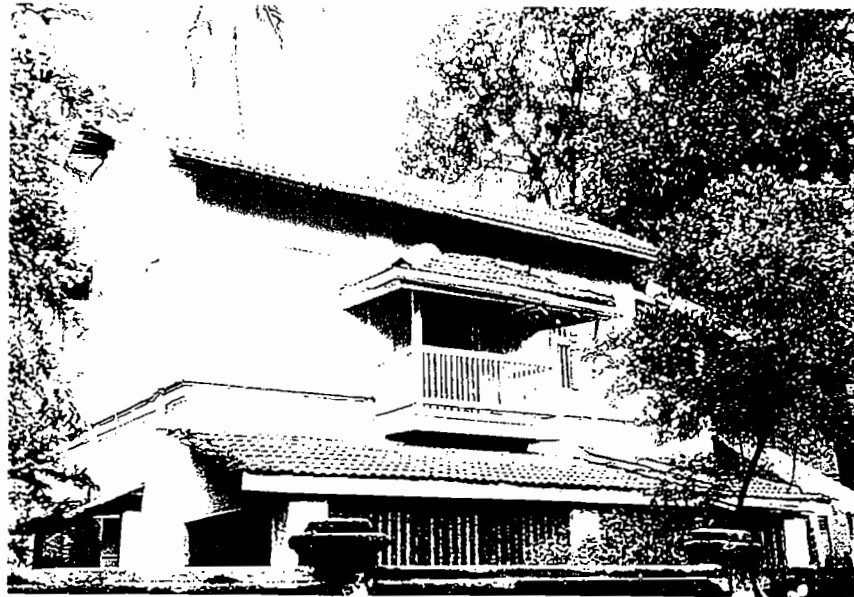
9 BRAHMAN SOCIETY

Name of Building : Pendse Building

State of Preservation : Very good.

Proposed grade : III (Type1) B

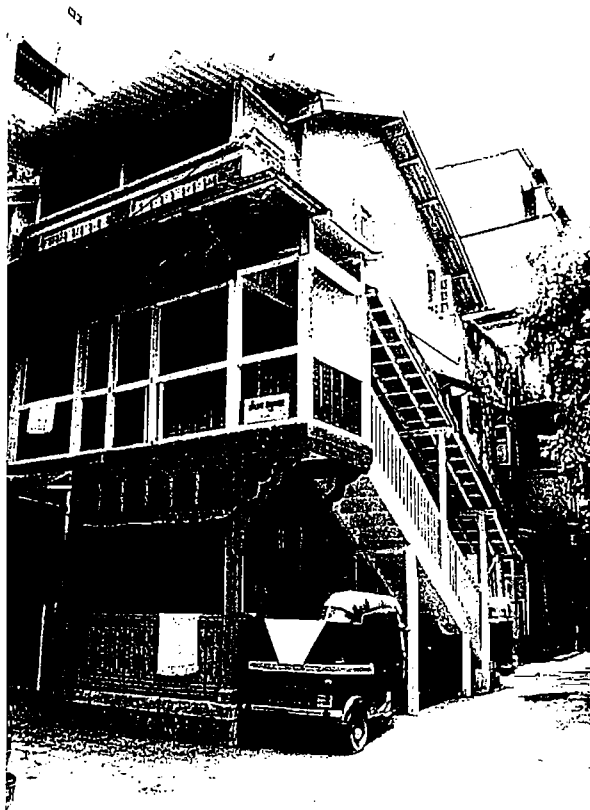
10 BRAHMAN SOCIETY

Name of Building	: Ganga Bhuvan
Location	: Brahman Society
Plot / Survey No.	: Not available
Landuse	: Residential.
Ownership Status	: Private
Name of Owner	: Not available
Date of Construction	: 1934
Present Use	: Residential
Past Use	: Residential

Height of Structure	: G + 2
Notable Features	: Verandah. External staircase. Cast iron railing. Stainglass infill panels. Brackets. Stucco work.
Architectural Style	: Vernacular
Ornamentation	: Decorative cast iron railings. Wooden brackets.
Additions & Alterations	: Terrace entirely enclosed to form rooms. AC sheets added as chajja for the balcony on the first floor.
Remarks	: Nil
State of Preservation	: Good
Proposed grade	: III (Type1) B

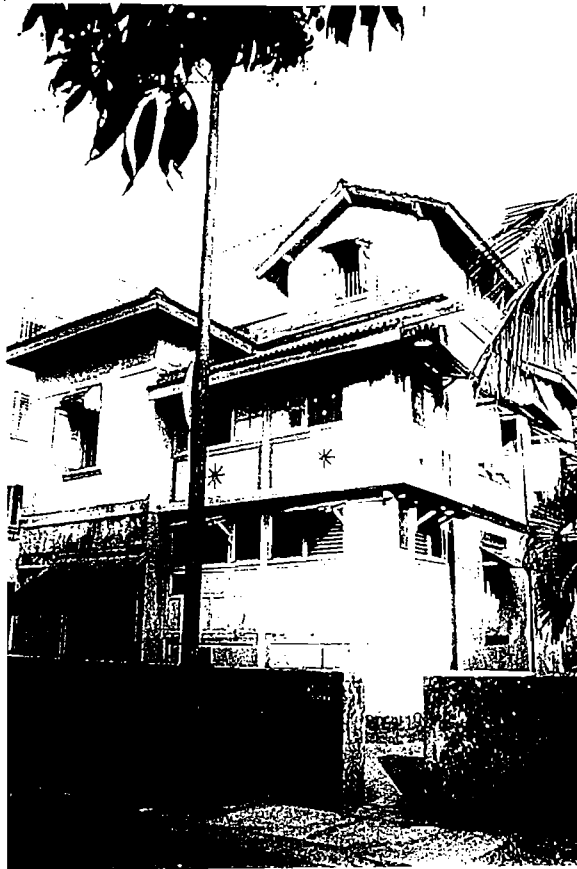
11 BRAHMAN SOCIETY

Name of Building	: Vaidya Banglow
Location	: Brahman Society.
Plot / Survey No.	: 4
Landuse	: Residential
Ownership Status	: Private
Name of Owner	: Mr. P. T. Vaidya.
Date of Construction	: 1932
Present Use	: Residential
Past Use	: Residential

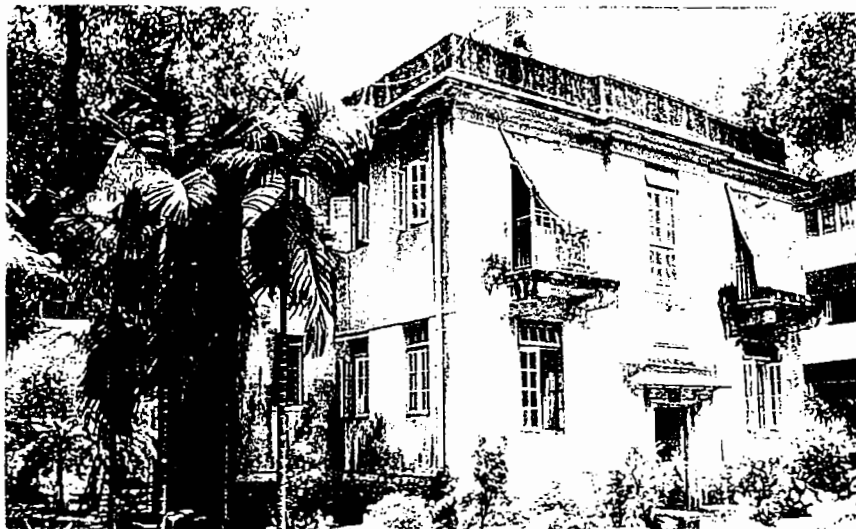
13 BRAHMAN SOCIETY

Name of Building	: Shri Sadan
Location	: Brahman Society
Plot / Survey No.	: Not available
Landuse	: Residential
Ownership Status	: Tenanted. Owner stays in the same premises
Name of Owner	: Mr. Shrinivas D. Kale
Date of Construction	: 1935
Present Use	: Residential

Past Use	: Residential
Height of Structure	: G + 1
Notable Features	: Cast iron railings. Projecting balcony.
Architectural Style	: Vernacular
Ornamentation	: Cast iron railings
Additions & Alterations	: Nil
Remarks	: Nil
State of Preservation	: Fair
Proposed grade	: III (Type 1) B

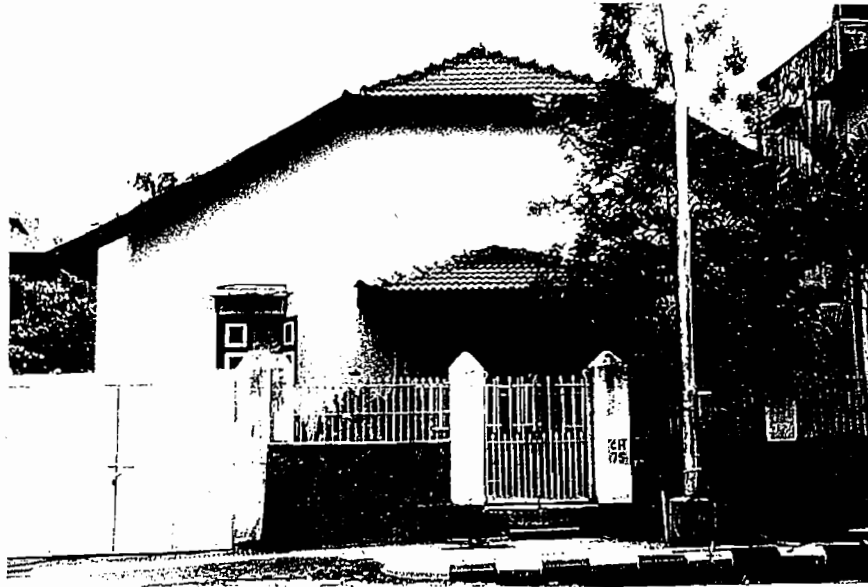
1 K - VILLA

Name of Building : Rodrigues Bungalow
Location : Uthalsar Road, K-Villa
Plot / Survey No. : / 5
Landuse : Residential
Ownership Status : Private
Name of Owner : Mr. Rodrigues
Date of Construction : 1940
Present Use : Residential

State of Preservation : Fair

Proposed grade : III (Type 1) B

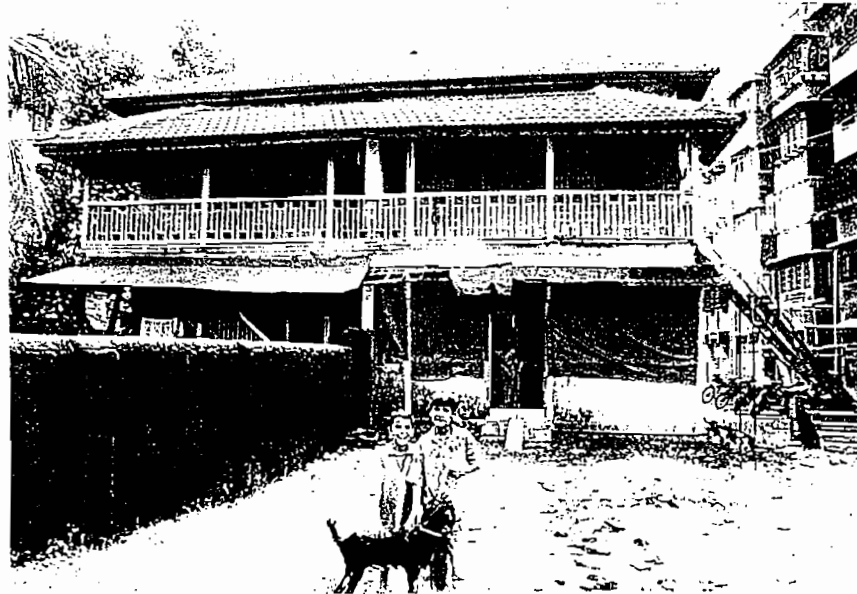
3 K – VILLA

Name of Building	: Not available
Location	: K - Villa
Plot / Survey No.	: 56
Landuse	: Residential
Ownership Status	: Private
Name of Owner	: Mr. Serpes
Date of Construction	: 1940
Present Use	: Residential
Past Use	: Residential

Height of Structure	: G + 1
Notable Features	: House form. Fascia.
Architectural Style	: Vernacular
Ornamentation	: Decorative Fascia
Additions & Alterations	: Nil
Remarks	: Information denied by owner
State of Preservation	: Fair
Proposed grade	: III (Type 1) B

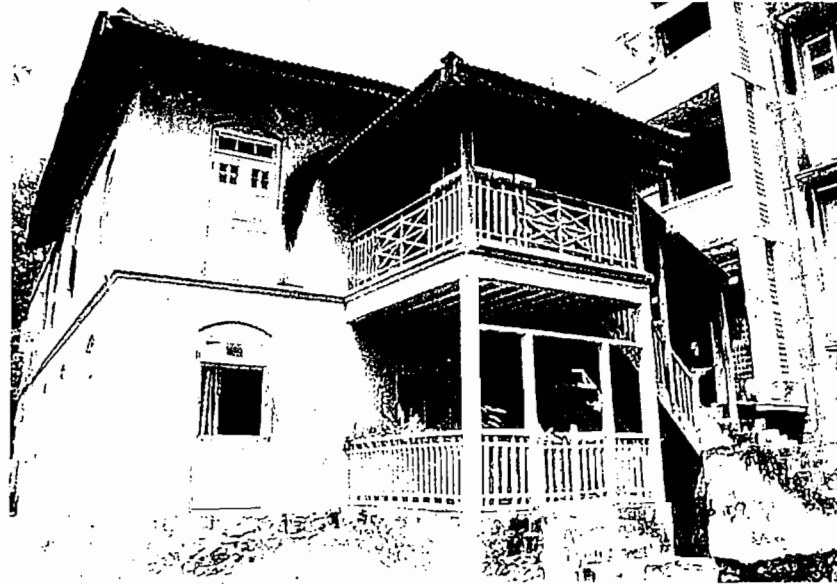
4 K VILLA

Name of Building : Rodrigues Building

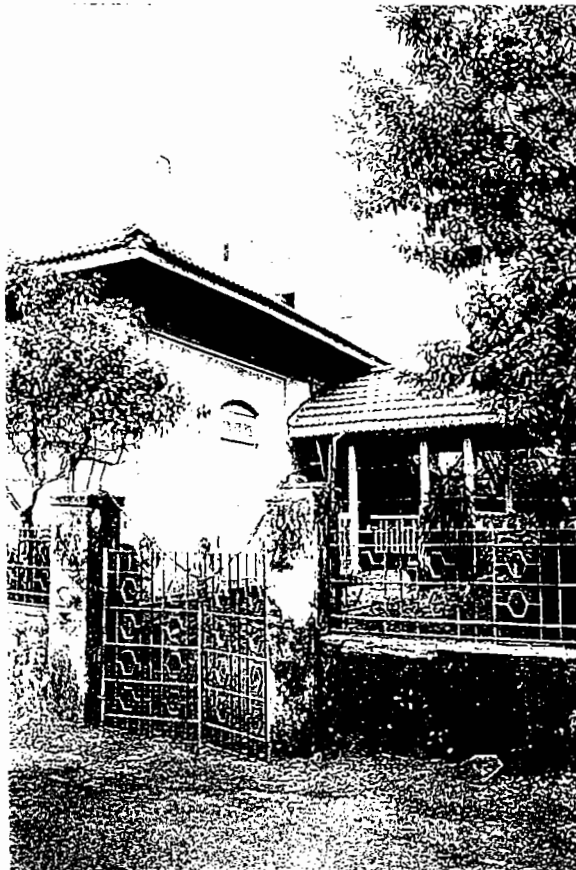
5 K VILLA

Past Use : Residential
Height of Structure : G (Having attic)
Notable Features : House form, front porch with cast iron railings
Architectural Style : Vernacular
Ornamentation : Cast iron railings.
Additions & Alterations : Store room added on the rear side.
 Entire house partitioned into two symmetrical halves due to ancestral inheritance.
Remarks : Structure has high pitched roof.
 Attic present.
State of Preservation : Good
Proposed grade : III (Type 1) B

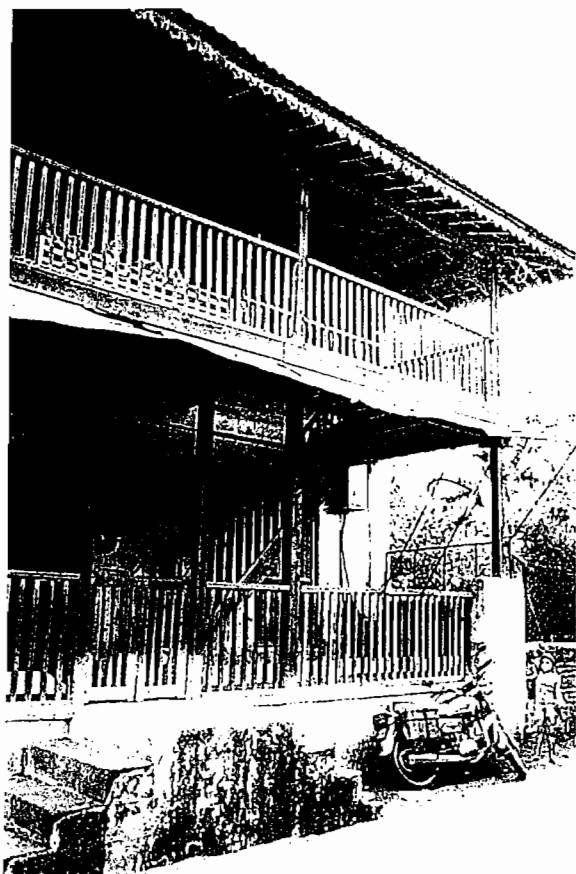
7 K- VILLA

Name of Building	: Remedios House
Location	: K - Villa
Plot / Survey No.	: Not available
Landuse	: Residential
Ownership Status	: Private
Name of Owner	: Mr. Terence Remedios
Date of Construction	: Not available
Present Use	: Residential.

Past Use	: Residential.
Height of Structure	: G + 1
Notable Features	: External Staircase. Wooden Railings. Fascia.
Architectural Style	: Vernacular
Ornamentation	: Decorative Fascia
Additions & Alterations	: Nil
Remarks	: No response from the owner.
State of Preservation	: Fair
Proposed grade	: III (Type1) B
