A COMPREHENSIVE LISTING OF HERITAGE VALUES IN THANE

PART II

FOREWORD

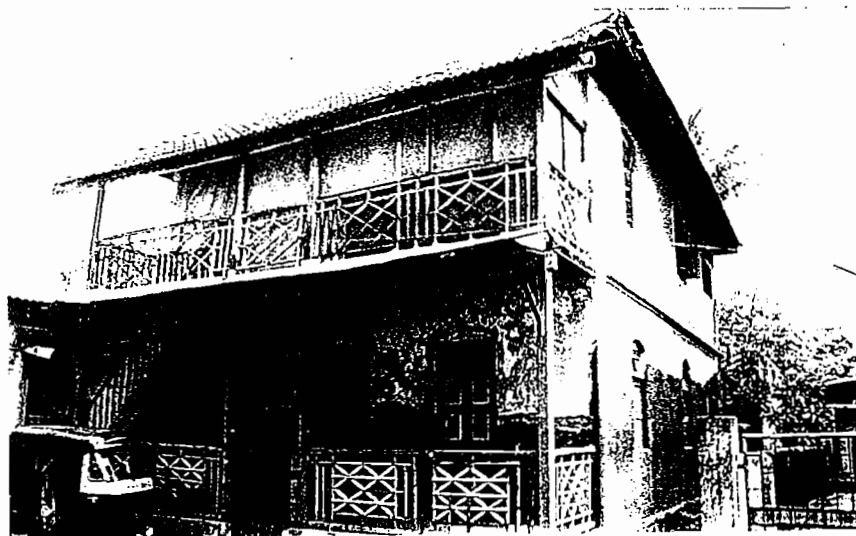
8 K VILLA

Name of Building	: Serpes House
Location	: K Villa
Plot / Survey No.	: 98 / 127
Landuse	: Residential
Ownership Status	: Private
Name of Owner	: Mr. J. J. Serpes
Date of Construction	: 1940
Present Use	: Residence
Past Use	: Residence

State of Preservation : Fair

Proposed grade : III (Type1) B

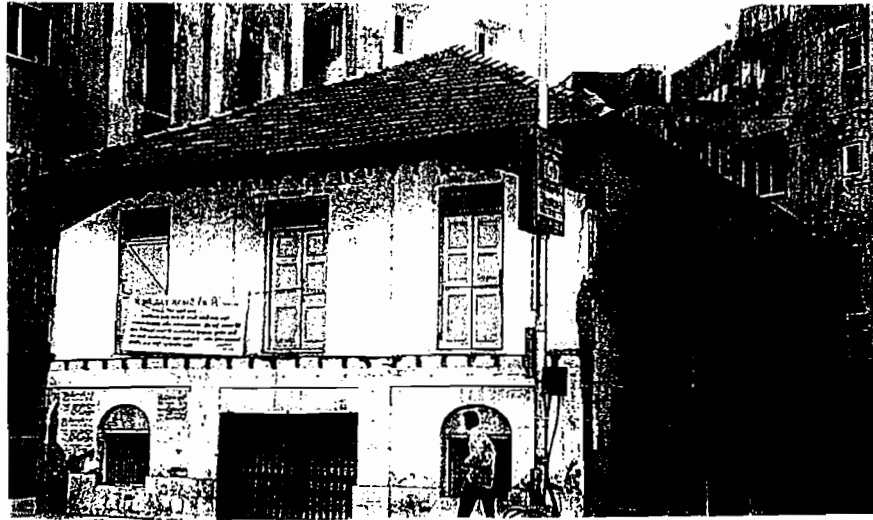
9 K- VILLA

Name of Building	: Shah House
Location	: K - Villa
Plot / Survey No.	: Not available
Landuse	: Residential
Ownership Status	: Private
Name of Owner	: Mr. Sunil Shah
Date of Construction	: Not available
Present Use	: Empty.
Past Use	: Residential.

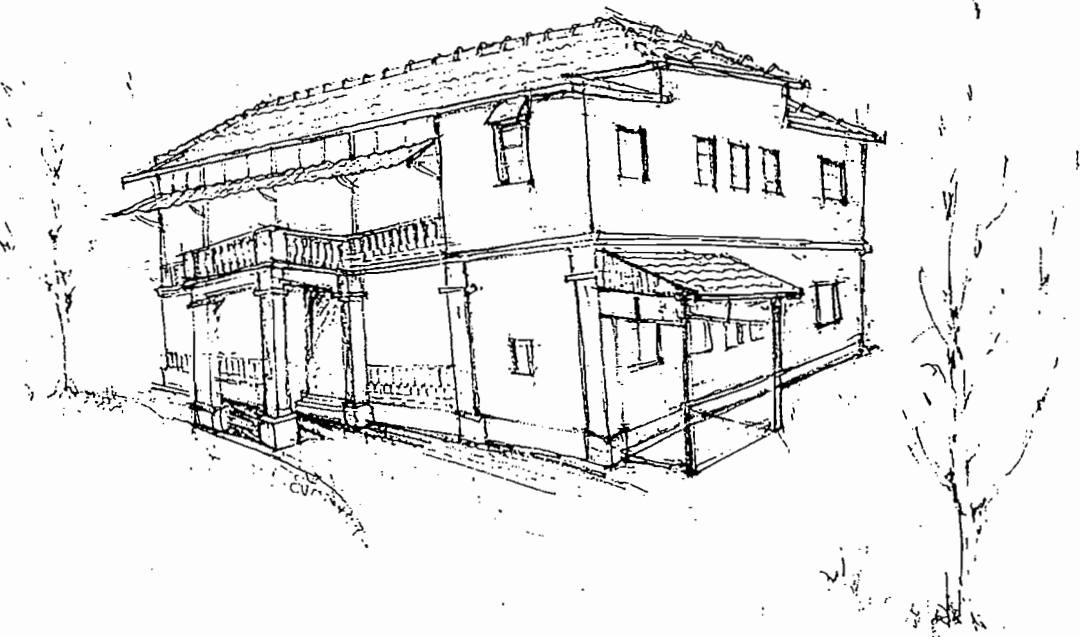
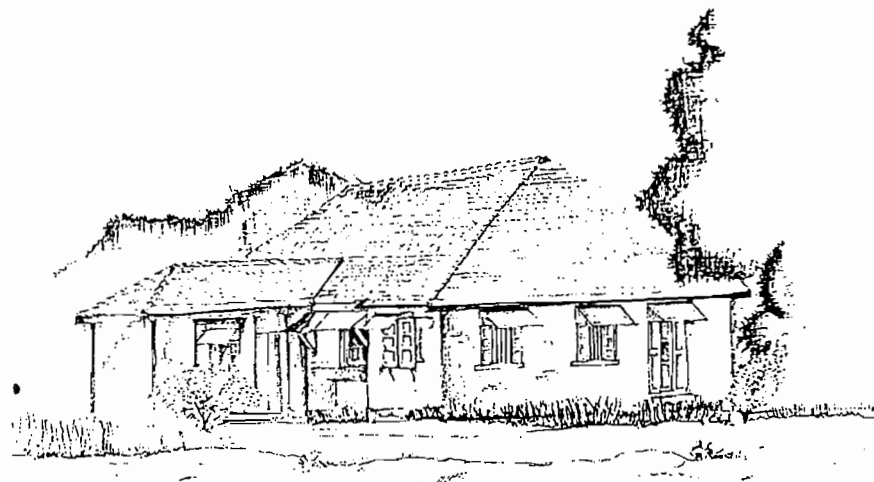
BARA BANGLA

A well-planned residential area consisting of about thirteen bungalows built by the Public Works Department sometime in 1924 to provide accommodation to top government officers and their families. The entire area housing these bungalows is a sprawling place, very thoughtfully planned with each bungalow having a spacious garden with abundant flora and fauna. Although the houses differ in size and can be categorised into two categories accordingly, it can be observed that a typical pattern has been followed throughout.

If observed particularly, every house has been provided with separate servants' quarters at the rear side of the main structure. A driveway approaches the main bungalow and a porch highlights the entrance. These porches seem to be later additions, acting as a terrace on the first floor and as a covered parking space for the residents' car.

The most important characteristic of this entire area is the planning which has been thoughtfully worked out. The network of internal roads is well planned and the open plots have been subdivided to accommodate individual bungalows. The entire area also has a club meant for the use of the residents complete with all facilities. The area is very serene and almost an ideal residential place.

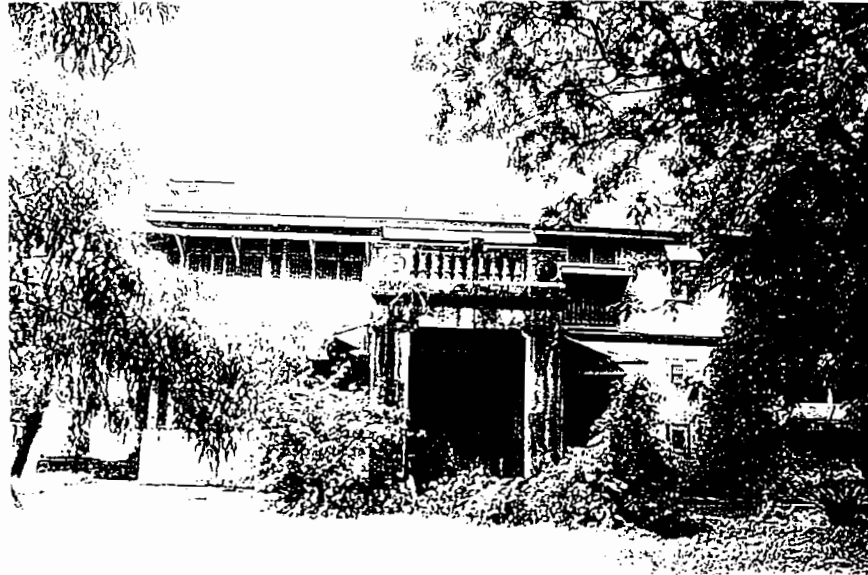
1 BARA BANGLA

Name of Building	: Indrayani
Location	: Bara Bangla, Kopri
Plot / Survey No.	: 1
Landuse	: Residential
Ownership Status	: Government
Name of Owner	: Government
Date of Construction	: 1924
Present Use	: Residential
Past Use	: Residential

Height of Structure	: G + 1
Notable Features	: Entrance porch. Balcony atop the porch. Cornice. Exposed stone construction in some portion. Corbelling at column - beam junction.
Architectural Style	: Colonial
Ornamentation	: Decorative Newel post. Staircase balustrades showing screens composed of simple and pierced panels. Scrolled tread ends. Simple geometric bosses and vase shaped balustrades for the balcony.
Additions & Alterations	: Cast iron spiral staircase added later on to serve as a service staircase. Chajja added later on. Balcony enclosed with MS grilles for the sake of security.
Remarks	: Nil
State of Preservation	: Good
Proposed grade	: III (Type 1) A

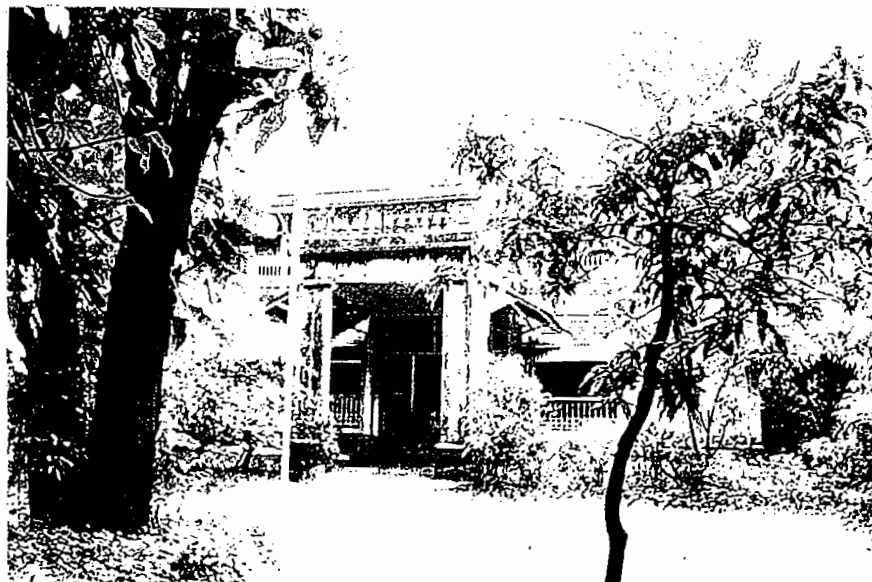
2 BARA BANGLA

Name of Building : Dhanvantri
Location : Bara Bangla, Kopri
Plot / Survey No. : 2
Landuse : Residential
Ownership Status : Government
Name of Owner : Government
Date of Construction : 1924
Present Use : Residential
Past Use : Residential

State of Preservation : Good

Proposed grade : III (Type 1) A

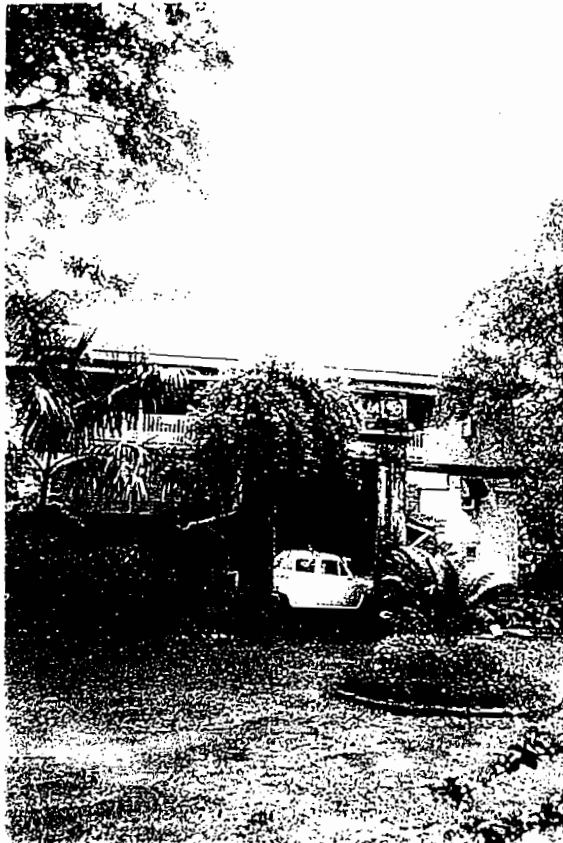
3 BARA BANGLA

Name of Building : Vikas
Location : Bara Bangla, Kopri
Plot / Survey No. : 3
Landuse : Residential
Ownership Status : Government
Name of Owner : Government
Date of Construction : 1924
Present Use : Residential
Past Use : Residential

State of Preservation : Good

Proposed grade : III (*Type 1*) A

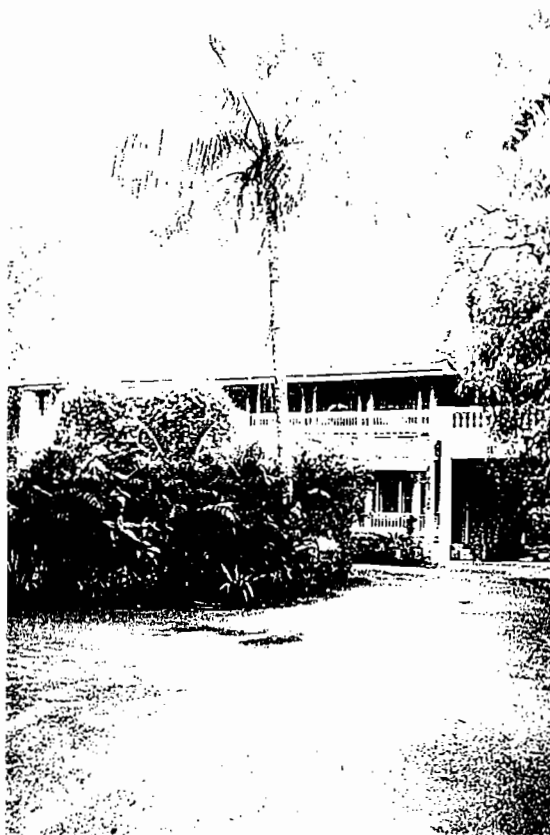
5 BARA BANGLA

Name of Building	: Priyadarshini
Location	: Bara Bangla, Kopri
Plot / Survey No.	: 5
Landuse	: Residential
Ownership Status	: Government
Name of Owner	: Government
Date of Construction	: 1924
Present Use	: Residential
Past Use	: Residential

Height of Structure	: G + 1
Notable Features	: Entrance porch. Balcony atop the porch. Cornice. Corbelling at column - beam junction.
Architectural Style	: Colonial
Ornamentation	: Decorative Newel post. Staircase balustrades showing screens composed of simple and pierced panels. Scrolled tread ends. Simple geometric bosses and vase shaped balustrades for the balcony.
Additions & Alterations	: Spiral Staircase added later on to serve as a service staircase. Chajja added later on.
Remarks	: Nil
State of Preservation	: Good
Proposed grade	: III (<i>Type 1</i>) A

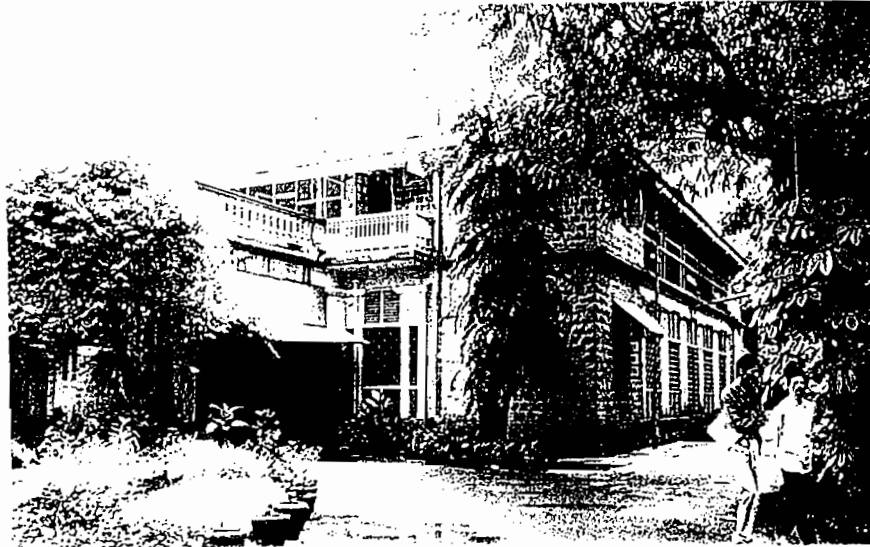
6 BARA BANGLA

Name of Building	: Rajgruh
Location	: Bara Bangla, Kopri
Plot / Survey No.	: 6
Landuse	: Residential
Ownership Status	: Government
Name of Owner	: Government
Date of Construction	: 1924
Present Use	: Residential
Past Use	: Residential

Height of Structure	: G + 1
Notable Features	: Entrance porch. Balcony atop the porch. Cornice. Exposed stone construction in some portion. Corbelling at column - beam junction.
Architectural Style	: Colonial.
Ornamentation	: Decorative Newel post. Staircase balustrades showing screens composed of simple and pierced panels. Scrolled tread ends. Simple geometric bosses and vase shaped balustrades for the balcony.
Additions & Alterations	: Spiral Staircase added later on to serve as a service staircase. Chajja added later on. Flooring replaced with ceramic tiles. Balcony and verandah enclosed with MS grill.
Remarks	: Nil
State of Preservation	: Good
Proposed grade	: III (Type 1) A

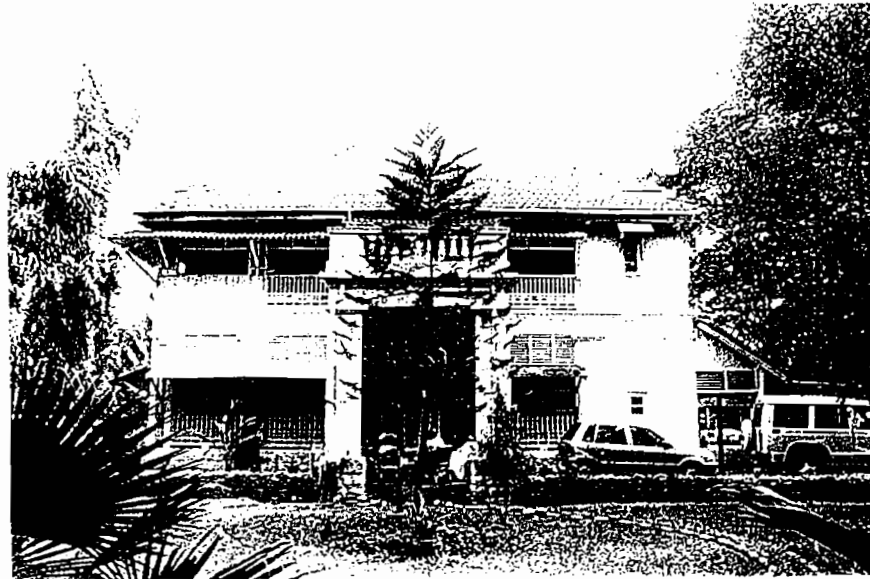
9 BARA BANGLA

Name of Building	: Van Bhavan
Location	: Bara Bangla, Kopri
Plot / Survey No.	: 9
Landuse	: Residential
Ownership Status	: Government
Name of Owner	: Government
Date of Construction	: 1924
Present Use	: Residential

Past Use	: Residential	Additions & Alterations	: Spiral Staircase added later on to serve as a service staircase. Chajja added later on.
Height of Structure	: G + 1	Remarks	: Nil
Notable Features	: Entrance porch. Balcony atop the porch. Cornice. Corbelling at column - beam junction.	State of Preservation	: Good
Architectural Style	: Colonial	Proposed grade	: III (Type 1) A
Ornamentation	: Decorative Newel post. Staircase balustrades showing screens composed of simple and pierced panels. Scrolled tread ends. Simple geometric bosses and vase shaped balustrades for the balcony.

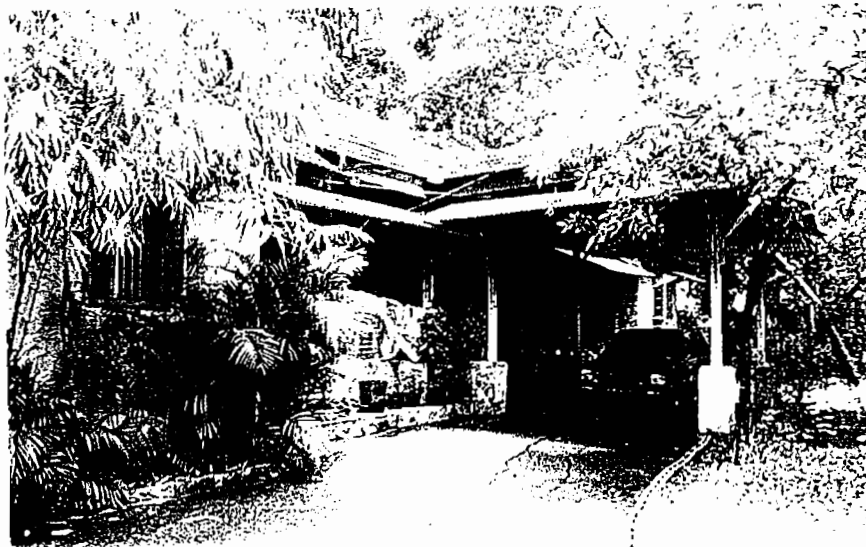
10 BARA BANGLA

Name of Building	: Konark
Location	: Bara Bangla, Kopri
Plot / Survey No.	: 10
Landuse	: Residential
Ownership Status	: Government
Name of Owner	: Government
Date of Construction	: 1924
Present Use	: Residential

Past Use	: Residential
Height of Structure	: G
Notable Features	: Entrance porch. Verandah. High internal room height.
Architectural Style	: Colonial
Ornamentation	: Pendant used in porch. Timber balustrades.
Additions & Alterations	: Nil
Remarks	: Nil
State of Preservation	: Good
Proposed grade	: III (<i>Type 1</i>) B

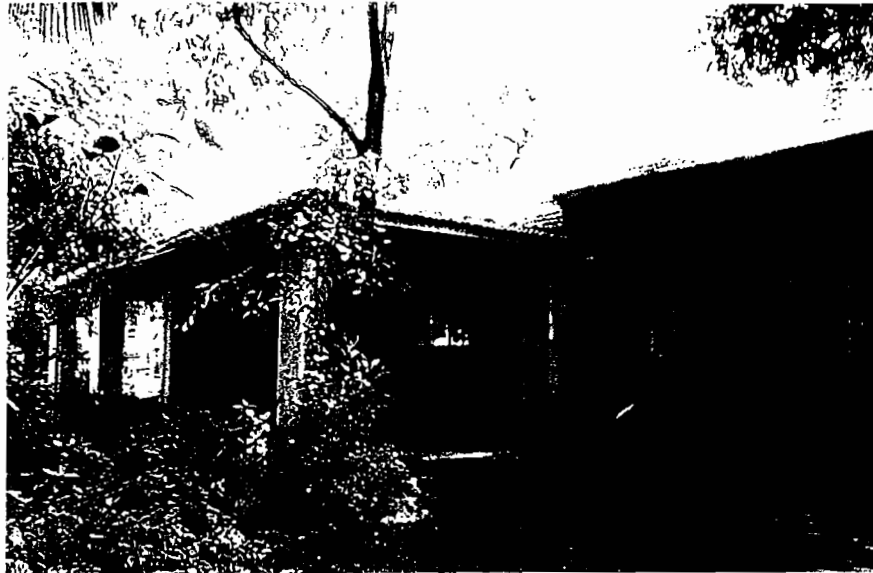
11 BARA BANGLA

Name of Building : Devgiri
Location : Bara Bangla,
Kopri
Plot / Survey No. : 11
Landuse : Residential
Ownership Status : Government
Name of Owner : Government
Date of Construction : 1924
Present Use : Residential

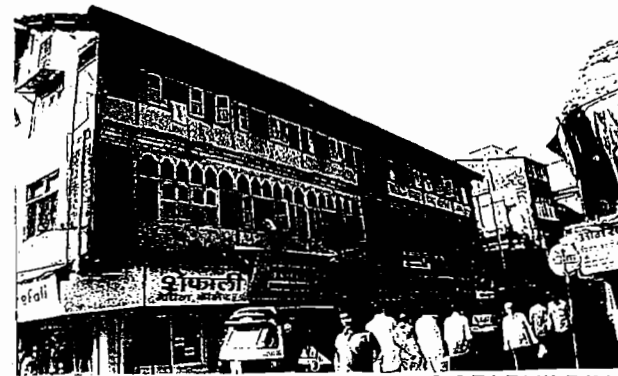
BORI BUILDING

OLD STATION ROAD

This road is one of the oldest in Thane city. Also known as the 'Bazaar Peth', this road serves as an extensive shopping area. The street character on either side of this road depicts vernacular architecture. Typical built-forms with sloping roofs line the entire stretch of the road. All buildings have a shopline on the ground floor fronting the street. The upper floors are used as residences.

Earlier this road was an important thoroughfare between the areas around the Collector's office and Thane Railway Station. But to date, the scene is totally different. Rampant encroachments, illegal extensions, unchecked commercial activity etc. have become major causes for the degeneration of the entire street. The original character of the street, whatever left is hidden behind advertisement hoardings and recent structural additions to the original buildings.

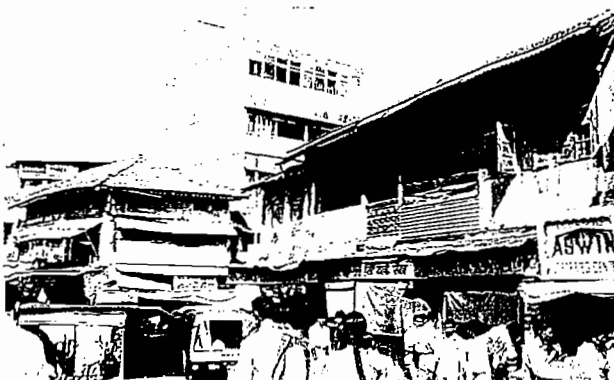
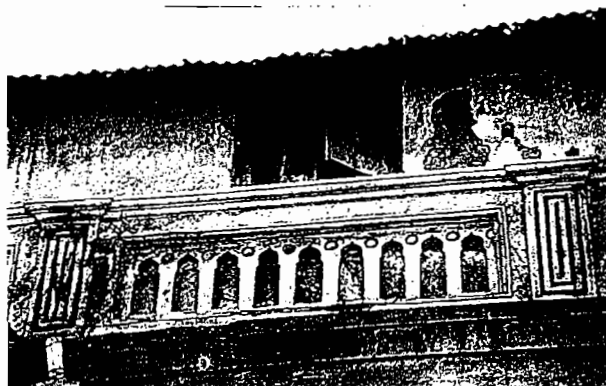
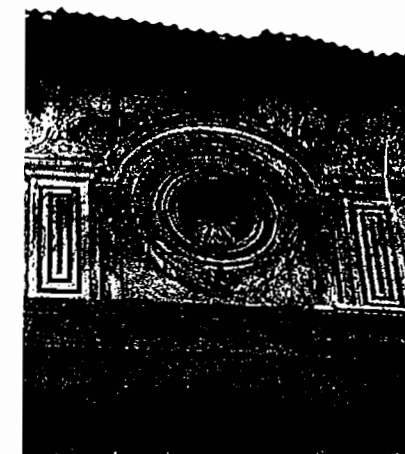
DECORATIVE
DETAILS

An extensive ornamentation work is visible on the surviving structures along the entire length of the road. Stucco work, carved brackets, decorative railings in cast-iron and timber, etc. are typical characteristic of this streetscape. They provide a visual enhancement to the built-form and maintain a continuity throughout the length of the street.
