CONSERVATION OF BOMBAY CASTLE (RESTORATION - PHASE I)

OWNERS: NAVAL DOCKYARD, MUMBAI

PROJECT CONSULTANTS: K. UNWALLA ARCHITECTS, MUMBAI

STRUCTURAL CONSULTANTS: Epicons Consultants Pvt. Ltd.

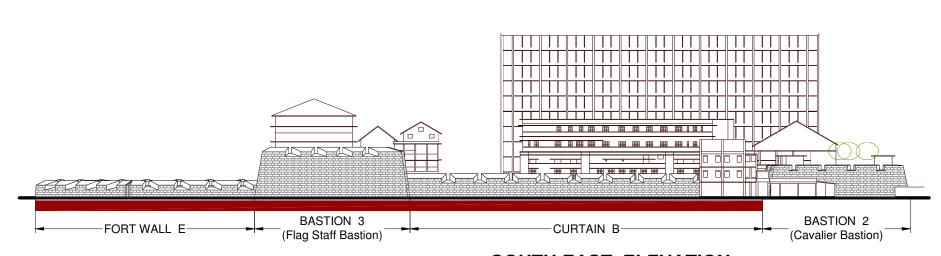
SOUTH EAST ELEVATION

- 1. Clearing the clutter
- 2. Removal of Concrete Coba fill on the Battlements and replace with brick bat coba & lime plaster
- 3. Stone cleaning
- 4. Re-Jointing and Re-Pointing
- 5. Stone replacement

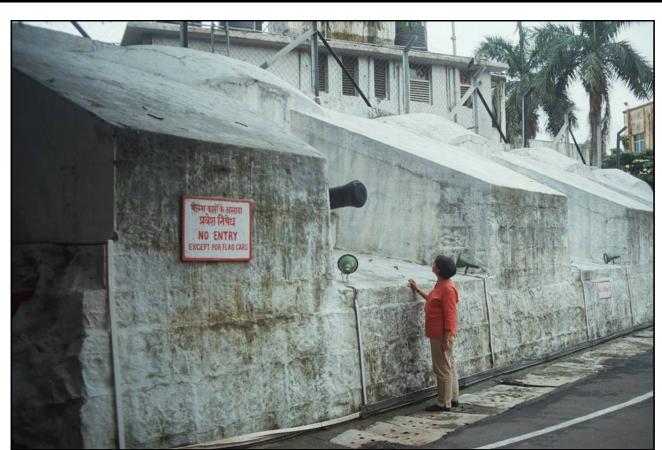
Security fencing in steel angles & mesh was mounted onto the Fort wall directly. This has been cleared and the walls restored.

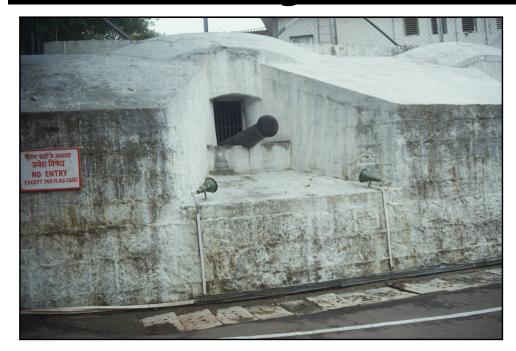
Condition prior restoration – accretions of cement paint

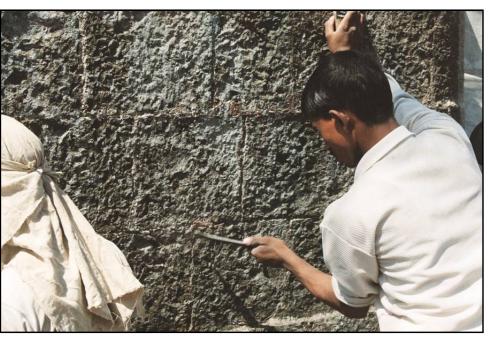
Removal of cementatious accretions by gentle tapping & soft brushing of prewetted stone surfaces

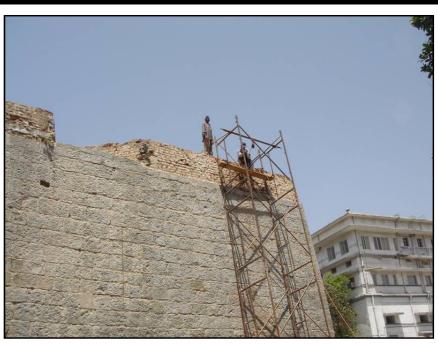
Battlements on the Bastion 3 in brick work

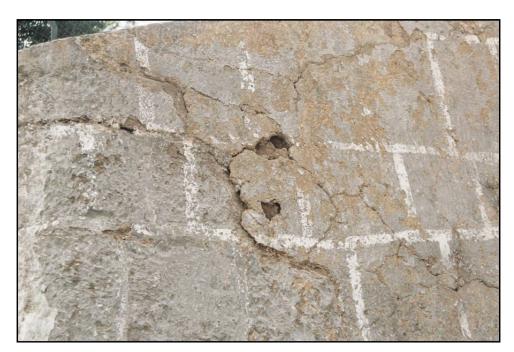
Condition prior restoration – accretions of cement plaster

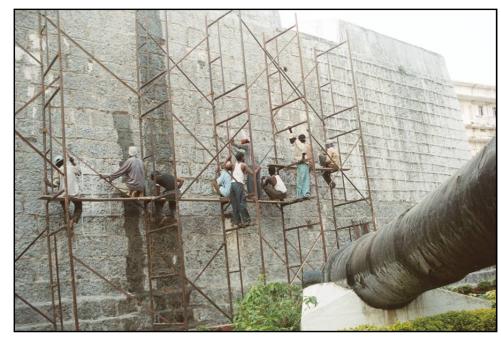
Gentle tapping to remove paint accretions

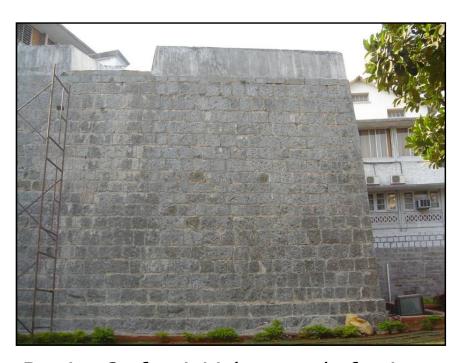
Bastion 3 after initial removal of paint

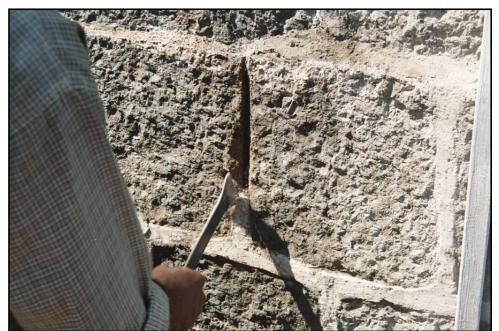
Raking out weakened jointing mortar and flushing out loose mortar

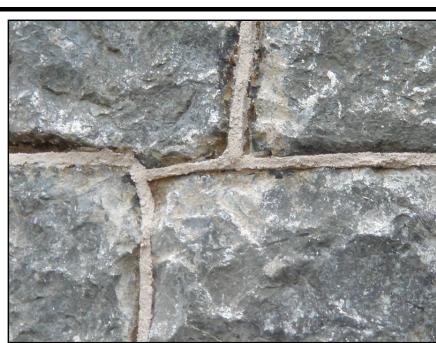
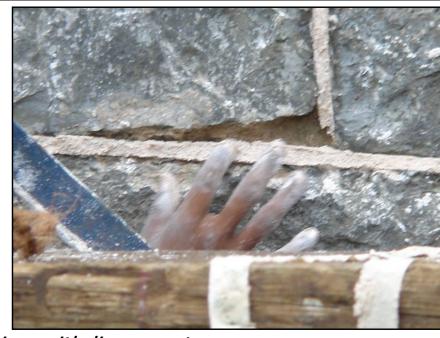
Re-jointing and re-pointing with lime mortar

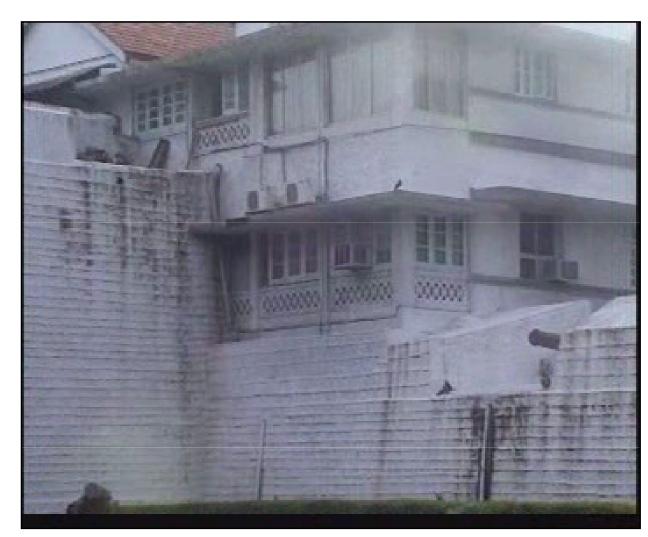
Condition prior to restoration

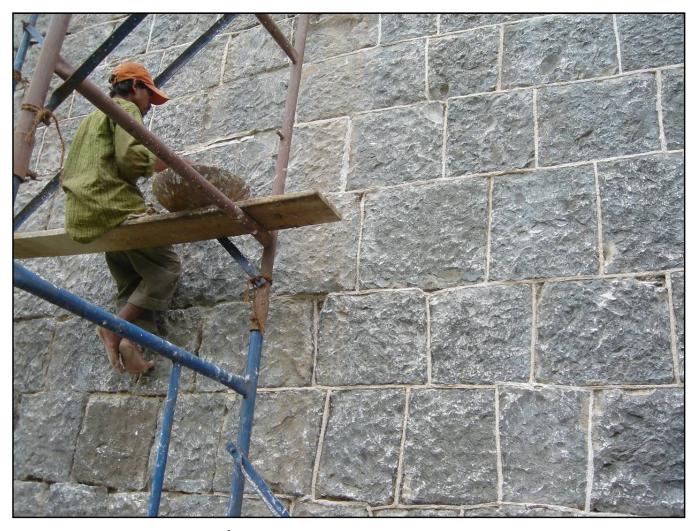
Part pointing complete.

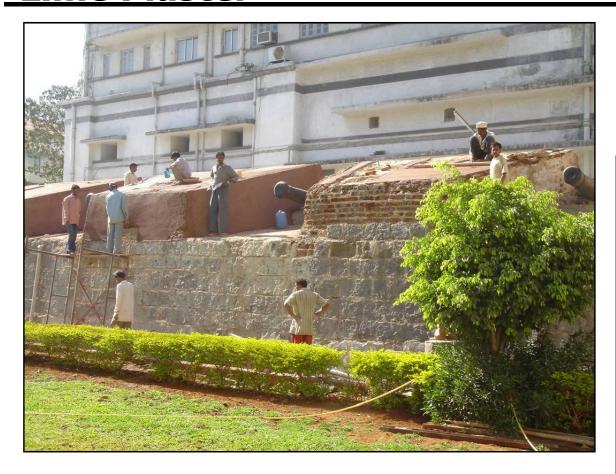
curtain wall while beginning with a single layer of grey basalt stone, its final form completed with brick masonry, unlike the battlements of the Fort Wall. Topped with mass cement concrete, it was replaced with brick bat coba in lime mortar and lime plaster finish.

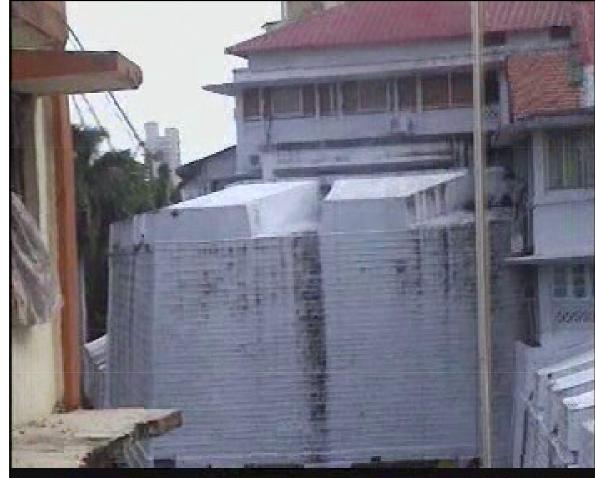
Before Restoration

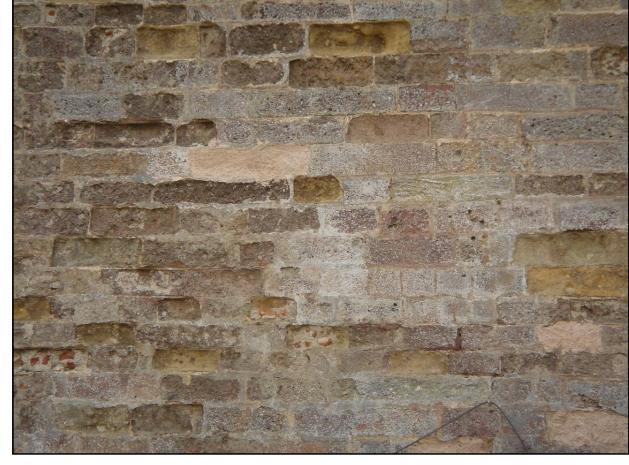
Condition of Laterite stones exposed after removal of paint & cement plaster

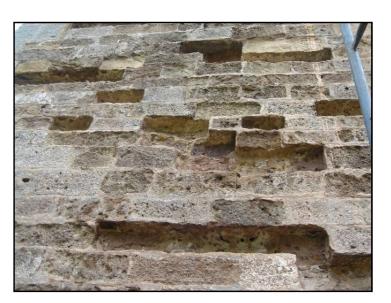
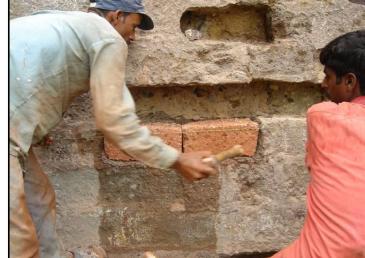
Stone replacement in process

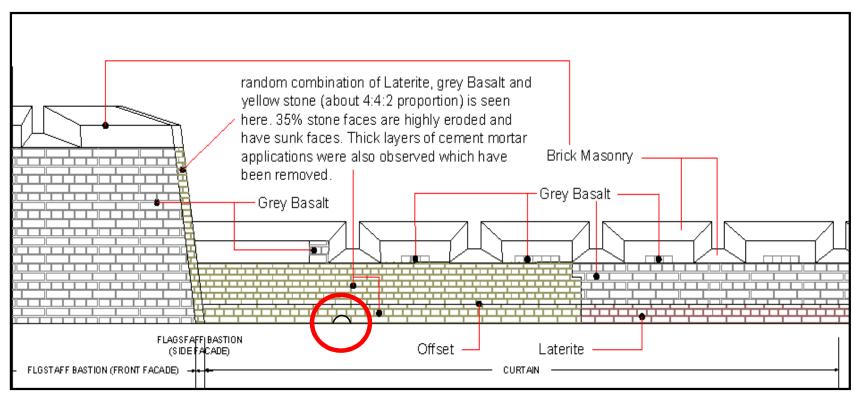
<u> Unearthed Feature — Passage Tunnel in Curtain B</u>

Location of Passage tunnel at Curtain B. this wall originally would have been fronting the shore line of the eastern coast.

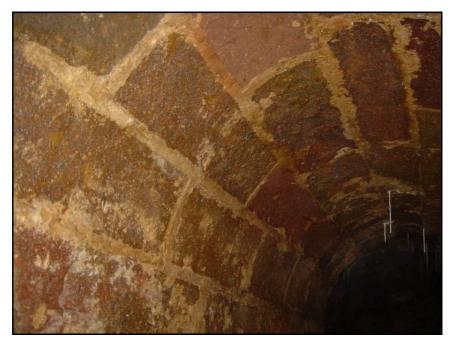
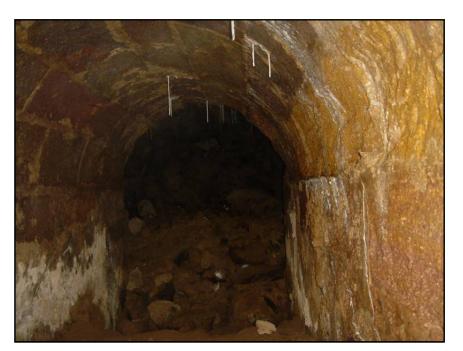
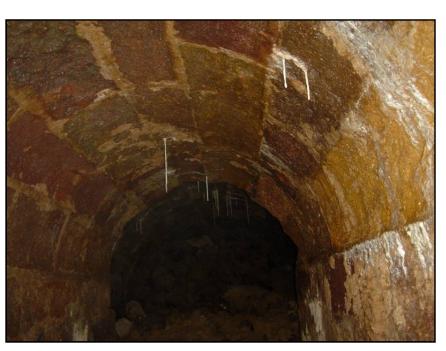
During carrying out the process of stone replacement in Curtain B, this passage tunnel (1.5m wide & 1.2m tall) has been unearthed. It has been decided to undertake further research subsequent to which further excavation and restoration work may be carried out.

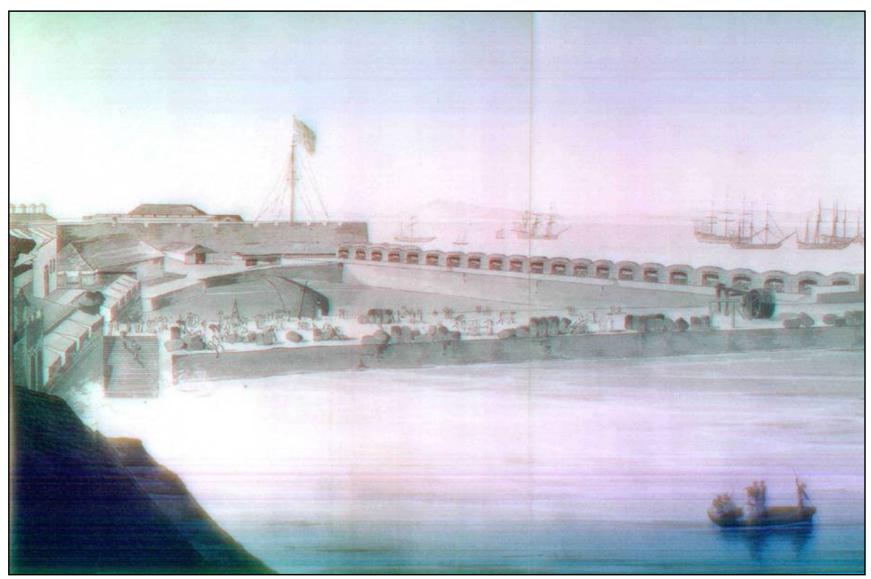
Restoration of Original Features in Fort Wall

The restoration process while removing the obtrusive application of cement plaster exposed the original stone arches. The arches have now been restored and maintained in an exposed state.

The guns with the constructed pedestal are of recent intervention and have been maintained as such.
