# Action Plan for Heritage Conservation and Environment Improvement of Erangal Precinct

## Stage 2 Part 1: Detailed Condition Assessment Major Findings and Inferences

August 2010

HCP Design and Project Management Pvt. Ltd.  
(HCPDPM)

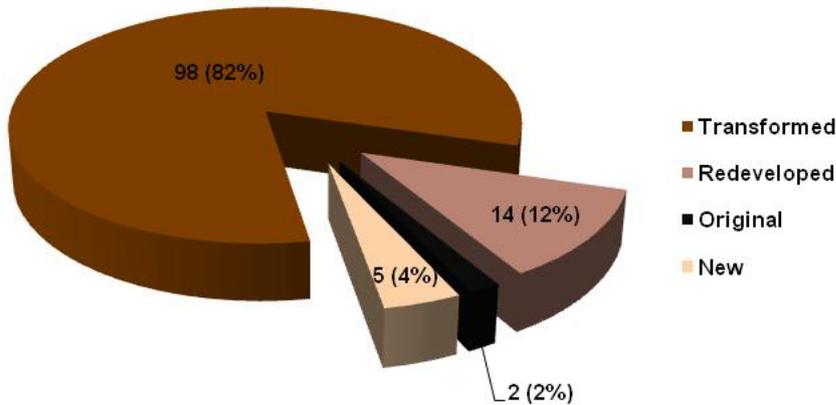
**Figure 17: Transformation of Structures**

There are only 2 structures in the settlement, which have retained their original condition. Around 94% (112) of the structures have been either transformed or redeveloped. Of these around 82% (98) have been transformed and 12% (14) have been redeveloped. One of the redeveloped structures (No. 17) does not reflect or respect the typology of the precinct. Around 4% (5) of the structures are new:

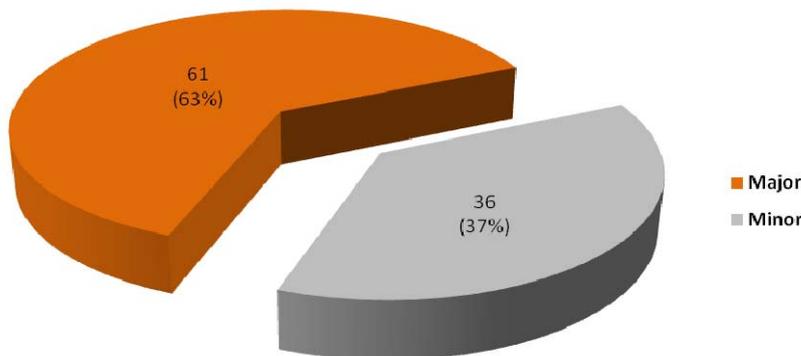
**Figure 18: Extent of Transformation**

Of the transformed structures, around 63% (62) have undergone major transformation. Around 37% (36) have undergone minor transformation. The purpose of the renovation is both functional and social i.e. it addresses the need for increased space requirements, represents their socio-economic position and reflects their aspirations to modernize. These are manifested through different typologies, new materials, colours and elements, some of which are detrimentally affecting the character of the settlement. For example, flat roofs, doors with cartoon characters etc.

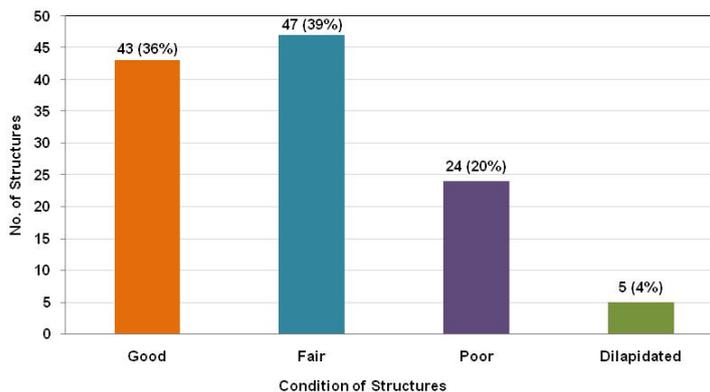
Figure 19: Condition of Structures

Approximately 75% (90) of the structures are in good or fair condition. Around 25% (29) of the structures in the precinct are in poor or dilapidated condition. The structures in the precinct are generally characterized by poor quality of natural light. This is particularly applicable to structures with common walls and a linear typology.

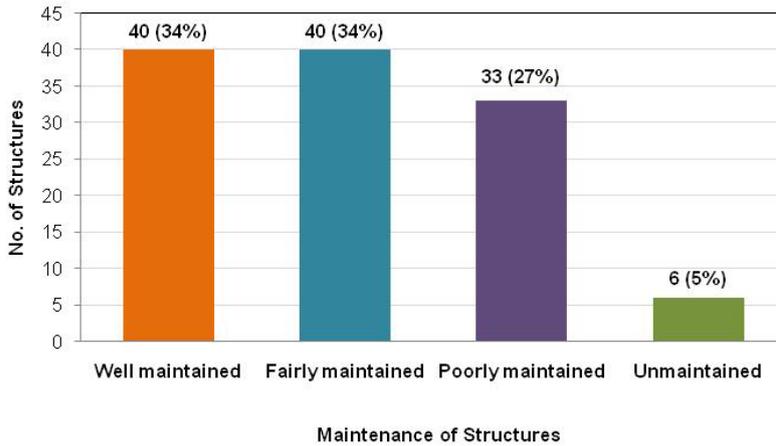
**Figure 20: Maintenance Level of Structures**

Approximately 68% (80) of the structures are well maintained or maintained. Around 1/3rd structures in the precinct are either poorly maintained or unmaintained.

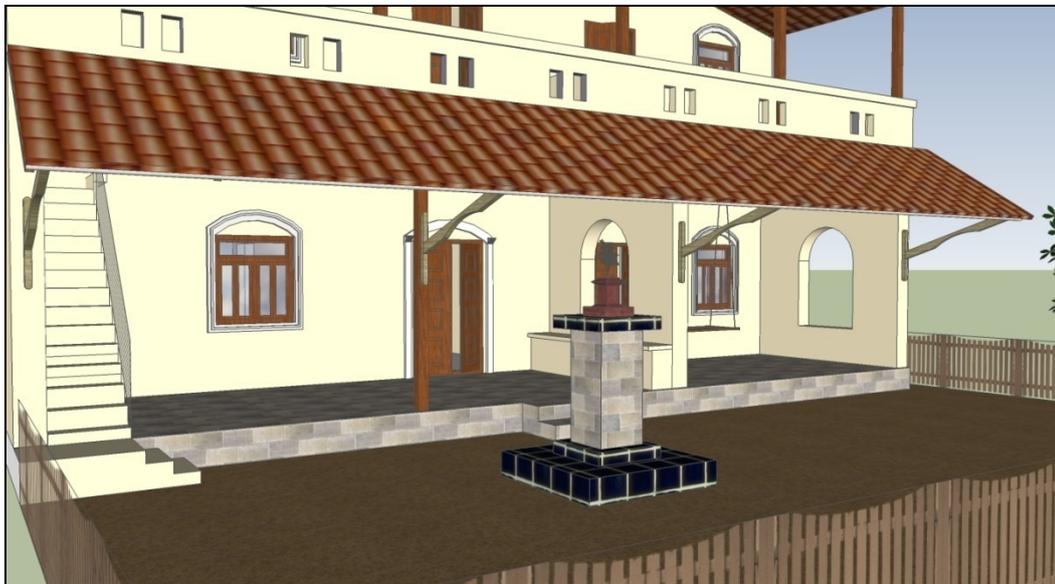
VIEW OF THE VERANDAH

9.5	OPENINGS	<p><u>Doors:</u> Painted, wooden shutters in wooden frames. The external doors have arched lintels.</p> <p><u>Windows:</u> Painted, wooden shutters in wooden frames with vertical iron bars and arched lintels. The first floor windows have a ventilator with stained glass.</p>

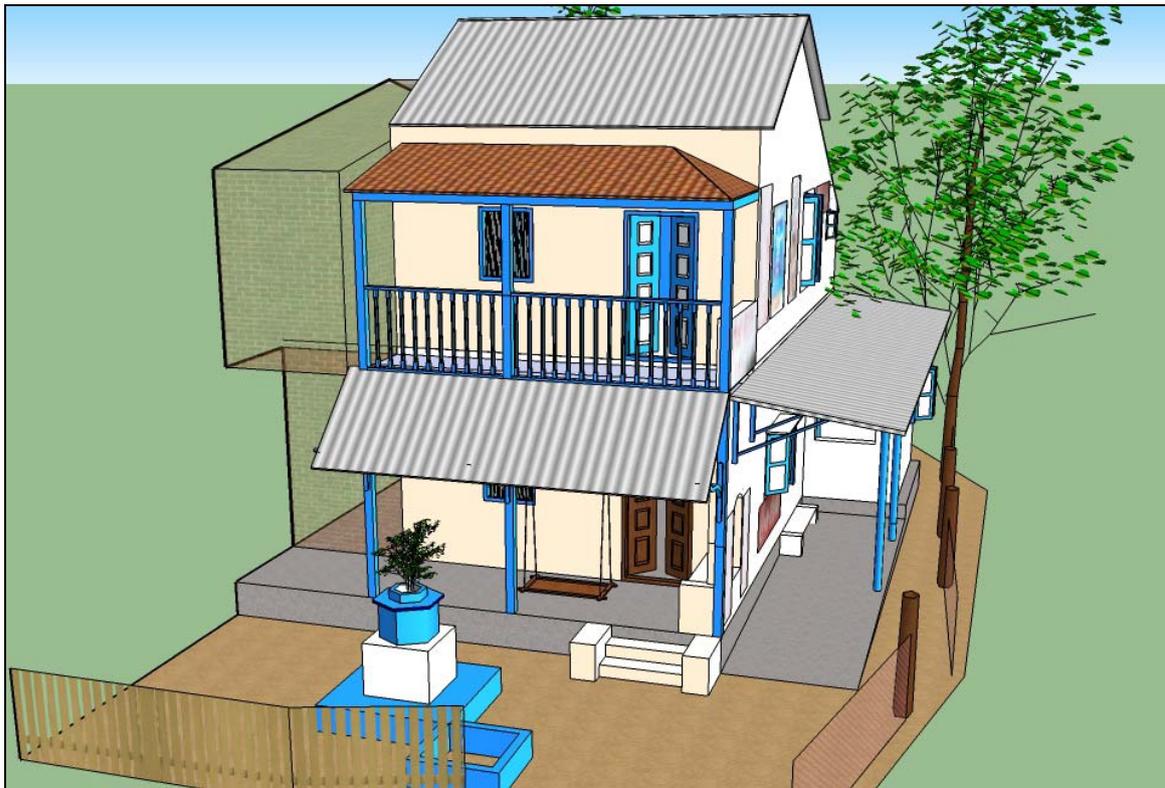
FRONT VIEW

12.2	STRUCTURE	NA.	
12.3	ELEMENTS & FINISHES	Ceramic dado in the toilet and the kitchen.	
13.0	DP REMARKS / PERCEIVED THREATS	NA.	
14.0	ADDITIONAL NOTES	The exterior side walls have advertisements for soft drinks, which are detrimental to the aesthetic of the structure.

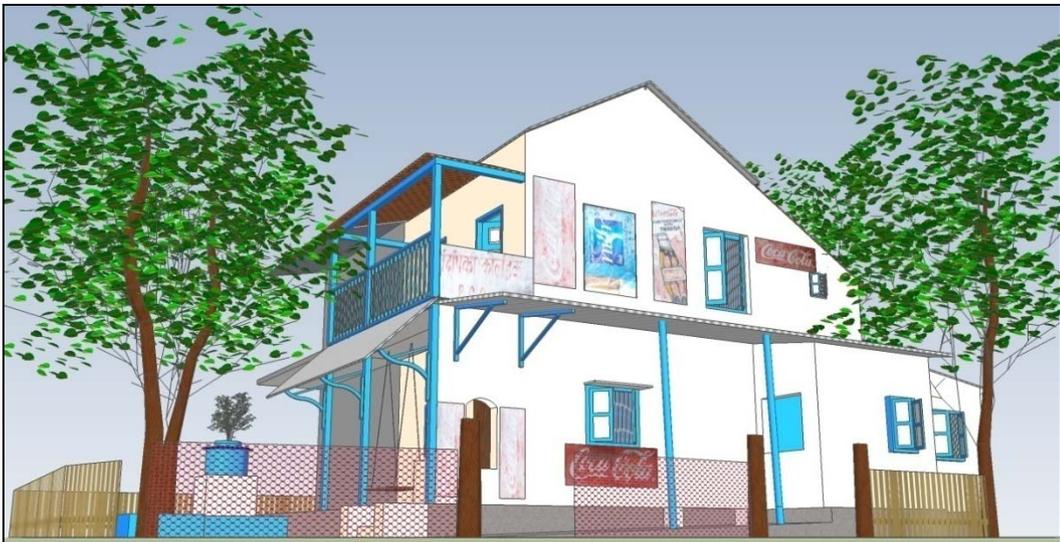
VIEW

<b>14</b>			
11.9	OUTBUILDINGS	NA.	
11.10	OVERALL CONDITION	Fair.	MAINTENANCE LEVEL Poorly maintained.
<b>12.0 TRANSFORMATION</b>			
12.1	FORM	<p>There have been incremental renovations over the years.</p> <ol style="list-style-type: none"> <li>1. Renovation 30 yrs ago <ul style="list-style-type: none"> <li>- Finishes of plinth changed from mud to cement koba</li> </ul> </li> <li>2. Renovation 20 yrs ago <ul style="list-style-type: none"> <li>- Toilet and kitchen added</li> </ul> </li> <li>3. Renovation 10 yrs ago <ul style="list-style-type: none"> <li>- Shop added</li> </ul> </li> <li>4. Renovation 2 yrs ago <ul style="list-style-type: none"> <li>- Roof material partially changed from mangalore tiles to AC sheets.</li> </ul> </li> </ol>

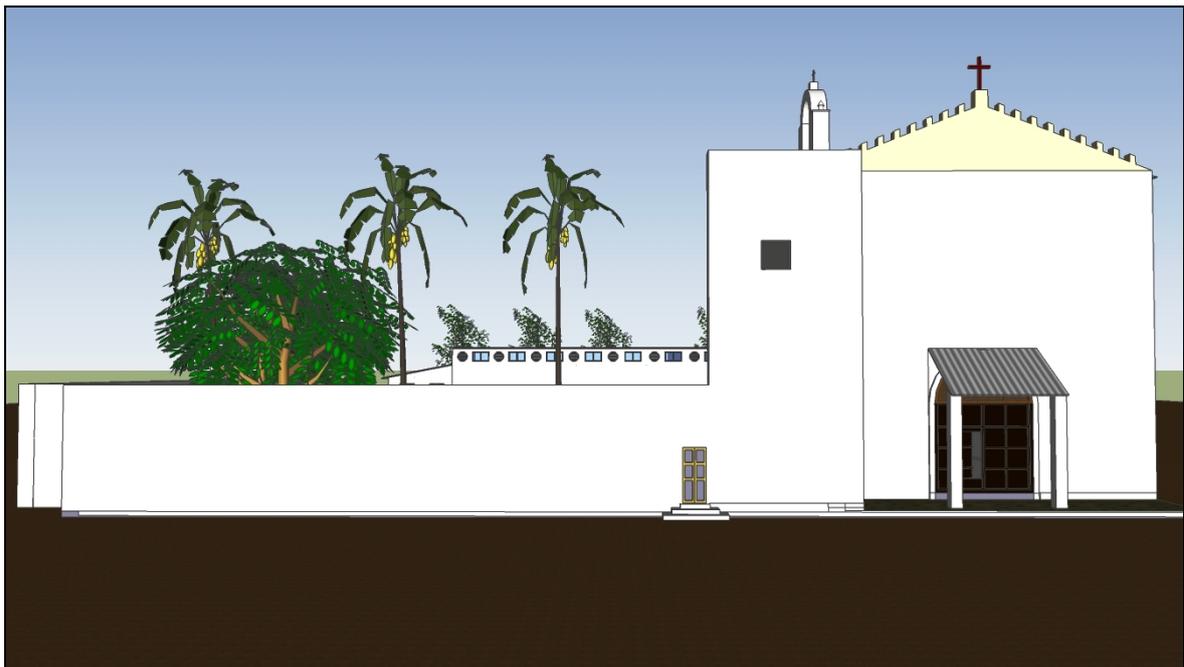
FRONT ELEVATION

1.1	NAME OF THE PREMISE	St. Bonaventure Catholic Church.	
1.2	EARLIER NAME	St. Bonaventure Catholic Church.	
1.3	BUILT-IN	1575/1599.	EXTENSION (if any): Kitchen, picnic room and toilet block.
<b>2.0 ACCESS</b>
