# MAHALAKSHMI TEMPLE PRECINCT

## DOCUMENTATION & URBAN GUIDELINES

### VOL. I – DOCUMENTATION & ANALYSIS

**ABHA NARAIN LAMBAH**  
CONSERVATION ARCHITECT  
7, GULAB BUILDING, CARTER ROAD, BANDRA (W)  
MUMBAI 400 050. TEL: 605 5756 FAX: 646 4364

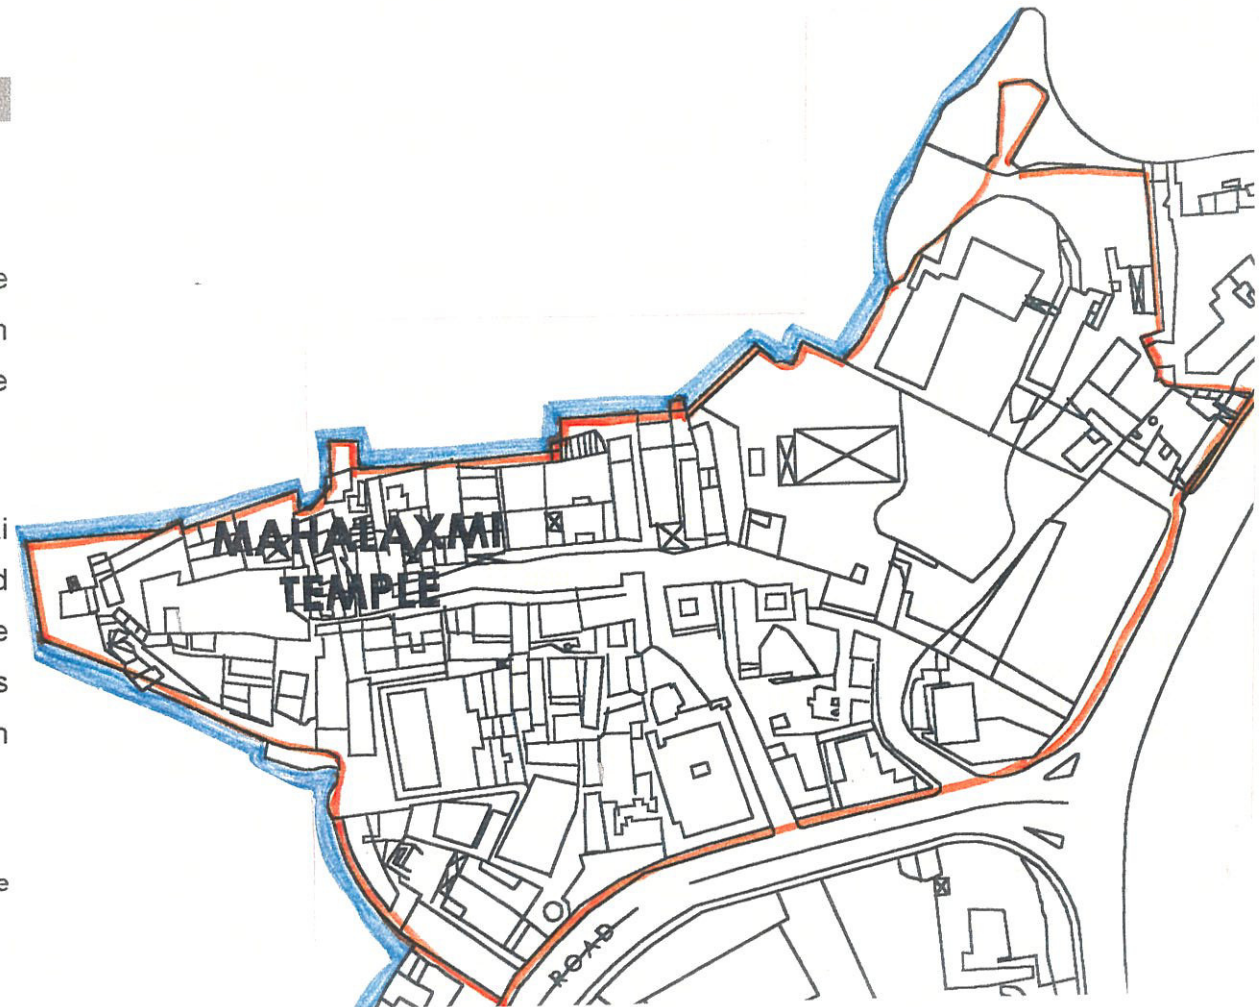
Right: Map showing the precinct demarcation of the Mahalakshmi Temple Precinct as per the 1995 Heritage Regulations for Greater Bombay.

The present precinct boundaries identify a linear area, leading from the Bhulabhai Desai Road and Pedder Road junction, towards the Mahalakshmi Temple located at the edge of the sea. This is defined by a long main street that bifurcates the precinct, acting as its central pedestrian spine and primary artery. This delineation is distinctly marked by the sea at the northern and western edges while the southern and eastern edges are marked by Bhulabhai Desai Road.

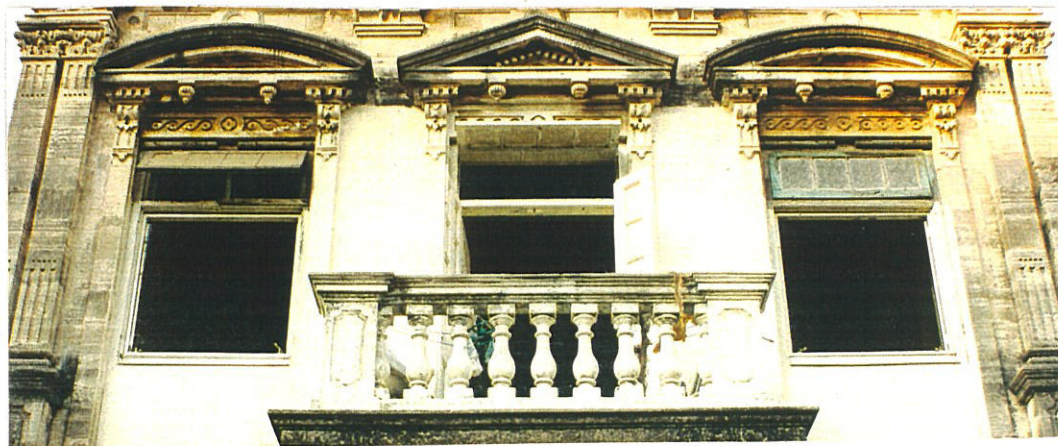
Below and Right: Some typical architectural details that are characteristic of the precinct

Mahalakshmi is not only significant as a streetscape of valuable vernacular buildings, but also represents one of the most picturesque historic residential areas, with a unique pedestrian scale and neighbourhood quality. Mahalakshmi precinct comprises a fragile collection of charming vernacular dwellings that have largely survived the onslaught of the modern construction. The neighbourhood has an immense wealth of architectural heritage in the form of quaint vernacular houses with interesting architectural features like wooden fretwork balustrades, wrought iron work and stone pediments and sloping terracotta tiled roofs.

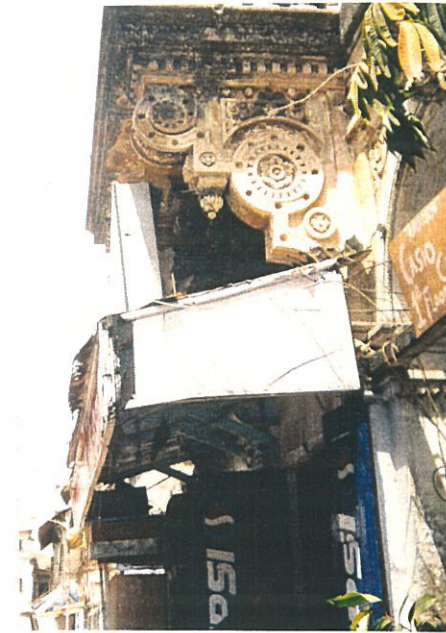
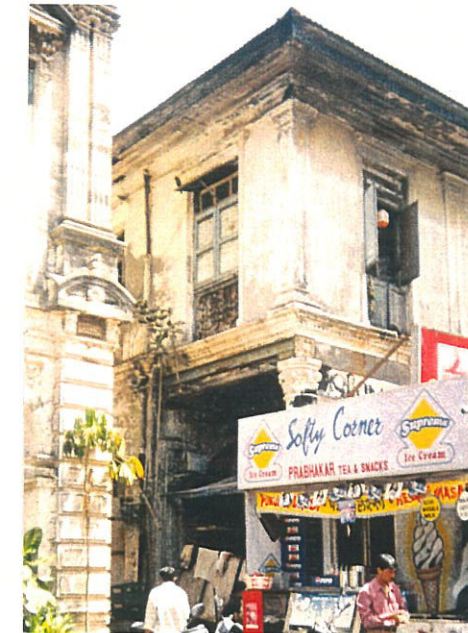
Images: Rampant encroachment and slums threaten the integrity of this heritage precinct

Sadly today, much of the area has suffered due to rapid urban transformations as well as a breakdown of civic infrastructure. In the absence of any defined conservation guidelines or specific architectural controls for the area, there has been rampant transformation that is incongruous with the essence of a historic precinct. Many historic buildings have been replaced by tall concrete blocks, or have been left to neglect and decay. Encroachments have sprung up all over the area, specially the main temple street, greatly detracting from its original character. The access roads too are in need of upgradation, as well as better cleanliness.

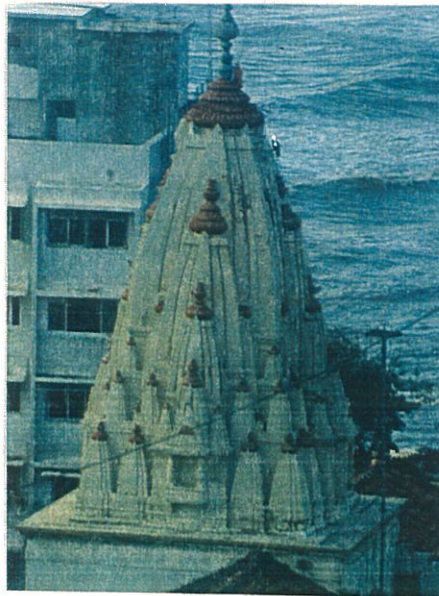
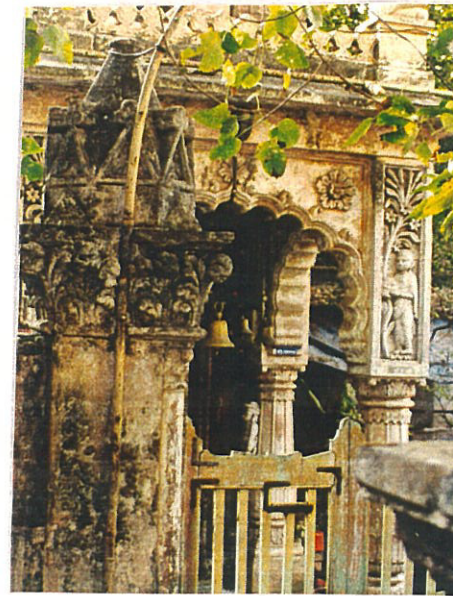
Below: Examples of some architectural types found in the precinct

The majority of the buildings in this precinct are vernacular dwellings representative of the vernacular hybrid and multiple tenanted buildings seen in most of Mumbai's 19<sup>th</sup> and early 20<sup>th</sup> century domestic architecture.

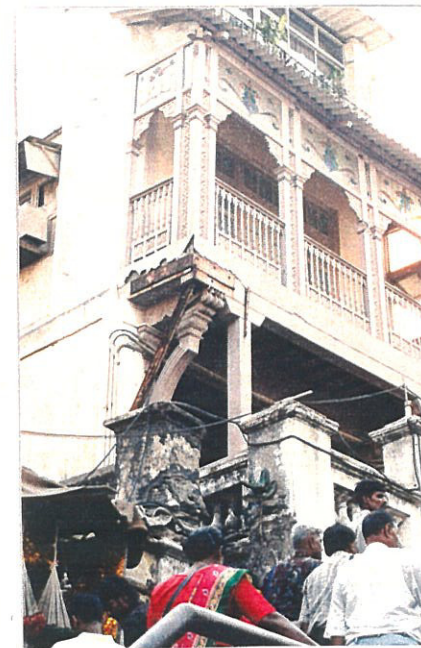
Below: Images of some buildings of heritage value in need of protection

In addition to these structures, the precinct is also dotted with some remnants of neo-Gothic railings and gateposts, along with a neo classical gateway marking the entrance of the Temple street.

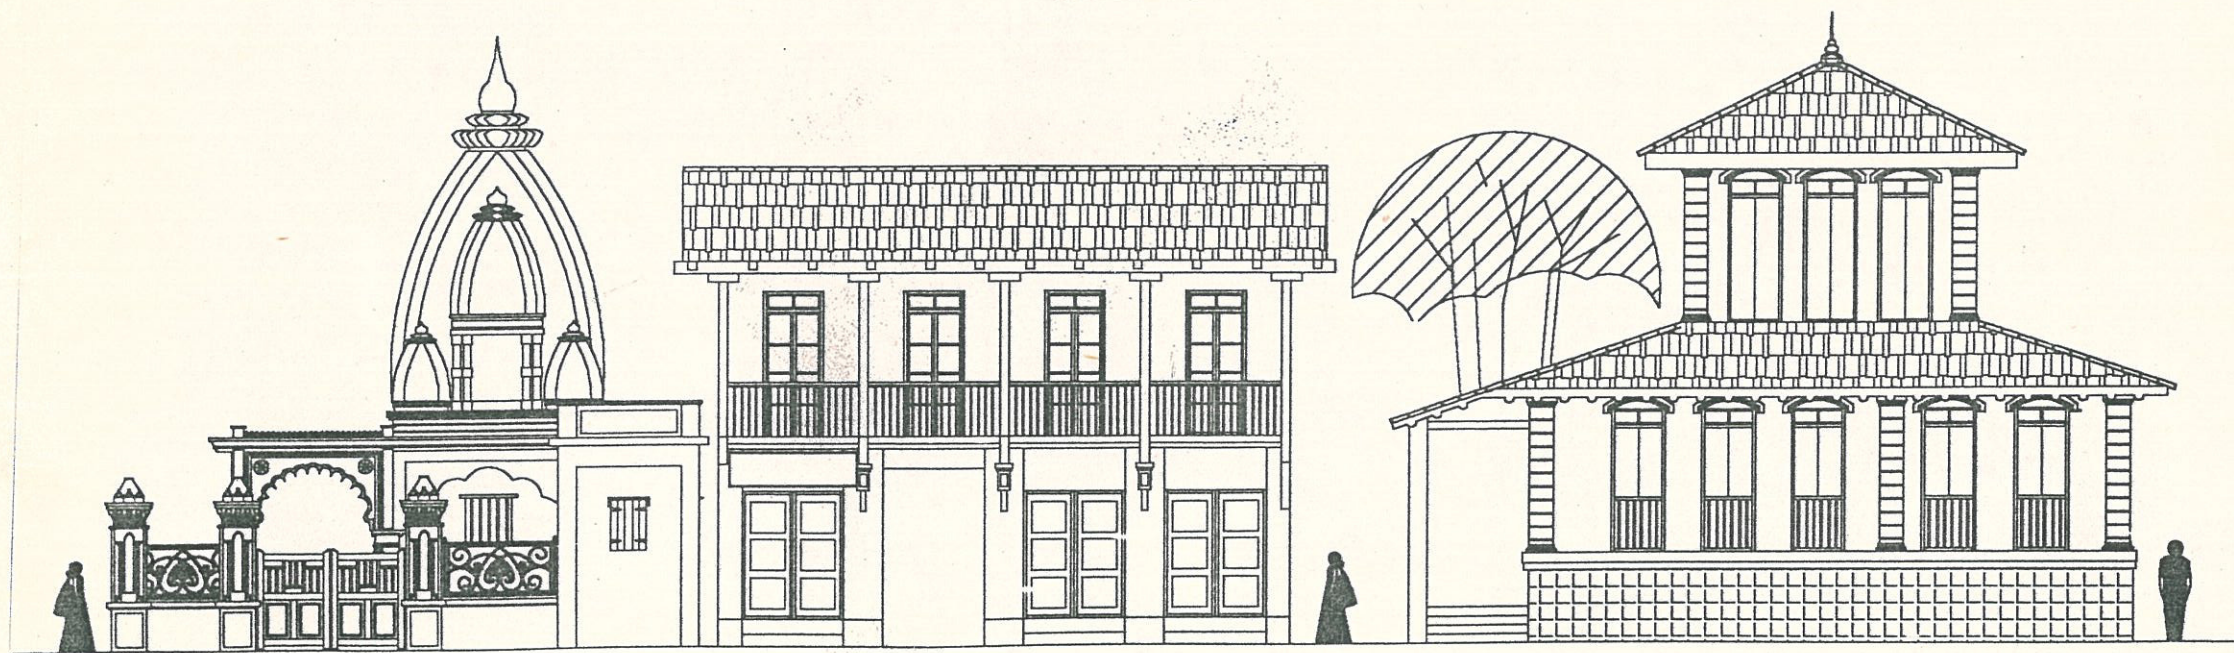
Below: Elevations of some buildings that are worthy of preservation

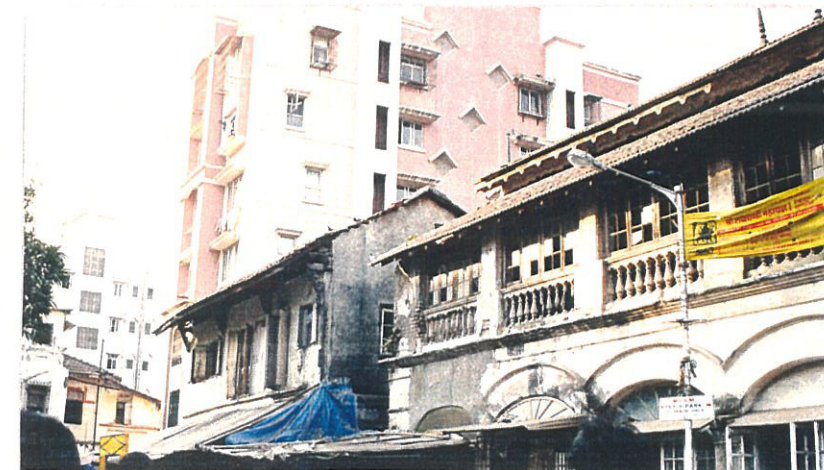
Right: Tall infill structures disturb the once harmonious skyline of the temple precinct  
Above: Statistical data on the building heights in the area

Increasingly in the past however, there have been some infill structures in modern blocks, that are incongruous to the character of the historic precinct and disturb the skyline and scale of the neighbourhood. Along the peripheral areas, there are higher structures, primarily because of the removal of older buildings to construct tall concrete apartment blocks. This is true in the case of apartment blocks to the north of the temple street, such as Rewa Apartments, Sheela and Summerville.

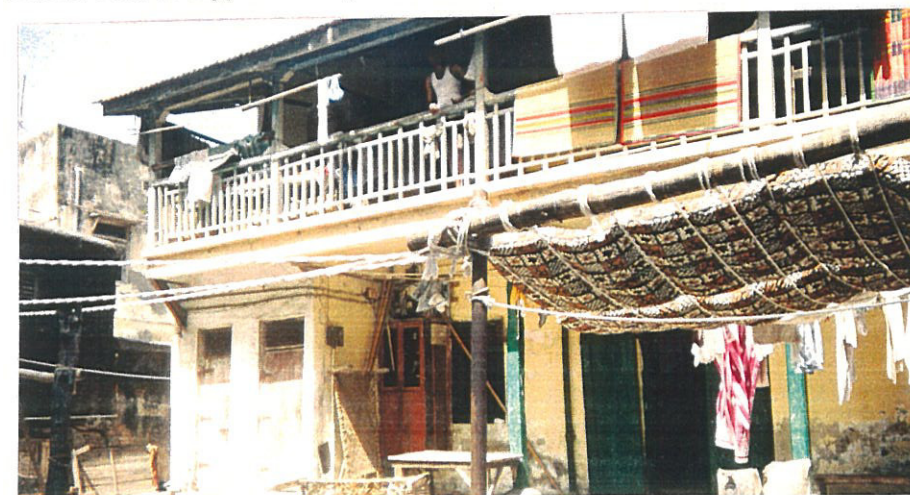
Below: View of a typical multiple tenanted structure

Apart from these, most of the modern high rise apartment consist of ownership flats or a co-operative. There is however, a large housing stock of multiple tenanted structures and other residential buildings that have one or more tenants. Examples of these are Kusum Sadan, Ramdas Bansali Chawl, Premji Keshtee Building and Lohar Panchganga Chawl, among others. Thus, leaving out the religious and institutional buildings, a large chunk of the residential structures are tenanted and thus suffer from typical issues such as lack of maintenance, Cess rules and Rent Control issues as per the existing legislation.

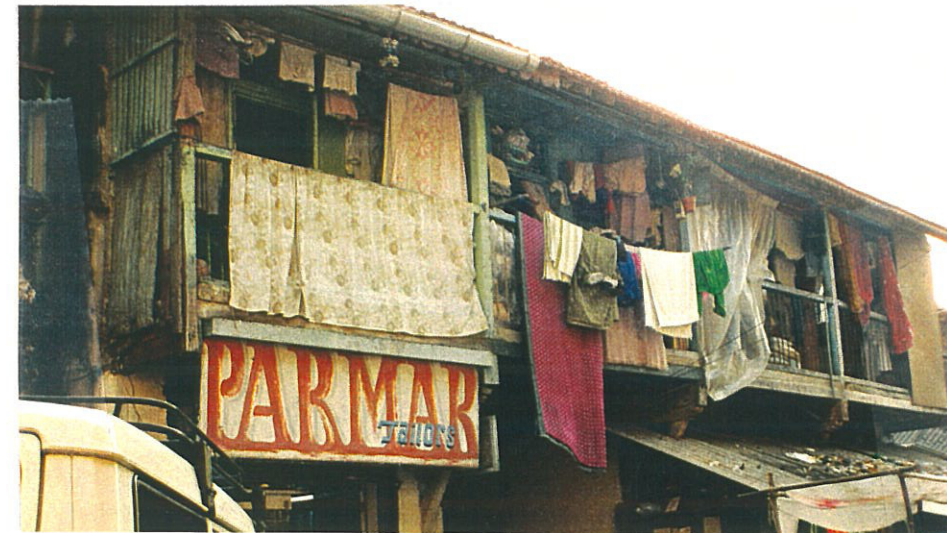
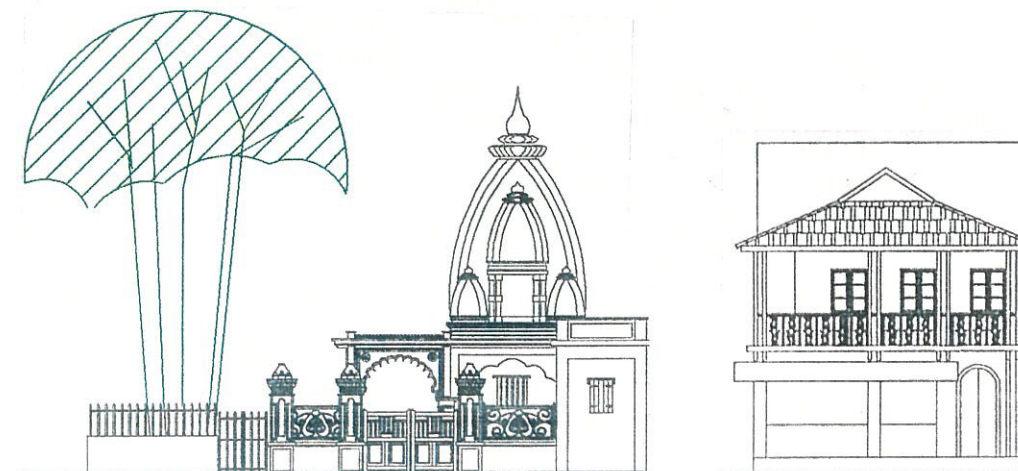
Right: Building typologies range from multiple tenanted houses (above), to temples and smaller cottage structures.

A range of multi tenanted community housing forms too exist in this neighbourhood, more frequently seen in the interiors of the precinct. These derive from a mix of domestic residential architecture seen in the city and use a largely linear plan form with front verandas acting as connecting spaces between individual tenements.

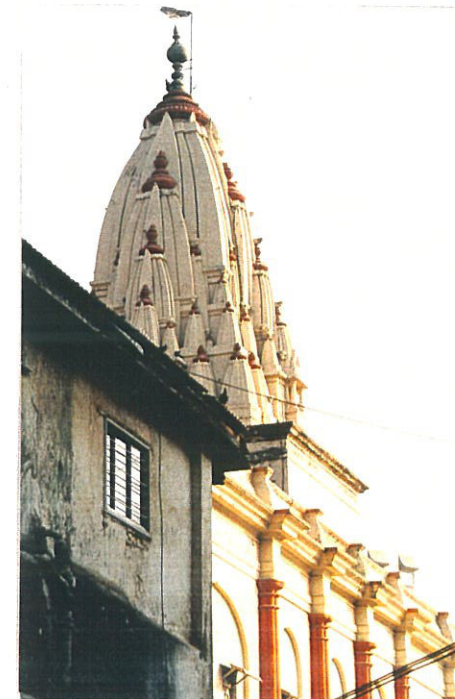
Below: The range of temple forms dotting the Mahalakshmi Temple precinct

Among the other temple forms in the precinct are the *Ma Kalimata* temple, with an almost domestic vernacular character, the newly re-constructed concrete structure of the *Rani Sati Mandir* and the elegant *ParamRameshwar Mahadeo Mandir* which though much smaller, is by far the most well crafted temple shrine with its stone columns, well proportioned “shikhar” and the graceful stone “nandi” marking the entrance to the Shiva temple.

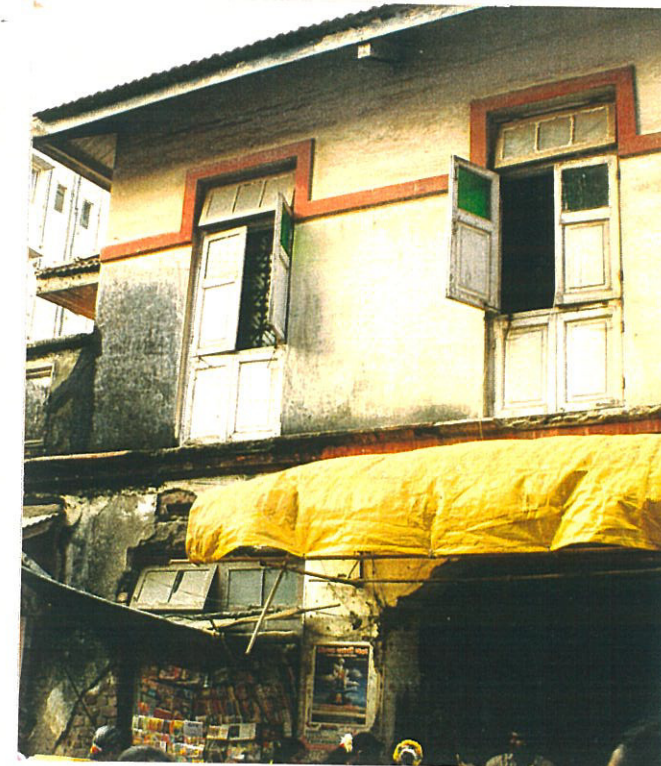
##### N 03 BHAGWAN BHAWAN

BUILDING NAME : Bhagwan Bhawan  
HEIGHT : Ground + 1 storey  
ARCHITECTURAL STYLE : Hybrid Neo-Classical with Hindu door brackets  
PRESENT LISTING : None  
PROPOSED LISTING : Grade III

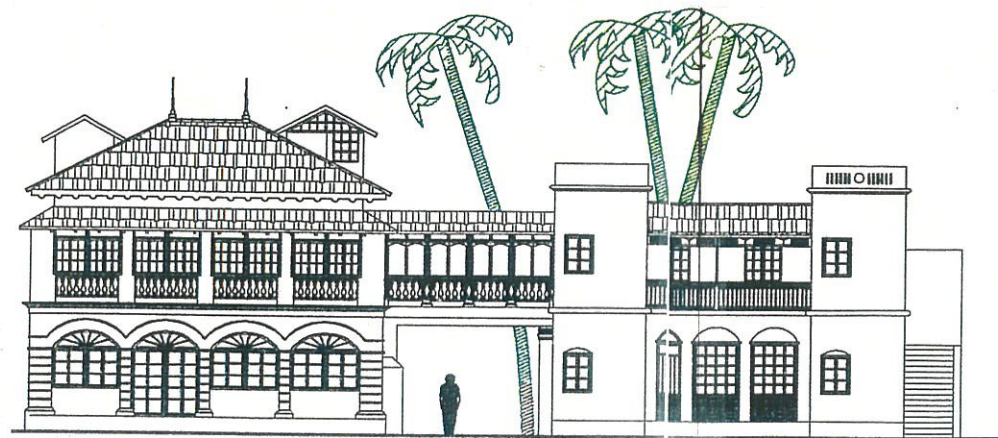
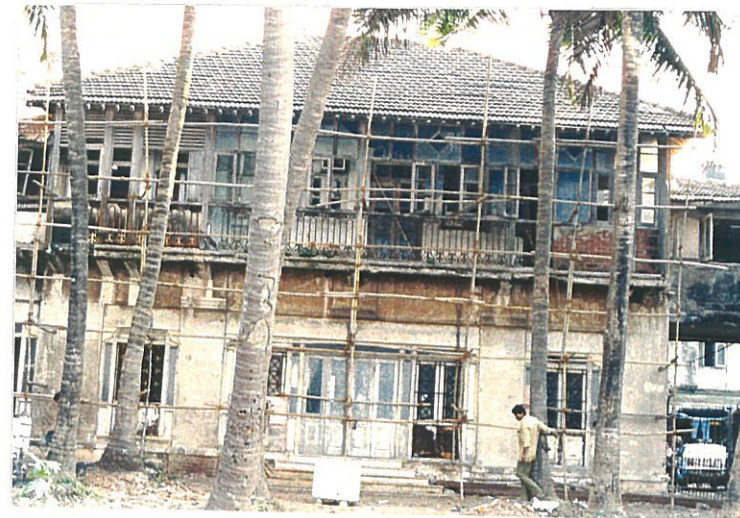
##### N 06 MULJEE JETHA BUILDING

**BUILDING NAME** : Muljee Jetha Building  
**HEIGHT** : Ground + 1 storey  
**ARCHITECTURAL STYLE** : Portuguese influenced vernacular domestic  
**PRESENT LISTING** : None  
**PROPOSED LISTING** : Grade III

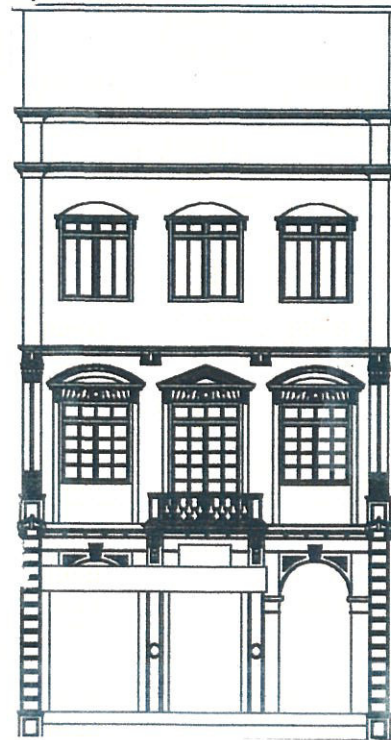
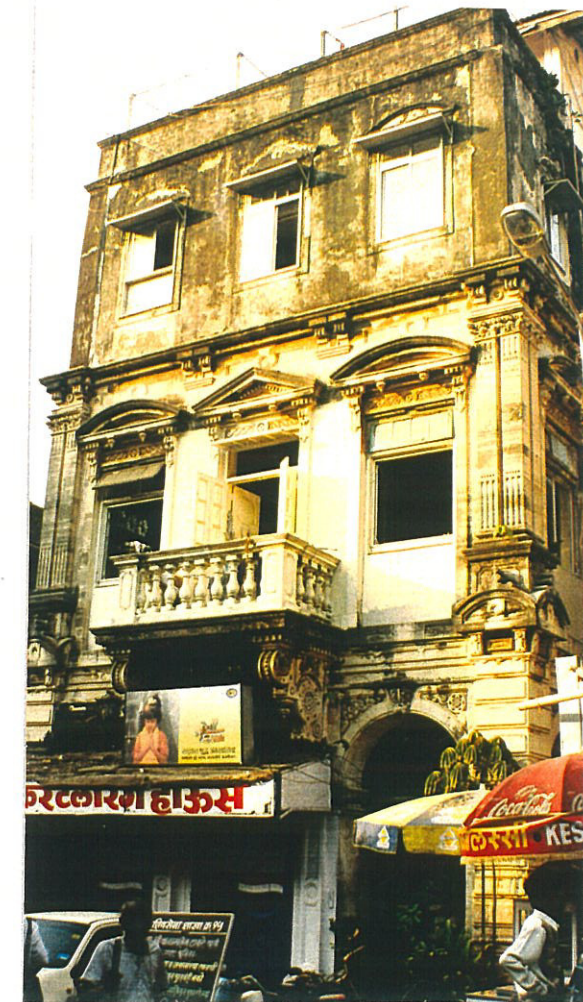
##### N 07 BHATIA BUILDING

BUILDING NAME	: Bhatia Building
HEIGHT	: Ground + 2 storey and half of third floor with setback
ARCHITECTURAL STYLE	: Neo Classical
PRESENT LISTING	: None
PROPOSED LISTING	: Grade III

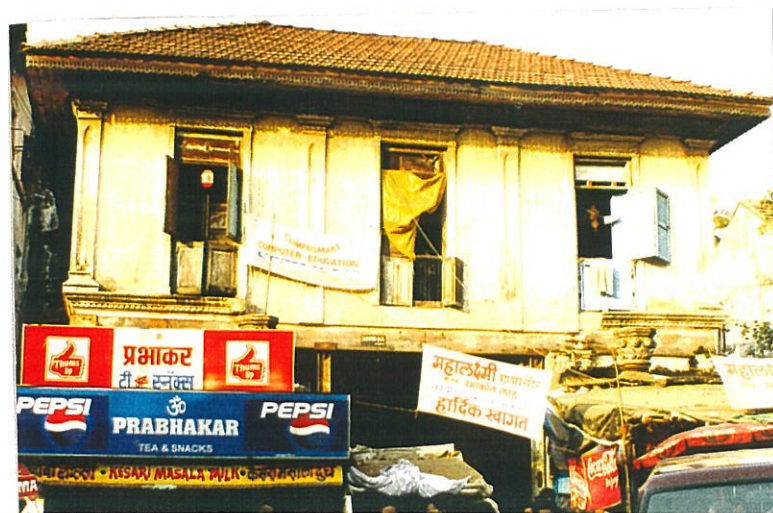
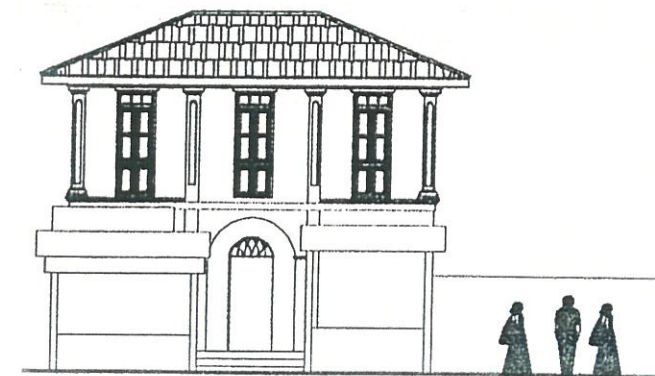
##### N 08 KASTURBAI BUILDING

BUILDING NAME : Kasturbai Building  
HEIGHT : Ground + 1 storey  
ARCHITECTURAL STYLE : Portuguese influenced  
PRESENT LISTING : None  
PROPOSED LISTING : Grade III

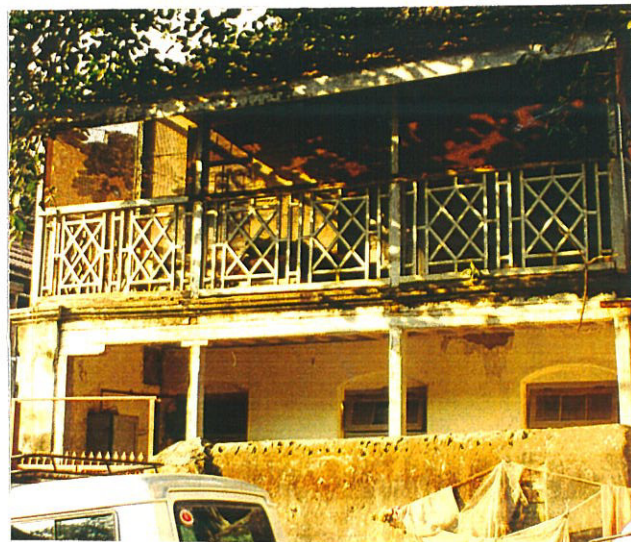
##### N 09 SANYASI ASHRAM

BUILDING NAME : Sanyasi Ashram  
HEIGHT : Ground + 1 storey  
ARCHITECTURAL STYLE : Hindu Vernacular  
PRESENT LISTING : None  
PROPOSED LISTING : Grade III

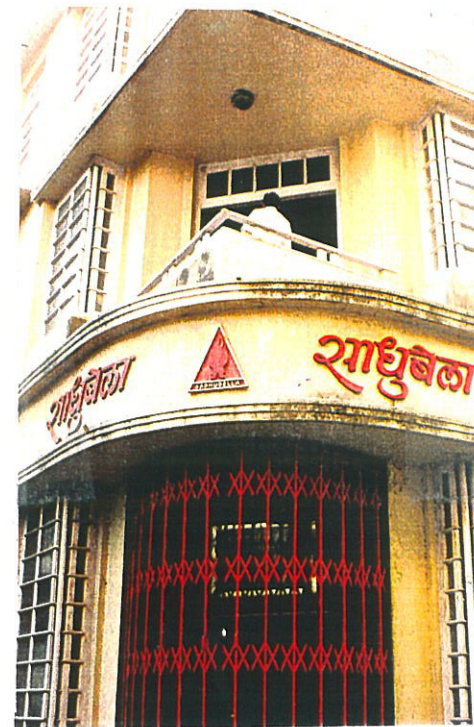
##### S 05 SADHUBELA UDASIN ASHRAM

BUILDING NAME : Sadhubela Udasin Ashram  
HEIGHT : Ground + 2 storeys  
ARCHITECTURAL STYLE : Art Deco  
PRESENT LISTING : None  
PROPOSED LISTING : Grade III

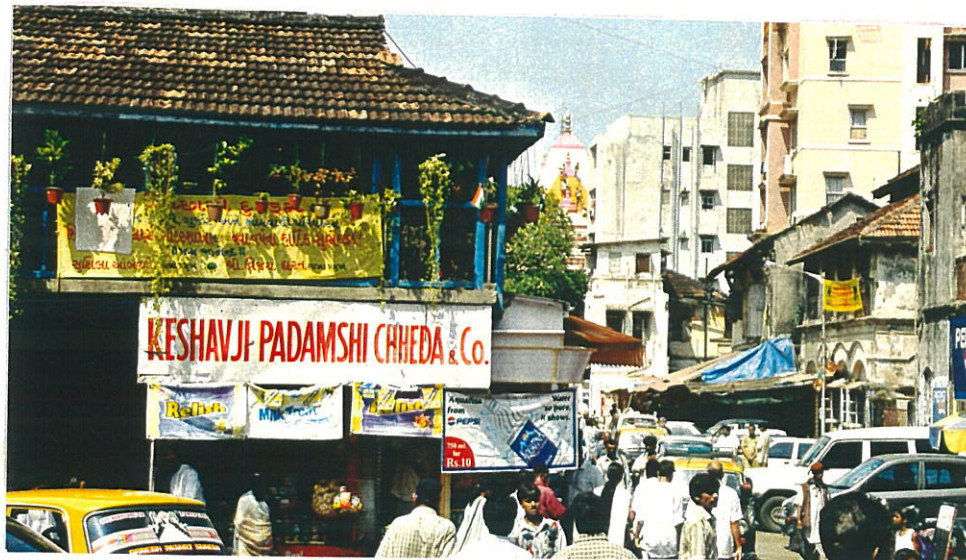
##### S 19 RAMDAS BANSALI CHAWL

BUILDING NAME : Ramdas Bansali Chawl  
HEIGHT : Ground + 1 storey  
ARCHITECTURAL STYLE : Vernacular Chawl structure  
PRESENT LISTING : None  
PROPOSED LISTING : Grade III

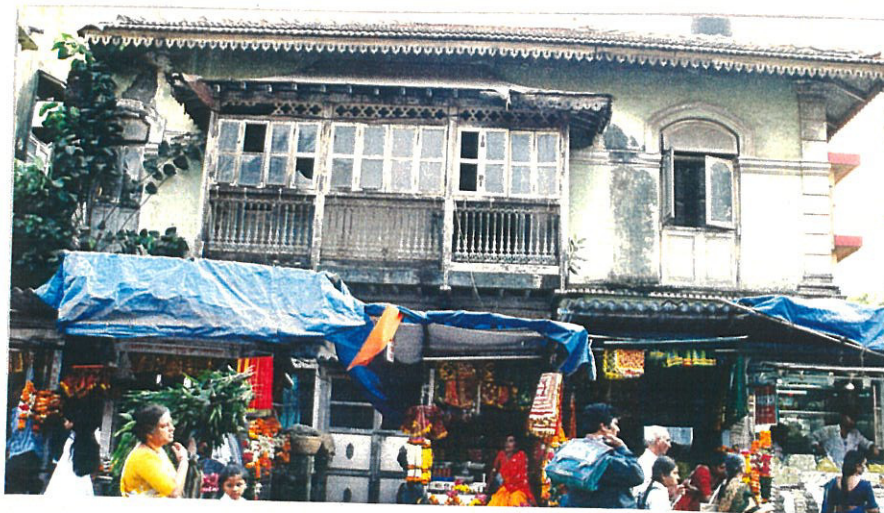
##### S 21 KETKAR MOTIWALA BUNGALOW

**BUILDING NAME** : Ketkar Motiwala Bungalow  
**HEIGHT** : Ground + 1 storey  
**ARCHITECTURAL STYLE** : Portuguese influenced  
**PRESENT LISTING** : None  
**PROPOSED LISTING** : Grade III

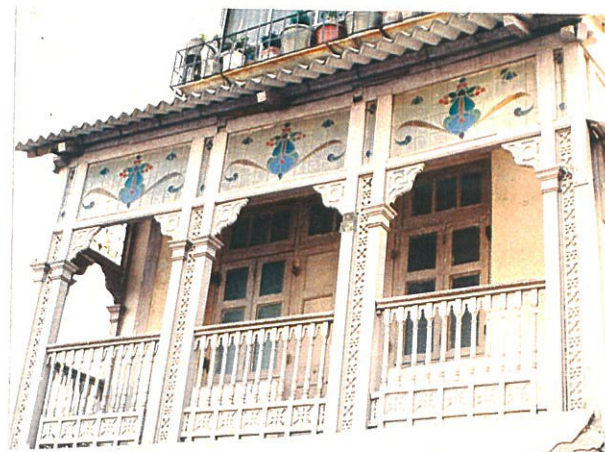
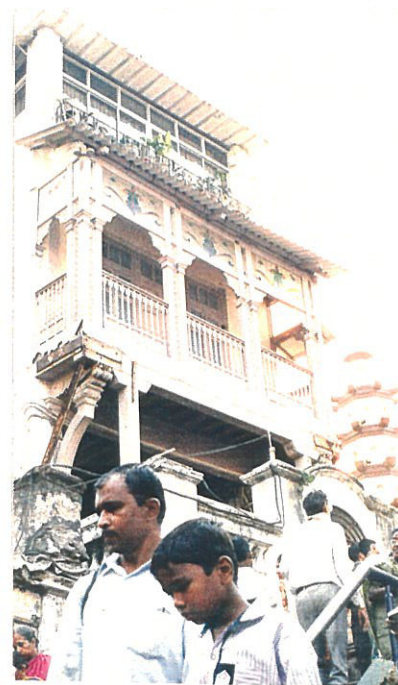
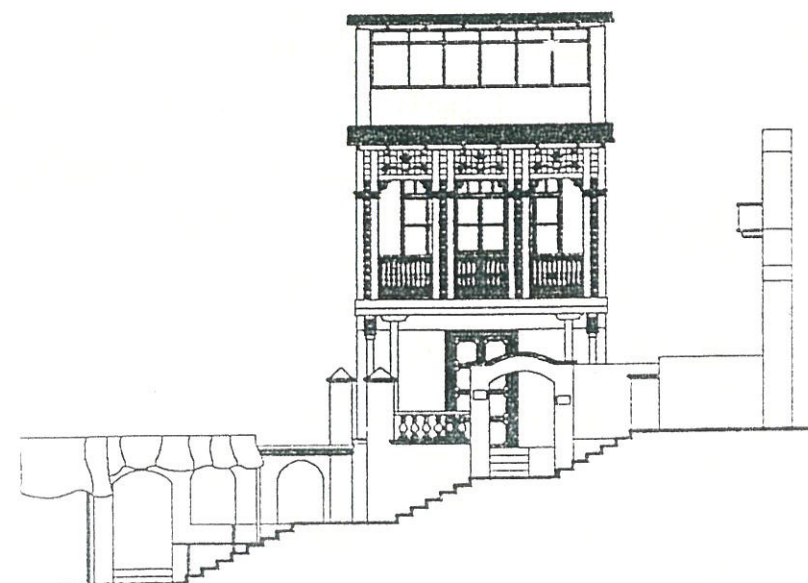
##### S 36 JARIWALA BUILDING

BUILDING NAME : Jariwala Building  
HEIGHT : Ground + 2 storeys  
ARCHITECTURAL STYLE : Vernacular residential  
PRESENT LISTING : None  
PROPOSED LISTING : Grade III

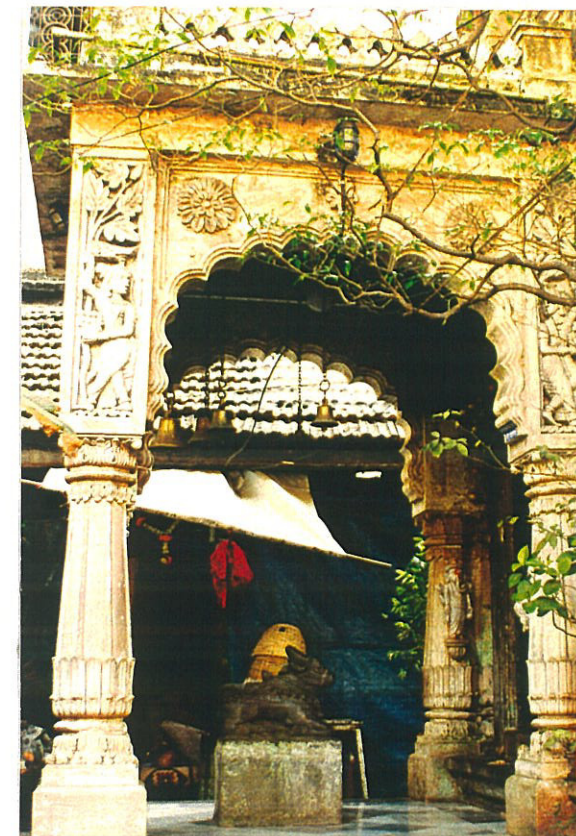
Right: The *Param Rameshwar Mahadeo* temple, a fine example of nineteenth century temple traditions that has been excluded from the list

Even within the listing of temples, there seems to be anomalies, with beautiful examples of temple architecture such as the *Param Rameshwar Mahadeo Mandir* being left out of the listing. Similarly, though the entire complex of the *Mahalakshmi Mandir* has been declared Grade III, this does not allow any freezing of development in the complex, since Grade III allows for un-built F.S.I. to be consumed in the plot, through addition of new structures.

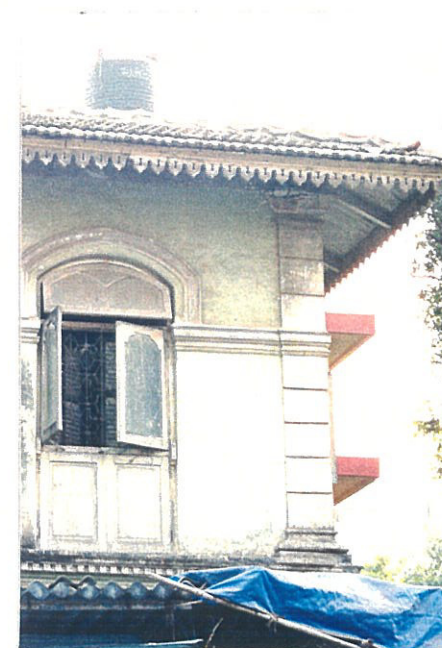
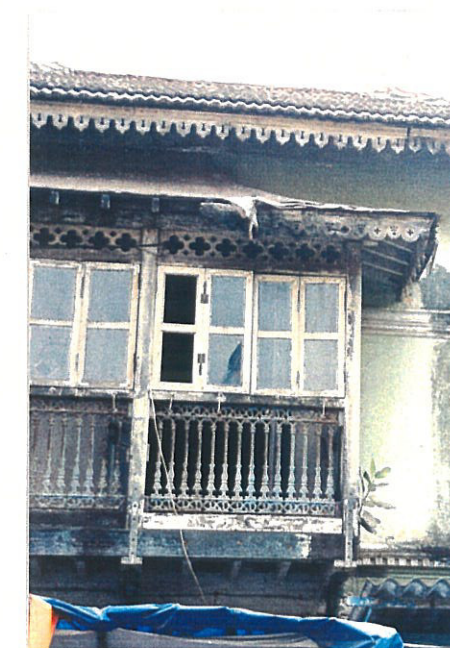
Above: Elegant detailing that would soon be lost if specific architectural controls are not soon implemented in the area.

The Mahalakshmi temple precinct is significant in terms of its architectural features such as ornate balusters, tiled roofs, timber barge boards, wrought iron railings and stucco mouldings that lend it a quaint character. Unfortunately, these structures are not protected by listing and even the blanket protection offered by their inclusion in a heritage precinct, does not protect their unique architectural features or details, thus making them entirely at risk of incongruous additions and alterations.

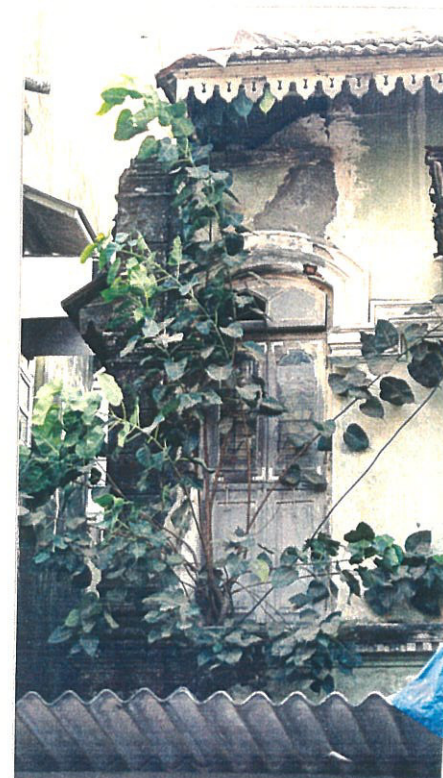
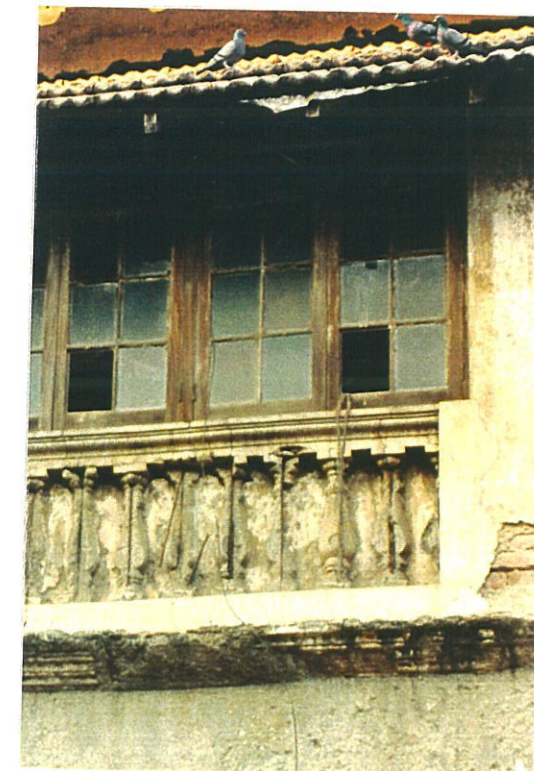
Right: Issues ranging from roof leakage, to ficus growth, structural overloading arising out of age and sheer neglect threaten to damage the architectural fabric of the precinct.

The structures in the precinct range from old stone structures, to vernacular brick and stone construction with timber elements and even modern concrete and brick buildings. Though the structural condition varies, it is largely seen that most of the old structures of heritage value face some threat to their integrity. Largely under the category of tenanted buildings, a large number of structures are already included in the Cess list, making it imperative to view their future preservation from the point of view of MHADA Repair Board practices.

Even in the case of relatively well stable buildings, threats are posed due to a variety of issues ranging from over loading due to incremental changes and alterations to the structure, to ficus growth, roof leakage and such issues.

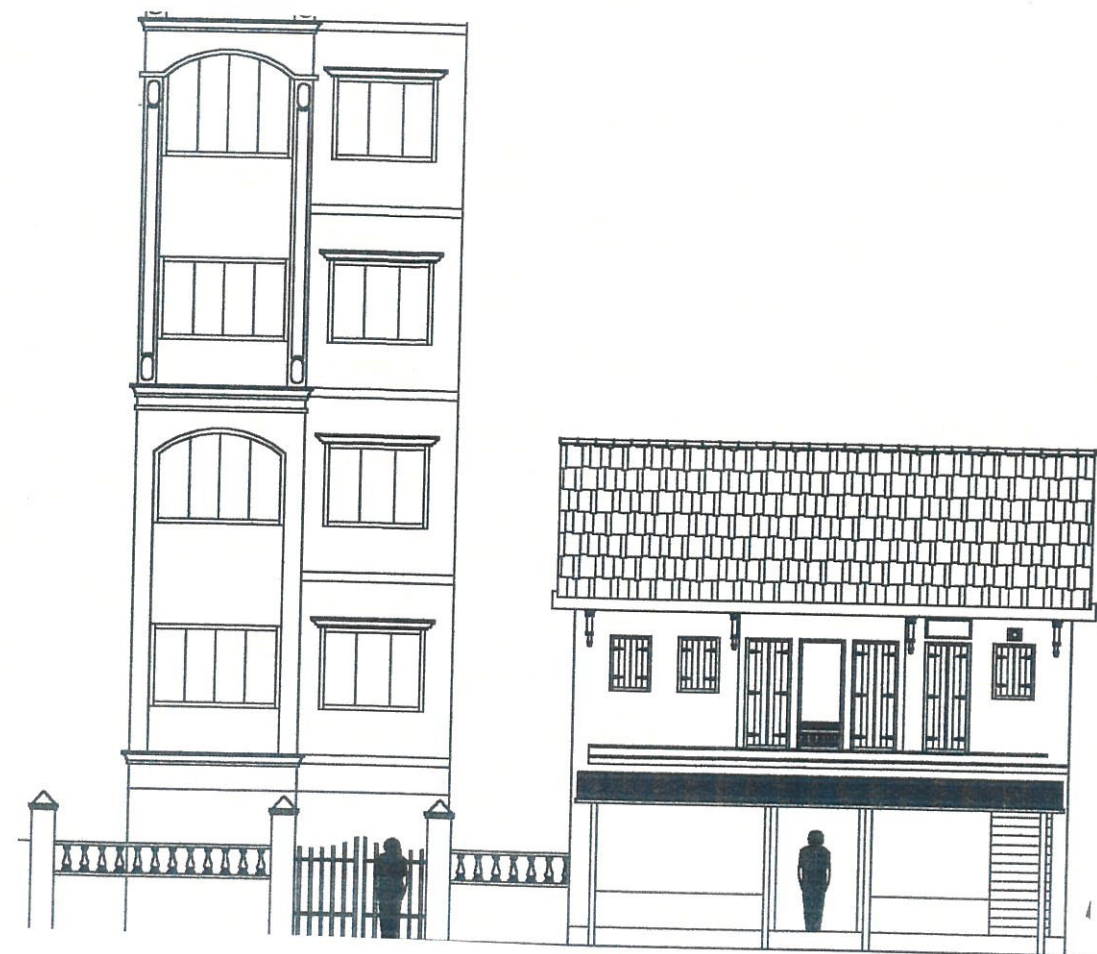
Right: Image indicating how the architectural character of the streetscape is damaged due to insensitive infill constructions.

The unique architectural character of the central temple spine would have once been reflected in the rest of the precinct. This has however been lost due to rampant transformations caused as a result of heavy urbanization and densification of this precinct, given its high real estate value. What we have left today, is just a fraction of what the precinct quality would have been a century ago and even that is threatened today by incongruous high rise concrete blocks that have sprung up.

These modern constructions are not only wholly insensitive to the scale of the neighbouring buildings, but disturb the once harmonious skyline. Even in their architectural vocabulary, they contrast with the original vernacular genre. In order to salvage what is left of the precinct, it is imperative to create mandatory height restrictions and skyline controls as well as directive guidelines that would guide the future course of building in the precinct, such that the architectural character of this heritage precinct is maintained.

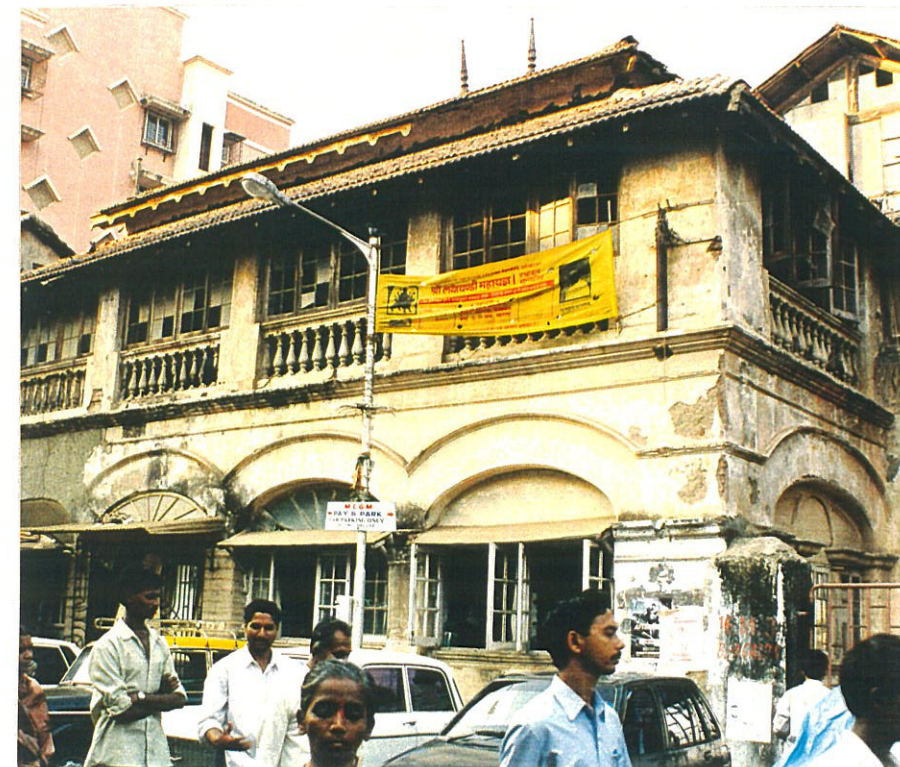
Right: Incongruous accretions destroy the architectural integrity of the heritage buildings

Incongruous signage needs to be strictly dealt with and all commercial establishments should be made to conform to a set of signage guidelines to ensure that the architectural integrity of the buildings is not obliterated.

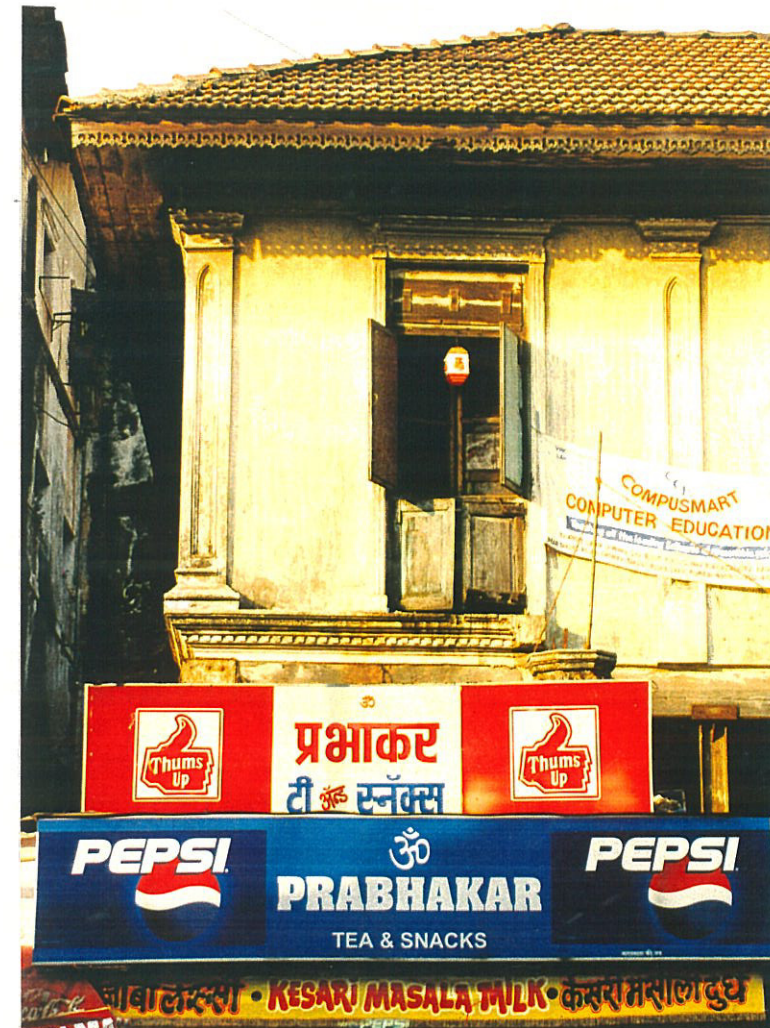
Below and Right: A proliferation of sign boards and shopfronts add to the visual chaos.

Along with the commercialization of the precinct, a growing trend has been that of the proliferation of shop fronts and brightly painted shop signs to attract the visitors to the precinct. This has been adopted by most of the prasad and sweet sellers in the precinct as well as the small tea stall and general store, adding to the visual clutter in the area. There is a strong need for aligning these shop fronts and making them conform to some specific guidelines laid out for the area.

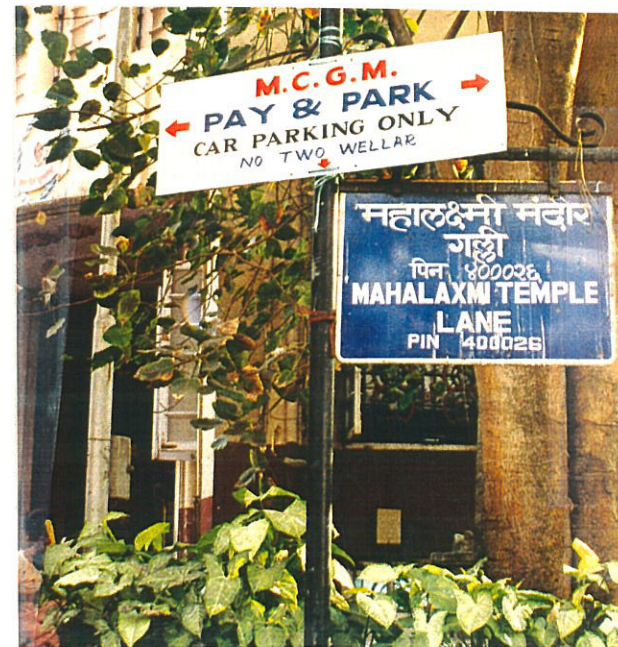
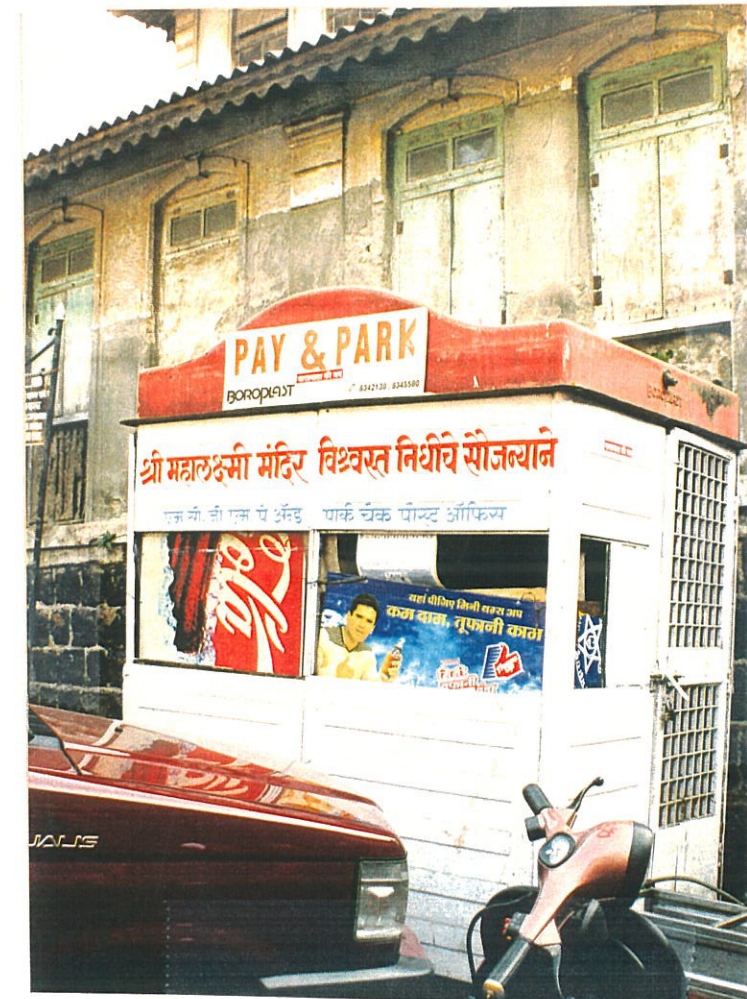
Below: The main Mahalaxmi Temple Lane that is the point for both pedestrian and vehicular traffic leading into the precinct.

Right: The pay and park stall at the corner of the Shree Ma Kalimata Mandir

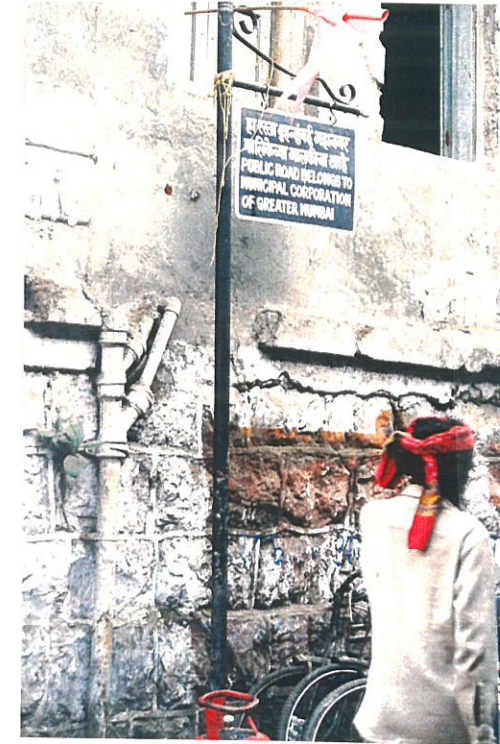
Right: A sign board indicating that the road belongs to the Municipal Corporation. Another image showing the division of pedestrian traffic through the In and Out signs placed on the temple steps.

The pedestrian infrastructure today is highly threatened by the overlay of vehicular traffic. This results in cases of typical conflict where the pedestrian circulation in the main pedestrian street for example, has been reduced to a marginal strip as most of the road width is occupied by vehicular parking. In the absence of any properly defined zone or pavement stretch, the two traffic movements continue to overlap, causing much inconvenience. The pedestrian infrastructure therefore is quite inadequate with no proper pavement, or good surfacing for circulation. Neither is there any good distribution of street furniture like litterbins or benches which are much needed in a precinct which is a popular pilgrim destination.

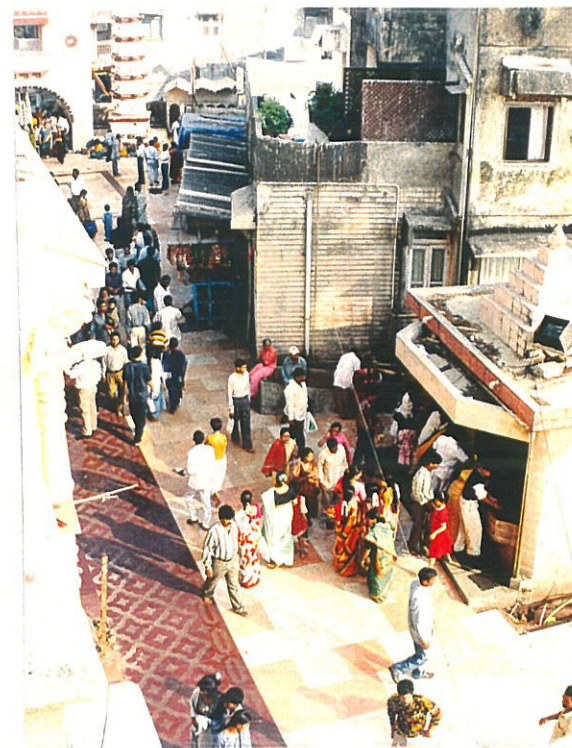
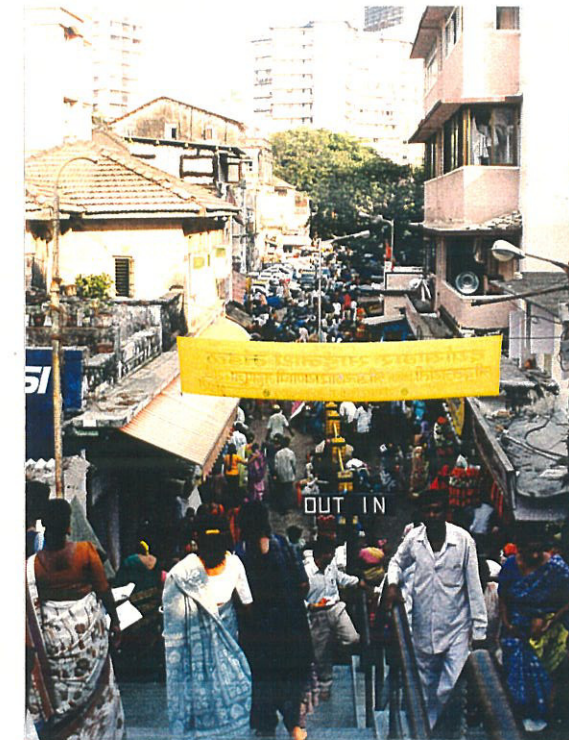
the temple platform with visitor amenities like benches for seating. During the hot festivals, canopies are placed to shade the devotees from the hot sun.

is limited to some road signs and an IN and OUT sign marked at the temple direct visitor circulation. There is a central divider railing along the stretch from temple steps to further divide the visitor movement into the required direction. There are some seating arrangements at the upper platform level in Shree Mahalakshmi Mandir for the devotees, along with lamp fixtures, benches for drinking water and toilets. These however are directly provided and managed by the Temple Trust.
