Stone Cleaning of Heritage Buildings in Mumbai

A Handbook

MUMBAI METROPOLITION REGION HERITAGE CONSERVATION SOCIETY

Architectural Conservation Cell, Research and Consultancy Directorate, The Associated Cement Companies Ltd.

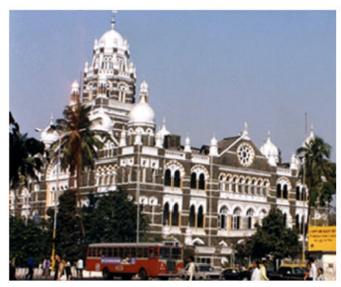
. Figure 1: The Western Railway headquarters building at Churchgate is constructed of Kurla basalt and limestone

Bluish grey basaltic rock: Basaltic rocks are grey to dark grey in colour and of fine to medium grain texture with some glassy component. A typical example is the

Western Railway headquarters buildings at Churchgate. The dark colour is due to the presence of the ferro-magnesium mineral, augite, in addition to plagioclase of labradorite composition. These rocks show columnar jointing and spheroidal weathering. During the course of cooling the lava flows develop a variety of secondary minerals as alteration products, or as secretion fillings, imparting pale green colour to these rocks (Wadia 1961, Pascoe 1964). This enhances the suitability of these rocks as a building stone.

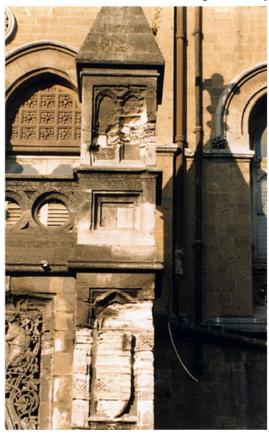
Figure 10: Contour scaling of limestone. Crystallisation of salts is often confused with wind erosion. The mechanical removal of stone by wind borne particles occur only in exceptional circumstances. Any increase in the rate of decay in the areas that are particularly susceptible to wind is usually due to increased rate of evaporation which leads to an accumulation of salts in the areas together with a greater frequency of crystallisation effects

Airborne dust particles damage the surface of monuments by the abrasive action of the dust carried by it, Fig~I0. The winds from the sea are laden with salts from the sea. These salts abrade and/or corrode the surface of buildings as well as get deposited in the pores of the stones. This can cause salt damage to the masonry. The windward facades of buildings, particularly those facing the sea, experience full blast of these winds and are more likely to show advanced signs of such decay and soiling.

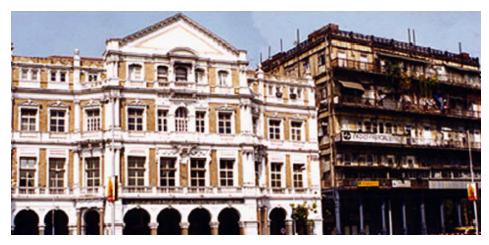
Figure 36: A comparison between cleaned buildings and one that is not

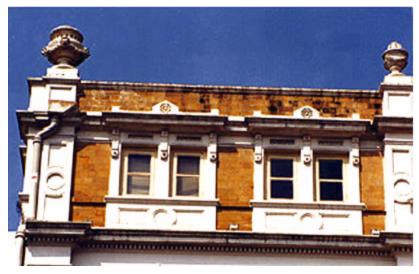
Figure 38: Recurrence of soiling after cleaning

should not be totally relied on. Horrendous results have been noticed in Mumbai, where such chemicals have been used without much understanding of their long-term behaviour in the environment. Removal of these stains and residual salts can be tedious and expensive.

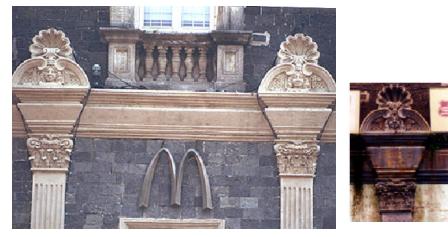
Figure 39 Before and after cleaning

The hard Kurla basalt was cleaned using the conventional sand blasting technique. The soft Porbundar limestone was delicately cleaned using the special suction blast technique. Suction blast was tested with success under laboratory conditions and was found to be the precise technique for cleaning this particular stone. Chemical cleaning was also tried but was found to be inadequate for the effective removal of layers of paint.

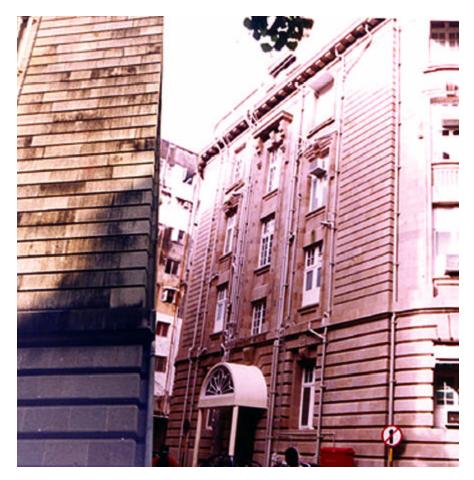
Figure 40 A portion of the building just before cleaning. The same portion after cleaning.

(vii) application of transparent, antistatic, pore lining, UV resistant, hydrophobic coating in two layers
