# KHOTACHIWADI - A HERITAGE PRECINCT

Prepared by : ACACEMY OF ARCHITECTURE

# AN OVERVIEW

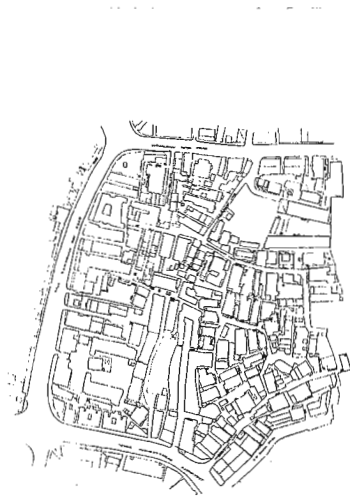
THE EXTENT OF THE KHOTACHIWADI PRECINCT, DEMARCATED AS PER THE HERITAGE REGULATIONS FOR GREATER BOMBAY 1995 (GOVERNMENT OF MAHARASHTRA PUBLICATION).

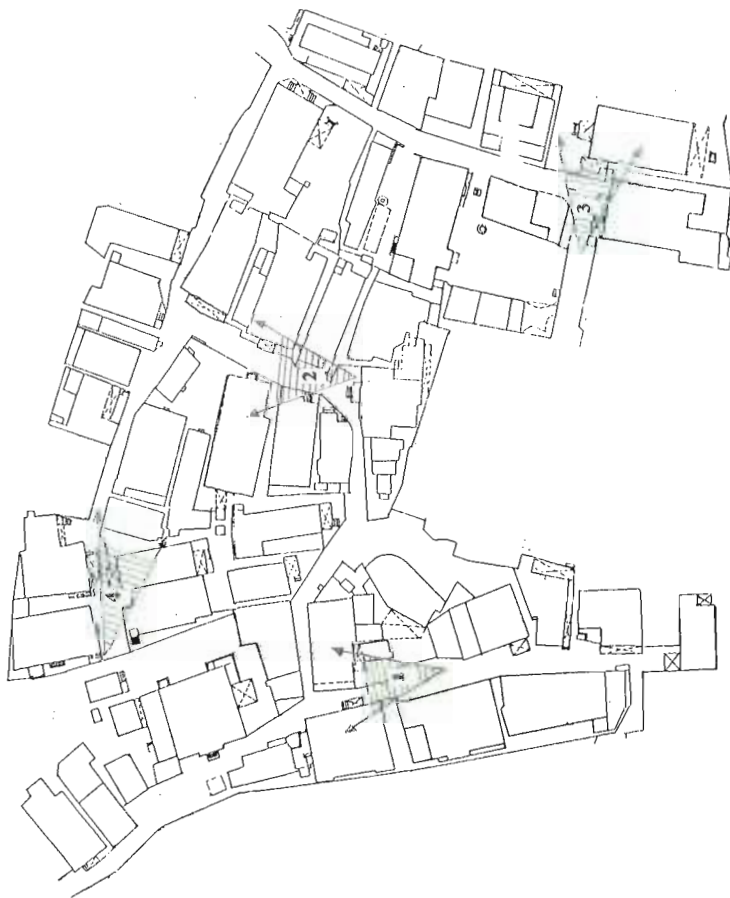
Based on the building typology and the character, for the purpose of this study, the precinct has been divided into three zones: the CORE, the BUFFER and the PERIPHERY.

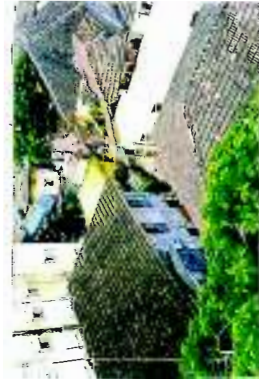
#### THE LOW-LYING SLOPING ROOFS

Except for a few modern buildings, none of the structures exceed ground and two storeys. The roofs are pitched, covered with Mangalore tiles

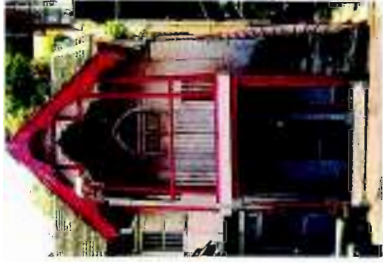
#### THE FRONT PORCH

It is evident that all the structures have their main entrances located on the front side i.e. abutting the street. The simple entrance, in each case is visually emphasised to form a porch. The elegantly detailed balusters and wooden fretwork enhance it.

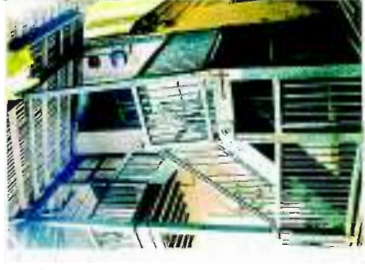
#### THE EXTERNAL STAIRCASE

The presence of an external staircase, leading from the front porch to the upper floors is another common feature among the houses in Khotachiwadi.

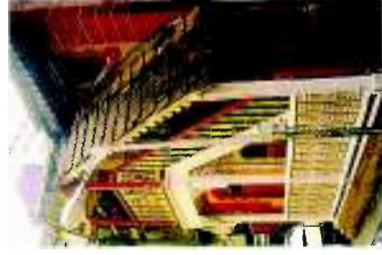
#### THE ELEGANT DETAILING

The structures have colourful external facades, highlighted by the elegant detailing in mouldings, in both cast iron and woodwork, wooden fretwork balustrades, carved fascia boards and cornice details.

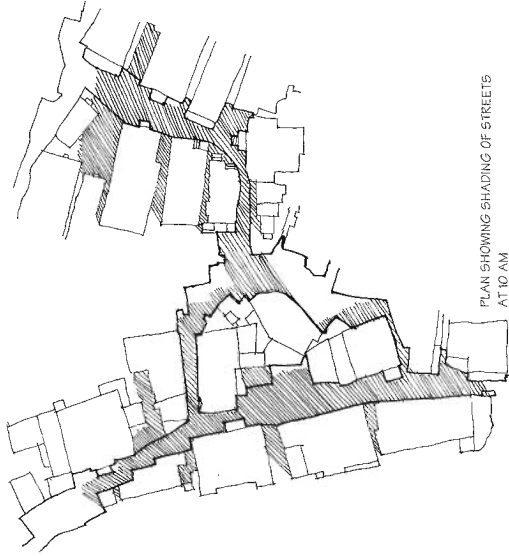
The houses are positioned in such a way so that the streets remain shaded through most of the day.

PLAN SHOWING SHADING OF STREETS AT 10 AM

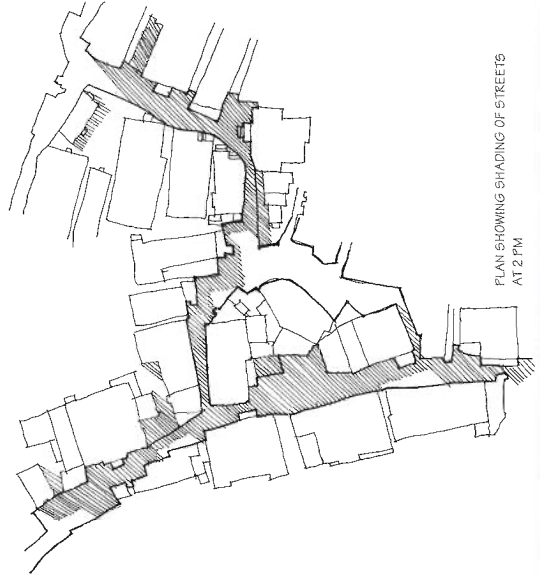
PLAN SHOWING SHADING OF STREETS AT 2 PM

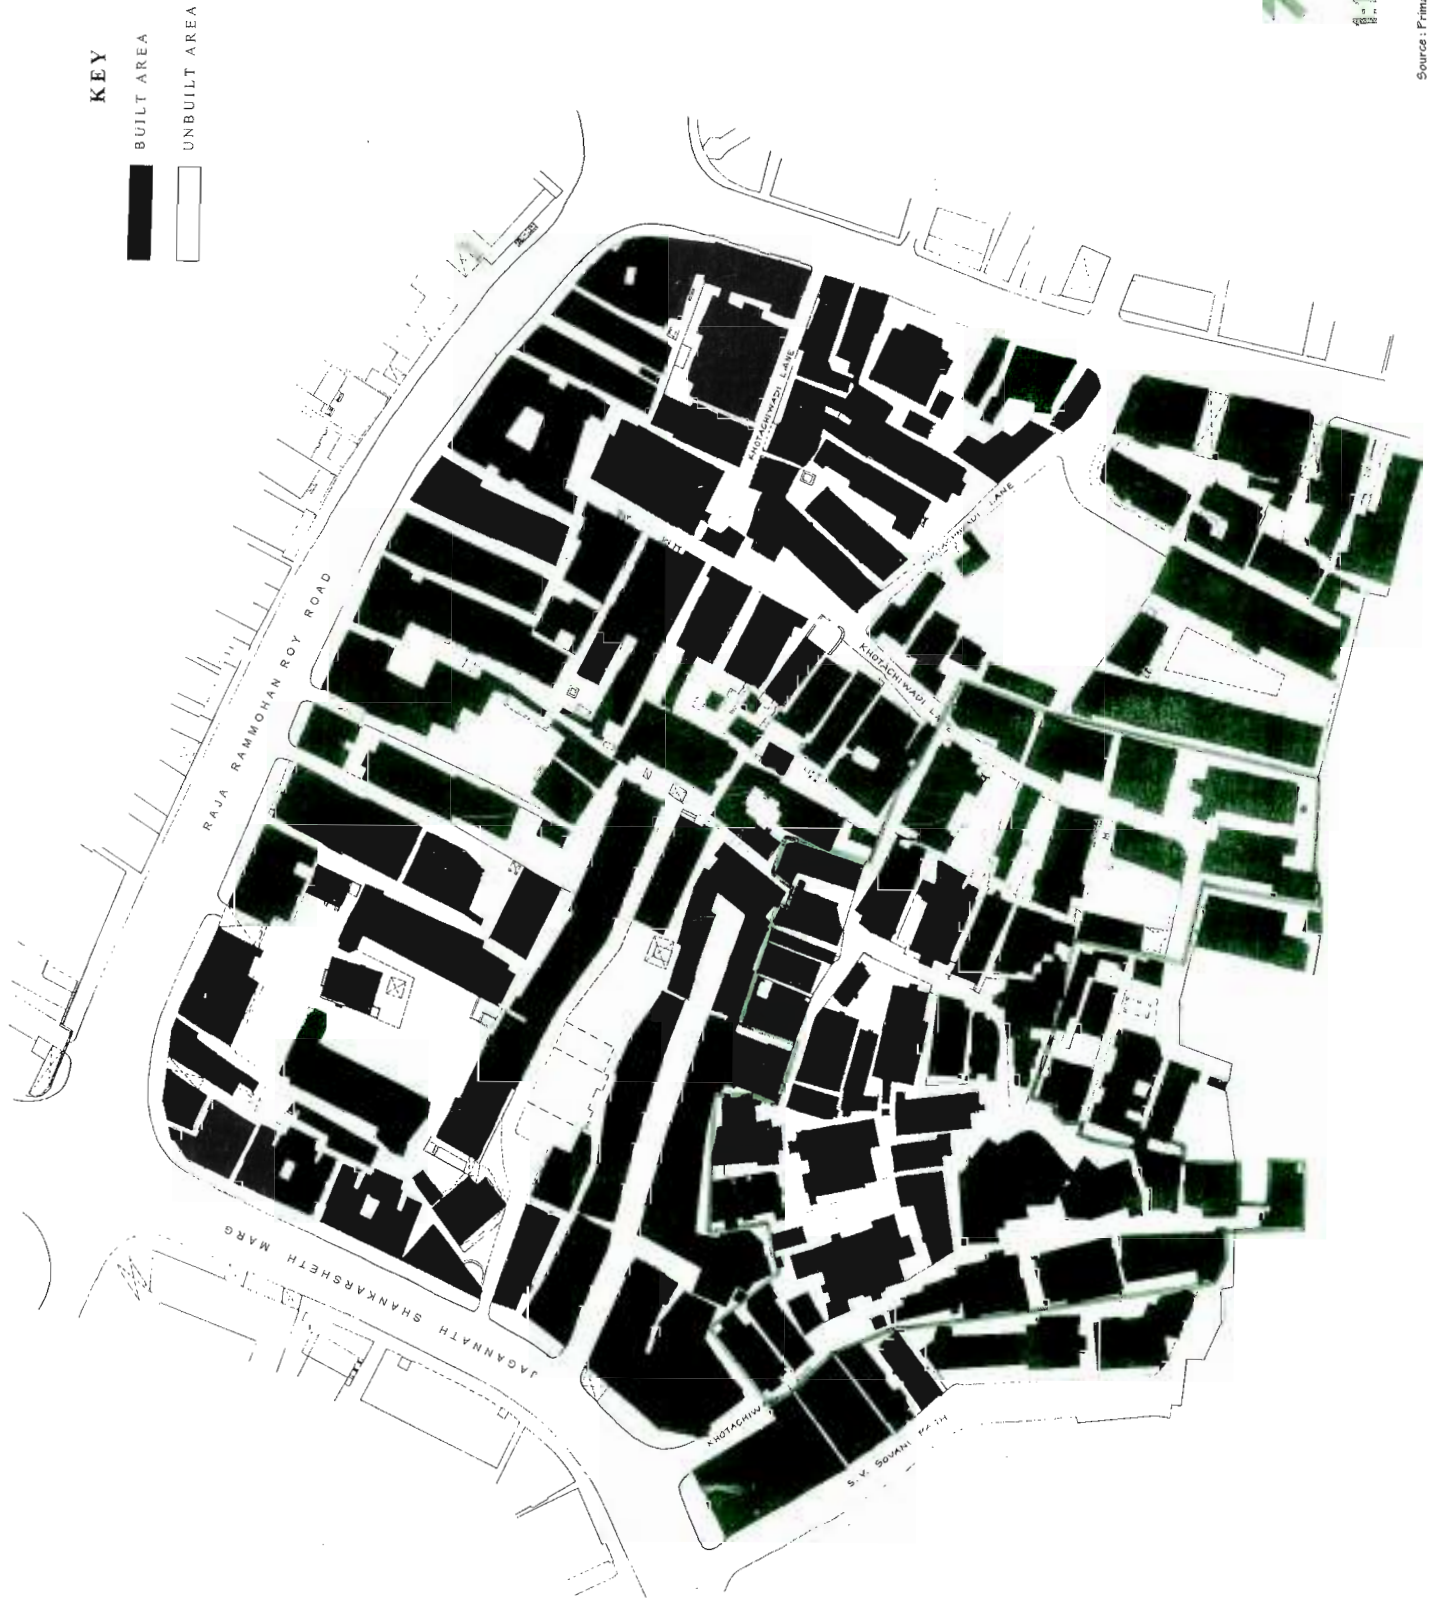
The map shows the heights of the buildings within the demarcated Khotachiwadi area and makes apparent the general topography of the area.

In and around the core area, the structures range from ground storeyed, ground level to ground and two upper storeyed buildings.

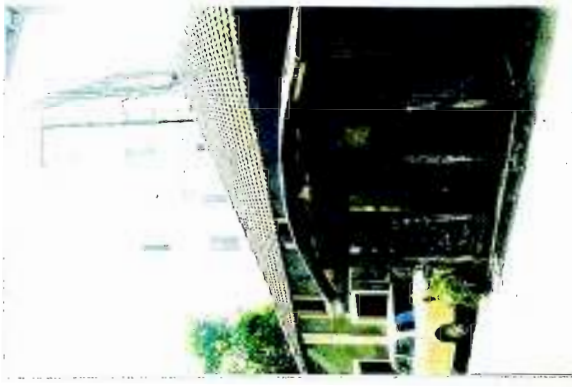
This homogeneous pattern of low rise, medium density buildings in the core precinct is interrupted by a few incongruous aberrations, which are the result of the blanket bye-laws that do not impose height restrictions for any new developments within the precinct. The building of the Girgaum Palace Lodge and the Sai Niwas are the obvious aberrations.

PORCH HOUSE WITH  
THE MULTI-STORIED  
GIRGAUM PALACE IN  
THE BACKGROUND,  
AN EYESORE AS  
COMPARED TO THE  
LOW-LYING  
CHARACTER OF THE  
CORE

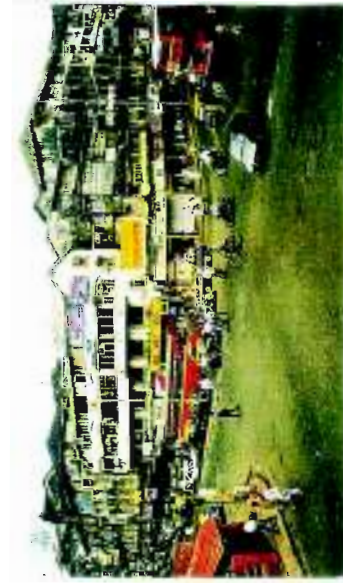
INTERSECTION OF RAJA RAMMOHAN ROY ROAD AND J.S. MARG

- The primary roads are the main arterial roads of J.S. Marg, Raja Ram Mohan Roy Marg and V.P. Road. These are the hub of the business and commercial activities, on which there is heavy vehicular traffic.

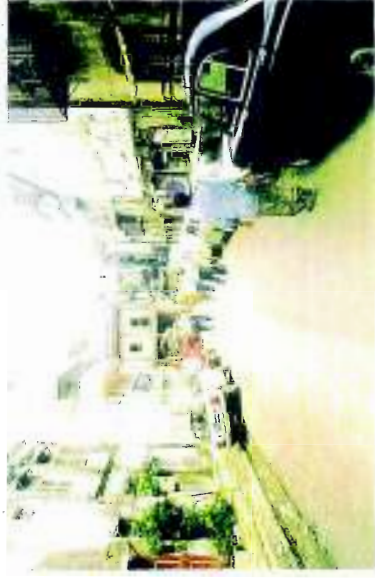
S.V. SOVANI PATH

- The Secondary streets are the 6-8 m wide internal access roads and are mainly residential streets though they also have a few shops. E.g. S.V. Sovani path. They are wide enough to allow for two-way traffic and off-street parking.

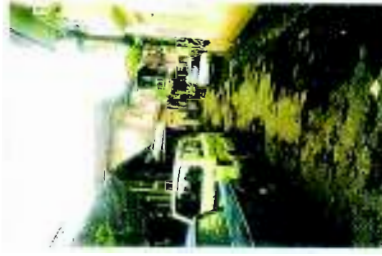
KHOTACHIWADI LANE

- The tertiary streets range between 3-6 m depending upon the distance between the structures on either side. E.g. Khotachiwadi Lane has a varying width being alternately one-laned and two-laned.

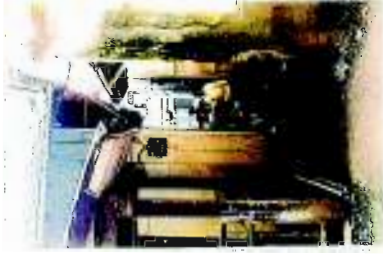
THOROUGHFARE BETWEEN CRASSTO HOUSE AND 47E

- The Quaternary streets are less than 2 m wide and often have dead ends. These narrow criss-crossing bye-lanes, allow for only two-wheeler and pedestrian access.

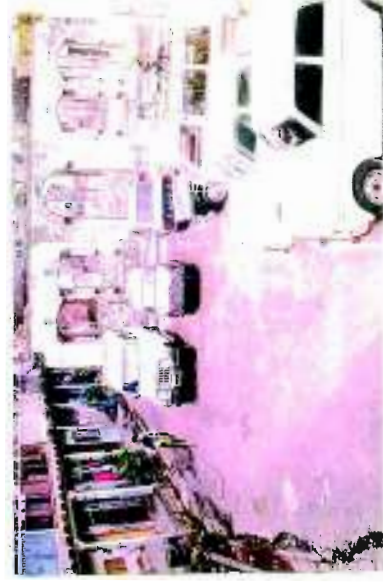
THE CENTRAL OPEN SPACE WITHIN A CHAWL USED AS A PARKING LOT (Kudal Deshkar Brahman Nivase)

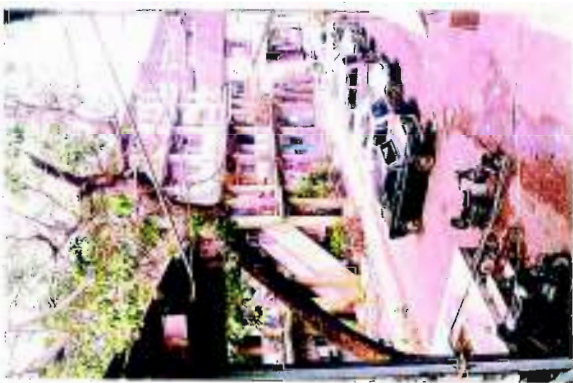
OPEN SPACE WITHIN THE AMRUTWADI CHAWL

- The only open space of any consequence is that formed between buildings i.e. courtyard-like space within the Amrutwadi, Kshatriya Gnyati Niwas and Khanderao chawls. Unfortunately these spaces are used for parking, due to the lack of any other, in close proximity

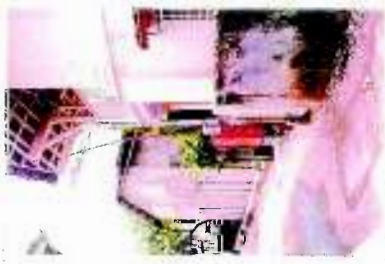
These are insufficient in number and too far apart to be completely effective.

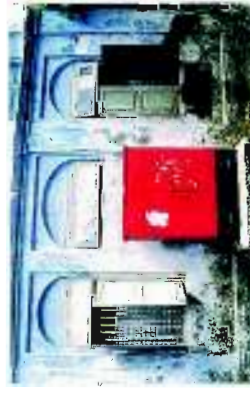
The incongruous placement of some meter boxes mars the façade of the structures, in front of which they are placed.

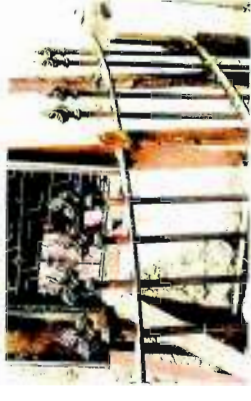
Some old surviving examples of cast iron fencing are also visible.

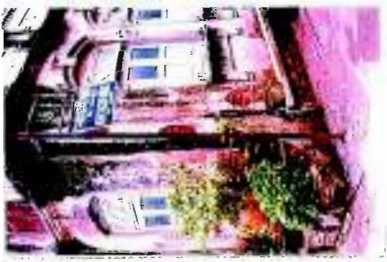
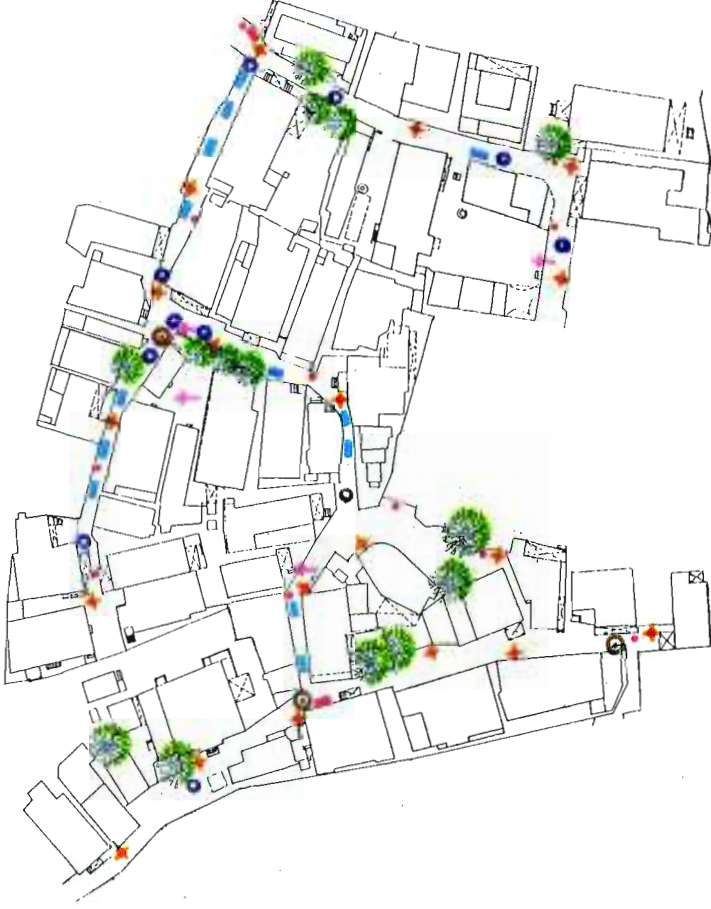
| | STREET SIGN |

The street signs that are present at the head of the Khotachiwadi Lane, on the various entrances to the Precinct, are not visually prominent and tend to get obscured amidst the clutter of the other shop signs and advertisement hoardings.

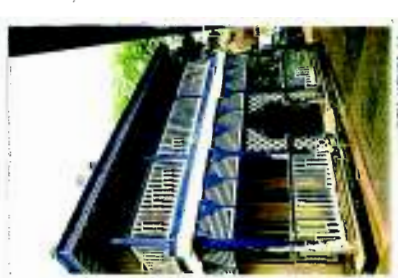
FERRERA HOUSE (47 G)

These structures display a strong **Portuguese influence** on the vernacular style, which emphasized the traditional architectural elements and ornamentation such as fascia boards, balustrades, porches etc. Many more similar vernacular dwellings were built during the nineteenth century in the Khotachiwadi area.

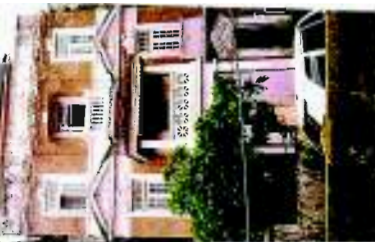
KRISHNA BHUVAN (24)

In addition to this there is a sprinkling of old Colonial-style buildings resembling **Renaissance villas** that have a distinctly different character.

The building of the Maharashtra Lingayat Education Society, abutting the main Khotachiwadi Lane and the Krishna Bhuvan (on the extended Khotachiwadi Lane, opening up on V.P. ROAD) are two such examples.

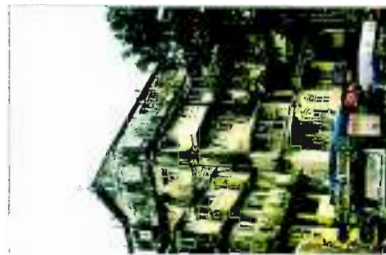
MIRA KRUPA (163)

The buildings along J.S. Marg are mostly variations of the chawl-type structures and possess features that are typical of the Girgaum area. A few buildings located further south on the same road, namely Meera Krupa and Narayan Niwas, are again distinctly different; they are of a composite style – four/five storied, decorative brackets, ornamental fenestrations, Corinthian columns flanking the entrance and a tiled sloping roof with elegant cast-iron ridge detailing.

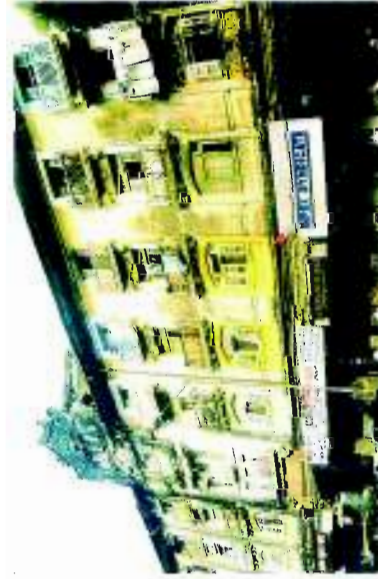
STREETFRONT ALONG RAJARAMMOHAN ROY ROAD

The streetfront along Raja Rammohan Roy Road and V.P.Road is uniform in terms of height and scale as well as architectural style and is characterized by a **continuous ground level shopline**. The buildings are three-five storied, chawl or apartment-type structures punctured with large defining entranceways.

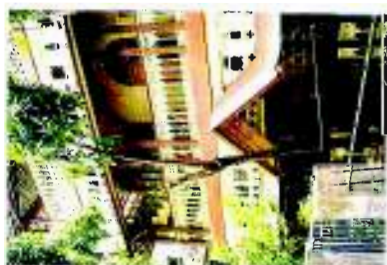
GROUND FLOOR PLAN

**PRESENT CONDITION :**  
 GENERAL - Good  
 LEVEL OF MAINTENANCE -- Well-maintained and original features retained. Painted and water proofing done periodically.  
 THREATS - None.  
 INSENSITIVE ADDITIONS -- None

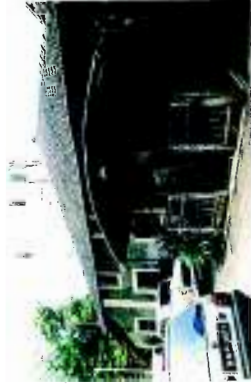
FRONT ELEVATION

**PRESENT CONDITION :**  
 GENERAL - Good  
 LEVEL OF MAINTENANCE - Well-maintained and is one of the very few houses with no alterations.  
 THREATS - Since front porch is lower than the road level, it is prone to water accumulation.  
 INSENSITIVE ADDITIONS - None

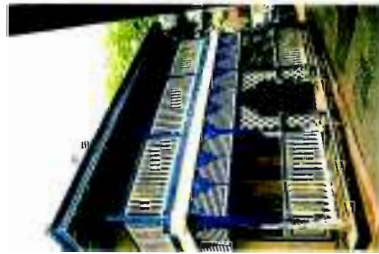
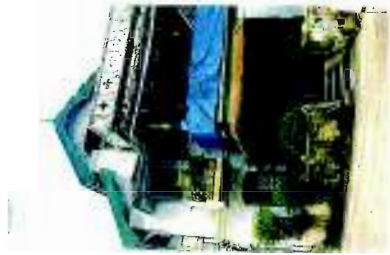
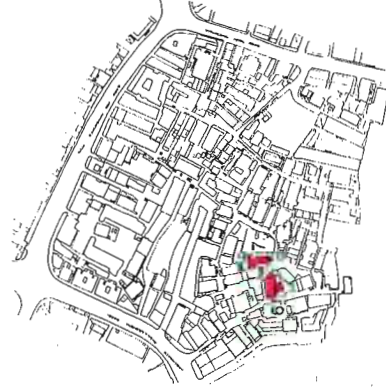
FRONT ELEVATION

**PRESENT CONDITION :**  
**GENERAL -** Good  
**LEVEL OF MAINTENANCE –** Periodically painted and well maintained.  
**THREATS -** Sagging terrace floor and roof is propped.  
**INSENSITIVE ADDITIONS –** None

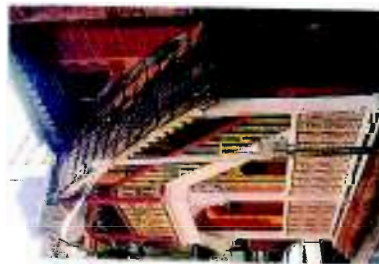
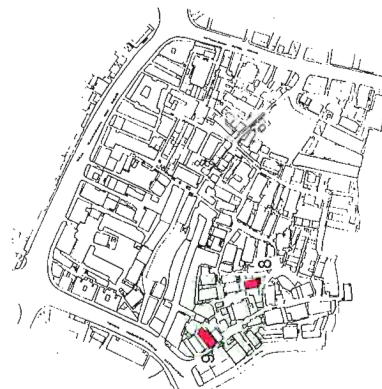
**9**  
**Gomes House / 66**

**NAME OF OWNER :**  
**TENANCY / OCCUPANCY :**  
**CESSED CATEGORY :** Not cessed  
**ARCHITECTURAL STYLE:**  
**TYPE OF CONSTRUCTION –** Load bearing structure with timber framed veranda and porch.  
**BUILDING TYPOLOGY –** Bungalow type  
**SPECIAL FEATURES MERITING**  
**CONSERVATION :** Projecting balcony, eaves, fascia and external staircase.  
**PRESENT HERITAGE GRADING :** Not graded.  
**PROPOSED HERITAGE GRADING :** Grade III

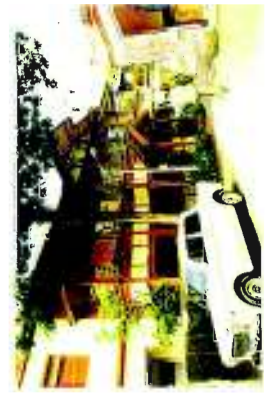
Fernandes House / 56

**NAME OF OWNER :** Trust: St. Stevens Church, Cumbala Hill.  
**TENANCY / OCCUPANCY :** Tenanted  
**CEASED CATEGORY :** A  
**ARCHITECTURAL STYLE:**  
TYPE OF CONSTRUCTION – Load bearing structure with timber framed veranda and porch.  
BUILDING TYPOLOGY – Bungalow type  
**SPECIAL FEATURES MERITING CONSERVATION :** Entire  
**PRESENT HERITAGE GRADING :** Not graded  
**PROPOSED HERITAGE GRADING :** Grade III

**PRESENT CONDITION :**  
GENERAL – Good  
LEVEL OF MAINTENANCE – Periodically painted and well maintained.  
THREATS -None  
INSENSITIVE ADDITIONS – Replacement of a few timber balustrades with brick infill, A.C sheet covering on the external staircase and high compound wall on one side mar the character of the street elevation.

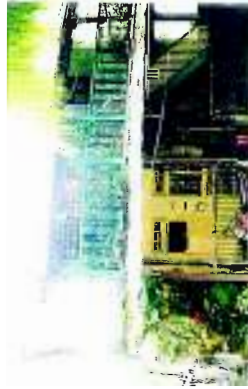
**NAME OF OWNER :**  
**TENANCY / OCCUPANCY :** Tenanted  
**CEASED CATEGORY :** A  
**ARCHITECTURAL STYLE :**  
**TYPE OF CONSTRUCTION :** Load bearing structure with timber porch and veranda.  
**BUILDING TYPOLOGY :** Bungalow type  
**SPECIAL FEATURES MERITING CONSERVATION :** cast iron balustrade  
**PRESENT HERITAGE GRADING :** Not graded  
**PROPOSED HERITAGE GRADING :** Grade III

**PRESENT CONDITION :**  
**GENERAL -** Good  
**LEVEL OF MAINTENANCE -** Although the main structure is in good condition, the timber veranda on the front facade is propped up and is in need of immediate repairs.  
**THREATS -** Water seepage and ficus growth.  
**INSENSITIVE ADDITIONS -** Tin sheet chajja on the front facade mars the character of the streetscape.

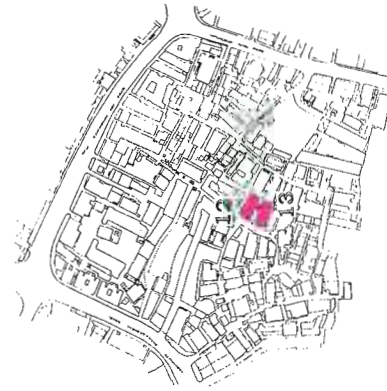
FRONT ELEVATION

**PRESENT CONDITION :**  
**GENERAL -** Good  
**LEVEL OF MAINTENANCE -** Periodically painted and repairs undertaken regularly.  
**THREATS -** None  
**INSENSITIVE ADDITIONS -** Balustrade of the first floor replaced by acrylic sheet and tin sheet roofing used for external staircase.

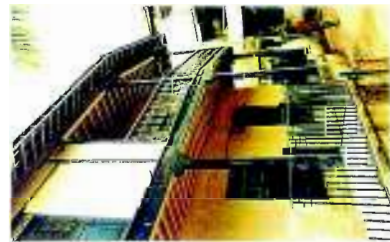
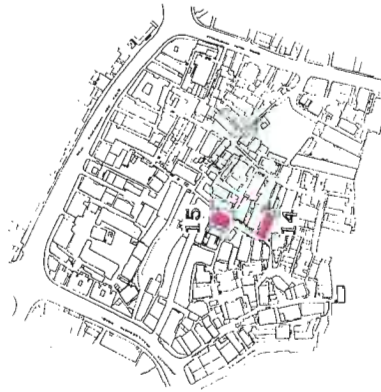
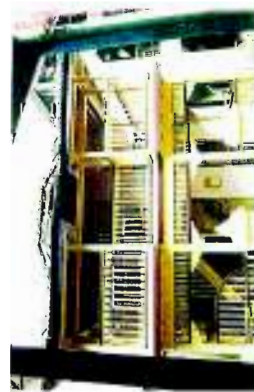
GROUND FLOOR PLAN

**NAME OF OWNER :** Ferandez  
**TENANCY / OCCUPANCY :** Self-owned  
**CEASED CATEGORY :** A  
**ARCHITECTURAL STYLE:**  
**TYPE OF CONSTRUCTION –** Load bearing structure.  
**BUILDING TYPOLOGY –** Bungalow type  
**SPECIAL FEATURES MERITING CONSERVATION :** wrought iron balusters  
**PRESENT HERITAGE GRADING :** Not graded  
**PROPOSED HERITAGE GRADING :** Grade III

**PRESENT CONDITION :**  
**GENERAL -** Good  
**LEVEL OF MAINTENANCE –** Periodically painted and well maintained.  
**THREATS –** Rising damp from the floor.  
**INSENSITIVE ADDITIONS –** Railing on ground floor replaced.

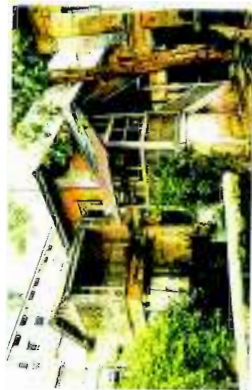
**GENERAL - Fair**  
**LEVEL OF MAINTENANCE** – Although, main structure is in fairly good condition, the entrance porch and the projecting balcony above it have sagged and are in need of immediate repairs.  
**THREATS** - Water seepage through cracks in walls and from the ground due to capillary action.  
**INSENSITIVE ADDITIONS** – None

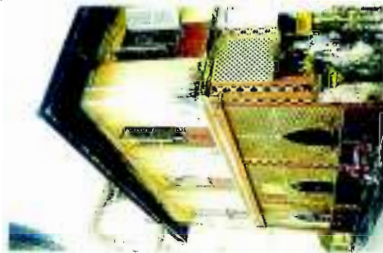
Perreira House / 29 B

**NAME OF OWNER :**  
**TENANCY / OCCUPANCY :** Tenanted  
**CEASED CATEGORY :** A  
**ARCHITECTURAL STYLE:**  
**TYPE OF CONSTRUCTION** – Load bearing structure with timber framed veranda and porch.  
**BUILDING TYPOLOGY** – Bungalow type  
**SPECIAL FEATURES MERITING**  
**CONSERVATION :** Jali-work covering the entire front façade.  
**PRESENT HERITAGE GRADING :** Grade III  
**PROPOSED HERITAGE GRADING :** Grade III

**PRESENT CONDITION :**

**GENERAL - Good**  
**LEVEL OF MAINTENANCE** – Well maintained and jali-work on the front façade is retained in its original state.  
**THREATS** – Faces a threat of being reconstructed as land lord in insensitive to its heritage value.  
**INSENSITIVE ADDITIONS** –

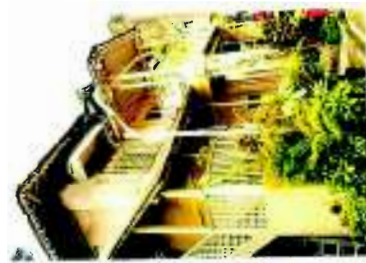
NAME OF OWNER : R. Naik  
TENANCY / OCCUPANCY : Self-owned  
CEASED CATEGORY : Not ceased  
ARCHITECTURAL STYLE:  
TYPE OF CONSTRUCTION – Load bearing structure.  
BUILDING TYPOLOGY – Bungalow type  
SPECIAL FEATURES MERITING  
CONSERVATION : Front porch with brackets, fascia.  
PRESENT HERITAGE GRADING : Grade III  
PROPOSED HERITAGE GRADING : Grade III

PRESENT CONDITION :  
GENERAL - Good  
LEVEL OF MAINTENANCE – Periodically painted and well maintained.  
THREATS - None  
INSENSITIVE ADDITIONS – Tin sheet roofing to external front staircase as also to windows.

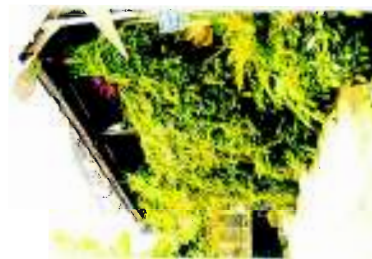
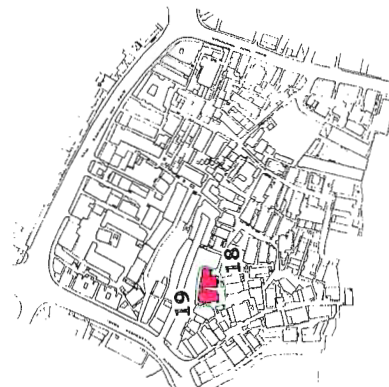
Bldg. No. 30 D

NAME OF OWNER : B. Pereira  
TENANCY / OCCUPANCY : Tenanted  
CEASED CATEGORY : A  
ARCHITECTURAL STYLE:  
TYPE OF CONSTRUCTION – Load bearing structure  
BUILDING TYPOLOGY – Bungalow type  
SPECIAL FEATURES MERITING  
CONSERVATION : Entire  
PRESENT HERITAGE GRADING : Not graded  
PROPOSED HERITAGE GRADING : Grade III

PRESENT CONDITION :  
GENERAL – Good. Front façade completely covered with creepers and hence difficult to ascertain the condition of members.  
LEVEL OF MAINTENANCE – Although the main structure is in good condition, the roof and wrought iron balusters on the front façade are in need of immediate repairs.  
THREATS – Roof leakage and rising damp from the floor.  
INSENSITIVE ADDITIONS – None

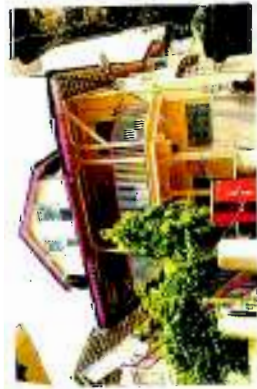
**Baptista House /27**

**NAME OF OWNER :** Baptista  
**TENANCY / OCCUPANCY :** Self-owned  
**CESSED CATEGORY :** Not cessed.  
**ARCHITECTURAL STYLE:**  
 TYPE OF CONSTRUCTION – Load bearing structure with timber veranda and porch.  
 BUILDING TYPOLOGY – Bungalow type.  
**SPECIAL FEATURES MERITING**  
**CONSERVATION :** Entire  
**PRESENT HERITAGE GRADING :** Not graded  
**PROPOSED HERITAGE GRADING :** Grade III

**PRESENT CONDITION :**  
 GENERAL - Good  
 LEVEL OF MAINTENANCE – Periodically painted and well maintained.  
 THREATS - None  
 INSENSITIVE ADDITIONS – Ground floor windows altered. Side open space encroached. Timber staircase replaced with R.C.C. Box grills on the front façade.

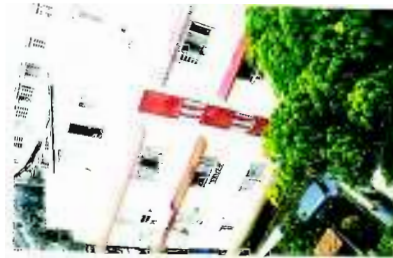
FRONT ELEVATION

**PRESENT CONDITION :**  
 GENERAL - Fair  
 LEVEL OF MAINTENANCE – Badly maintained, not painted and cracks can be detected on external wall.  
 THREATS - Poor maintenance.  
 INSENSITIVE ADDITIONS – Original timber staircase altered to steel stringer and concrete treads and risers.

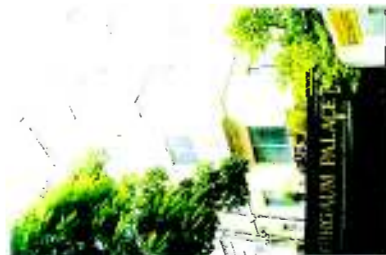
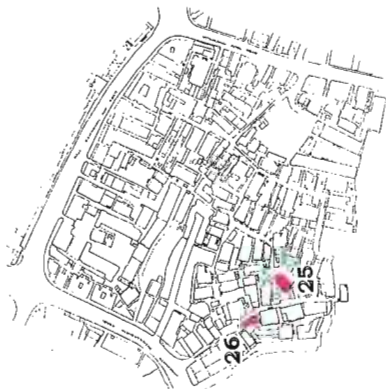
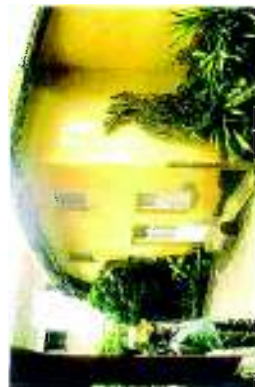
FRONT ELEVATION

**GENERAL -** Fair  
**LEVEL OF MAINTENANCE -** Painted externally and internally well maintained preserving the character of Goan-Portuguese houses.  
**THREATS -** None  
**INSENSITIVE ADDITIONS -** Tin sheet roofing on part portion of front façade mars the character of the streetscape.

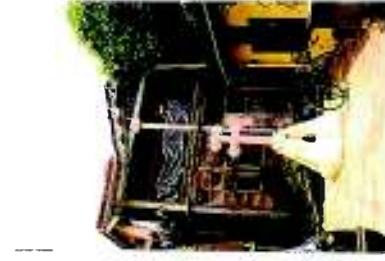
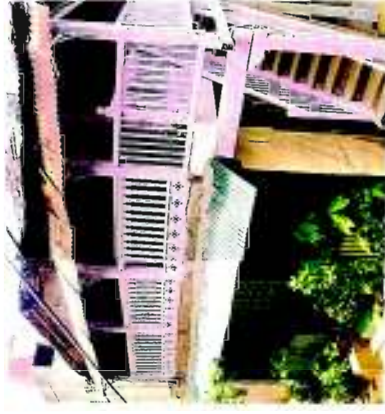
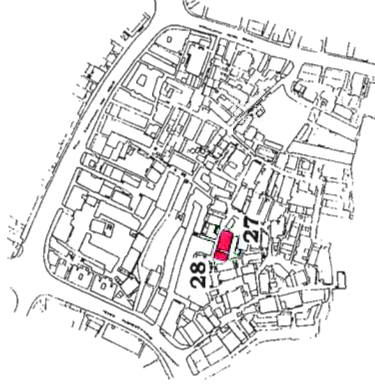
28

GENERAL - Poor  
LEVEL OF MAINTENANCE – Not maintained externally, although internally in good condition.  
INSENSITIVE ADDITIONS – Structural changes carried out, such as, replacement of timber joists and posts with steel members and stanchions. First floor balcony reconstructed completely. Ground floor veranda bricked-in.

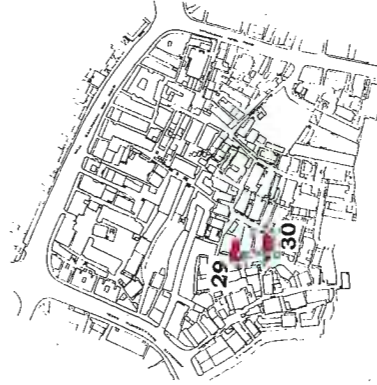
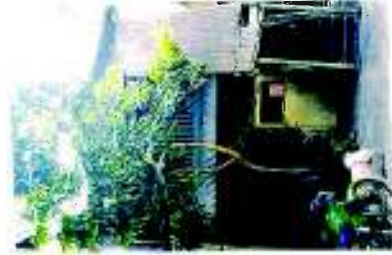
**NAME OF OWNER :** M. Subaya  
**TENANCY / OCCUPANCY :** Tenanted  
**CESSED CATEGORY :** A  
**ARCHITECTURAL STYLE:**  
 TYPE OF CONSTRUCTION – Load bearing structure.  
 BUILDING TYPOLOGY – Bungalow type  
**SPECIAL FEATURES MERITING**  
**CONSERVATION :** None  
**PRESENT HERITAGE GRADING :** Not graded  
**PROPOSED HERITAGE GRADING :** None

**PRESENT CONDITION :**  
 GENERAL - Fair  
 LEVEL OF MAINTENANCE – Repairs carried out regularly.  
 THREATS – Water seepage and figus growth.  
 INSENSITIVE ADDITIONS – Tin sheet roofing to the external staircase.

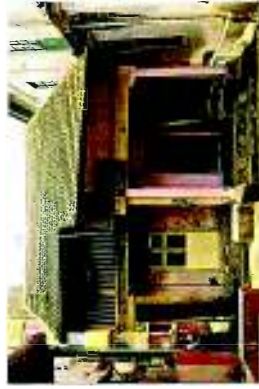
**NAME OF OWNER :** Vasant Pathare  
**TENANCY / OCCUPANCY :** Occupied by landlord and tenant.  
**CESSED CATEGORY :** Not cessed  
**ARCHITECTURAL STYLE:**  
 TYPE OF CONSTRUCTION – Timber framed structure with sandstone walls.  
 BUILDING TYPOLOGY – Bungalow type  
**SPECIAL FEATURES MERITING**  
**CONSERVATION :** Low-lying roof profile forms an integral part of the streetscape.  
**PRESENT HERITAGE GRADING :** Not graded.  
**PROPOSED HERITAGE GRADING :** None

**PRESENT CONDITION :**  
 GENERAL - Fair  
 LEVEL OF MAINTENANCE – Not well maintained and the exterior needs upkeep with respect to the surface finishing of the front facade.  
 THREATS – Roof above the staircase is sagging and cracks can be detected on the exterior surface.  
 INSENSITIVE ADDITIONS – T.V. antenna, sign board.

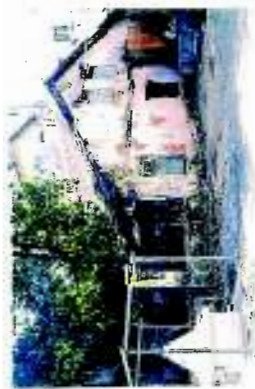
Palkar cottage / 29 E

**NAME OF OWNER :**  
**TENANCY / OCCUPANCY :** Tenanted and under ownership of a Trust / Institution.  
**CESSED CATEGORY :** A  
**ARCHITECTURAL STYLE:**  
 TYPE OF CONSTRUCTION – Load bearing structure.  
 BUILDING TYPOLOGY – Bungalow type.  
**SPECIAL FEATURES MERITING CONSERVATION :** None  
**PRESENT HERITAGE GRADING :** Not graded  
**PROPOSED HERITAGE GRADING :** None

**PRESENT CONDITION :**  
 GENERAL - Poor  
 LEVEL OF MAINTENANCE - Although adequate repair work is carried out periodically it is substandard and not carried out properly.  
 THREATS - Water seepage from the roof and presence of figs growth.  
 INSENSITIVE ADDITIONS -

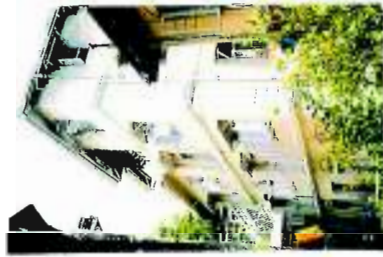
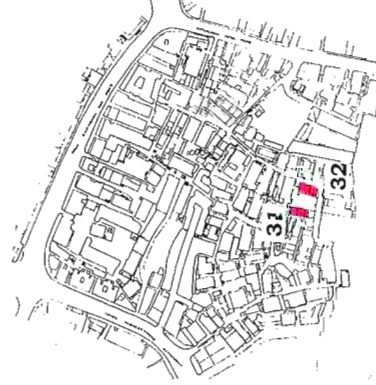
Chaudhary House / 29 C

**NAME OF OWNER :** N. L. Chaudhary  
**TENANCY / OCCUPANCY :** Tenanted and occupied by landlord.  
**CESSED CATEGORY :** A  
**ARCHITECTURAL STYLE:**  
 TYPE OF CONSTRUCTION – Load bearing brick structure with timber flooring.  
 BUILDING TYPOLOGY – Apartment type.  
**SPECIAL FEATURES MERITING CONSERVATION :** Internal staircase elements.  
**PRESENT HERITAGE GRADING :** Not graded  
**PROPOSED HERITAGE GRADING :** None

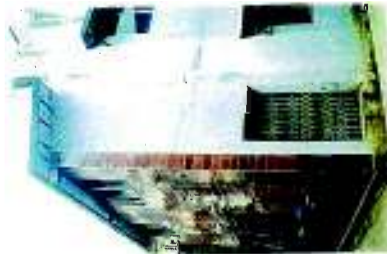
**NAME OF OWNER :**  
**TENANCY / OCCUPANCY :**  
**CEASED CATEGORY :** Not cessd.  
**ARCHITECTURAL STYLE:**  
**TYPE OF CONSTRUCTION - R.C.C**  
**BUILDING TYPOLOGY - Non-descript**  
**SPECIAL FEATURES MERITING**  
**CONSERVATION :** None  
**PRESENT HERITAGE GRADING :** Not graded  
**PROPOSED HERITAGE GRADING :** None

**PRESENT CONDITION :**  
**GENERAL - Fair**  
**LEVEL OF MAINTENANCE -**  
**THREATS -**  
**INSENSITIVE ADDITIONS -** Front façade completely clad with granite, which is not in harmony with the street elevation.

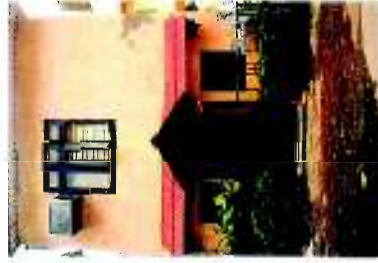
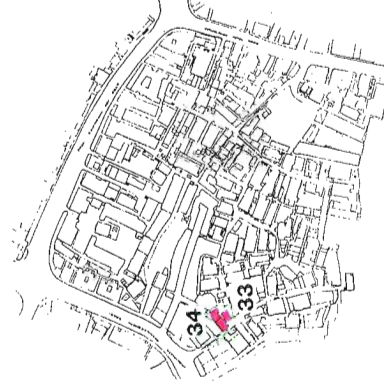
Bldg. No. 62

**NAME OF OWNER :** Gandhi  
**TENANCY / OCCUPANCY :**  
**CEASED CATEGORY :** A  
**ARCHITECTURAL STYLE:**  
**TYPE OF CONSTRUCTION -** Load bearing structure.  
**BUILDING TYPOLOGY -** Bungalow type  
**SPECIAL FEATURES MERITING**  
**CONSERVATION :** Windows with jalis, brackets eaves and fascia.  
**PRESENT HERITAGE GRADING :** Not graded.  
**PROPOSED HERITAGE GRADING :** None

**PRESENT CONDITION :**  
**GENERAL - Good**  
**LEVEL OF MAINTENANCE -** Periodically painted and well maintained.  
**THREATS - None**  
**INSENSITIVE ADDITIONS - None**

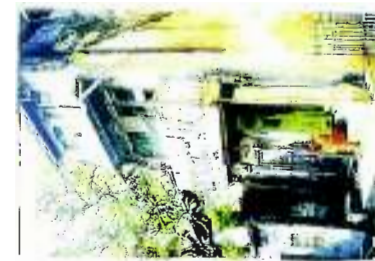
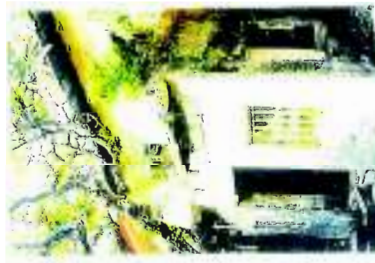
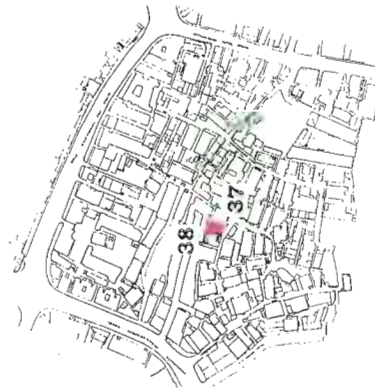
39

GENERAL - Poor  
LEVEL OF MAINTENANCE – Not well maintained and very little repair work carried out.  
THREATS – Walls damp due to rising damp from the floor and ficus growth.  
INSENSITIVE ADDITIONS – Encroachment of front open space.

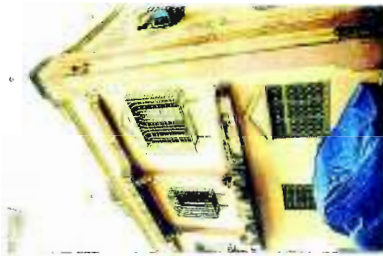
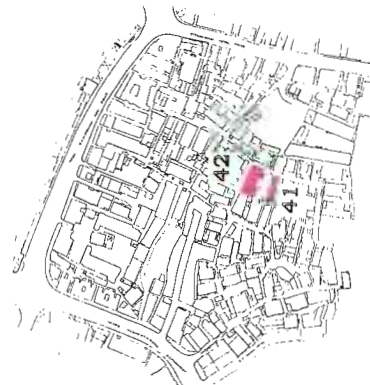
Nidhi / 29

**NAME OF OWNER :**  
**TENANCY / OCCUPANCY :** Self-owned  
**ASSESSED CATEGORY :** A  
**ARCHITECTURAL STYLE:**  
**TYPE OF CONSTRUCTION -** R.C.C (Initially a load  
 bearing structure but completely re-built in 1992)  
 Building Typology - Bungalow type  
**SPECIAL FEATURES MERITING**  
**CONSERVATION :** None  
**PRESENT HERITAGE GRADING :** Grade III  
**PROPOSED HERITAGE GRADING :** None

**PRESENT CONDITION :**  
**GENERAL -** Good. New construction and hence  
 relatively in good condition.  
**LEVEL OF MAINTENANCE -** Well maintained and  
 periodically painted.  
**THREATS -** None  
**INSENSITIVE ADDITIONS -** Existing structure has been  
 completely reconstructed only keeping the foot-print,  
 the outline of the plinth, the same and is devoid of the  
 original features of the previous structure, and does not  
 relate to the character of Khotahiwadi.

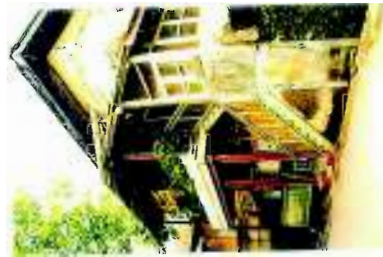
Bldg. No. 27 D

NAME OF OWNER :  
TENANCY / OCCUPANCY : Tenanted and under ownership of the church.  
CEASED CATEGORY : A  
ARCHITECTURAL STYLE:  
TYPE OF CONSTRUCTION – Load bearing structure with timber veranda and porch.  
BUILDING TYPOLOGY – Bungalow type  
SPECIAL FEATURES MERITING  
CONSERVATION : Low-lying roof profile forms an integral part of the streetscape.  
PRESENT HERITAGE GRADING : Not graded  
PROPOSED HERITAGE GRADING : None

PRESENT CONDITION :  
GENERAL - Good  
LEVEL OF MAINTENANCE – Periodically painted and well maintained.  
THREATS - None  
INSENSITIVE ADDITIONS – Replacement of timber posts with steel stanchions and wooden balusters with m.s rods.

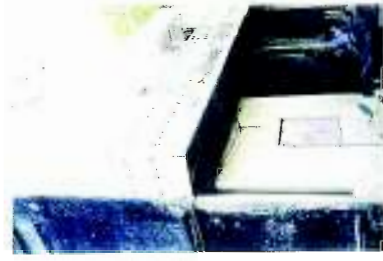
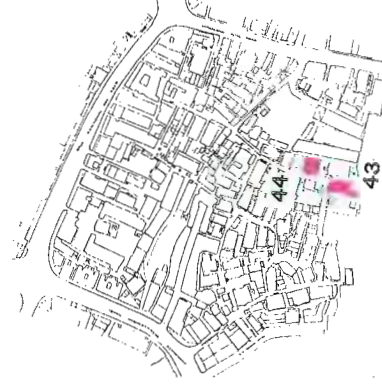
Heroy House / 27 B

NAME OF OWNER :  
TENANCY / OCCUPANCY : Tenanted and occupied by landlord.  
CEASED CATEGORY : Not ceased.  
ARCHITECTURAL STYLE:  
TYPE OF CONSTRUCTION – Load bearing structure  
BUILDING TYPOLOGY – Apartment type.  
SPECIAL FEATURES MERITING  
CONSERVATION : None  
PRESENT HERITAGE GRADING : Not graded.  
PROPOSED HERITAGE GRADING : None

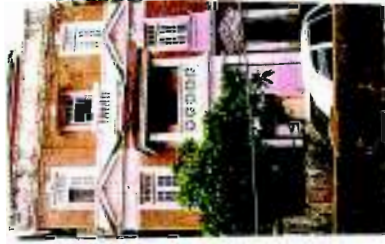
GROUND FLOOR PLAN

**GENERAL -** Good  
**LEVEL OF MAINTENANCE –** Well maintained, periodically painted and repairs carried out regularly.  
**THREATS –** None  
**INSENSITIVE ADDITIONS –** Additional floor (5<sup>th</sup>) is devoid of any features and hence is not compatible with the original structure.
