PREPARATION OF ACTION PLAN FOR CONSERVATION OF HERITAGE- PRECINCT IN MMR

Task V for Agashi Precinct, Vasai-Virar Sub Region. Stage -1

PROJECT CONSULTANTS
K.UNWALLA
ARCHITECTS

FOR
M.M.R. HERITAGE
CONSERVATION
SOCIETY

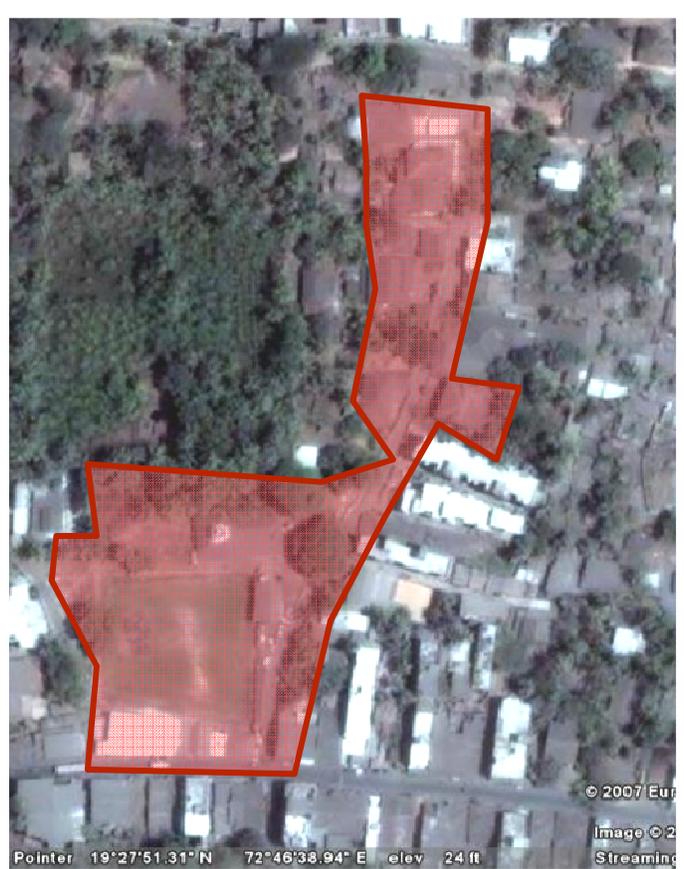
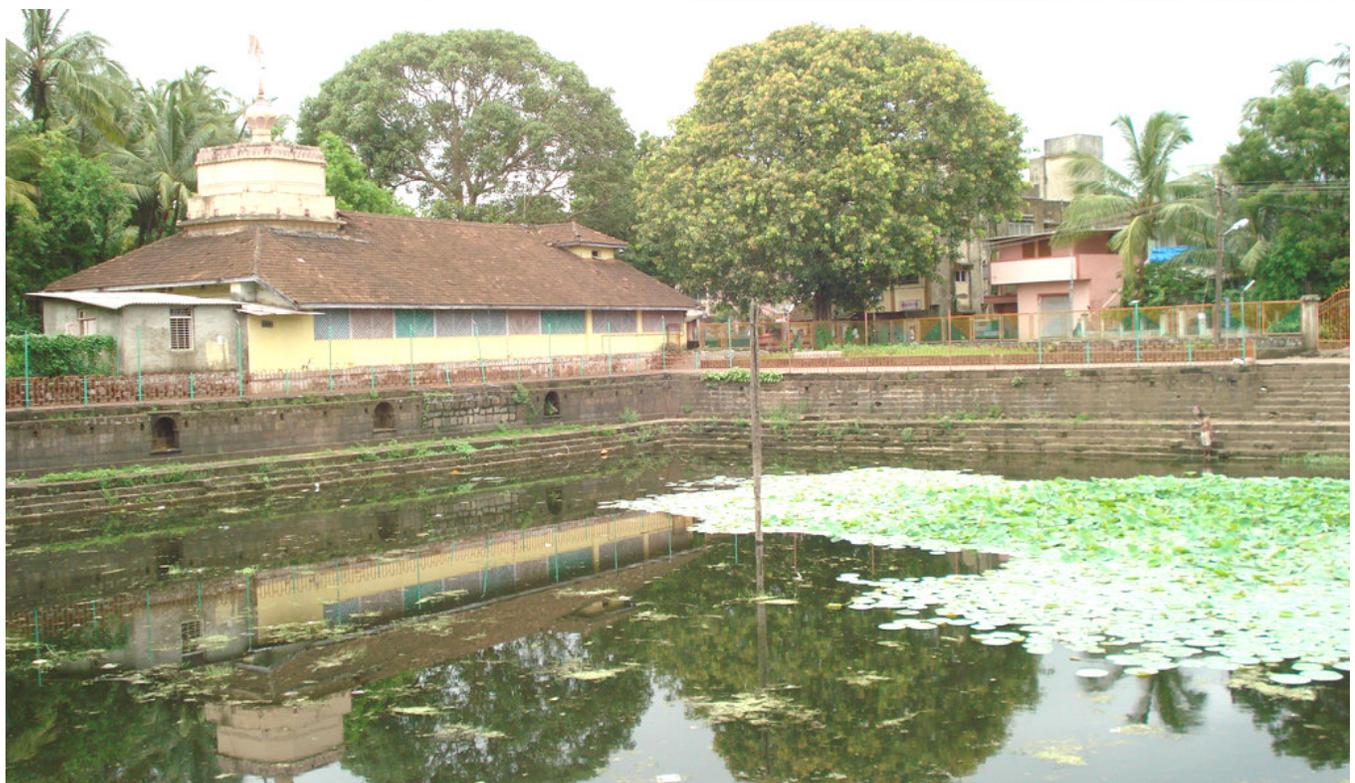
Talav and the fabric comprising of the temple and residential buildings around the talav

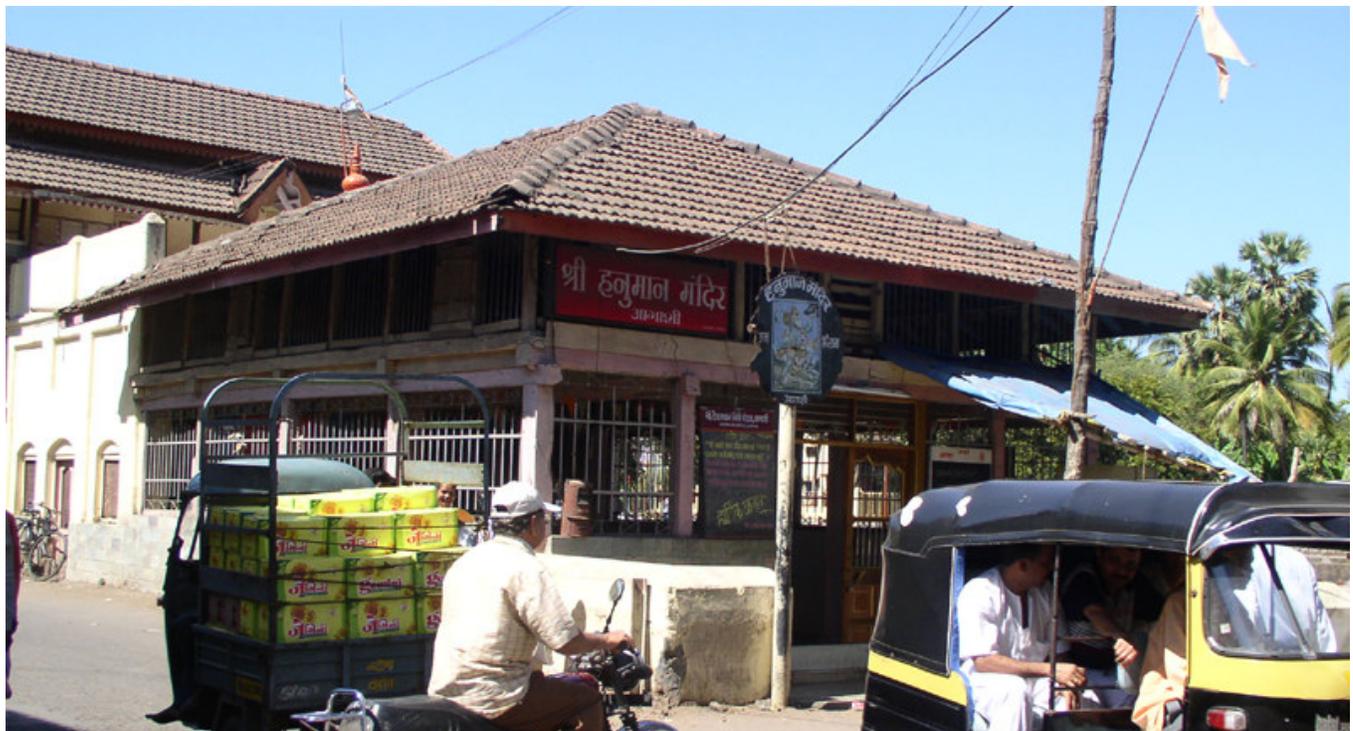
Pitched roof hovering above the building form s distinctive architectural element

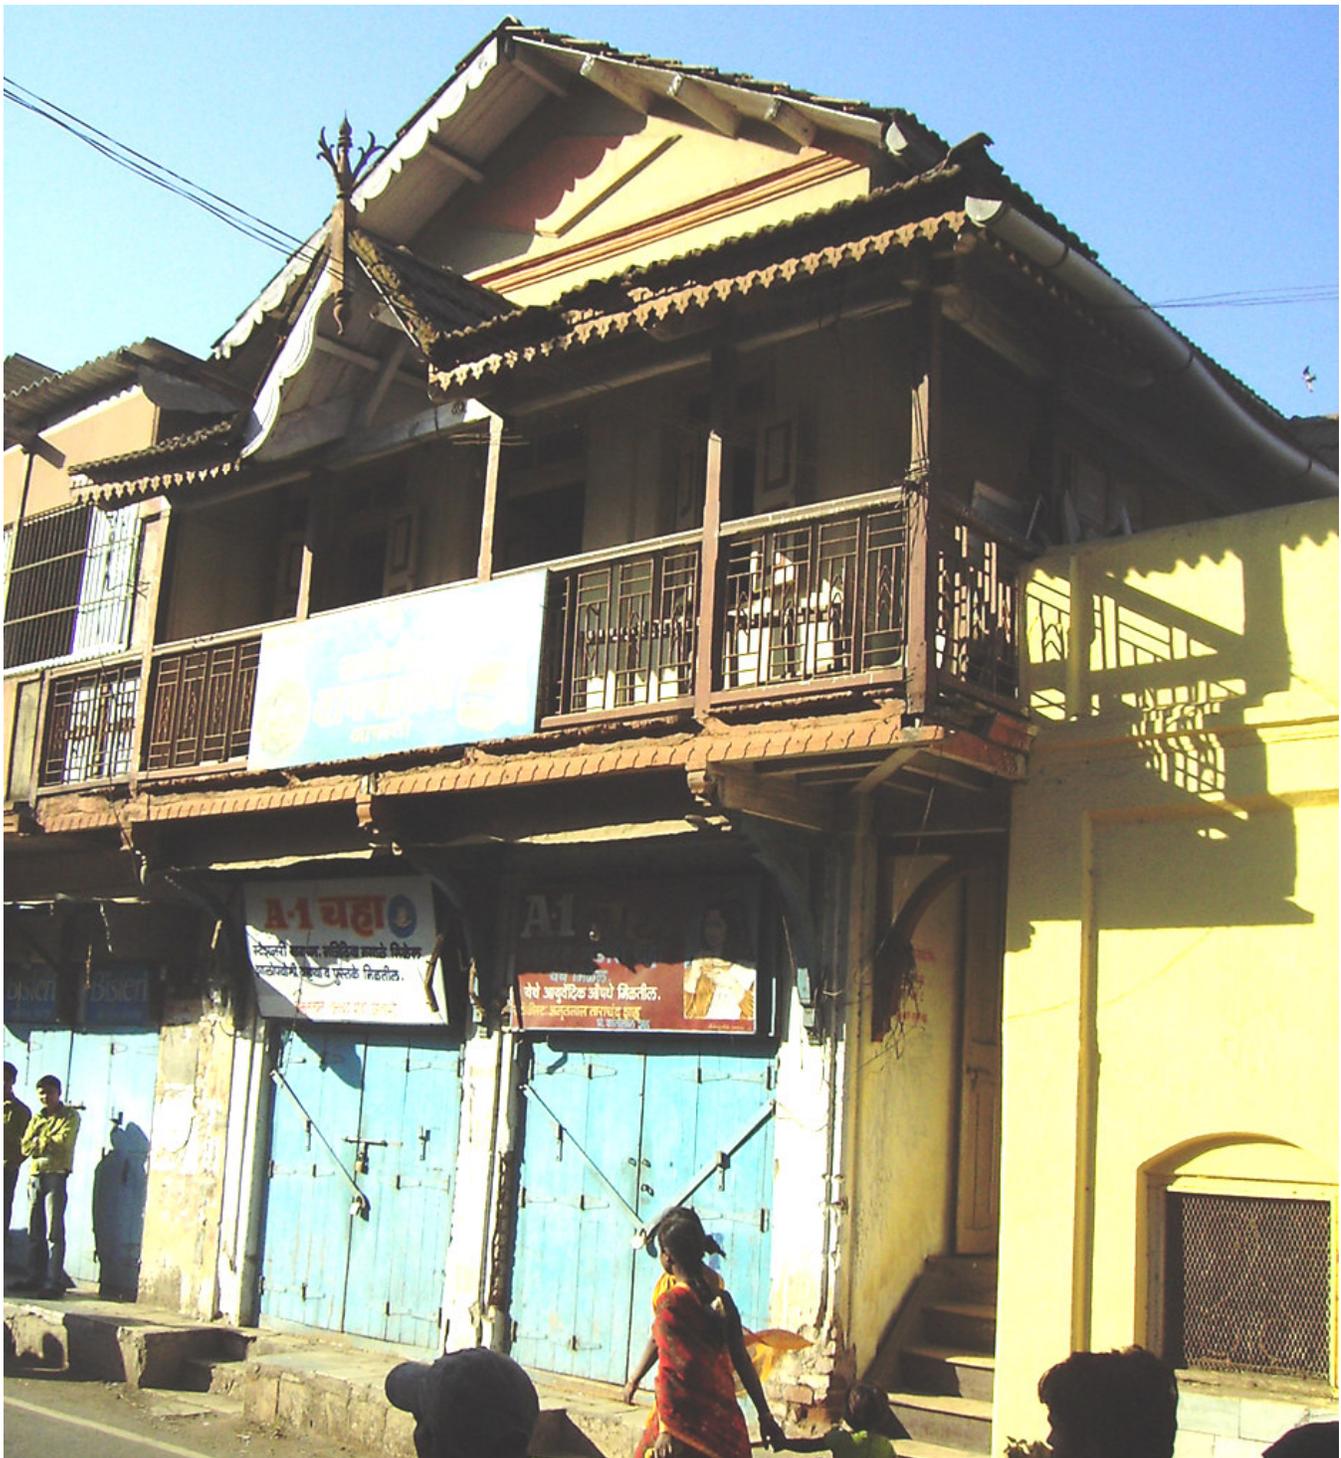
Mixed use type – commercial on the ground and institutional on the first level; Cantilevered balcony forms an important architectural element

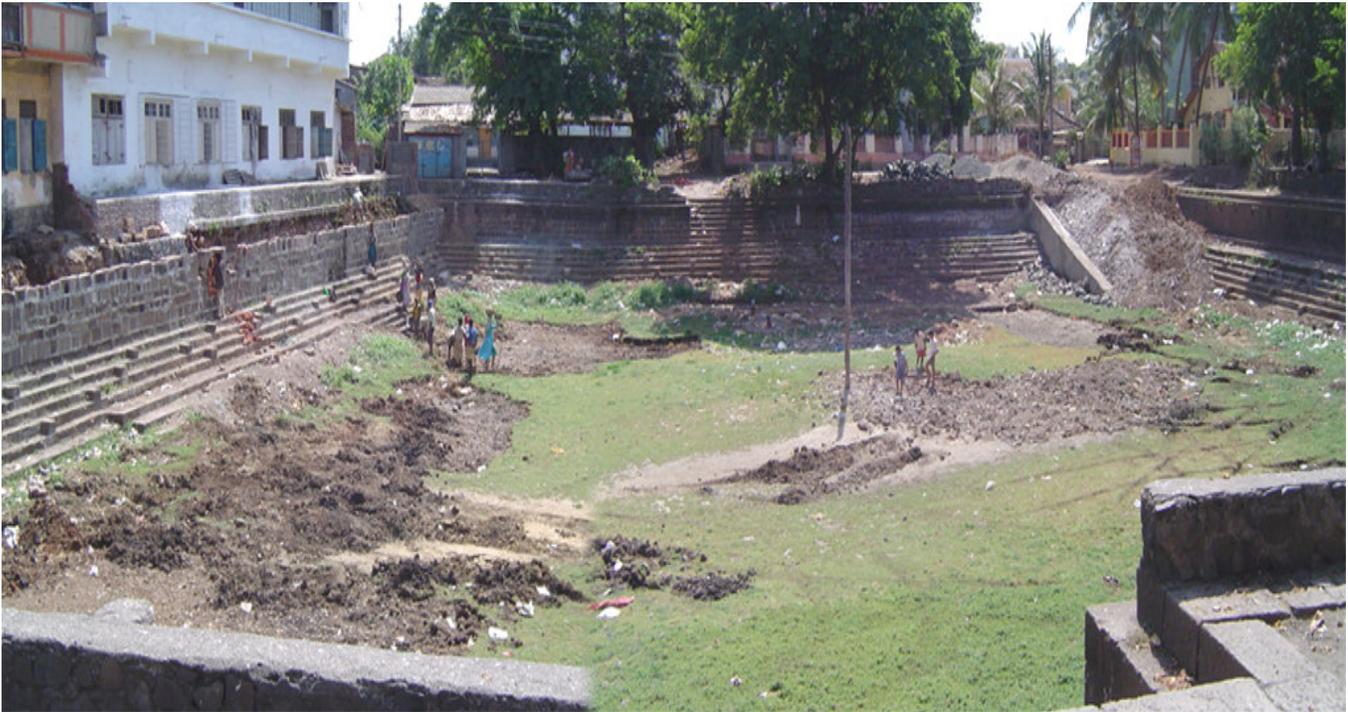
Pitching and beautification work in process

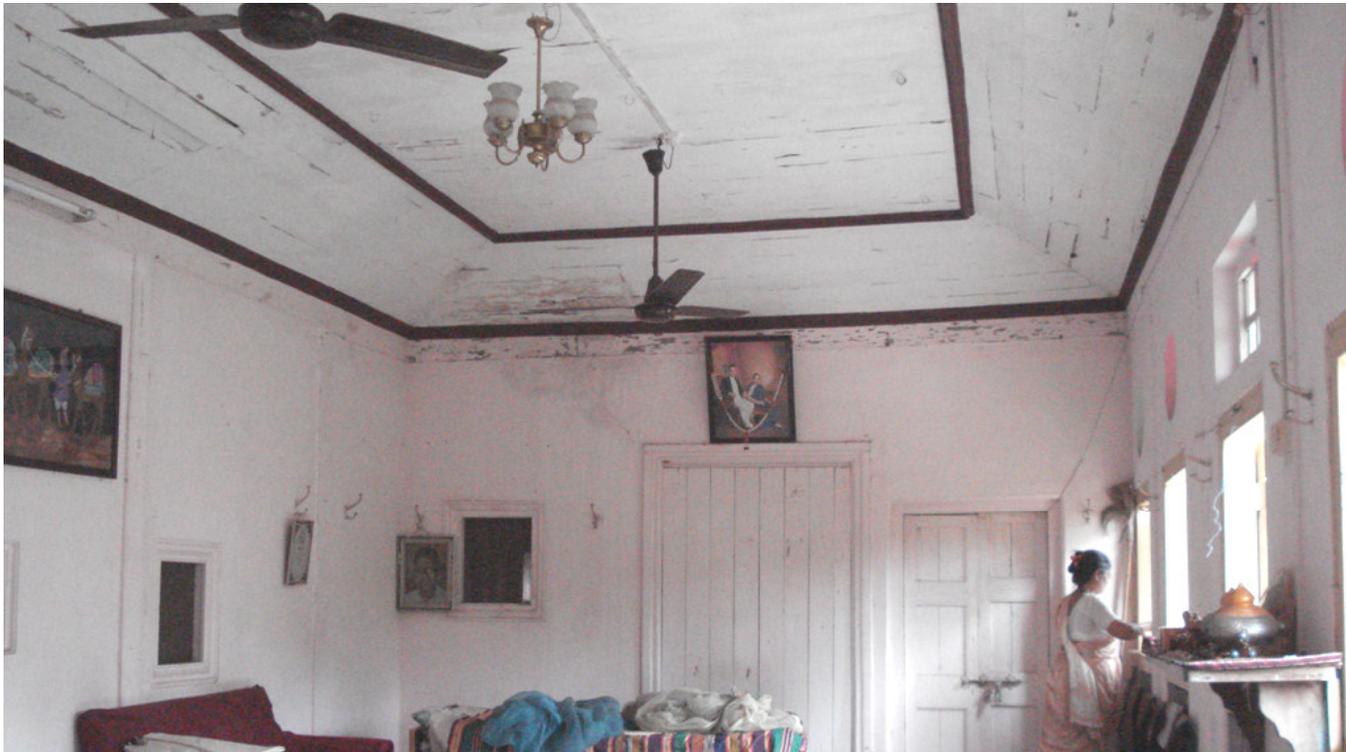
Internal view of the upper level assembly space of the erstwhile Peshwa guest house

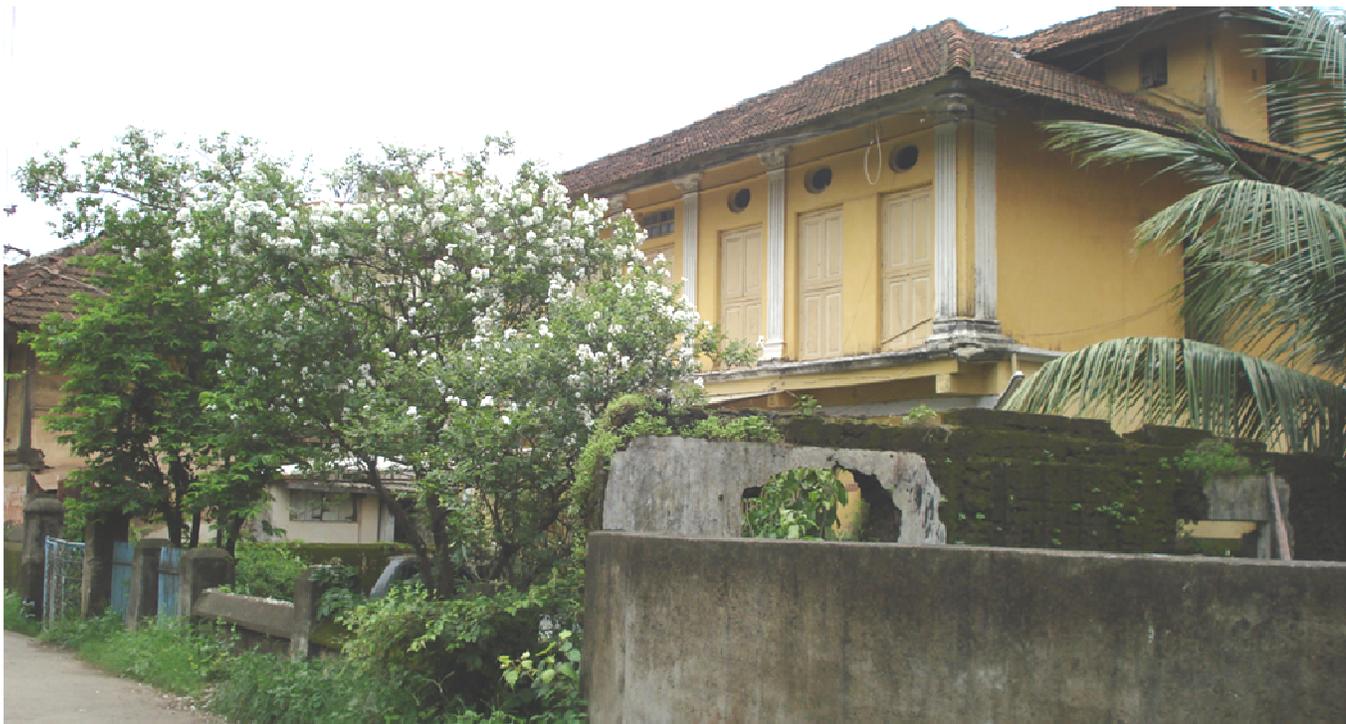
External view with decorative pilasters and full length openings

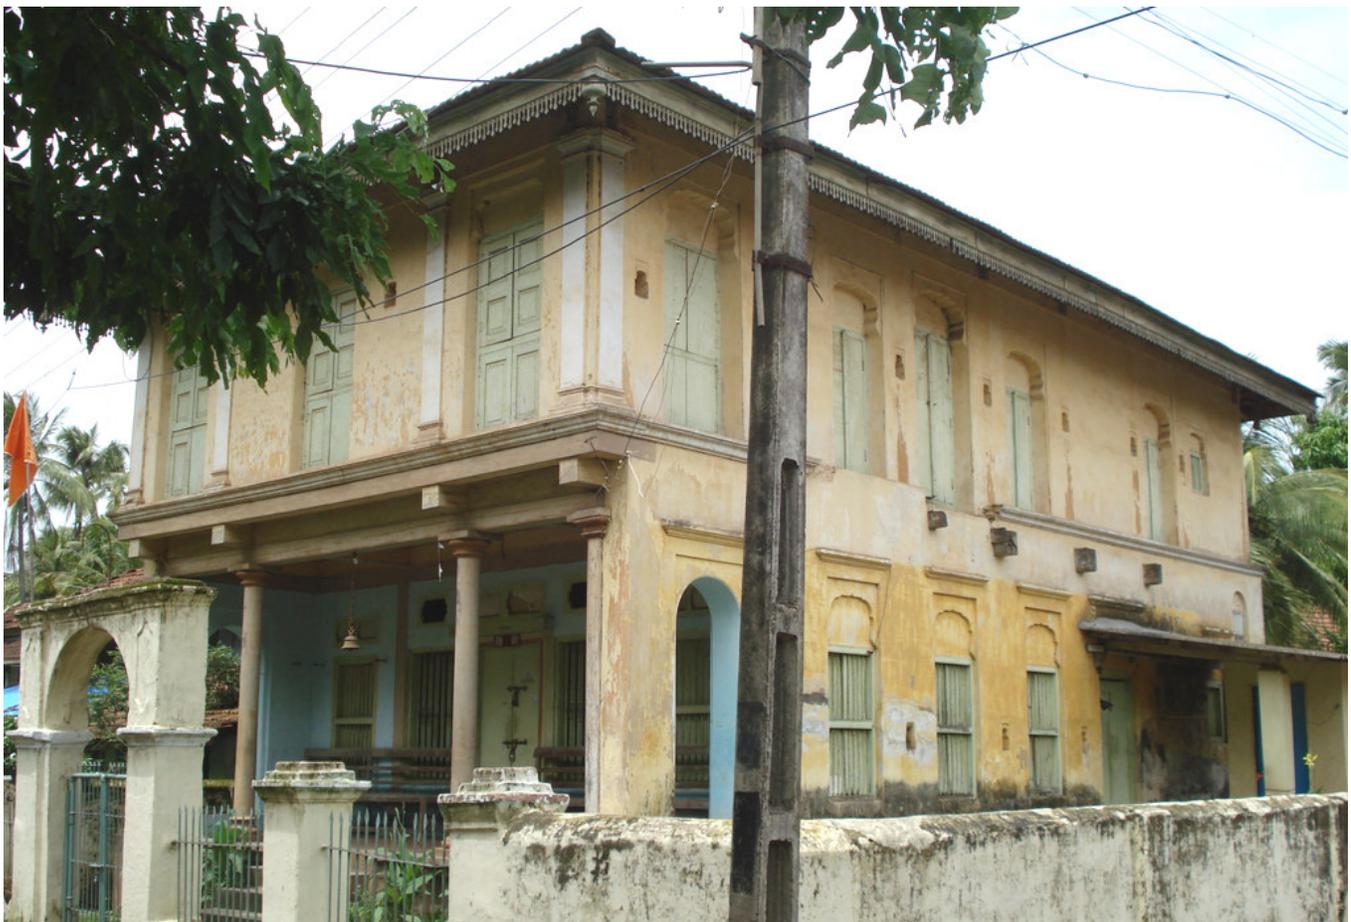
The entrance of the temple has a verandah which is a characteristic of a wada in this region

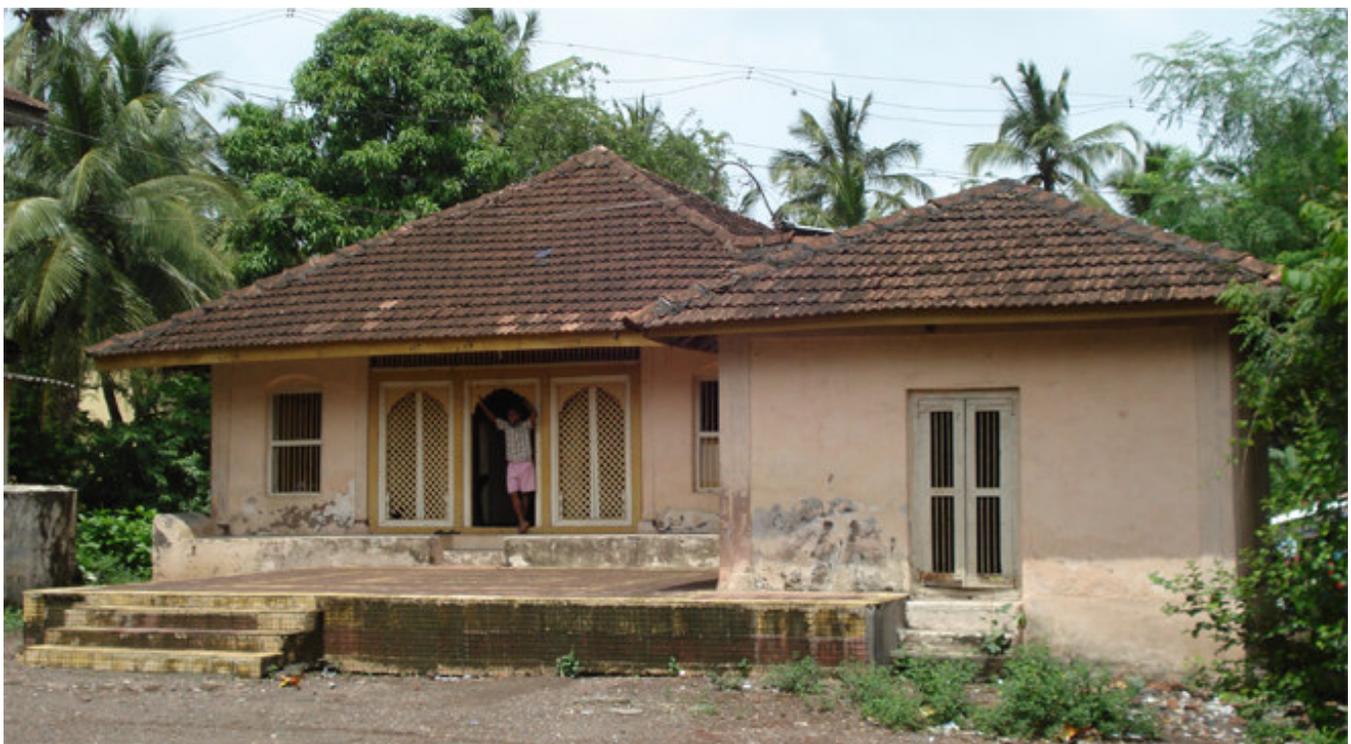
Entrance to the temple through a large plinth that opens up to the road

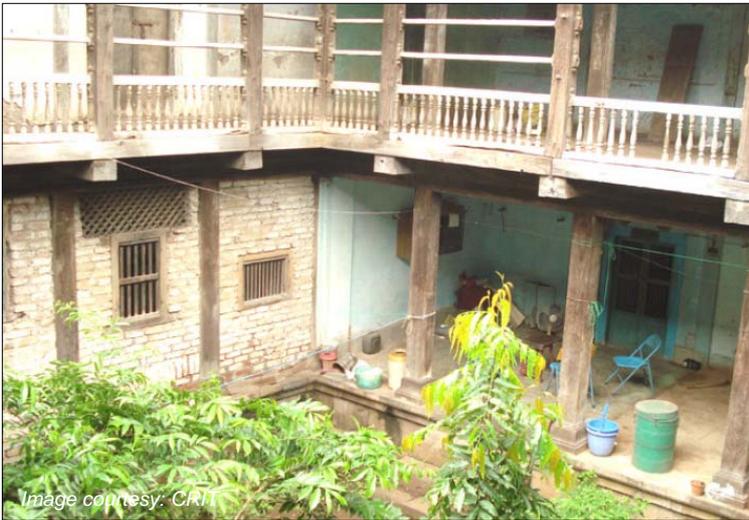
Inner courtyard with details of wooden posts and brackets

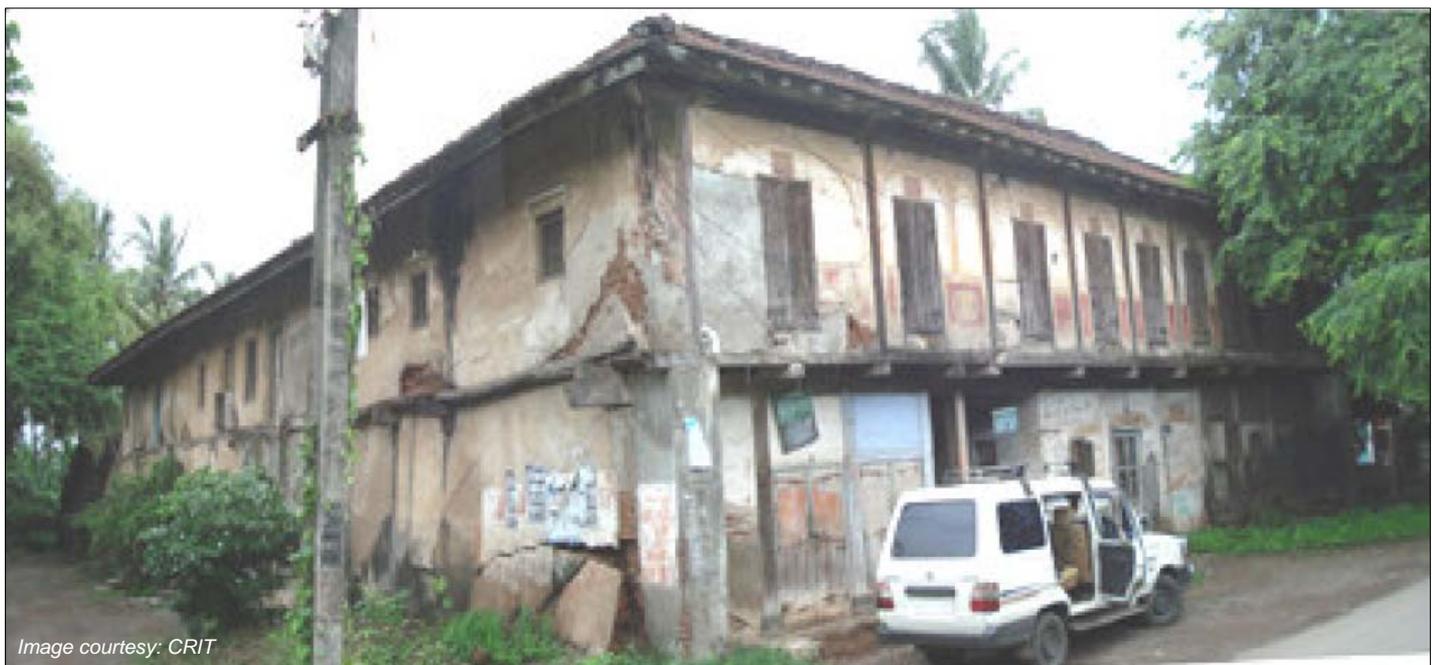
Wada showing decay and dereliction prior demolition

The trends for development as per the DP for VVSR has already taken a toll. Phadke Wada is a very good example for such actions... Phadke Wada today stands demolished for redevelopment. Phadke Wada is identified as a listed building as per CRIT report under Grade IIA.

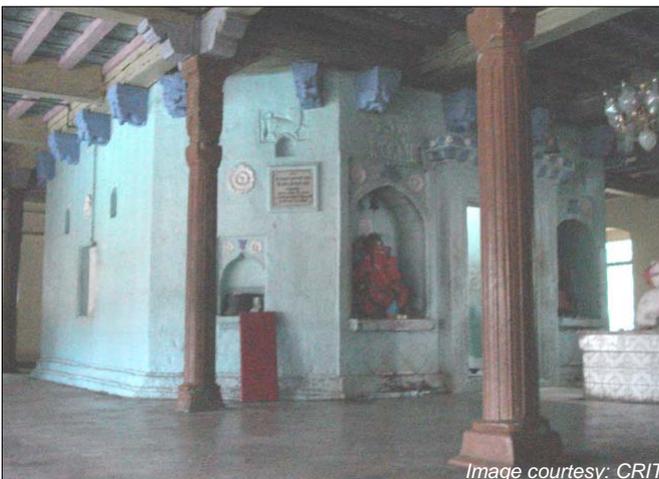
View of the garbhagriha.

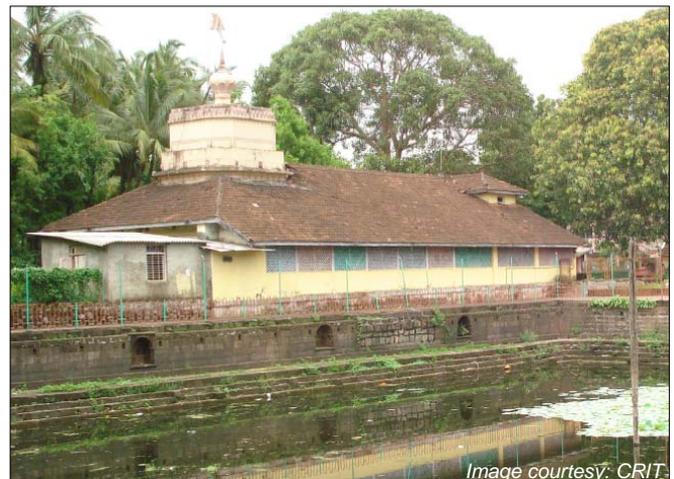
Roof of the garbhagriha emerging out of the pitched Mangalore tile roof

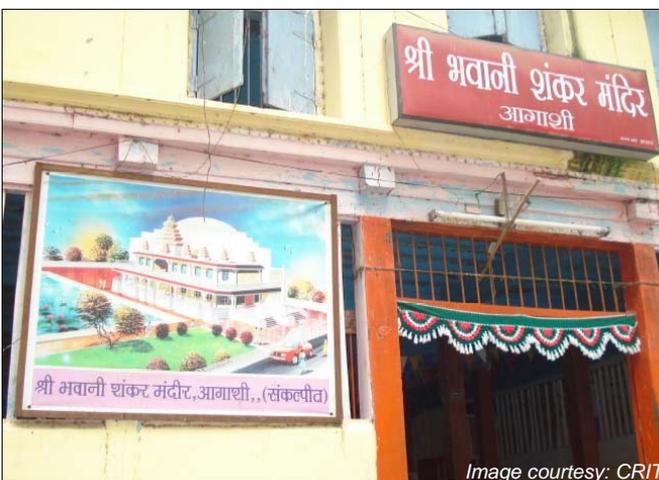
Hoarding on the front entrance showing future proposal for the temple

Trends for Redevelopment: The DP-VVSR does not recognize the suggested Heritage List by CRIT. As such the aspirations of owners take a precedence for redevelopment which is a risk to the heritage.

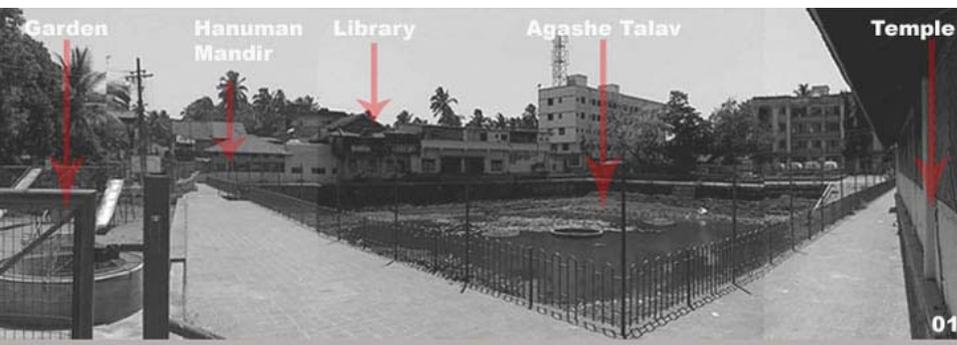
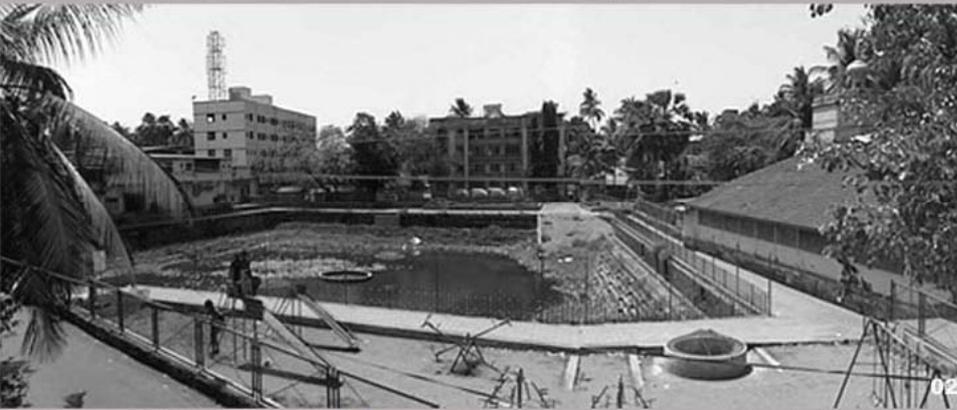
Agashe Talav & its surroundings

Architectural Characteristics: The talav has steps running all along its edge, which allow access the water. There are provisions made on the steps to keep oil lamps. These lend the talav a distinct architectural character

Public edge to the Talav
[Temples, Library, Childrens' Garden, pavement & road]
