Card No.: F/n-1

Ward (Part): F north-VI

Date: May, 2005

**Photo** T-III-Fn:\Ward F north\ **Ref.:** N. C. Nariealvala Fire

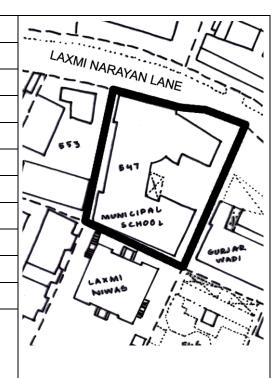
F-North 3 and 4 Repairing Office & Municipal School

8.6	Fire precaution	Not provided		
8.7	Other (HVAC / BMS / Security Systems)	Not provided		
9.0	Condition			
9.1	Plinth	Poor (No settlement observed, cracks and dampness observed which makes the plinth weak)

9.2	Walls	Fair (Crack seen on internal walls)		
9.3	Floor	Fair (Wooden members need maintenance)		
9.4	Stairs	Fair (Sagging observed at few places, some trees broken)

9.5	Openings	Poor (Wooden members need maintenance)		
9.6	Roofing	Poor (Mangalore tiles broken at some places, leakage observed, fascia needs repairs)

9.7	Articulation & Finishes	Poor (Plaster chipped off, façade attacked by moss, trees growth observed on facade)		
9.8	Services	Poor		
9.9	Outbuildings	Poor

9.10	Overall condition	Poor Maintenance level Poor		
10.0	Transformation	<u> </u>		
10.1	Form	No transformation		
10.2	Structure	No transformation		
10.3	Articulation & Finishes	No transformation

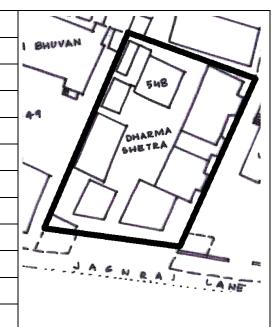
Dharmkshetra Compound

9.1	Plinth	Fair (No settlement observed, cracks observed at some places)
9.2	Walls	Fair (Dampness observed at some places)
9.3	Floor	Fair (Sagging observed at some places)

9.4	Stairs	Fair (Wooden members need maintenance)
9.5	Openings	Fair (Some windows need repairs)
9.6	Roofing	Fair (Mangalore tiles and fascia need repairs)

9.7	Articulation & Finishes	Fair (Plaster attacked by moss)
9.8	Services	Fair (Broken pipes need replacement)
9.9	Outbuildings	Fair
9.10	Overall condition	Fair Maintenance level Fair

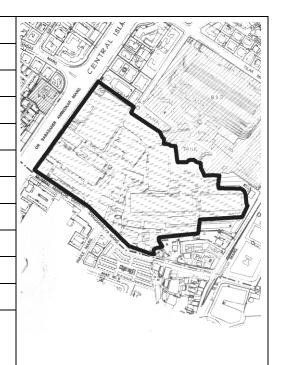
**Photo** T-III-Fn:\Ward F north\ **Ref.:** Kohinoor Mills 1 and 2

9.9	Outbuildings	Poor		
9.10	Overall condition	Poor	Maintenance level	Poor
10.0	Transformation			
10.1	Form	No transformation		
10.2	Structure	No transformation

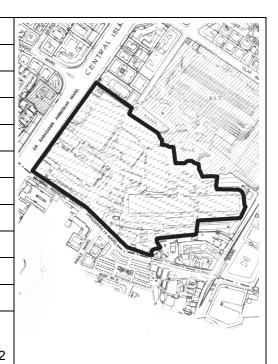
Photo T-III-Fn:\Ward F north\
Ref.: Carding, Structure 8B,

8.6	Fire precaution	Not provided		
8.7	Other (HVAC / BMS / Security Systems)	Not applicable		
9.0	Condition			
9.1	Plinth	Fair (No settlement and cracks observed at some places)

9.2	Walls	Fair (Internal walls broken, tree growing on façade)		
9.3	Floor	Fair (Sagging observed at some places, Corrosion in M.S. members observed)		
9.4	Stairs	Fair (Needs maintenance of corroded M.S. members observed)

9.5	Openings	Poor (Broken windows pains replaced by teen sheets)		
9.6	Roofing	Poor (Leakage observed at some places, A.C. sheets need repairs)		
9.7	Articulation & Finishes	Poor (Plaster chipped repairs off at many places)

9.8	Services	Poor (Shut down, not in use)		
9.9	Outbuildings	Fair		
9.10	Overall condition	Poor Maintenance level Poor		
10.0	Transformation			
10.1	Form	No transformation

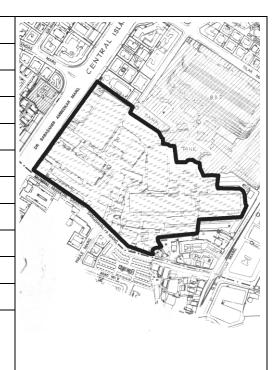
Photo T-III-Fn:\Ward F north\ Spinning & Ringing, Structure 8B, Kohinoor Mills No. 1 & 2

8.6	Fire precaution	Not provided		
8.7	Other (HVAC / BMS / Security Systems)	Not provided		
9.0	Condition			
9.1	Plinth	Fair (Settlement and cracks observed)

9.2	Walls	Fair (Internal walls broken, tree growing on façade)		
9.3	Floor	Fair (Sagging observed at some places, Corosion in M.S. members observed)		
9.4	Stairs	Fair (Needs maintenance of corroded M.S. members observed)

9.5	Openings	Poor (Broken windows pains replaced by teen sheets)		
9.6	Roofing	Poor (Leakage observed at some places, A.C. sheets need repairs)		
9.7	Articulation & Finishes	Poor (Plaster chipped repairs off at many places)

9.8	Services	Poor (Shut down, not in use)		
9.9	Outbuildings	Poor		
9.10	Overall condition	Poor Maintenance level Fair		
10.0	Transformation			
10.1	Form	No transformation
