BALLARD BUNDER GATEHOUSE

CONSERVATION REPORT

DOCUMENTATION, ANALYSIS & PROCESS

K.UNWALLA ARCHITECTS, MAY 2005

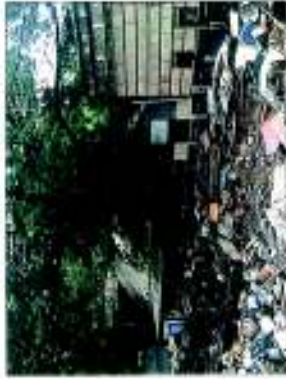
BALLARD BUNDER GATEHOUSE AMIDST CHAOS - BEFORE RESTORATION

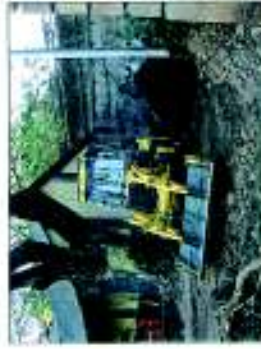
Removal of debris between the structure and the tree after demolition of the shed

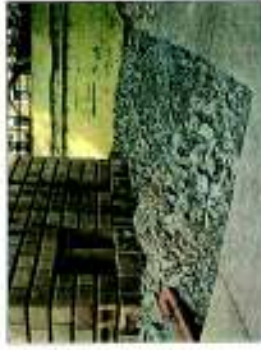
Layer of P.C.C. and murrum around the structure was much deeper than estimated.

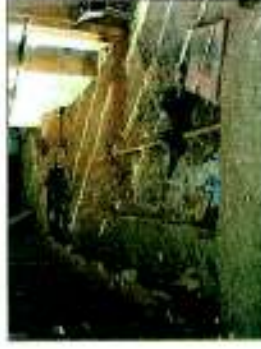
Cobbles laid in continuation with the main floor of the Gatehouse were unearthed from the rear open space.

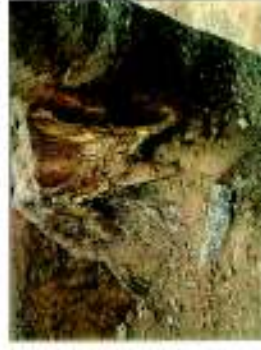
Dead tree trunk completely buried under the filling was restored and integrated in landscaped setting.

Interestingly, a large tree trunk was unearthed along the eastern open space of the monument suggesting the existence of an old tree almost identical in size and position as the rain tree on the west. It was decided to retain the dead tree trunk and accordingly align the new security wall to accommodate the natural artifact within the landscaped setting.

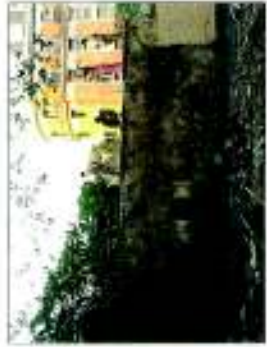
SECURITY WALL BEFORE DEMOLITION

ACTION: IT IS PROPOSED TO BRING DOWN THE WALL AND REPLACE IT WITH GRILLS AND FENCING OF A DESIGN APPROPRIATE WITHIN THE NEO-CLASSICAL SETTING. THE SECURITY ASPECT OF THE NAVAL DOCKYARD I.e. IT IS DIMINISHED IN THE ABOVE ACTION IS PROPOSED TO BE RESTRICTED BY TURNING AROUND THE WALL AT THE REAR OF THE STRUCTURE. THE PROCESS AFFORDS A PROPER SETTING TO THE GATEHOUSE BY CREATION OF A PROPER PLOT AREA WITH OPEN SPACES.

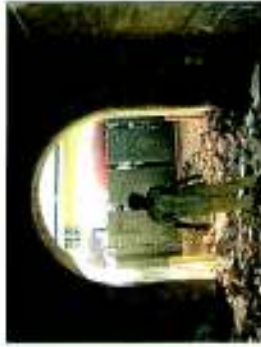
Rear archway opened up after demolition of infill brick masonry.

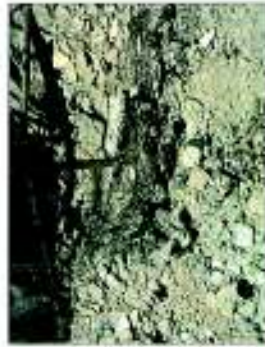
Layers of concrete (with wire mesh reinforcement) removed from roof slab

Interventions to the slab, in the past decade to afford a water proofing layer had been carried out. The interventions are of a superficial nature by an addition of a top concrete layer reinforced with steel wire mesh, covered with tar felt AND repair of the sffit concrete (reinforcement cover) of the slab.

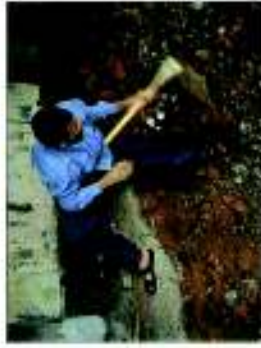
P.C.C. floor and filling within the structure being removed

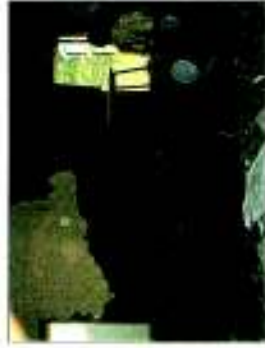
Removal of plaster exposes the composite masonry (Stone masonry with brick leaf wall)

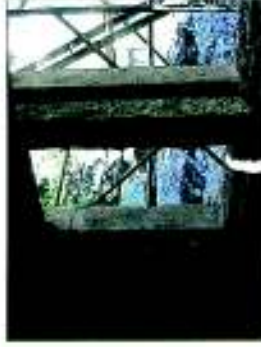
Window frames and shutters dismantled - the dressed stone surrounds exposed.

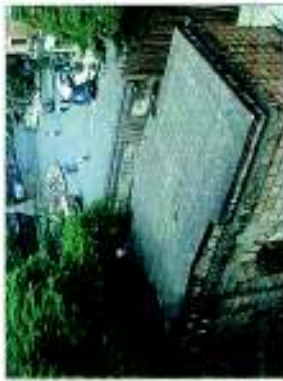
ROOF OF THE GATEHOUSE BEFORE RESTORATION

A detailed assessment of the condition of the slab was identified to be in an **urgent need for structural strengthening.**

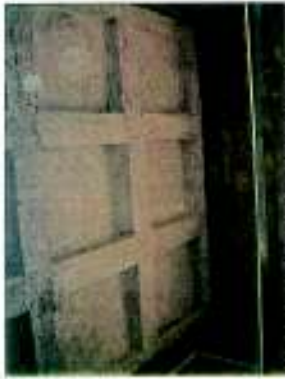
COFFERED SLAB OF CENTRAL HALL BEFORE RESTORATION

Bulging of cover / loose cover at some locations indicating cracking of the cover, leakage stains indicating ingress of water, rusting / scaling of reinforcement. The reinforcement of an adequate design.

- Loose, disintegrated and cracked concrete broken and removed using chipping hammer and / or light chisel upto sound core concrete.
- Loose rust from reinforcement removed by light tapping, chipping, hammering and scrubbing

- Brush application of Rusticide to rusted steel
- Additional reinforcement placed at the bottom and secured to the new stirrups
- New stirrups provided by drilling holes and anchoring the same into the rib of existing RC beam with epoxy putty.

- Application of 2 coats of Polyalk Fixoprime and cement slurry
- Application of Polyalk EP + cement slurry as Bonding coat after 45 hours to entire broken surface

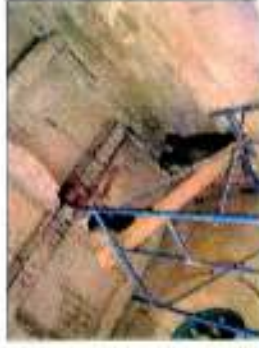
Laying of electronic cables prior to Polymer treatment to coffered slab.

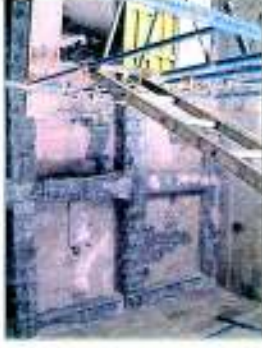
Strengthened coffered slab before application of Polymer modified mortar

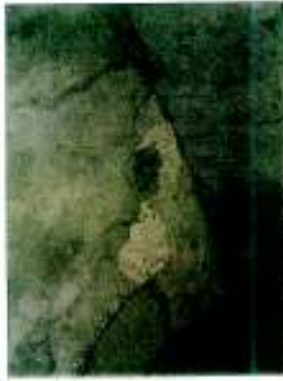
SLAB SOFFIT IN ROOMS BEFORE RESTORATION

Bulging of cover / loose cover at some locations indicating cracking of the cover, leakage stains indicating ingress of water, rusting / scaling of reinforcement. The reinforcement of an inadequate depth.

- Loose, disintegrated and cracked concrete broken and removed using chipping hammer and / or light chisel upto sound core concrete.
- Loose rust from reinforcement removed by light tapping, chipping, hammering and scrubbing

- Brush application of Rusticide to rusted steel
- ISMB 250 introduced spanning across the length of the room to reduce the effective span of existing RC slab. Secured to the stone walls by special ("Hilti" make) bolts insertion of steel wedges between the steel beam and the slab.

- Application of 2 coats of Polyalk Fixoprime and cement slurry
- Application of Polyalk EP + cement slurry as Bonding coat after 46 hours to entire broken surface

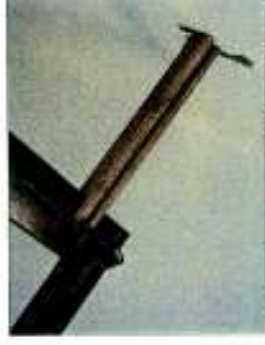
Wooden frame suspended from slab with GI link chains to install lighting fixtures

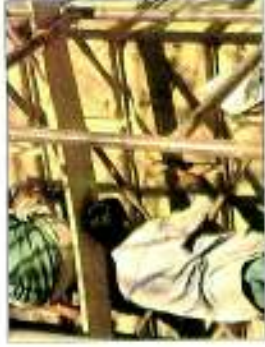
Removal of cement from recessed joints and dressed stone surfaces

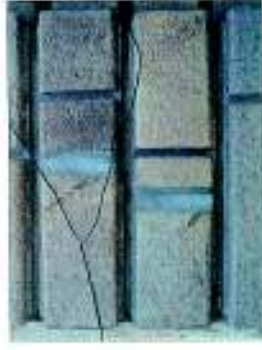
Deep recessed joints in stone masonry filled with cement mortar (before restoration)

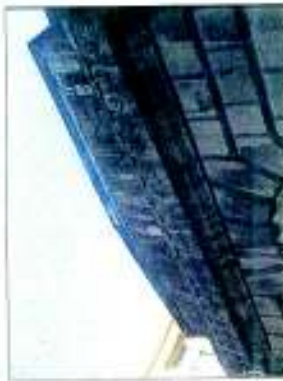
FRONT PEDIMENT BEFORE RESTORATION

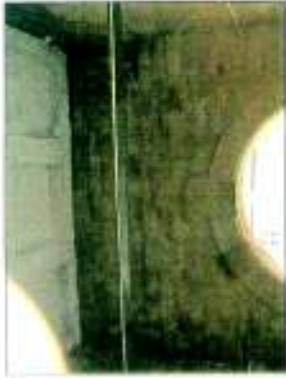
EXPOSED ASHLAR MASONRY IN THE CENTRAL HALL BEFORE RESTORATION

- Staining of stone surface due to water ingress from the roof and rising damp from the foundations is evident.
- Stains associated to adjoining filling / dump / P.C.C.
- Stains of cement applications on stone surface
- Several punctures / holes
- Electrical wiring without respecting the features and configuration of joints

- Cleaning of internal stone surfaces by appropriate method.
- Manual - light tapping / scrubbing / water application
- Careful removal of Nails / wooden blocks etc and sealing the holes / depressions with lime
- Jointing + flush pointing in lime mortar
- Sealing cracks with Lime mortar
- Minimum interventions and damage to stone walls while installing electric wiring / arranging display

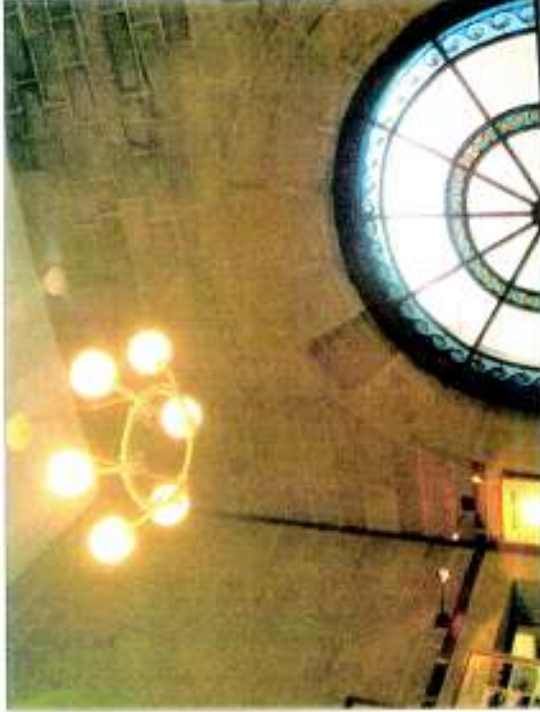
RESTORED ASHLAR MASONRY IN THE CENTRAL HALL

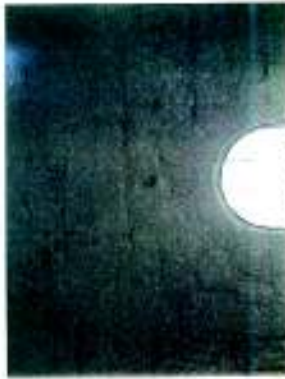
EXPOSED STONE MASONRY OF NORTH WALLS OF THE ROOMS DURING RESTORATION

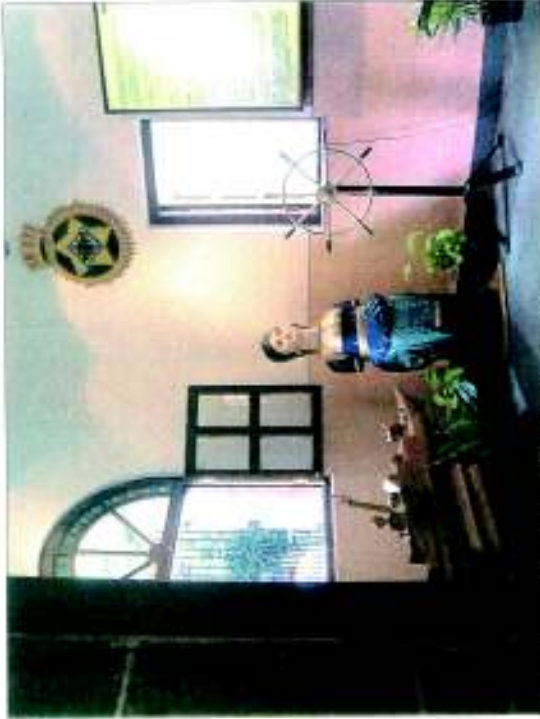
LIME PLASTERED WALLS AFTER RESTORATION

- Re-plaster brick leaf wall in lime mortar, subsequent to removal of all loose and disintegrated material, while consolidating the structure of the wall with brick bat packing.
- Stitching with Stainless Steel pins carefully designed and grouted into the parent stone wall along the line of fracture of the crack.
- Finish the surface in Lime wash (two shades).

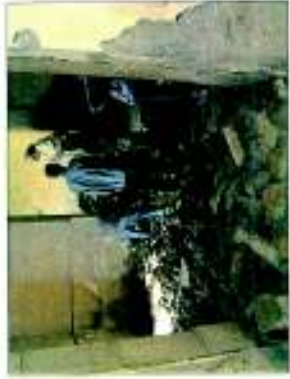
ORIGINAL COBBLED FLOOR EXPLORED DURING EXCAVATION

- The original floor of Central Hall comprising of cobble stones lay buried under substantial layers of brick bat, murram and P.C.C. before it was exposed.
- Dressed Stone steps (two risers) leading to the ante-rooms were unearthed during excavation. This revealed a level difference of 20 cms between the floor levels of the hall and the rooms.
- On cleaning, the cobbled floor of the Hall was found in excellent condition hence it was decided to maintain the same with marginal restoration and cleaning.
- The original flooring in rooms comprised of Shalhad stone slabs which were fairly damaged and had lost the level. The floor in the rooms was interrupted by later additions of partition walls and hence it was decided to replace it by new Kotah stone flooring.

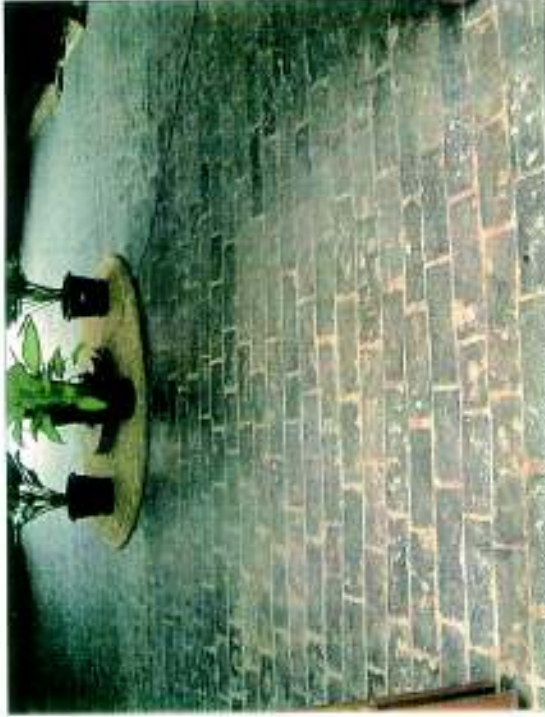
COBBLED FLOOR OF CENTRAL ROOM AFTER RESTORATION

- Scrubbing / tapping to remove dirt, cement accretions from cobbles.
- Replacement of damaged cobbles (by cobbles obtained elsewhere on site)
- Painting in Lime
- Kotah stone slabs, size 33 cm x 33 cm laid in diagonal pattern
- Skirting of Kotah stone (half tile)

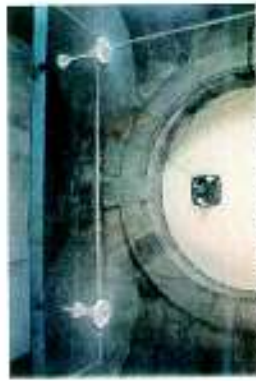
ARCHED OPENING (FRONT) BLOCKED BY MASONRY WALL BEFORE RESTORATION

- As per the original design of the structure, the doorways (Front and Rear) were open that allowed passage through the Gatehouse which was meant to be an entrance portal to the Landing Jetty at Ballard Bundar.
- The front opening probably had a Cast Iron Gate as a wicket gate hung on a pivot. This is evident from a protruding remnant of a CI rod in the stone jambs of the arched opening, at either ends, level with the springing points of the arches. The embedment lay deep into the stone walls as found on further investigation.

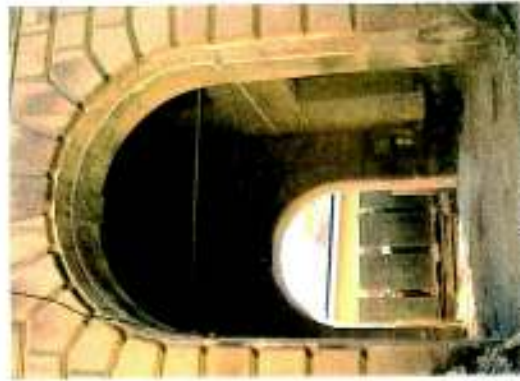
Gateway opened up during restoration.

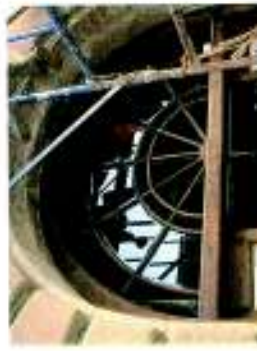
Front door during the execution stage.

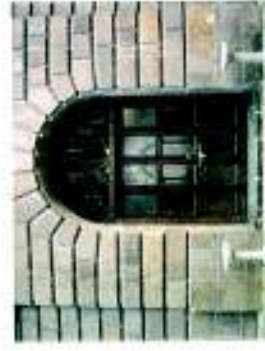
Front door design suited to the scale of the grand opening and based on fenestration design of heritage structures in the dockyard.

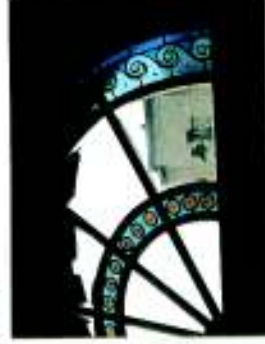
The Stained glass patterns are borrowed from the motifs on the facade. Use of blue colour reiterates its relation to the sea.

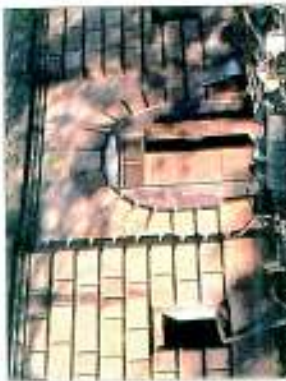
REAR ARCHWAY OPENING BLOCKED
(BEFORE RESTORATION)

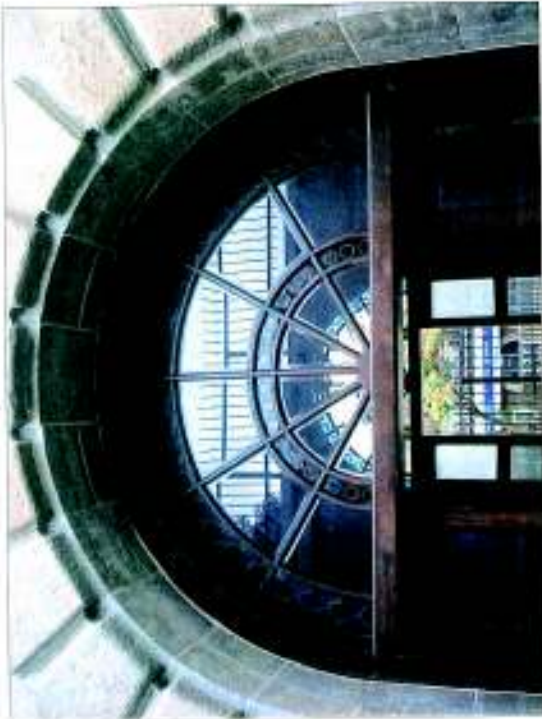
REAR OPENING AFTER RESTORATION

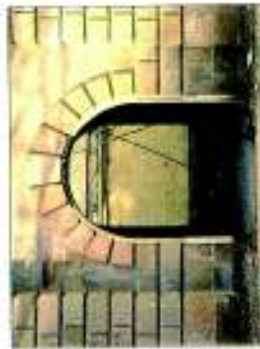
Rear arch opened up during restoration

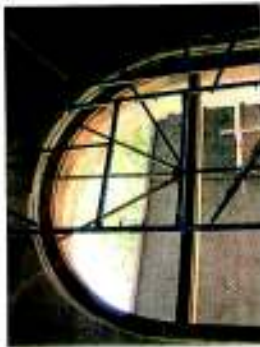
Installation of timber frame

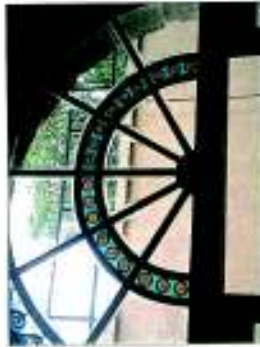
Stained glass adds colour and delicacy to the otherwise robust design of doors.

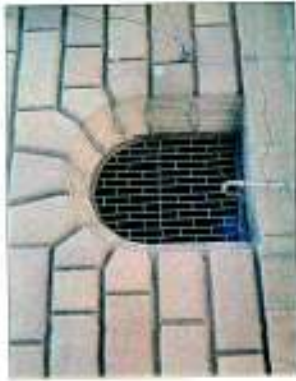
SEMICIRCULAR ARCHED WINDOW
OPENING BEFORE RESTORATION

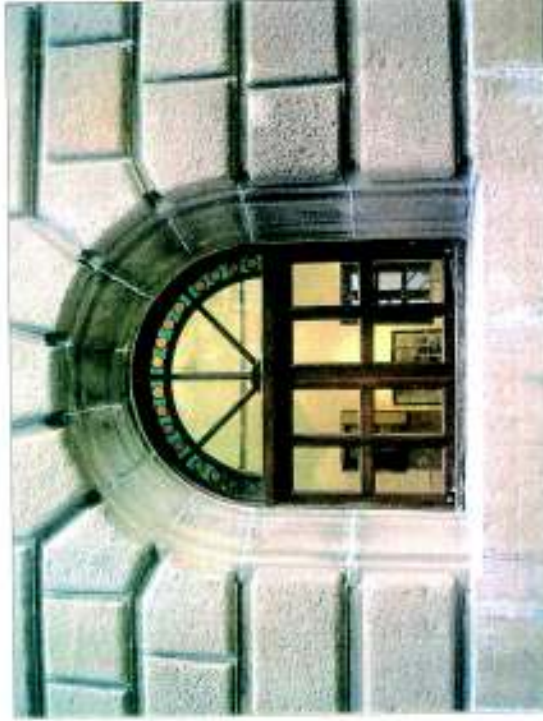
WINDOW OPENING AFTER RESTORATION

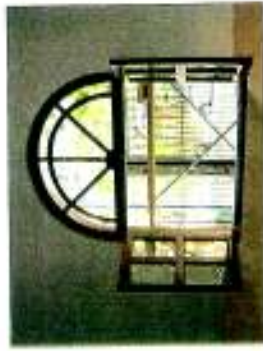
Window during execution stage. Pattern
of original direction of openings retained.

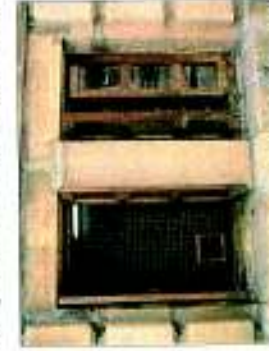
Rectangular openings in the rooms before
restoration.

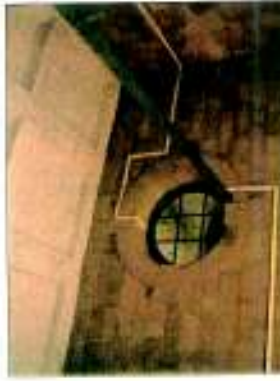
OX EYE WINDOW BEFORE RESTORATION

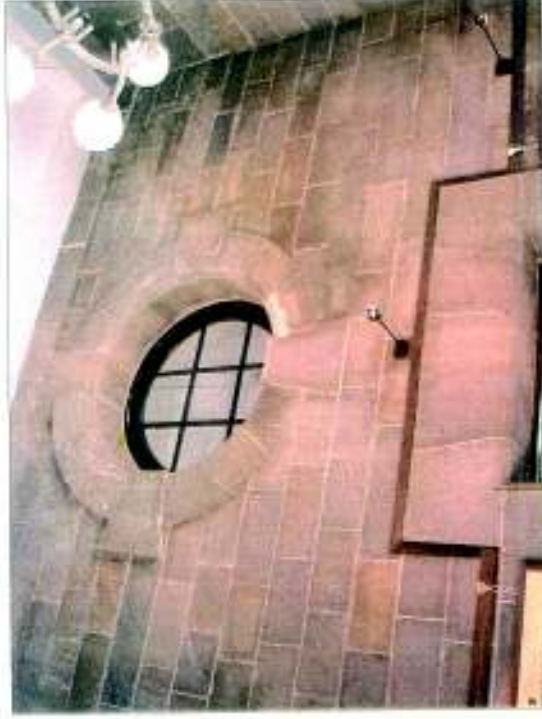
RESTORED OPENINGS IN THE CENTRAL HALL

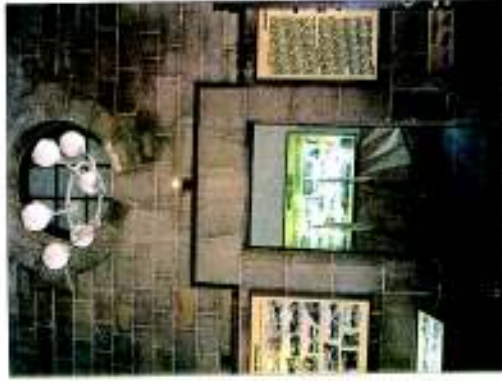
opening with broad band of architrave - Cave is taken to restore and enhance the masonry articulation while arranging the display.

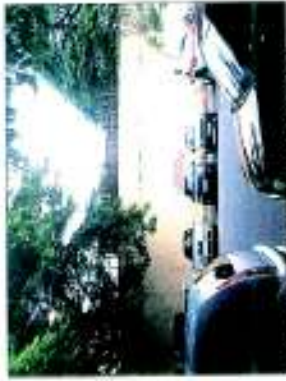
HIGH SECURITY WALL OBSTRUCTING VIEW OF THE GATEHOUSE - BEFORE RESTORATION

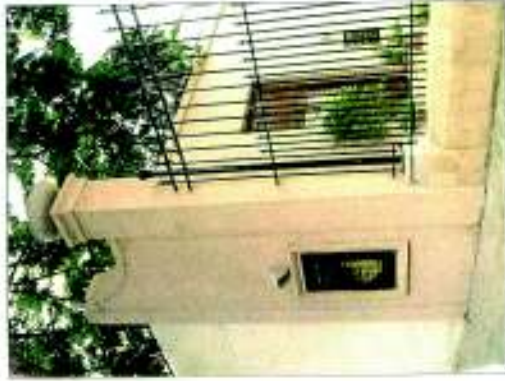
Junction of old and new security walls sensitively treated to achieve a subtle transition. A Brass Plaque with a key map of Ballard Estate area is aptly placed here.

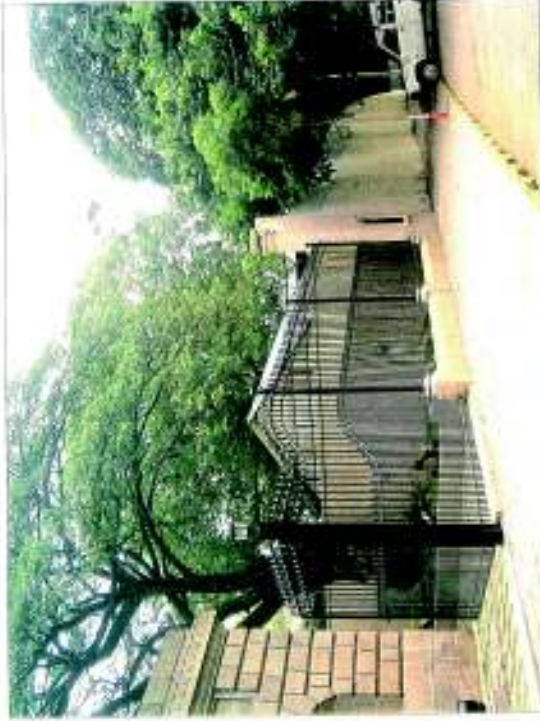
OLD SECURITY WALL REPLACED BY GRILL FENCE AND NEW SECURITY WALL

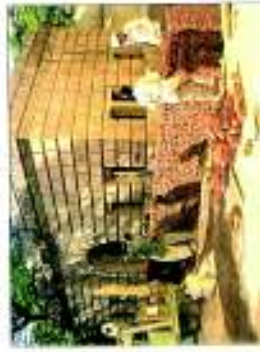
Construction of new security wall

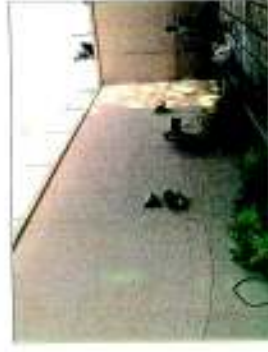
Malad creta plaster with textured finish for the security wall with the surface area broken into joints of uniform width.

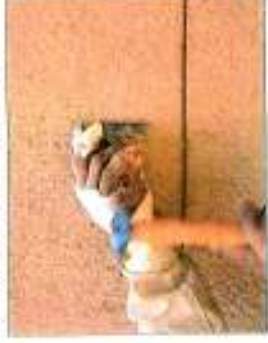
Malad creta plaster being hacked manually to form serrations on the surface. Its color complements the yellow basalt stone facade of the Gatehouse.

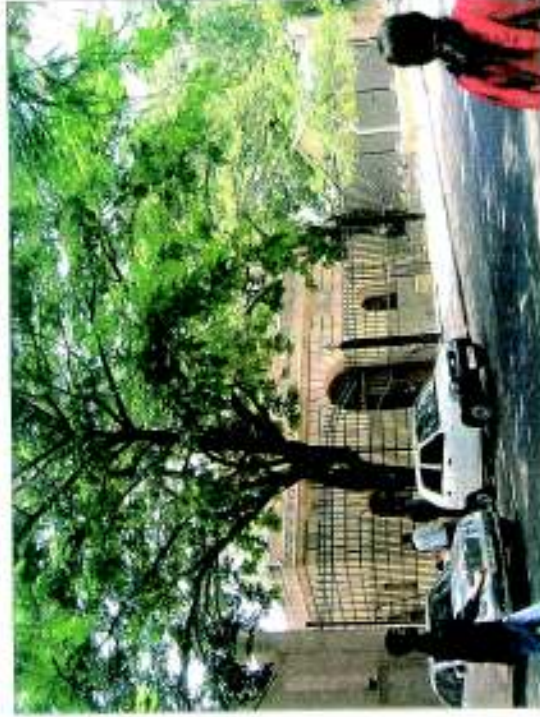
THE GRILL FENCE OPENS THE STRUCTURE TO PUBLIC VIEW RESTORING THE IMAGE OF THE NODAL SETTING - AFTER RESTORATION

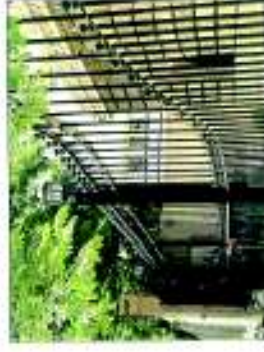
Impressive expansive, bold curvilinear profile and moderately decorative design elements are the highlights of the grill fence.

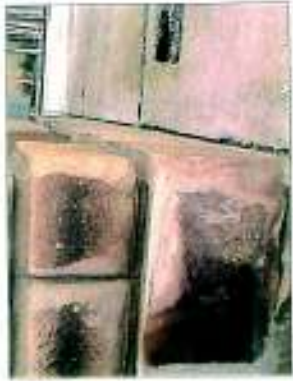
NETWORK OF SERVICES AROUND THE STRUCTURE LACKED ORGANISATION - BEFORE RESTORATION

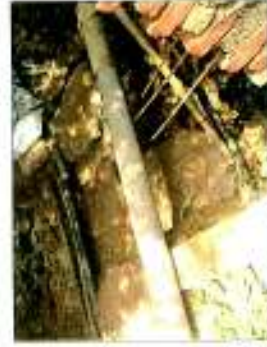
Organisation of the HT and LT cable network of was a challenging task

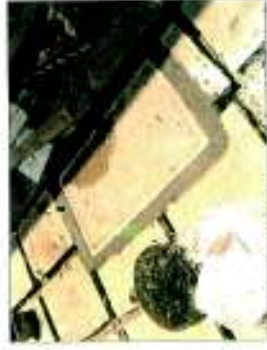
Inspection chambers and service chambers integrated with paving pattern.

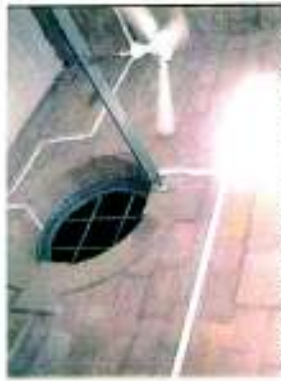
SENSITIVE DESIGN AND LAYOUT OF ELECTRICAL WIRING AND FITTINGS - BEFORE RESTORATION

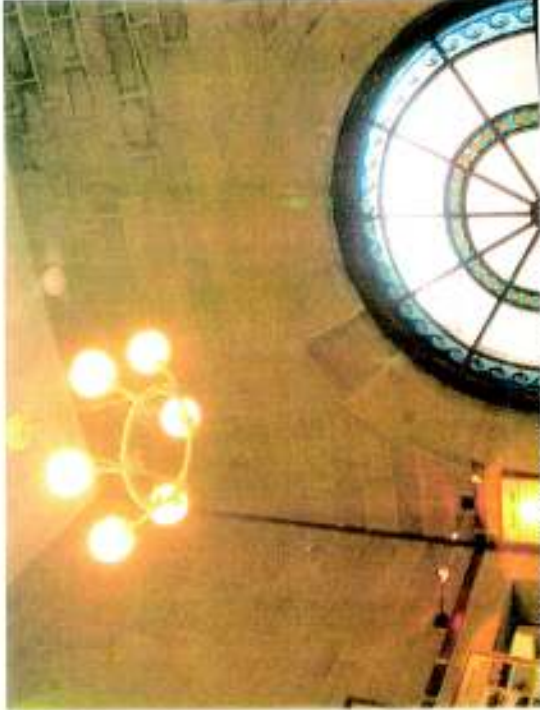
NEW ELECTRICAL WIRING AND FIXTURES IN HARMONY WITH THE HISTORIC STRUCTURE - AFTER RESTORATION.

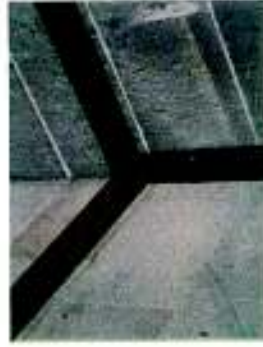
Capping casing in polished wood specially designed to mark the electrical wiring.
