**RESTORATION WORKS AT CHHATRAPATI SHIVAJI MAHARAJ VASTU SANGRAHALAYA**  
**Completion Report for Phase I Exterior Restoration Works**

**Abha Narain Lambah Associates: Conservation Architects & Historic Building Consultants**  
**Structural Rehab Consultant**

December 2008

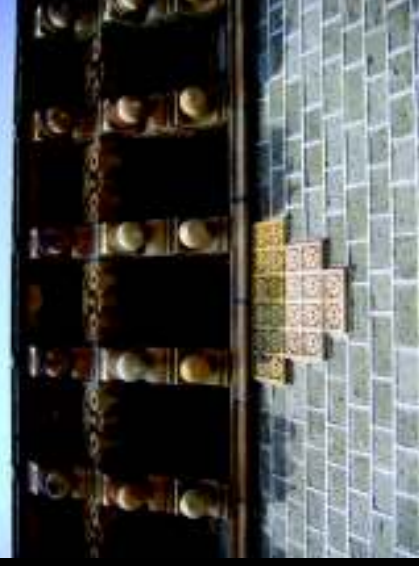
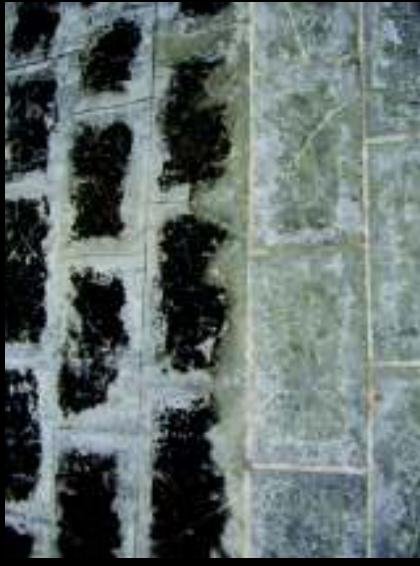
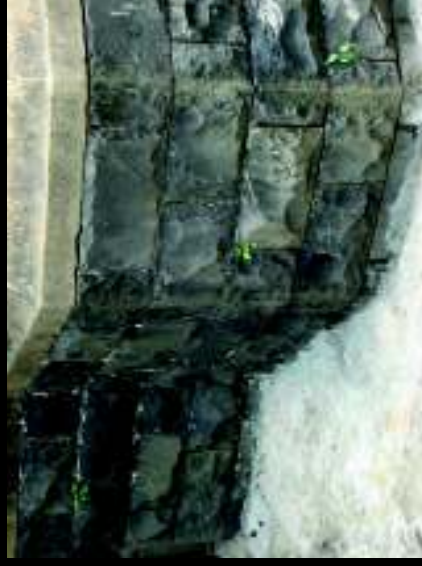
- Deterioration of Pointing
  - Loss of pointing
  - Hard pointing
  - Ribbon pointing

Top to Bottom: Photographs showing hard ribbon pointing in cement, partially removed hard ribbon pointing to expose the finer joints and plinth level masonry with deteriorated pointing that needs to be repointed in lime mortar.

The original stone joints were very fine joints and ensured the breathability of the masonry, allowing trapped moisture to evaporate. Hard pointing in cement introduced at a later stage in the building, in fact competed with the strength of the stone masonry. As a result, it caused the moisture to evaporate from the stone surface, stressing the stone masonry and causing deposition of salts and consequently stone delamination. Removal of Hard pointing and re doing the same in fine lime pointing.

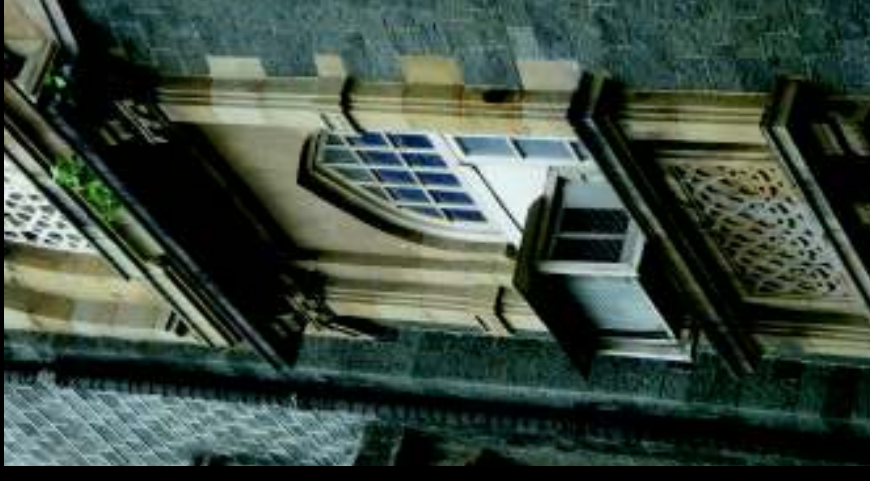
Photograph showing the Deterioration of the window frames  
Right: Photograph showing a window air conditioner unit mounted on the sill  
Below: Photograph showing the original window design with a glass fanlight and glazed shutters.

The window restoration work included making of new shutters and frames where they were damaged beyond reasonable repair, restoration of window shutters and frames where they were damaged to a lesser extent and for those windows which were sound, only scraping of old paint layers and repainting.

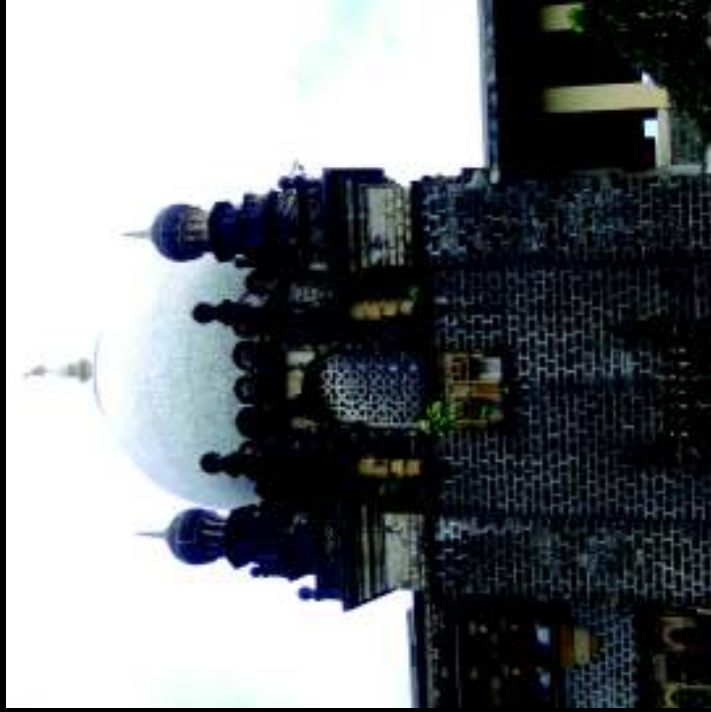
Left and Right Above: Photographs showing the domes surfaces that indicate past grouts as well as patchwork plastering over the surface. Any exercise to undertake major roof repair of the domes should be preceded by thorough non destructive testing and structural investigations.

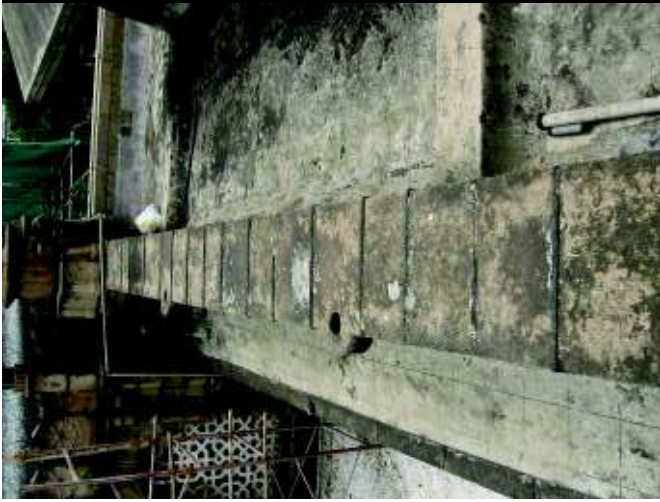
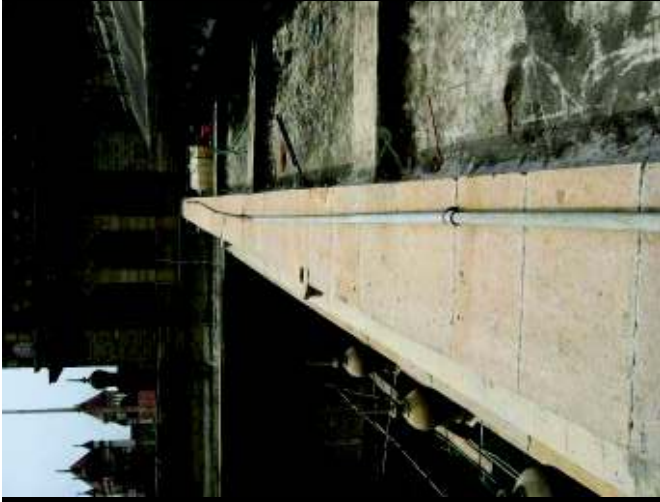
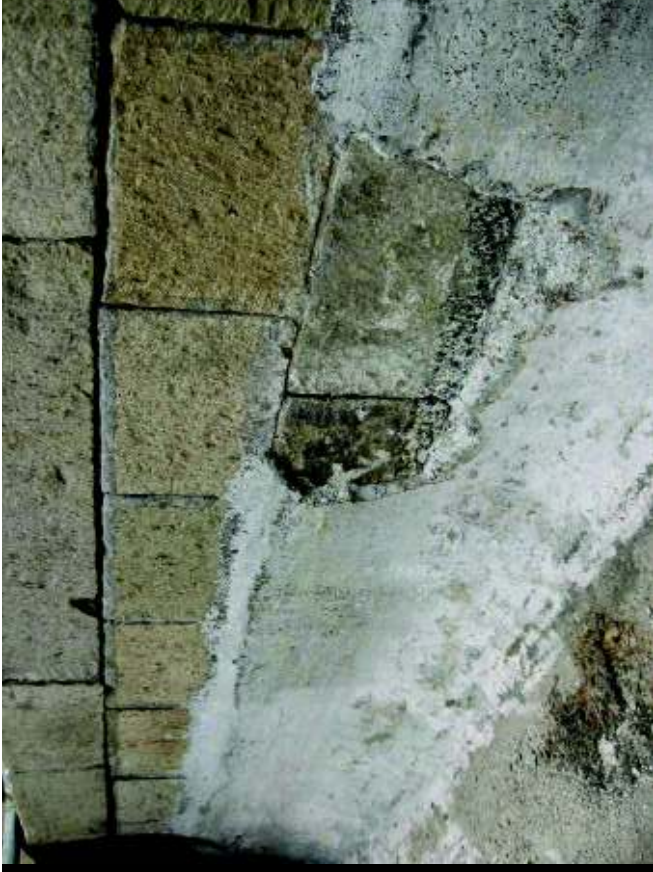
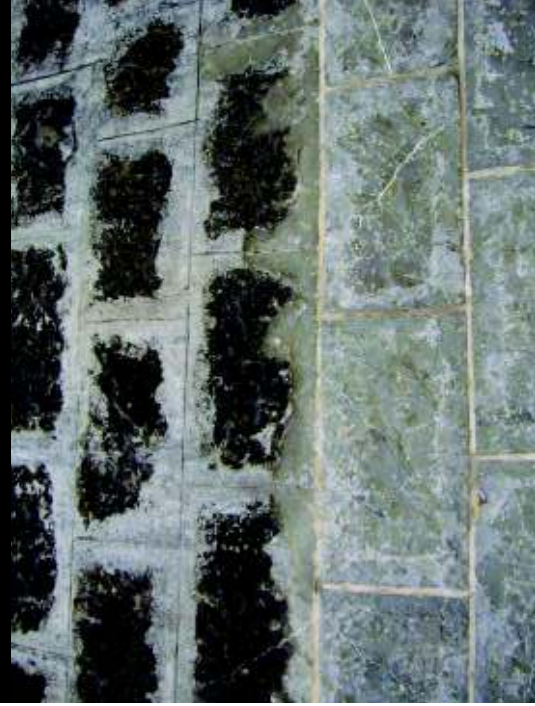
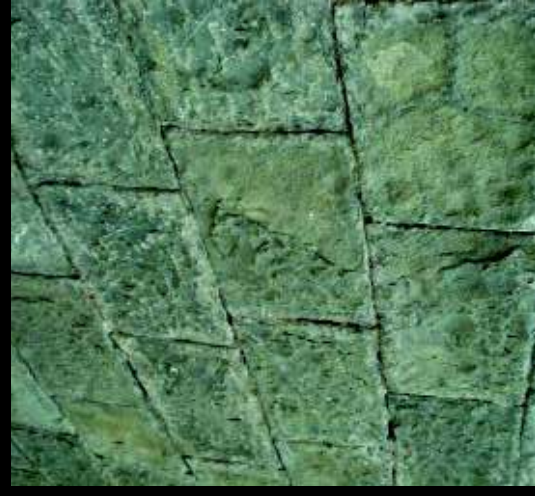
This pointing exercise was undertaken in the 1970's and the pointing mix was not compatible with the original softer lime pointing. Almost the entire façade of the North West and the south east protruding block has been re-pointed in cement. Ribbon pointing juts out from the surface of the masonry, is much wider than the original joint and different from the original texture of pointing, therefore altering the visual aesthetics of the stone. The careful removal of this hard ribbon pointing was undertaken as a first step in the restoration process.

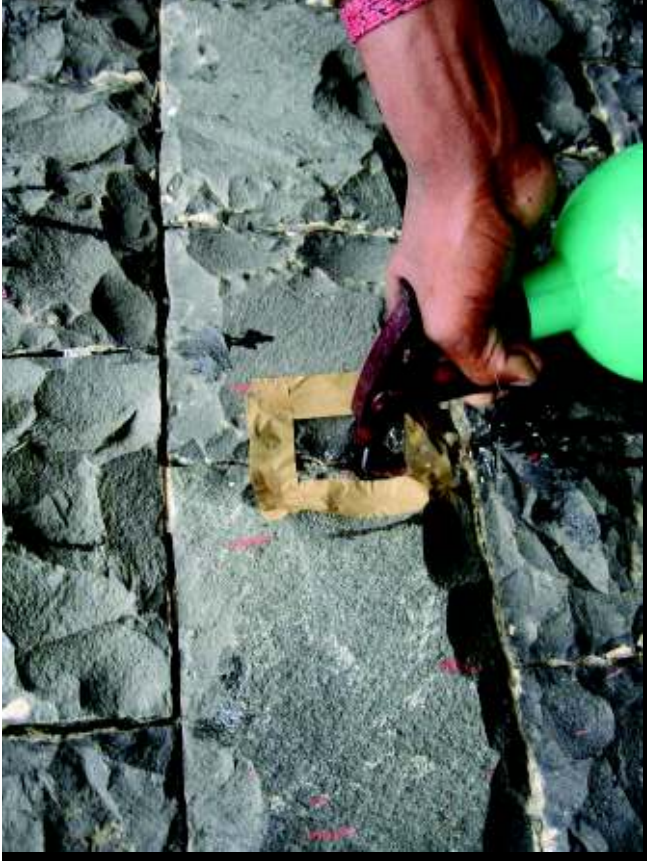
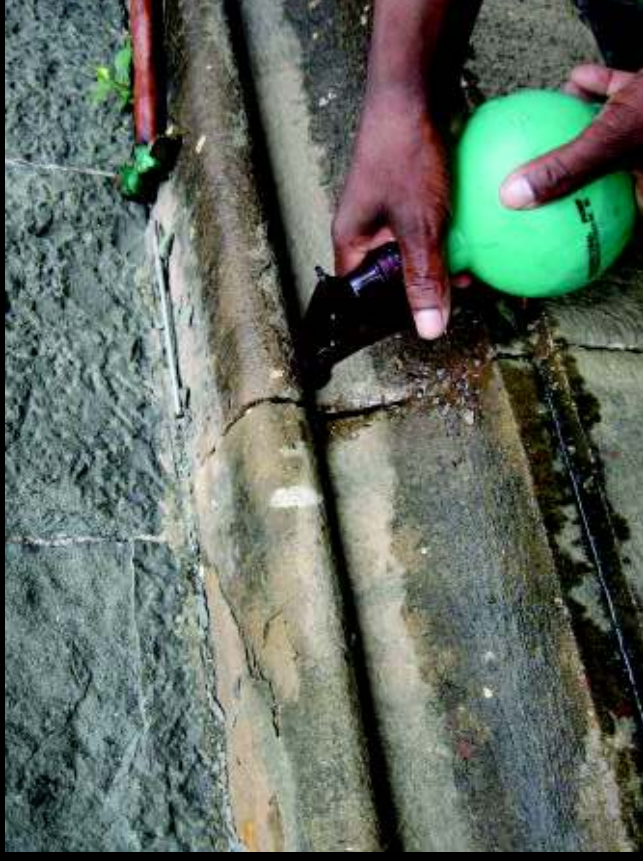
Areas along rainwater down takes were prone to ficus growth as the constantly wet masonry harboured such plant growth. In the case of smaller ficus (peepal /banyan) plants growing out of the stone joints, the methodology adopted was that of pulling out the plant and using a syringe to inject the ammoniacal biocide into the root system. In case of larger plants, a length of the main stem was cut out at a convenient height above the stone surface. The plant was then sprayed over with biocides and the parent stem, after cutting was cut into a frill girdle, and coated with a paste made from Ammonium sulphamate crystals. This is a better system than using acids, but in cases of extremely stubborn growth, when the above measures are not effective, and the masonry is not a soft limestone, only then can the option of injecting acid be adopted, and that too after ensuring that no surface overflowing of the solution takes place.

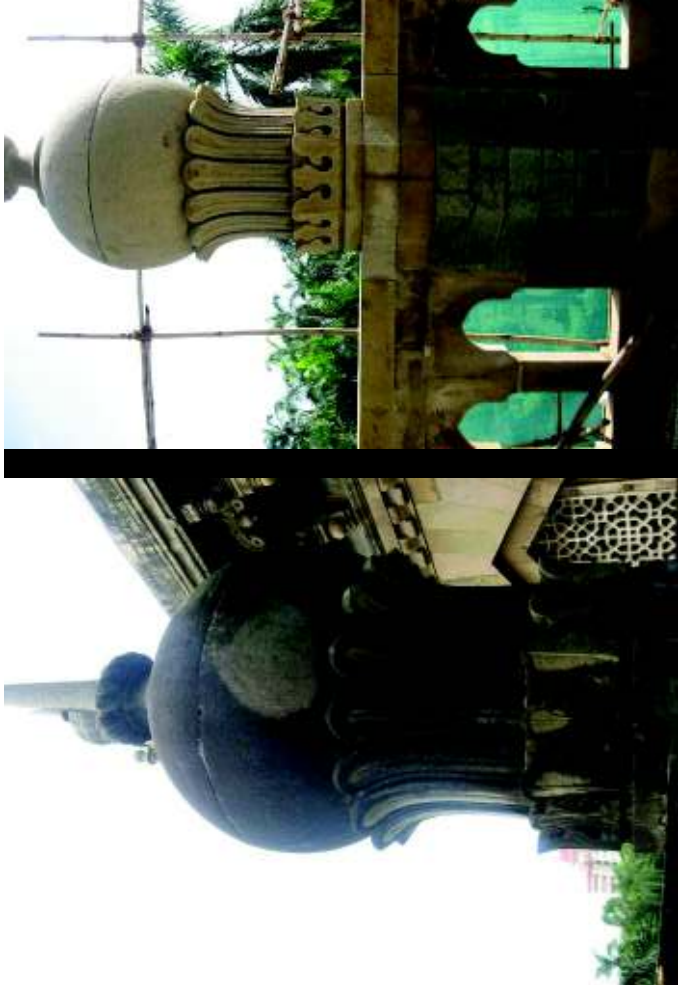
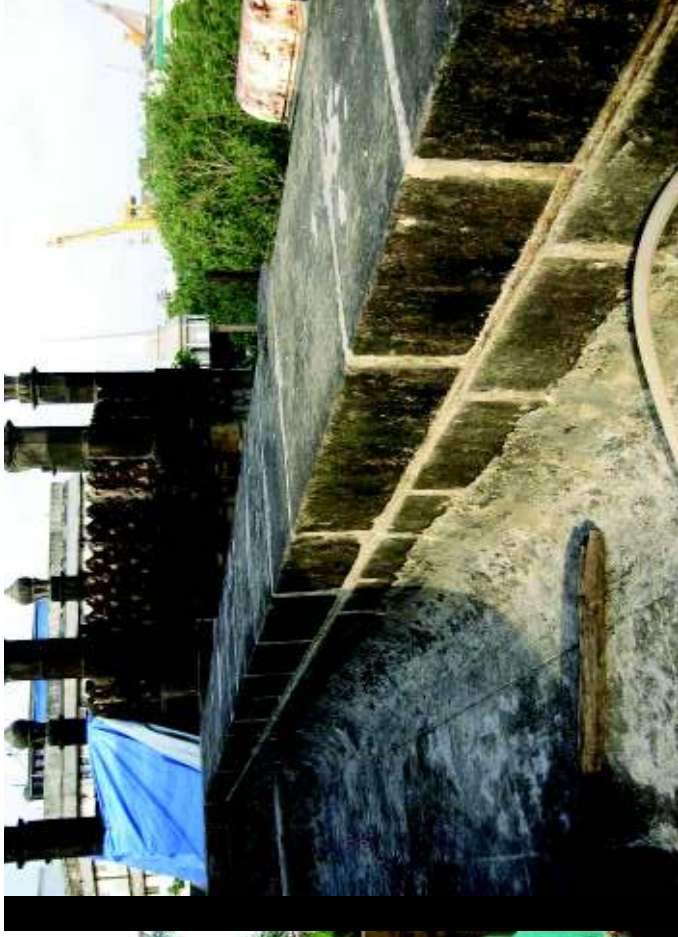
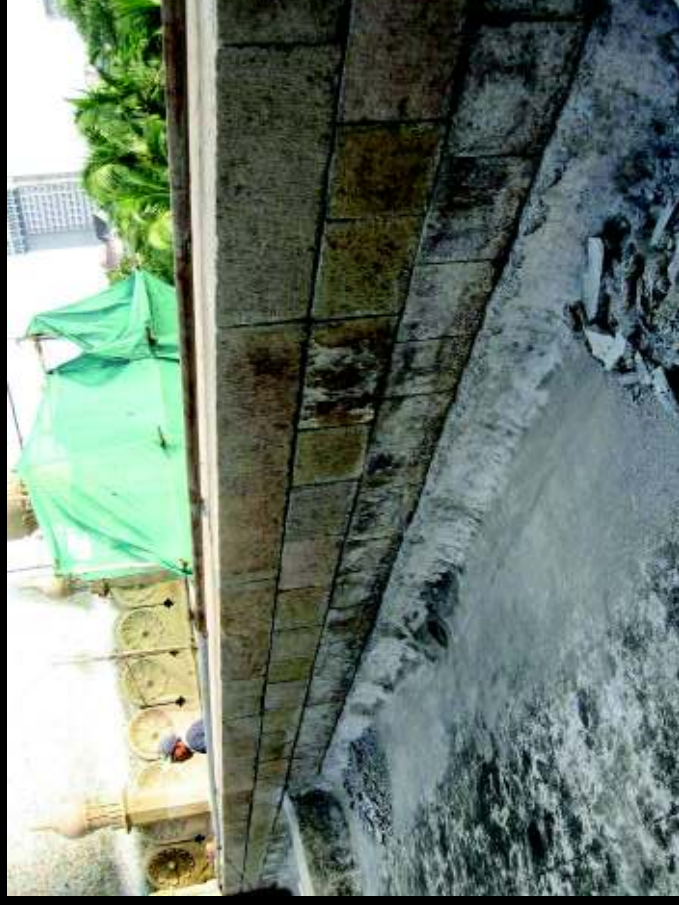
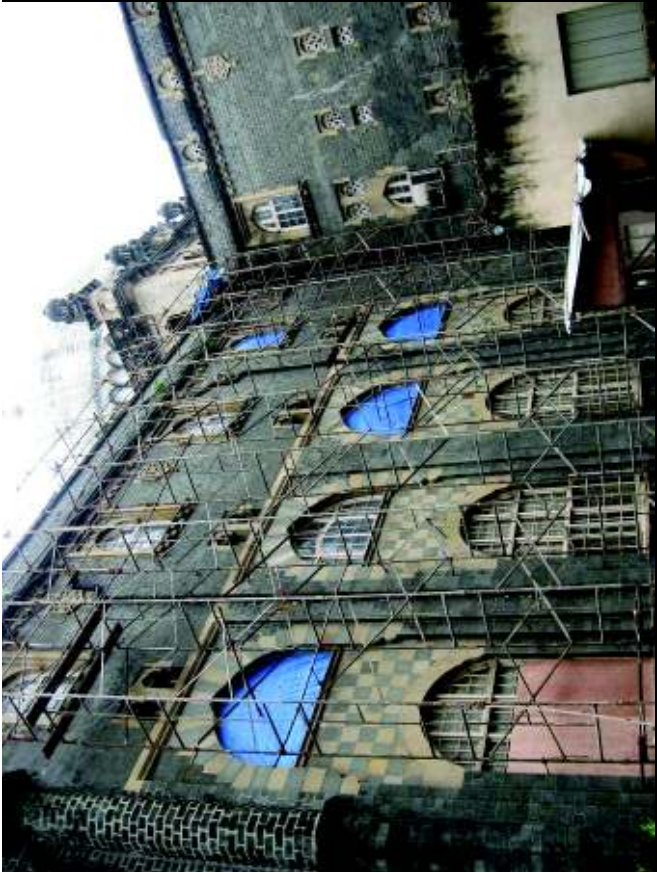
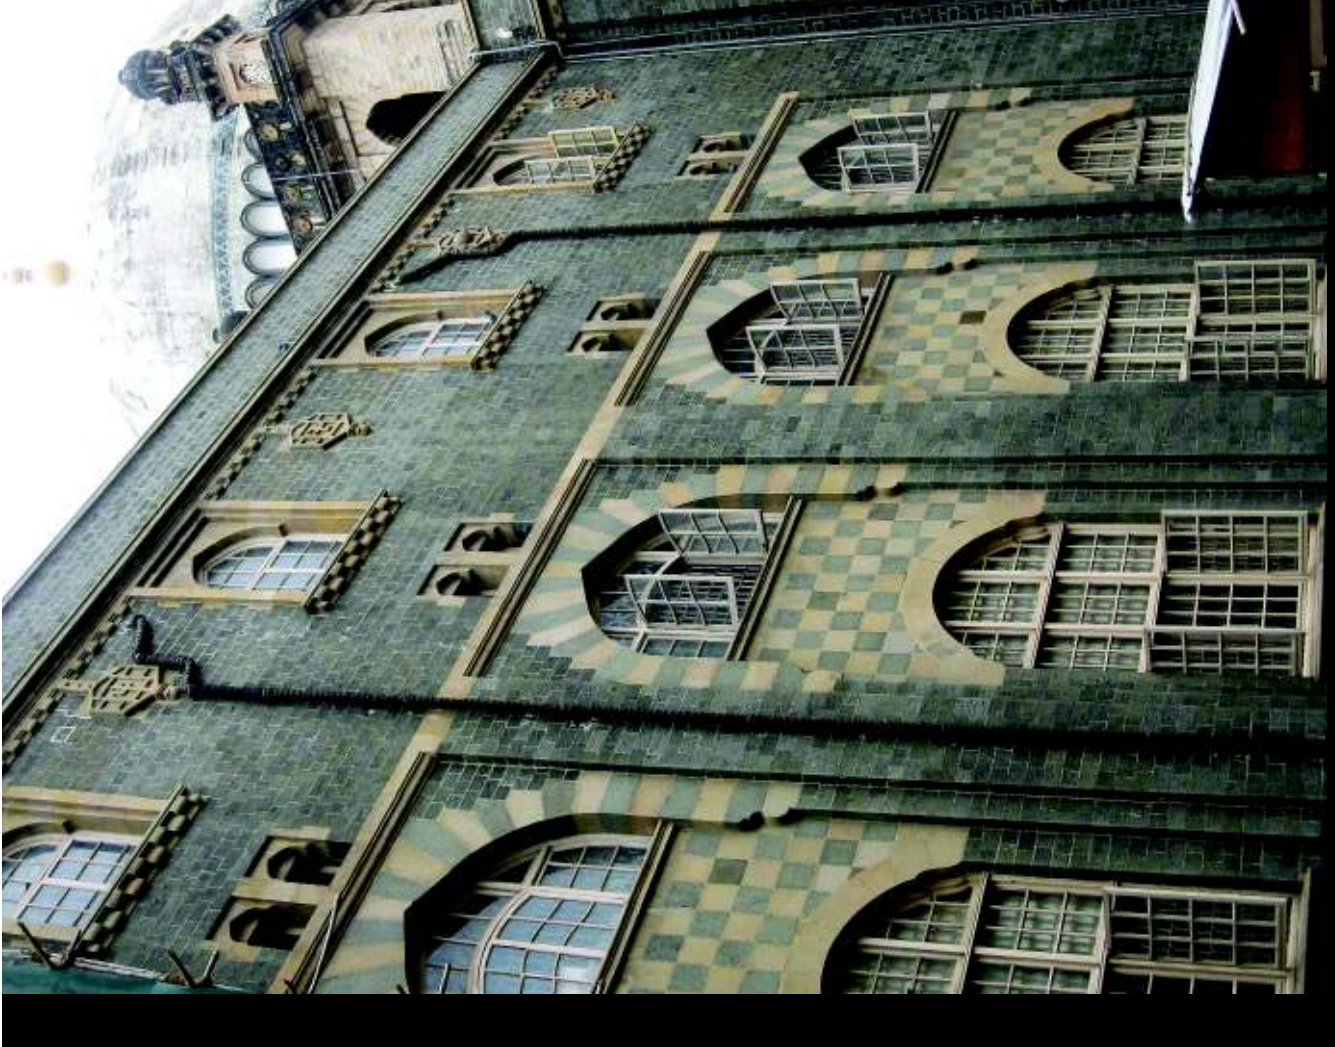
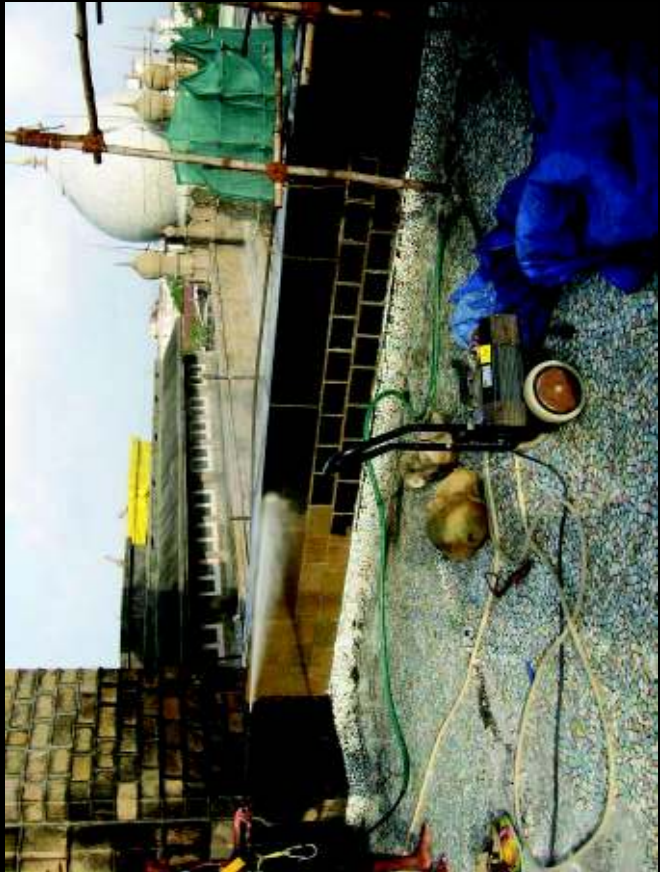
**WATER MISTING AND SPECIALISED STONE CLEANING**

The building has an external stone facing of grey Kurla Basalt stone, combined with buff coloured stone brackets and decorative bands in Malad stone that is a variety of trachyte. The masonry however, exhibits some amount of stone staining and stone surfaces on the external facades exhibit surface deposits, general staining and accretion of pollutants. The turrets and domes dotting the skyline were especially exposed to surface deposits and dark staining, while the patches of masonry near water spouts showed salt deposits and sulphate growth. Stone Cleaning with carefully calibrated water misting was employed and the sample areas were approved by the Architects.

The entire stone cleaning systems adopted have employed non abrasive, sensitive methods, without any use of harsh chemicals.

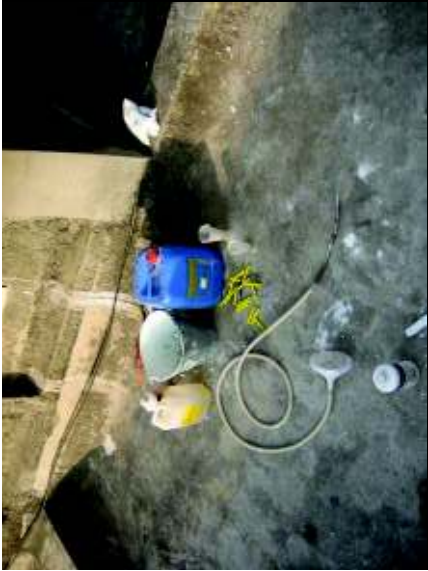
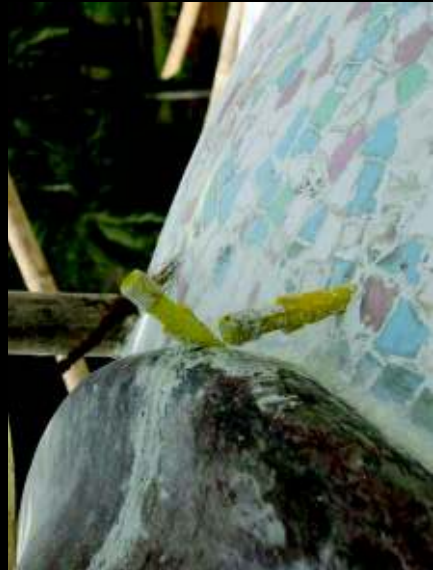
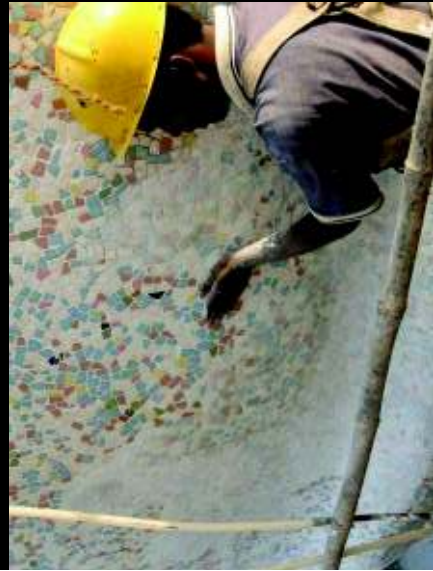
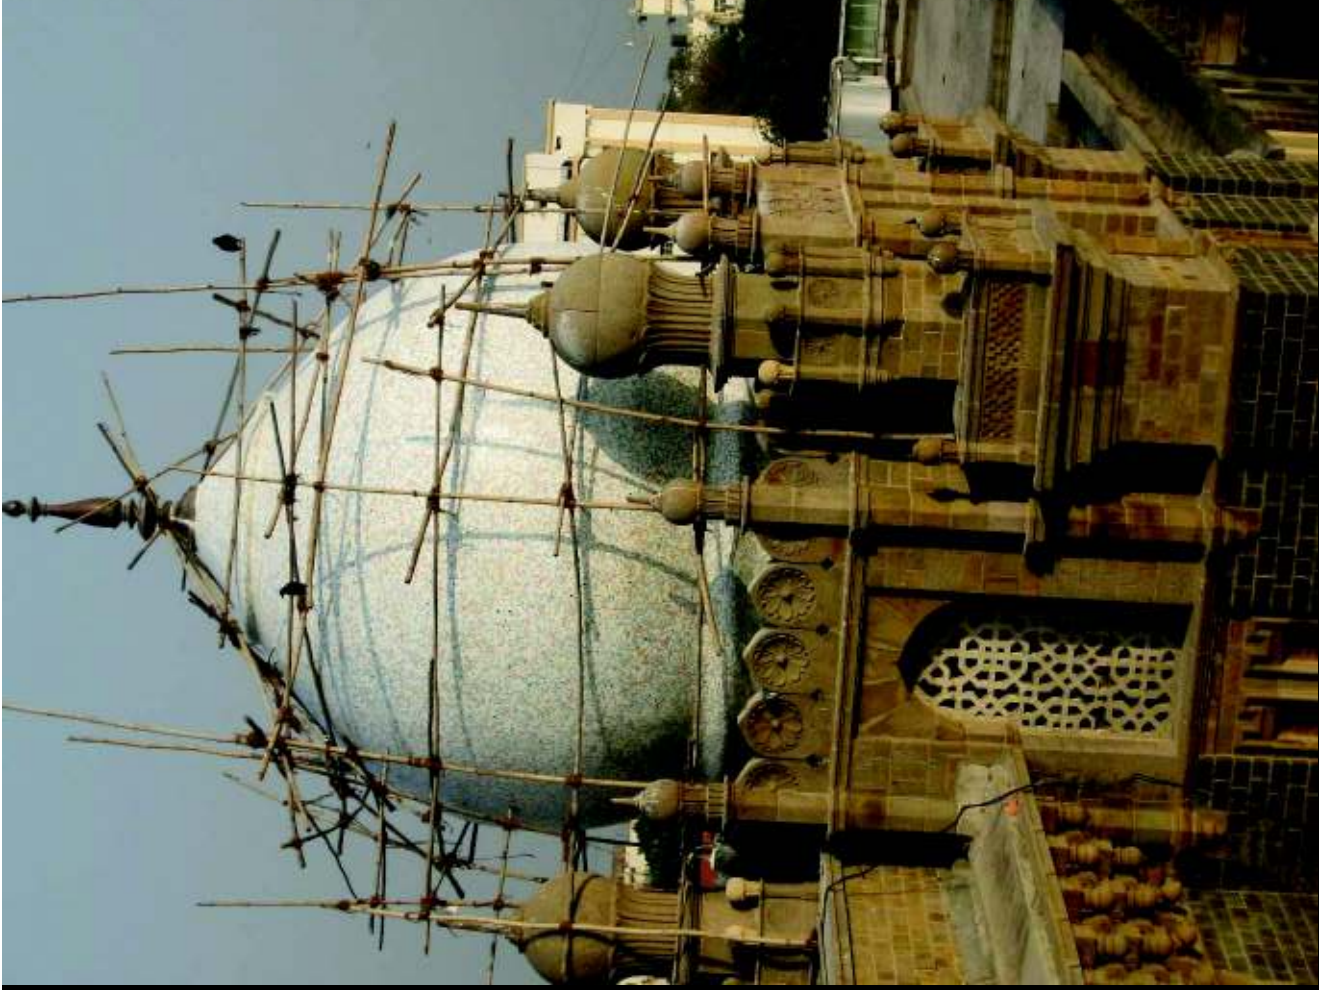
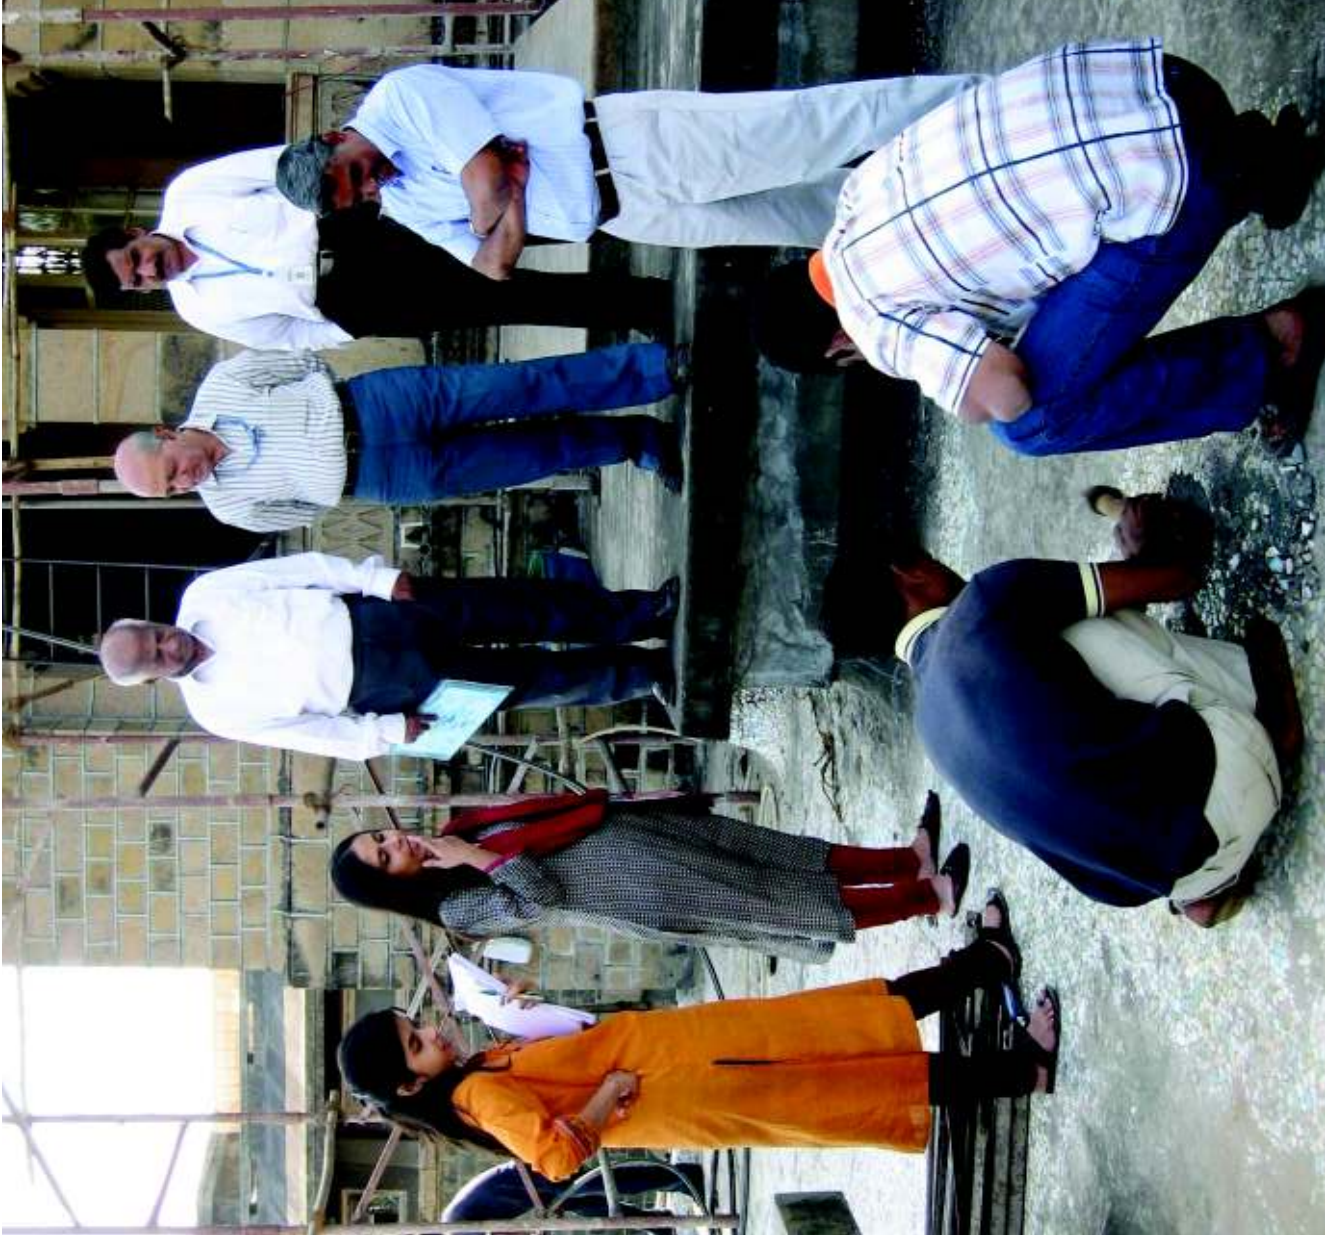
The Consultants have inspected sections of the terrace waterproofing that had been cracked and after opening out sections of hollow and cracked terrace waterproofing the team jointly decided that redoing the China Mosaic waterproofing would be a more effective treatment for addressing the waterproofing as the underlying layer of screed was very friable and had an extremely low cement content.

Joint meetings between the Architects, Structural Consultant, Project Management Consultants and Contractors have been undertaken to assess the quality and progress of work.
