RESTORATION OF DAVID SASSOON LIBRARY AND READING ROOM 2005 - 2006

RESTORATION OF DAVID SASSOON LIBRARY AND READING ROOM
Consultants: BOMBAY COLLABORATIVE URBAN DESIGN AND CONSERVATION PVT. LTD.

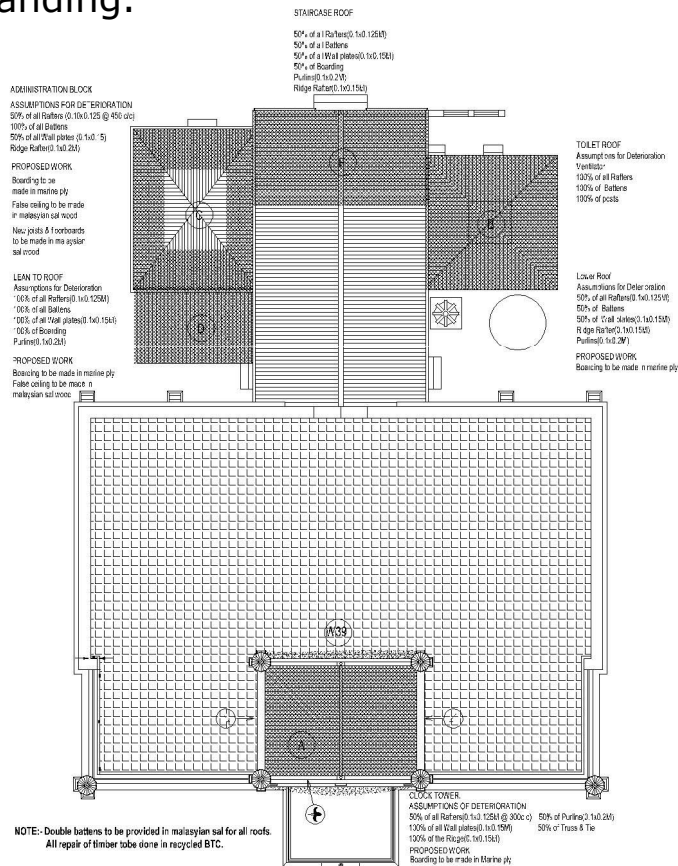
PROPOSED WORK BEFORE OPENING OF ROOF

Initially it was decided to open up only 25% of the entire roof, as the ends showed deterioration and damp condition. The assumption of deterioration before opening up the 25% was 50% of all rafters, 50% of all battens, 50% of all wall plates, 50% of boarding, purlins and ridge rafters.

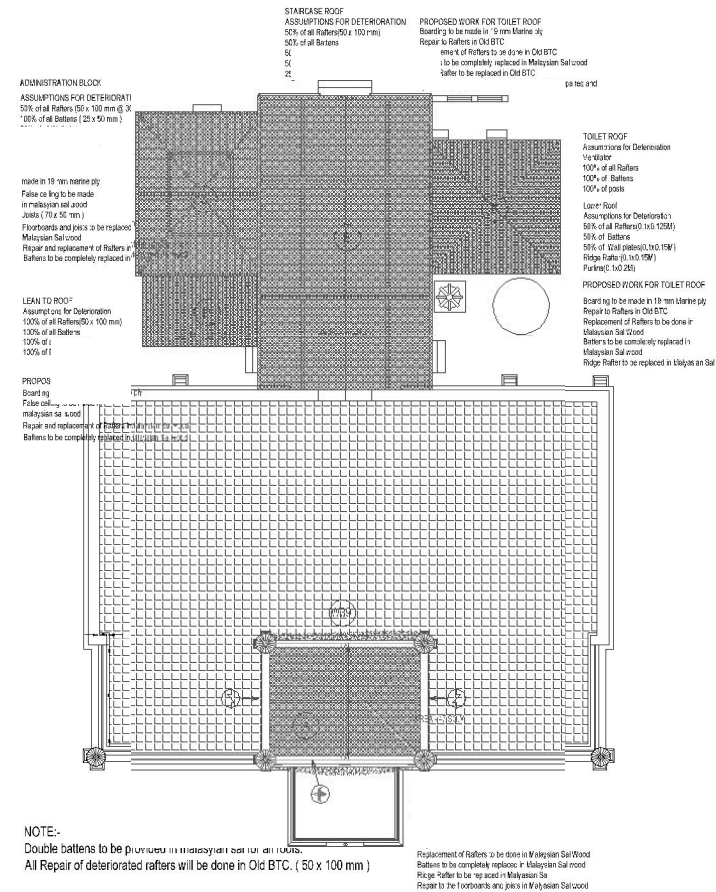
PROPOSED WORK AFTER OPENING OF ROOF

After opening up, as there was extensive termite infestation and the entire roof had to be opened to check on extent of repair.

The junctions at the parapet wall were largely the source of water leakage. Additionally, the wood boarding of the angular pitch was badly warped and had resulted in a sagging of the roof. This required extensive replacement of the old wooden boarding with new wooden members.

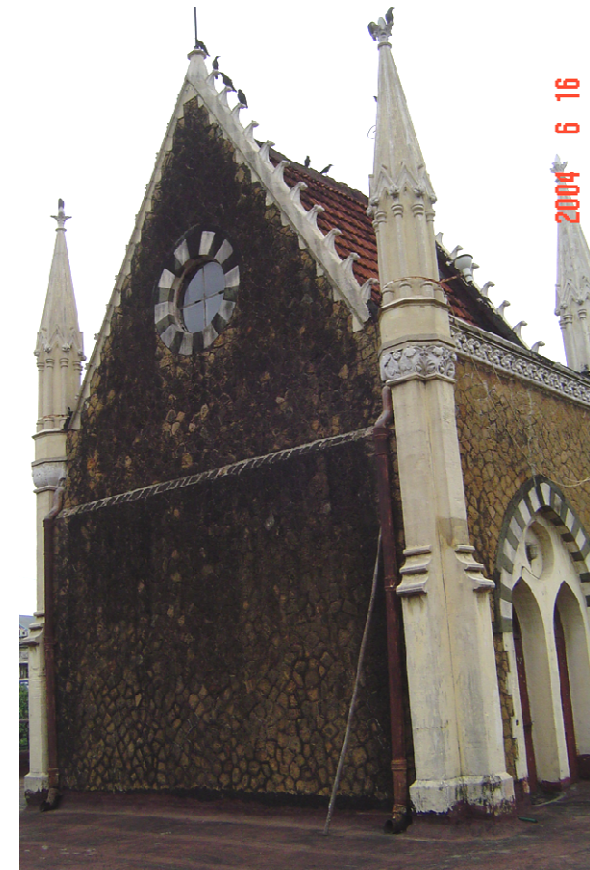
Clock Tower Roof

Assumptions of deterioration – 50% of all rafters, 100% of all wall plates, 100% of the ridge, 50% of purlins and 50 % of roof and tie.

Boarding made in 19mm Marine Ply

Repair to Rafters in Old BTC

Replacement to Rafters in Malaysian Sal Wood

Battens completely replaced in Malaysian Sal Wood

Ridge Rafter replaced in Malaysian Sal Wood

Repair to floorboards and joists in Malaysian Sal Wood

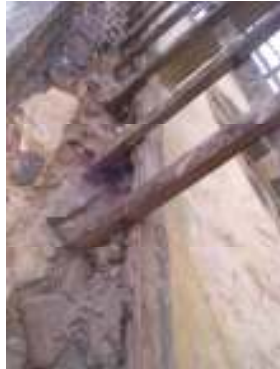
The truss member was in an extremely deteriorated condition. Hence it was decided to strengthen the main truss members by supporting it with U-steel plates and brackets at the ends. Also, the flat roof jack arched needed attention.

Deteriorated end condition of timber truss

The truss member was in an extremely deteriorated condition. Hence it was decided to strengthen the main truss members by supporting it with U-steel plates and brackets at the ends.

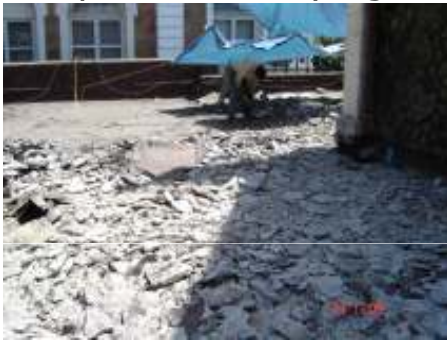
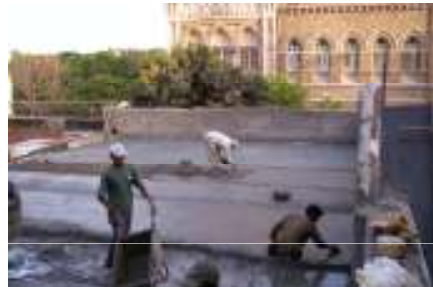
The terrace surface has cracked with evidence of water seepage on the ceiling below - within the reading room and veranda. Hence it was necessary to repair the bitumen layer and re-lay a waterproofing membrane. Due to shortage of space, the terrace is used actively for the library activities and functions. Hence tiling it with appropriate tiles will help in the long run.

When the waterproofing of the flat terrace was dismantled, structural cracks were visible in the slab, which was then attended to, and measures were taken to stitch the cracks. The work is complete with laying of texa

Texsa Membrane –
Deviated Item

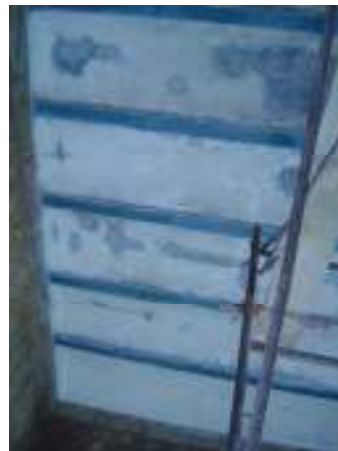
Committee Room Roof

Assumptions for Deterioration: 50% of all Rafters, 100% of all Battens, 50% of all wall plates, Ridge rafter.

The work in the committee room mainly comprised of replacing all deteriorated wooden members.

All Boarding made in 19mm Marine Ply

False Ceiling made in Malaysian Sal Wood

Floor boards and joists replaced in Malaysian Sal Wood

Repairs and Replacement of Rafters in Malaysian Sal Wood

Battens completely replaced in Malaysian Sal Wood

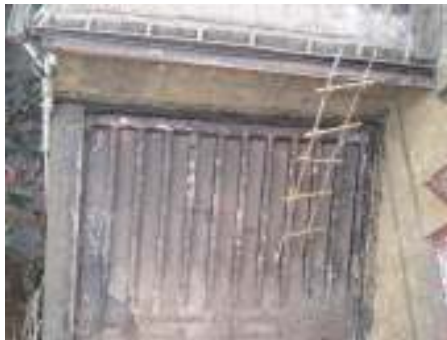
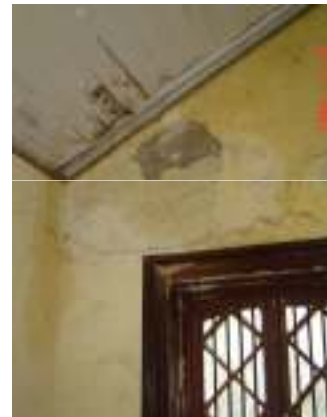
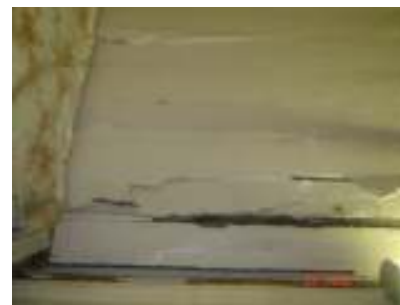
Secretary Room Roof

Assumptions for Deterioration: 100% of all Rafters, 100% of all Battens, 100% of all wall plates, 100% of boarding.

Boarding in 19mm Marine Ply

False Ceiling made in Malaysian Sal Wood

Repairs and Replacement of Rafters in Malaysian Sal Wood

Battens completely replaced in Malaysian Sal Wood

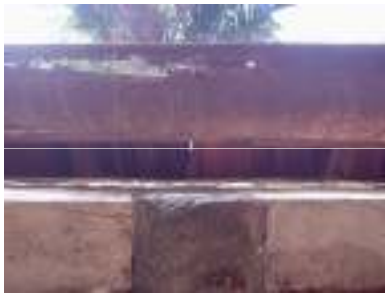
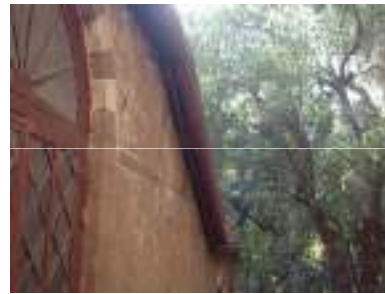
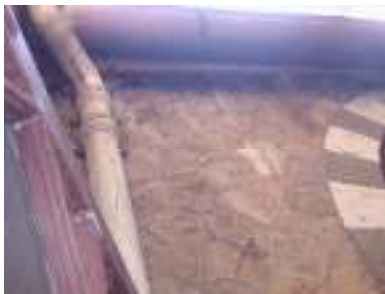
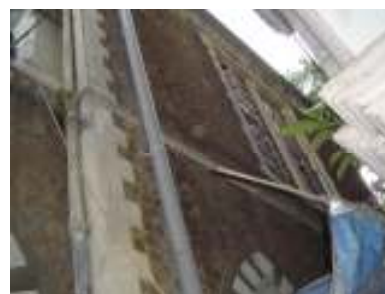
2.6 Plumbing Works

The gutters of the pitched roof had deteriorated completely. As the roofs are high, it is difficult to access the gutter to remove the dirt and leaves lodging at their junctions that cause water penetration through the walls. Additionally poor plumbing connections had also caused water leakage. Gutters needed to be removed and retained only wherever essential and where they can be accessed easily. Instead of gutters, roof overhangs need to be extended to allow the water to flow over without splashing on the wall.

The plumbing job is to replace all corroded pipes with PVC pipes along with removal of old gutters and providing with new GI gutters.

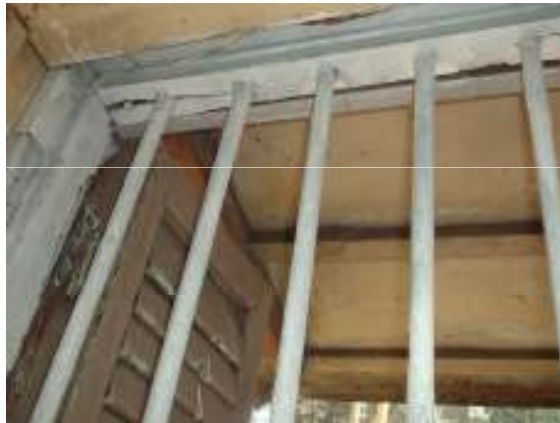
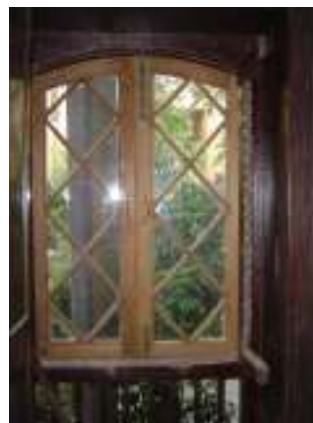
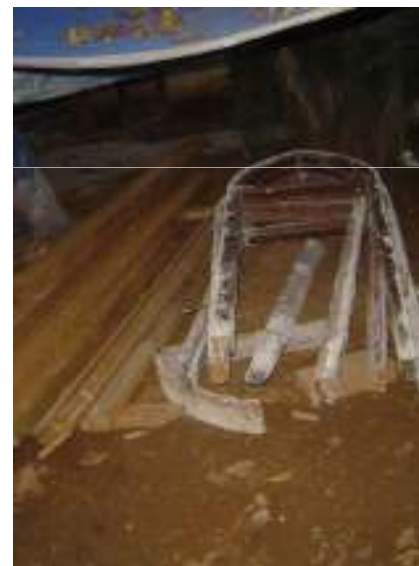
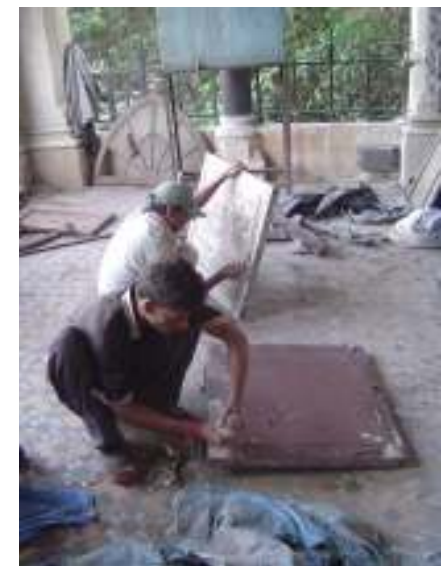
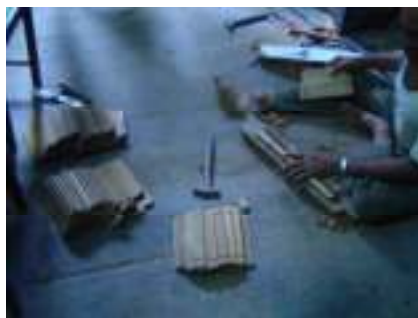
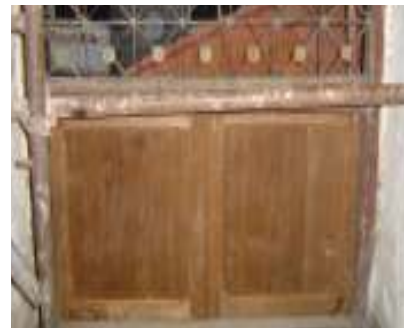
All the deteriorated doors and windows will be dismantled for repair works. The repair and restoration of the doors and windows will constitute of patch repair to the deteriorated wood in doors and windows in recycled Burma T.W. replacing missing and broken glass, mullions in T.W. and refixing it back to its correct line and alignment. the doors and windows will also be treated with termite resistant solution and/or solignum along with painting and polishing.

The toilet windows are being replaced by fixed glass louvered windows. The doors and windows that are completely deteriorated have considered as a completely new item.

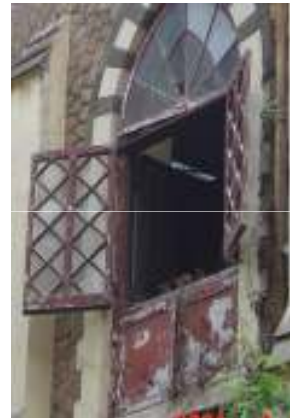
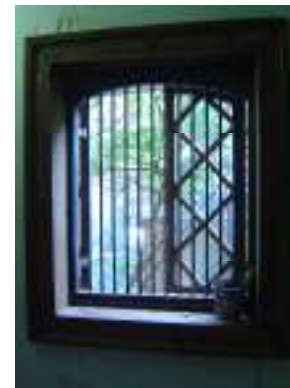
4.2 Making New Doors and Windows

The doors and windows are mostly original and have weathered over the years. Most of the frames are largely intact. However the woodwork of openings facing the west and south sides have deteriorated considerably due to the direct effect of the rains and needed to be replaced. Some windows require glazing replacement and refitting of the mullions. Additionally the beading which hold the mullions need to be replaced for practically all the windows. Along with all the wooden joinery, the hardware and hinges for all the windows needed to be refixed wherever essential.
