Mumbai University Convocation Hall

Scheme for Restoration

Abha Narain Lambah Associates – Conservation Architects & Historic Building Consultants

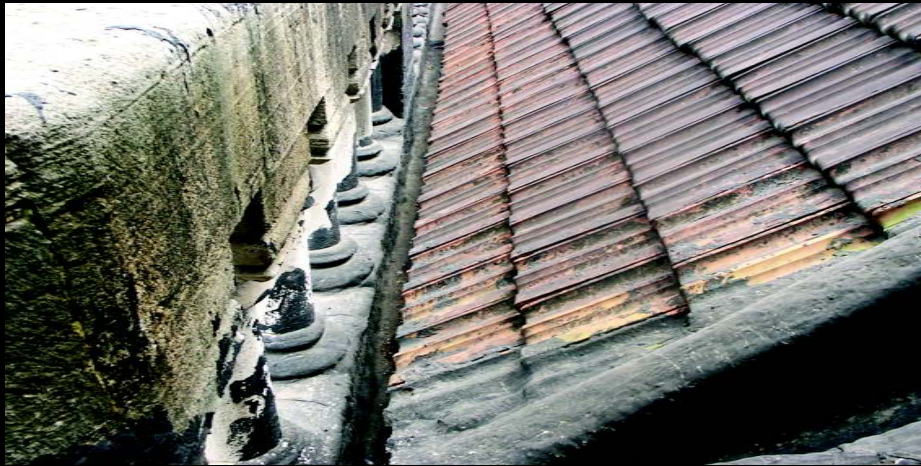
Upper Level Gutter

Lower Level Gutter

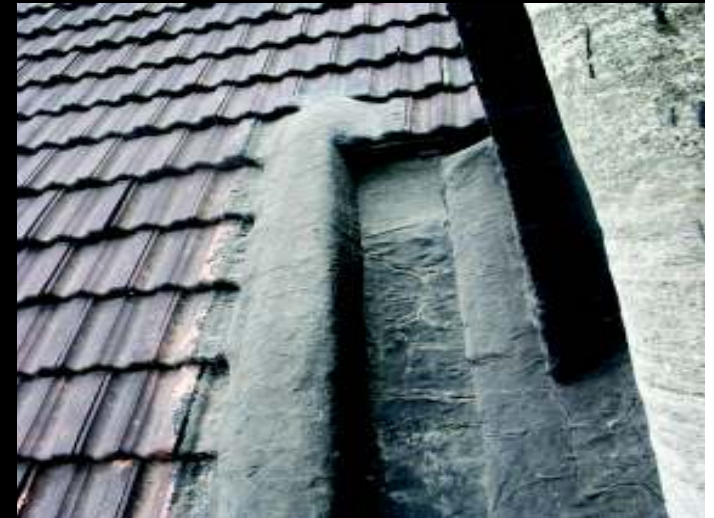
Gutter along Gable end

Upper & Lower Level Gutter
