DOCUMENTATION AND PREPARATION OF CONSERVATION GUIDELINES
for
HERITAGE BUILDINGS AND PRECINCTS IN VASAI - VIRAR SUB - REGION
VOLUME IV: HERITAGE ASSETS IN THE GREEN ZONE

Final Report of the
DOCUMENTATION AND PREPARATION OF CONSERVATION GUIDELINES
for
HERITAGE BUILDINGS AND PRECINCTS IN VASAI – VIRAR SUB – REGION

VOLUME IV: APPENDICES
LIST OF HERITAGE ASSETS IN THE GREEN ZONE

December 2008

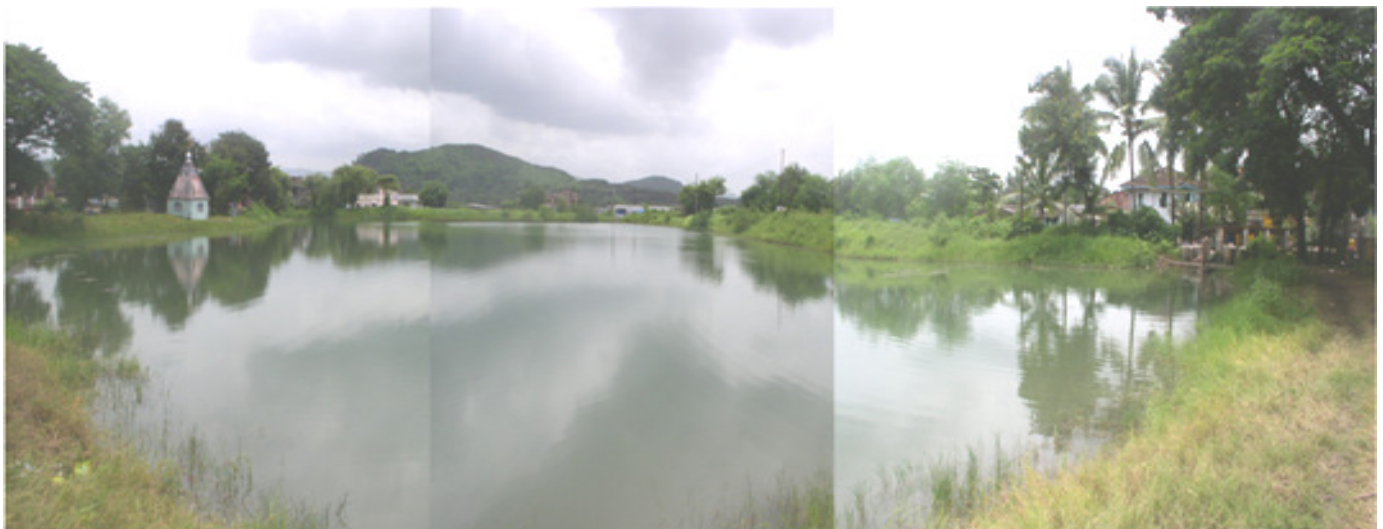
Path along the internal edge of the talav

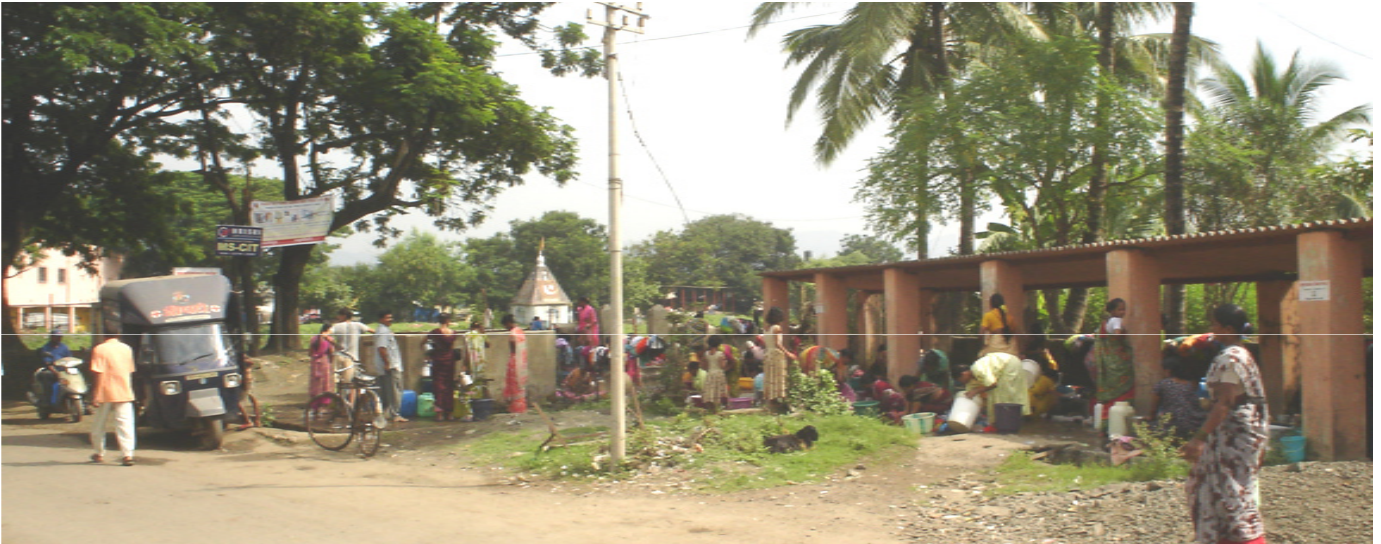
Washing shed along the longer edge which prevents waste water from entering the talav

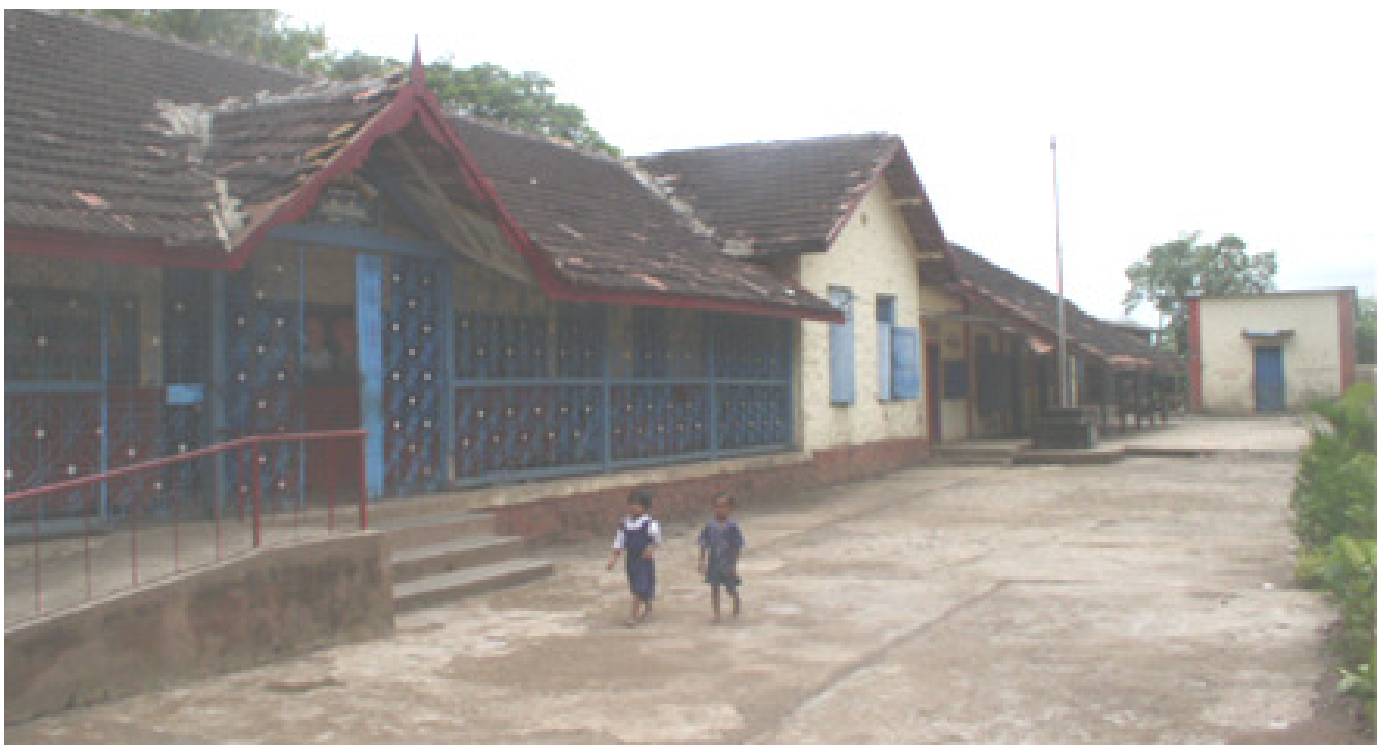
The school building with the verandah and the mangalore tile roof forms a background to the courtyard

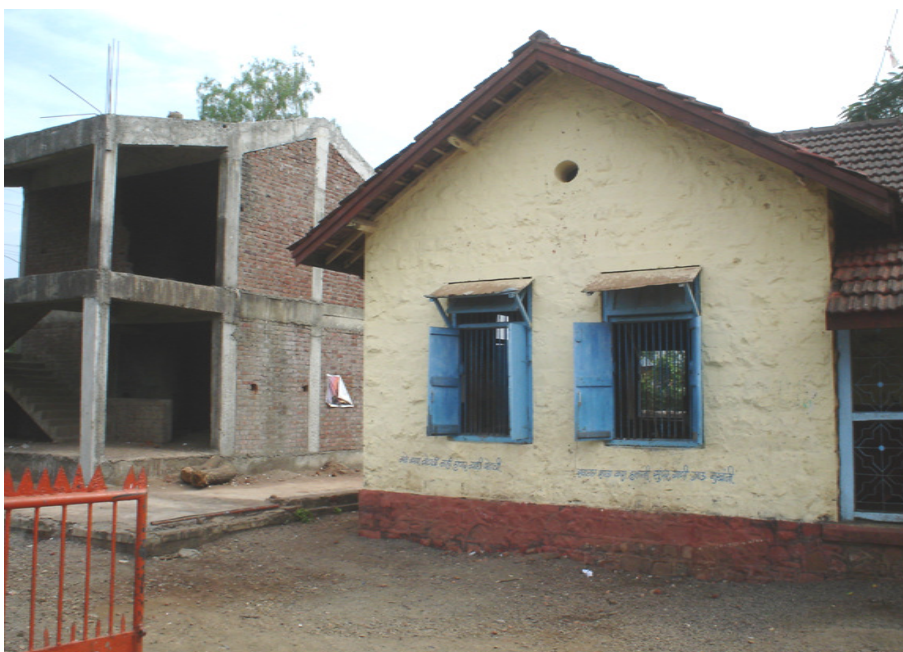
0: RUIN / NON EXISTENT 1: POOR 2: FAIR 3: GOOD	
6	FUTURE RELEVANCE	
6.1	DP Remarks: Reserved as an Institution (School). Perceived Threats: Expansion is required on a priority basis. However, if the expansions are done in an adhoc manner, they would destroy the significant architectural characteristics like the open space and the continuous open verandah.

Extension to the school building

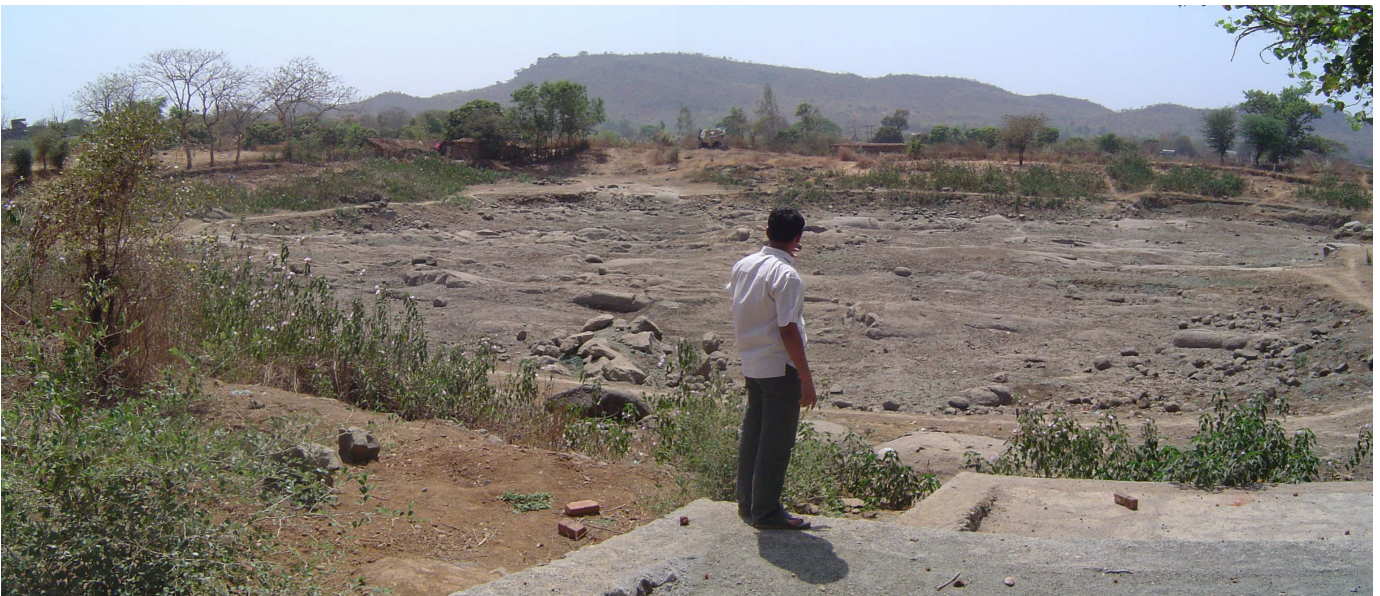
6.2	Owners / Tenants / Occupants / Community / Organizational Aspirations: The stone at the base of the talav is porous due to which the water stored in it percolates easily into the ground. Due to this the talav goes dry for most of the summer months from February to May. The Grampanchayat wants to increase the water retention capacity of the talav.	
7	MISCELLANEOUS	
	Additional Notes / References and Documents Available: Records and information gathered from the Kaman Grampanchayat. Area details verified from the Land Records and Revenue Department (Vasai Taluka).	
8	RECOMMENDATIONS & SUGGESTIONS FOR IMPLEMENTATION	
	Steps should be taken to immediately preserve the artefacts (stone sculptures) in a museum environment. Facilities for washing and cleaning should be provided around the talav. The edges of the talav which presently have large areas of a soft landscape need to be maintained and any repairs, modifications, changes, extensions made to the talav should be sensitive to this physical character of the talav.

Low water retention capacity of the rock leads to the drying up of the talav during summer

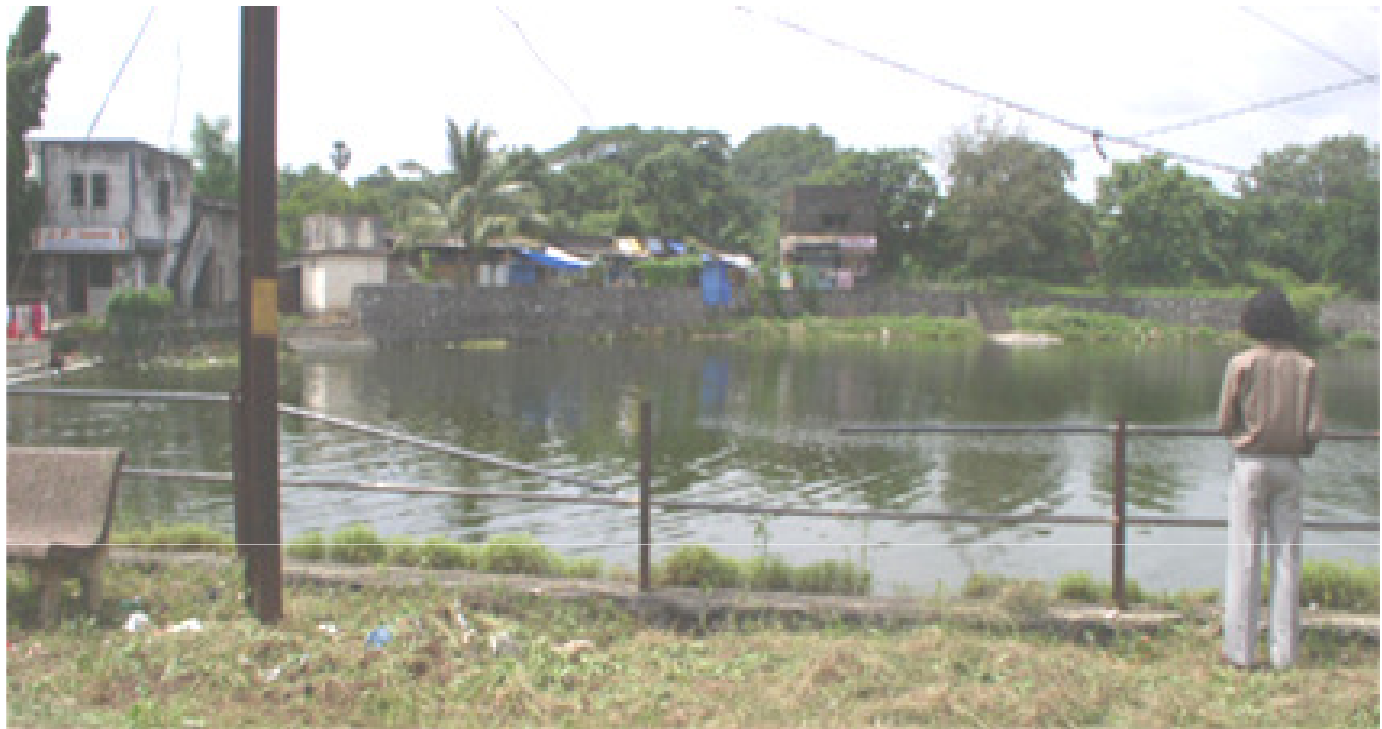
Transforming gaothan along the edge of the talav

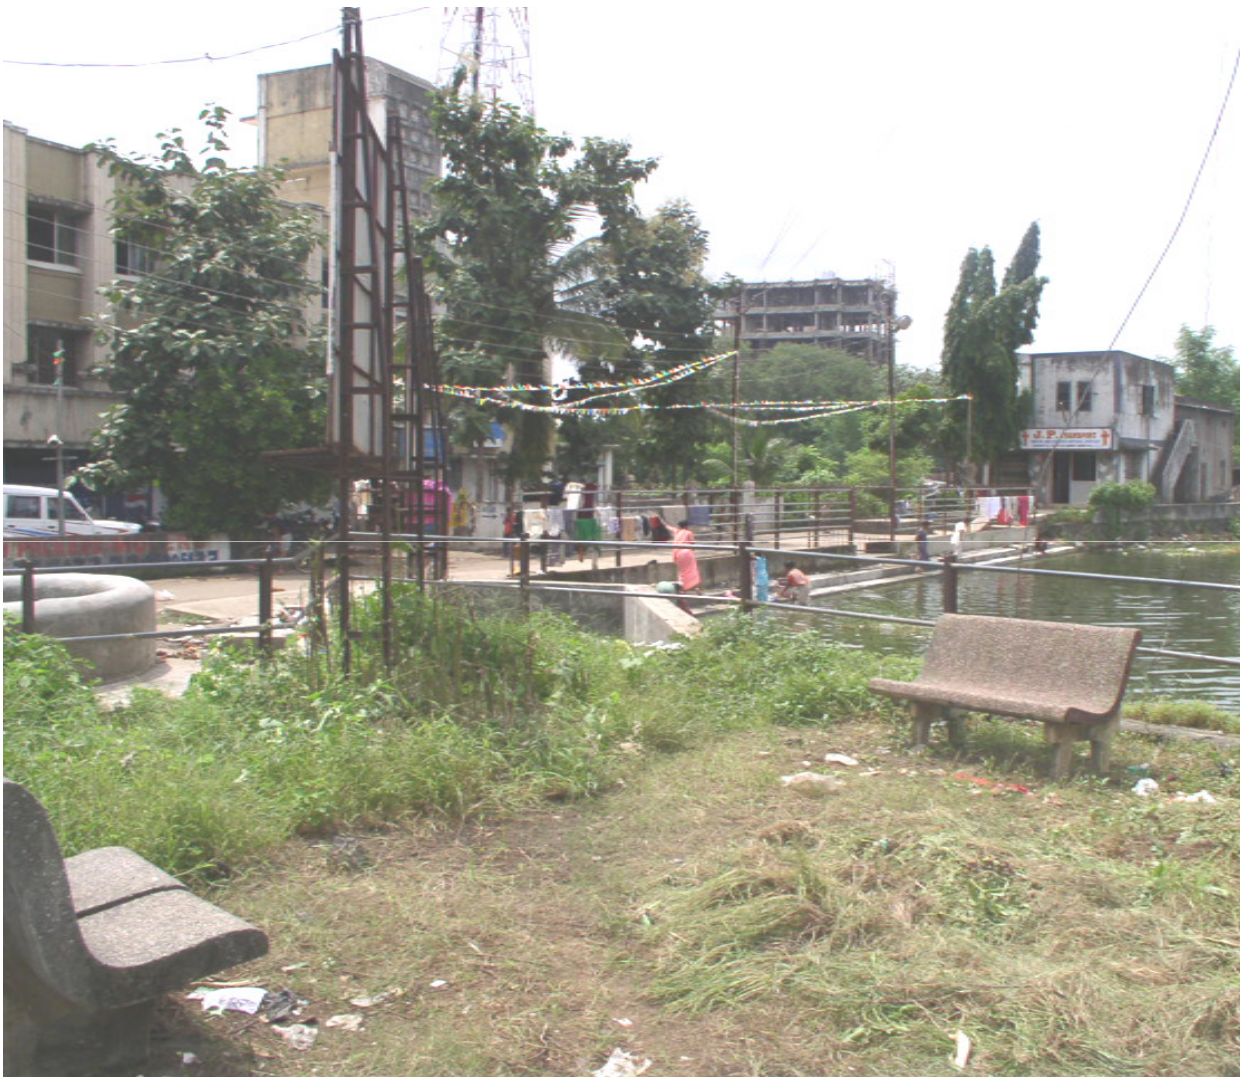
Park along the benches for seating which are unused not maintained regularly

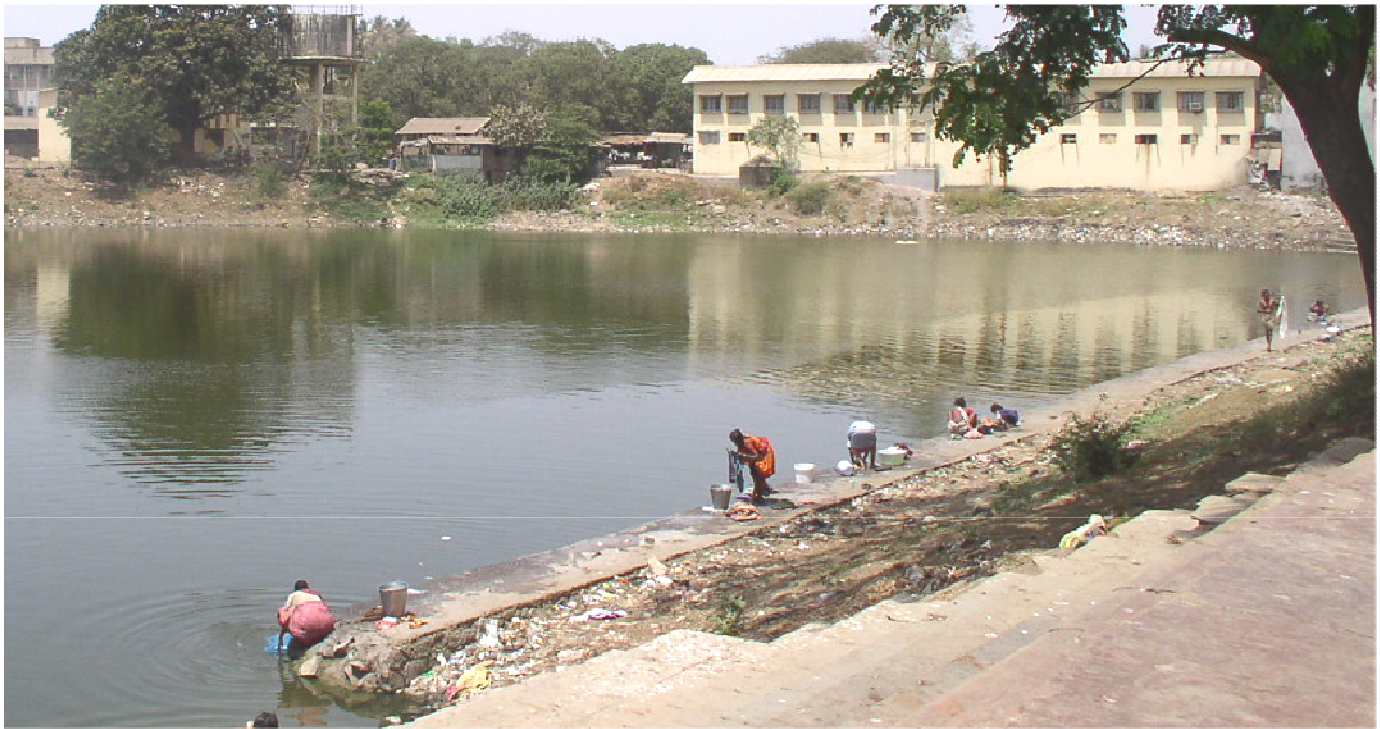
5.2	Physical Infrastructure						Assessment	
Lighting: Inadequate steet lights around the edge of the talav.						Poor		
Sanitation: Solid waste disposal is observed along the edges of the talav.						Poor		
Storm Water Drainage: Water from the surrounding flows into the talav.						Fair		
Public Facilities: Steps to access the water are provided which form washing ghats. Parts of these are broken						Poor

Washing activities along the ghats

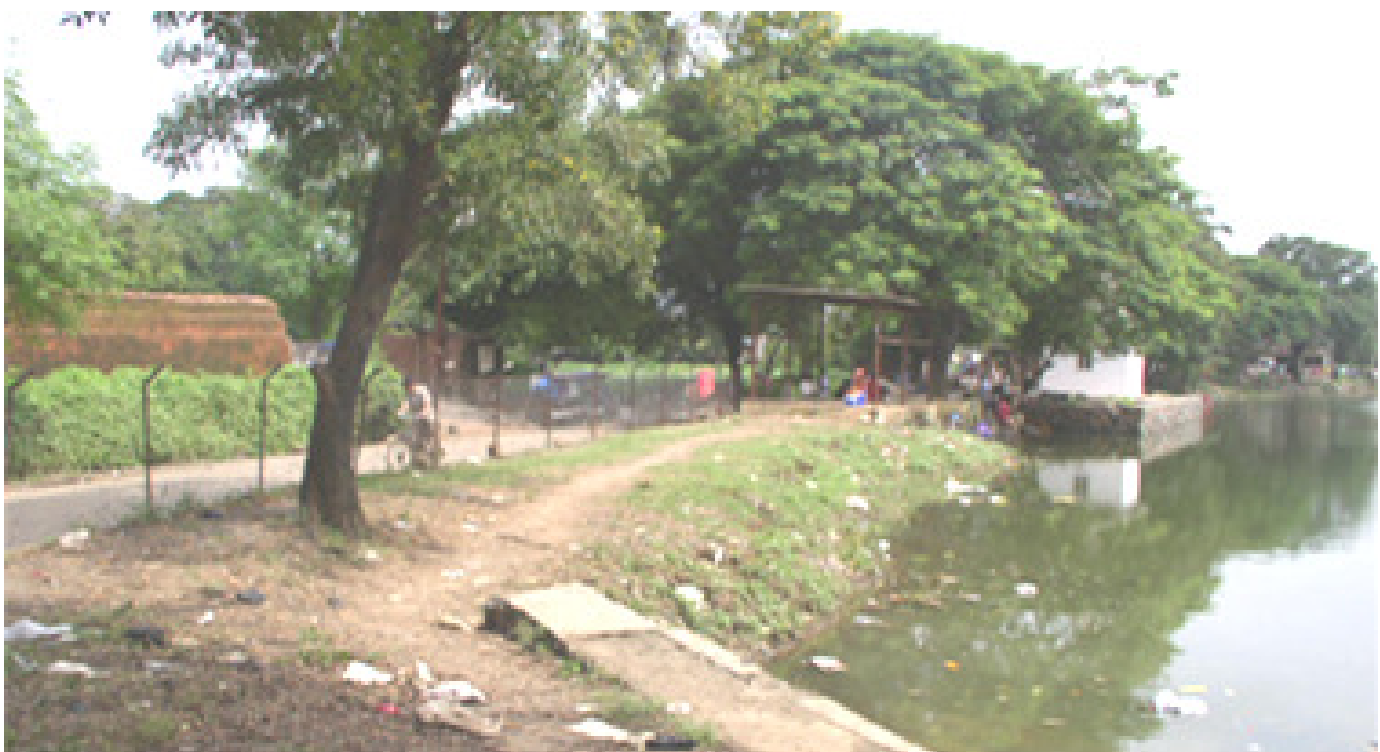
0: RUIN / NON EXISTENT 1: POOR 2: FAIR 3: GOOD		
6	FUTURE RELEVANCE		
6.1	DP Remarks: Reserved as a Water Body.		
	Perceived Threats: The increasing amount of garbage strewn into the talav will lead to the environmental degradation of this important heritage asset.

The edge has programmes like a temple, washing shed and is littered with garbage

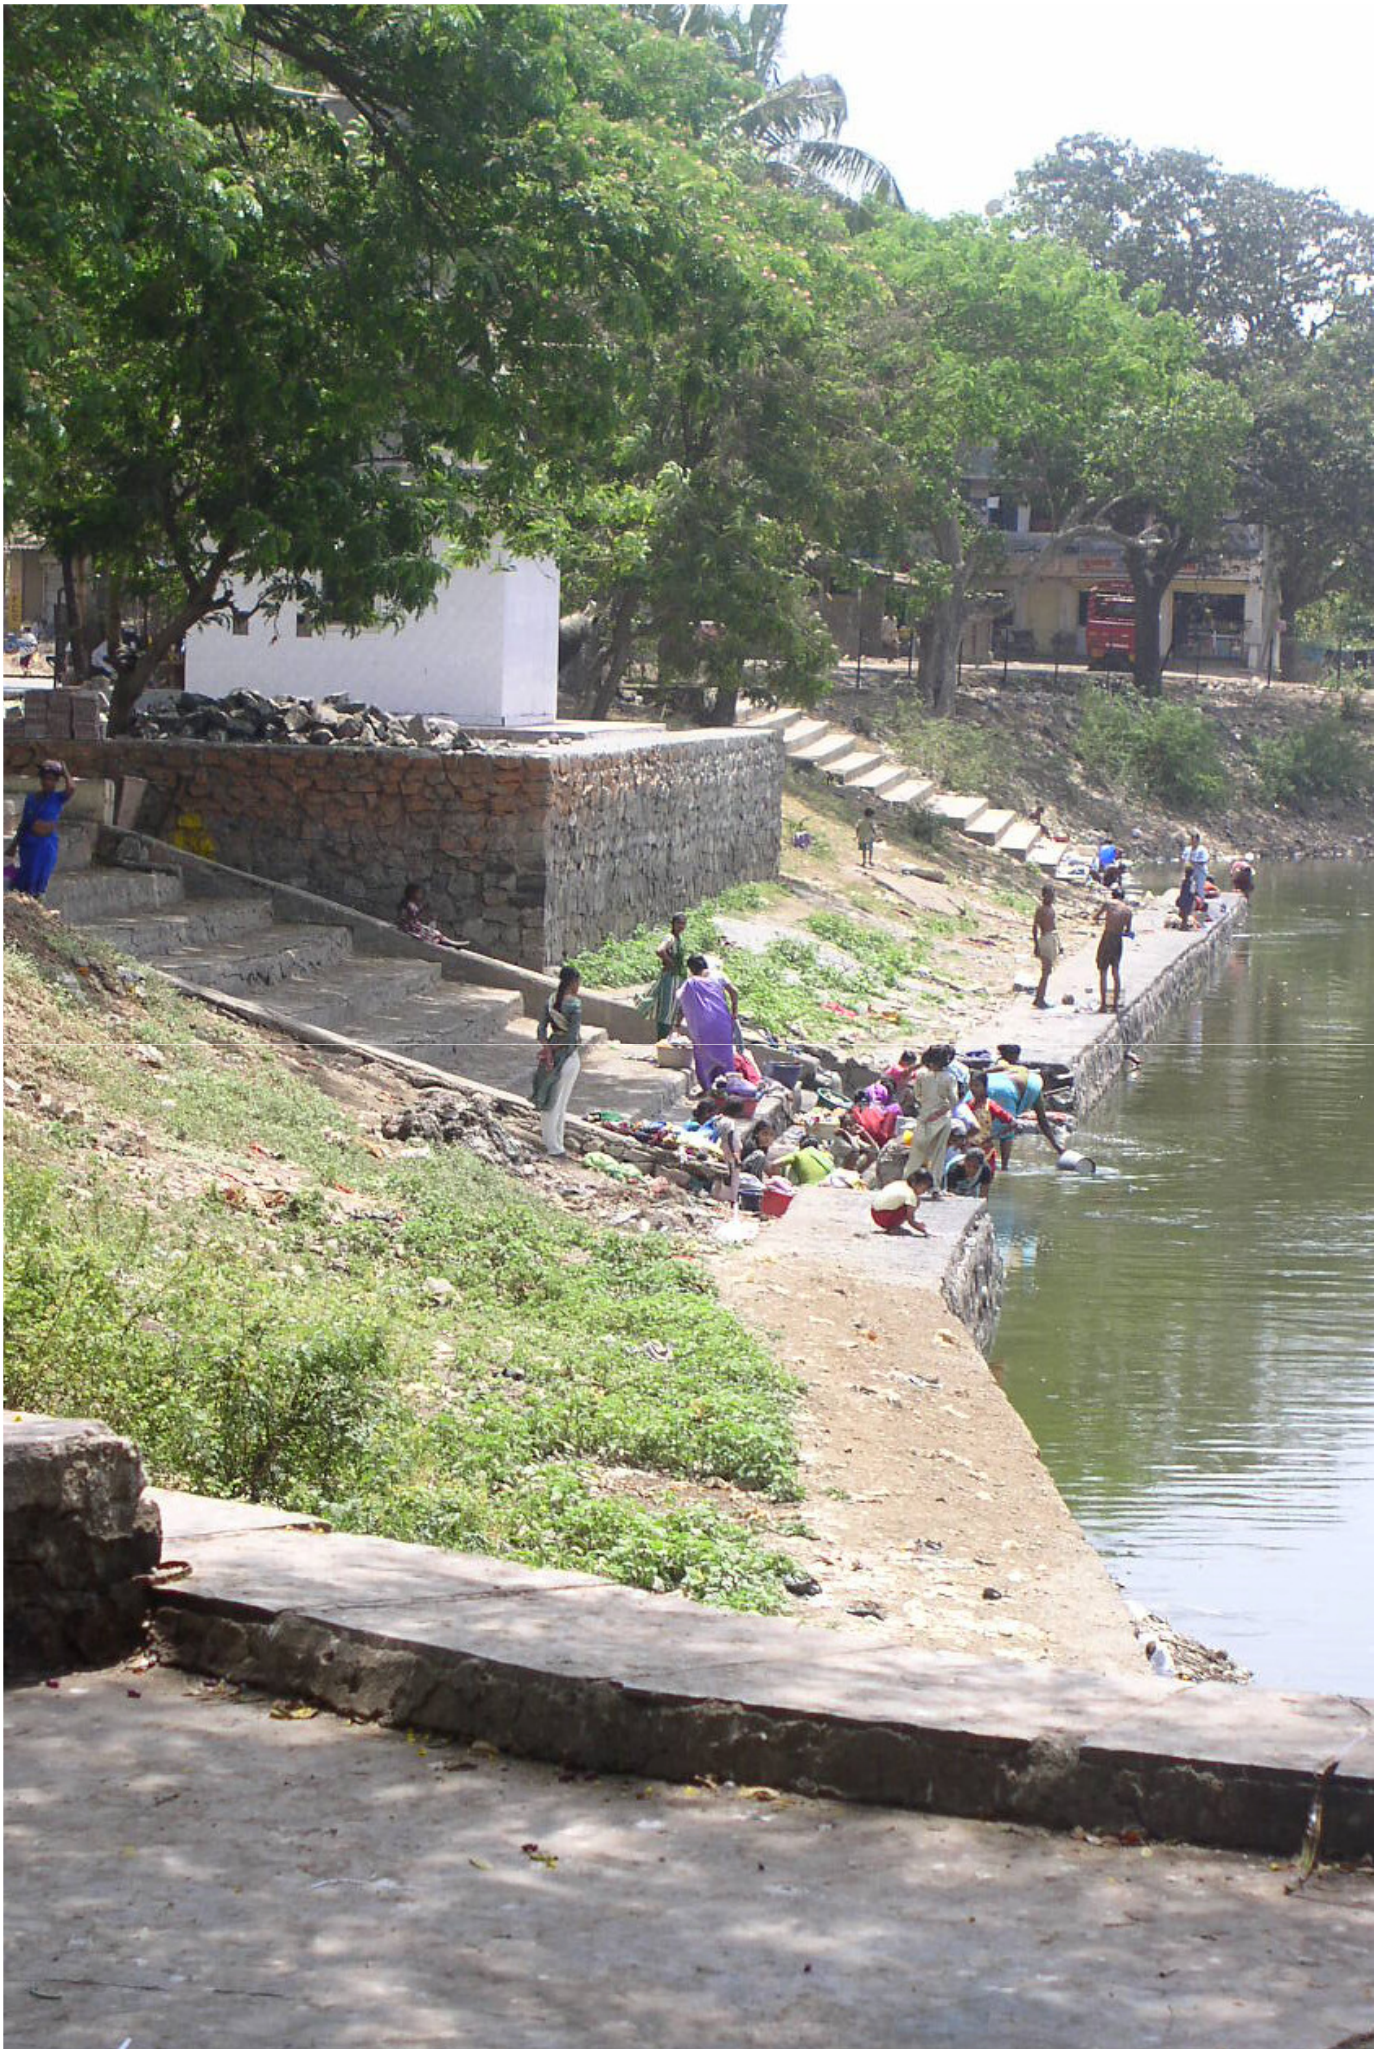
Newly constructed ghats along the edge

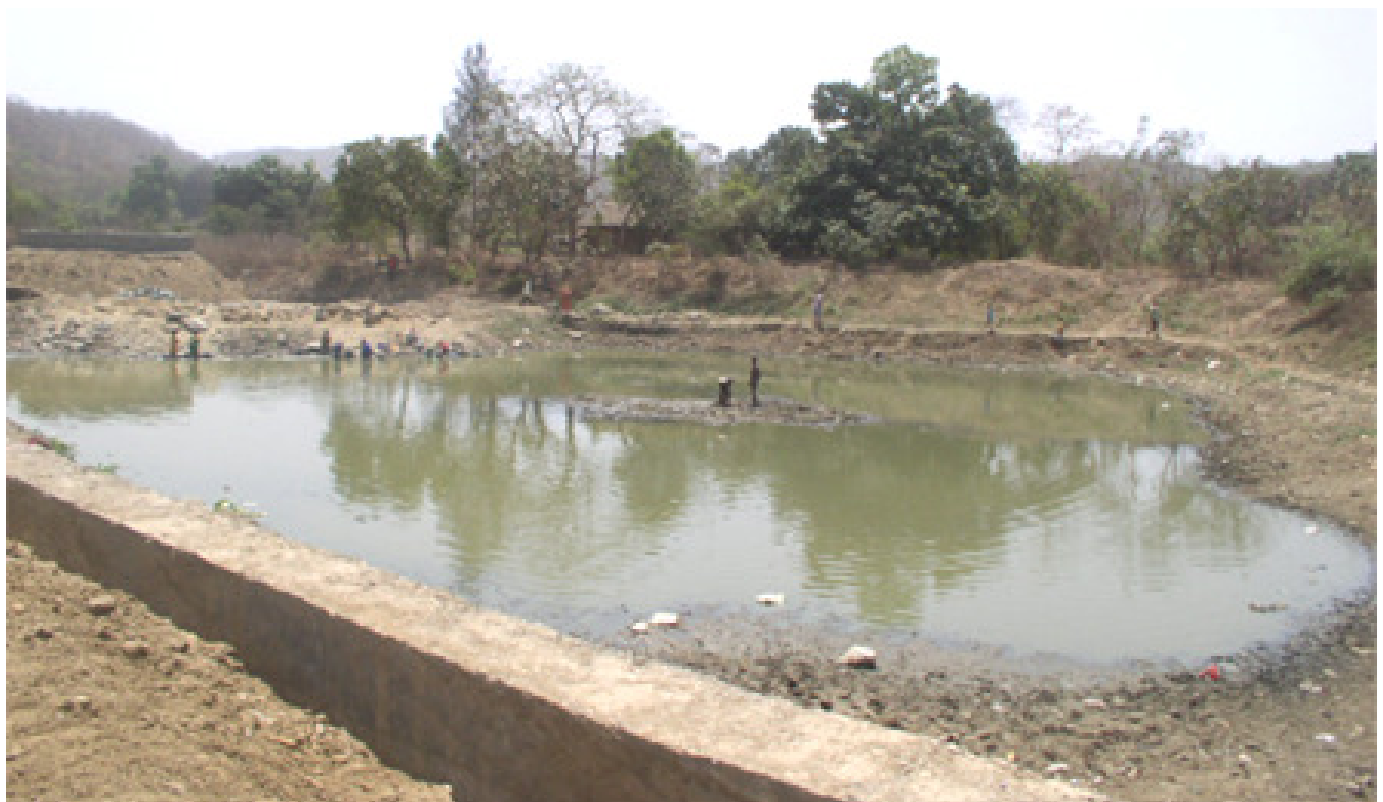
Measures: No monthly maintenance measures undertaken. Annual maintenance measures are based on the availability of funds. A retaining wall has been recently built towards the road edge.	Poor
	Agency and Capacity: Sativli Grampanchayat A need is felt to strengthen the edge of the talav and well as for taking measures to clean the talav. The Grampanchayat does not have the financial capacity to carry out large repairs and maintenance works for which external funds are required.	Poor

Retaining wall along the road edge

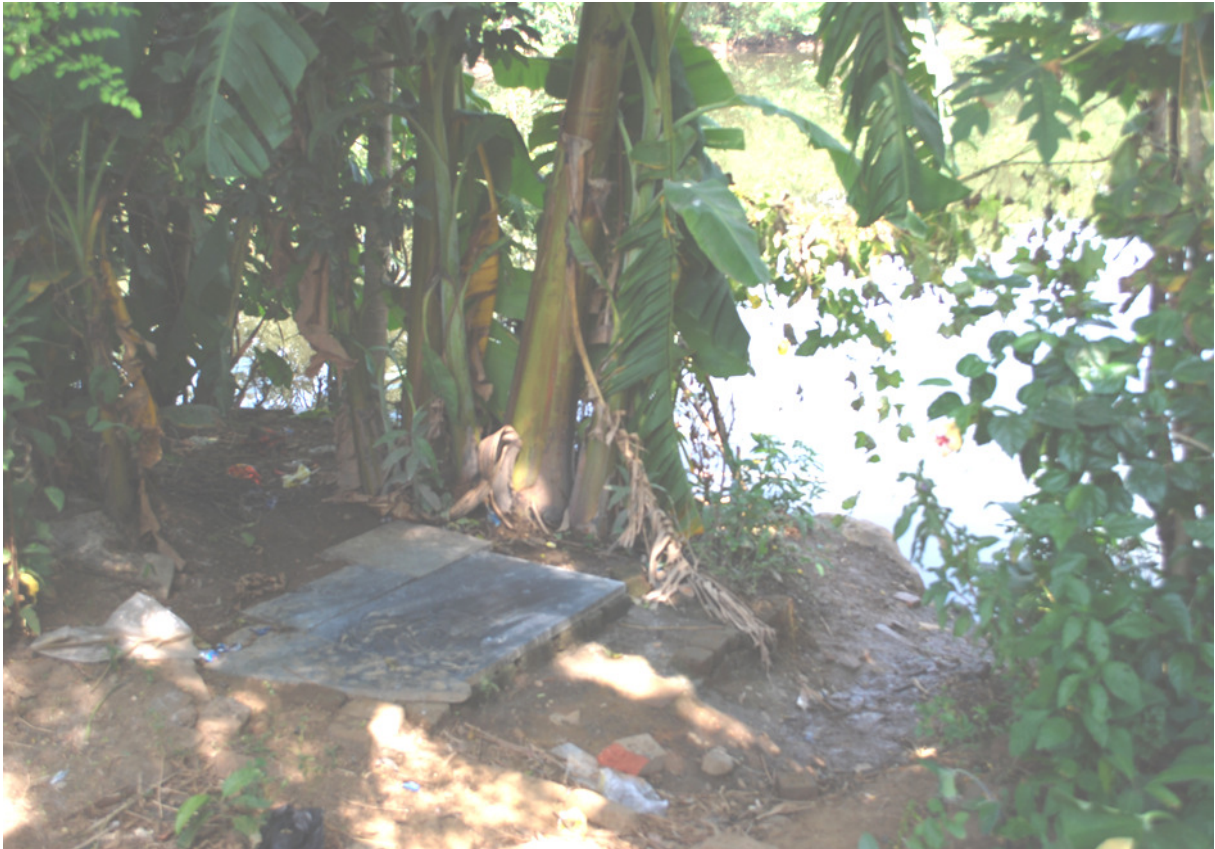
5.2	Physical Infrastructure						Assessment
	Lighting: Street lights have not been provided around the talav.						Non Existent
	Sanitation: No garbage or open defecation is observed on the edge of the talav. The edges of the talav have been maintained in a good condition.						Good
	Storm Water Drainage: Water from the surrounding flows into the talav.						Fair
	Public Facilities: No public facilities for washing or cleaning have been created. Small openings in the dense vegetation have been created by the residents from the adivasipada.						Poor

Opening created in the thick vegetative growth to access the talav

6.2	Owners / Tenants / Occupants / Community / Organizational Aspirations: None identified.	
7	MISCELLANEOUS	
	Additional Notes / References and Documents Available: Information gathered from the Kaner Shirsad Grampanchayat. Area details verified from the Land Records and Revenue Department (Vasai Taluka).	
8	RECOMMENDATIONS & SUGGESTIONS FOR IMPLEMENTATION	
	Small infrastructural improvements need to be undertaken in the form of providing washing platforms or steps to access the water.

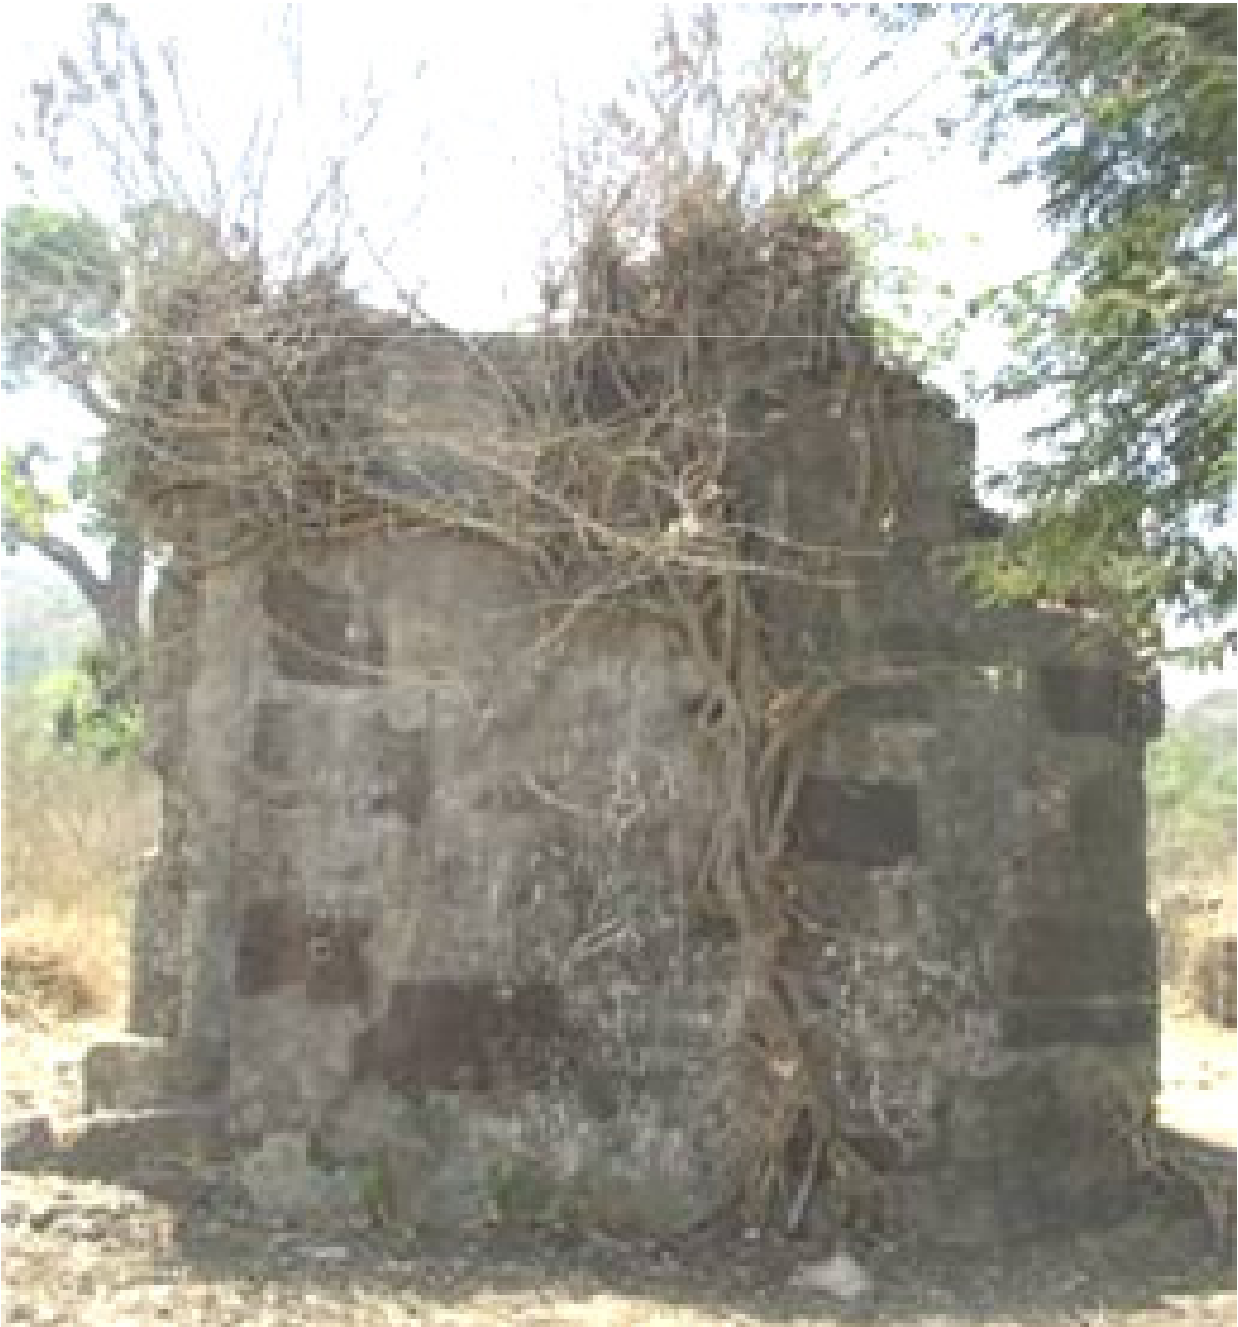
6.1	DP Remarks: None identified.				
	Perceived Threats: Presently, this asset is in ruins and the physical condition of the asset is rapidly deteriorating. If no corrective action is taken on a priority basis, the structure will collapse in the near future.

Derelict structure within the fort showing growth of vegetation

6.2	Owners / Tenants / Occupants / Community / Organizational Aspirations: None identified.				
7	MISCELLANEOUS				
	Additional Notes / References and Documents Available: Records and information gathered from the Mandvi Grampanchayat.				
8	RECOMMENDATIONS & SUGGESTIONS FOR IMPLEMENTATION				
	The ASI or the State Archaeology Department need to take immediate action for the preservation, restoration and management of this heritage asset. This relatively unknown fort has the potential to form an important node in the tourist circuits for the entire VVSR.

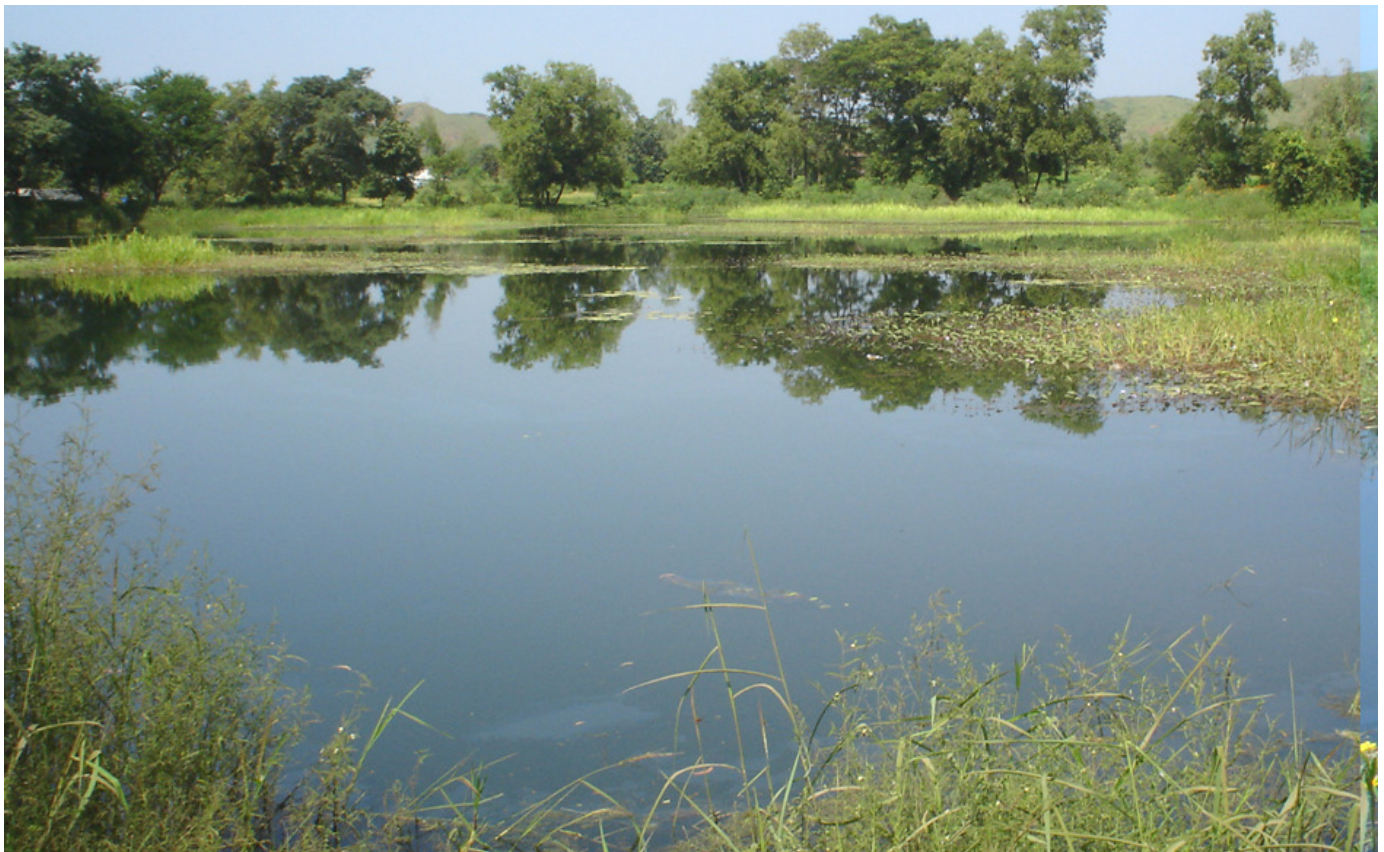
Growth of water plants in the talav along with soft landscape on the edges

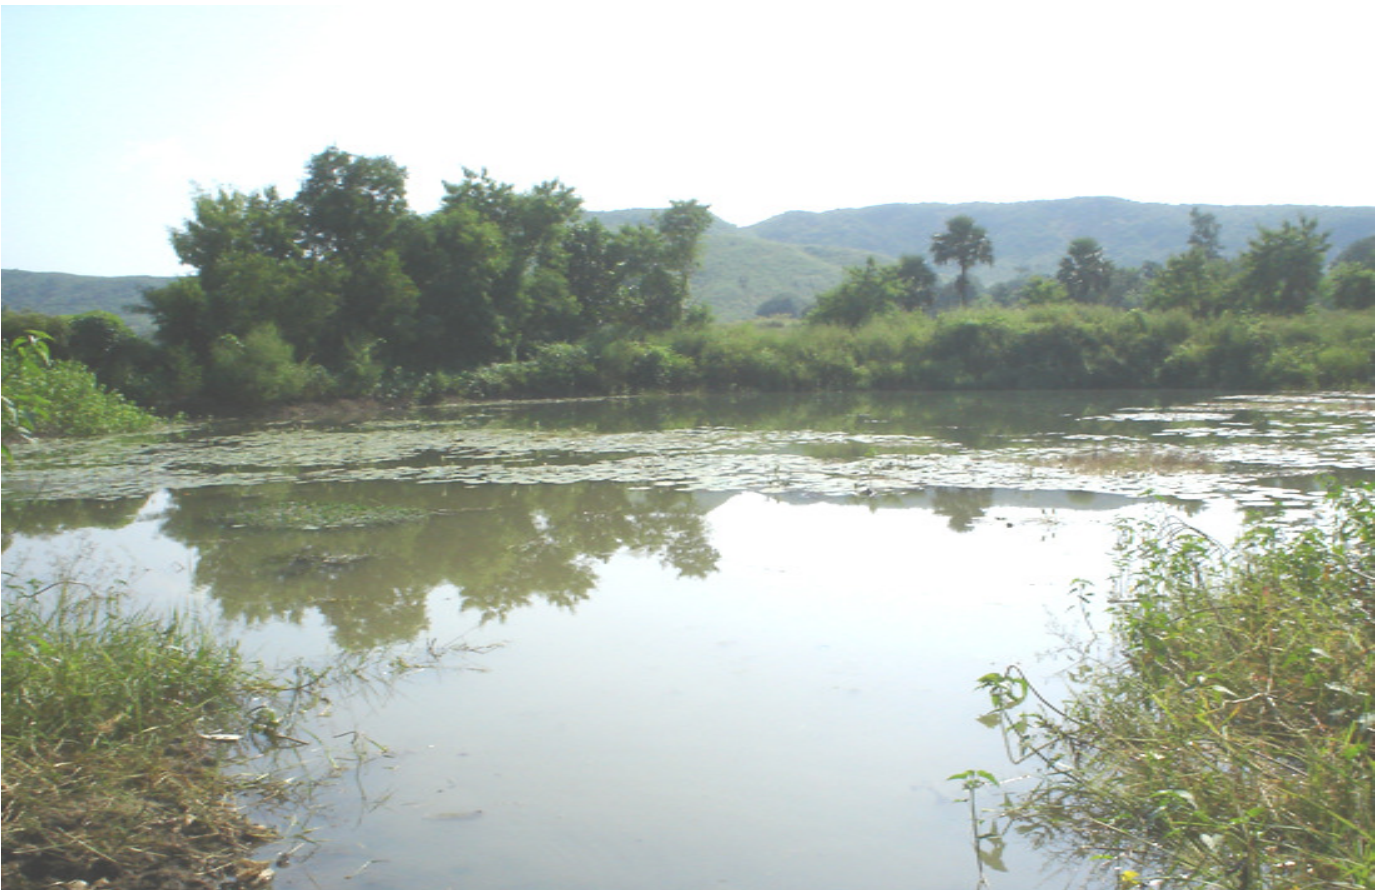
Growth of water plants in the talav along with soft landscape on the edges

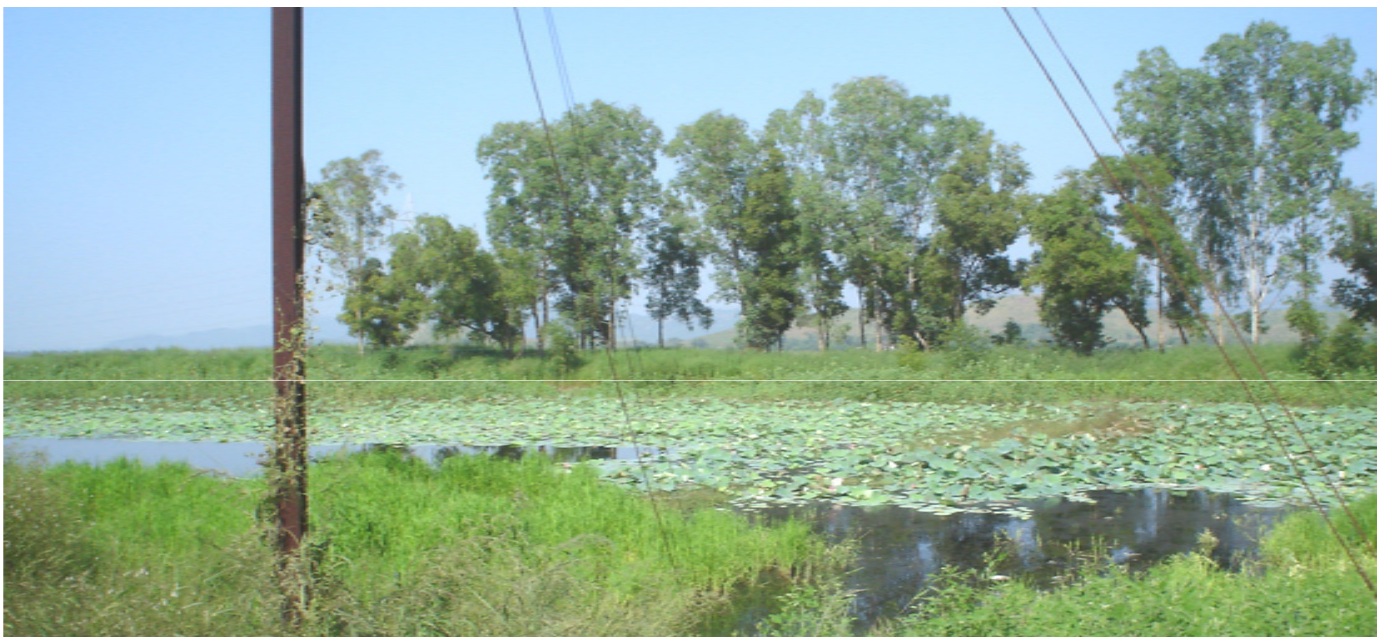
Growth of water plants in the talav along with soft landscape on the edges
