Mahatma Education Society's
PILLAIS' COLLEGE OF ARCHITECTURE Research Cell
10, Sector 16, New Panvel (e) 410206
Telephones: (022) 27456100, 27451700
e-mail: picapanvel@hotmail.com

Contents

Volume II

Area A- Villages

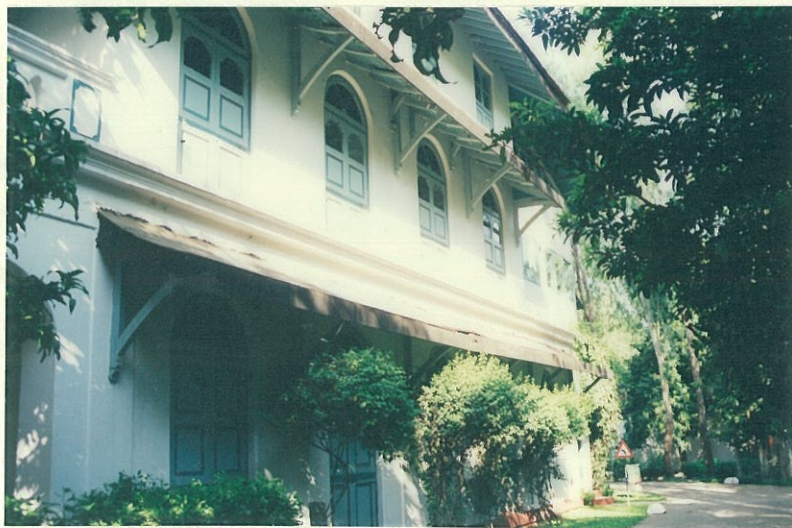
Side view showing a running, deeply overhanging chhajja

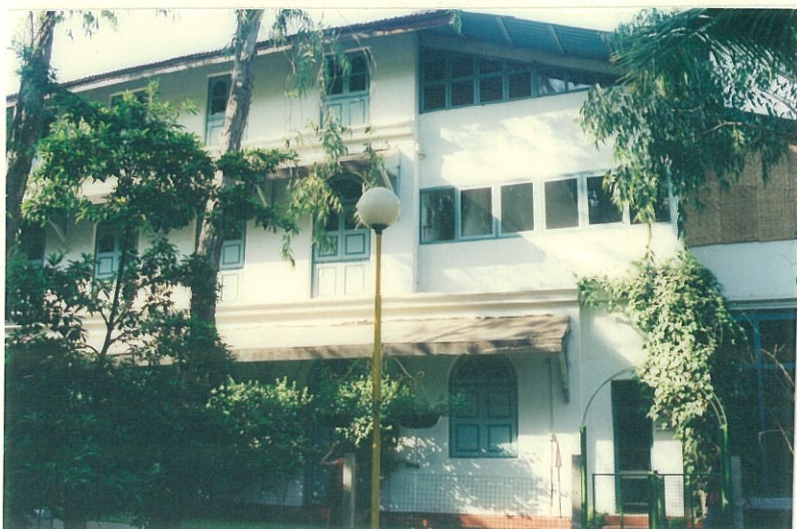
Side view showing extension at the back

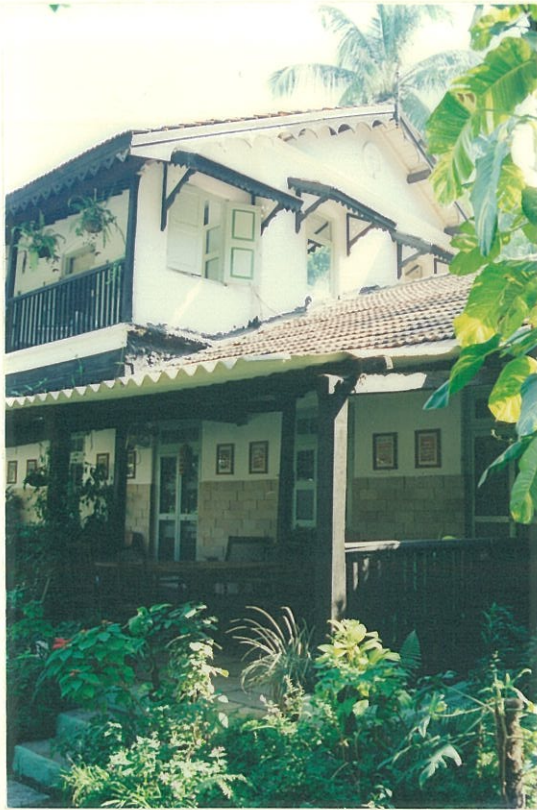
Side view showing gable end windows with deep awnings and decorative fascia

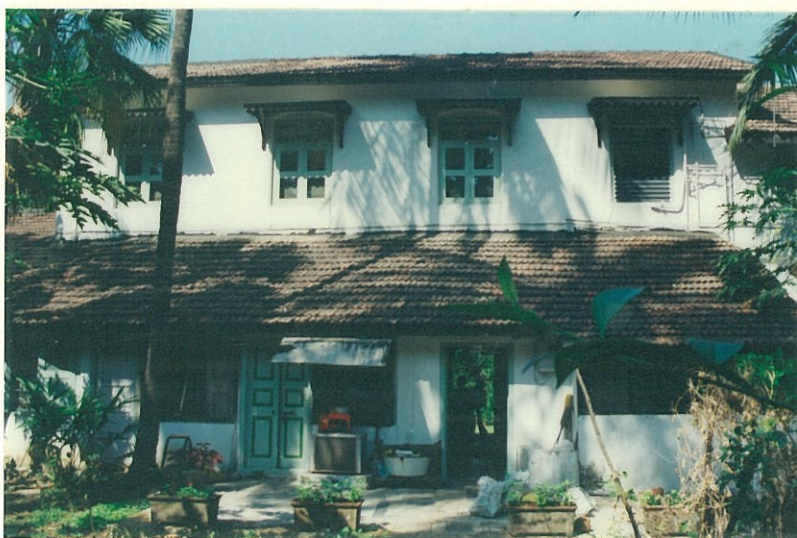
The back yard of the house faces the internal road of the campus

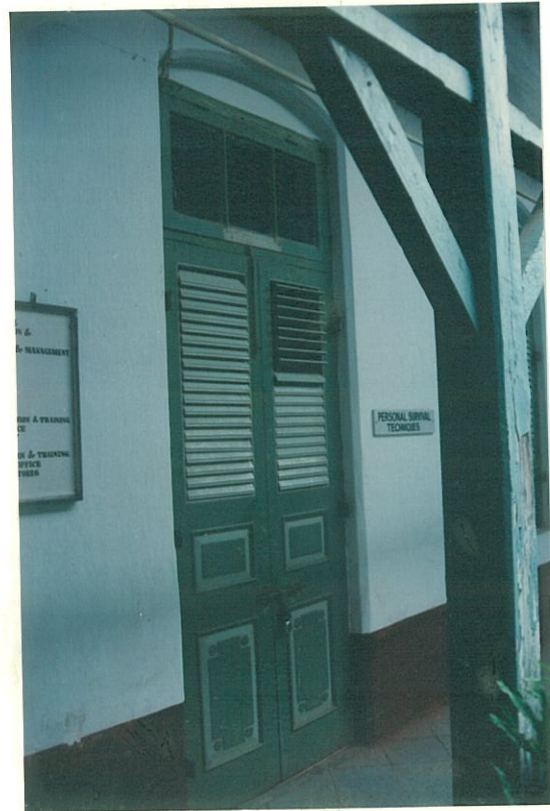
Door detail showing movable wooden louvers

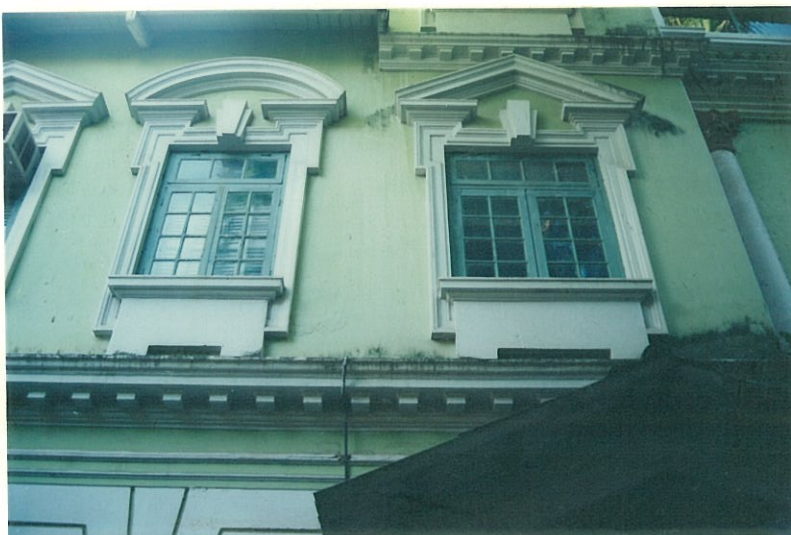
Windows with highlighted stucco mouldings with broken pediments and exaggerated key stones

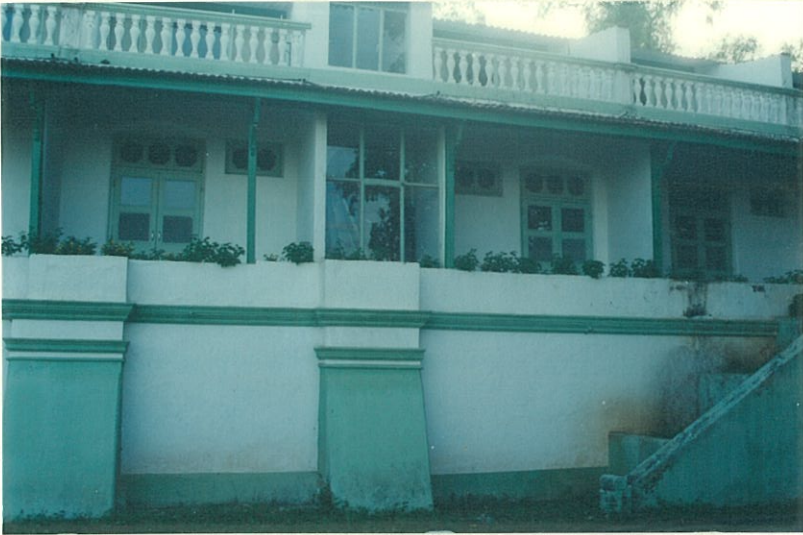
Common Reference No.	VL 13
Card No.	12
Name of Property	Sagaresh Suites, Nhava

The back of the building with heavy buttresses. The verandahs face the sea

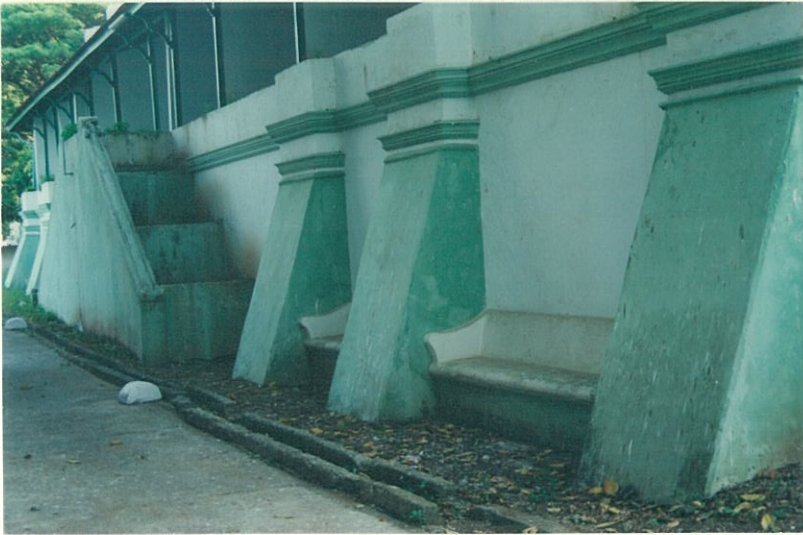
Built in seats between the buttresses, facing the sea

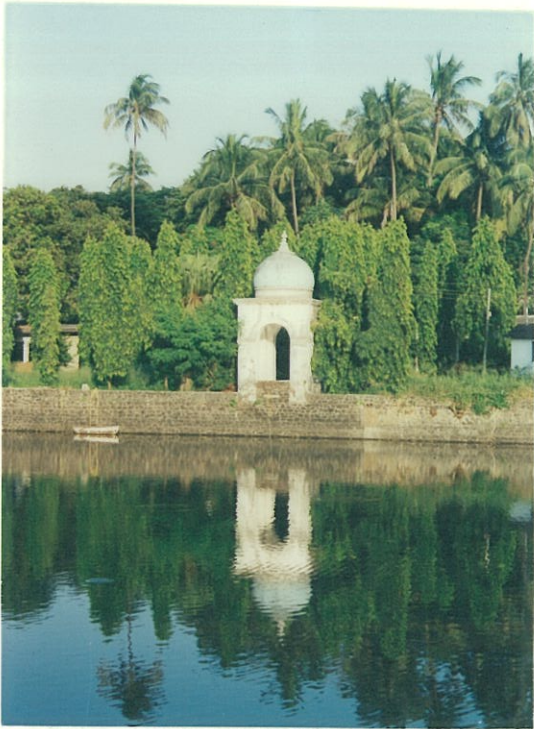
Common Reference No.	VL 14
Card No.	13
Name of Property	Nhava Tank, Nhava

View of the Talav and the memorial chhatri from the village side

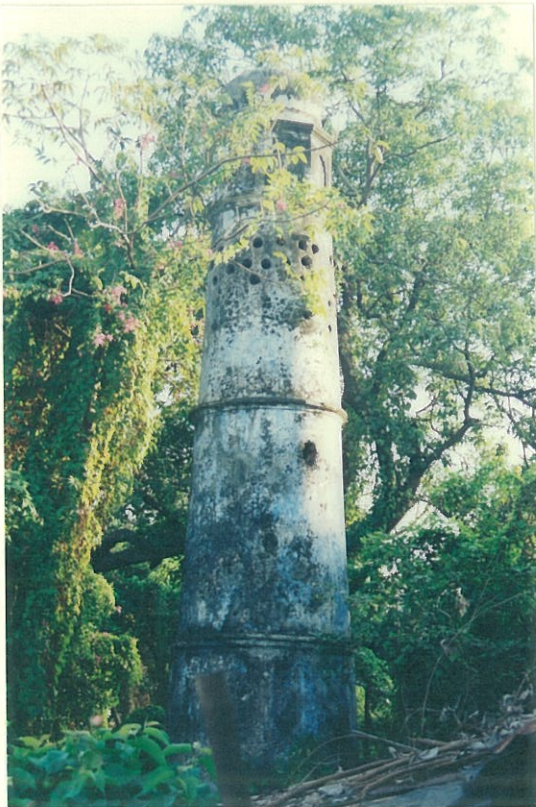
Corner minaret, one in each corner of the square tank

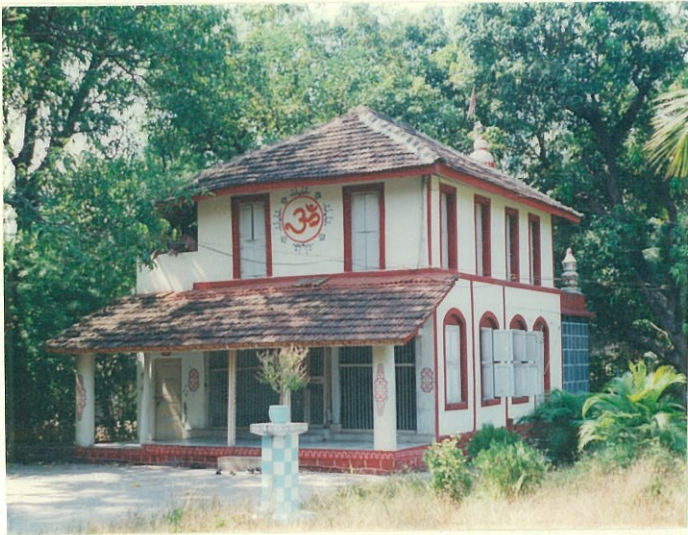
Common Reference No.	VL 15
Card No.	14
Name of Property	Vinayak Mandir, Kegaon

Front view of the temple showing typical Konkan style timber construction and articulation

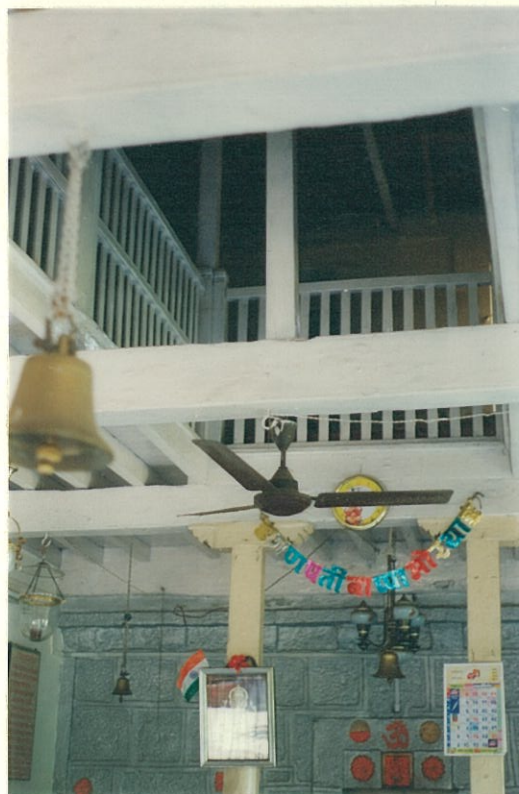
9.6	Roofing	The roof is sagging and is out of shape in parts, a few rafters are broken. The timber boarding of the attic ceiling is coming apart in places. In need of immediate repair.

Interior view showing TW mezzanine, all around a central cut out, supported over bracketed timber columns

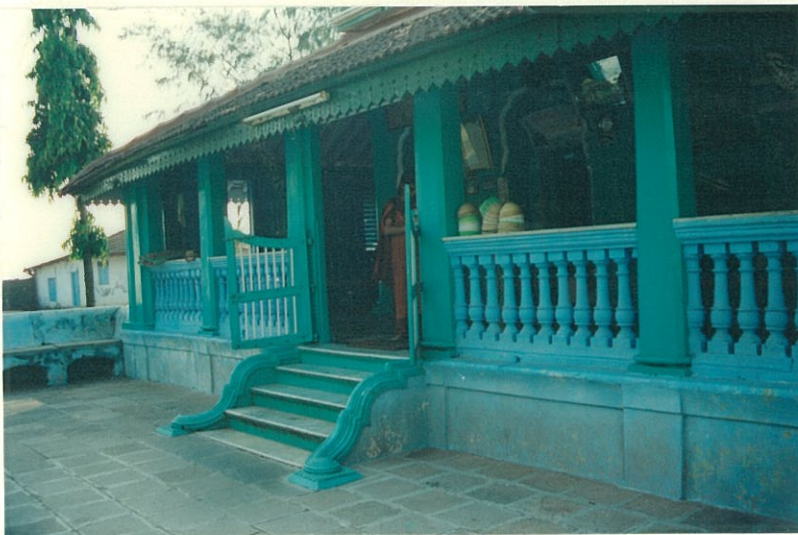
Steps from the front court lead to the timber frame verandah surrounding the tomb chamber

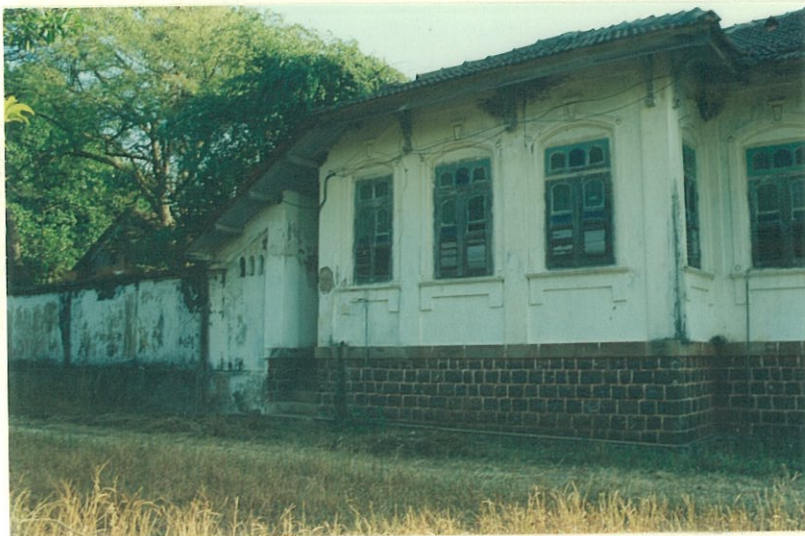
Side view of the building showing articulated bays and a high stone plinth

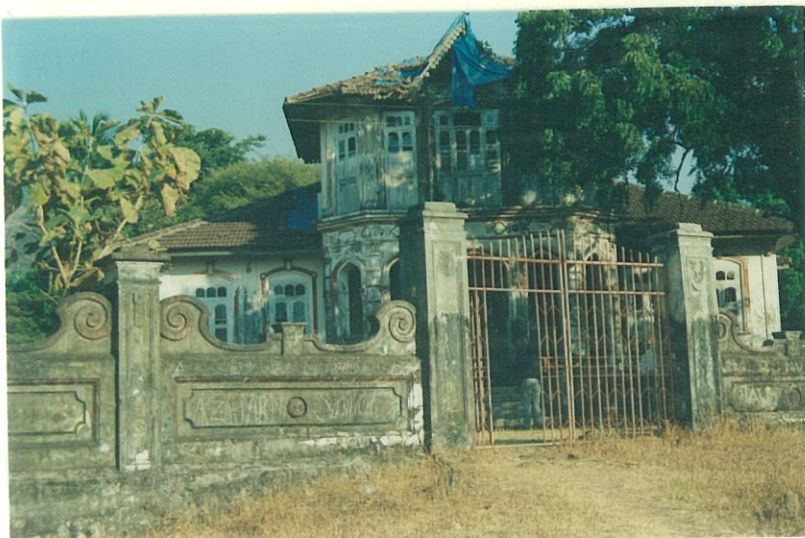
The building is set inside a compound with an ornamental masonry compound wall

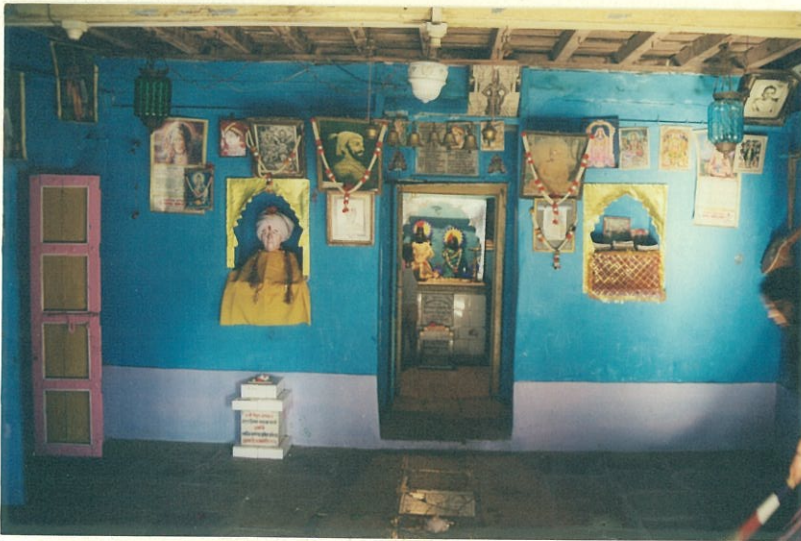
9.5	Openings	Good. The edges of the openings are well maintained. The TW frames and panels in fair condition.	
9.6	Roofing	The roof is sagging and is out of shape in parts, a few rafters are broken. The timber boarding of the attic ceiling is coming apart in places. In need of immediate repair.

View of the interior with decorative TW ceiling. Glimpse of the garbhagriha
