# Navi Mumbai (Raigad) Heritage Project

## Stage II Report

## Area B- Panvel

by  
the Pillais College of Architecture Research Cell  
New Panvel

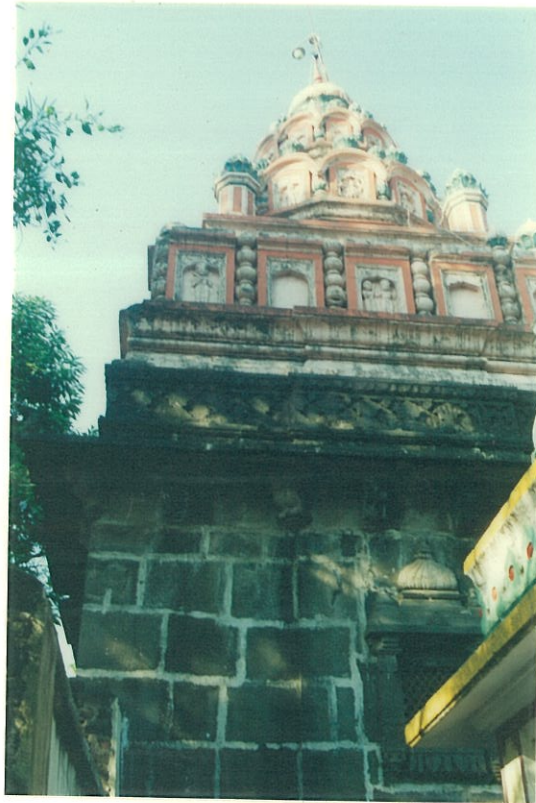
9.3	<b>Floor</b>	Good
9.4	<b>Stairs</b>	NA
9.5	<b>Openings</b>	Some jaails are broken
9.6	<b>Roofing</b>	Stucco ornament over shikhara need repair, stone amalaka is out of joint

Peshwahi style Shikhara over stone masonry garbhagriha

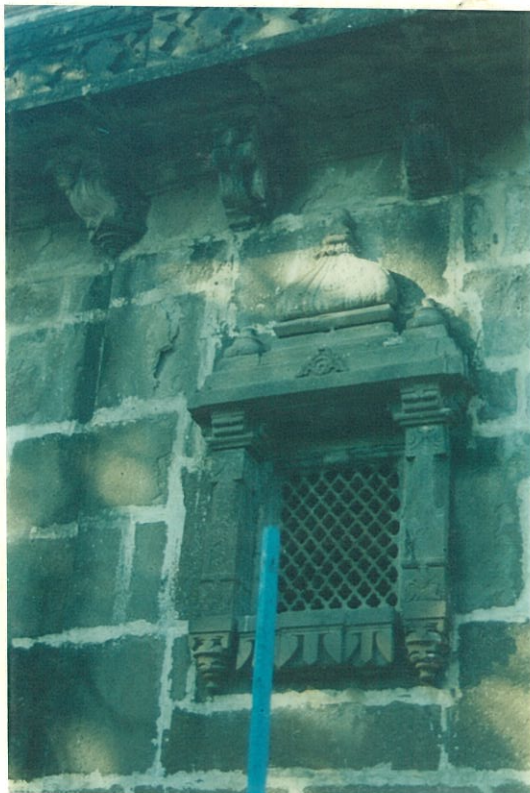
Detail of a decular window with carved stone jaali

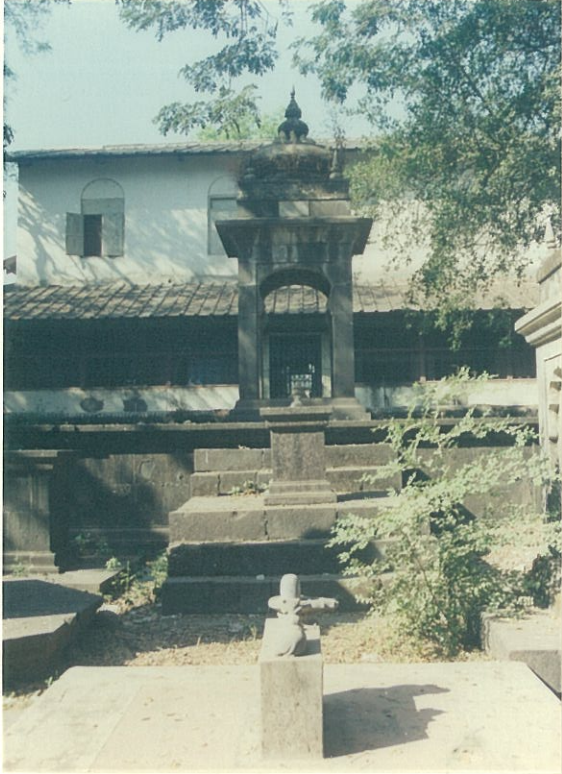
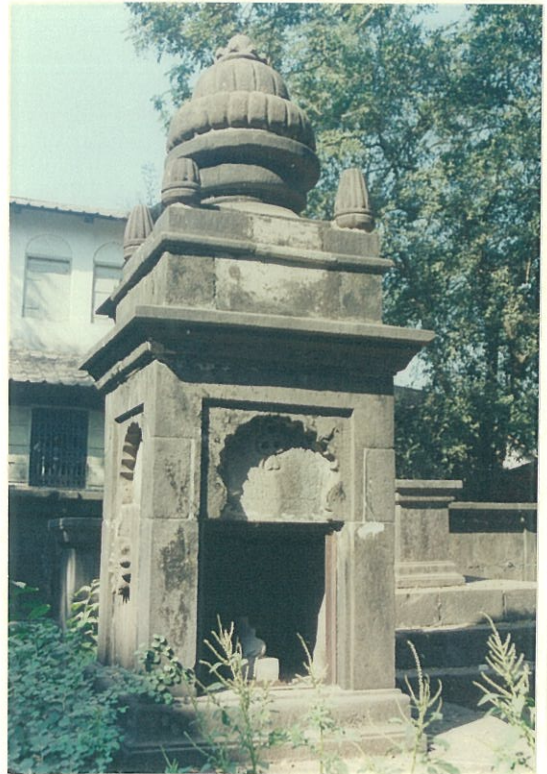
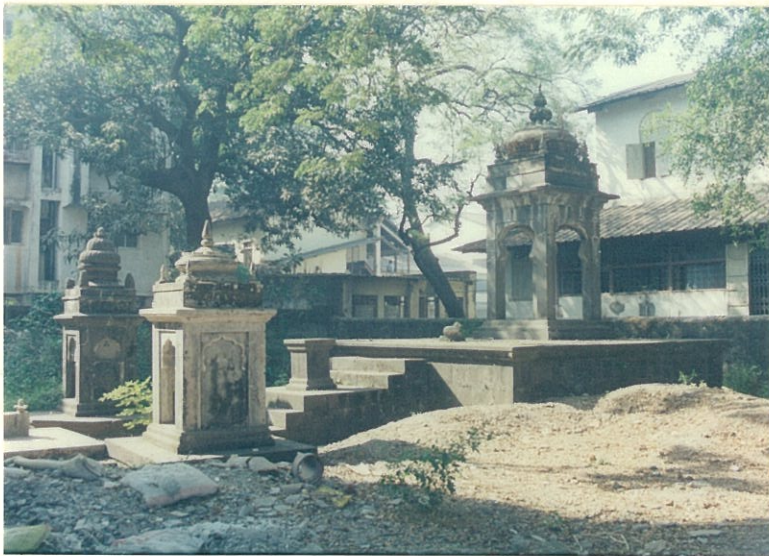
Common Reference No.	PL 5
Card No.	23
Name of Property	Lingayat samadhis

9.0		<b>Condition</b>
9.1	<b>Plinth</b>	Good. The stone finishes are still well dressed and sharp with no significant erosion or breakage
9.2	<b>Walls</b>	Fair. No obvious damage, but suffers from neglect.

9.3	<b>Floor</b>	NA
9.4	<b>Stairs</b>	NA
9.5	<b>Openings</b>	Good. The decorative arched openings are in good condition.
9.6	<b>Roofing</b>	The stone domes are in fair condition, despite neglect. There is some plant overgrowth on the superstructure.

9.7	<b>Articulation &amp; Finishes</b>	Some noticeable vandalism and the results of years of neglect are visible
9.8	<b>Services</b>	NA
9.9	<b>Outbuildings</b>	Other structures in the site are similar to the condition of the main structure

9.10	<b>Overall condition</b>	Fair
		<b>Maintenance level</b> Completely neglected
10.0		<b>Transformation</b>
10.1	<b>Form</b>	No significant change. New cenotaphs added on the site as and when significant burials took place. Recently, construction of an out building has started on the plot, which is completely out of tune with the character of the burial ground.

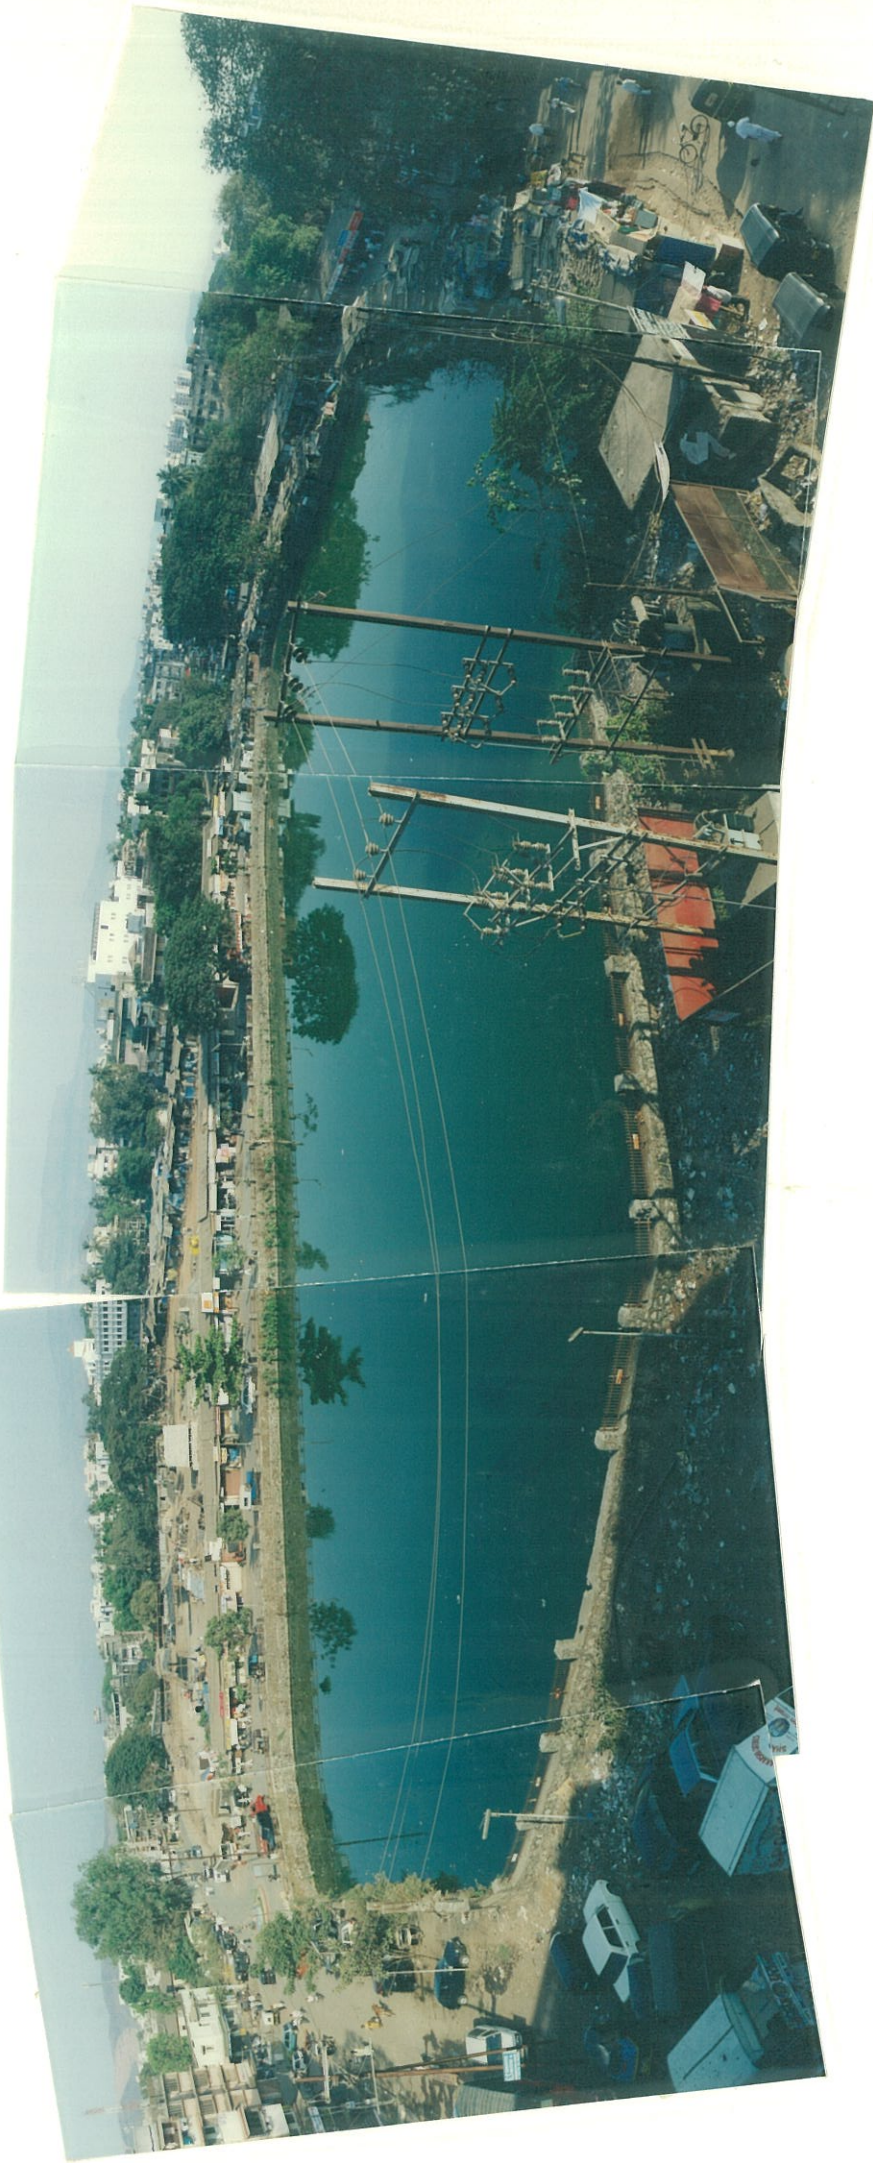
Common Reference No.	PL 7
Card No.	25
Name of Property	<b>Krishnale Talav</b>

Condition of the steps leading to water level

<b>9.8</b>	<b>Services</b>	Fair	
<b>9.9</b>	<b>Outbuildings</b>	The nandi porch and the care taker's house are in poor state.	
<b>9.10</b>	<b>Overall condition</b>	The condition of interior space is fair, exteriors needs repair and restoration urgently.	<b>Maintenance level</b> Poor
<b>10.0</b>		<b>Transformation</b>	
<b>10.1</b>	<b>Form</b>	The main form of the temple has been added to in an ad-hoc manner, like the nandi porch and the caretaker's house in the front and a store at the back of the temple.	
<b>10.2</b>	<b>Structure</b>	The roof has been arbitrarily extended over the added portions.	
<b>10.3</b>	<b>Articulation &amp; Finishes</b>	Floor finishes are changed.	
<b>11.0</b>		<b>DP Remarks / Perceived Threats</b>	
		A living temple, interior spaces preserved through use, but obscured by ad-hoc changes and dilapidation. The waterfront connection has largely been obscured. Krishnale Talav and steps are in poor condition.

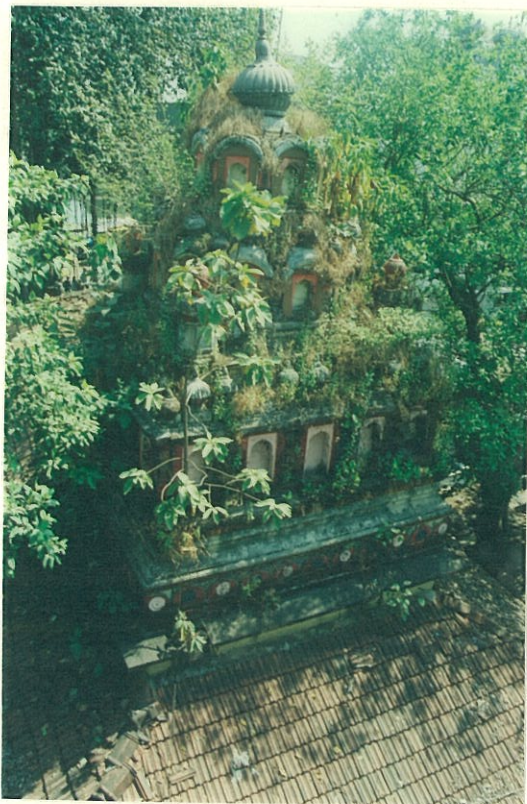
<b>8.6</b>	<b>Fire precaution</b>	None	
<b>8.7</b>	<b>Other (HVAC/BMS/ Security Systems)</b>	None	
<b>9.0</b>		<b>Condition</b>	
<b>9.1</b>	<b>Plinth</b>	The plinth is in a worn out state, especially in the portion of the pradakshina path.	
<b>9.2</b>	<b>Walls</b>	Walls and openings enclosing the pradakshina path are in very poor state. This is due to the path not being used for its intended purpose. It is locked off to possibly be used as a store.	
<b>9.3</b>	<b>Floor</b>	Fair	
<b>9.4</b>	<b>Stairs</b>	NA	
<b>9.5</b>	<b>Openings</b>	Not in very good shape.	
<b>9.6</b>	<b>Roofing</b>	Shikhara is infested with plant growth and its stucco ornament is in need of repair. Stone kalasha is out of joint. Timber roof has sagged in many places; quite a lot of roofing tiles are broken. The edges of the roof at the eaves end have lost their trimming fascia. In general the roof is in poor shape.	
<b>9.7</b>	<b>Articulation &amp; Finishes</b>	Ornament showing wear and tear

Peshwahi style shikhara over the central garbhagriha and TW lean-tos over the surrounding pradakshina

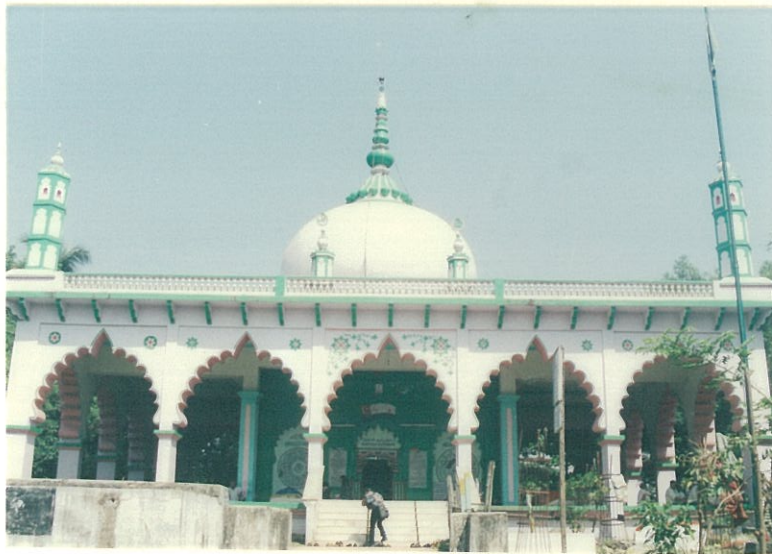
Front view of the Dargah showing the renovated arcade around the original tomb chamber and dome

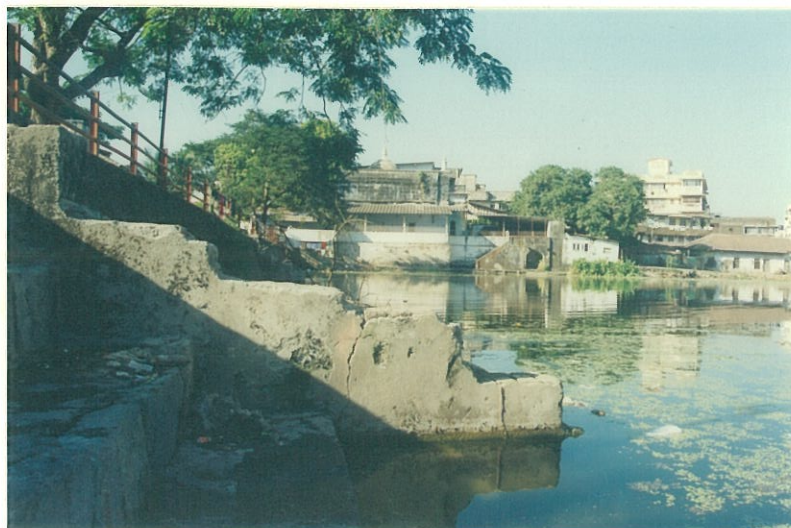
Steps leading to the water level

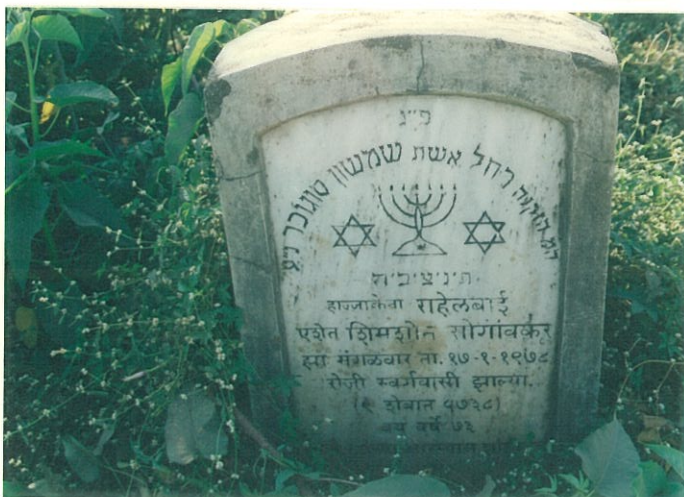
9.10	Overall condition	The ground is in an extremely unkempt condition. Only a small portion is cleared off relatively clean where recent burials have taken place. The rest of the area is covered with scrub and filth. The cenotaphs are crumbling and tomb stones are broken, many of them uprooted and lying about. Clearly the older burials are no longer cared for as their families may have migrated. However, the overall poor condition of the entire ground does not befit its purpose and mars the sanctity of such a place.
		<b>Maintenance level</b> Completely neglected

Tomb stone with inscription in 3 languages

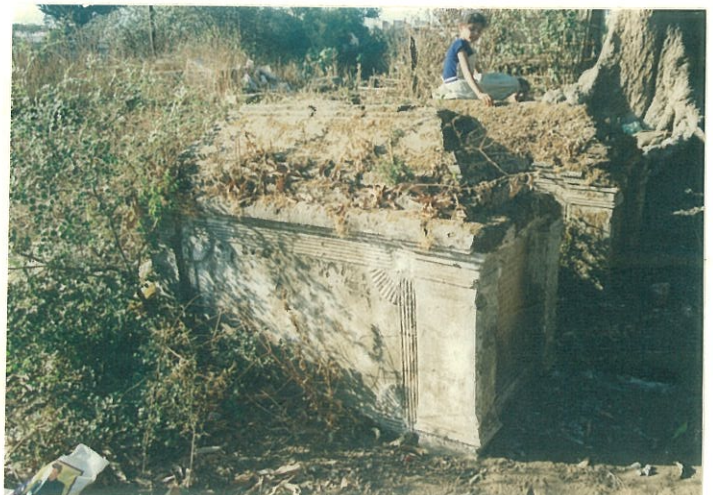
An old built up tombstone

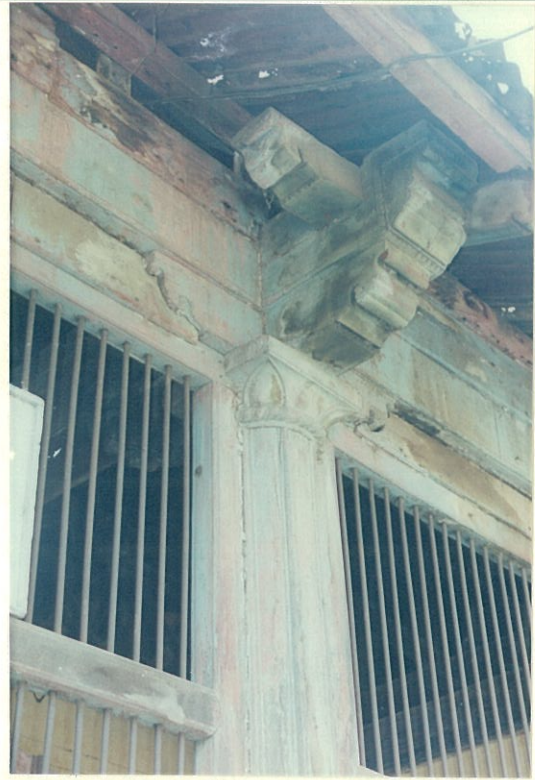
9.1	<b>Plinth</b>	Poor. Plaster on the outer perimeter of the plinth is in poor shape, exposing the masonry behind to further damage.
9.2	<b>Walls</b>	Fair. No obvious damage. Plaster on the outside is mostly in poor condition, has come off at many places and has been patch worked at several other places. TW posts in the front verandah show a few vertical cracks.

Timber column with carved capital and ornamental brackets

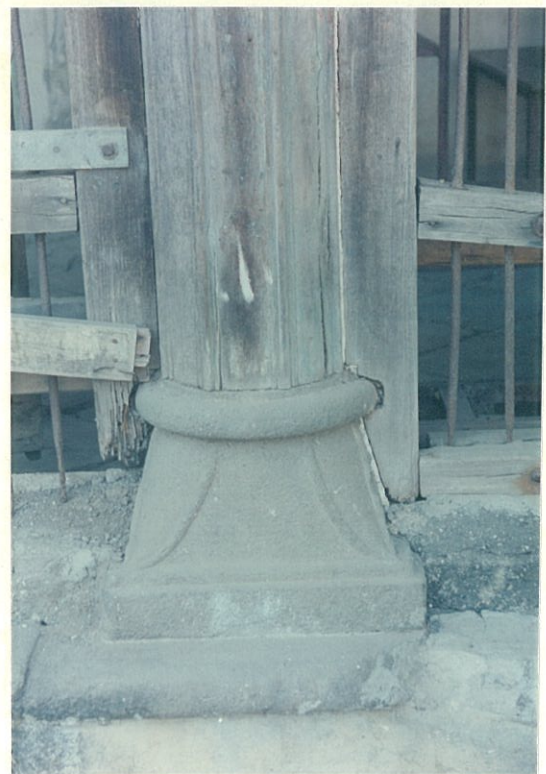
Carved timber column resting on a carved stone base

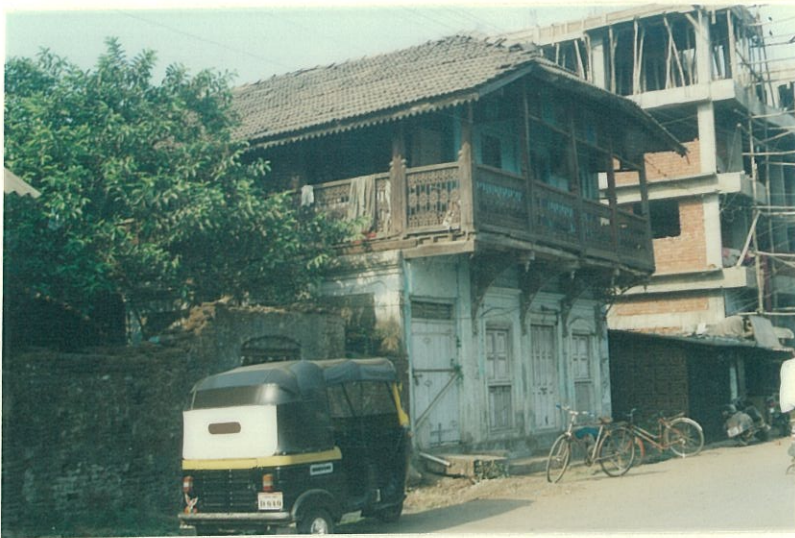
The corner view showing upper floor corridor turning the corner and becoming a projecting balcony on the street.

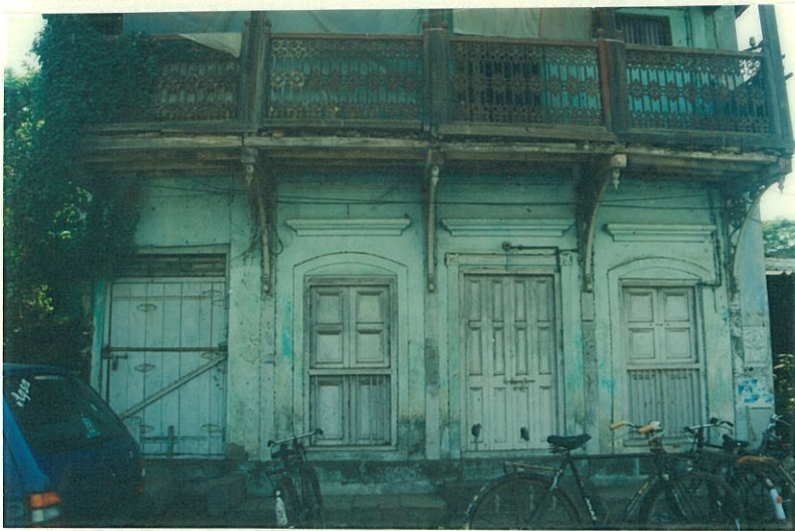
9.2	<b>Walls</b>	Poor, coming apart at the rear.
9.3	<b>Floor</b>	Fair. The timber beams have cracked in many places. The timber balcony purlins and fascias, being exposed, show a visible sign of weathering

Projecting balcony supported on WI brackets. Lower floor *kothars* with timber frame structure

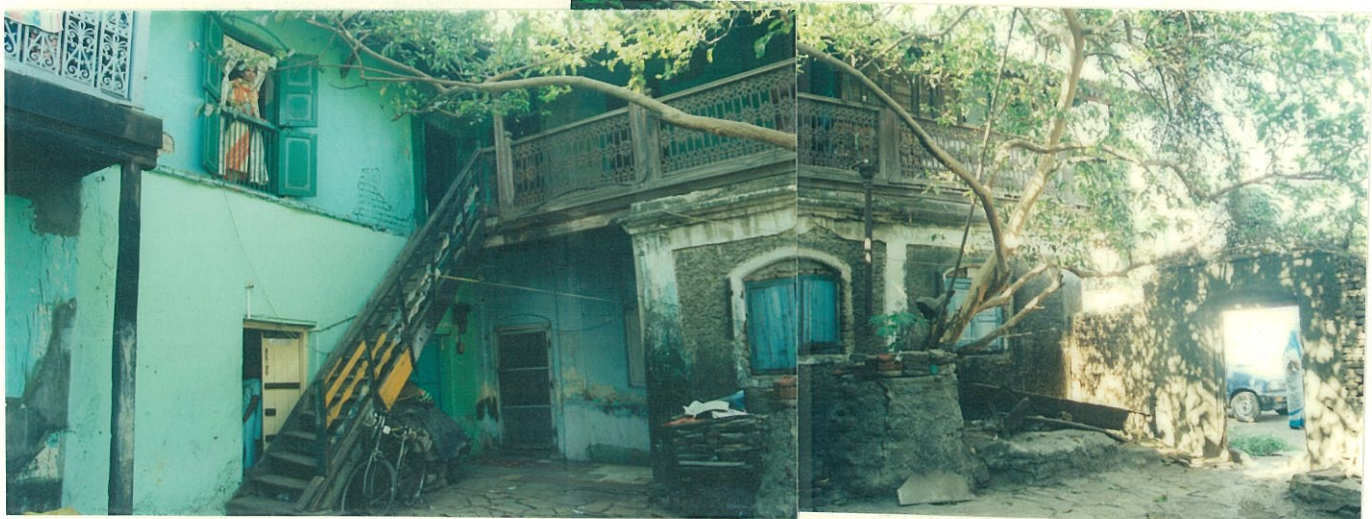
9.4	<b>Stairs</b>	The front staircase has become rickety. A few risers are broken. The rear staircase has almost come apart and is structurally unsafe.

Panoramic view of the courtyard showing straight flight staircase leading to the upper floor corridor. Dindi Darwaza is seen on the right

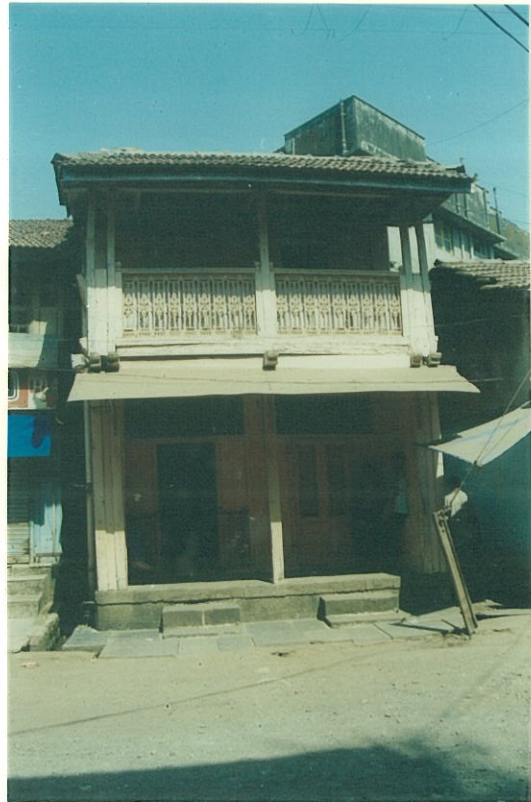
Common Reference No.	PL 24
Card No.	42
Name of Property	<b>Samel House, Bazaar Peth</b>

9.1	<b>Plinth</b>	Good. It is in good line and level retaining sharp edges
9.2	<b>Walls</b>	Fair. No obvious damage. Plaster on the outside in good condition. The TW posts show some weathering and minor cracks.

9.3	<b>Floor</b>	Fair. The timber members are in fair condition, except the floor beam of the balcony whose surface has considerably worn out.
9.4	<b>Stairs</b>	Fair.

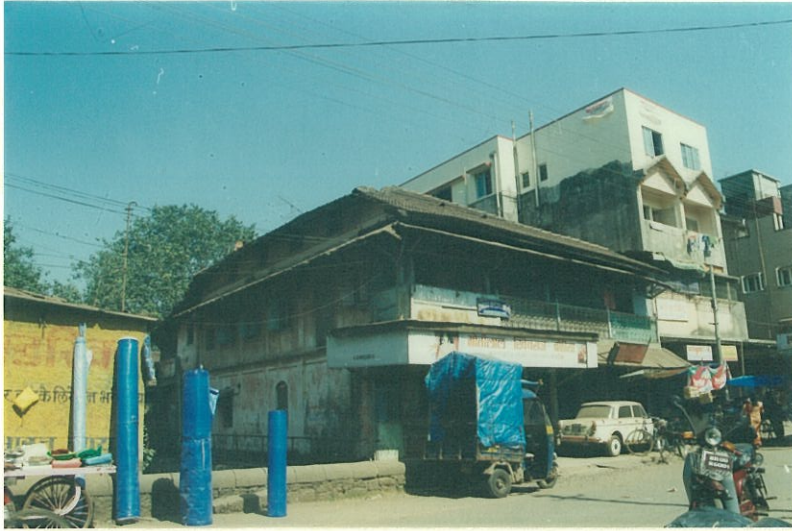
Common Reference No.	PL 25
Card No.	43
Name of Property	<b>Motilal Banthia House, Bazaar Peth</b>

8.7	<b>Other (HVAC/BMS/ Security Systems)</b>	None
9.0	<b>Condition</b>	
9.1	<b>Plinth</b>	Good. It is in good line and level retaining sharp edges
9.2	<b>Walls</b>	Fair. A few cracks seen in some places. Plaster on the outside is in poor condition

9.6	<b>Roofing</b>	Sound structural condition, roofing tiles recently replaced. However, the overhang at lower level needs repair.
9.7	<b>Articulation &amp; Finishes</b>	Finishes on the ground storey where shops are in poor shape.

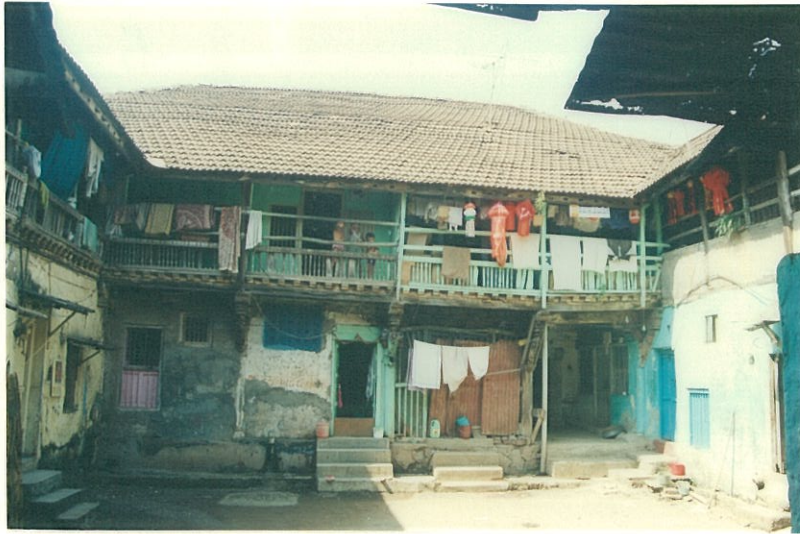
Common Reference No.	PL 27
Card No.	45
Name of Property	<b>Bapat Wada, Tilak Road</b>

9.10	<b>Overall condition</b>	This huge Wada is in a state of disrepair, especially all the tenanted parts. The front courtyard is used as a dumping ground by the residents. By and large structurally sound but unkempt.
		<b>Maintenance level</b> Poor

View of the internal courtyard. The Krishna Mandir can be seen on the left hand side (upper floor). Living spaces on the other three sides of this courtyard, where the annual Gokulashtami festival is being celebrated since 1730

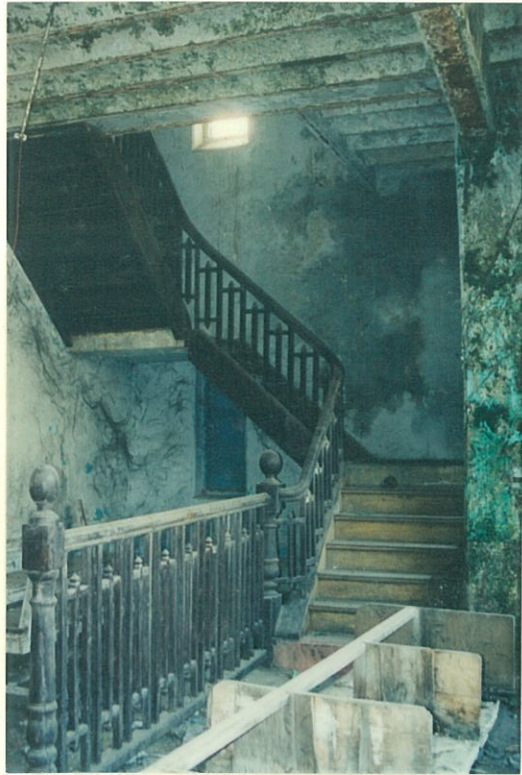
Common Reference No.	PL 29
Card No.	47
Name of Property	<b>Ratan Talkies</b>

9.3	<b>Floor</b>	Poor The timber members are in an utter state of neglect and disrepair, all the glazing is shattered.	
9.4	<b>Stairs</b>	The staircases rickety and the stairwell's railings and newel post are relatively in fine condition.

9.7	<b>Articulation &amp; Finishes</b>	Due to the utter state of neglect and disrepair several of the details have crumbled	
9.8	<b>Services</b>	Poor	
9.9	<b>Outbuildings</b>	Ticket Booth's condition is very poor

View of the staircase showing decorative balustrade

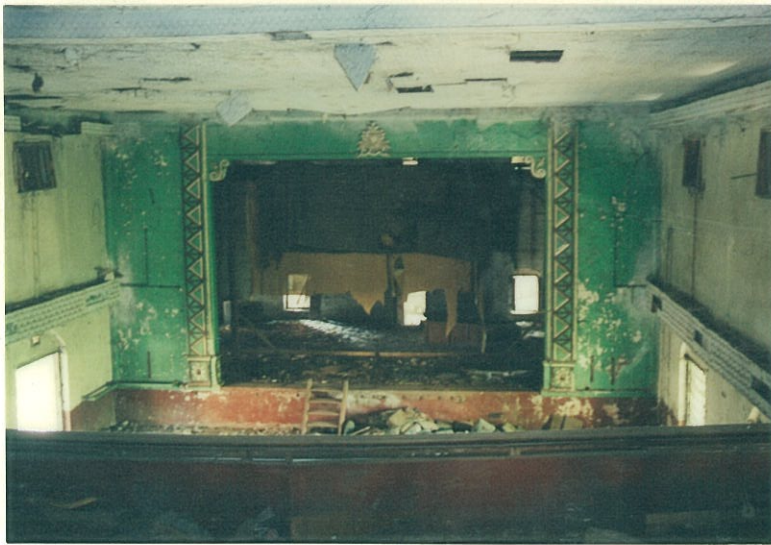
9.5	<b>Openings</b>	Openings, windows, their shutters, glazing are in run down condition.	
9.6	<b>Roofing</b>	Poor structural condition not maintained and neglected. False ceiling has fallen in many places

Interior view of the auditorium

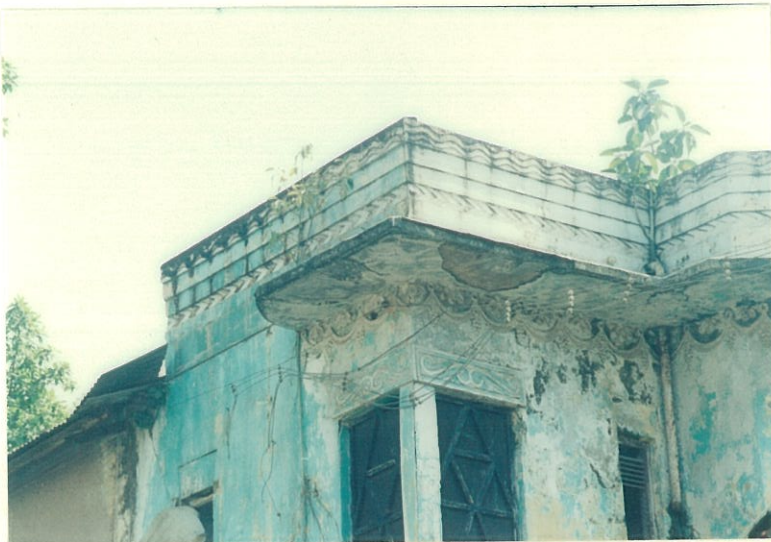
10.2	<b>Structure</b>	The metal frame on which the building is structured is exposed in several places due to the crumbling masonry and plaster and is subsequently rusting and falling apart.

Corner detail

10.3	<b>Articulation &amp; Finishes</b>	No transformation, but showing the ravages of neglect and vandalism	
11.0	<b>DP Remarks / Perceived Threats</b>		
	This building is in very poor condition, and sure to collapse by itself unless immediate curative measures are taken. The problem seems to be that the Ratan Talkies is under legal dispute of ownership among several members of the Banthia Family. The Cinema is also under tax shadow with the government in defaulting on entertainment tax payments.

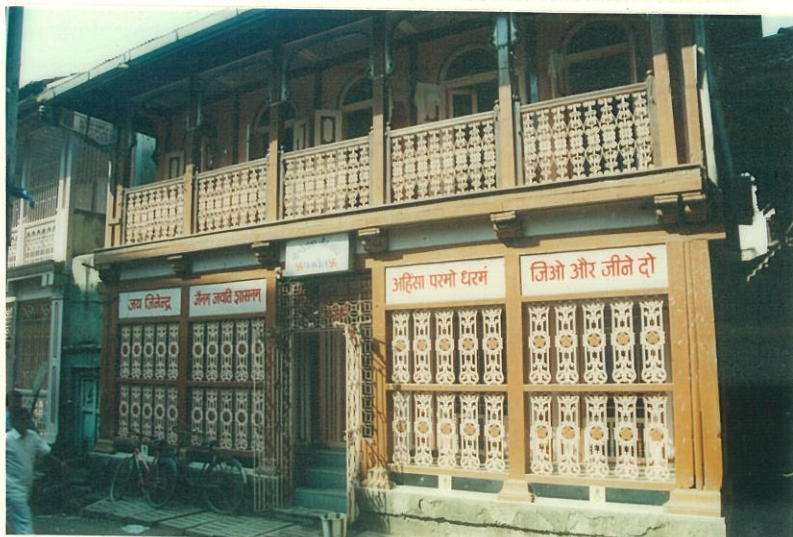
Detail of the front façade

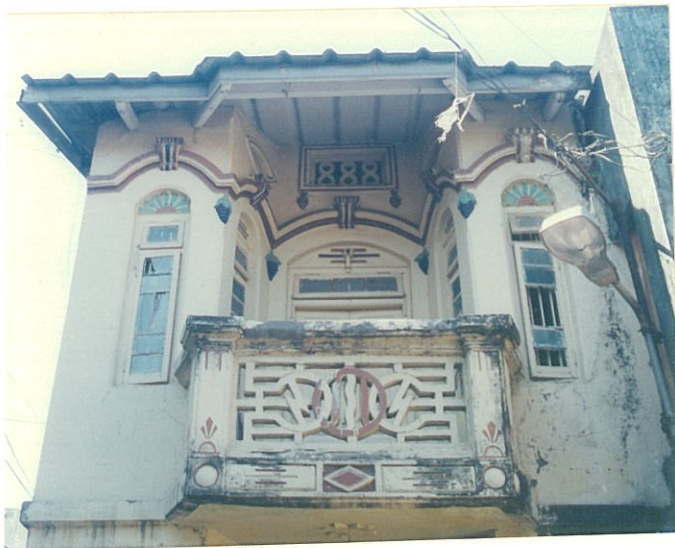
9.4	<b>Stairs</b>	The RCC waist slab and cantilever beam have badly cracked, with reinforcement becoming exposed.
9.5	<b>Openings</b>	Fair. A few glass panels are broken on the front windows. The timber shutters on the side walls are in poor shape.

Front façade detail

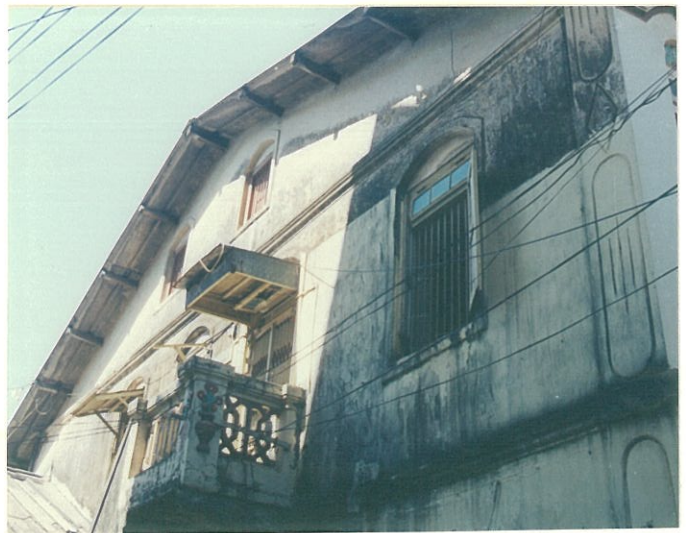
9.10	<b>Overall condition</b>	Fair
		<b>Maintenance level</b> Fair
10.0	<b>Transformation</b>	
10.1	<b>Form</b>	No visible change in the overall house, except a few partition walls in timber are added to work as dispensary on the lower floor. Chhajjas are added to the windows on the side façade. They are in poor shape.

Side façade detail

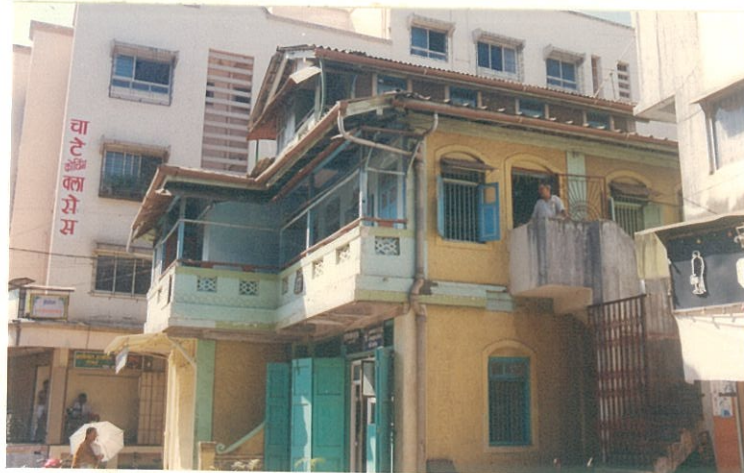
9.4	<b>Stairs</b>	Fairly good condition
9.5	<b>Openings</b>	Fair.
9.6	<b>Roofing</b>	Sound structural condition. The roof gutters are in poor shape and the down take pipes are laid in a haphazard manner. The eaves boards are broken in a few places.

Side view of the building

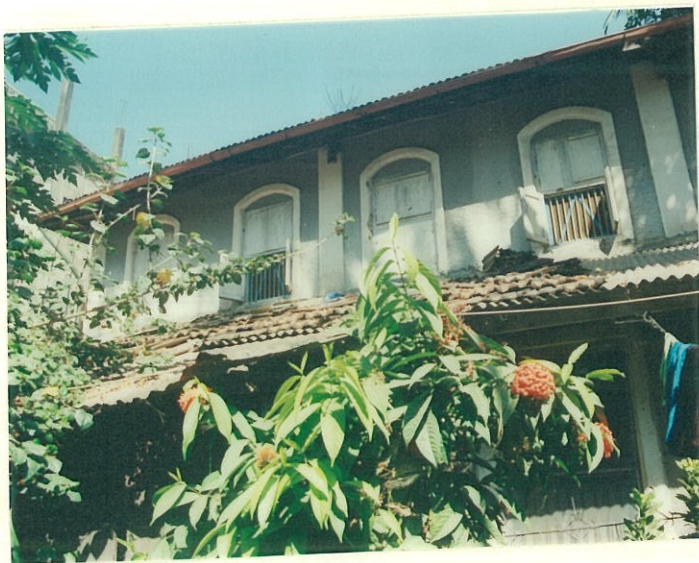
9.6	<b>Roofing</b>	Sound structural condition, several roofing tiles are missing and the patches have been recently replaced by tin sheeting in an ad-hoc manner.

9.7	<b>Articulation &amp; Finishes</b>	The upper floor seems to be largely unused and is showing signs of neglect and disrepair. The later added toilet block is in very poor condition.

Side view of the Wada

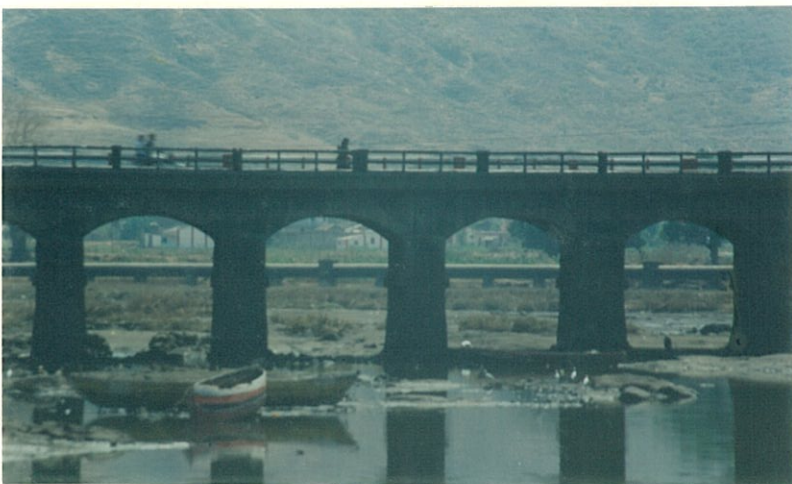
8.5	Drainage( Plumbing and Sanitation	NA	
8.6	Fire precaution	NA	
8.7	Other (HVAC/BMS/ Security Systems)	NA	
9.0		NA	
		<b>Condition</b>	
9.1	Plinth	Fair, in line and level. The bridge shows signs of weathering

10.0		<b>Transformation</b>	
10.1	Form	No visible change	
10.2	Structure	No visible change	
10.3	Articulation & Finishes	NA	
11.0		<b>DP Remarks / Perceived Threats</b>	
		The bridge is showing natural signs of weathering and wear and tear of daily usage. It may fall into disuse with the construction of additional road links to Uran from Panvel. However this is a landmark within the perception of the townspeople of Panvel and should be conserved.

Close-up of the arches and piers

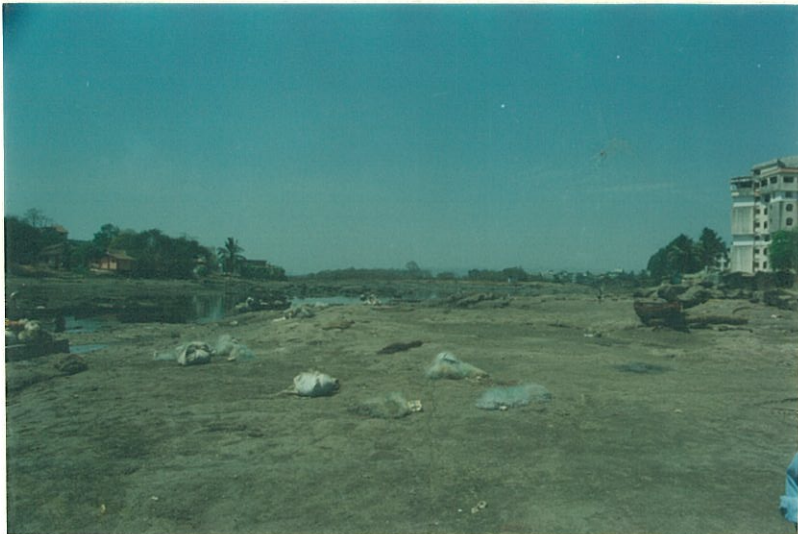
8.6	<b>Fire precaution</b>	NA			
8.7	<b>Other (HVAC/BMS/ Security Systems)</b>	NA			
9.0		<b>Condition</b>			
9.1	<b>Plinth</b>	NA			
9.2	<b>Walls</b>	NA.			
9.3	<b>Floor</b>	NA			
9.4	<b>Stairs</b>	NA			
9.5	<b>Openings</b>	NA			
9.6	<b>Roofing</b>	NA			
9.7	<b>Articulation &amp; Finishes</b>	NA			
9.8	<b>Services</b>	NA			
9.9	<b>Outbuildings</b>	NA			
9.10	<b>Overall condition</b>	The condition of the stretch under consideration is poor and unkempt. The space is currently used by the Kolis to repair their boats and nets. There is a lot of garbage about.	<table border="1"> <tr> <td><b>Maintenance level</b></td> <td>Poor</td> </tr> </table>	<b>Maintenance level</b>	Poor
<b>Maintenance level</b>	Poor				
10.0		<b>Transformation</b>			
10.1	<b>Form</b>	No change, except for accumulating garbage			
10.2	<b>Structure</b>	No visible change			
10.3	<b>Articulation &amp; Finishes</b>	NA			
11.0		<b>DP Remarks / Perceived Threats</b>			
		Marked on the DP as riverfront. Should be protected against encroachments.			
12.0		<b>Additional Notes / References / Documents Available</b>			
		Conversation with members of the Koli community

**View of the Open Space**

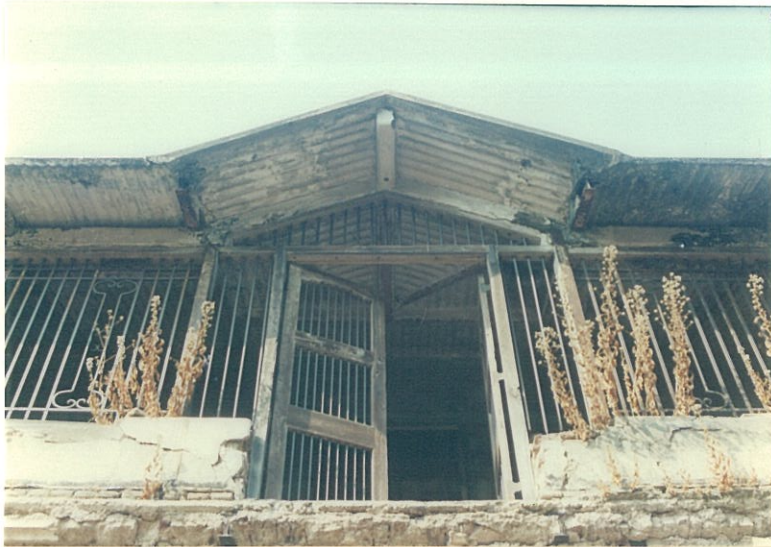
Common Reference No.	PL 58
Card No.	74
Name of Property	<b>Girija Bhuvan</b>

9.6	<b>Roofing</b>	Poor structural condition, not maintained and neglected	
9.7	<b>Articulation &amp; Finishes</b>	Due to the utter state of neglect and disrepair several of the details have crumbled or vanished

Soffit of the roof indicating pouring of concrete over corrugated sheets used as formwork

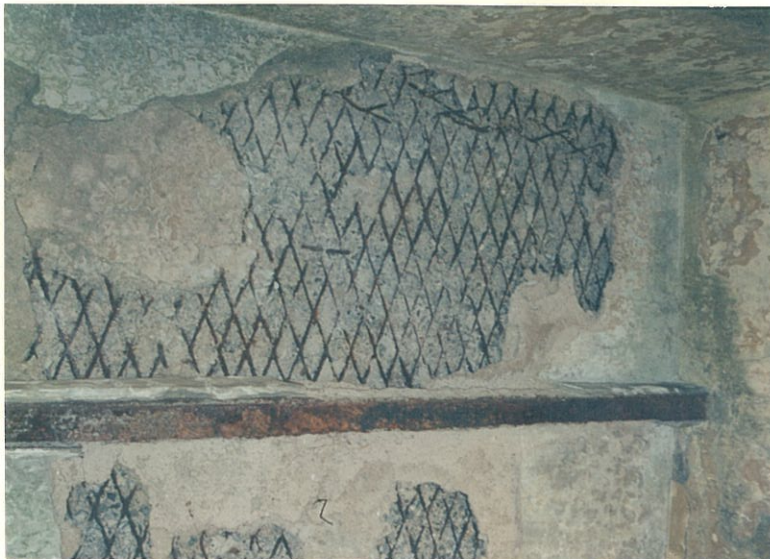
10.1	<b>Form</b>	The building is run down, neglected and in a state of disrepair. The port cohere has fallen down. Much of the building is crumbling.	
10.2	<b>Structure</b>	The metal frame on which the building is structured is exposed in several places due to the crumbling masonry and plaster and is subsequently rusting and falling apart.

Mild steel diamond mesh used as reinforcement for concrete

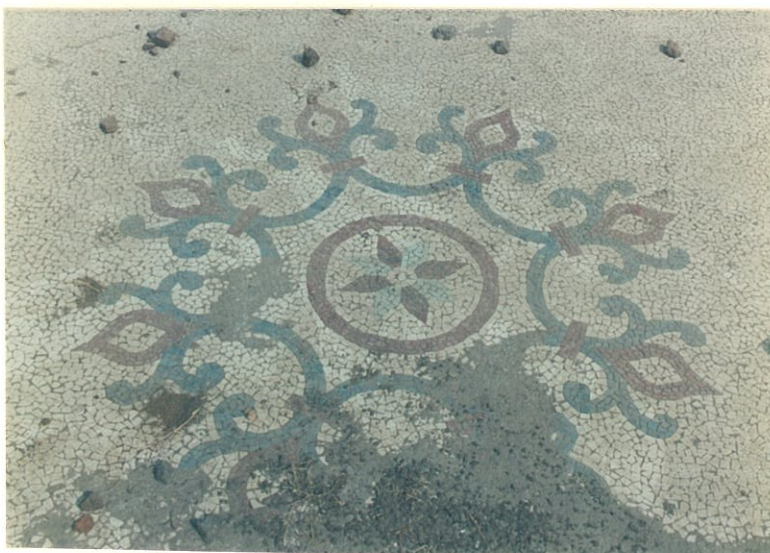
Floral pattern in china mosaic on the terrace

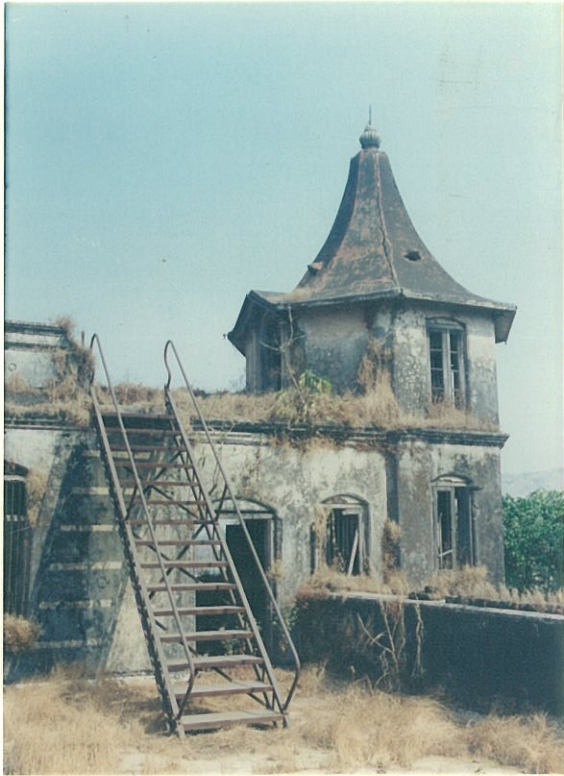
Octagonal corner tower with a pyramidal concrete roof

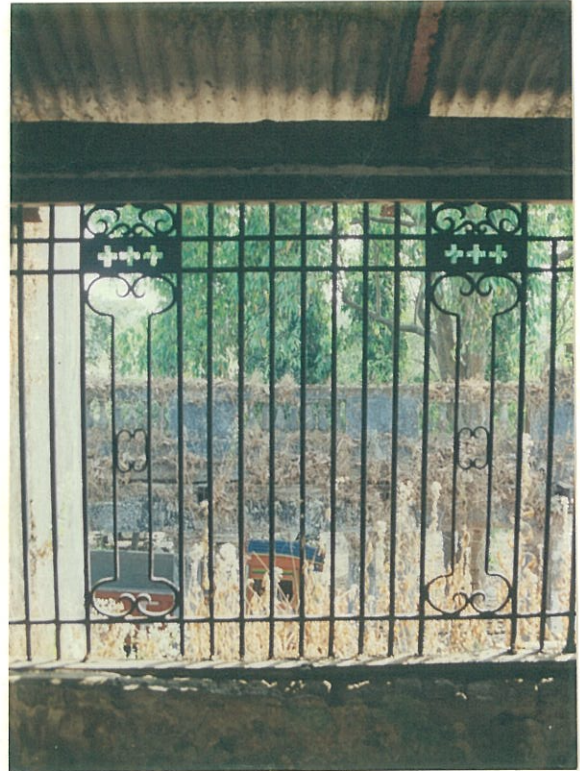
Ornamental metal grill

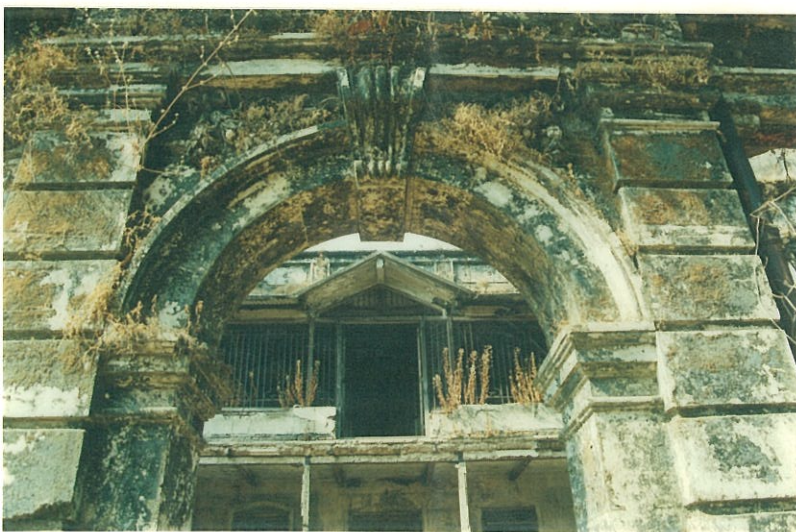
9.5	<b>Openings</b>	Arched openings, windows, their shutters, glazing and awnings are in run down condition. The port cohere's roof has long fallen as have some of the arches.

Front arcade with classical details
