Navi Mumbai (Raigad) Heritage Project

Stage II Report

Area C- Uran

List Cards No: 75 to 118

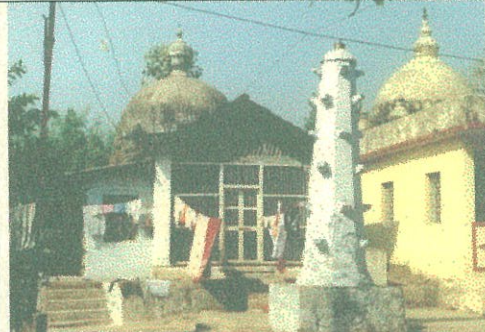
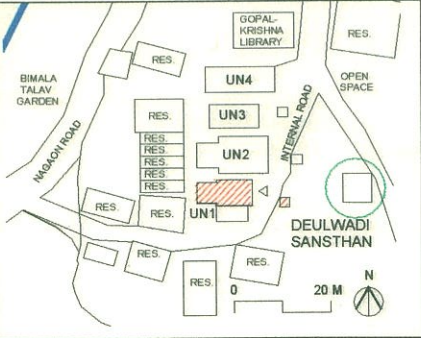
Common Ref No: UN1

9.6 Roofing	The timber frames on the front facade of the roof truss is weathered in few places, but generally sound. The Eave boards are in good condition. The dome is infested with vegetative growth on the top.

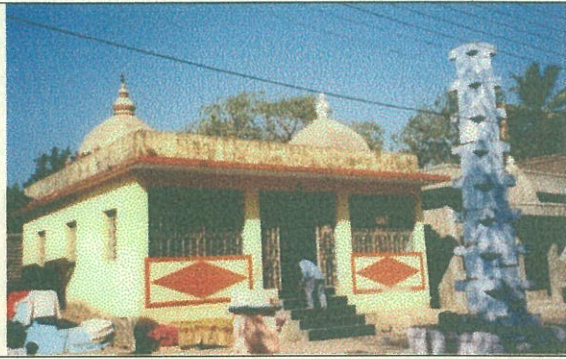
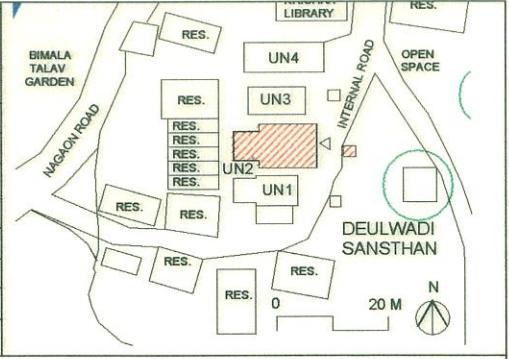
Common Ref No: UN2
Card No. 76
Ward(Part): 5
CS No./House No.: 154
Plot Area
B U Area
Date: 05.10.02
Record by: Sanjay / Sarvesh
Review by: Smita Dalvi
Int yes Ext yes
Photo Ref: U4, U5, U10

11.0	DP Remarks / Perceived Threats
	No immediate threat to the structure. The reconstruction of the temple has been carried out without realising the Intrinsic value of the original structure. This structure is considered while listing the structures because it has been identified as one of the several religious structures of Deulwadi Precinct.

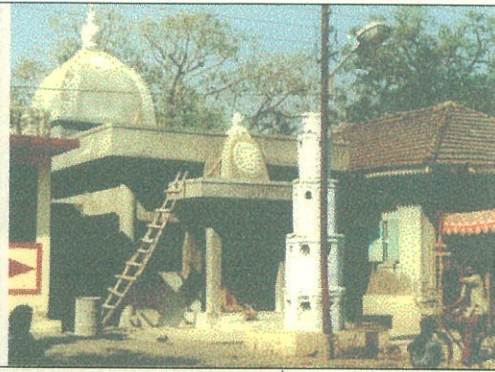
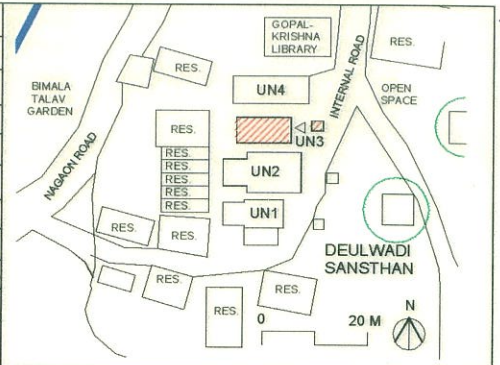
Common Ref No: UN3
Card No. 77
Ward(Part): 5
CS No./House No.: 153
Plot Area
B U Area
Date: 05.10.02
Record by: Sanjay/Sarvesh
Review by: Smita Dalvi
Int yes Ext yes
Photo Ref: U4

9.10	Overall condition	Good
		Maintenance level Good
10.0	Transformation	
10.1	Form	The temple constructed in Konkani style temple has changed to RCC column beam frame type structure with flat RCC slab. Garbhagriha has RCC dome over it.

11.0	DP Remarks / Perceived Threats None	
	No immediate threat to the structure. The reconstruction of the temple has been carried out without realising the Intrinsic value of the original structure. This structure is considered while listing the structures because it has been identified as one of the several religious structures of Deulwadi Precinct.

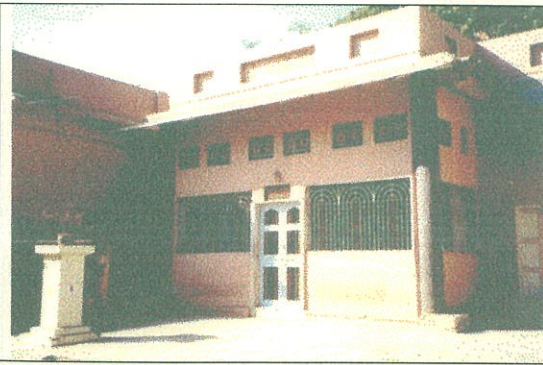
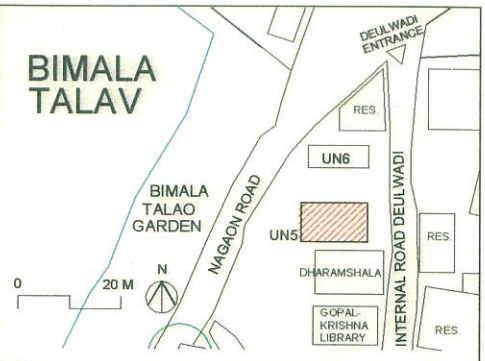
Common Ref No: UN5
Card No. 79
Ward(Part): 5
CS No./House No.: 147
Plot Area
B U Area
Date: 05.10.02
Record by: Sanjay/Gaurav
Review by: Smita Dalvi
Int Yes **Ext** Yes
Photo Ref: U4

10.2	Structure	The original Mangalore tile roofing was removed as it was damaged over a period of time due to deterioration of the timber frame.	
10.3	Articulation & Finishes	No significant articulation observed.

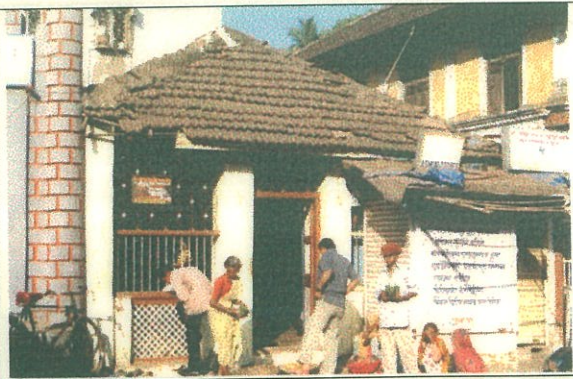
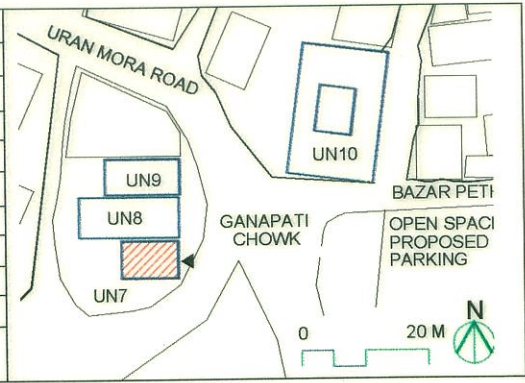
Common Ref No: UN7
 Card No. 81
 Ward (Part): 5
 CS No./House No.: 560
 Plot Area
 B U Area
 Date: 05.10.02
 Record by: Sanjay/Gaurav
 Review by: Smita Dalvi
 Int Yes Ext Yes
 Photo Ref: U9

9.6	Roofing	Needs to be attended to rearrange the Mangalore roof tiles.	
9.7	Articulation & Finishes	No decorative elements observed. Finishes appear to be fairly maintained.

10.2	Structure	Same as above	
10.3	Articulation & Finishes	No change	
11.0	DP Remarks / Perceived Threats		
	Shop in the front may be shifted to some other location to keep the temple front free of visual encroachment. Regular maintenance of property necessary.

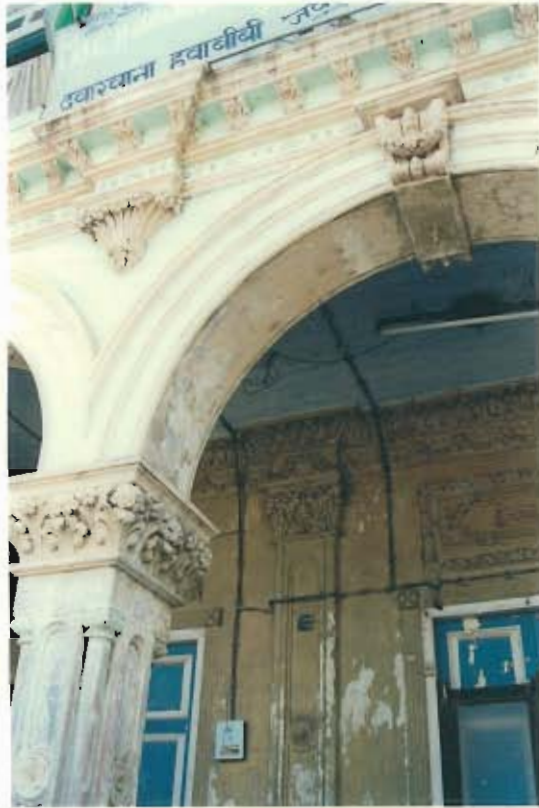
Common Reference No.	UN13
Card No.	87
Name of Property	Late Hawabibi Ibrahim Tungekar Hospital

View of details showing decorative stucco work on arch and masonry column.

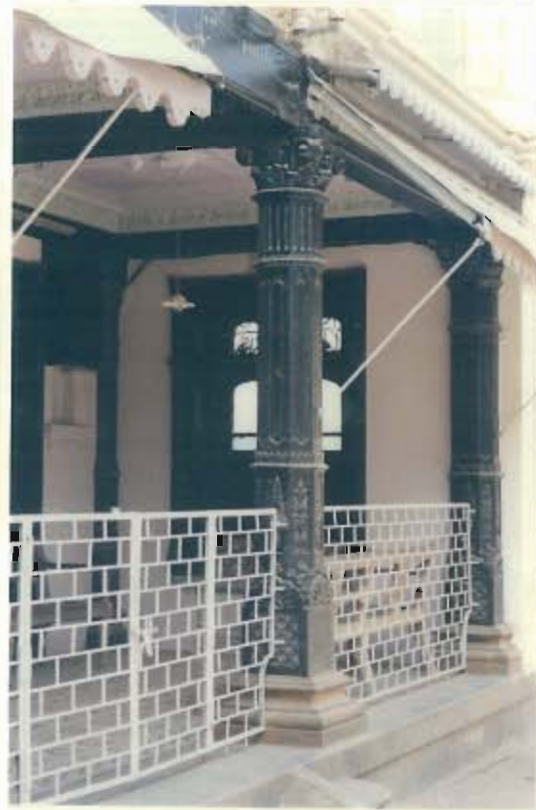
Common Reference No.	UN14
Card No.	88
Name of Property	Tungekar Manzil

View of a decorative timber column and carved stone pedestals

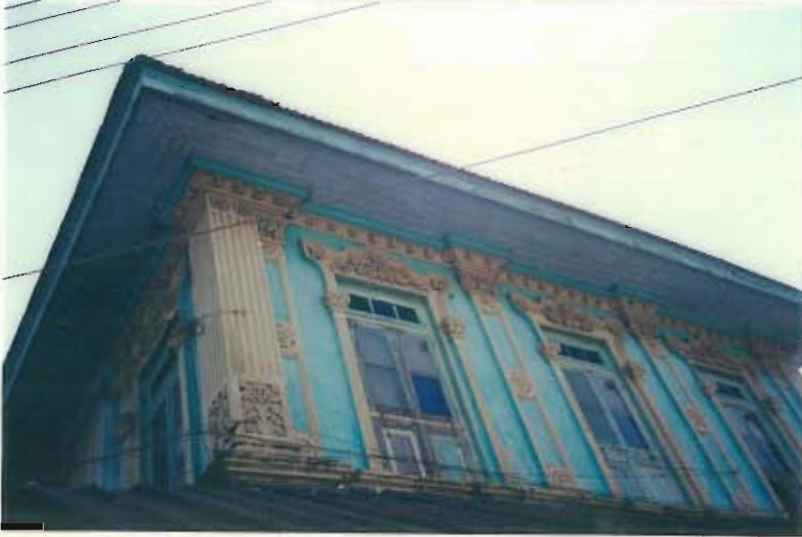
Common Reference No.	UN15
Card No.	89
Name of Property	Ismail Bhajji House

9.7	Articulation & Finishes	The ornamental bracket columns have been painted over by oil paint obscuring their original condition.	
9.8	Services	Fair	
9.9	Outbuildings	NA

View of details showing Baroque style stucco details on upper floor

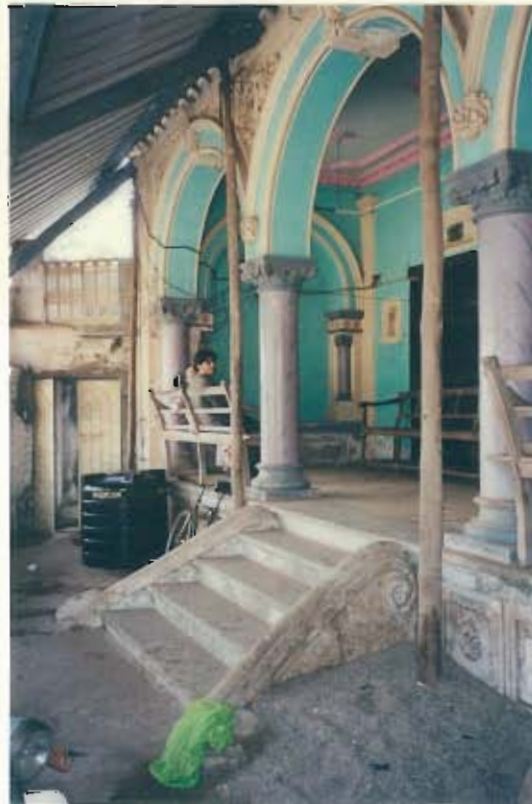
View of arched verandah with stucco work details seen on arches and columns

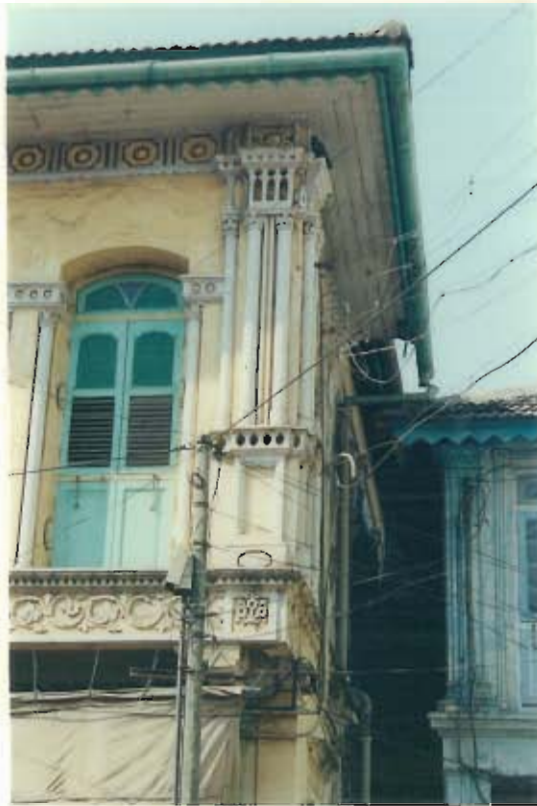
Common Reference No.	UNUN16
Card No.	90
Name of Property	Mookri House

View of the corner of the structure showing intricate Baroque style details and arched window

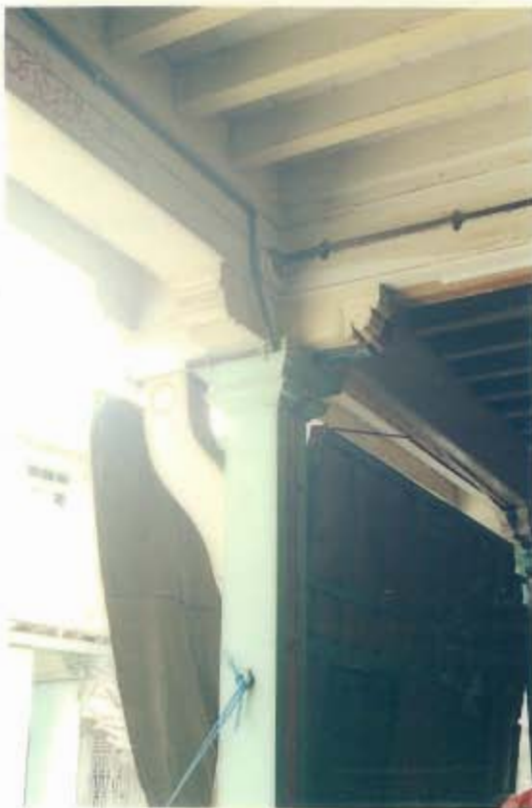
9.6	Roofing	The sloping roof in Mangalore tiles has eaves boards in fair condition.	
9.7	Articulation & Finishes	The ornamental bracket columns have been painted over by oil paint obscuring their original condition. Brick infill panels in the elevation are finished with decorative stuccowork with painting.

View of a typical bracket supporting with Projected beam with above

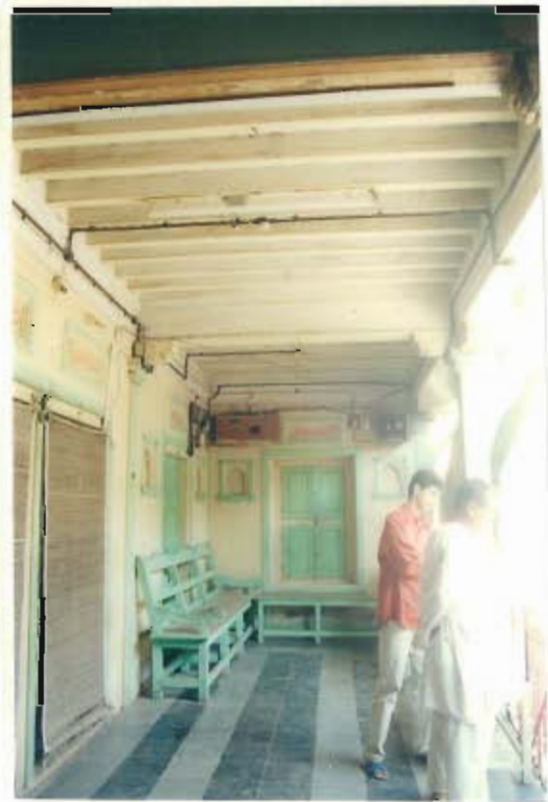
9.0	Condition		
9.1	Plinth	Good. In perfect line and level.	
9.2	Walls	Fair. No obvious damage. Plaster on the outside in good condition	
9.3	Floor	Fair. The timber members are in fair condition

View of the timber joists supporting upper floor boarding and also shows articulated window corners

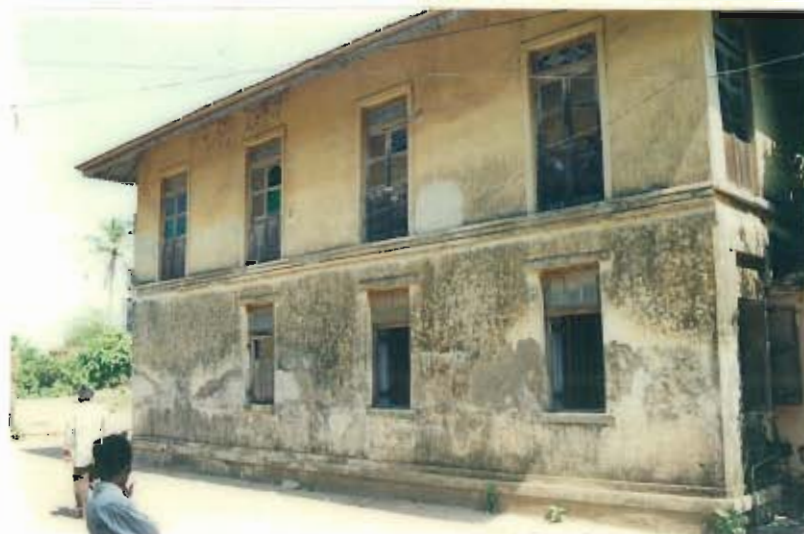
9.6	Roofing	The sloping roof in Mangalore tiles has eaves boards in fair condition.
9.7	Articulation & Finishes	External plaster needs to be repaired. It may affect the wall on the western side due to ill maintenance of the external surface. Timber posts and beams appeared to be in fair condition

Side elevation of the school building

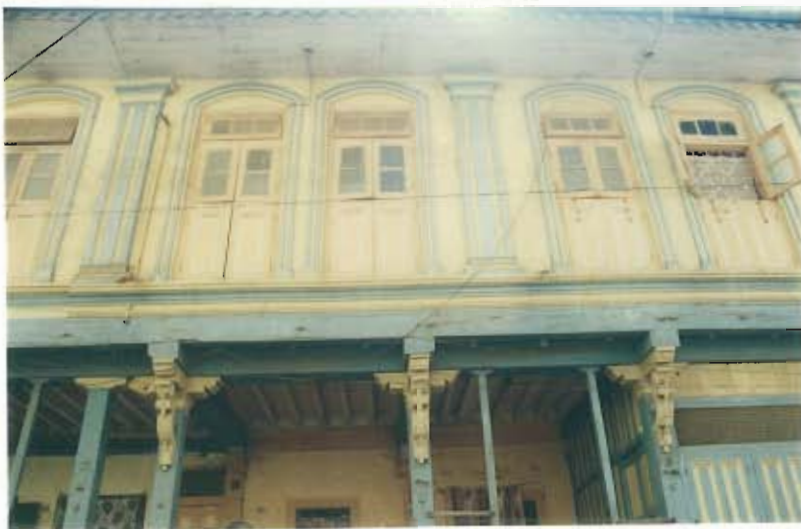
View of Bakshi House from Mir Samdani Road

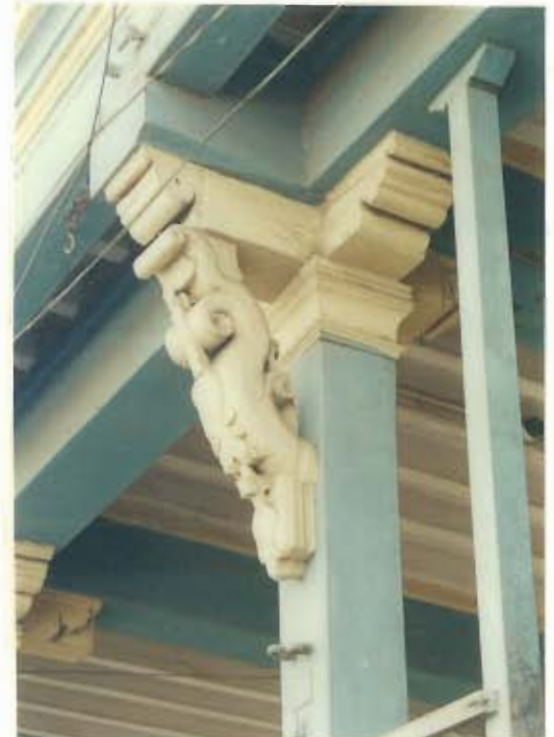
View of the articulated timber bracket

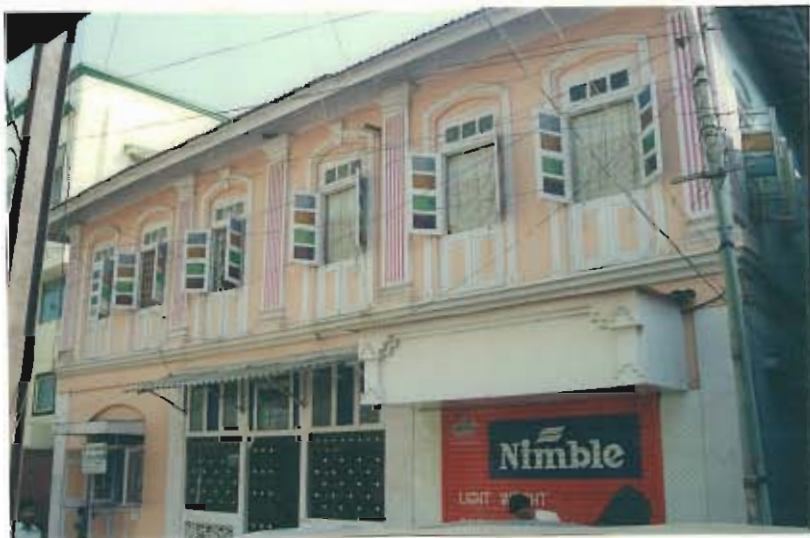
View of Nerekar's House from Bazaar Peth Road

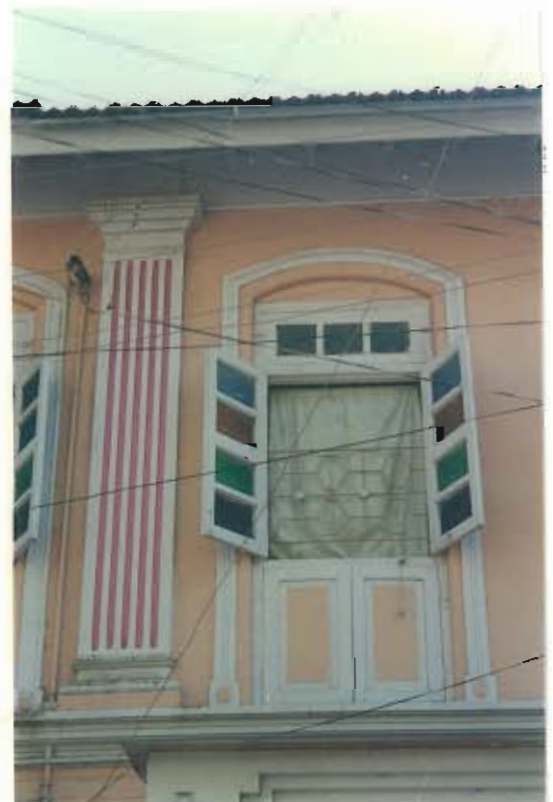
View of typical window from the street

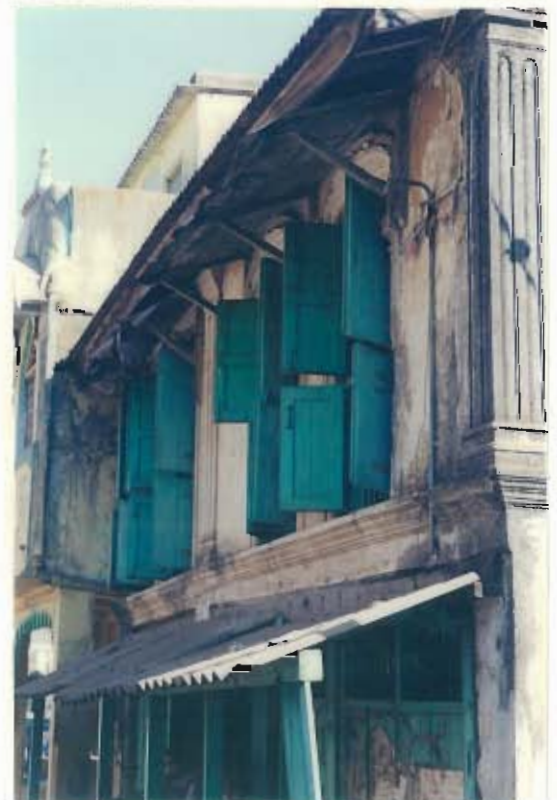
View of a Kanya Shala building from Wani Aali and open space junction.

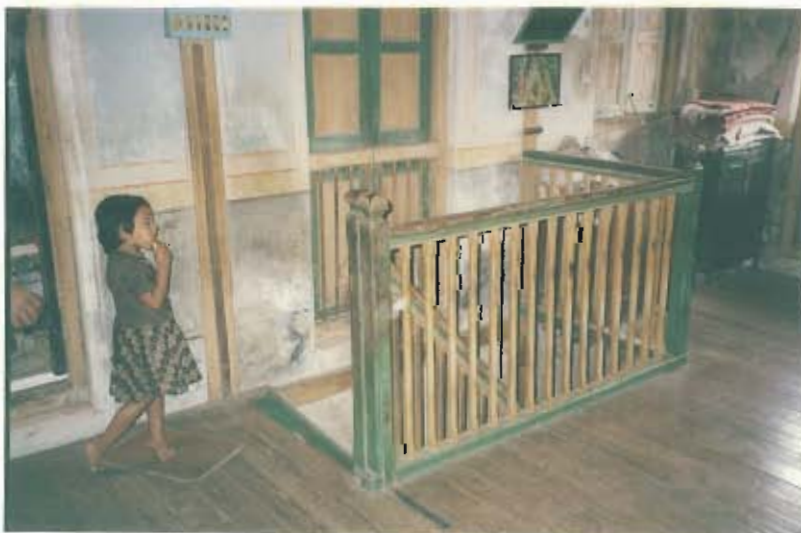
9.3	Floor	Fair. The timber members are in fair condition.
9.4	Stairs	Good. Sound structurally.
9.5	Openings	Fair. The front windows in poor condition.
9.6	Roofing	Sound structural condition except in the verandah where the rafters and fascia show signs of weathering.

View of the internal staircase with Structural frame and flooring in timber

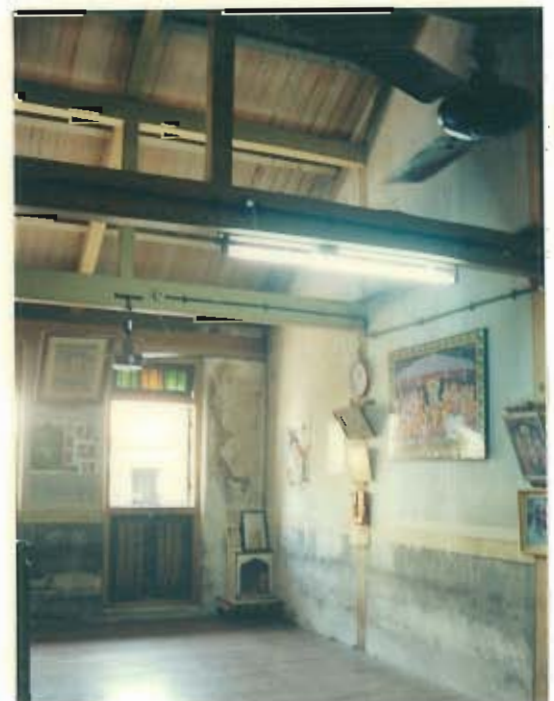
Internal view of the satsang hall timber roof details and timber flooring

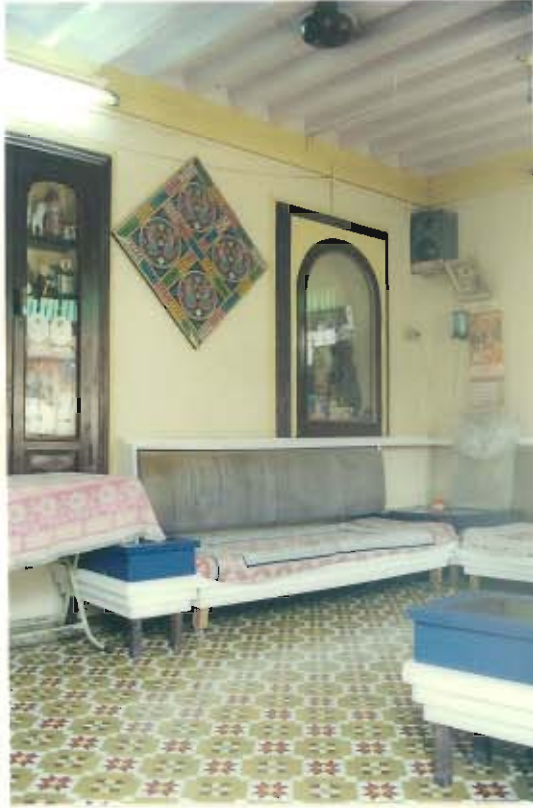
View of living hall on first floor showing patterned floor tiles and timber joist roofing with timber boarding

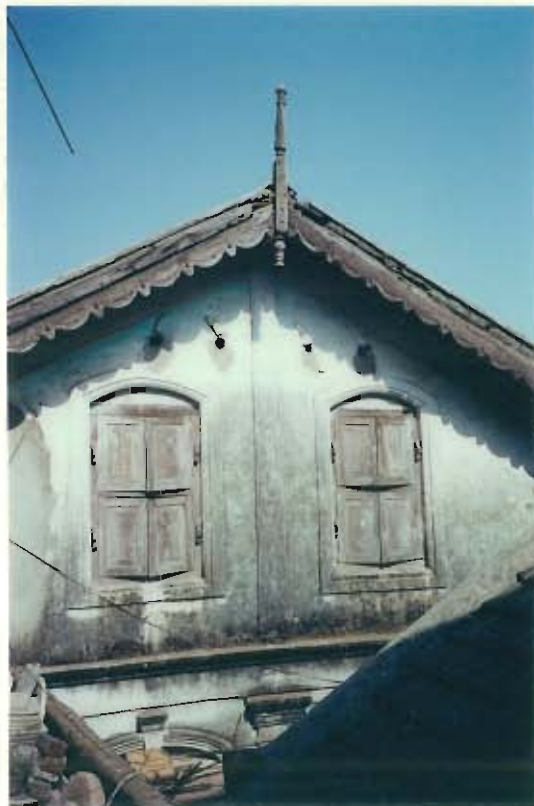
View of the windows of attic space and the gable end of Bhawan Bhavan as viewed from neighboring structure

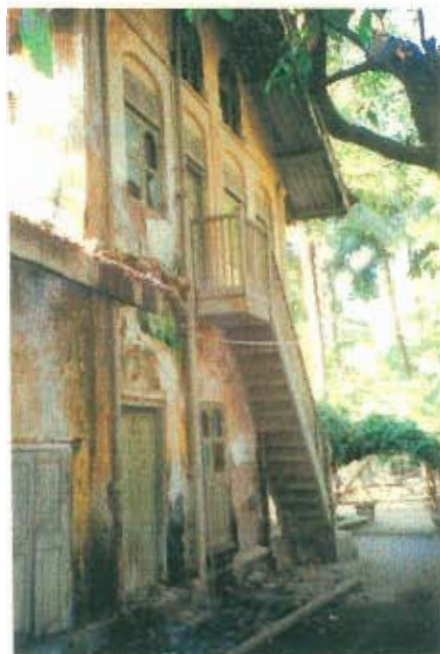
View of the north east corner of the structure

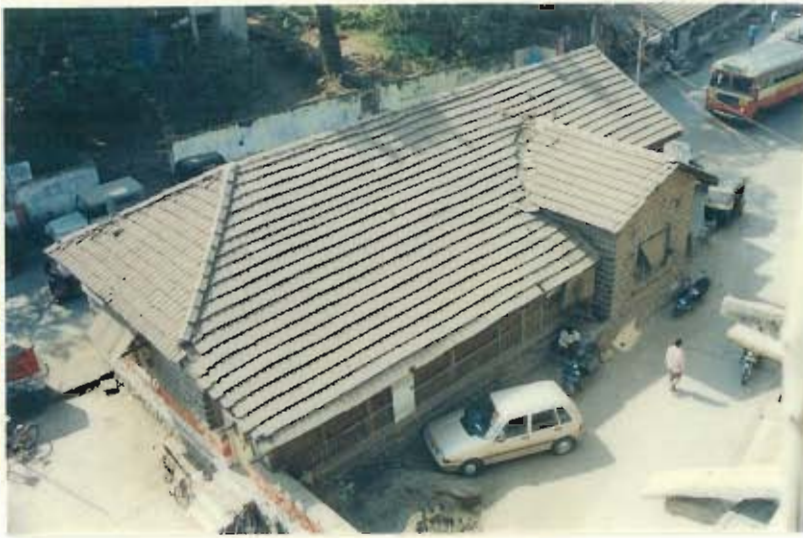
Arial view of the dispensary from North-east

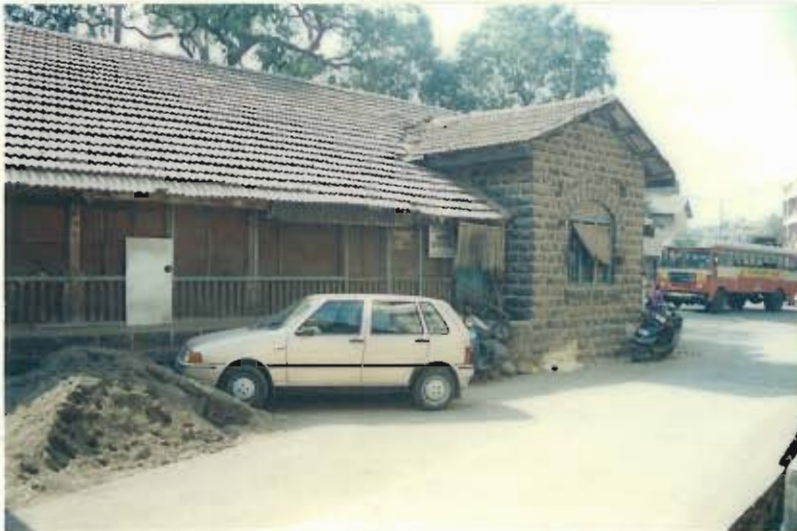
View from Wani Aali shows covered verandah with timber partition

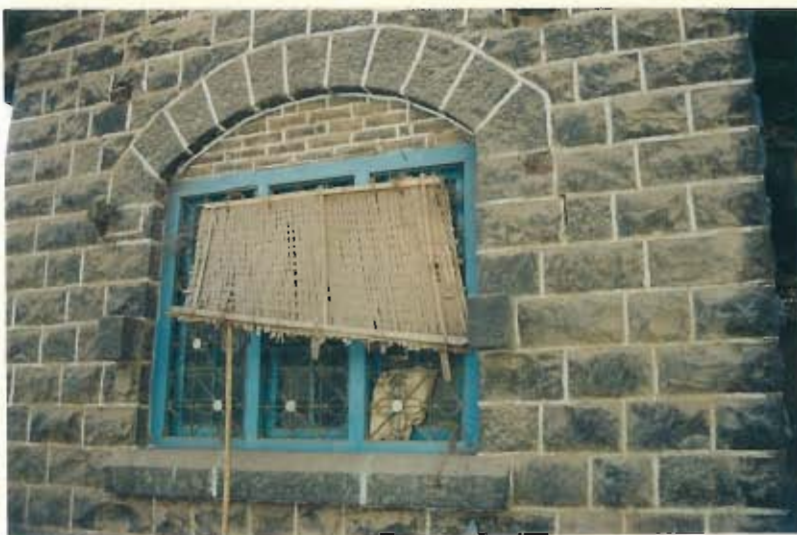
Typical window with stone masonry wall, arch and space infill with brick

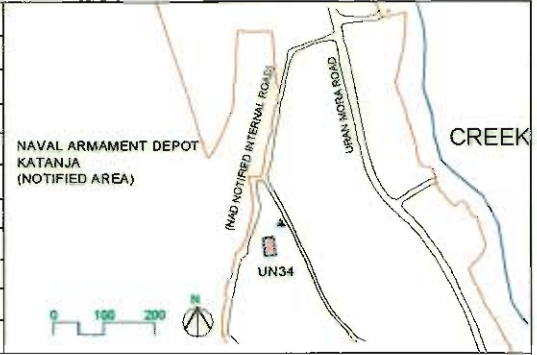
Common Ref No: UN34
Card No. 107
Ward (Part): 1
CS No./House No.: Not Known
Plot Area
B U Area
Date: 19.10.02
Record by: Sanjay/Gaurav
Review by: Smita Dalvi
Int Yes Ext Yes
Photo Ref: U1

7.9	Interiors (Movable & Immovable)	The timber false ceiling in the main hall is in poor state and may give away at any point of time. Other area were not observed.

9.4	Stairs	N.A.
9.5	Openings	Poor
9.6	Roofing	Need regular maintenance. Appears partially sunk
9.7	Articulation & Finishes	Poor condition
9.8	Services	N.A.

9.9	Outbuildings	Servants quarters located at the rear.
9.10	Overall condition	Poor
		Maintenance level Unattended premises
10.0	Transformation	
10.1	Form	No change in the original form of the building

10.2	Structure	No modification in the structure
10.3	Articulation & Finishes	No alterations carried out
11.0	DP Remarks / Perceived Threats	
	Indian Navy has acquired the property for security reasons. To rebuild and preserve the structure separate procedure need to be adopted. Only main hall of the building was allowed to see.

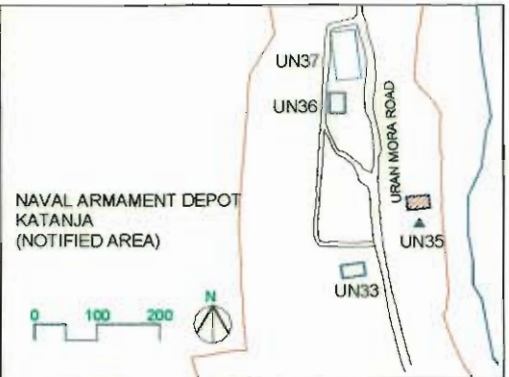
Common Ref No: UN35
Card No.: 108
Ward (Part): 2
CS No./House No.: 907
Plot Area
B U Area
Date: 19.10.02
Record by: Sanjay/Raj
Review by: Smita Dalvi
Int Yes Ext Yes
Photo Ref: U1

9.8	Services	Fair
9.9	Outbuildings	N.A.
9.10	Overall condition	Good
		Maintenance level Good
10.0	Transformation	
10.1	Form	No change
10.2	Structure	Not modified

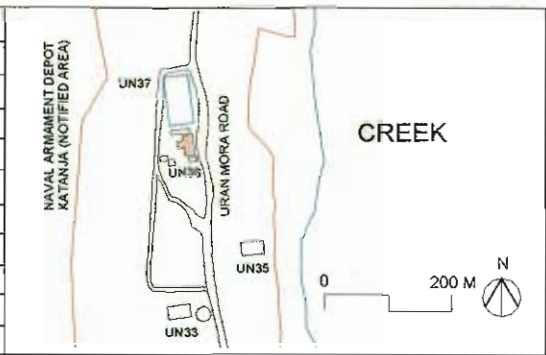
Common Ref No: UN37
Card No. 110
Ward (Part): 1
CS No./House No: N.A.
Plot Area
B U Area
Date: 28.12.02
Record by: Sanjay/Raj
Review by: Smita Dalvi
Int Yes Ext Yes
Photo Ref: U10, U11

9.4	Stairs	N.A.
9.5	Openings	N.A.
9.6	Roofing	N.A.
9.7	Articulation & Finishes	N.A.
9.8	Services	N.A.
9.9	Outbuildings	N.A.
9.10	Overall condition	Poor, Negligence on the part of Uran Municipal Council.
	Maintenance level	Poor, Attention required to maintain

10.3	Articulation & Finishes	N.A.
11.0	DP Remarks / Perceived Threats	
	Needs attention to maintain, Talav is under care of Uran Municipal Council.	
12.0	Additional Notes / References / Documents Available	
	Information parted By Shri. Shekhar Mhatre, Ex-Cairman, Uran Municipal Council Uran, information obtained from 'Uran Municipal Council, Centenary Celebration Volume 1987', and city survey maps made available by Uran Municipal Council. It is stated in the 'Uran Municipal Council, Centenary Celebration Volume 1987' that Manuel D'Souza, Mamledar, used the rubble taken out from the Portuguese fort that was in Uran (Present Kot Naka Area) to construct the wall around the Talav.

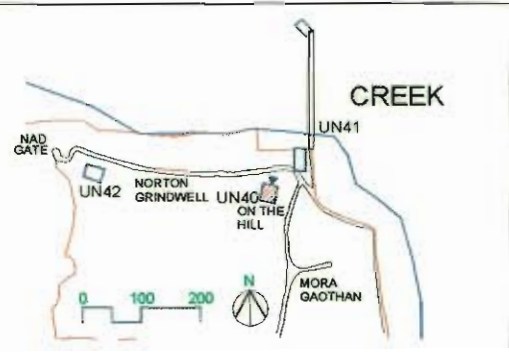
Common Ref No: UN40
Card No. 113
Ward(Part): 1
CS No./House No.: 1106
Plot Area
B U Area
Date: 28.12.02
Record by: Sanjay/Shruti
Review by: Smita Dalvi
Int Yes Ext Yes
Photo Ref: U1

8.7	Other (HVAC/BMS/ Security Systems)	N.A.
9.0	Condition	
9.1	Plinth	Poor condition
9.2	Walls	Dilapidated state
9.3	Floor	Sub floor exposed and uneven,
9.4	Stairs	N.A.

9.5	Openings	Frames for the openings either broken, or removed, arches spanning the openings remained
9.6	Roofing	Roofing unattended, level of the rafters and purlines are uneven over years of neglect.

9.7	Articulation & Finishes	Poor
9.8	Services	N.A.
9.9	Outbuildings	Kitchen and the stores are in dilapidated state
9.10	Overall condition	Poor
	Maintenance level	Nil

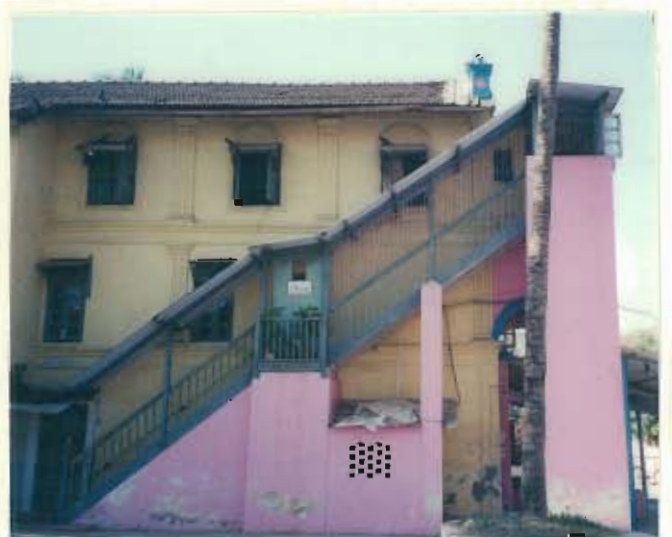
9.3	Floor	Tiling in the nave is in good condition
9.4	Stairs	External staircase appears to have been added later is in fair condition including its roofing.

View of the external staircase on the eastern side
