**University of Mumbai**  
Restoration of the Convocation Hall

Restoration of the Convocation Hall: The History

## Restoration of the Convocation Hall: Fabric Inspection

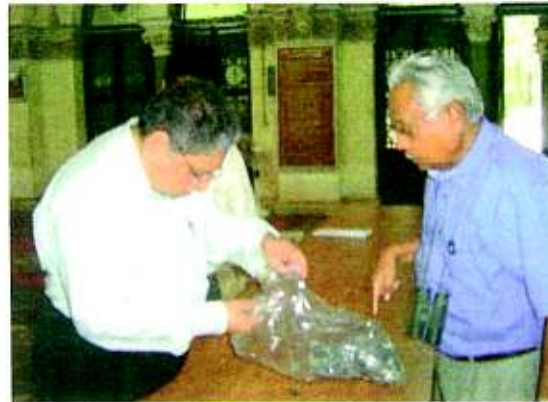
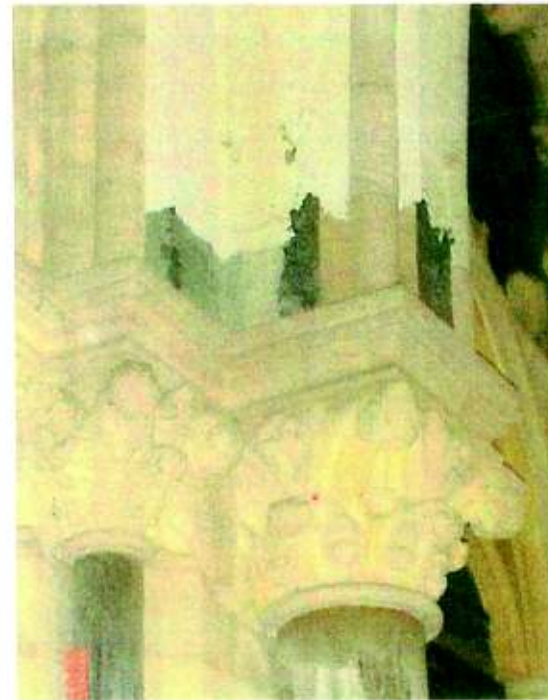
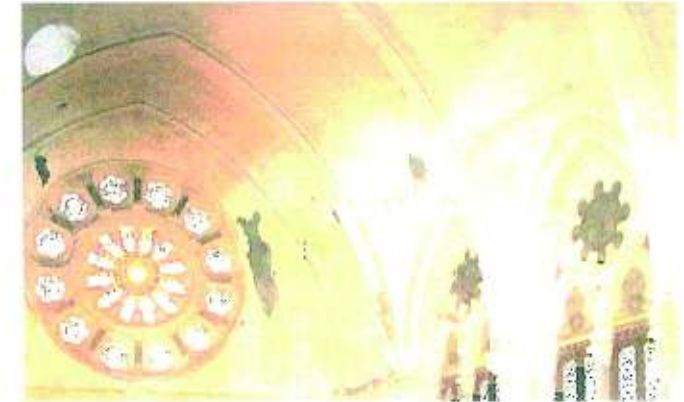
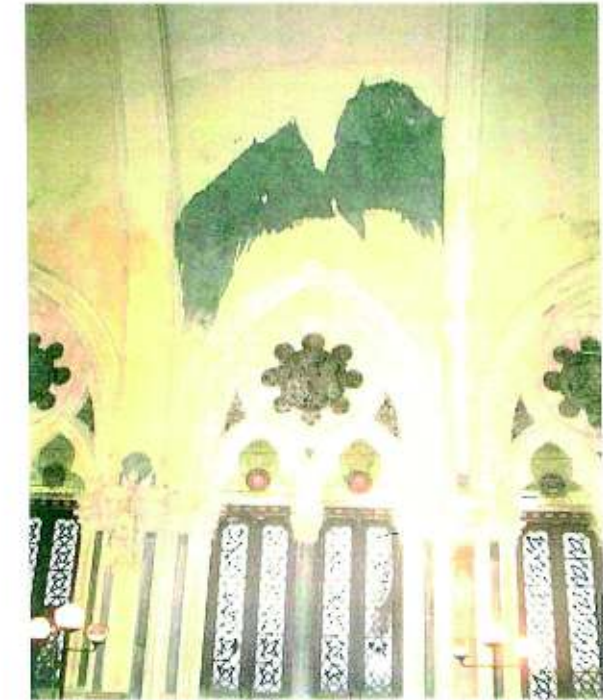
Top Right: Incessant leakage through the roof had created distinctly visible patches of discolored plaster along the underside of the vault. Bottom Right: Peeling point on the underside of the vault exposed the fibrous grey asbestos lining on the entire vault surface; Bottom Left: This asbestos fibre was seen along the vault and wall surfaces. Top Left: Consultants examining the flaking 'plaster' found this to be hazardous asbestos fibre.

Pull out tests were conducted on the acoustic layer on the under side of the vault and this was found to be an asbestos based fibre, that as later records revealed, had been introduced in the building in the 1940s.

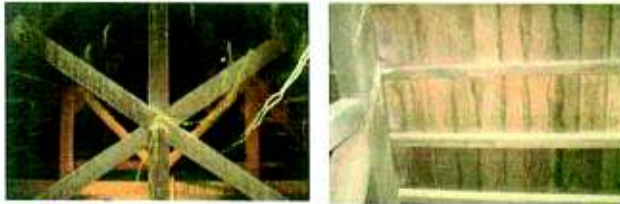
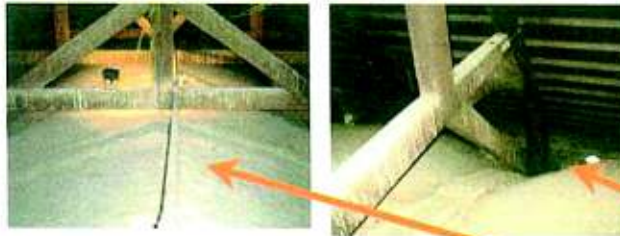
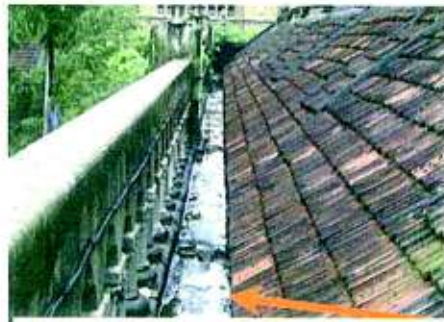
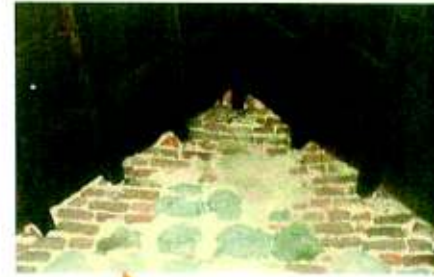
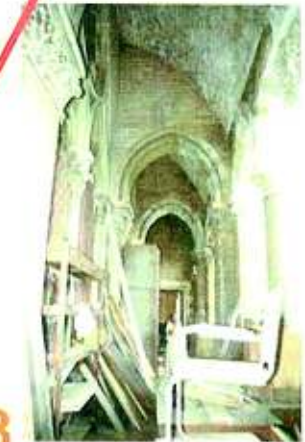
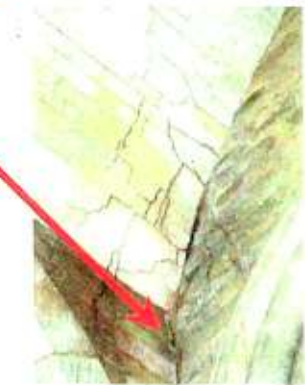
- 1 Gable end over Rose Window
- 2 Roof tiles over timber truss
- 3 Upper verandah cluttered
- 4 Extensive damp & termite seen along flying buttress
- 5 Incremental layers of tar felt have choked the water outlets
- 6 Vault and stone ribs under wooden truss roof

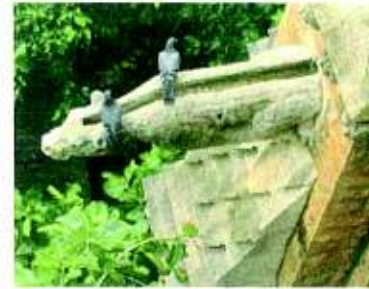
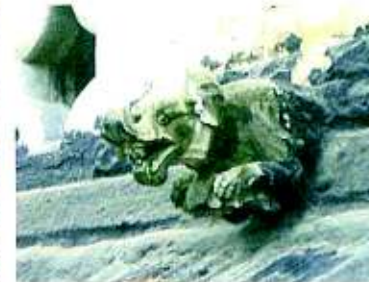
Images showing stone gargoyles at the upper and lower roofs choked with layers of bitumen, rendering them ineffective

Below: The drainage system of the roof indicated on a section through the building.

As the roof was layered with bitumen felt each year after the monsoons to prevent water ingress without properly addressing the roof, the layers of bitumen clogged the gargoyles, thus choking the drainage outlets. This caused water to collect at the roof levels, finally percolating through the vaults into the building and showing up as extensive peeling off of the internal plaster and paint in the interiors.

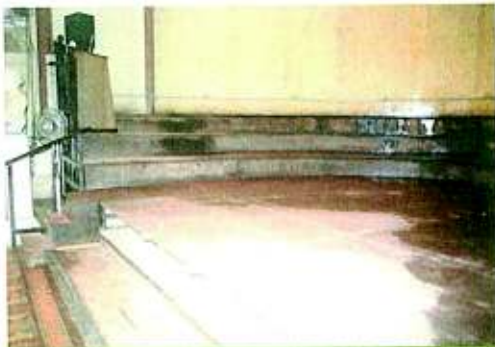
Moisture meter tests conducted during the assessment indicated that nearly 2/3<sup>rd</sup> of the roof vault was saturated with water during the monsoons. This caused serious concerns about its structural safety as chemical analysis of lime mortar samples in the vault showed that the ratio of lime to sand in the lower reaches of the vault had

Below: Fabric inspection drawing indicating the sections of the vaulted roof that were completely saturated with moisture. Left: Images showing the badly deteriorated apse roof resulting in water trickling down the apse end.

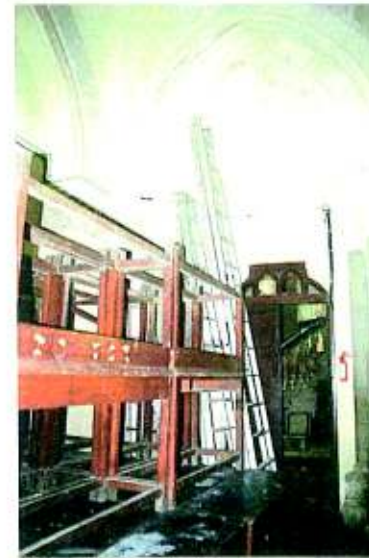
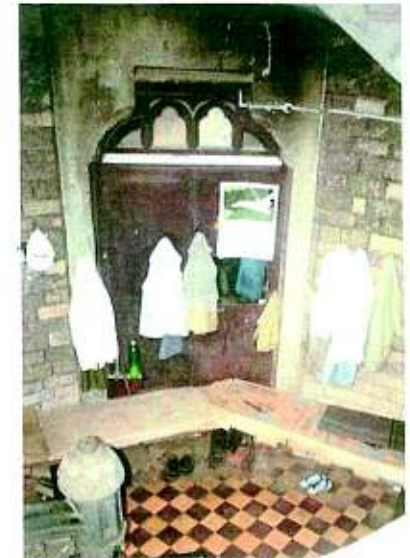
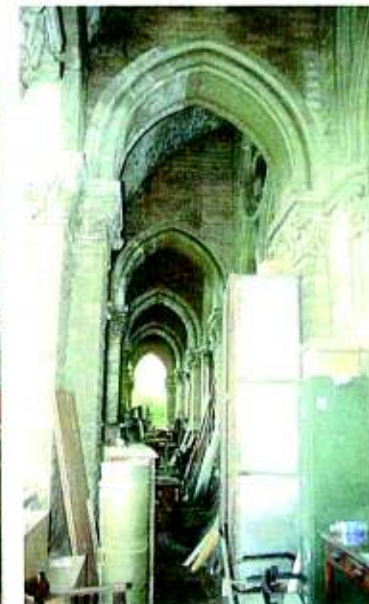
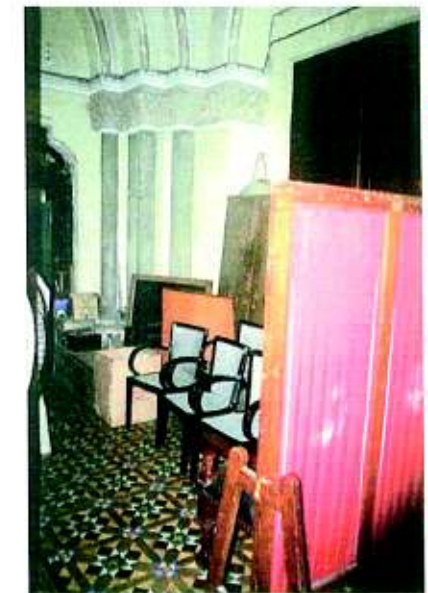
With years of neglect and improper maintenance, the circulation spaces as well as the phenomenal verandahs at the upper level between the flying buttresses, had been reduced to dumps for old disused furniture.

Termite runs were rampant along the inner walls of the verandahs, found to be eventually leading to the timber framing members of the inner acoustical treatment in the main hall. Water leakage from the lower roof levels had led to staining of the inner lime stone in the vaulted surface of the verandahs and led to extensive deterioration of the lime mortar in the masonry joints. Stairways were jammed with furniture and the entire wiring along the east stairwell was a mess of electrical conduits and meter boxes.

Below: Images taken in July 2005 showing the grand verandah spaces, passages and corridors jammed with old furniture and the staircase strewn with tools and furniture.

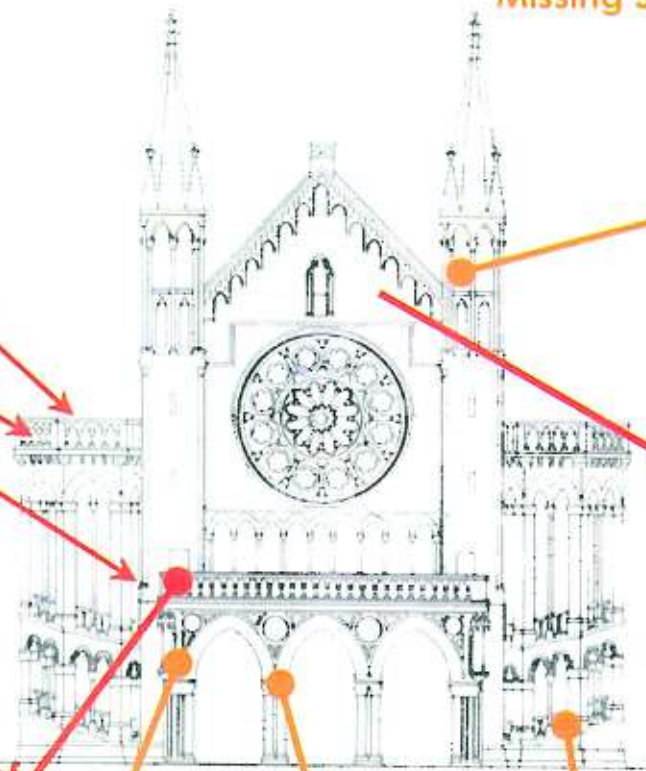
## Missing Sandstone column shaft

Issues facing the north façade ranged from displacement of the upper level parapet wall (top left) due to a plant growth, insensitive routing of electrical cables, ad hoc installation of rain water pipes and deterioration and cracking of stone columns in the front porch. The gable end had been re-pointed using hard epoxy pointing and missing sections of sandstone columns had been repaired in a cement mortar.

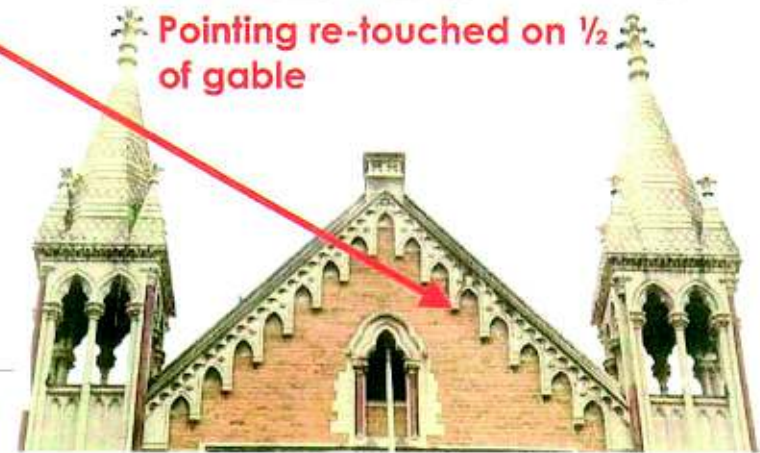
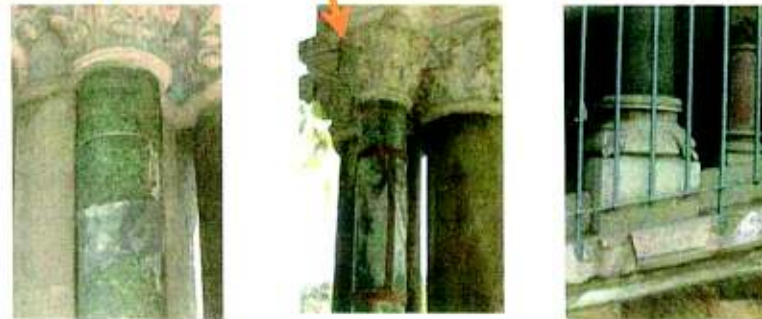
Splitting & Cracks in column shafts

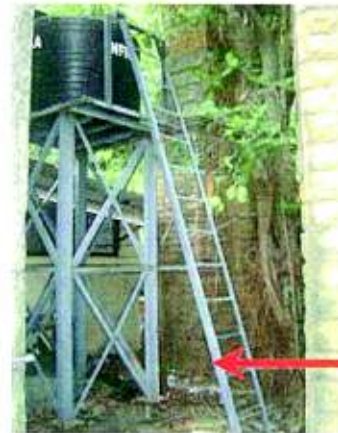
Issues facing the south façade ranged from ad hoc additions of sheds, water tanks and ugly fencing, to a large peepal tree growing into the foundation of the building. The upper level apse roof on the south face too was in a greatly deteriorated condition, resulting in extensive roof leakage.

Missing stone shaft

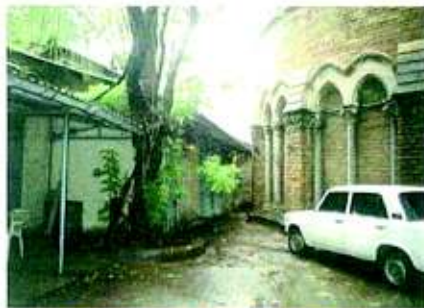
Insensitive location of Tank

Apart from the issues of stone staining, rising damp and deterioration of pointing, the one major issue with the south and east facades was the addition of incongruous sheds, water tanks, fencing and such unsightly additions that had been constructed in the 1960s – 1990s. The consultants proposed that these be removed to clear the building of all such

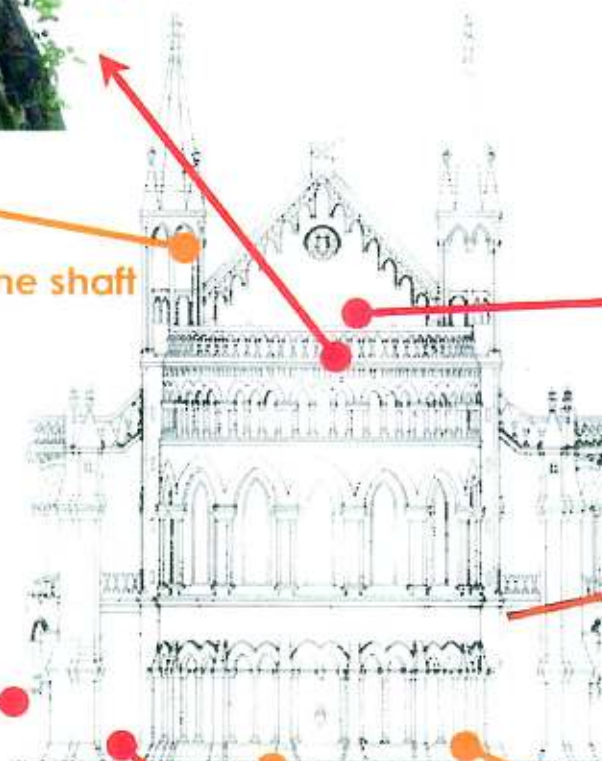
1 Ficus Growth

At the north east terrace level, there was a substantial crack along the masonry, with visible dislodging of the stone parapet. This was also true of the northern porch that had a similar problem. This was the result of a large *peepal* plant growing at the terrace level, with its root system embedded into the masonry down to a depth of over three meters. The solution to this was to

cut the ficus plant, pull out the root system and carefully dismantle and re-set the parapet level stones to restore the original level and line. Similar but much larger growths of full grown ficus trees was seen in the south east and south west ends where the root system was too close to the foundations, threatening settlement and cracks.

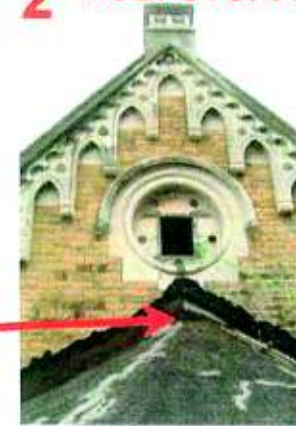
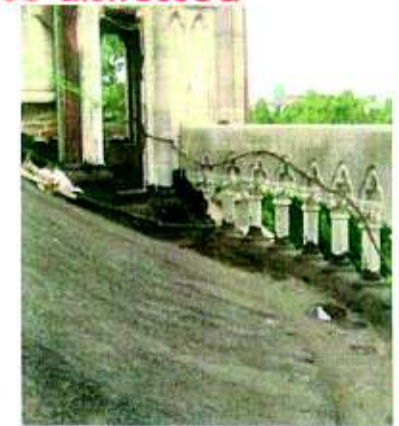
2 Roof over Apse distressed

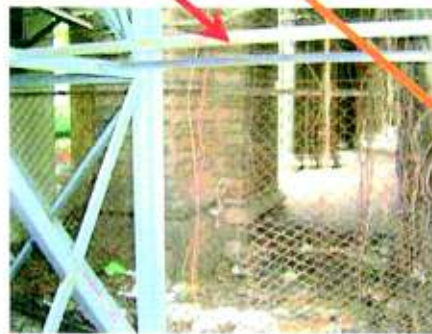
4 Gate & fencing design

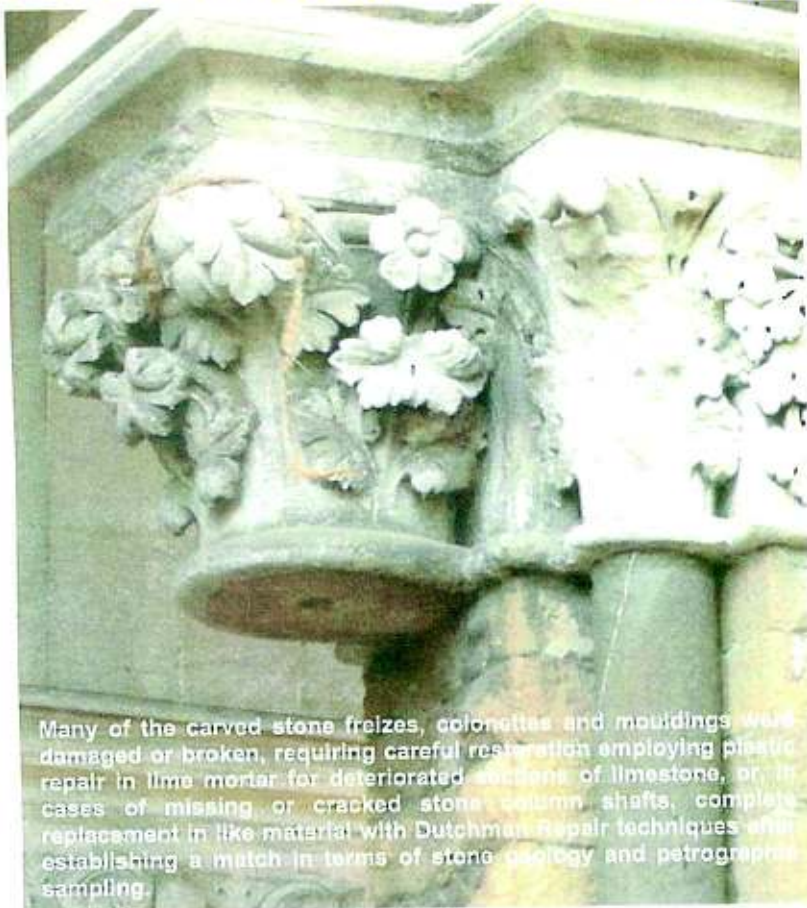
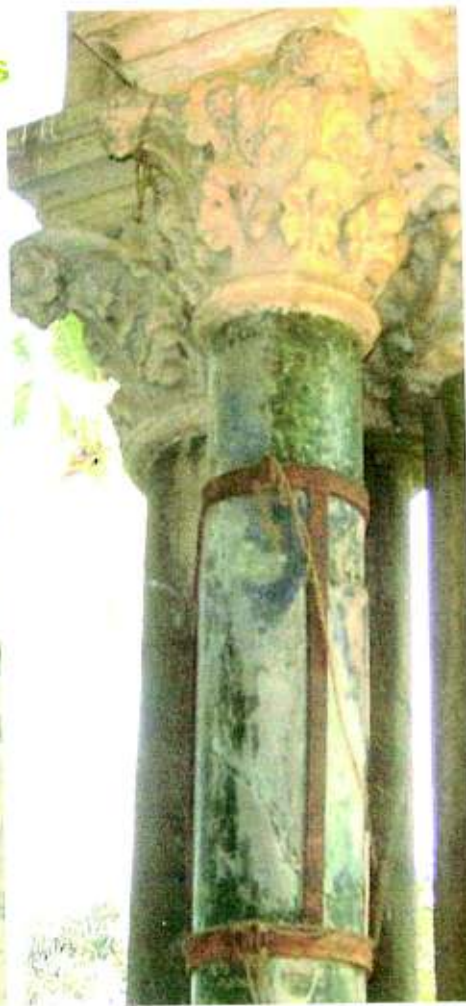
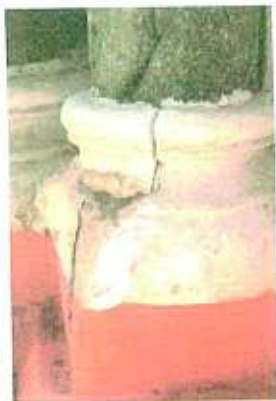
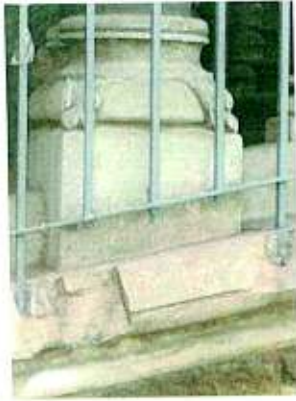
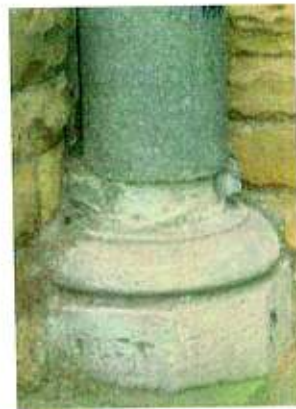
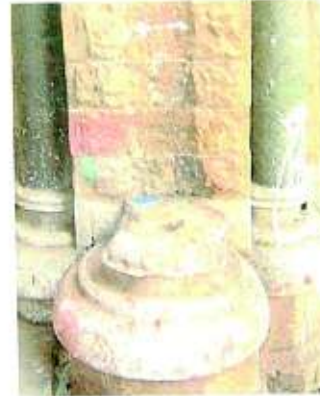
Many of the carved stone freizes, colonettes and mouldings were damaged or broken, requiring careful restoration employing plastic repair in lime mortar for deteriorated sections of limestone, or, in cases of missing or cracked stone column shafts, complete replacement in like material with Dutchman Repair techniques and establishing a match in terms of stone geology and petrographic sampling.

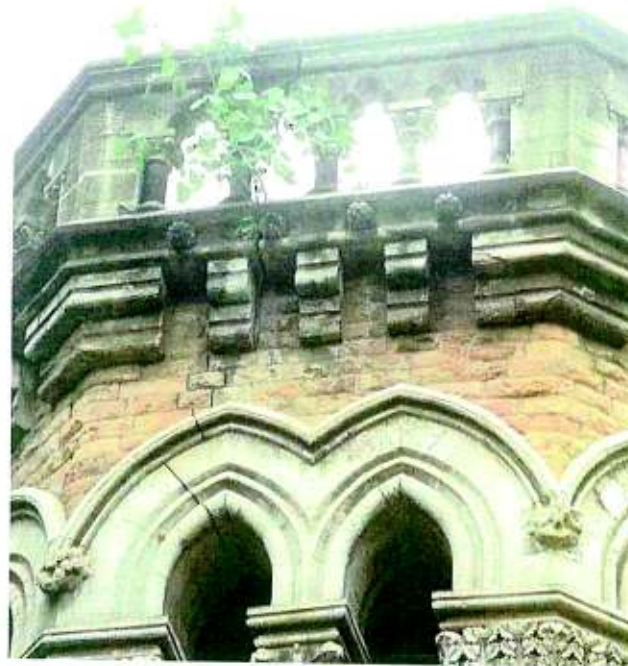
Ficus growth along crevices of the stone masonry were an issue that required addressal, as also the sulphate skins that were formed on the stone surface and gave a blackish residue on the stone. Other staining on the stone was found to be the result of a variety of causes

such as rust stains, bitumen staining and due to salt deposits as a result of water runs and rising damp. This was specially severe in the case of the limestone gargoyles where the sulphate skin build up was choking the spouts and interfering with the roof drainage.

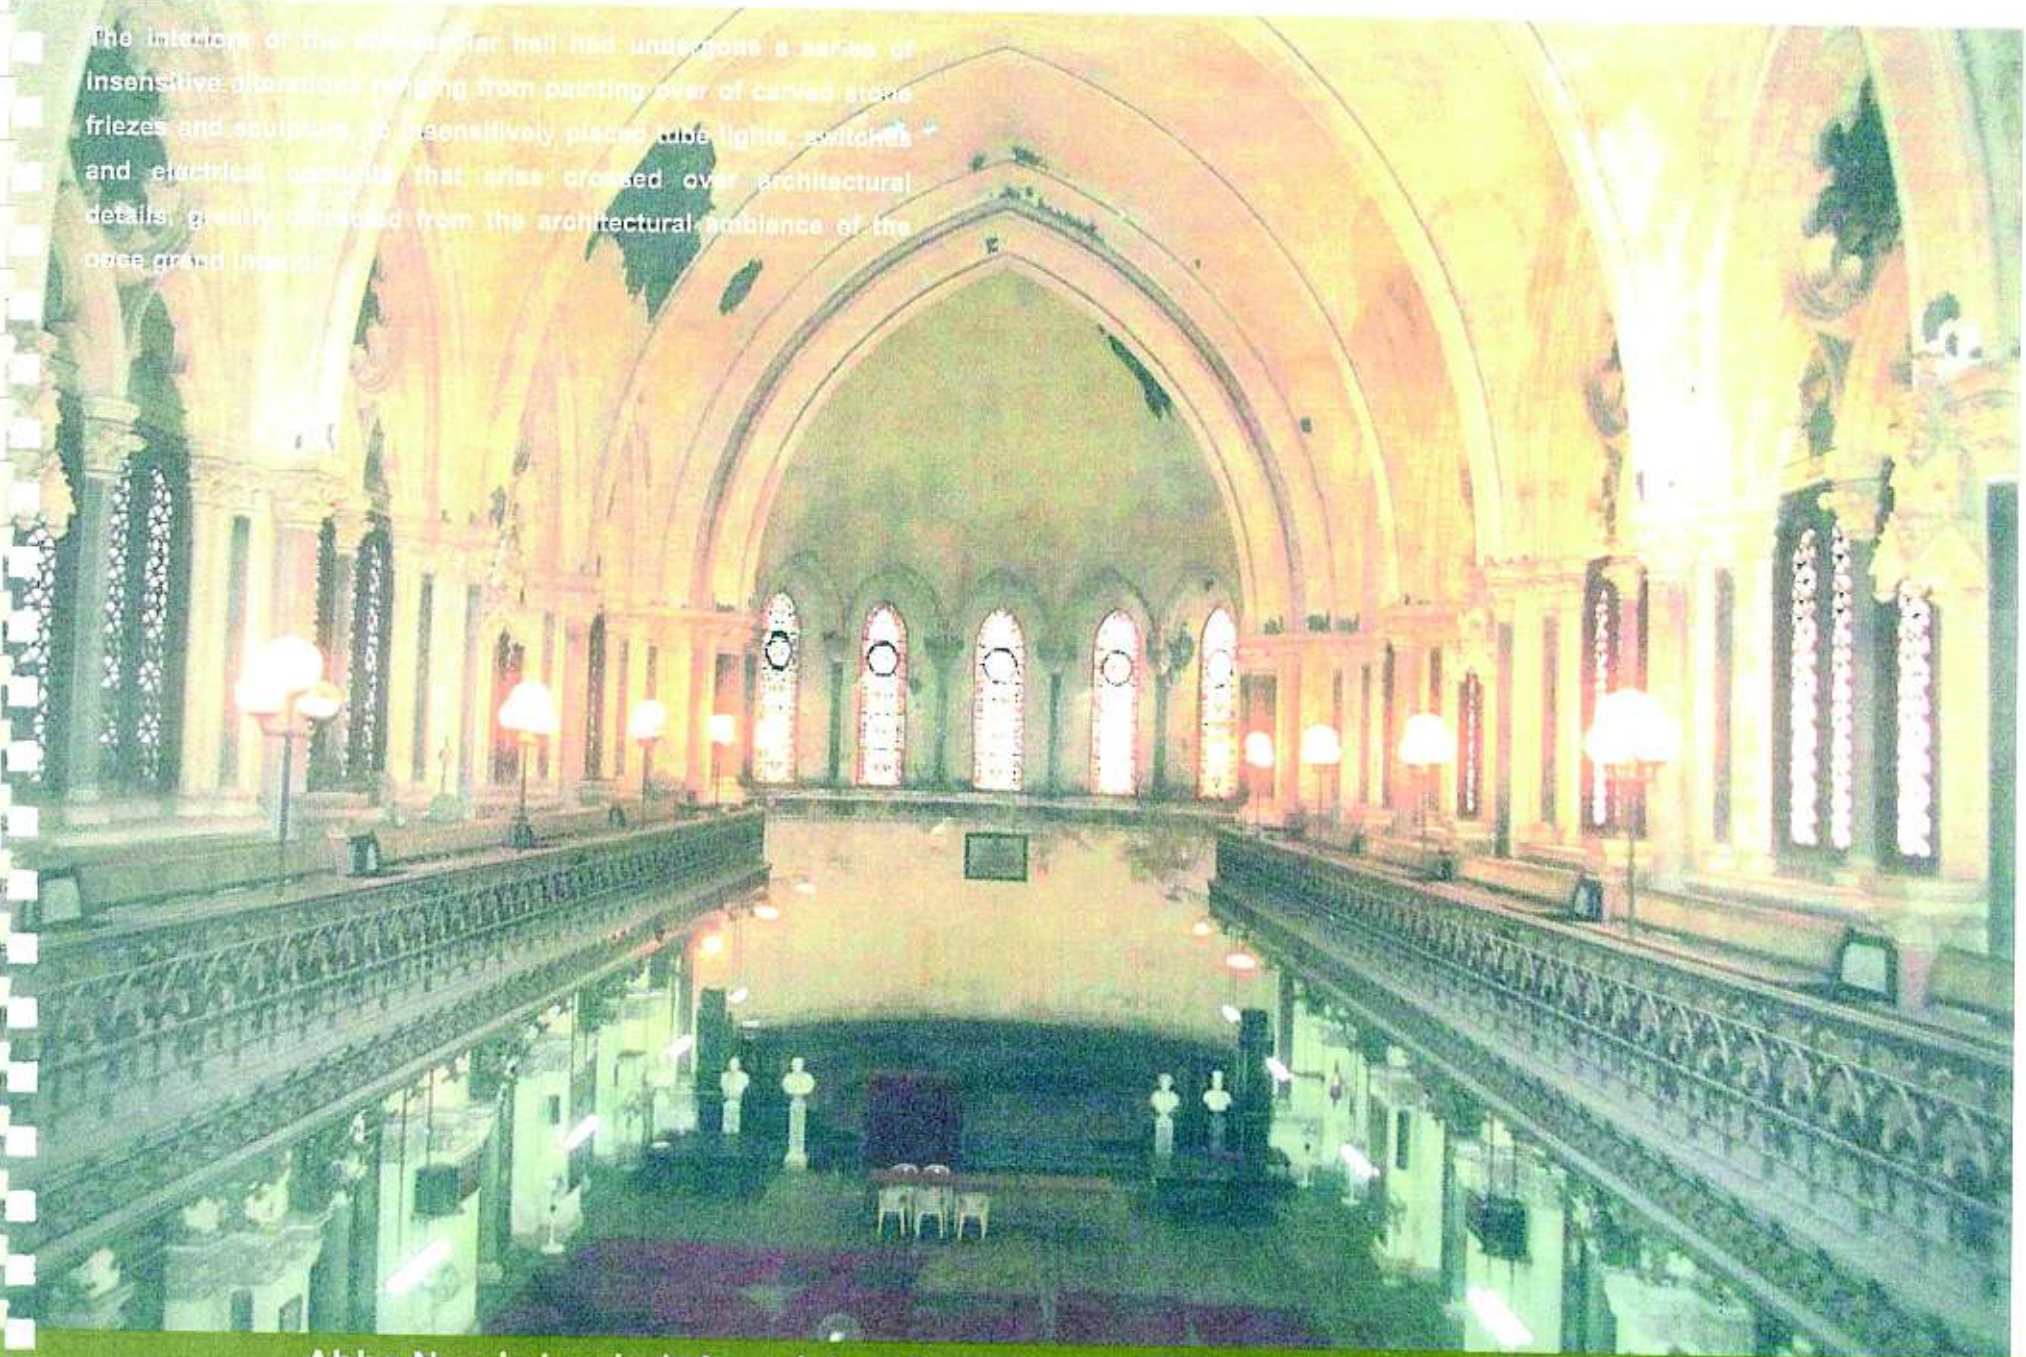
The interior of the convocation hall had undergone a series of insensitive alterations ranging from painting over of carved stone friezes and sculptures, to sensitively placed tube lights, switches and electrical conduits that criss crossed over architectural details, greatly damaged from the architectural ambience of the once grand interior.

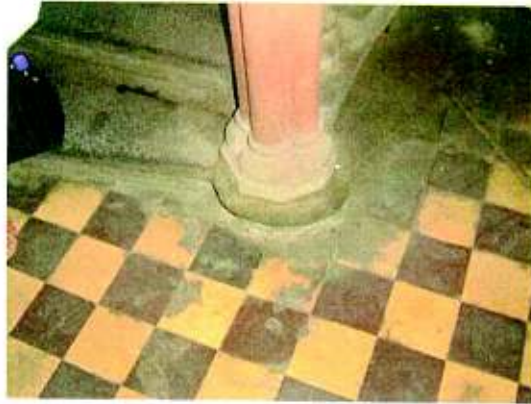
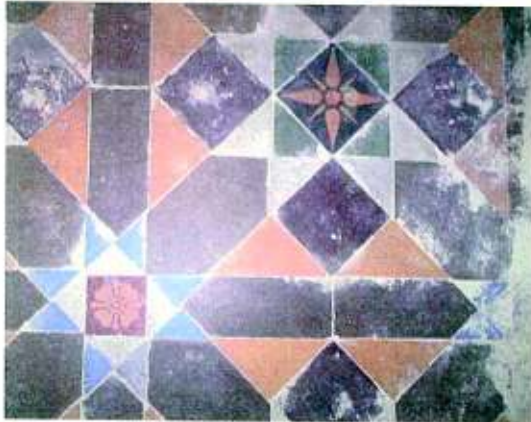
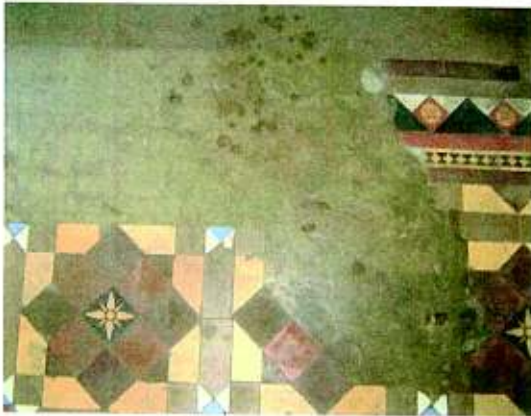
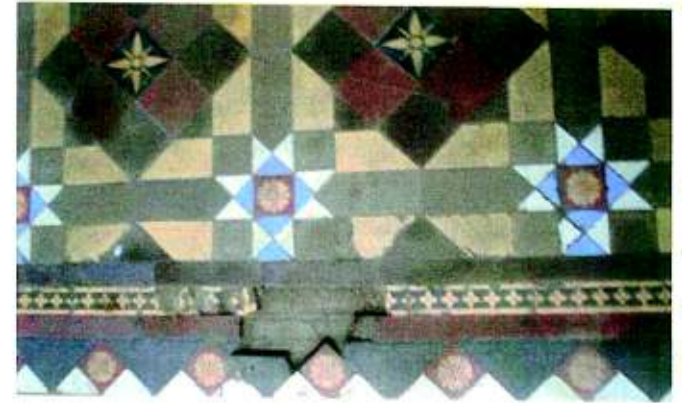
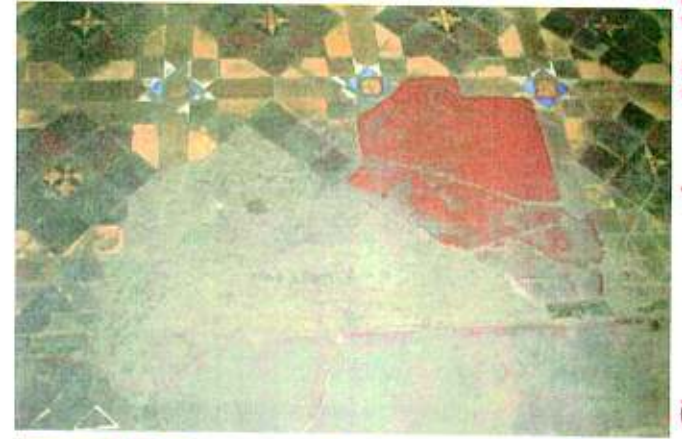
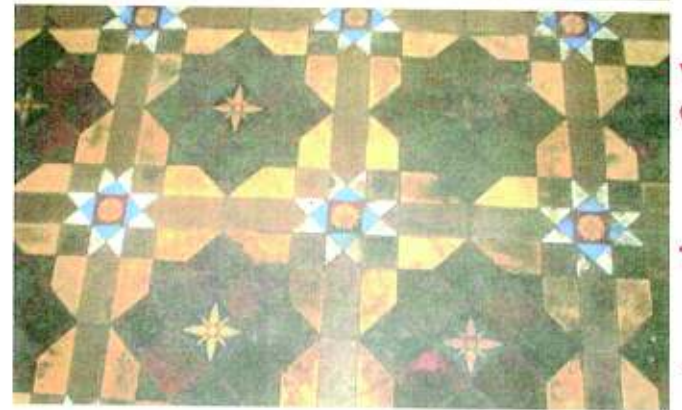
The many rich patterns of Minton tile floor imported from Minton Tile Co. in England, had been damaged at places, with bulged sections or entirely missing sections of tilework infilled with cement patchwork repairs.

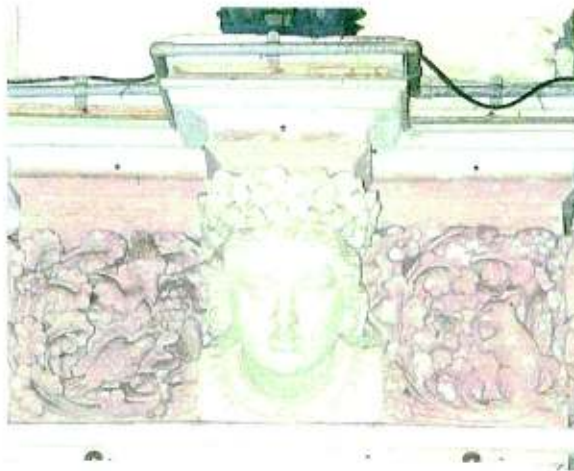
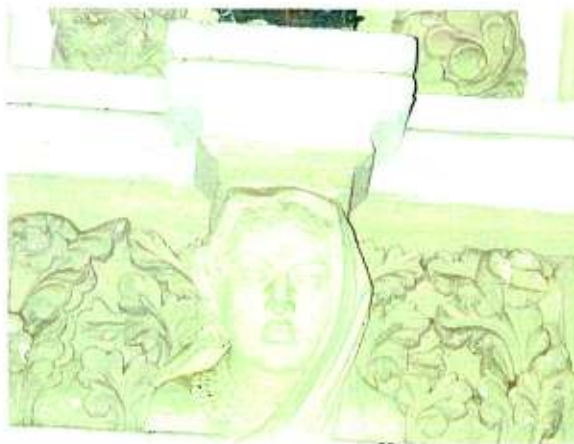
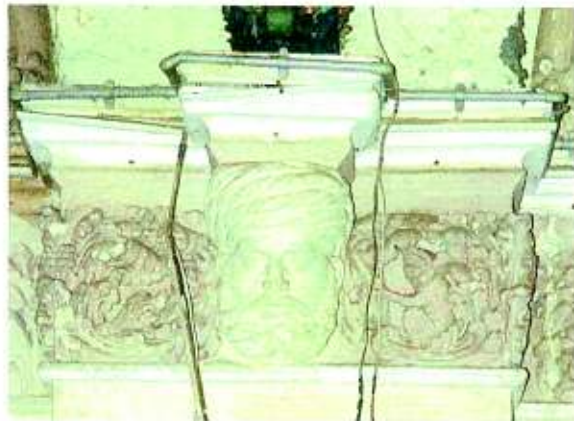
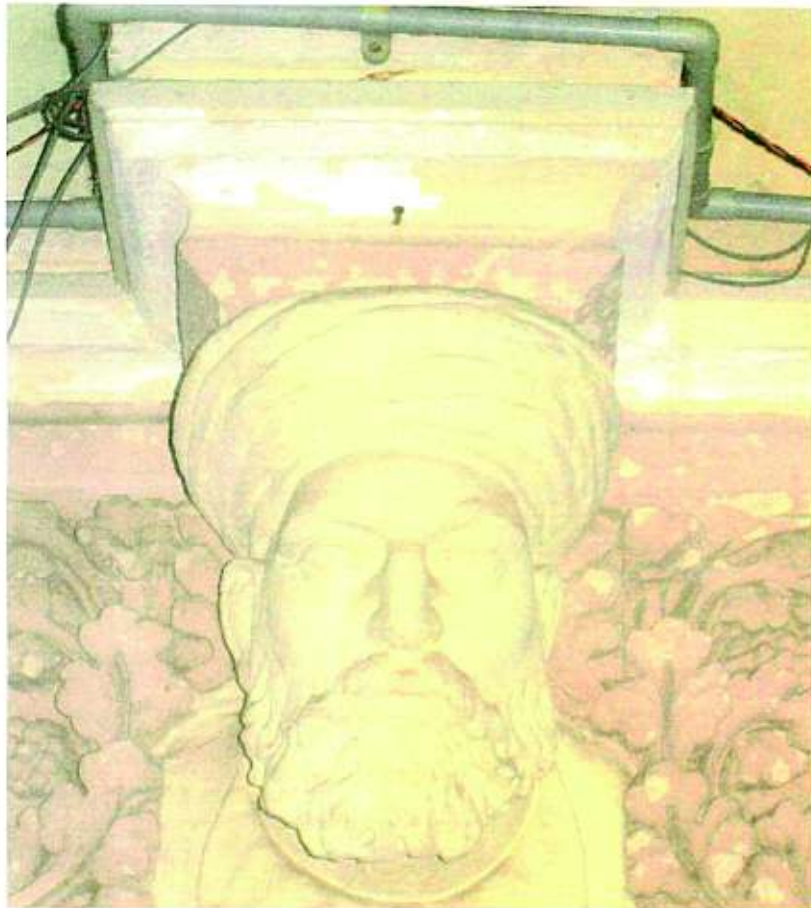
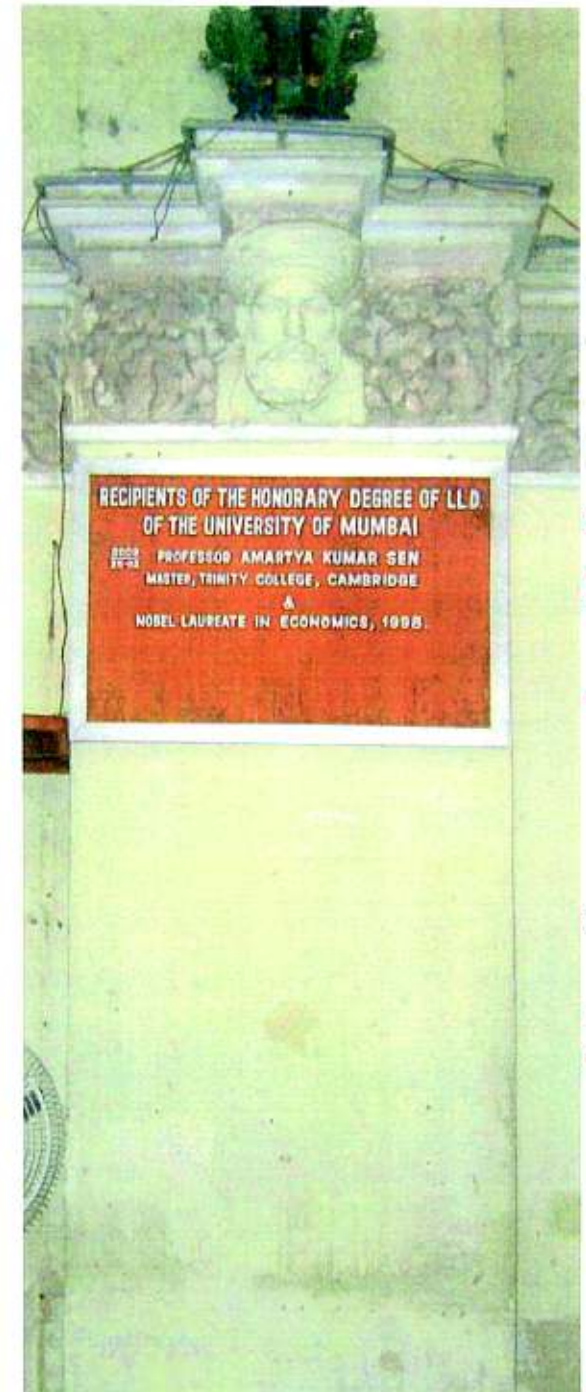
Crafted in soft Porbunder limestone by students of the Sir JJ School of Art under the guidance of Mukoond Ramchander, these carvings were insensitively painted over in layers of paint, obliterating the fine details and texture of the stone.

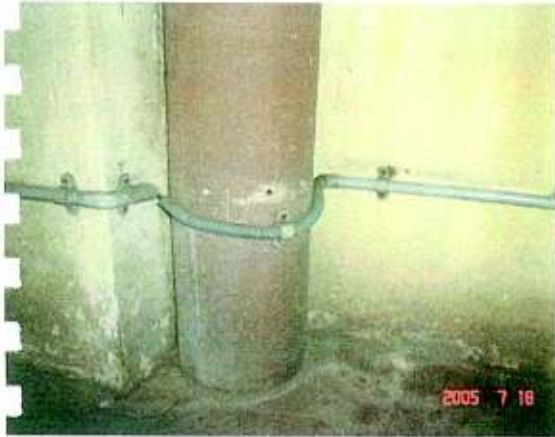
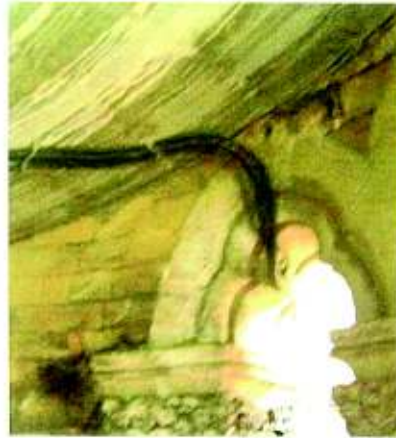
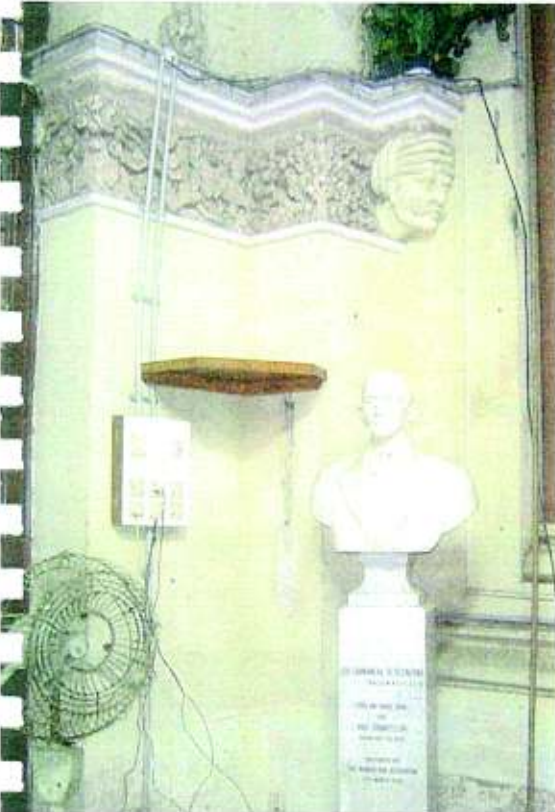
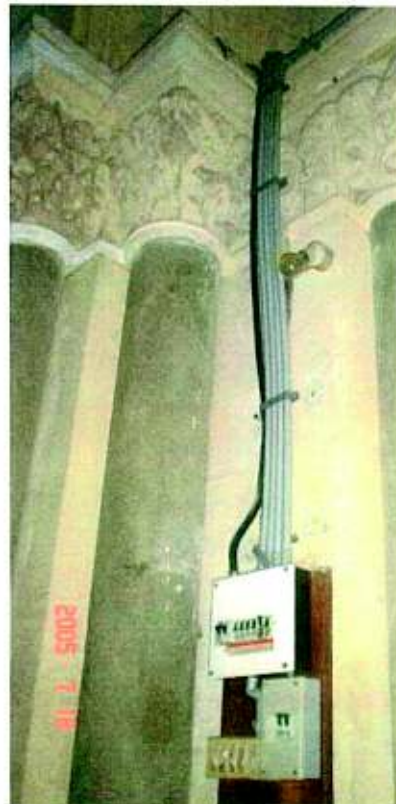
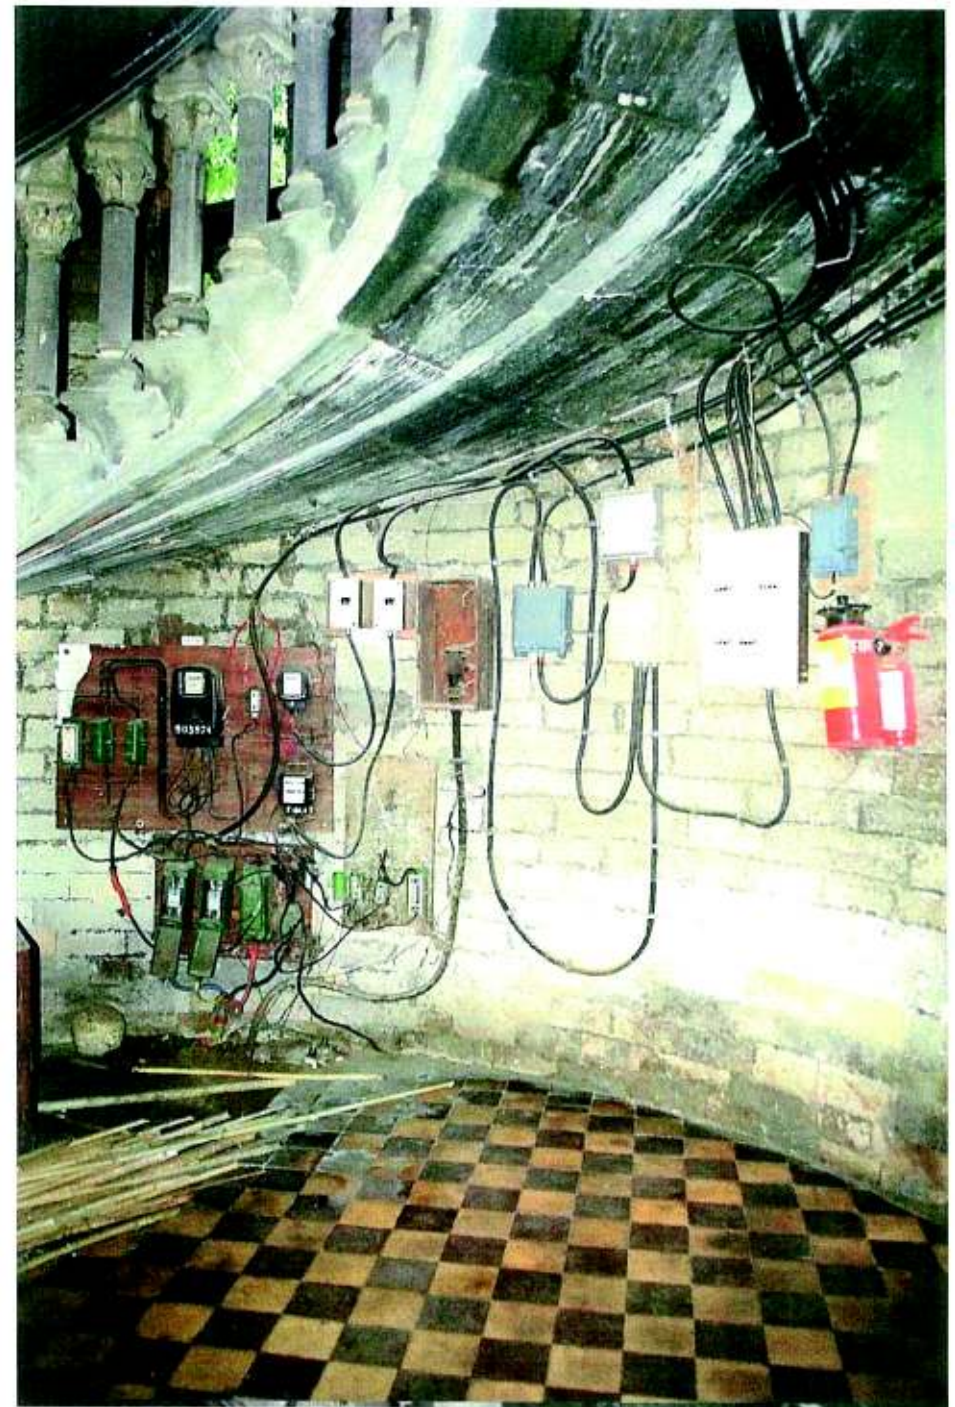
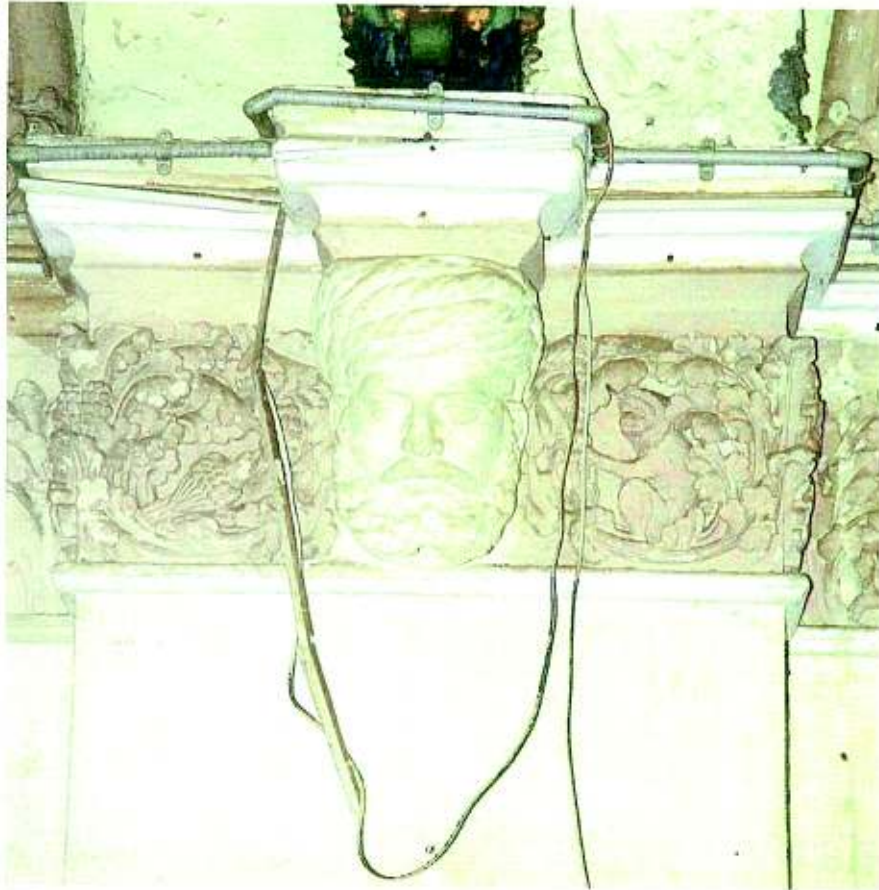
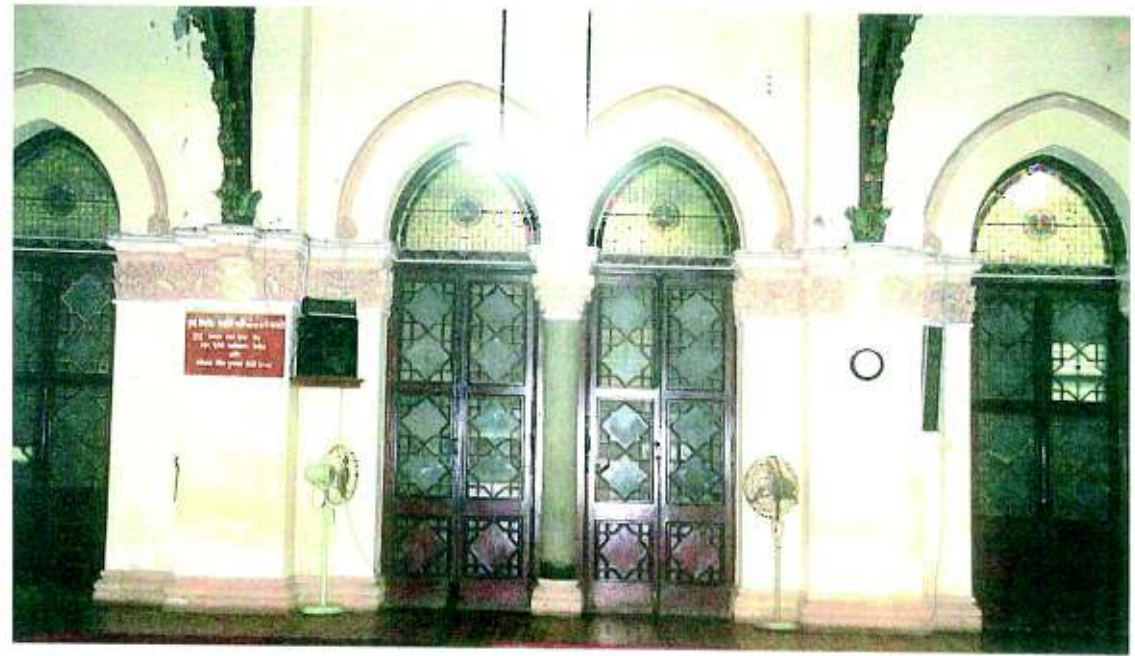
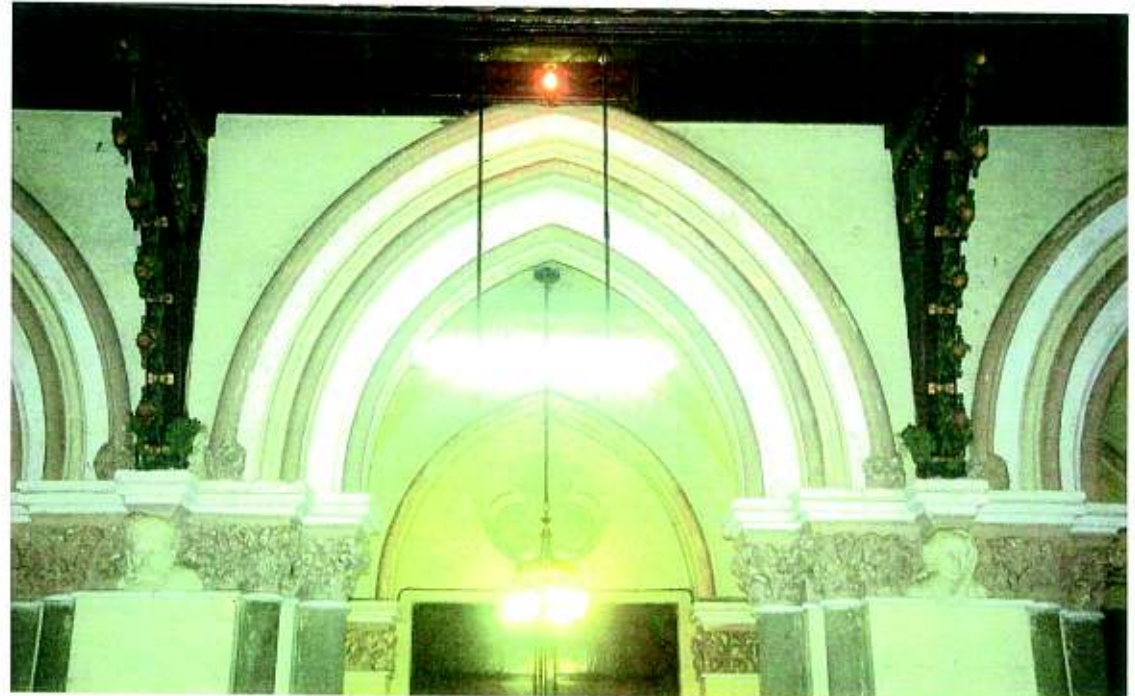
The original system for lighting had been based on gas lights, with a gas pipe running between the vault and upper roof, with a provision for chandeliers being hung from the ribs of the vault. The upper level balcony had a series of lights mounted on stands fed from concealed gas pipes. However, with the subsequent electrification of the building, the entire electrical wiring was incorporated in a most unsympathetic manner, criss crossing over decorative details and cutting across arches. Fluorescent tubelights were suspended from the balcony and visually detracting from the stained glass on the lower level. Electric fans and sound speakers too were incongruous.

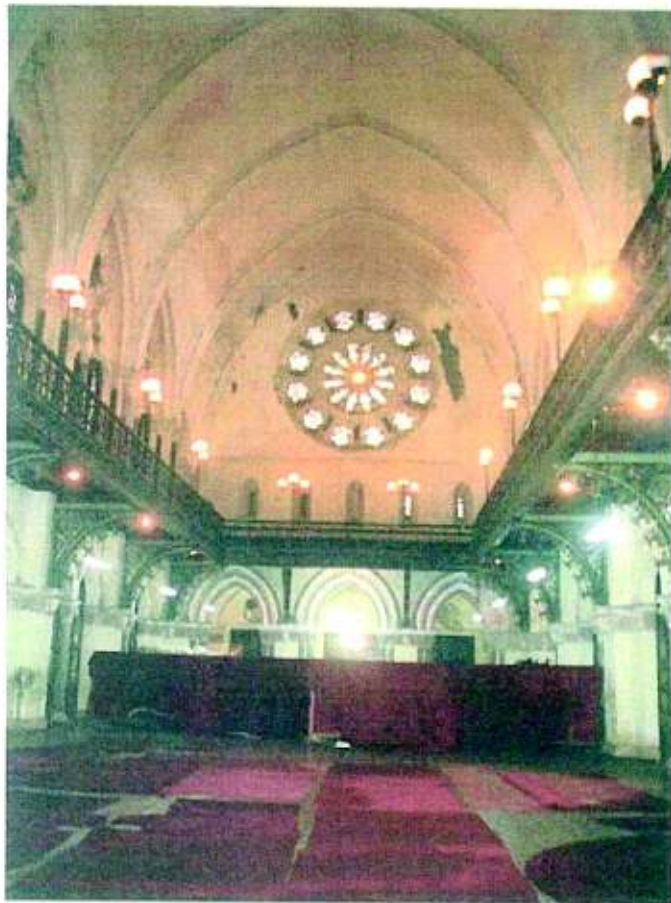
1

1. Zodiac Rose Window with damp on north gable end. Acoustic felt de-lamination
2. Centre piece of Rose Window by Heaton Butler & Bayne
3. Detail of Rose window showing Cancer and Leo
4. Iron Brackets designed by George Twigge Molecey
5. Insensitive installation of Tube lights
