**University of Mumbai**  
Restoration of the Convocation Hall

Restoration of the Convocation Hall: The History

## Restoration of the Convocation Hall: Fabric Inspection

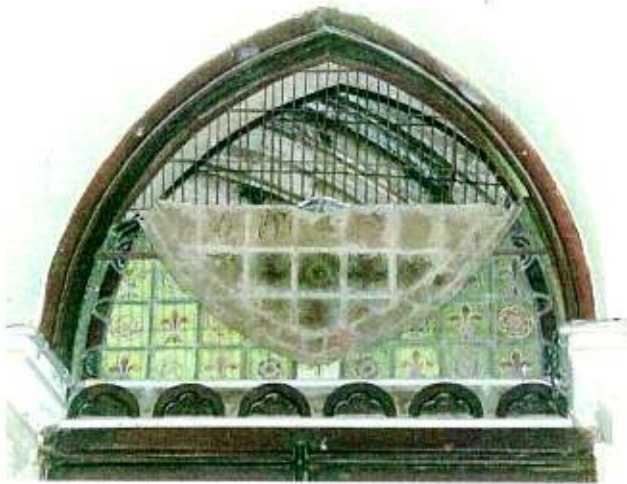
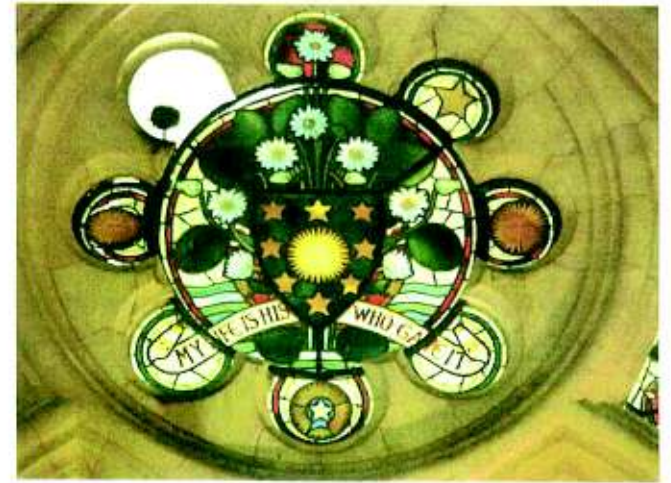
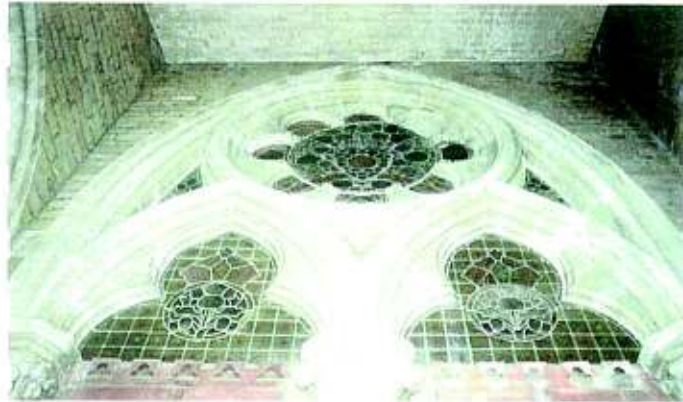
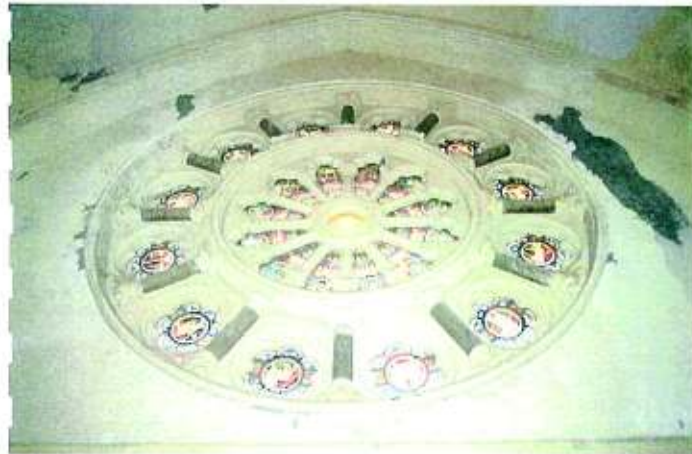
Over the decades, the fine stained glass panels too had developed issues ranging from soot deposition and loss of paint to more severe issues of cracks and shattering of glass, damage to the leading, visible cases of bulging or entirely missing sections. All this required specialized restoration by trained conservators.

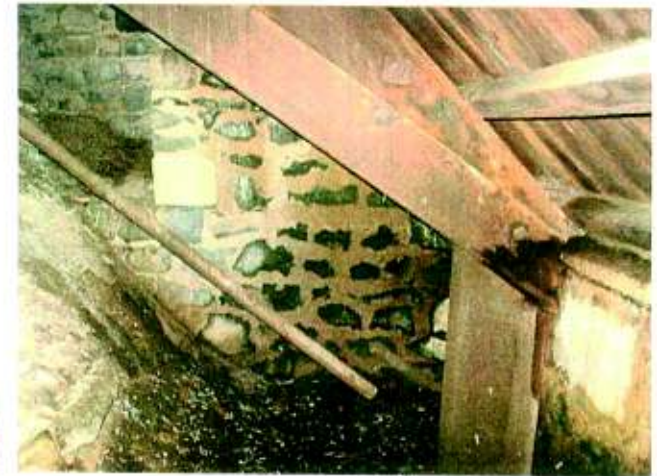
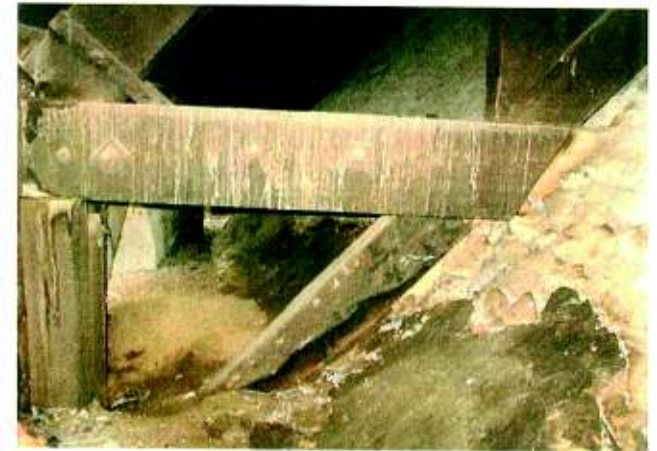
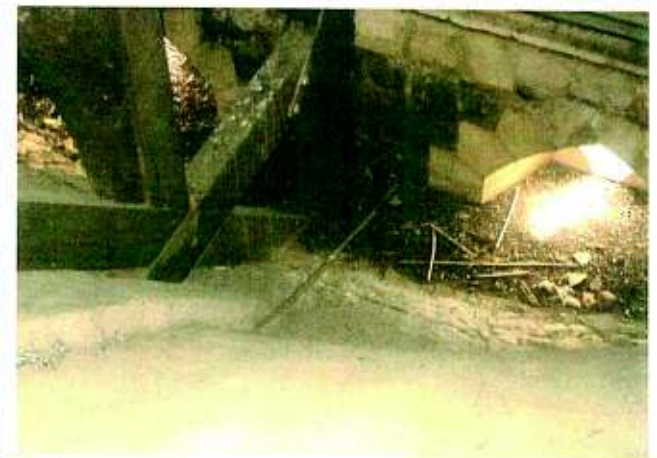
## Upper Roof: Condition Assessment of Stone Vault

The vault was one of the biggest structural challenges in the building as it was constructed with rubble stone and lime concrete. This was subject to a great amount of leakage over the years since the roof above had been leaking. The constant leakage from the roof had leached away at the lime binders holding up the stone vault and water had so saturated the vault that even the acoustic lining below the wall was peeling off as it was heavy with water. Investigations into the lime content and endoscopic examinations had revealed that the lime content had greatly reduced in the vault, threatening its structural stability. The vaulted roof thus required considerable structural investigation and analysis.

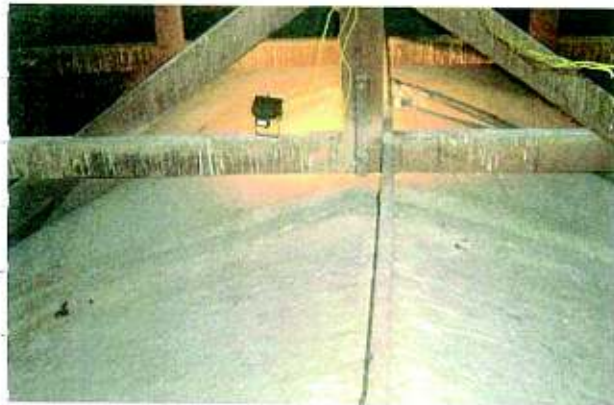
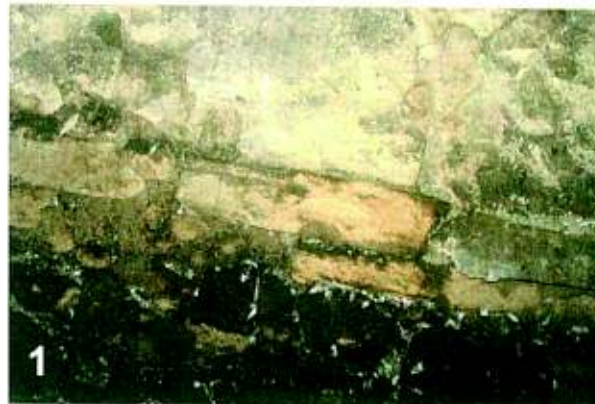
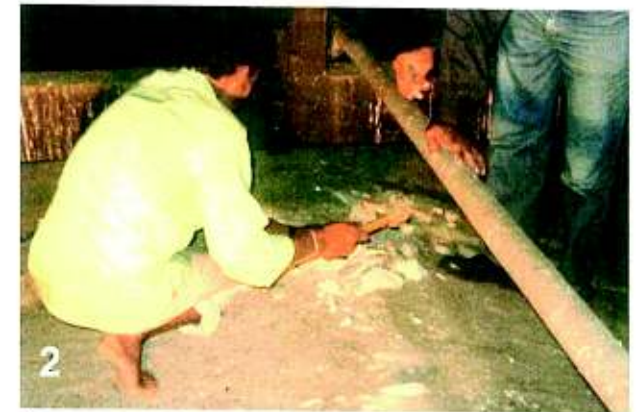
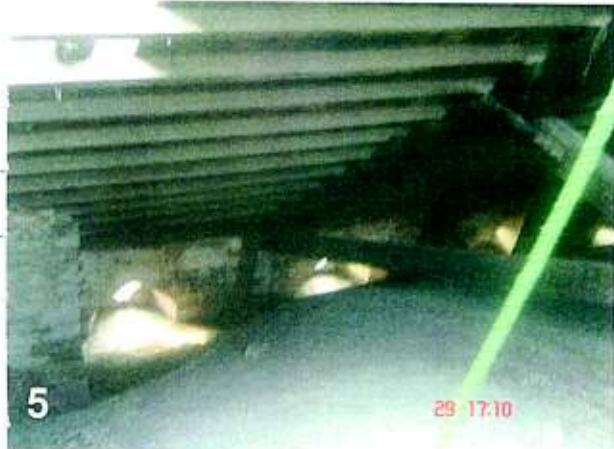
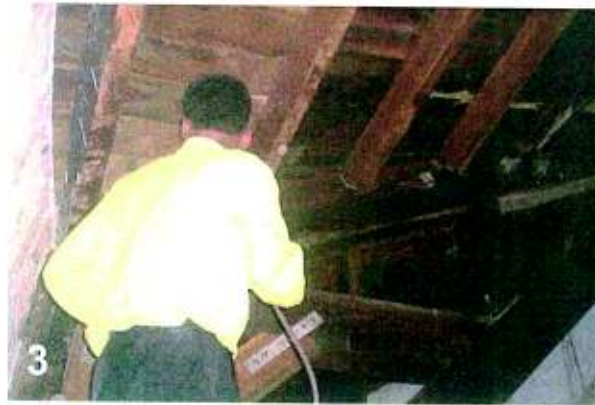
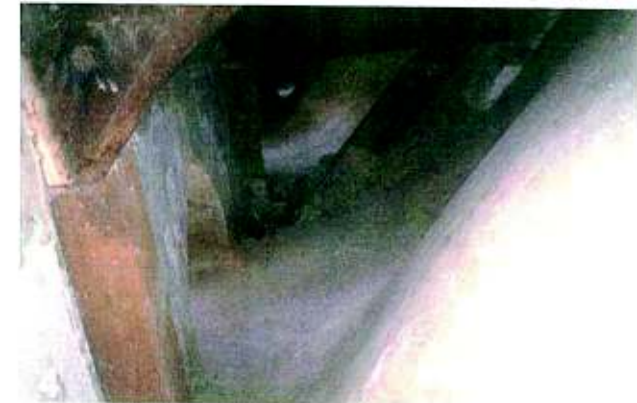
## Upper Roof: Structural Consolidation of Stone Vault

Views 1 to 4: Lime concrete on the surface of the dome was covered with algae and badly deteriorated. 2: The loose lime concrete being removed. 3: Gravity grouting of lime through tubes inserted in stainless steel nipples to restore the lime content in the dome. 4 & 5: The final coat of lime concreting on the surface of the shell after grouting. This was burnished with natural resins such as *gur* (jaggery), *guggal* (a tree resin) and *methi* (fenugreek) seeds boiled in water over a slow flame for 3 days and mixed in the non hydraulic lime for a waterproof finish. Below: Images of Gur and other additives by weight, boiled over days to mix with lime.

Lime was slaked on site to produce non hydraulic lime mortars to match the original used in the building. The upper stone vault was grouted with a fine lime slurry injected through fine nipples under the guidance of the structural rehabilitation specialist Mr. Arup Sarbadhikary, the structural engineer leading the structural repairs. After removing the weak and loose upper coating of lime and subsequently undertaking the grouting, the vault was given a coat of waterproof lime

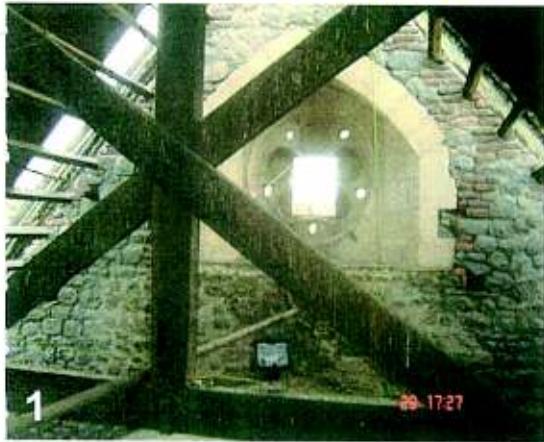
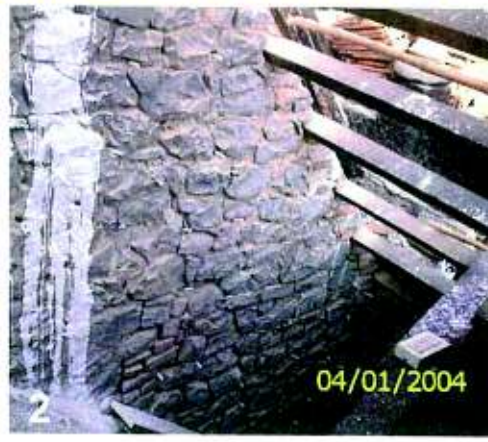
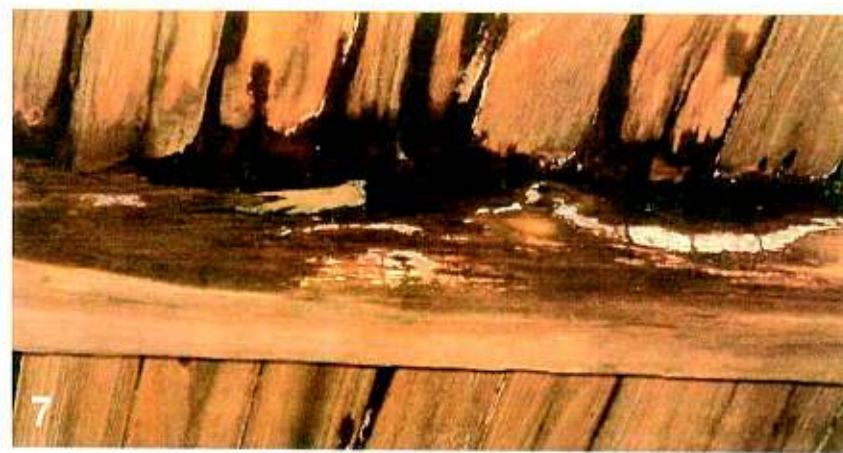
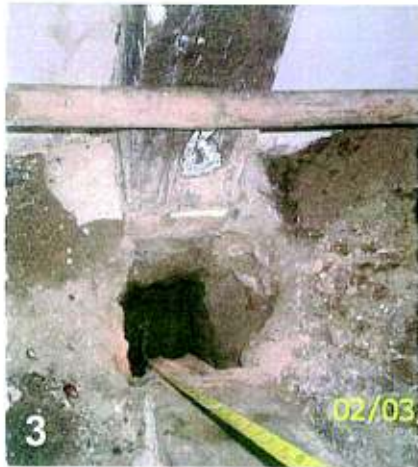
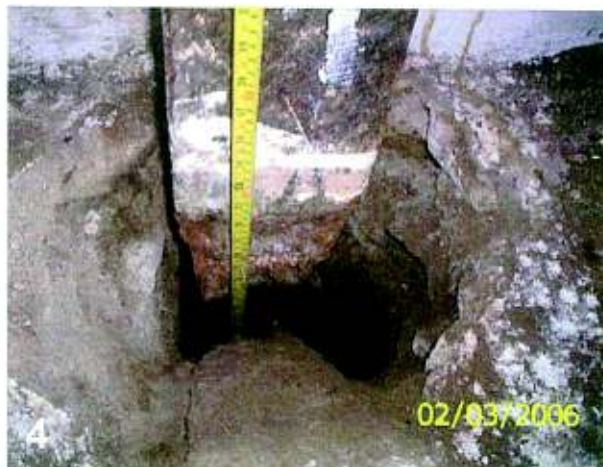
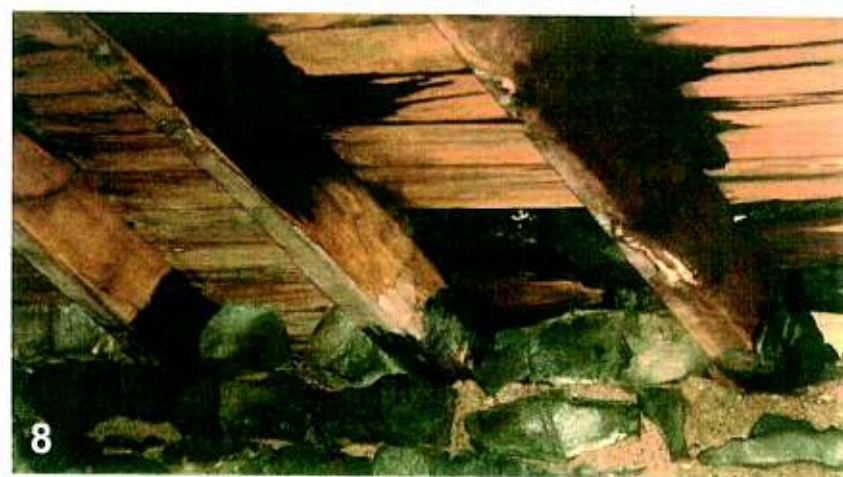
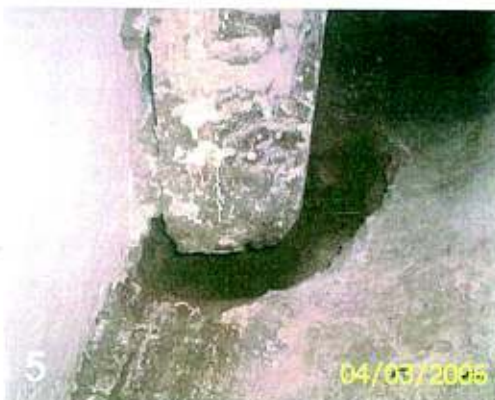
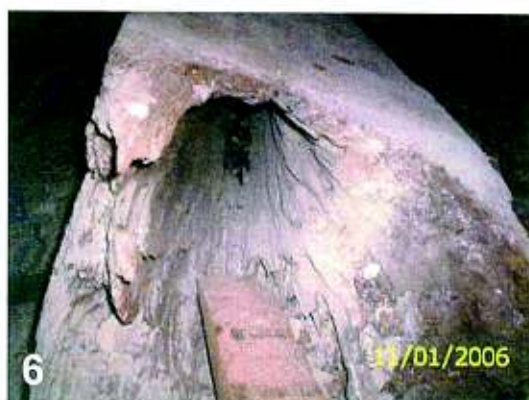
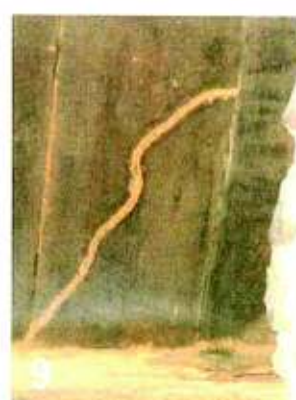
## Upper Roof: Condition Assessment of Roof Structural Members

Images 1 & 2: Timber boarding removed from the upper roof to expose the condition of the structural system; Images 3 to 6: Severe deterioration of the structural framework of the roof trusses with the entire section embedded into masonry completely rotted due to wet rot and fungal infestation. Images 7 & 8: Views showing the completely water logged and soaked timber rafters and boarding with whitish patches indicating fungal infestation. Image 9: Termite run visible in the timber boarding.

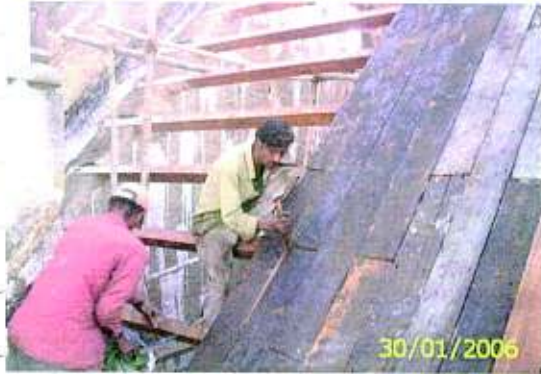
Left top: The roof battens were removed to expose the condition of the truss and rafter ends embedded in the masonry. Though the middle sections of the timber framework were alright, the cause of concern were the end sections of both the trusses and the rafters. These were found to be greatly damaged with wet rot having eaten away at the embedded end sections, thereby rendering them structurally unstable.

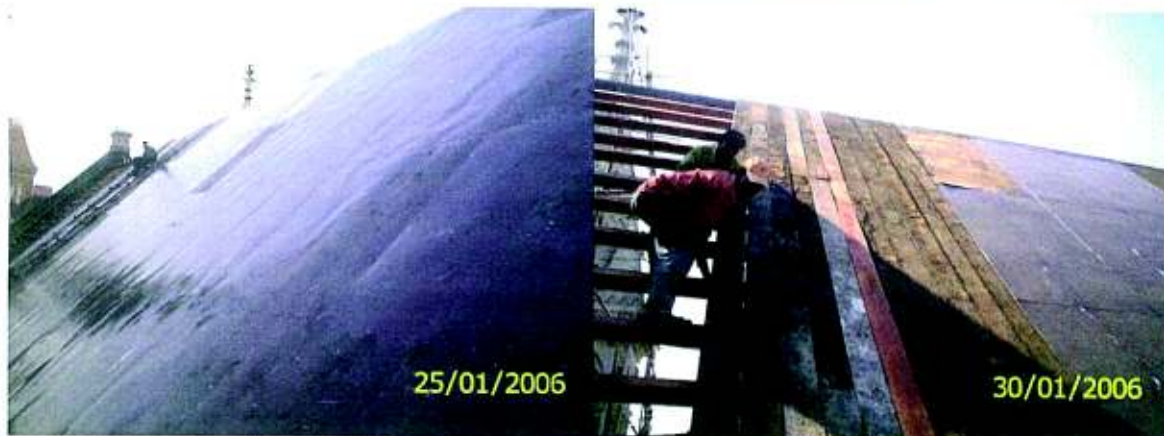
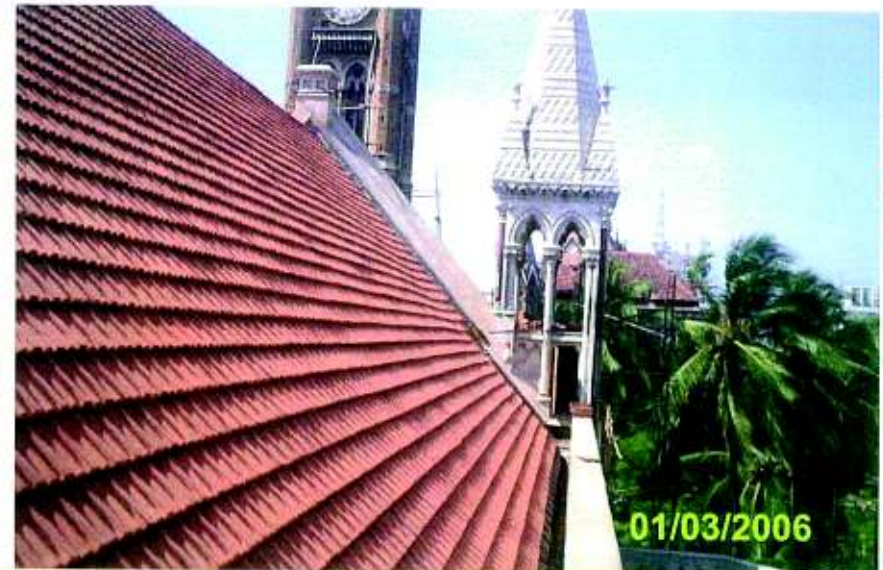
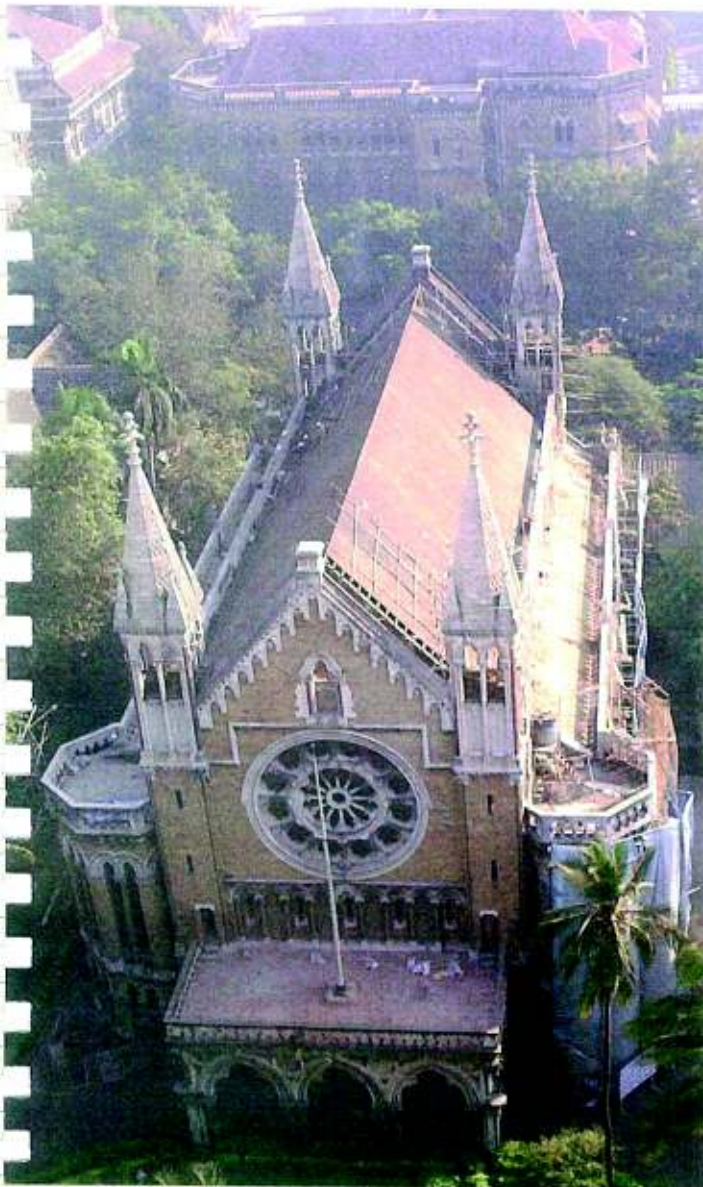
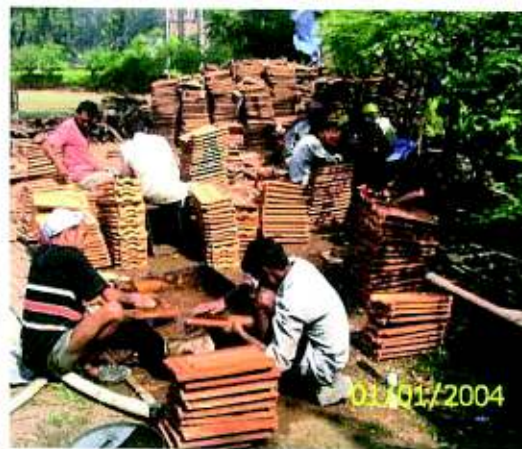
Above: Workmen cleaning the terracotta tiles to re use them on the roof after roof repairs. Most of the original terracotta tiles were retained, after carefully cleaning them, thus ensuring authenticity of material. Left: View of the roof showing the terracotta tiles removed to expose the timber battens for repair. Right: View of the upper roof with partial work on resetting the terracotta tiles complete. Below: Treatment of wooden members to prevent infestation.

The entire wooden framework of the trusses, rafters and boarding was thoroughly treated for any infestation. The roof tiles were relaid after cleaning them thoroughly, thus retaining maximum old tiles.

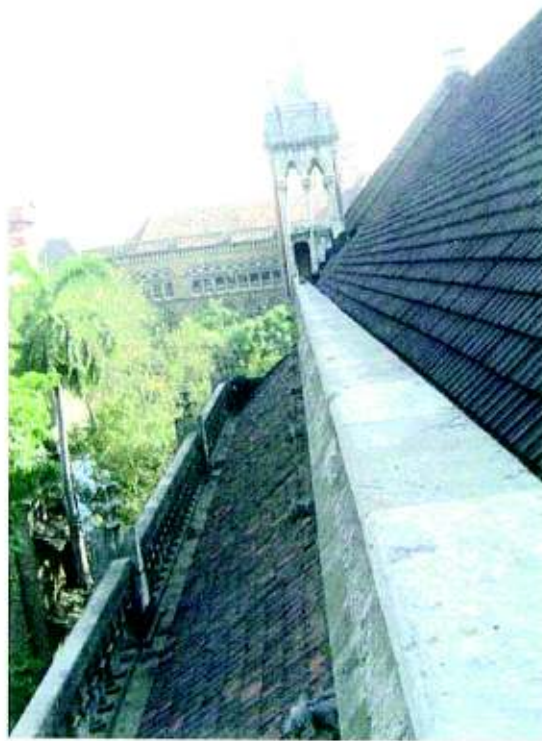
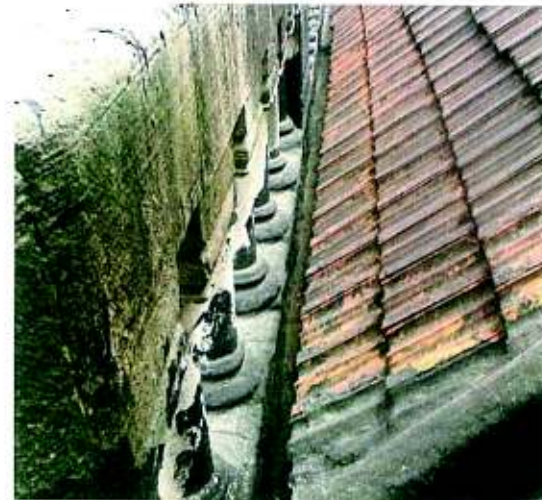
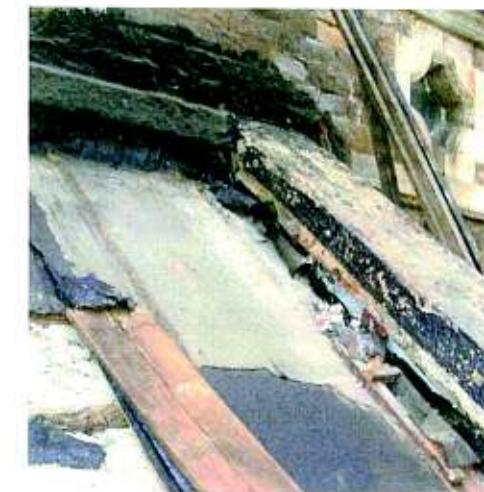
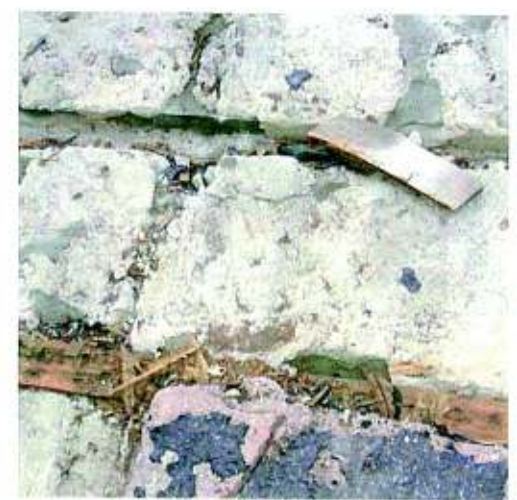
The lower roofs were designed to receive the water from the upper roof through a row of stone gargoyles and finally drain this water out of the building through another row of gargoyles below. Over the years, as debris choked the gargoyles on the upper roof level, water began penetrating through the stone masonry and with each year, instead of undertaking a comprehensive repair of the roof, the local staff just kept adding layers and layers of bitumen, the drainage gutters on the lower roof level too got choked with bitumen, hence making the water drainage system ineffective.

As the lower section of roof was opened out, it revealed a construction of a lime concrete base in which were set timber reapers, over which a tiled roof was laid. As the lime concrete was saturated with moisture, the timber inset in it, rotted and the entire roofing became loose.

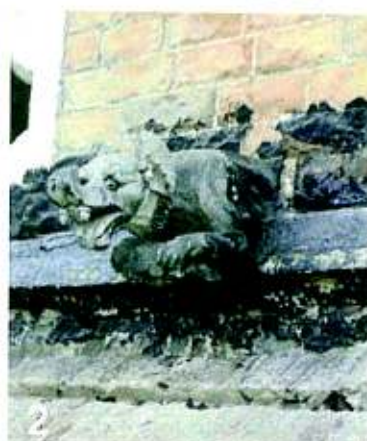
2: Removal of tar reveals lime concrete

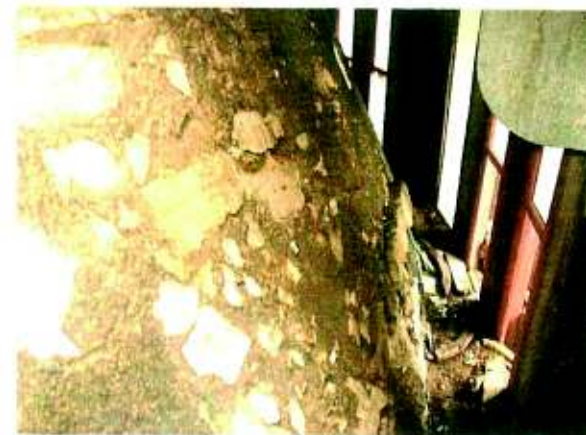
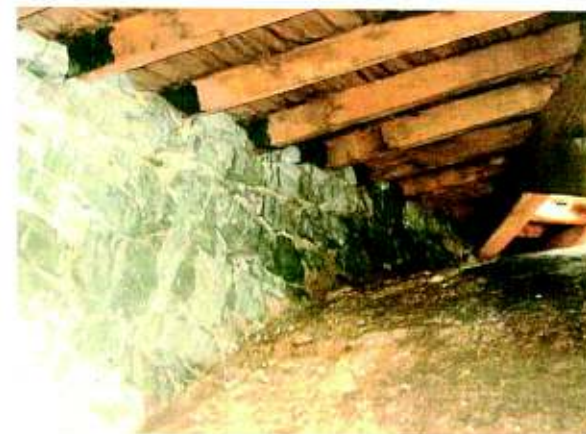
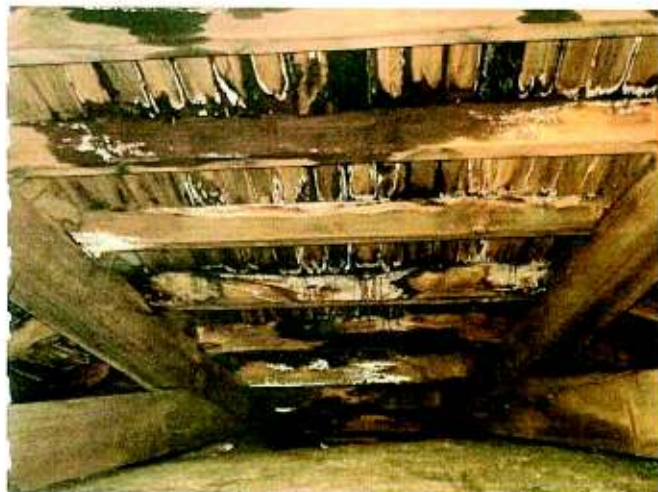
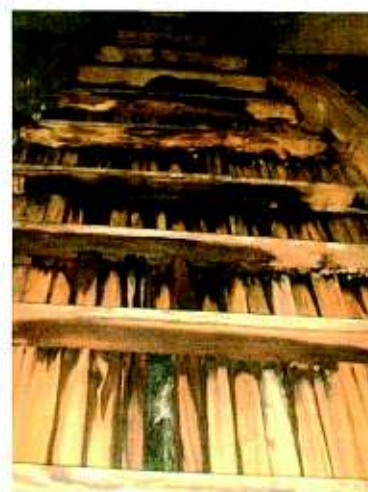
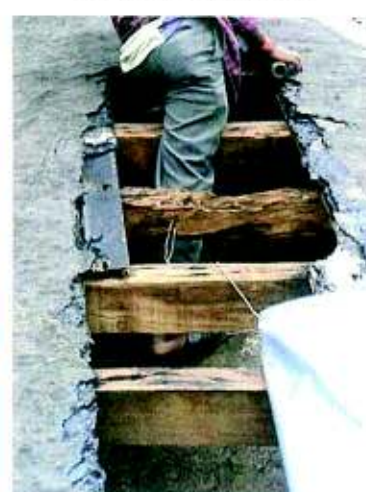
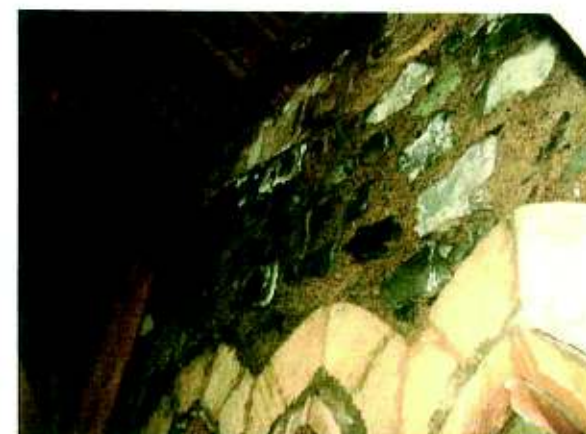
## Apse Roof: Condition Assessment

A major point of leakage was the southern apse roof that had been reduced to a layer of bitumen tar felt over timber planking, wholly inadequate for the monsoons. This tar felt too had greatly deteriorated, resulting in the apse roof leaking badly during the rain.

Opening up the tar exposed timber rafters in an advanced stage of decay and the stone and lime concrete vault below was distressed

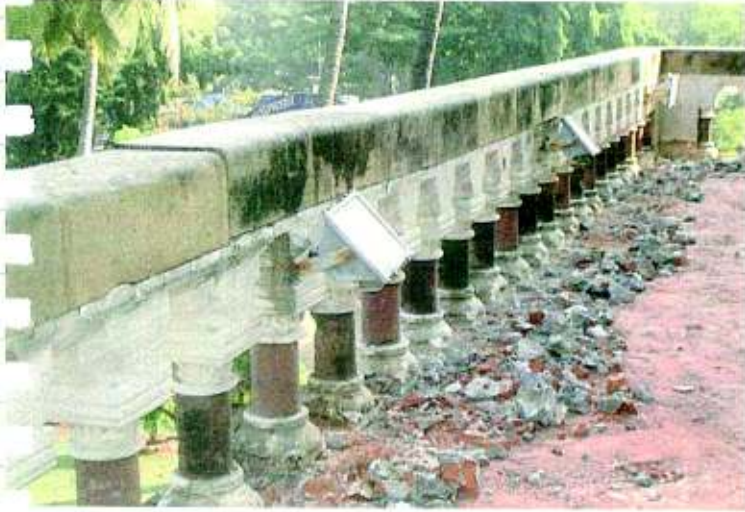
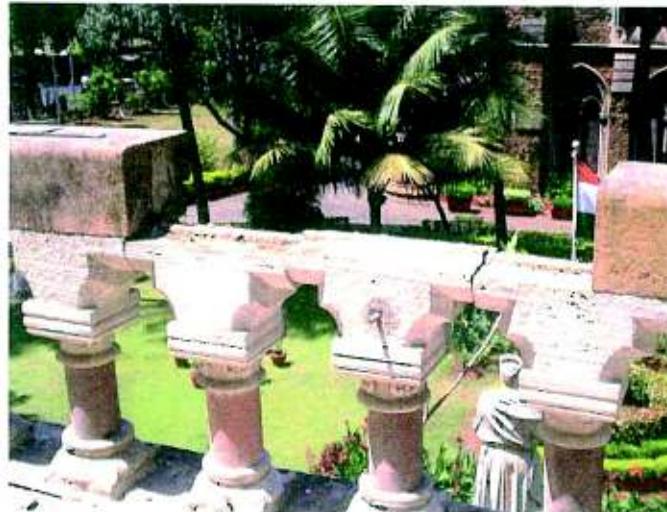
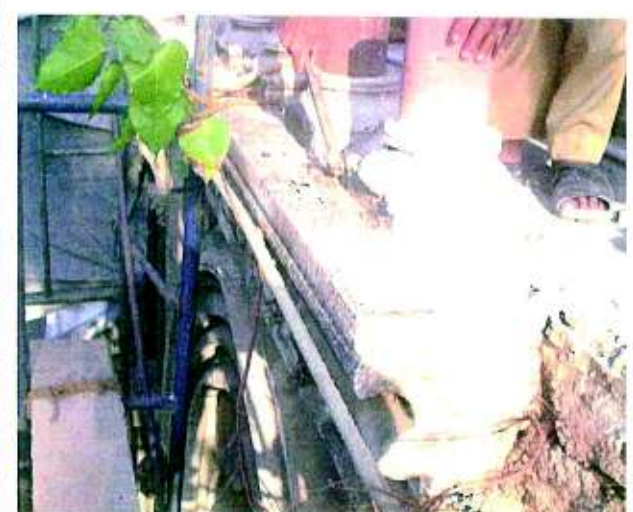
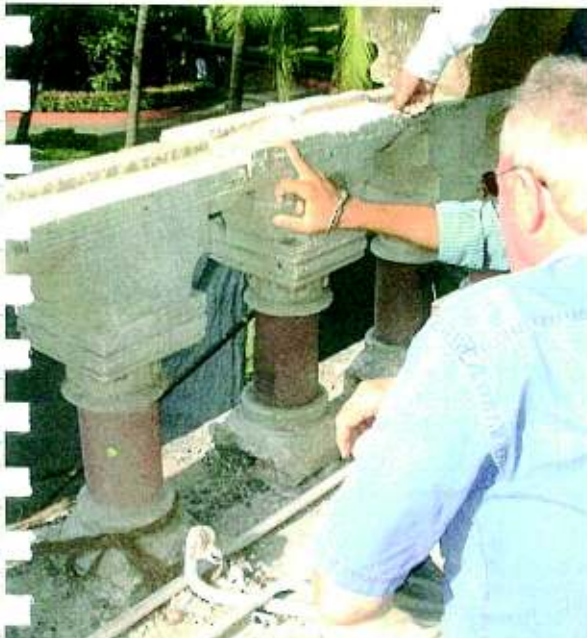
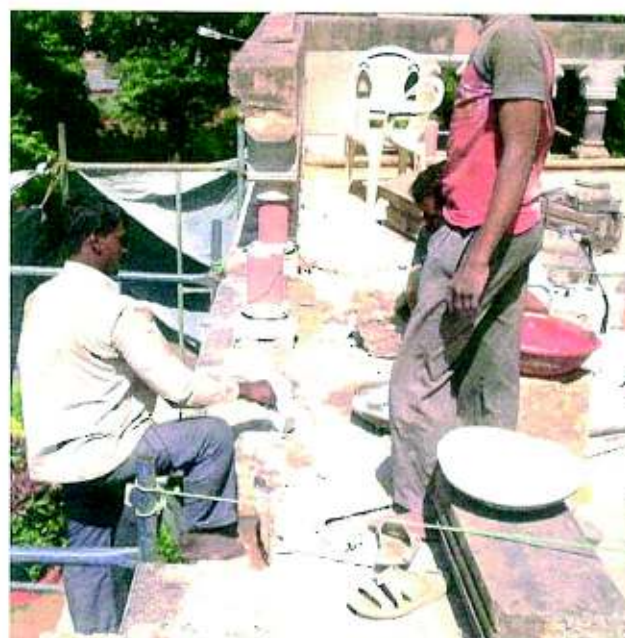
## Correction of Dislodged Stone Parapets

Stone parapets along the northern façade, especially along the front porch and upper terrace were dislodged at places. This was found to be the result of ficus plants growing into the masonry, with their root systems exerting pressure on the stone crevices, eventually leading to dislodged parapets. The tree growths were pulled out and completely removed from the roots by carefully dismantling the stone balustrade, pouring hot lime and the stone work carefully pieced together, correcting the levels.

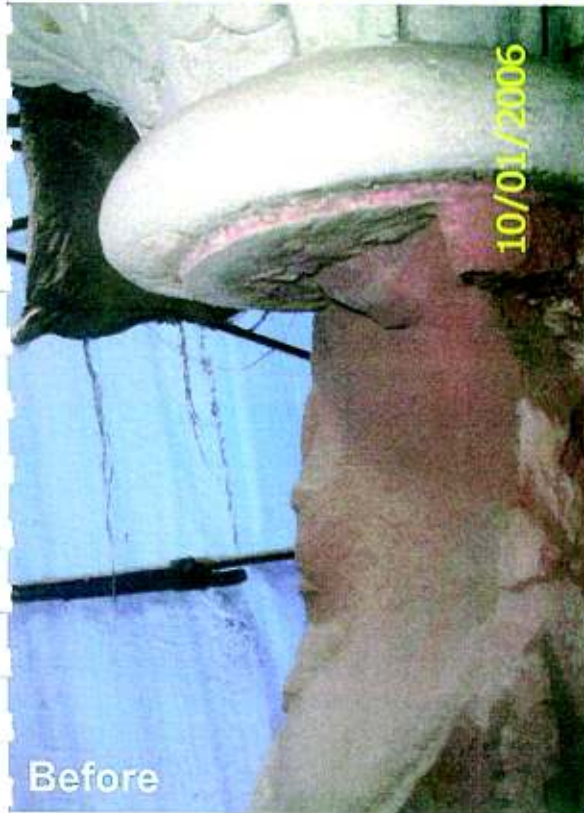
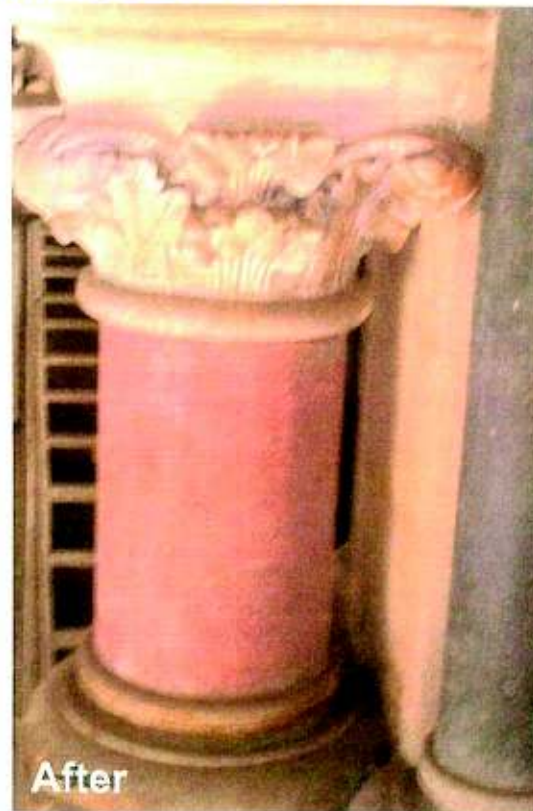
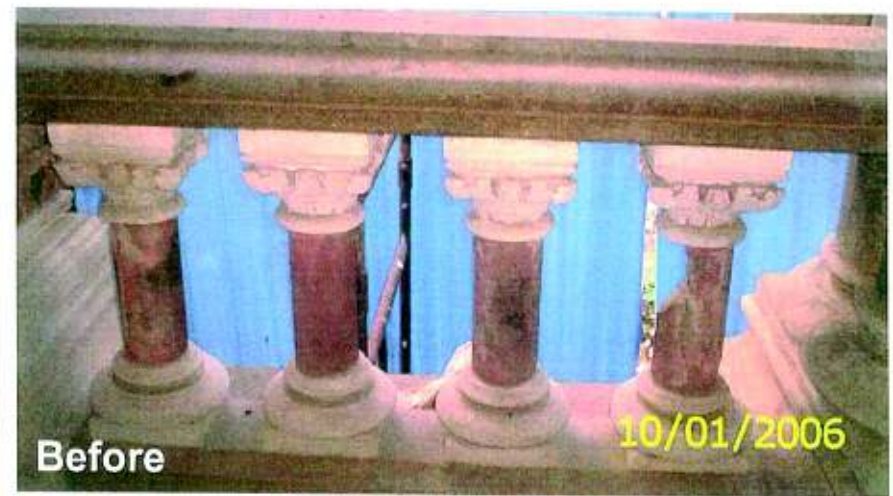
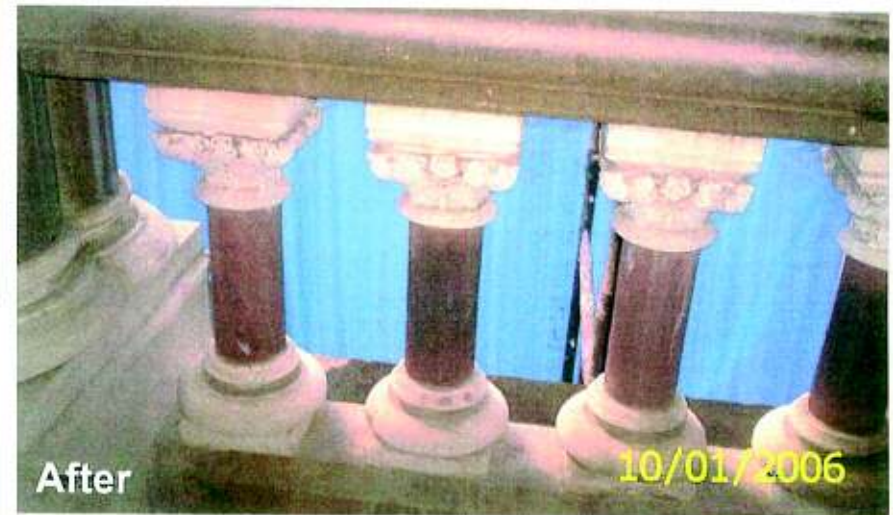
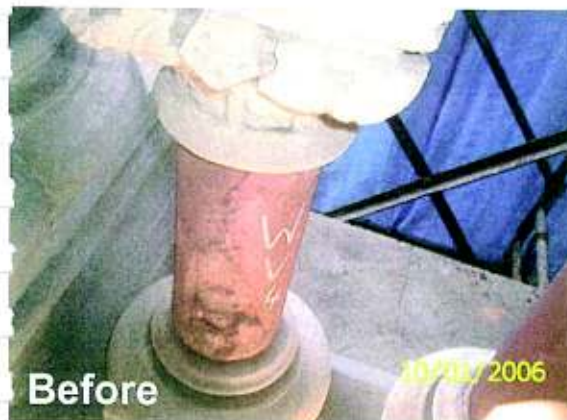
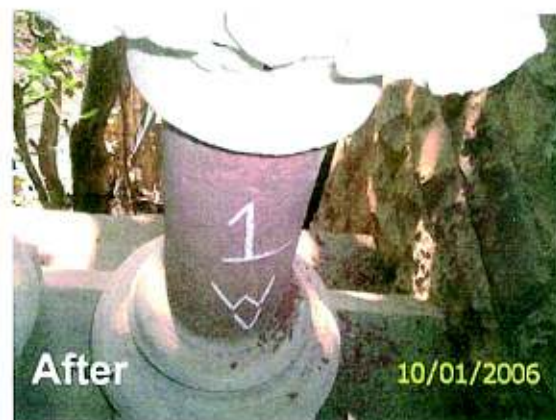
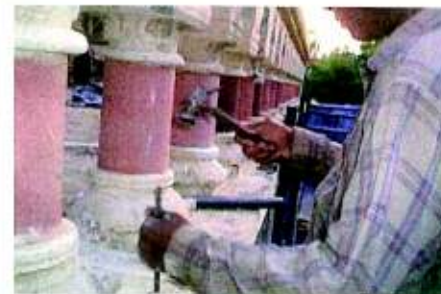
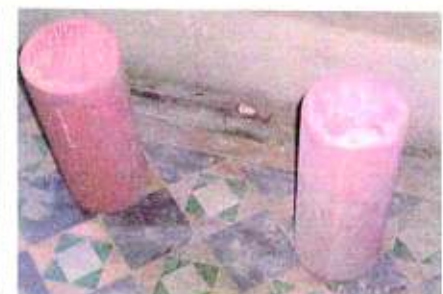
## Replacement of Severely Damaged Stone work

The greenish stone resembling Purbeck marble seen in many of England's cathedral visible in the porch was found to be a serpentine from Karnataka. This had severely deteriorated, and had been strapped with metal in the past. The matching stone was found and cut and traditional stone craftsmen from Gujarat were employed to carefully replace the damaged stone pillars with the new stone.

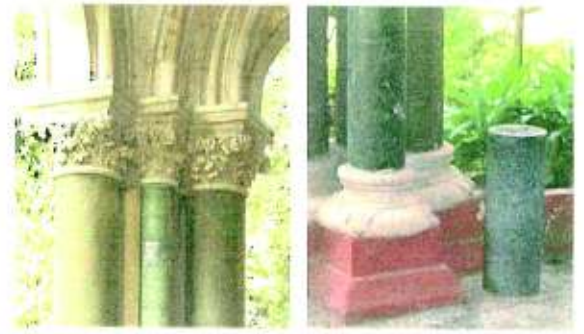
Petrographic analysis of stone samples helped ascertain the exact geological make up of the stones that required replacement. Senior professors from the University's Geology Department were consulted and the exact geology and properties of the stones were established.

Whereas the red sandstone was sourced from Dhrangadhra, the white limestone was sourced from Porbunder in Gujarat, thus keeping the source as close as possible to the original quarries.

The greenish stone resembling Purbeck marble in the porch was found to be a serpentine from Karnataka, whereas the grey basalt was sourced from Kurla and Ratnagiri in Maharashtra.

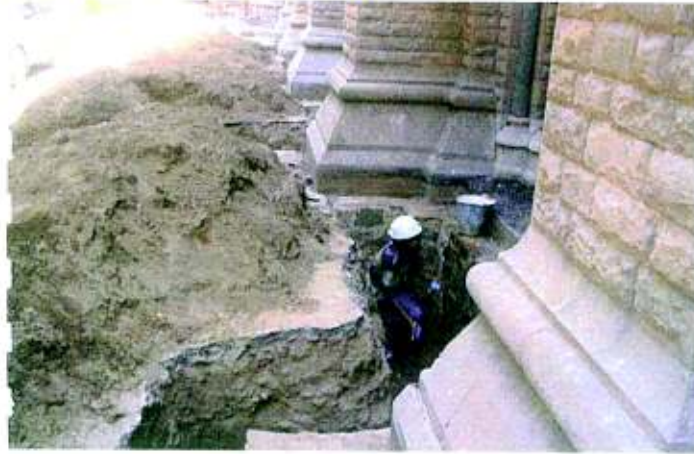
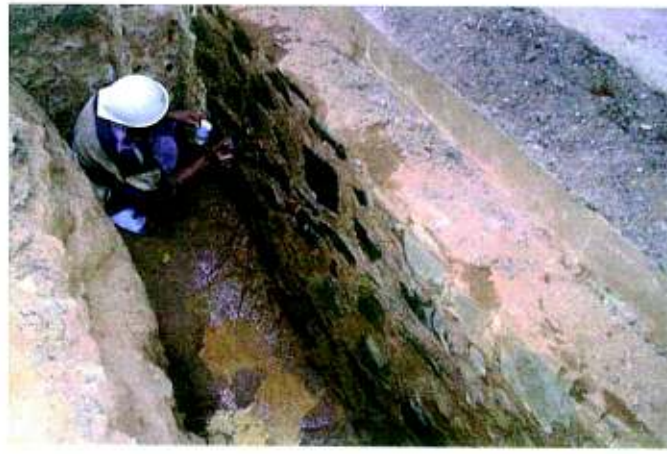
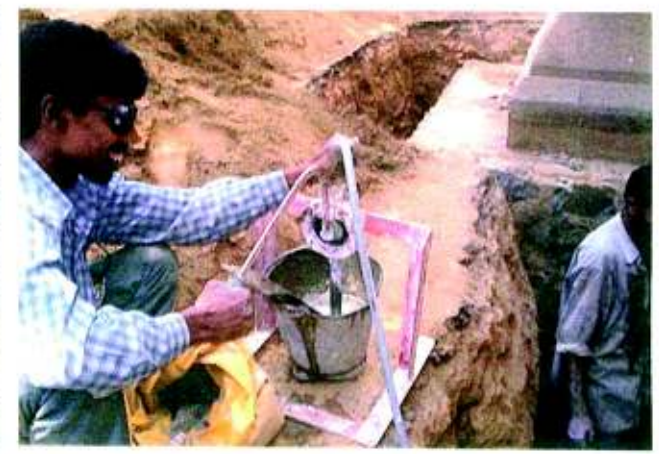
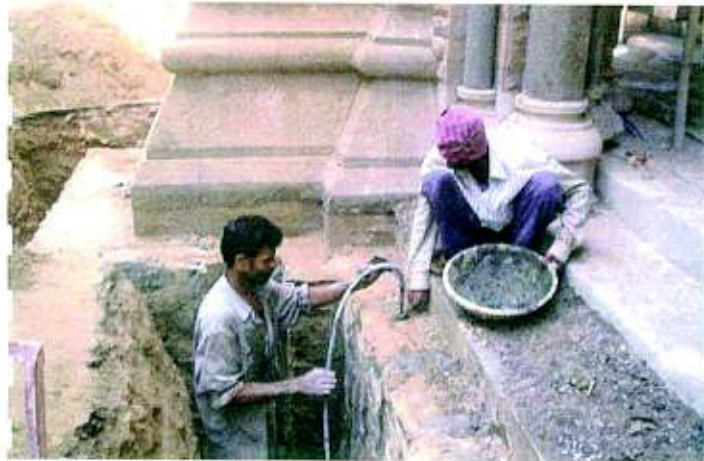
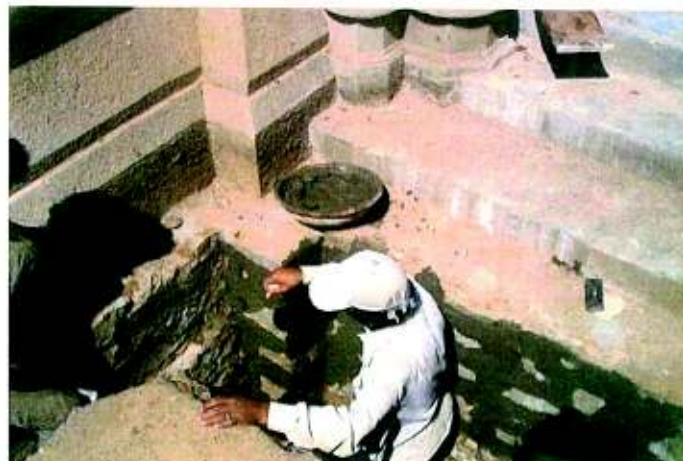
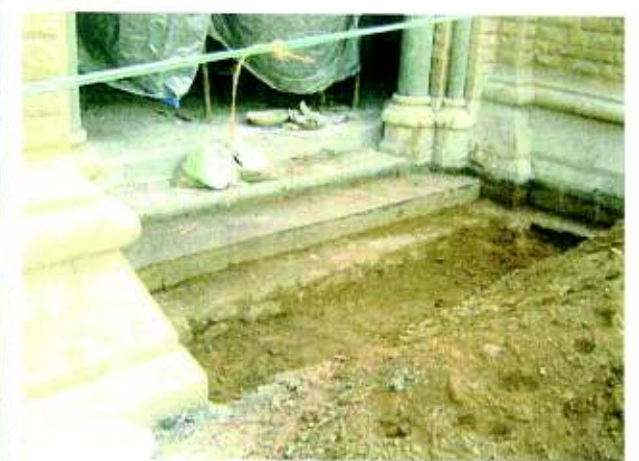
## Plinth Protection

In order to protect the base and plinth from rising damp, a trench was cut along the periphery of the entire building. The wide gaps in the rubble masonry were filled with mortar and grouted to ensure the base from water penetration. The earth was then filled back and site slopes for the entire campus were mapped out to provide a comprehensive scheme for water drainage in the plot.

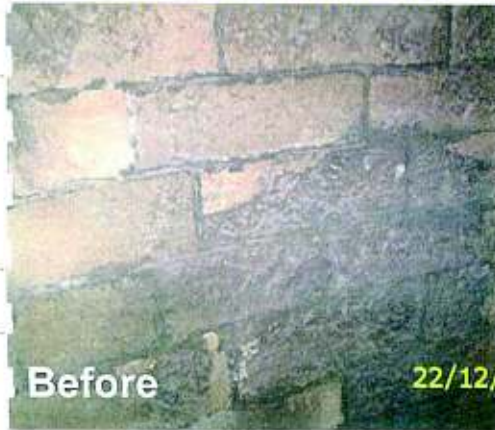
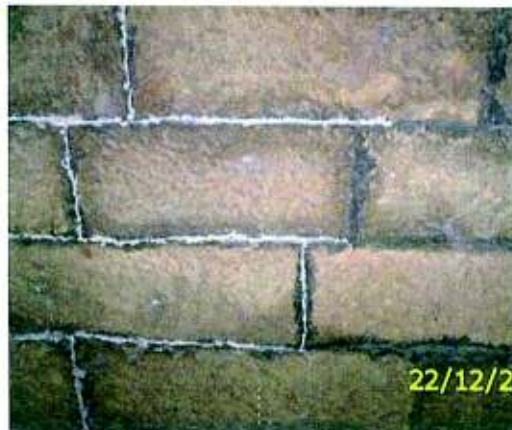
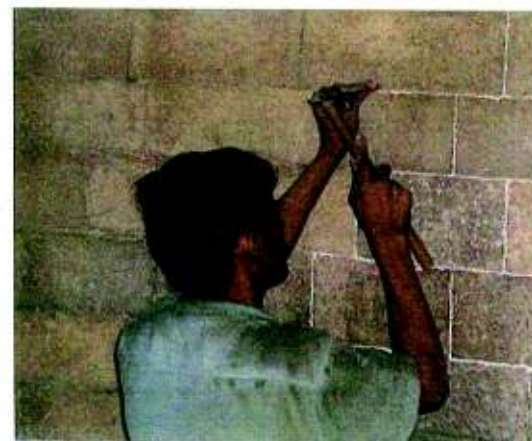
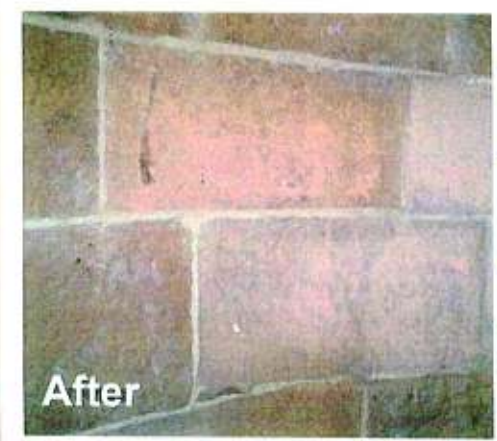
## Pointing in Lime Mortar

Views Above: Raking out of hard epoxy pointing in the staircase areas to repoint in lime mortar with masking tape to ensure thin, flush pointing joints.

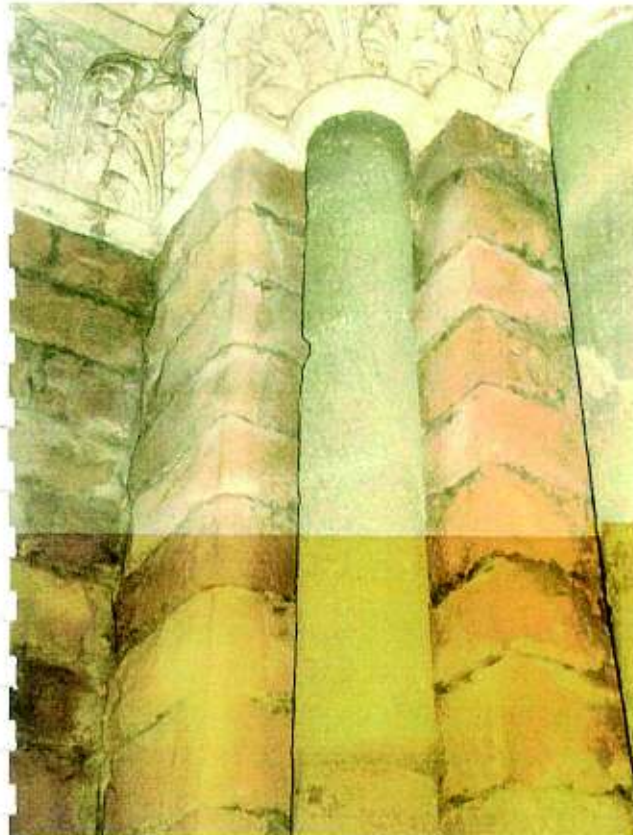
Left: Badly deteriorated stone joints along the verandahs were in need of lime pointing

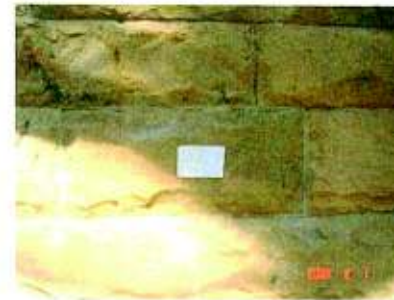
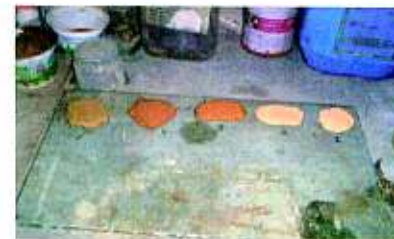
Right: Images showing various samples of lime pointing with additives to obtain a colour matching. Various samples were tried before the perfect match to the stone was obtained.
