**University of Mumbai**  
Restoration of the Convocation Hall

Restoration of the Convocation Hall: The History

## Restoration of the Convocation Hall: Fabric Inspection

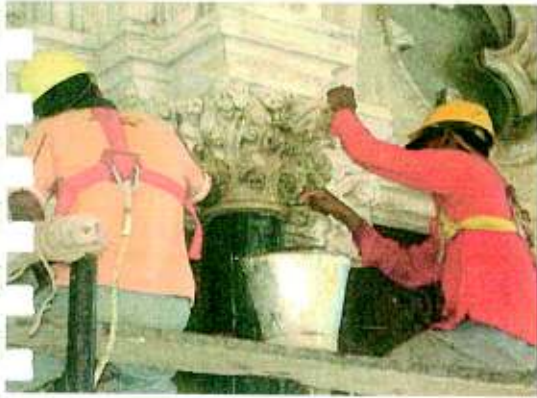
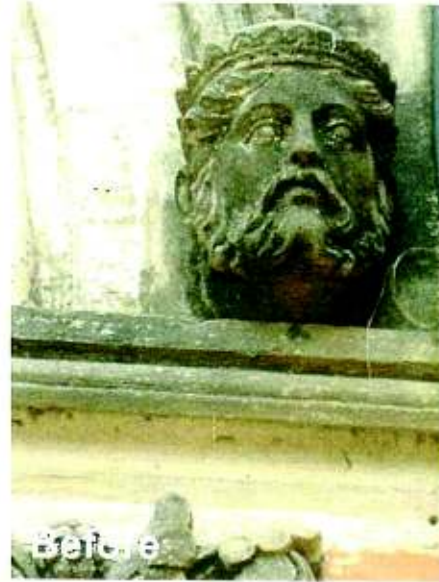
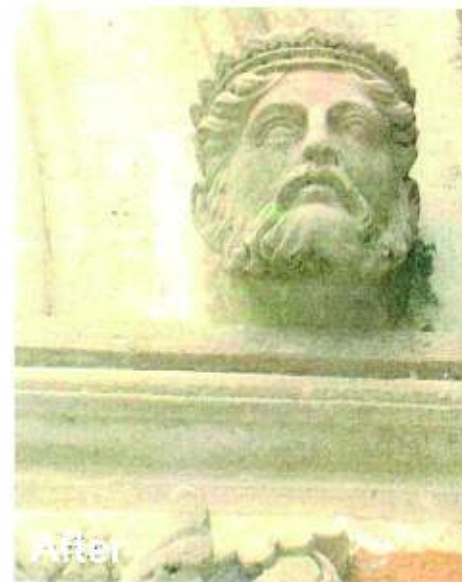
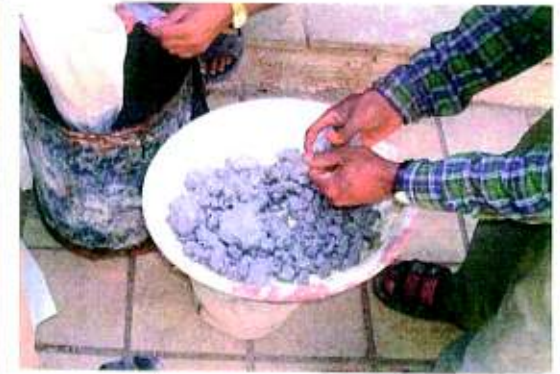
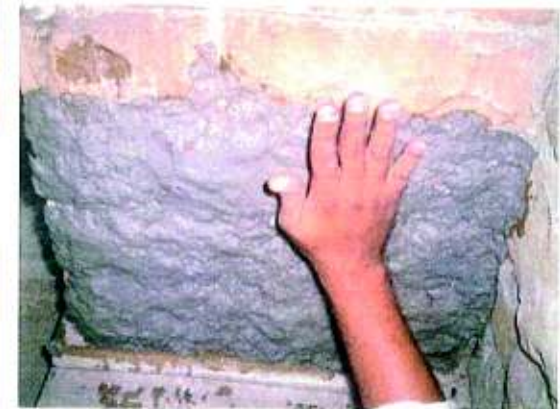
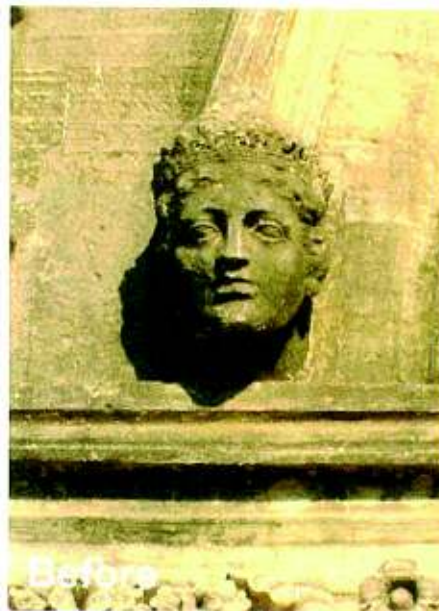
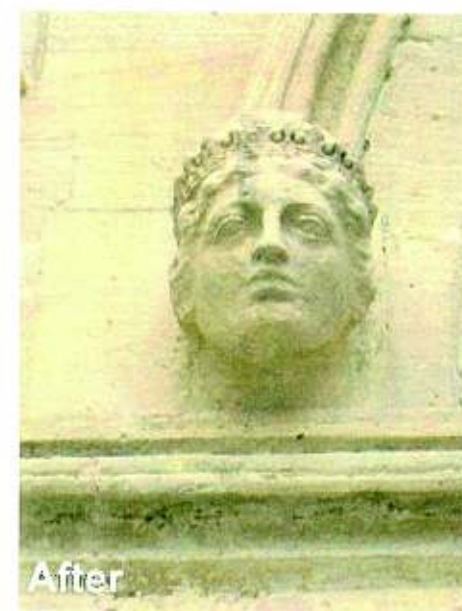
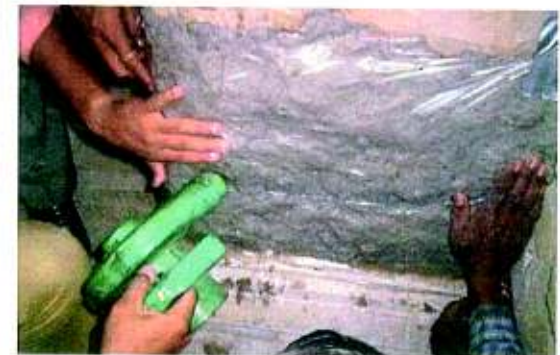
Bottom: Images of workmen cleaning limestone details with soft nylon brushes and water. Water Misting techniques were employed for general surface cleaning.

Middle: Before after images of cleaning carved stone faces. Extreme Right: Paper pulp mouldices employed in the cleaning of details.

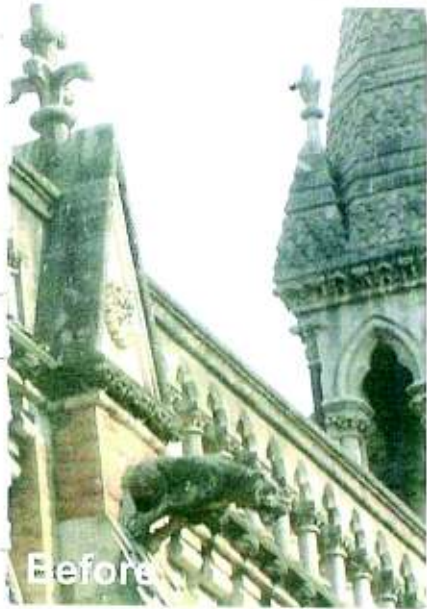
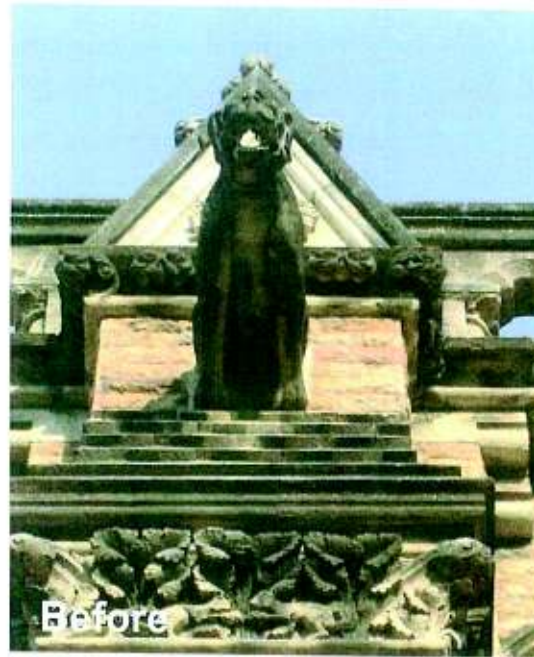
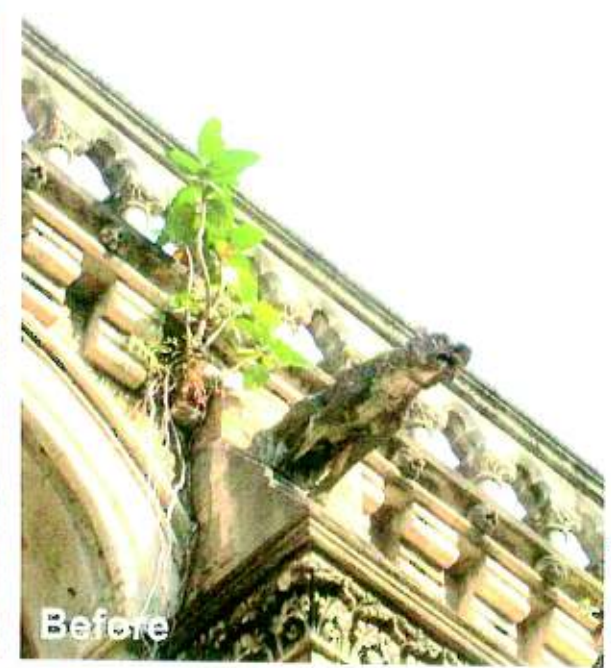
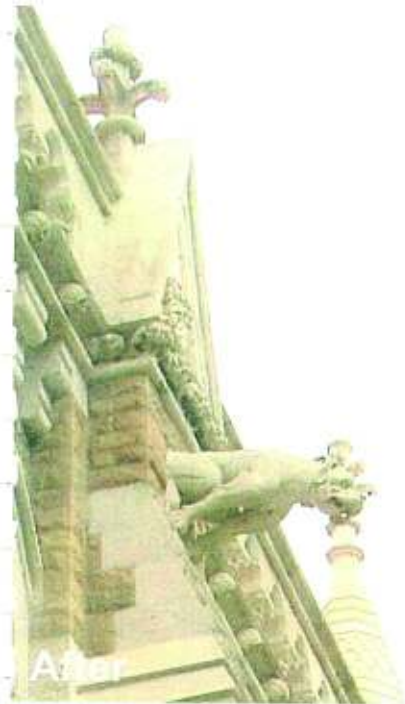
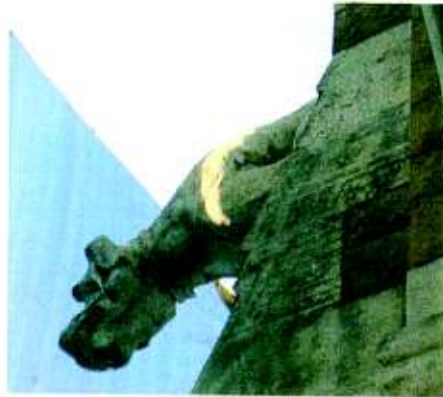
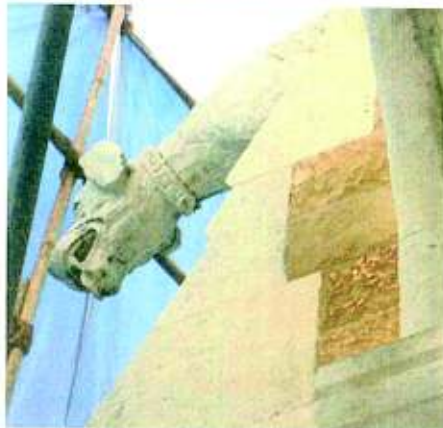
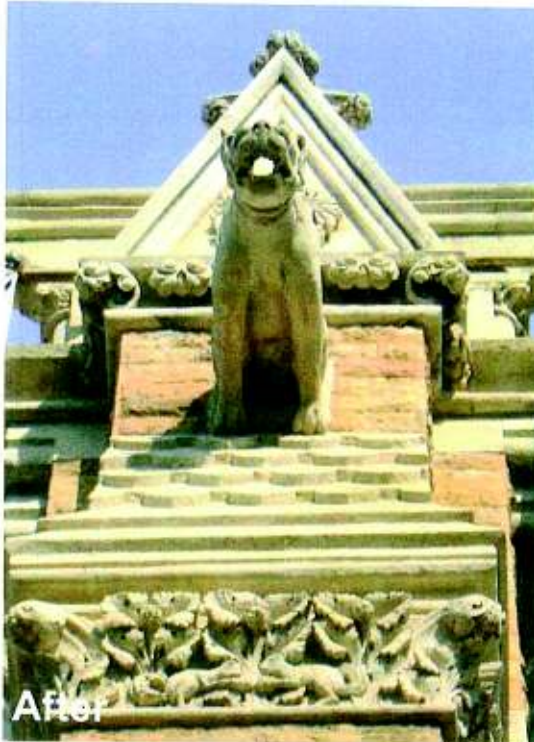
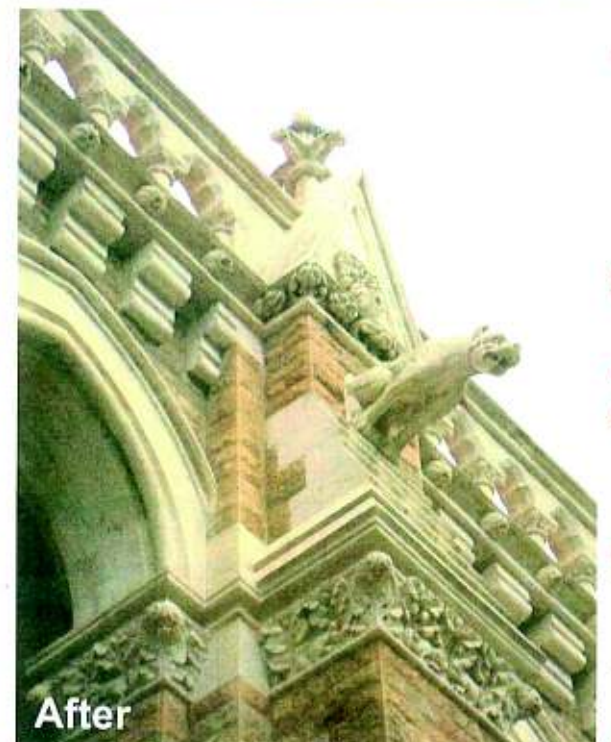
## Specialised Stone Cleaning: Gargoyles

The splendid stone gargoyles, integral to the roof drainage, were choked with thick encrustations of sulphate deposits, forming hard black skins on the surface. These were cleaned by specialized cleaning techniques of poulticing and water misting to restore the aesthetics and efficacy of these water spouts.

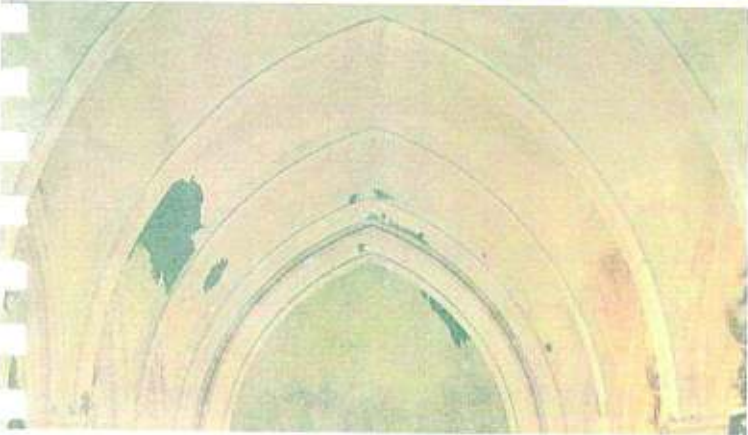
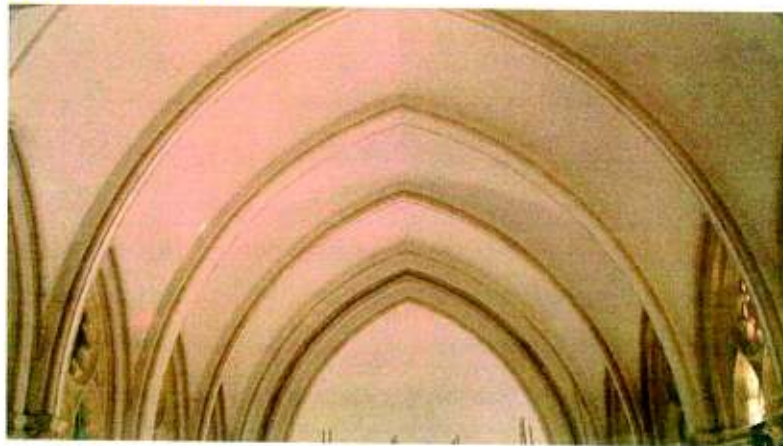
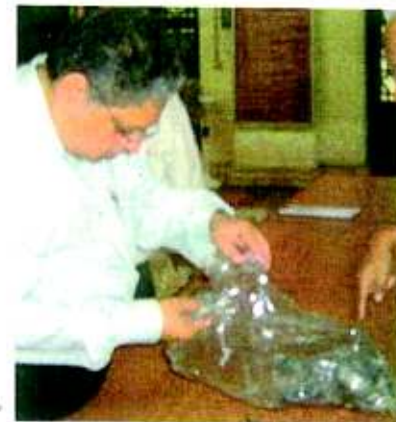
## Acoustic Treatment & Removal of Asbestos Fibre

The entire underside of the vault and all the inner surfaces of the walls had been covered with asbestos fibre in an attempt in the 1940s to address the issue of sound reverberation in the building. This was not only peeling off in patches due to the dampness in the building, but was a health hazard. With acoustics playing an important role in the functioning of a public hall in use, a specialist firm of Jhaveri & Jhaveri, acoustical engineers became an integral part of the team to study the present acoustical performance of the building and design a system that would give appropriate acoustical levels for public events. The hazardous asbestos fibre introduced in the 1940s as an acoustical treatment was not only peeling off with water leakage (image top left) but was also a serious health hazard for a public building. This lining covered the entire vault and lower level spandrels (image bottom left) and was removed with gas masks and protective gear.

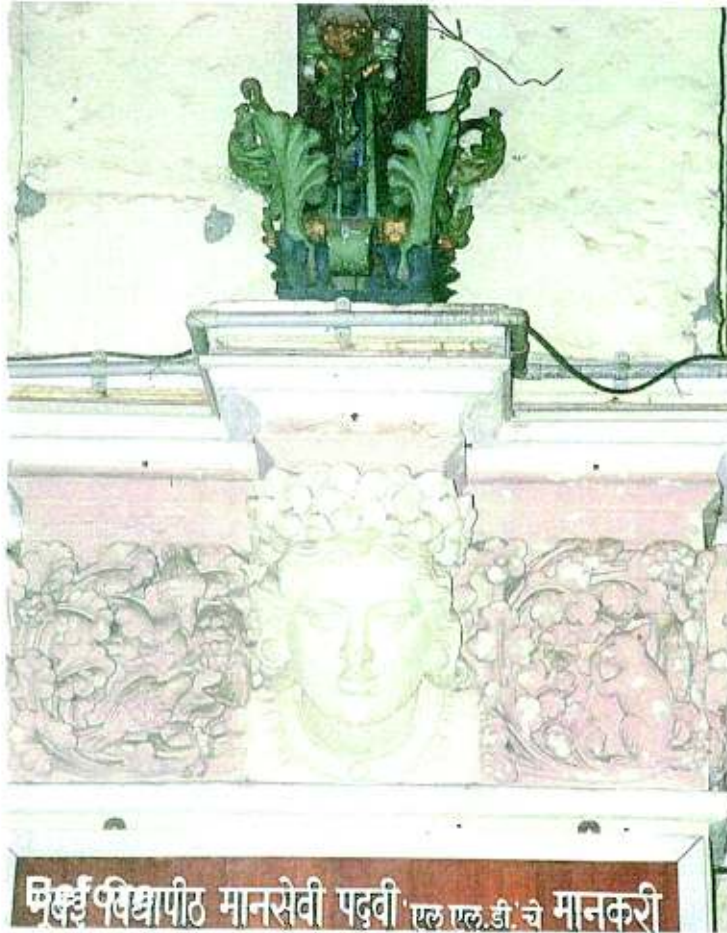
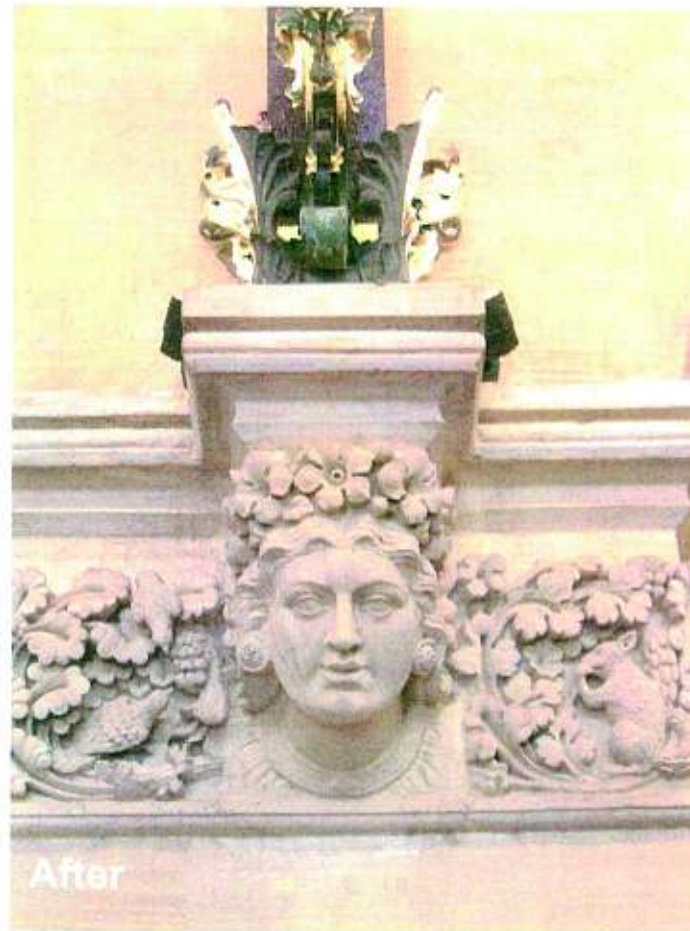
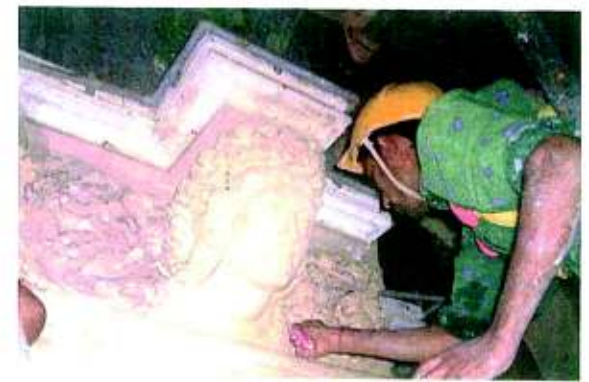
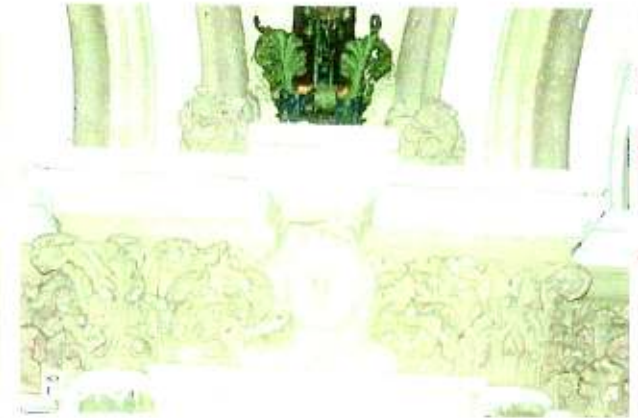
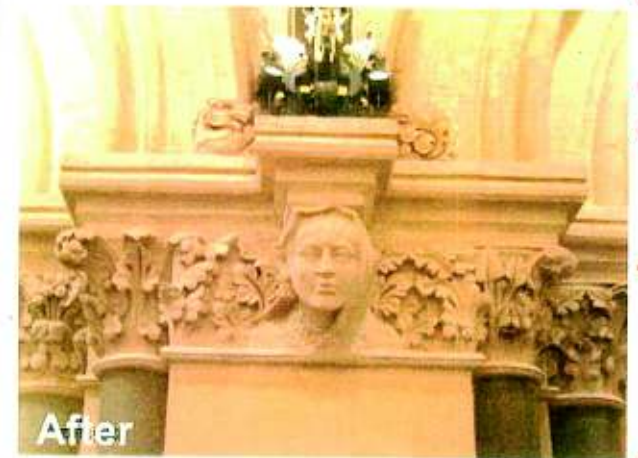
## Restoration of Interior Statuary

The entire interior statuary was covered by thick layers of paint. This was most unsightly and obliterated the original texture of the lime stone carvings. Paint layers were carefully removed from the stone by employing non abrasive paper poultices, water washing with nylon brushes and application of mild surfactants. The ugly electrical conduits running across the carved faces were re located to expose the beautiful stone carvings.

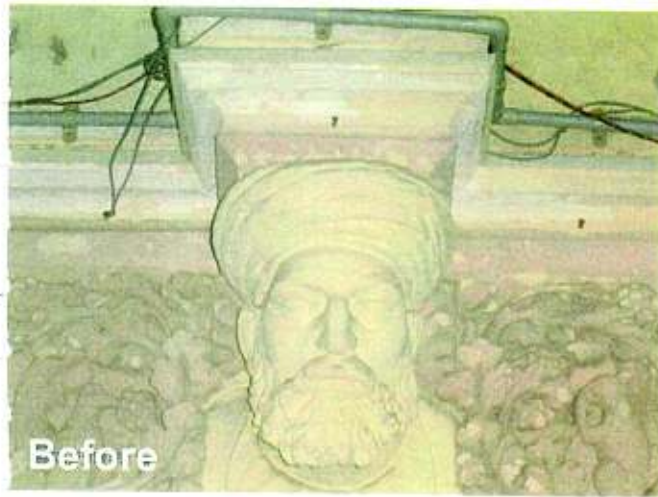
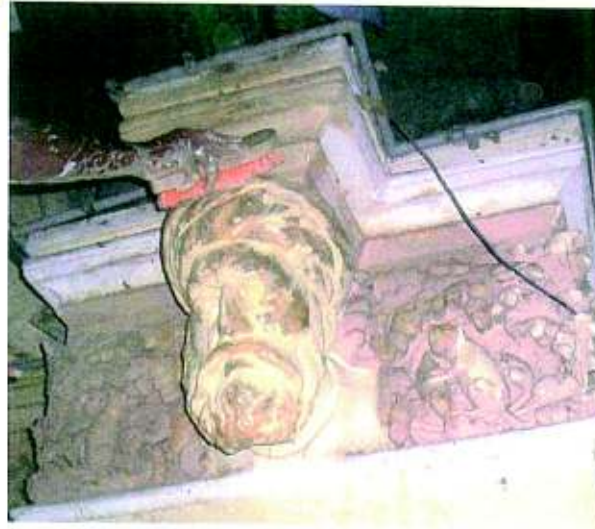
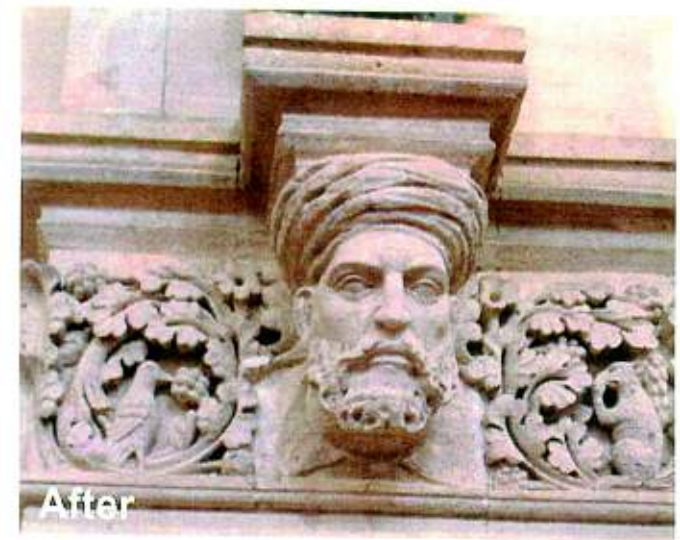
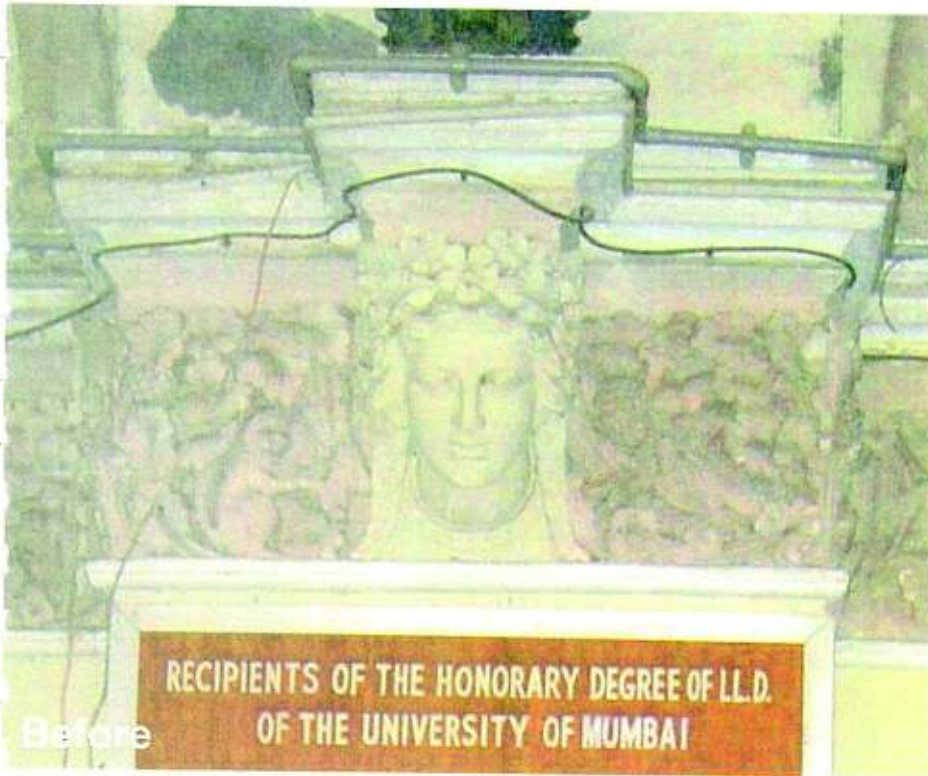
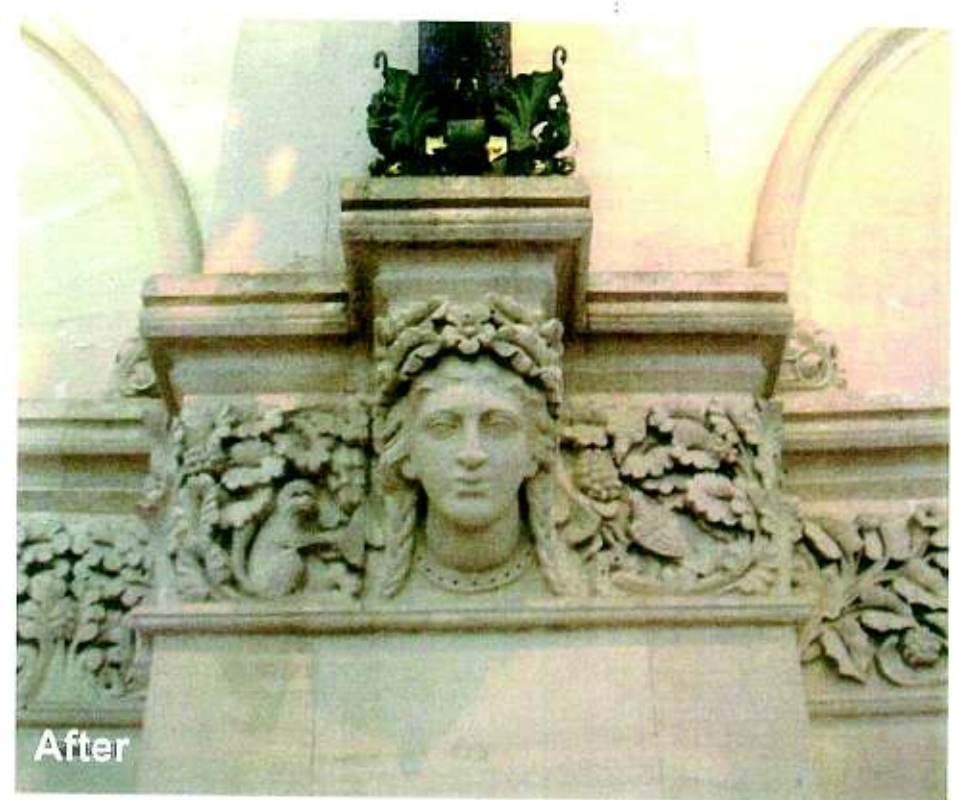
## Restoration of Interior Statuary

While the paint was being removed, in the case of 2 male heads, the base was found to be made of cast cement, with a steel armature. This was quite a surprise to the team as all the other figures were crafted out of limestone. This would have been a past intervention, possibly as a stone figure head was damaged. It was decided to retain this as a layering of past intervention and the head was given a surface covering of lime plastic repair to match it with the surrounding stone.

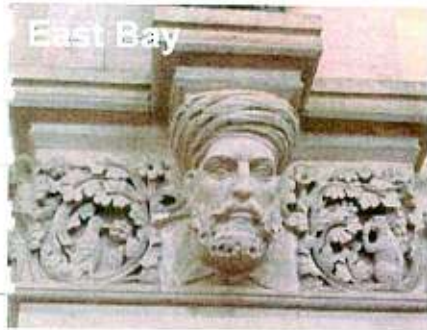
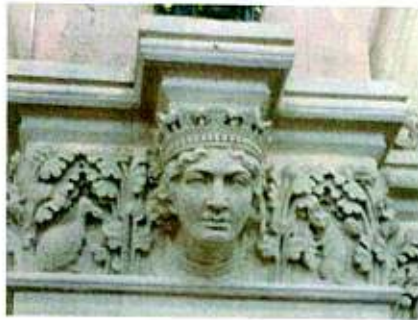
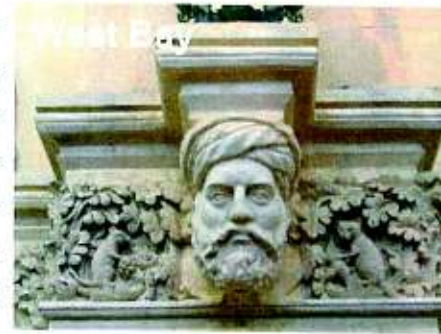
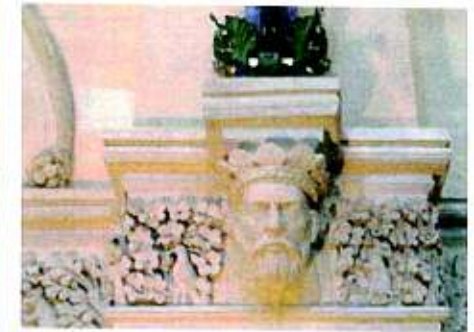
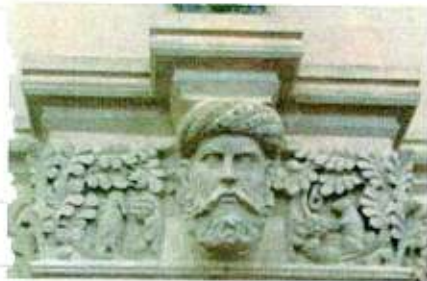
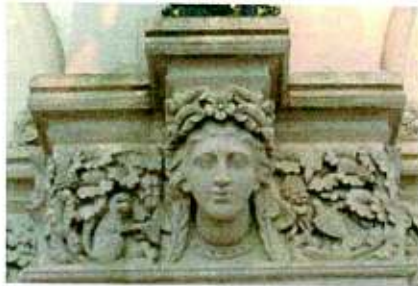
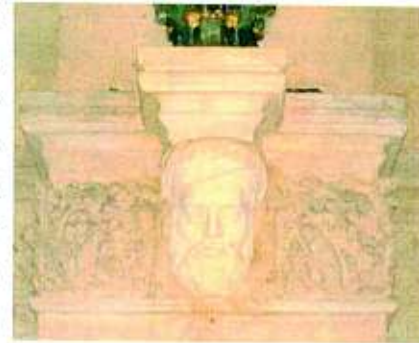
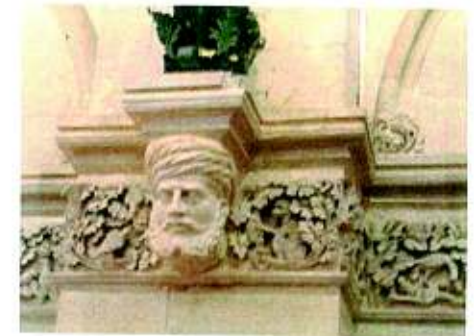
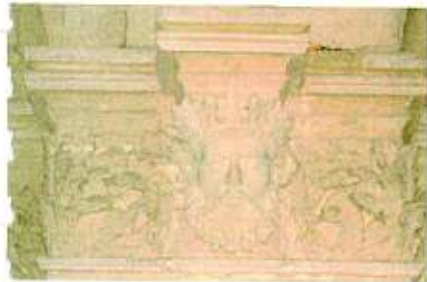
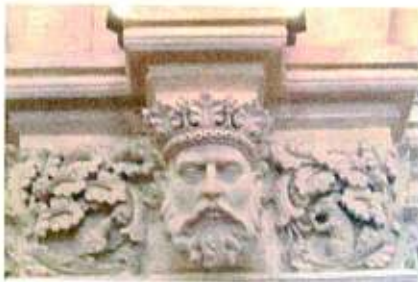
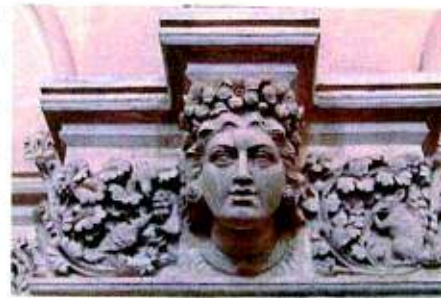
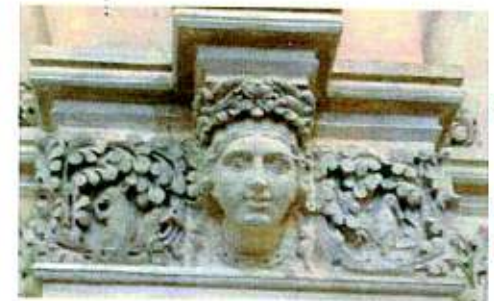
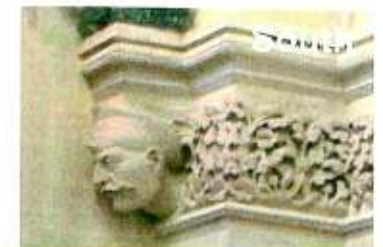
The entire interior statuary was covered by thick layers of paint. This was most unsightly and obliterated the original texture of the lime stone carvings. Paint layers were carefully removed from the stone by employing non abrasive paper poultices, water washing with nylon brushes and application of mild surfactants. The ugly electrical conduits running across the carved faces were re located to expose the beautiful stone carvings.

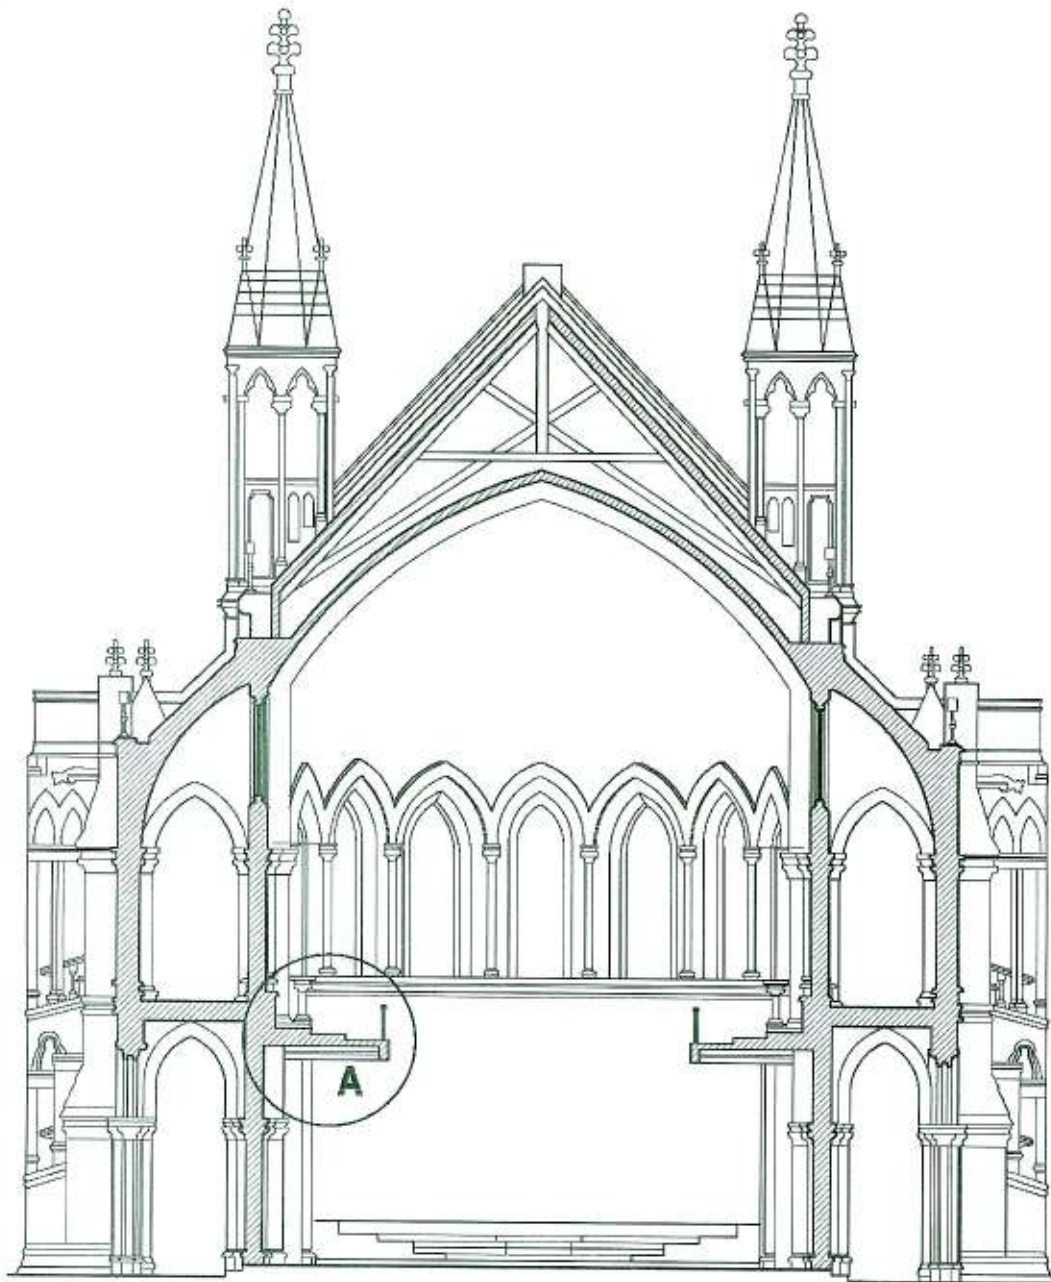
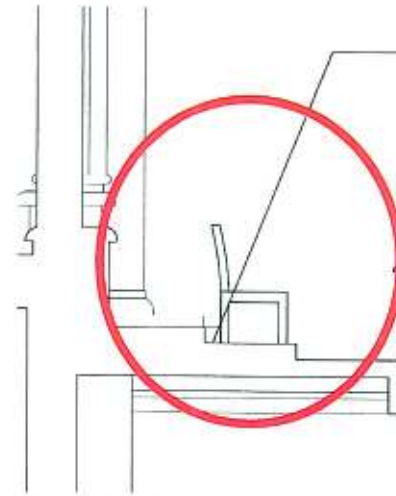
Electrical cables running along the length of the upper mezzanine and dropped at each decorative bracket to feed a row of lights.

The electrical wiring that ran in an ad hoc manner, defacing stone cornices and abruptly cutting across stone details has now been concealed, re-routing it under the timber boarding of the upper balconies to ensure that the architectural details are not obstructed.

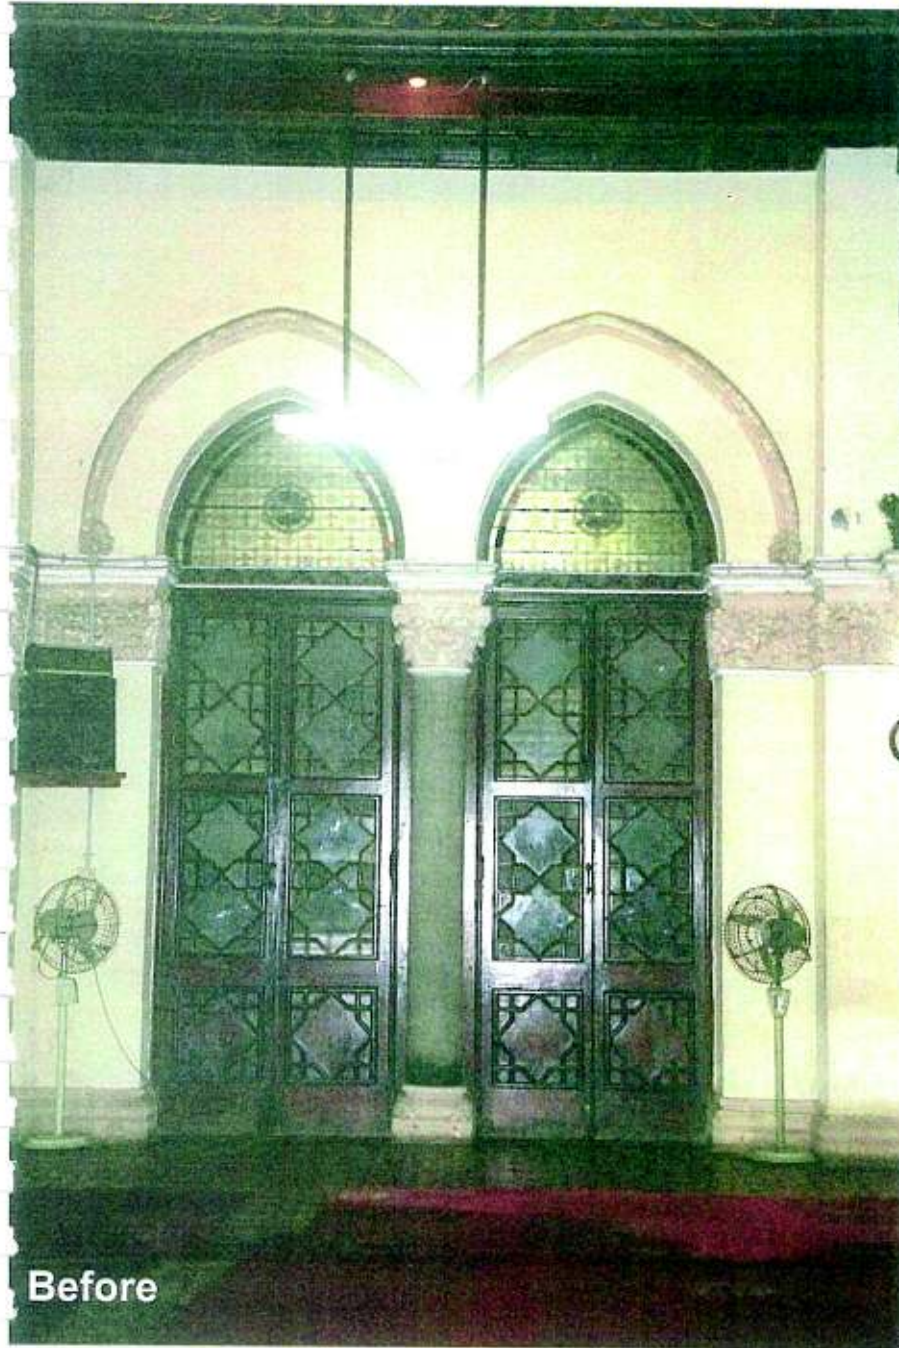
Before

The interiors of the spectacular hall had undergone a series of insensitive alterations ranging from insensitively placed tube lights, switches and electrical conduits that criss crossed over architectural details, greatly detracted from the architectural ambience of the once grand interior.

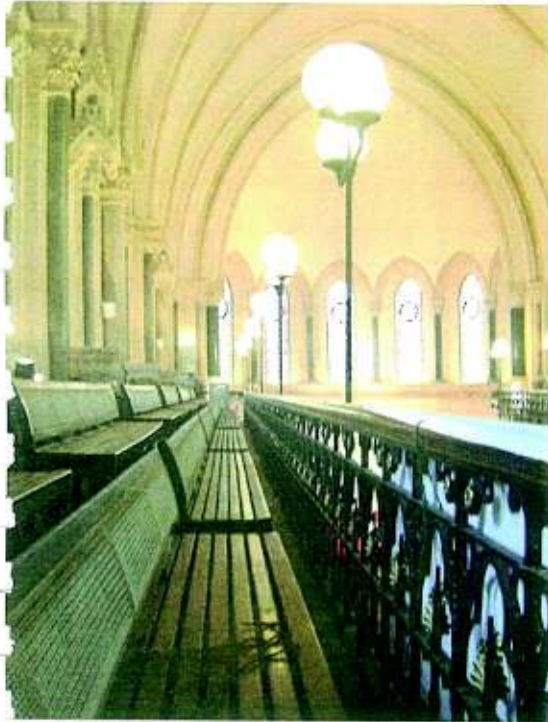
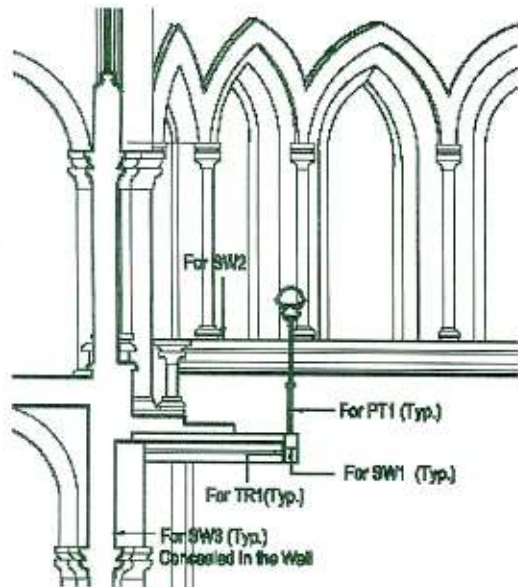
The original lighting for the hall had Victorian lamps as seen in the upper balconies. These were surviving in some cases, while in others, the glass domes were broken. The only other surviving light fixture of the original Victorian design was a brass disc fitting with six decorated glass fruits suspended from it. Over the years however, a range of ugly fluorescent tubelight fittings were suspended from the balcony, an eyesore. A design firm specializing in lighting design, was involved in designing a specialized lighting system for the interiors and exteriors, carefully calibrating lighting systems to appropriate designs and lux levels suited for such a historic structure. The electrical wiring that ran in an ad hoc manner, defacing stone cornices and abruptly cutting across stone details has now been concealed, re-routing it under the timber boarding of the upper balconies to ensure that the architectural details are not obstructed.

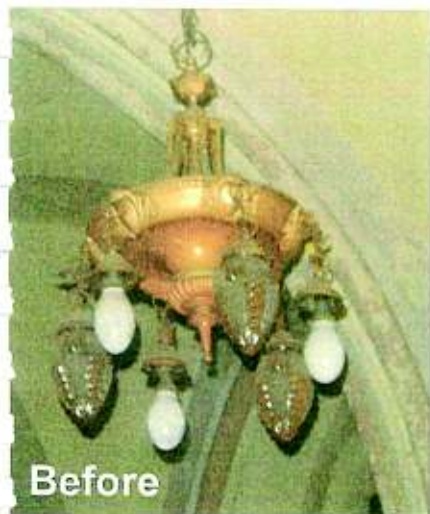
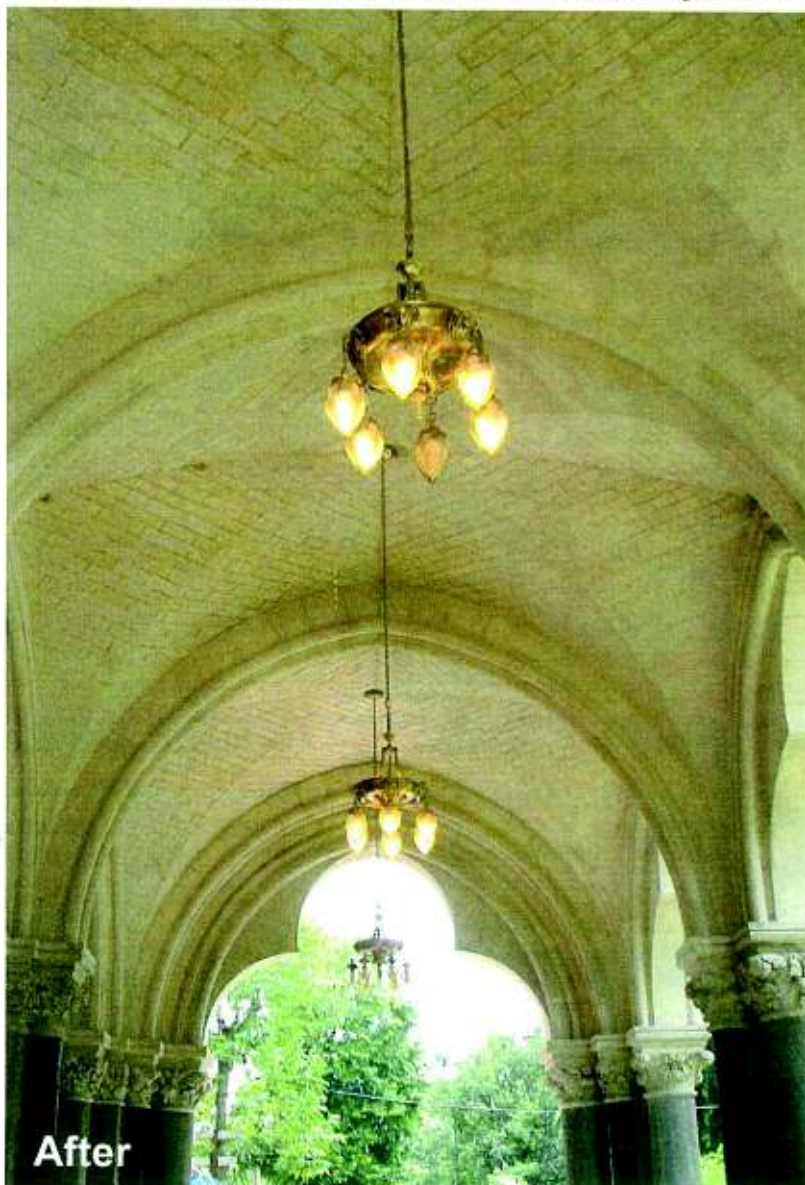
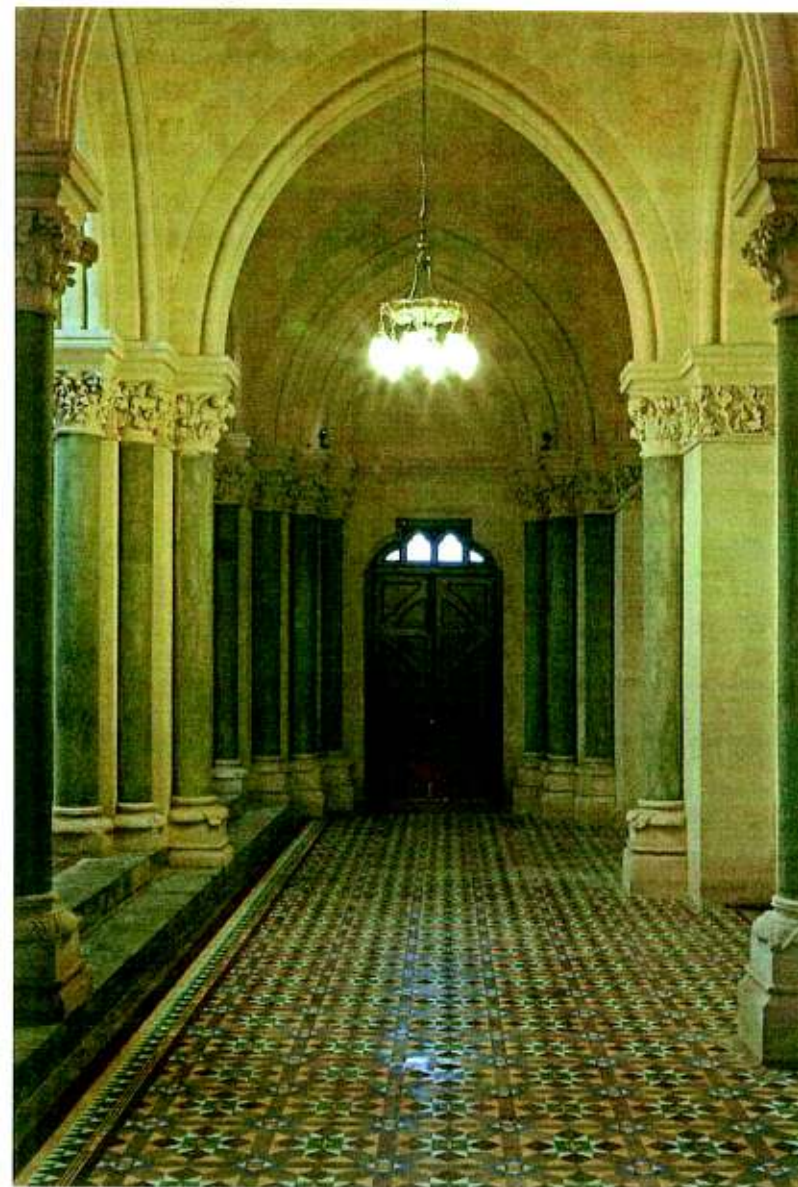
Apart from the vertical trident upstands placed along the upper viewing balcony, the other surviving light fixture of the original Victorian design was a brass disc fitting with six decorated glass fruits suspended from it. Of these, three of the glass fixtures had been broken with three surviving. The design was replicated in brass and blown glass and replicated for the three groin vaults on the porte cochere.

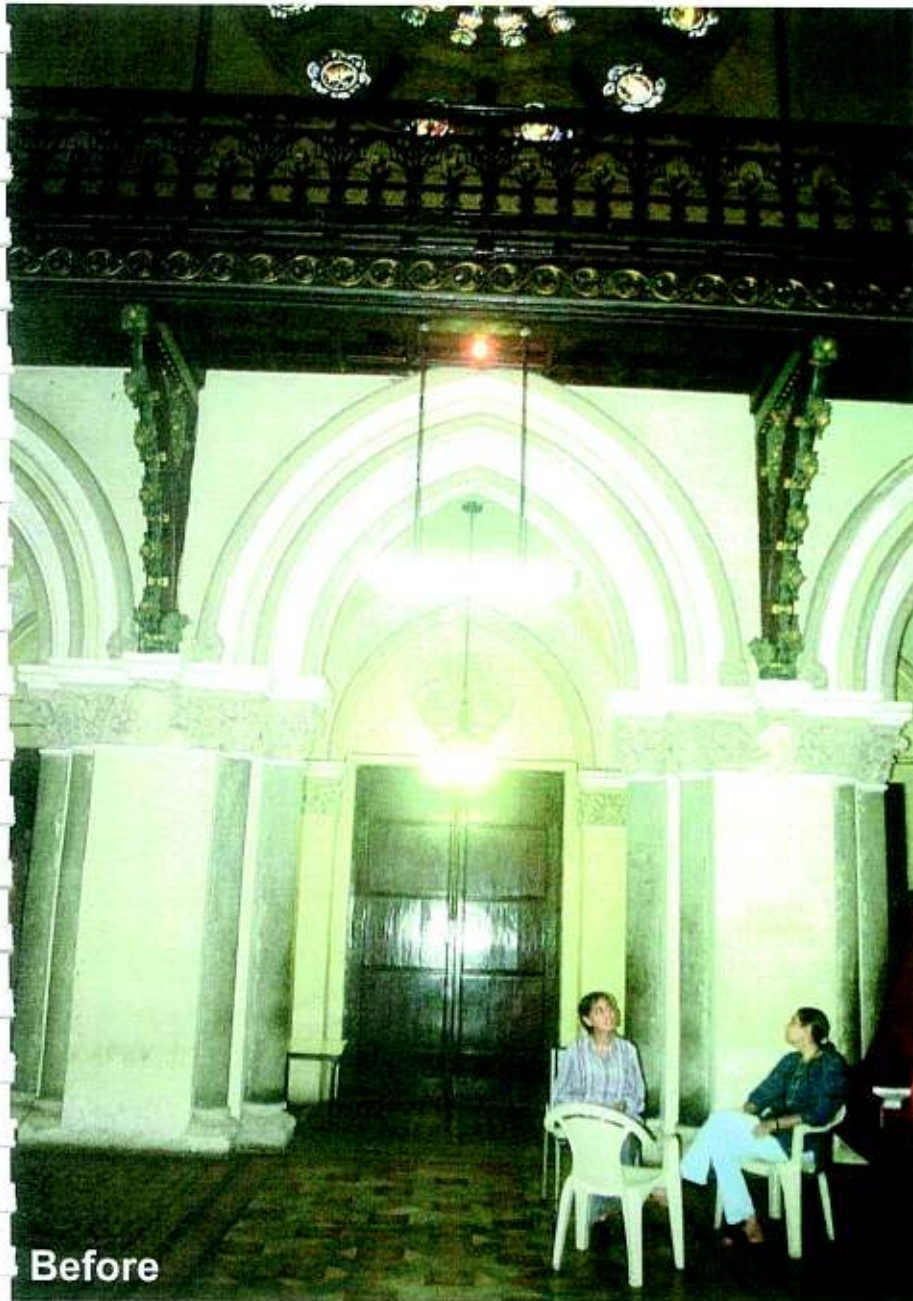
Before

Top Left: A row of ugly suspended fluorescent tube light fixtures cut off the line of sight to the brackets and stained glass beyond. Also visible, were electrical pvc conduits running along the length of the building, cutting across carvings and arbitrarily placed light bulbs. Above: These have been removed and discreetly placed lights under the beam soffit of the balcony focus on the architectural details, bathing them in a warm glow.

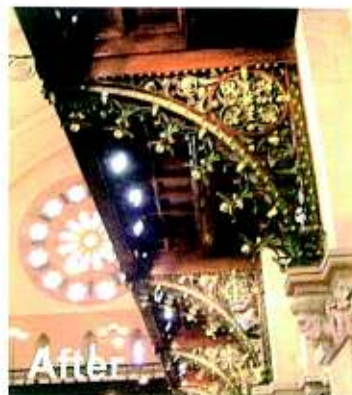
After

Fluorescent tube lights replaced by well designed lighting systems that create a warm glow in the interior and are visually unobtrusive

The lighting scheme seen in 2005 was that of fluorescent tube lights suspended from the ceiling. These were removed and lights were discreetly fixed under the soffit of the balcony beam to conceal them. Sharp white lights of the tubelights was replaced with warmer tones of lights focusing on architectural details such as brackets and carvings.

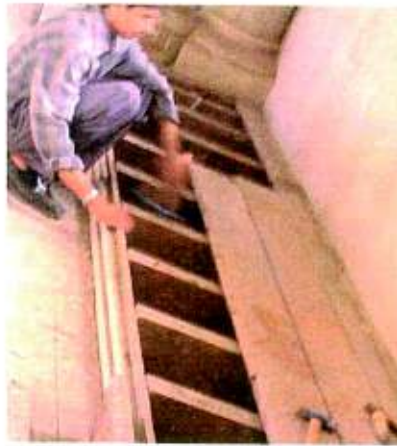
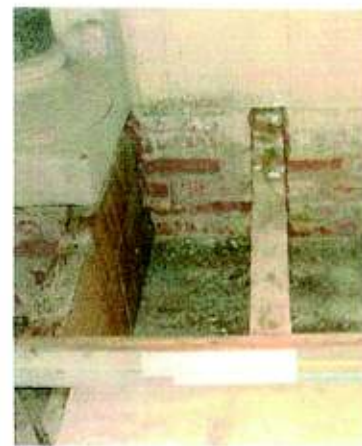
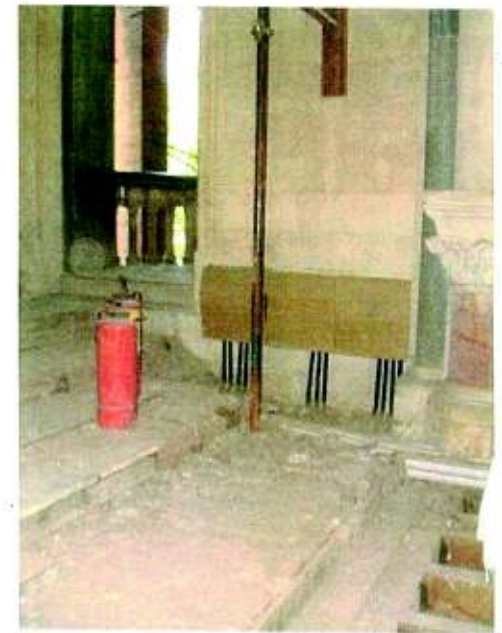
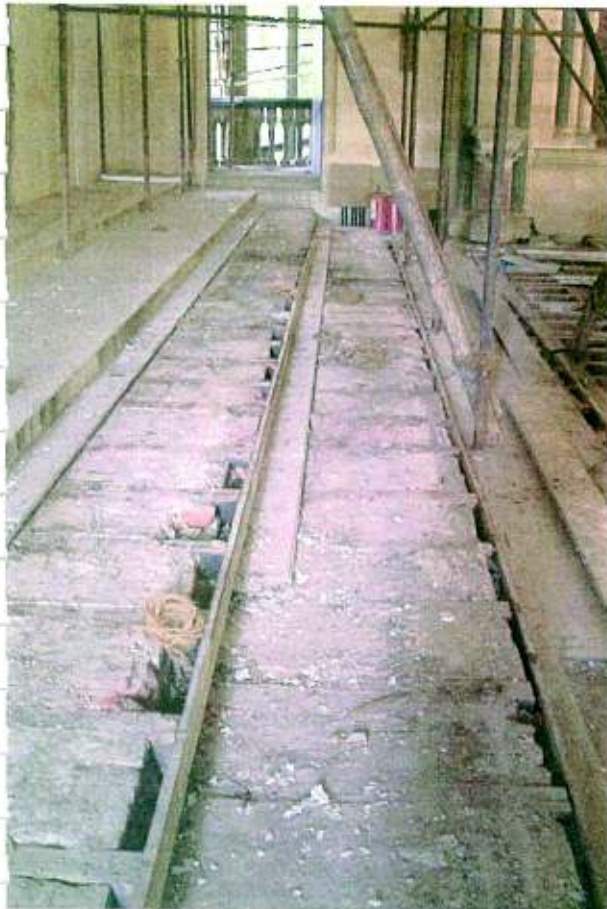
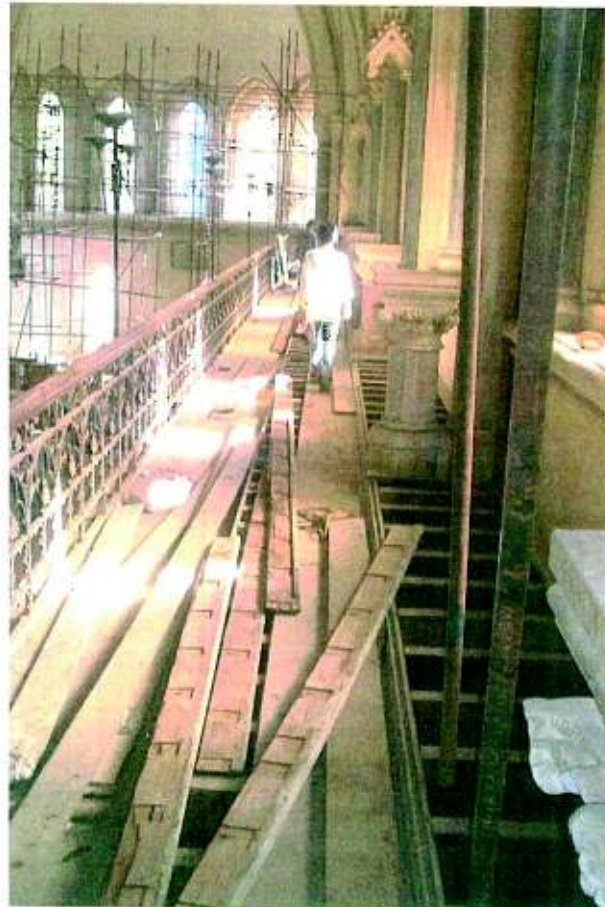
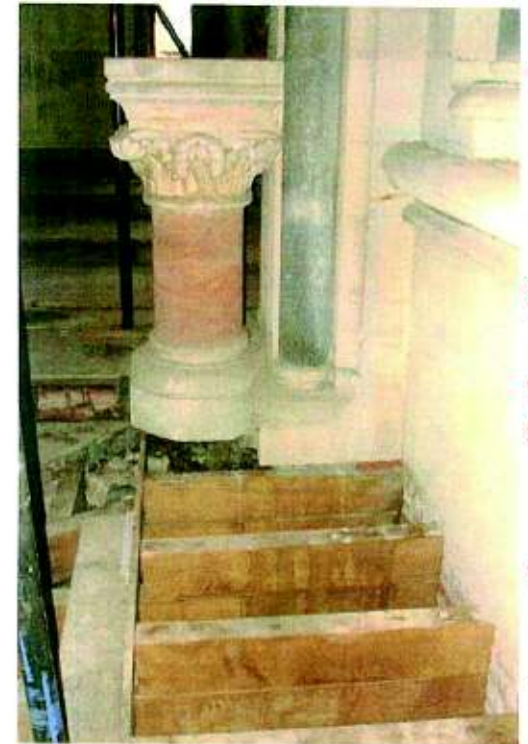
The upper viewing gallery was designed to seat 400 people for the Convocation and Senate Hall functions. However, completely cantilevered from the three ends, the structural stability of this balcony was to be ascertained. Timber planks were opened up and wet rot was suitably addressed. The steps running along this gallery were also used to route electrical conduits (images to right) to run through the entire length of the building without being visible from the hall at the ground level.

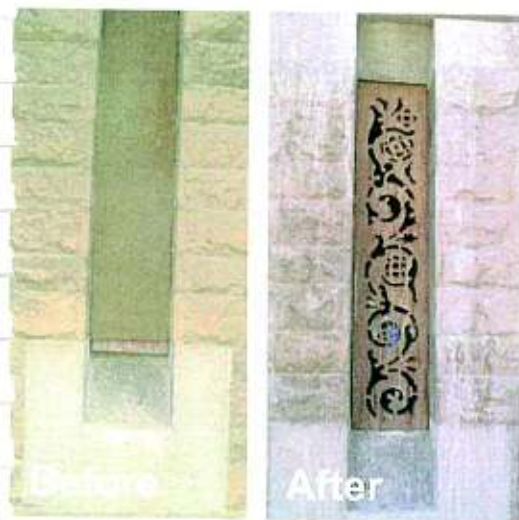
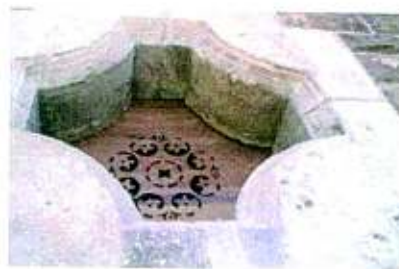
Above: Fretwork panel inserted in the quatrefoil windows of the upper roof to allow for ventilation of the roof that was earlier damp and un ventilated.

Below Left: Images showing a fretwork fanlight in the porch door restored after removing layers of oil paint.
