**University of Mumbai**  
Restoration of the Convocation Hall

Restoration of the Convocation Hall: The History

## Restoration of the Convocation Hall: Fabric Inspection

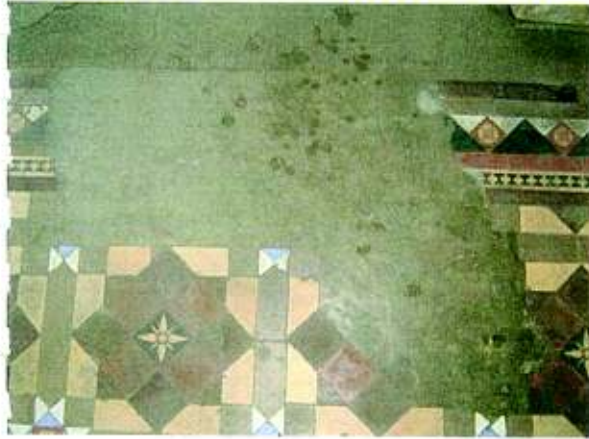
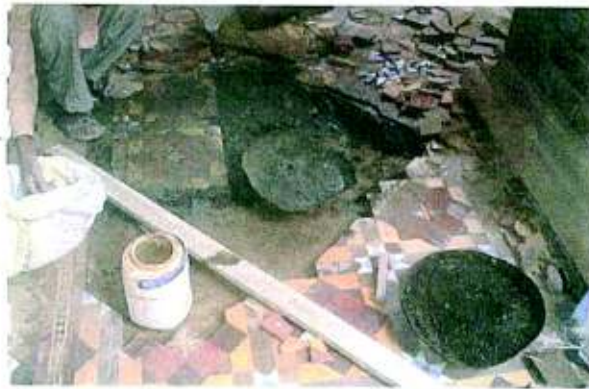
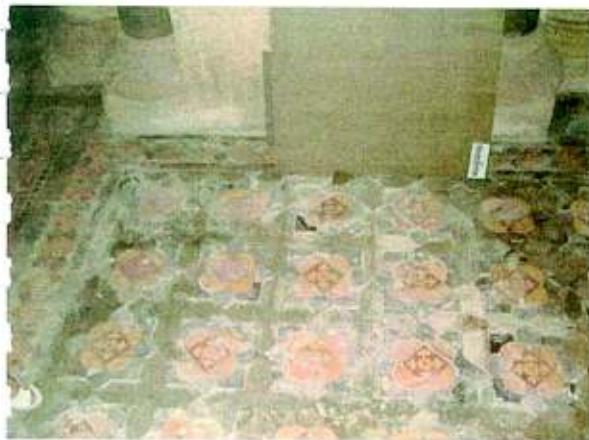
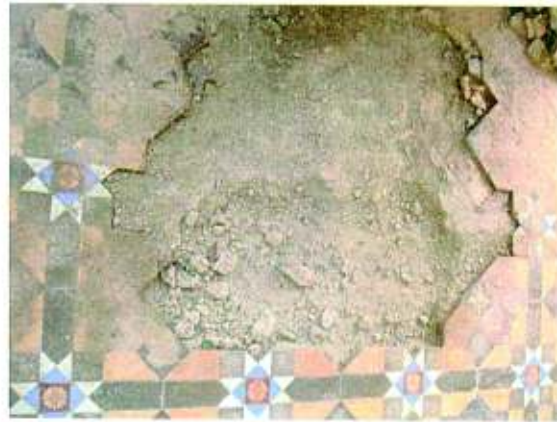
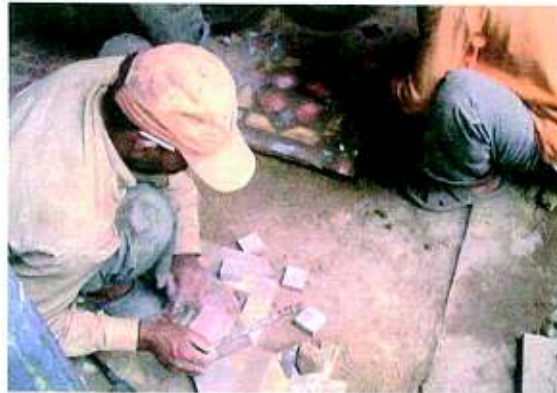
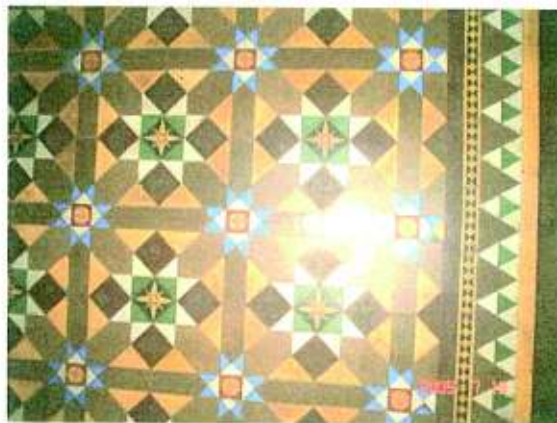
The entire hall, its staircases and verandah were fitted with encaustic Victorian tiles from Minton & Co. At the height of fashion for Victorian buildings of the era, these encaustic and geometric clay tiles were shipped in from Stoke on Trent in England. Inlaid within these at some patterns (top right) was marble. The tiles were found in a range of patterns in shades of ochre, terracotta, blue, beige, brown, green and grey. At many places, the tiles were damaged or missing, filled in with cement repair. In other sections, bulging of tiles required to be reset, carefully removing each tile from the bedding and cleaning them, after which they were reset in a lime mortar bedding and wax polished.

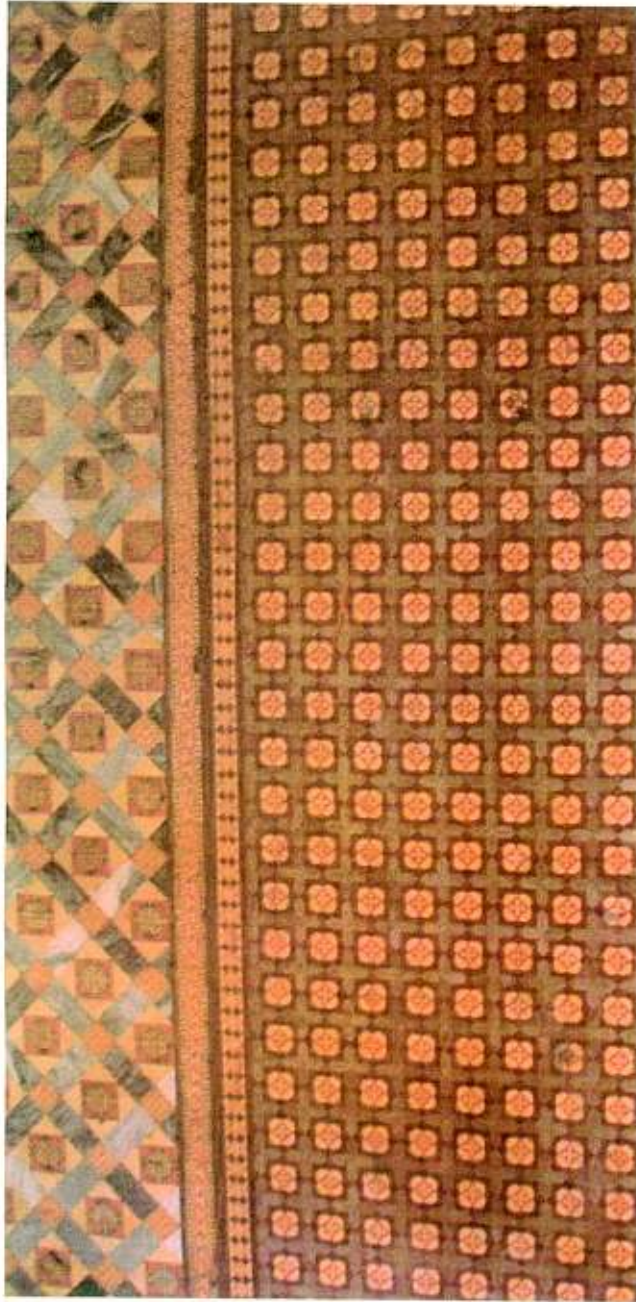
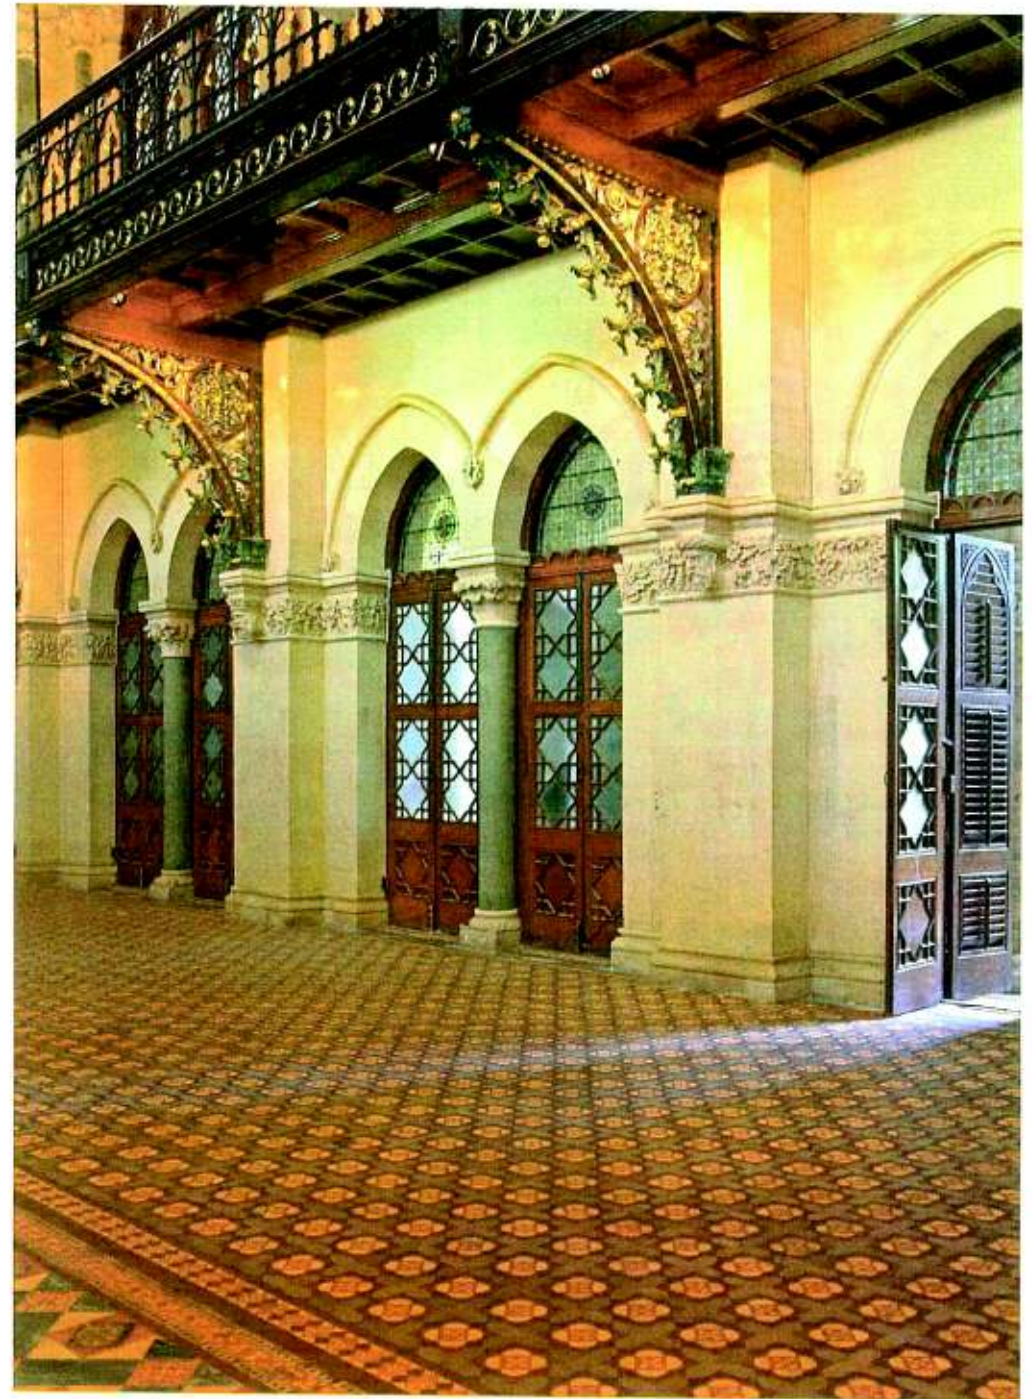
The entire hall, its staircases and verandah were fitted with encaustic Victorian tiles from Minton & Co. At the height of fashion for Victorian buildings of the era, these encaustic and geometric clay tiles were shipped in from Stoke on Trent in England. Inlaid within these at some patterns (top right) was marble. The tiles were found in a range of patterns in shades of ochre, terracotta, blue, beige, brown, green and grey. At many places, the tiles were damaged or missing, filled in with cement repair. In other sections, bulging of tiles required to be reset, carefully removing each tile from the bedding and cleaning them, after which they were reset in a lime mortar bedding and wax polished.

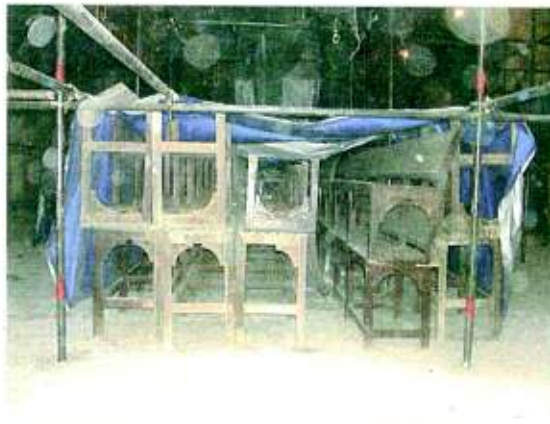
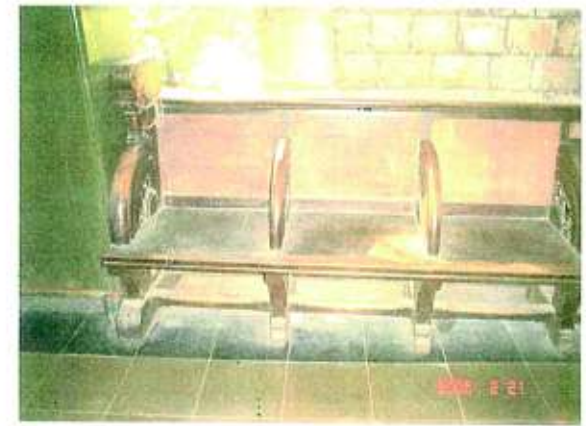
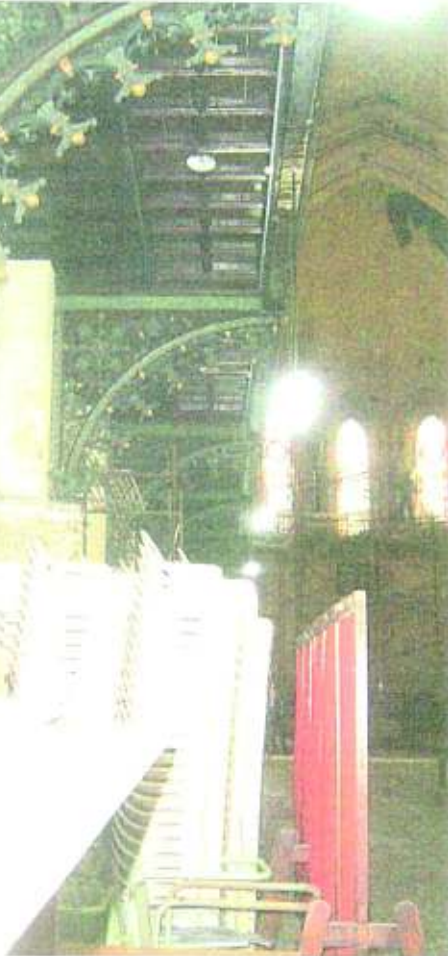
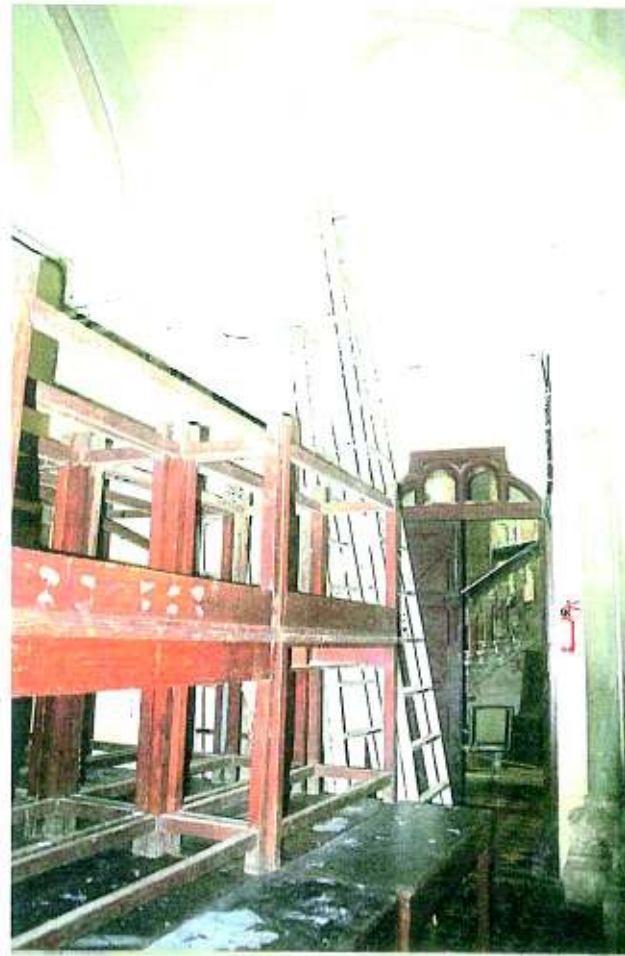
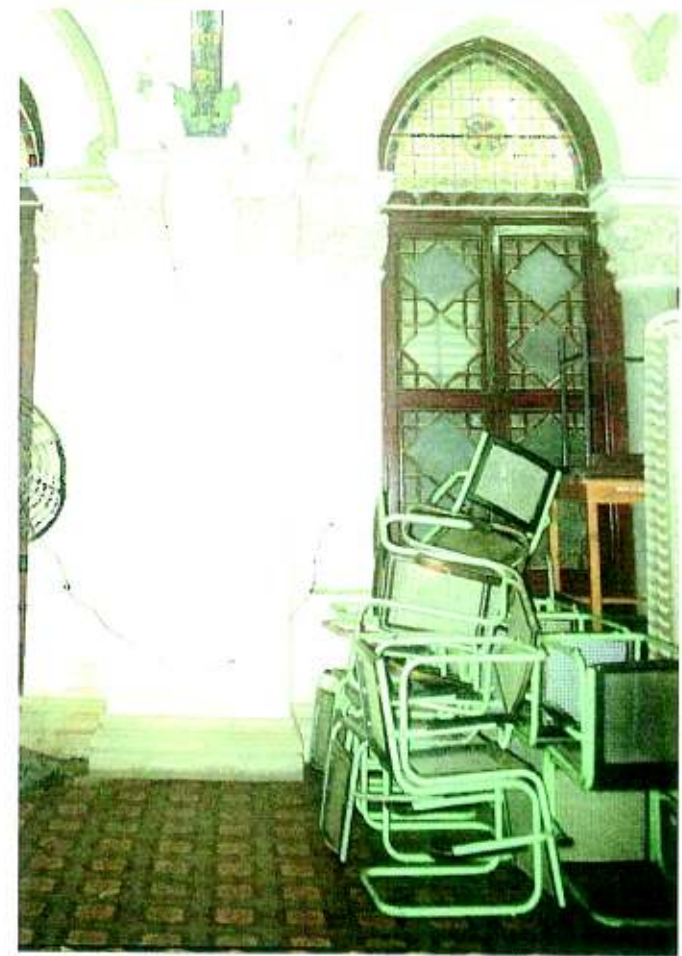
The Convocation Hall was originally fitted with Burma Teak wood furniture of the Gothic Revival design. The upper galleries had rows of benches with wicker weave backs and the lower hall was furnished with heavy pew like seating of a Gothic Revival design. When the project began, the condition of the upper balcony benches was greatly deteriorated but the lower hall original seating was entire missing. This had been replaced with aluminum chairs and plastic chairs, wholly unsuitable to a grand Victorian space.

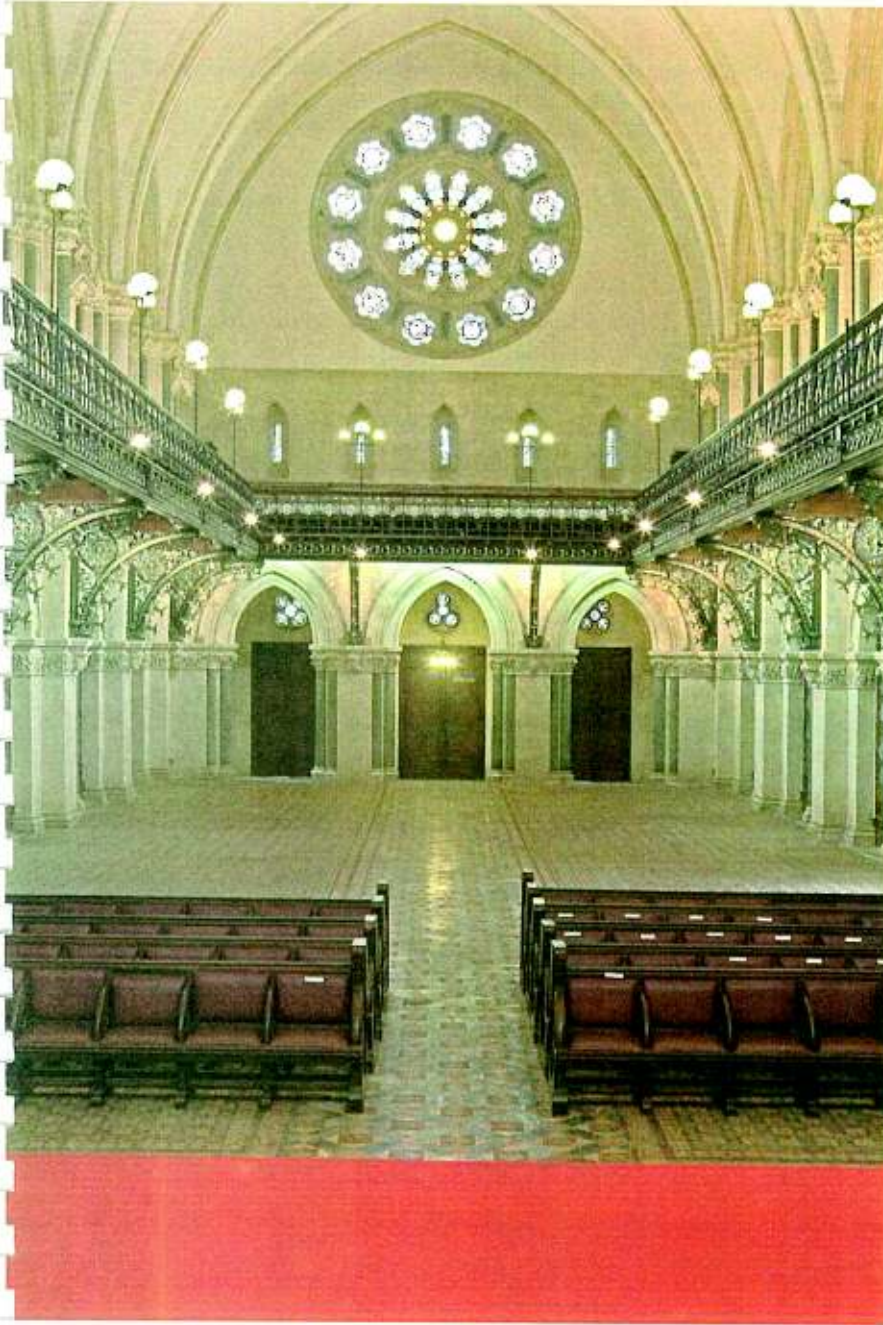
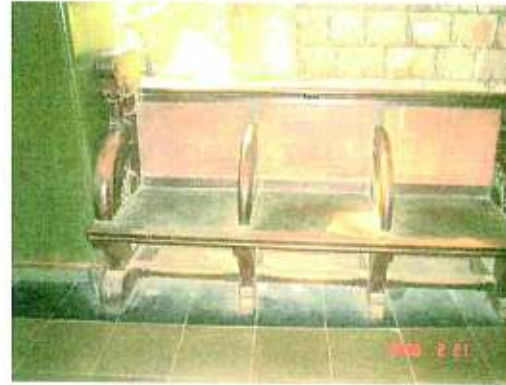
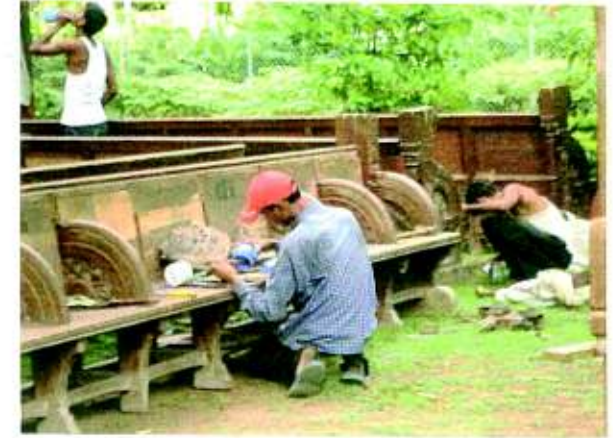
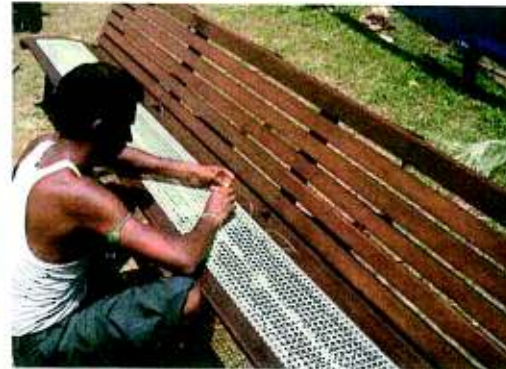
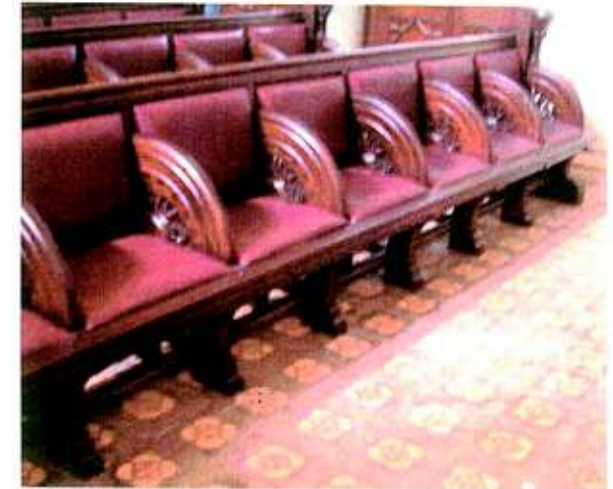
The architects found some wooden benches in a rather damaged condition scattered over the offices of the Registrar, and also in the Kalina campus in the suburbs. These were exactly the size of the seating bay in the ground level as defined by the Minton tiles and were of the Gothic revival design, in heavy sections of carved Burma Teak wood and with trefoil carvings. These were collected from all the various campuses and restored.

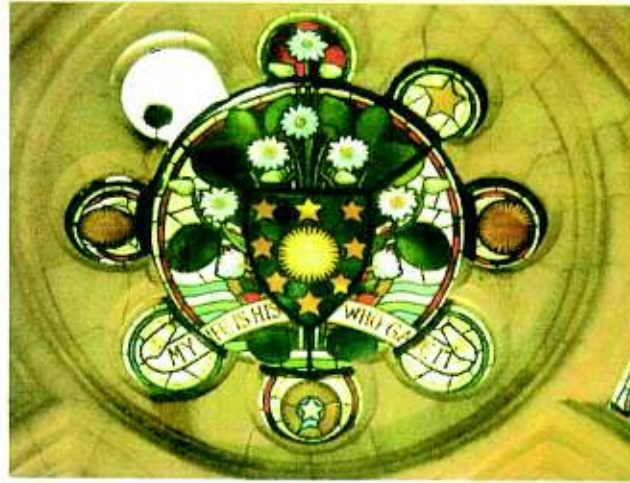
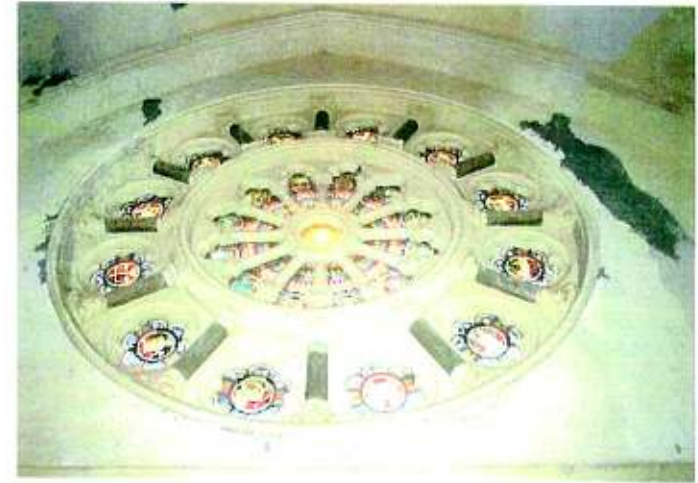
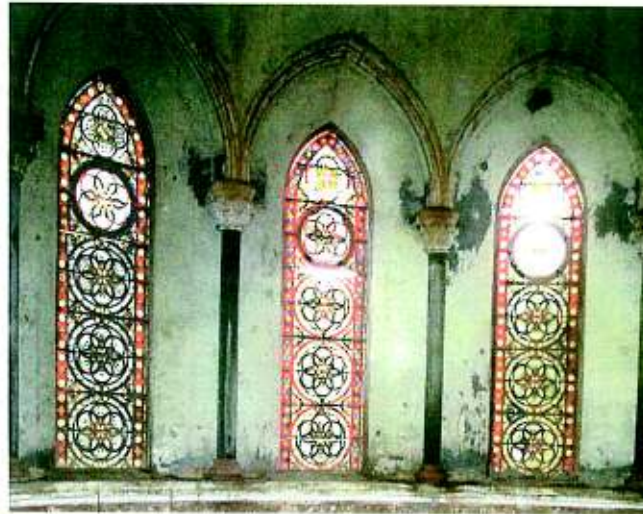
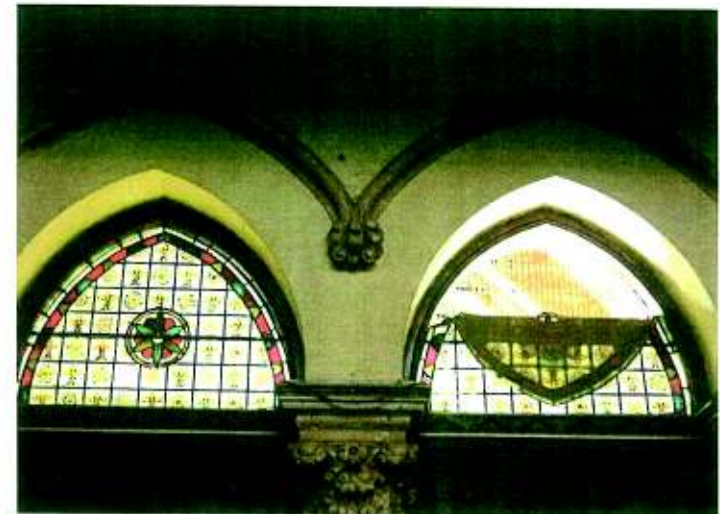
**Type I / The lancet Lights:** The general condition of all the seven lancets was found to be fragile. This was expected considering the south-west orientation of the lights and the onslaught of the rain and the wind currents in the monsoon months. Many panels had come loose of their steel framework and daylight was clearly seen between the 'T' sections and the panels. All seven Lights showed marginal to severe buckling in the lower two panels. There was bitumen on the glass and foliage trapped between glass and wire-guard. In the Head panel of Light NO 6, one of the four foils was missing, while the fourth panel ('d') had 100% paint-loss. Copper-ties of all the pivoted panels had come loose. Most of the mastic-putty had fallen out.

**Type II / The Wheel Window:** The Wheel window was found to be in stable condition, except for single cracks and slight stress in some panels. The damage to the panels was essentially due to broken masonry into which they were located.

**Type III / Tracery Lights:** The east side panels were in a better condition than their counterparts on the west side and their proximity to the sea. However, two traceries at the south end of the east wall (NOS 5 and 3) were previously damaged owing to heavy water leakage through the roof. Three foils and two large areas (in NOS 1, 5 and 6) were found to be completely missing, while many cracks were seen in the foils in NOS 7, 10, 11 and 12. The pivoted foils showed stress, glass loss and heavy rust build-up, as the pivots had completely corroded and imposed upon the panels. The trefoils only showed glass and paint loss, but no buckling due to the three tie-bars re-enforcing the panels. Only the 'Eyes' were in good condition as they were small and held well with a tie-bar each.

**Type IV / Tympanums:** The general condition of tympanums along the East wall was found in comparison with the West wall ones. Acute buckling was seen in NOS 2-B, 8-B, 9-A, 10-B, 11-B, 12-A. The upper section of NO 7-B had come loose and fallen over. Panel NO 11-A was completely missing.

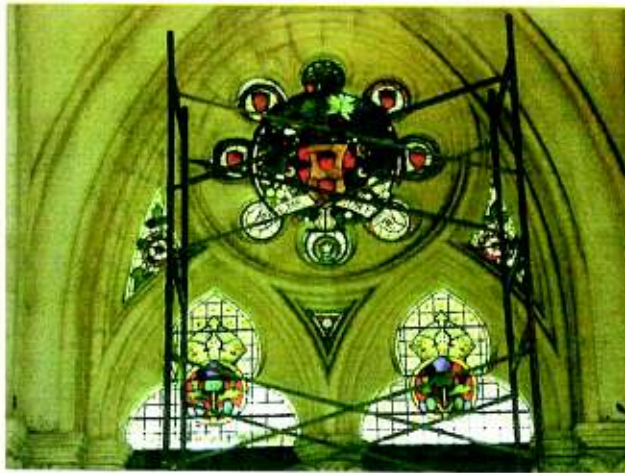
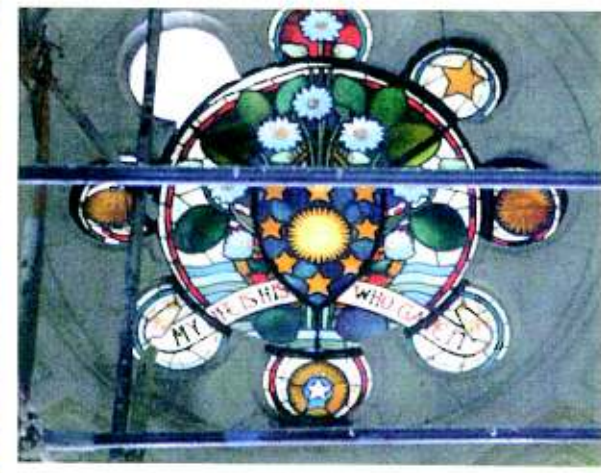
Top: Scaffolding was erected to closely study the extent of damage to the stained glass panels. These were carefully boarded up with protective plywood panels when the restoration work began. Later, as the stained glass work progressed, these were taken down for bench repair.

Above: View of a typical Tender Drawing prepared for stained glass, illustrating the kind of defects to be addressed

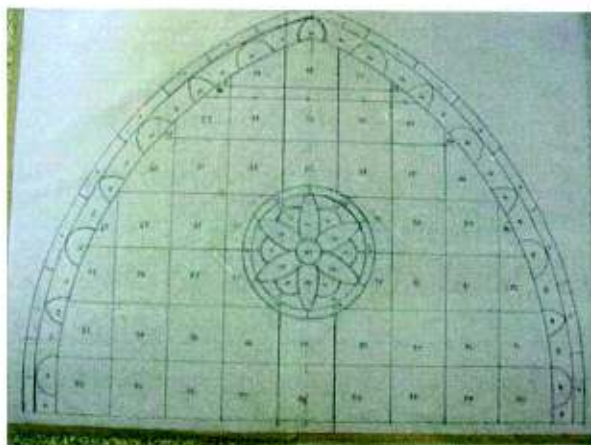
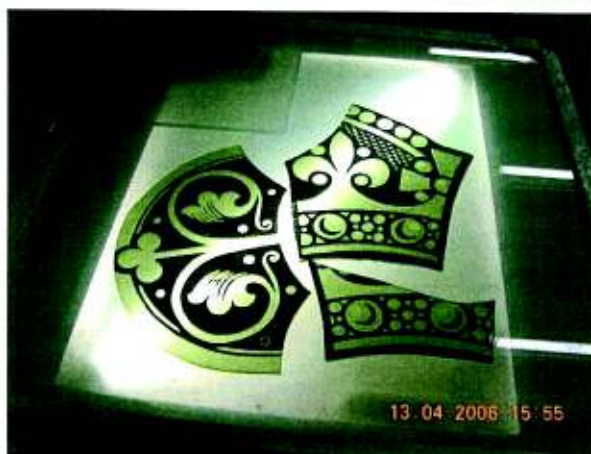
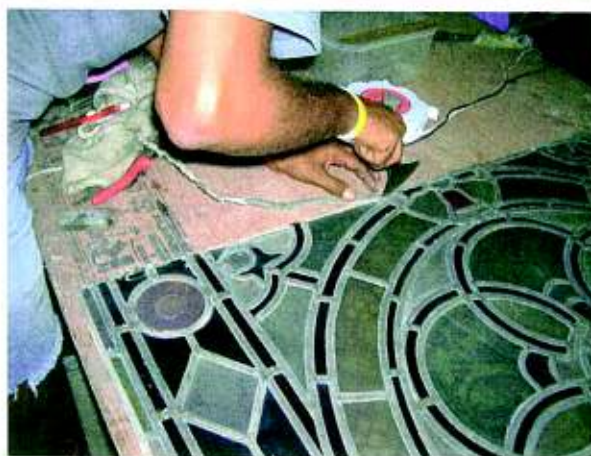
**Types of repair:** The panels were inspected closely by the conservators to determine the type of repair. In most cases, all single, neat cracks in the glass within a stable and firm matrix around it were either "strap-leaded" or sealed with an epoxy resin in-situ. As required. Glass with multiple cracks was removed from the leads and mended using either the copper-foil method (as "mending leads" were not available), where the glass edges were grozed, or by edge-bonding with silicone where the cracks were neat. The edge-bonded piece was then re-assembled into the panel with a 2mm

glass back-platted introduced inside the same leads. As for the lead matrix, care was taken not to dismantle it unless it showed over 50% lead-fatigue or lead-joint fractures. Only the damaged leads were replaced by new ones. In exceptional cases where the panels were found in a buckled state compounded by the above damage was complete re-leading undertaken.

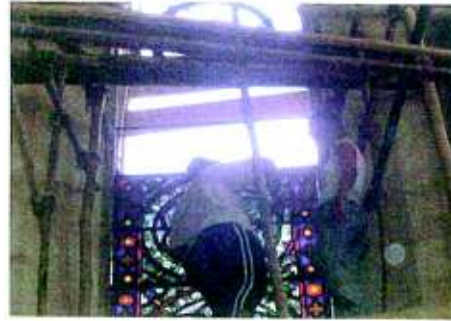
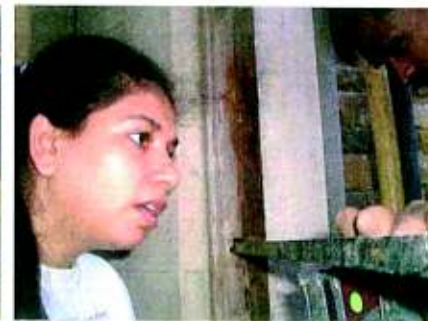
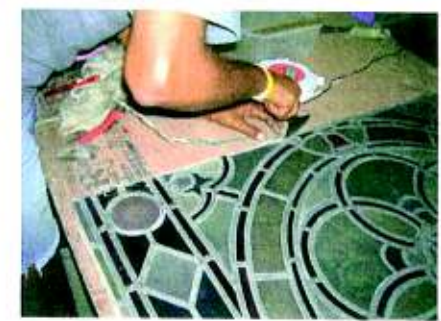
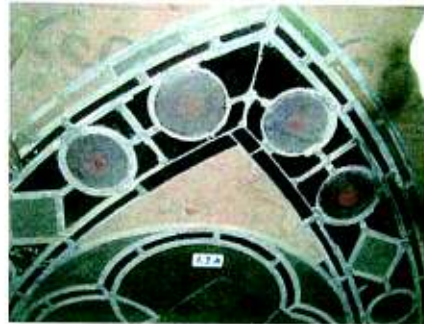
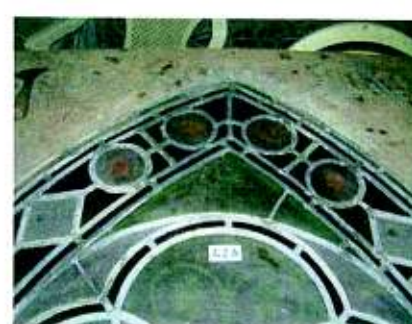
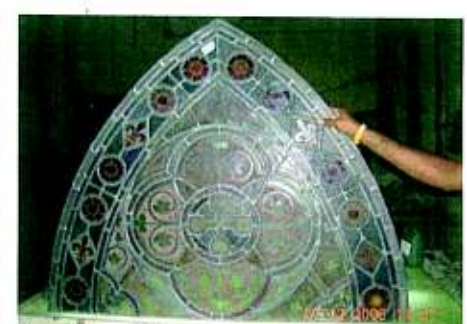
Small lengths of leads were 'nibbled at' by squirrels from the outer side of the panels.. However, this unusual activity had not weakened the leads, rather had only marred them visibly. Hence, these leads had to be replaced by new ones only partially rather than the entire length as is the practice.

Above From Left: Panel with lead came eaten by squirrel; During Bench Repair; Panel After repair of lead came

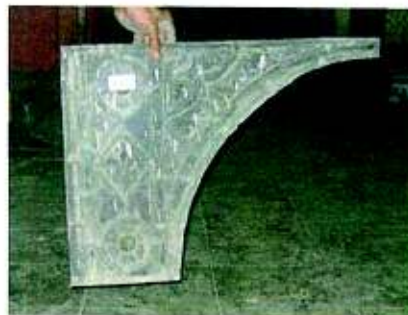
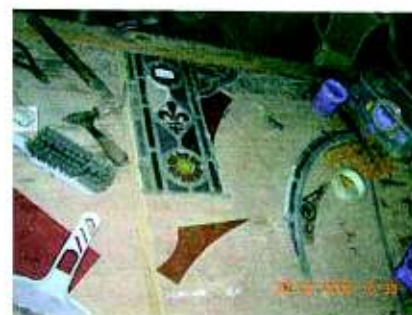
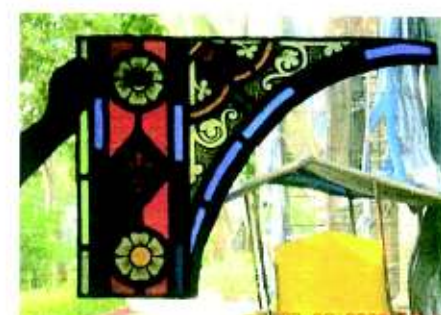
As for the lost paintwork, it was originally due to heavy use of borax (a common approach in the 19<sup>th</sup> century when glass was mass-produced) to quicken the firing. The paint had completely disappeared in many quarries especially (note: No. 6b), but the original glass was intact. Only a faint trace of the original line-work could be seen. A decision was taken by Ms Parveen Mistry to use the original glass and reconstruct the lost paintwork on it *instead of cutting new glass to match*. This was acceptable, because an exact match of the original glass could not be procured, and the original pigments had disappeared.

Above From Left: Panel before Restoration; During Bench Repair; Panel After Restoration

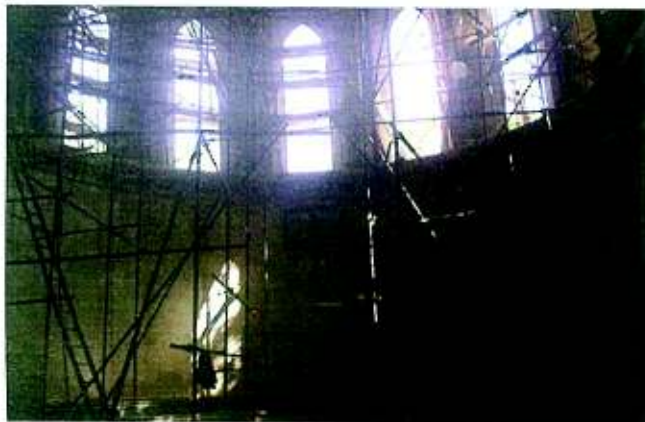
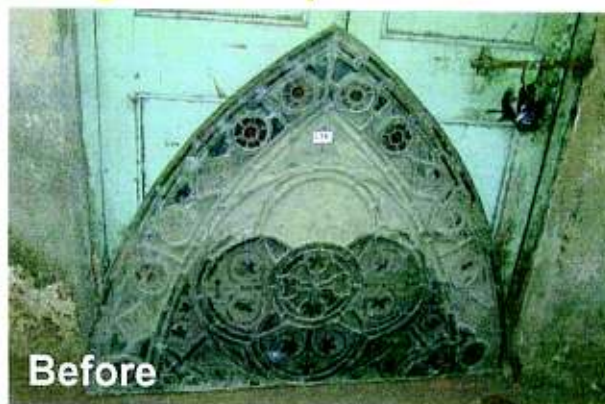
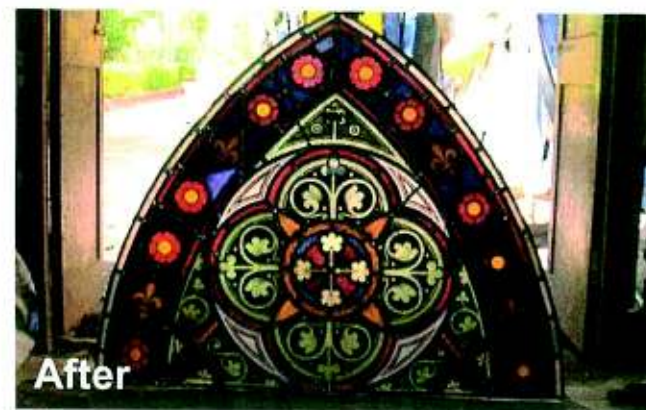
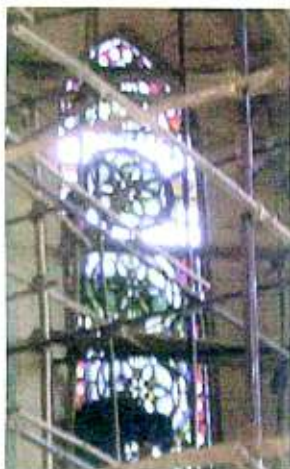
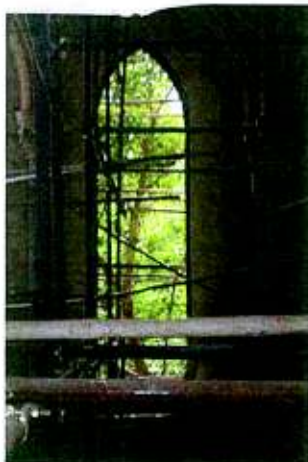
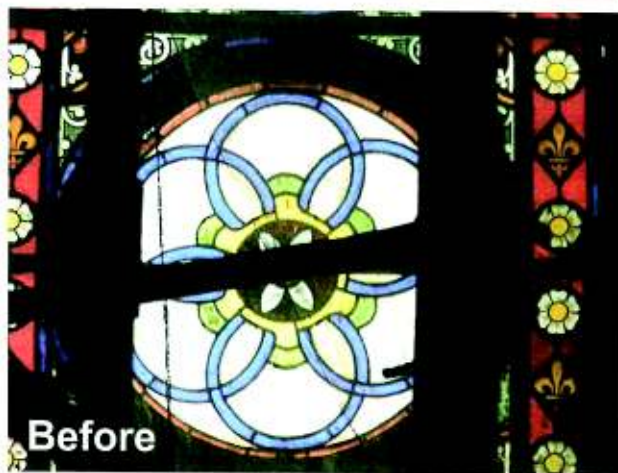
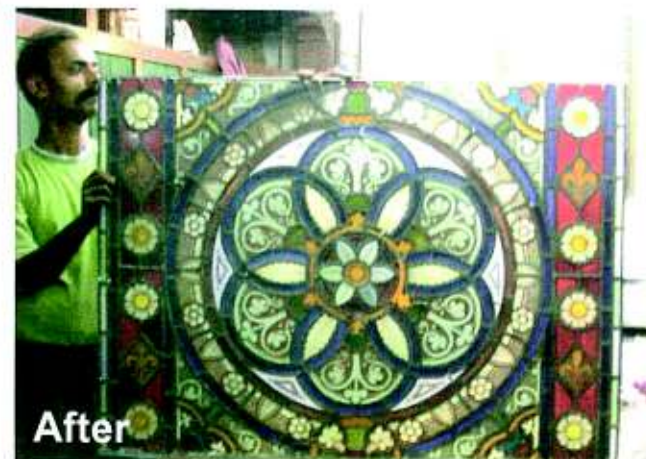
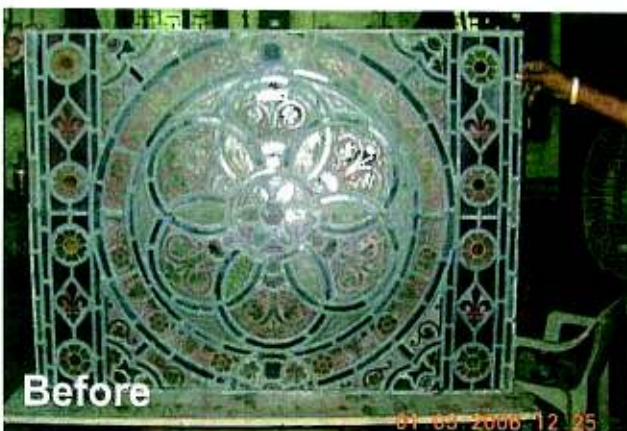
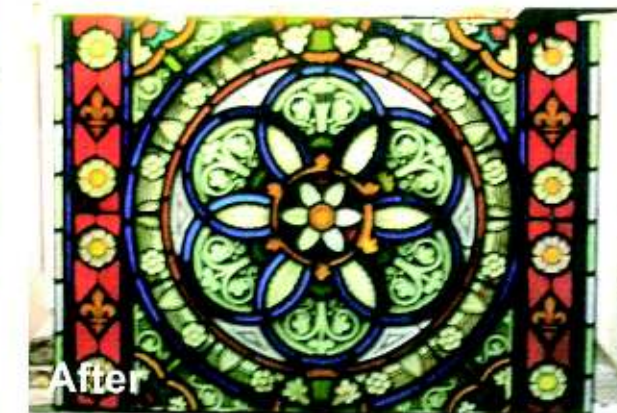
Top Left: The seven lancet lights in the south apse end were badly damaged due to the heavy leakage along this section of the roof. Above: The scaffolding was erected and the lights carefully removed to enable bench repair.

Right Top Row: Before and after Lancet 1

Right Bottom Row: Before and After images of a panel

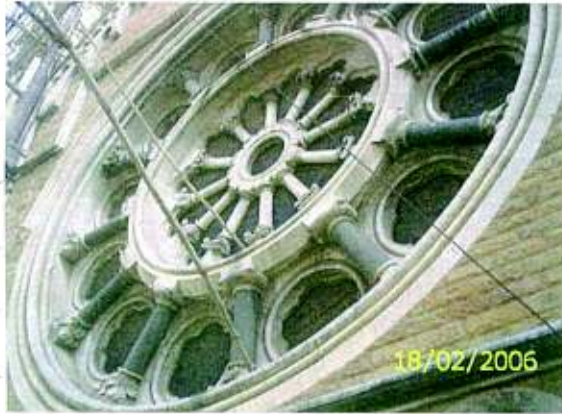
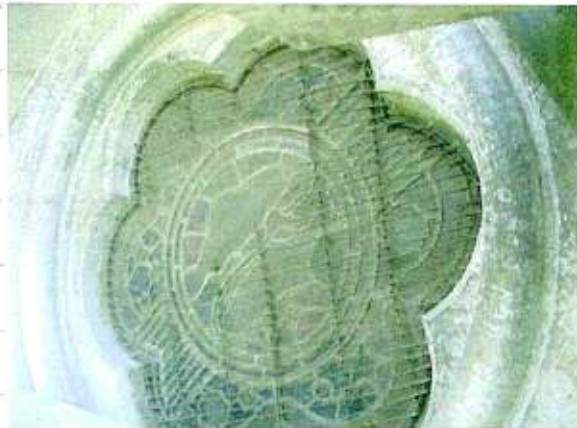
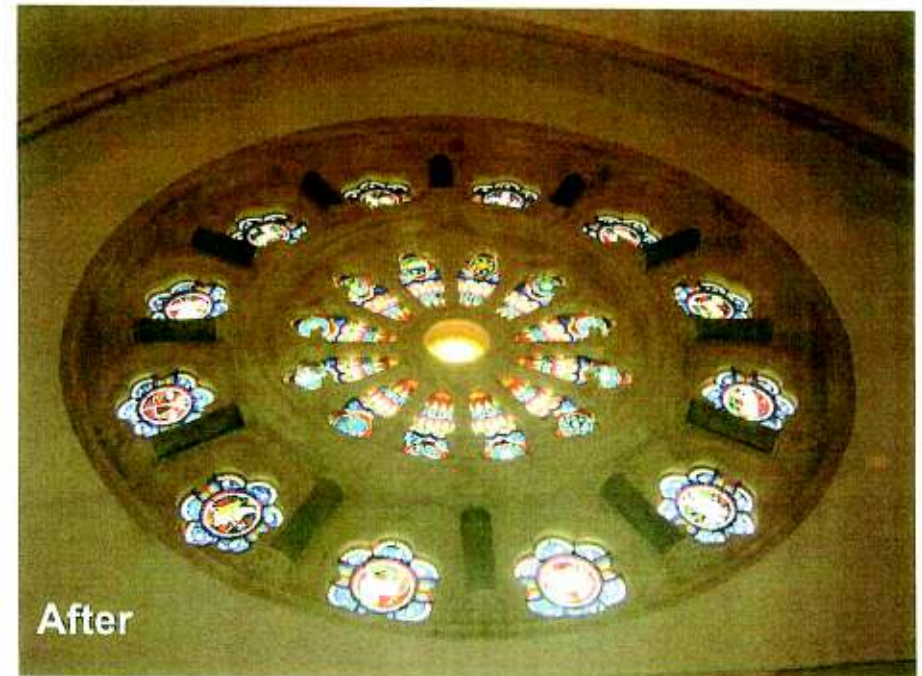
**2. The Wheel Window / Type II:** Here, twelve panels (50% of the window) were found to be buckled and damaged removed. However, as the surrounding material (stone and ferramenta) were found to be good condition, it was decided to repair the panels in-situ. This included stop-repairs to the cracks, re-enforcement of weak lead-joints and re-cementing of the panels on both sides. De-stressing in some panels was also conducted in-situ by loosening the copper-ties and lime-mortar. These time-consuming and complex activities were carried on by Mr Arethna and his team on the scaffolding in the most painstaking manner. Only panels that had paint and glass loss were removed for bench-repair.

Top: The wheel window seen from the interior before restoration.

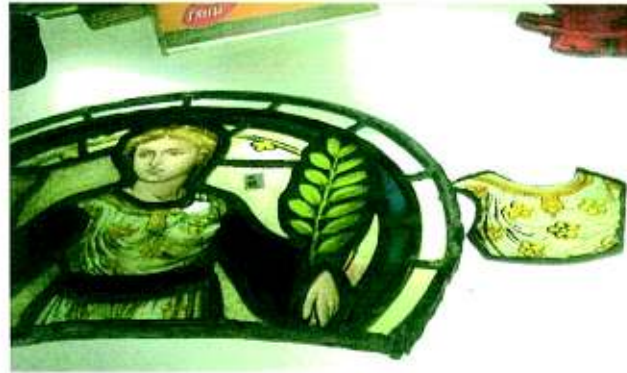
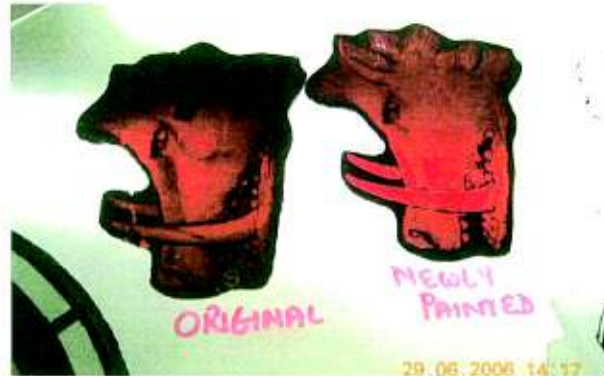
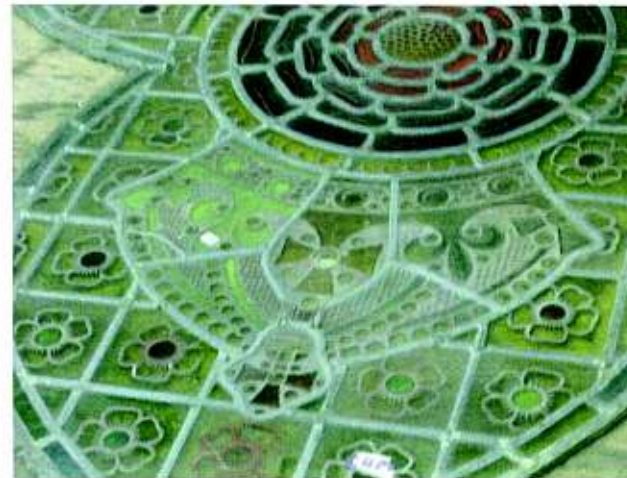
**3. The Tracery Lights / Type III:** Here, maximum damage was to the glass in the surrounding foils that were on pivots. The heavy rust build-up had caused these small panels to loosen from their frames.

Far Left: The exquisite details of paint on the tracery lights, by far the most superior work of painting

Top Left and Middle: Newly painted sections

The pivots were in cast-iron and were badly corroded. They were originally held into the stone cusps with the help of (MS) dowels. It was decided to replace the damaged and rusted pivots with new ones in MS rather than repair them being in cast-iron. The new pivots were heavier than the original and hence, in addition to their original fixing, they were also welded into the circular ring along their base. In case of the rings that held the circular panels, the damaged ones were completely replaced with new ones.

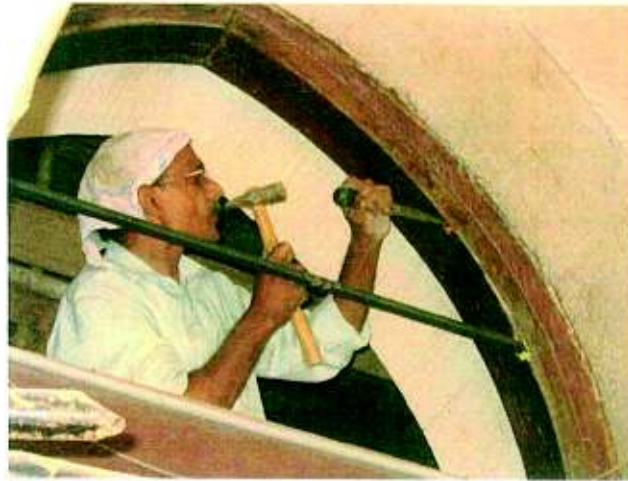
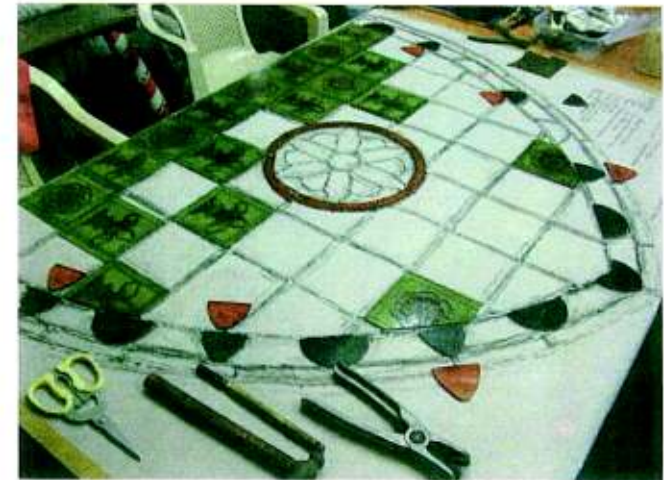
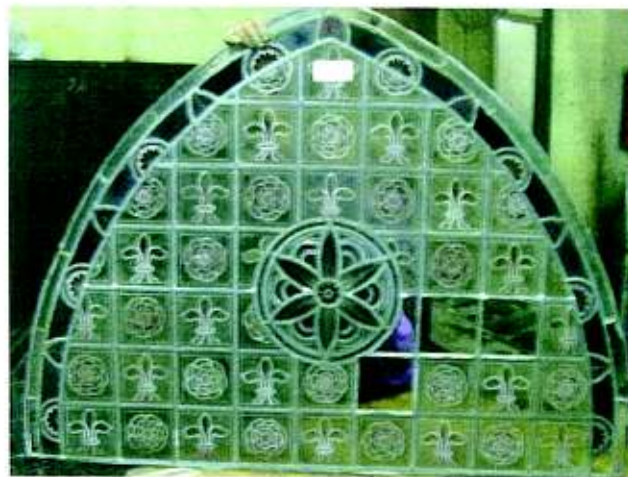
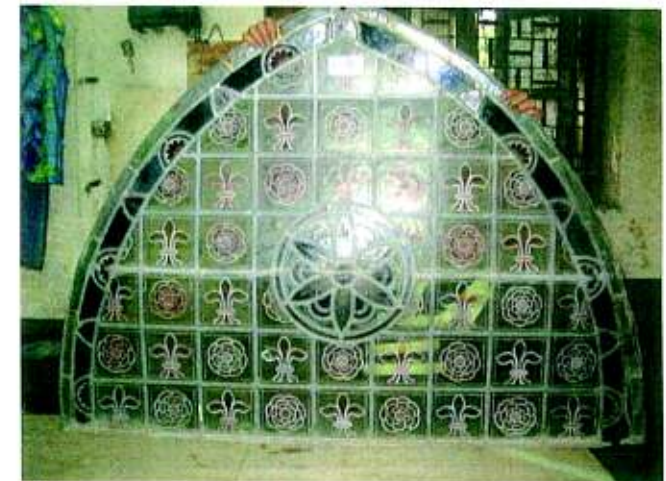
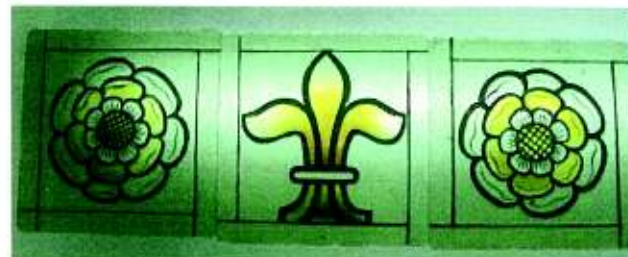
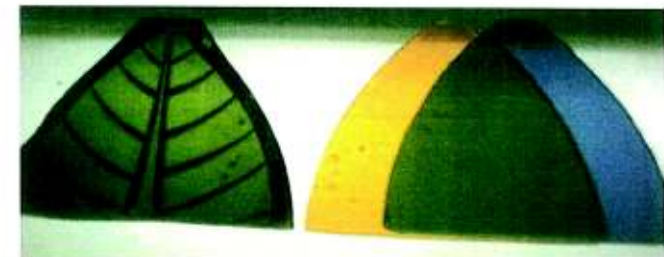
Many quarries showed partially or fully lost paintwork, though the silver-stain was found to be in impeccable condition. As re-painting is an irreversible process, it was decided to retain these quarries with silver-stain in tact and to restore the lost paint by painting on new matching glass. The lost paintwork was reconstructed 'face-to-face' on a 2mm back-plate and inserted into the leads with the original piece as one unit. The periphery of the two quarries was sealed with silicone to prevent condensation or cement seepage.

Middle Row: A missing section reconstituted

Bottom Row: Pieces silver stained and matching glass by back plating.

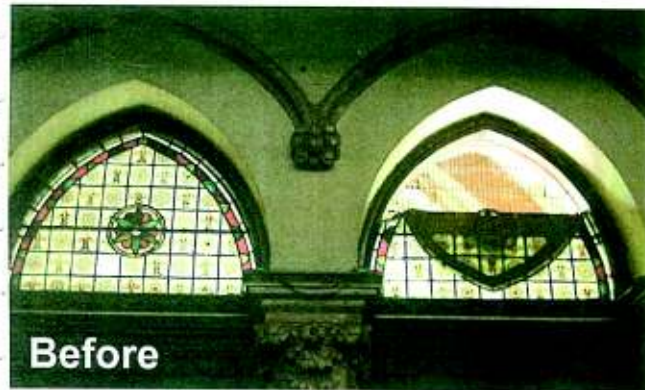
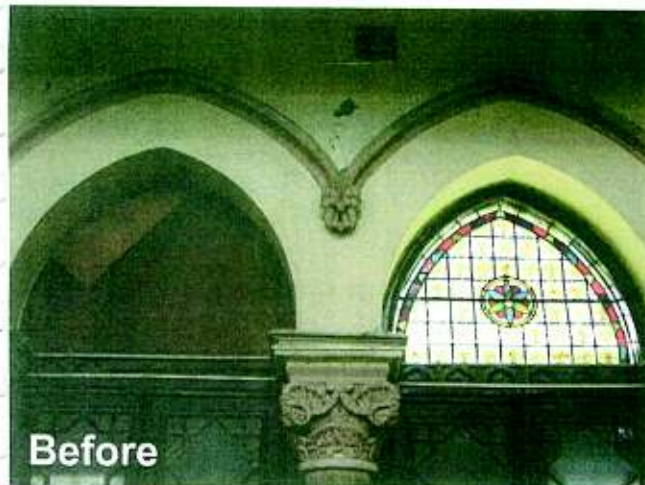
Below: The tympanums were badly damaged with some sections buckling and others completely missing

One missing tympanum (11A) was completely reconstructed. A new cartoon was made by Mr Arethna using the adjacent panel (11B) as reference and the same painting and staining style, and imagery was adopted. Attention was given to match the original glass, the lead profile and the leading technique. All departures from the basic principles of conservation were well argued by the conservators; and all interventions were made with the approval of the Architect and the stained glass Consultant, and were recorded.

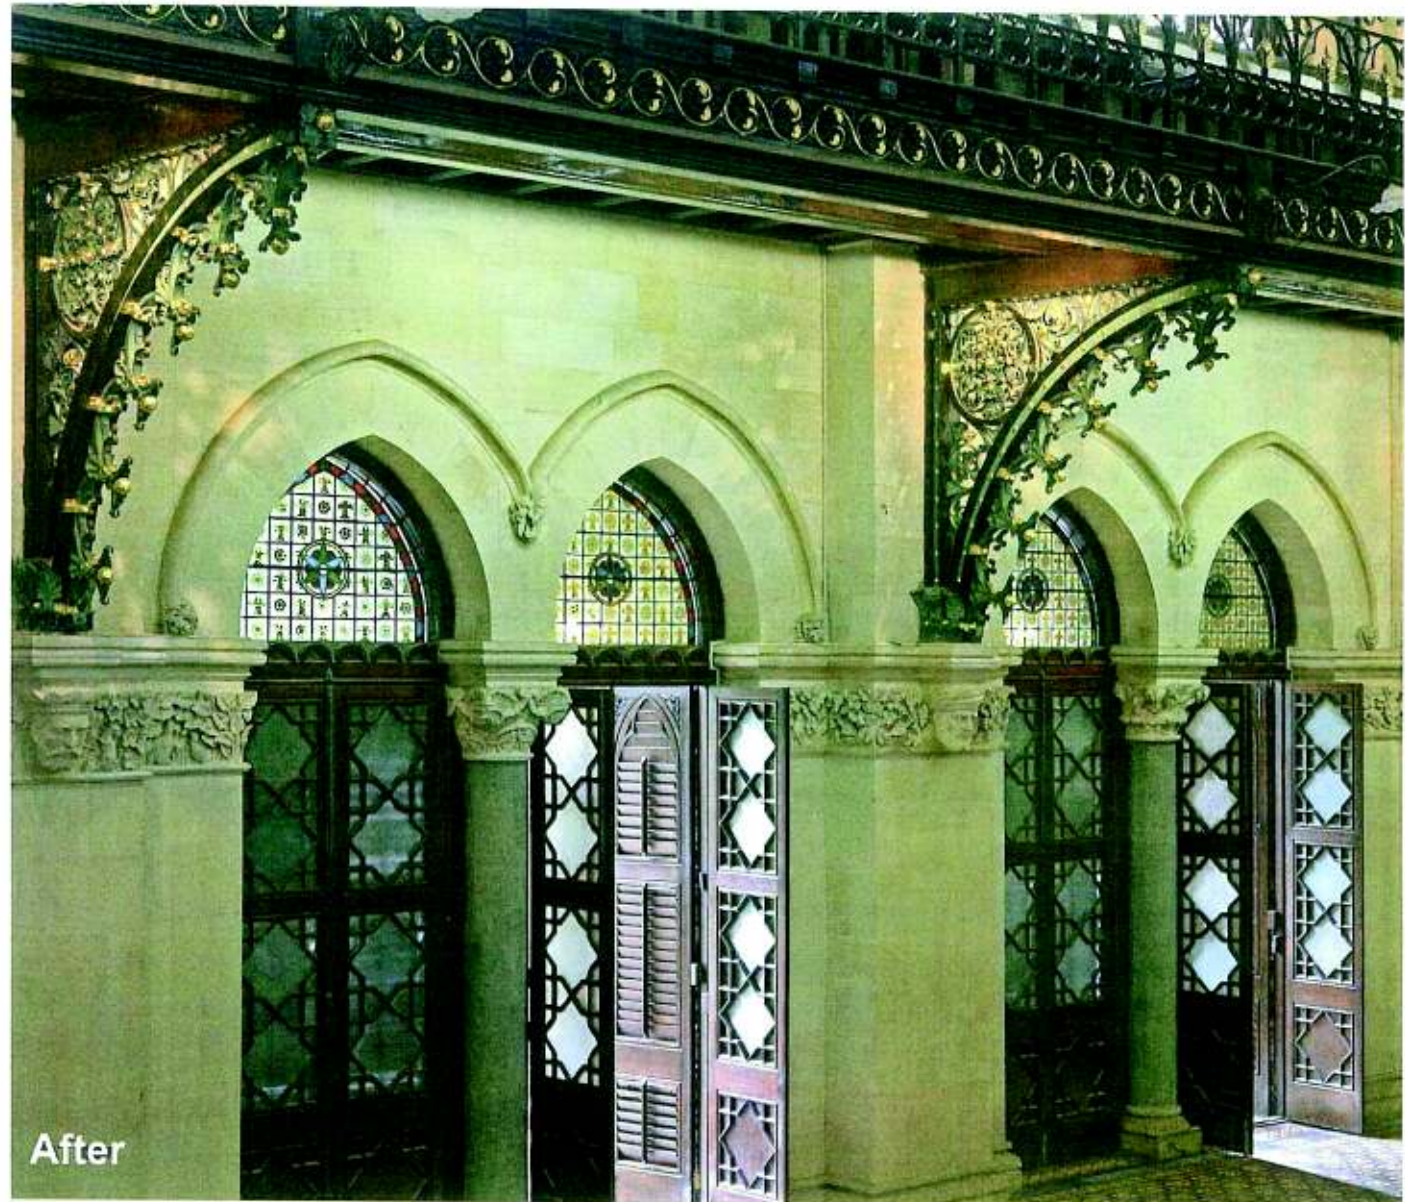
The entire stained glass restoration work which commenced on February 4, 2006 was completed in four months. Mr Rohinton Arethna completed his work on June 10, 2006, and Ms Parveen Mishra completed her work on June 25, 2006.
