LISTING & GRADING OF HERITAGE BUILDINGS & PRECINCTS IN MUMBAI
TASK II: Review of Sr. No. 317 to 632 of the Heritage Regulations

317 ZAOBA HOUSE		
 	Common Ref no:	2005/GII/317
	Card No.:	1
	Ward (Part):	C Ward
	CS No.	1963
	Plot Area:	318.63 sq m
	Date:	7 th February 05
	Record by:	Sheetal Gandhi
	Review by:	Aishwarya Tipnis
	Int: SG Ext: SG	
	Photo Ref:	317a

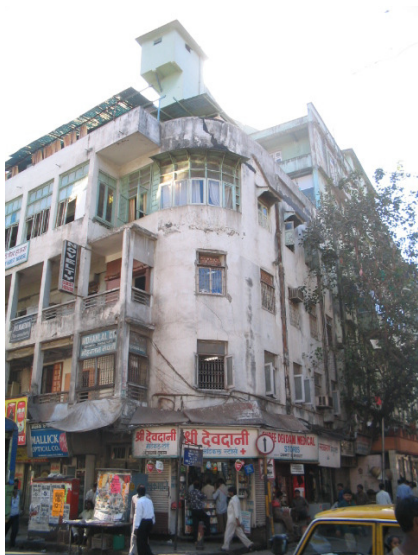
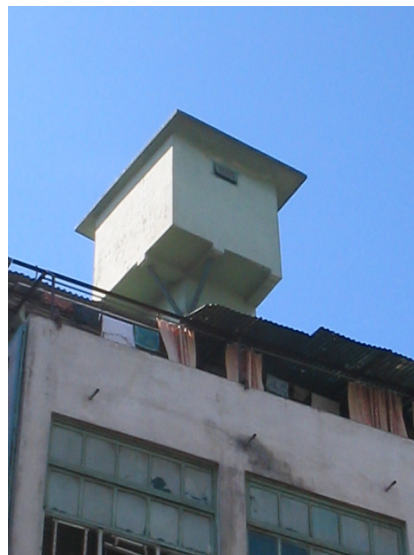
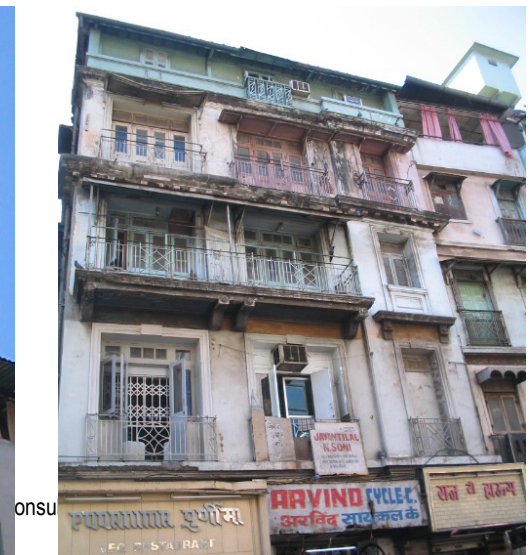
INSENSITIVE RECONSTRUCTION HAS LED TO LOSS OF DETAILS

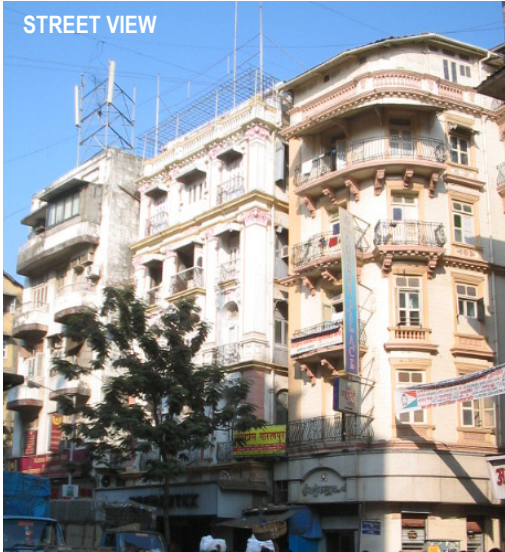
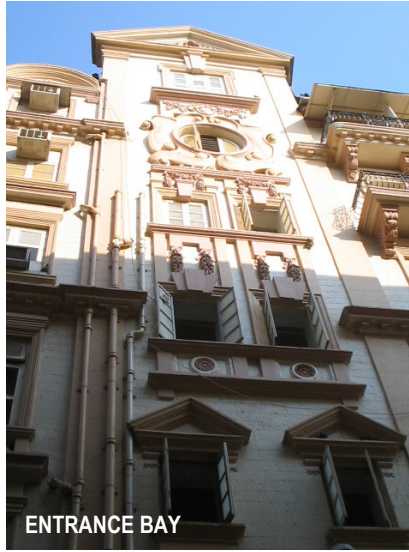
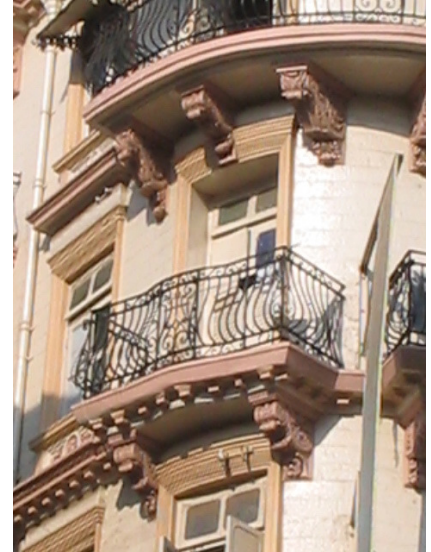
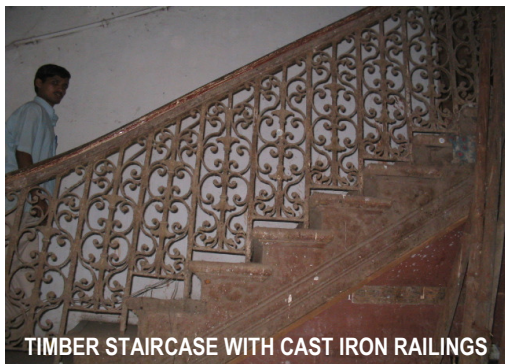
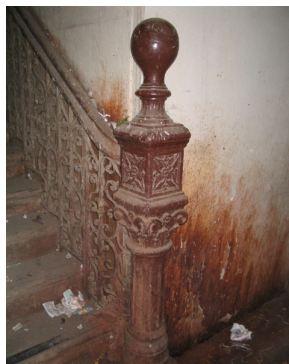
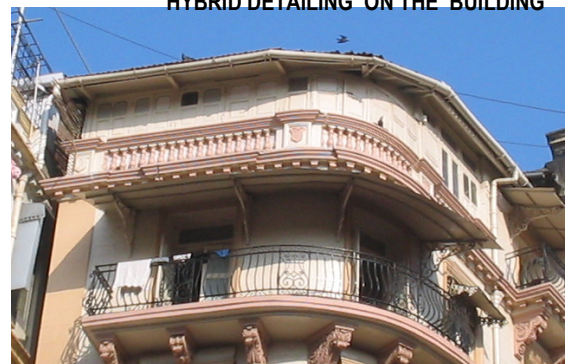
325 KEDAR BUILDING

9.0		CONDITION
9.1	Plinth	The plinth has large areas with paan stains along the plinth. The adjoining pavement is become higher due to repair work and changing the floor finish. This however, has not affected the plinth adversely.

9.2	Walls	The walls have no visible structural cracks or fissures. They do not exhibit any water seepage or dampness.
9.3	Floor	The jack arch system shows exposed reinforcement at all floor levels. There is also visible seepage from the floor, causing an increased amount of rusting in the jack arch system.

9.4	Stairs	The staircase structural members in timber show rotting of timber at various places. The main binder for the flight leading from the second to the third floor shows a large crack running through the length of the member.

11.0	DP REMARKS/PERCEIVED THREATS	
	None	
12.0	ADDITIONAL NOTES/REFERENCES/DOCUMENTS AVAILABLE/RECOMMENDATIONS & SUGGESTIONS FOR IMPLEMENTATION	
	The electrical , plumbing and air conditioning needs to be upgraded in keeping with the architectural integrity of the site.

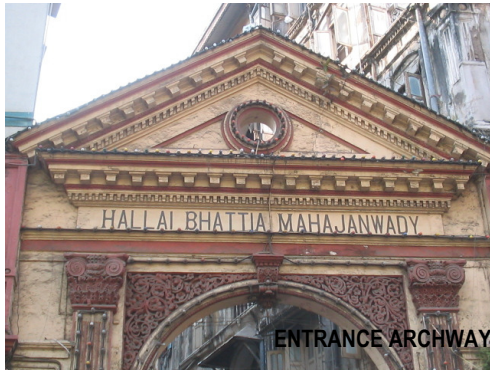
ENTRANCE ARCHWAY

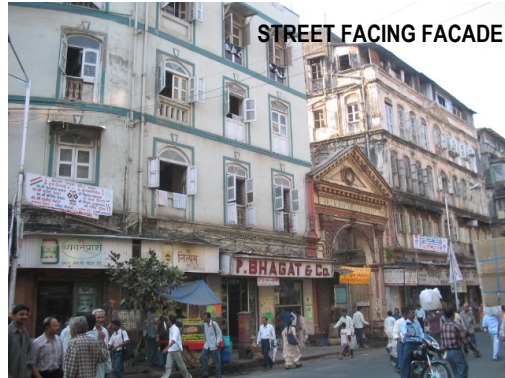
STREET FACING FACADE

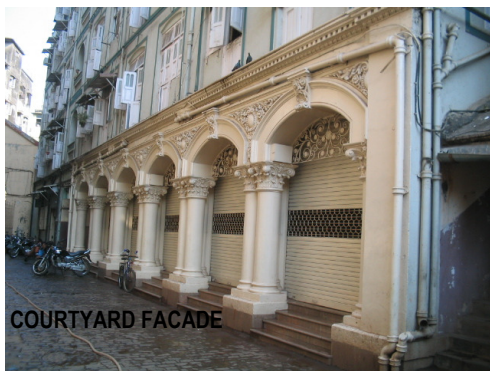
COURTYARD FACADE

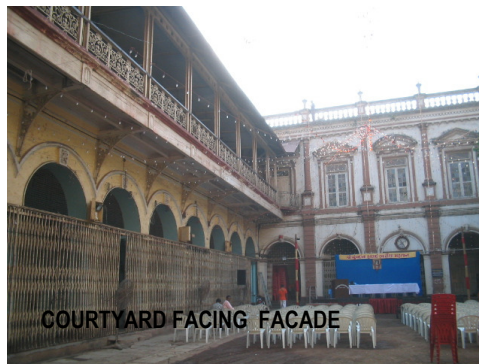
COURTYARD FACING FACADE

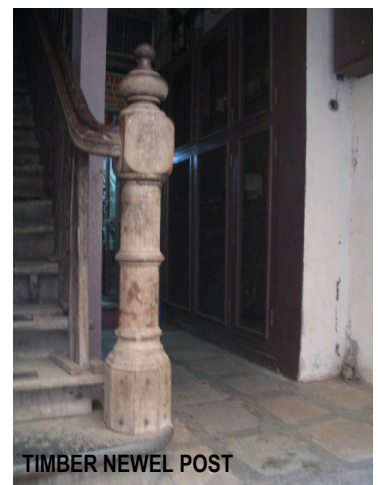
TIMBER NEWEL POST

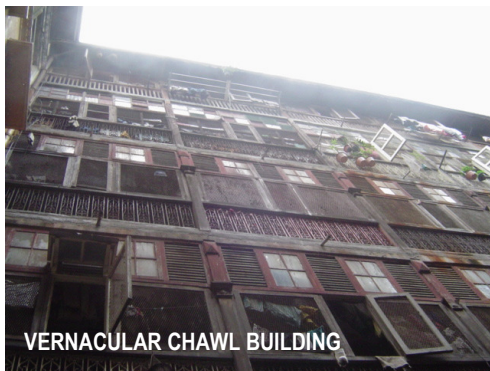
VERNACULAR CHAWL BUILDING

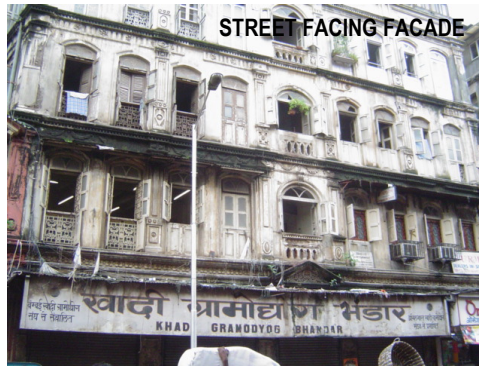
STREET FACING FACADE

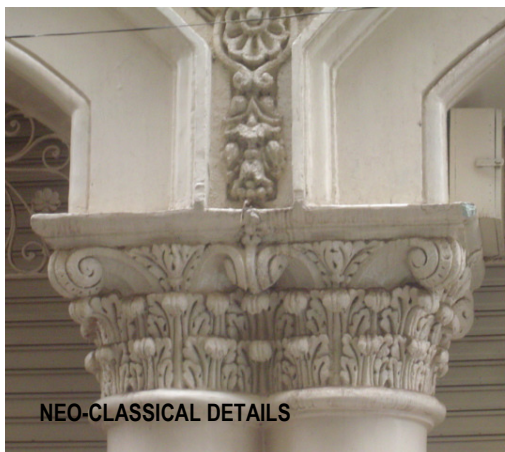
NEO-CLASSICAL DETAILS

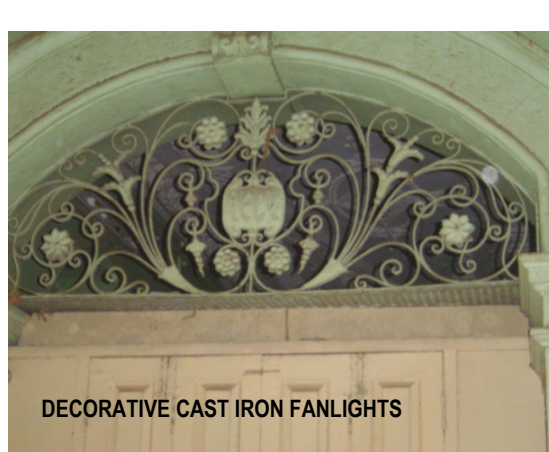
DECORATIVE CAST IRON FANLIGHTS

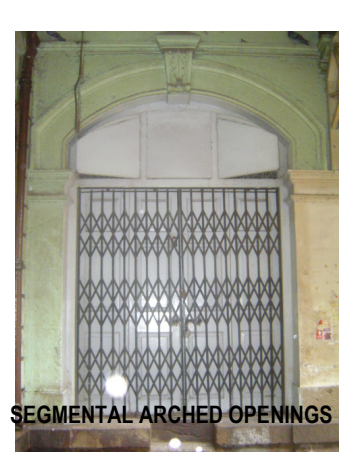
SEGMENTAL ARCHED OPENINGS

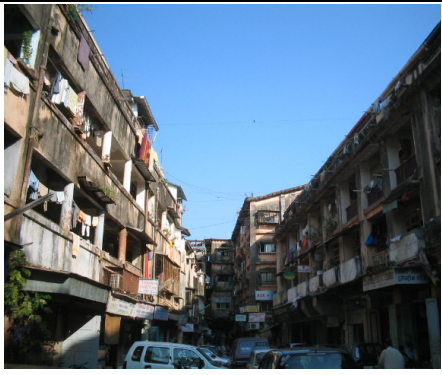
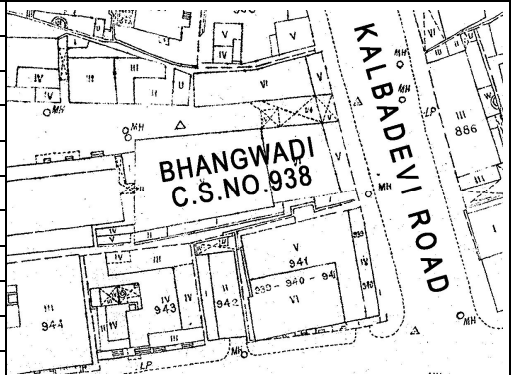
5.4	Value Classification	<p>Existing Grade: Grade III Recommended Grade: To be deleted</p> <p>The building is fully tenanted and excessive reconstruction and insensitive repairs have stripped the building of its architectural character and hence it is proposed to be deleted from the list.</p>

9.0		CONDITION
9.1	Plinth	Rising damp is observed on the front elevation of all the buildings. The main cause is the wrong site slopes and repeated tarring of the road. The tarring causes the road level to become higher and facilitates

329	BHANGWADI	
		dampness of the walls at ground level.
9.2	Walls	Seepage is common from roof on all gable walls and in verandahs on the upper floor. Water seepage on walls is also observed due to addition of AC units opening onto the verandahs.

9.3	Floor	Original flooring changed various materials within the complex. New RCC floors show structural issues like steel reinforcement being exposed and thus beginning to rust. Also dampness and cracks are observed at floor levels due to constant change of materials. Monitoring will help decide whether the cracks are structural or only on the surface.

9.4	Stairs	All staircases are in poor condition, oil painted in white colour. All timber staircases are replaced by RCC. The junction of the post and the first tread in RCC show cracks, thus leading to inward sagging of the balusters. The Shahbad tiles used as the finishes on the treads also show cracks. The walls abutting the staircases are in a state of neglect and have paan stains. Some abutting walls have ceramic tile dado up to 4 feet high.

9.6	Roofing	Where original timber roof exists, water seepage and warping of timber boarding is seen in the verandah, most ends of the timber rafters in the verandahs have rotted. Some of the Mangalore tiles at the junctions of the roof are broken and mostly all gutters are missing. In case where the timber roofs have given way to RCC flat slab, the reinforcement is exposed and the steel is rusting. The flat slabs also show signs of leakage and seepage from the roof. These defects could also be due to overloading from water storage tanks situated at the terrace level.

9.7	Articulation & Finishes	All detailing on the façade are in poor condition, balusters of the verandahs have been blocked with brick walls. Largely, detailing elements and finishes are not original and in a poor condition.

9.10	Overall Condition	Poor Maintenance level Regular with lack of conservation sensitivity.
10.0	TRANSFORMATION	
10.1	Form	The entire form of the building complex is transformed to a large extent. The structural members are replaced by RCC; the proportion of the structural members has altered the form. The ground floors have extended in front to house bigger offices with large box like signage fitted on them. Box grills have been introduced at few places on the verandahs, this

11.0		DP REMARKS/PERCEIVED THREATS
		None
12.0		ADDITIONAL NOTES/REFERENCES/DOCUMENTS AVAILABLE/RECOMMENDATIONS & SUGGESTIONS FOR IMPLEMENTATION
		<p>As the building has lost its urban group value and its architectural character has been diluted it is proposed to delete it from the list.</p>

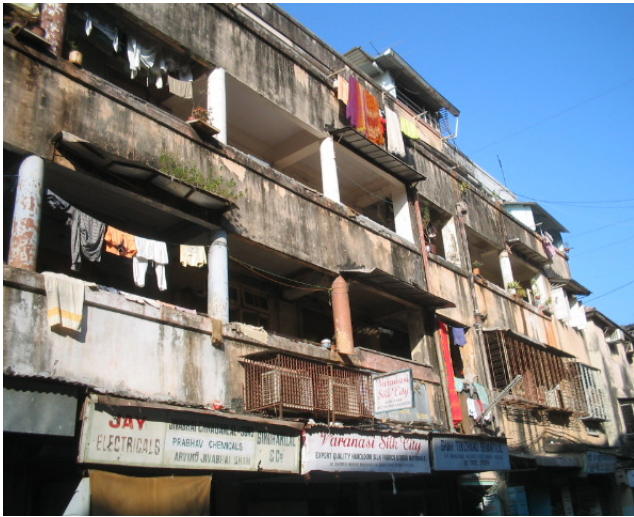
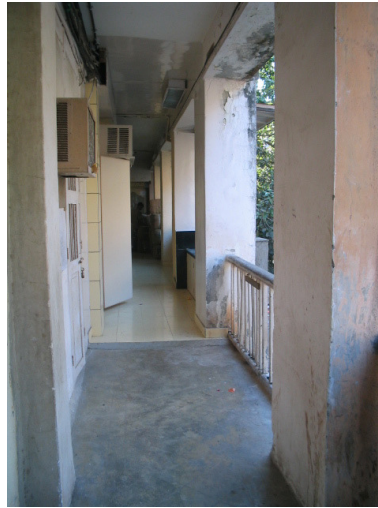
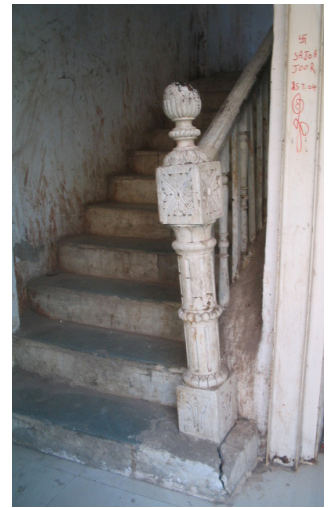
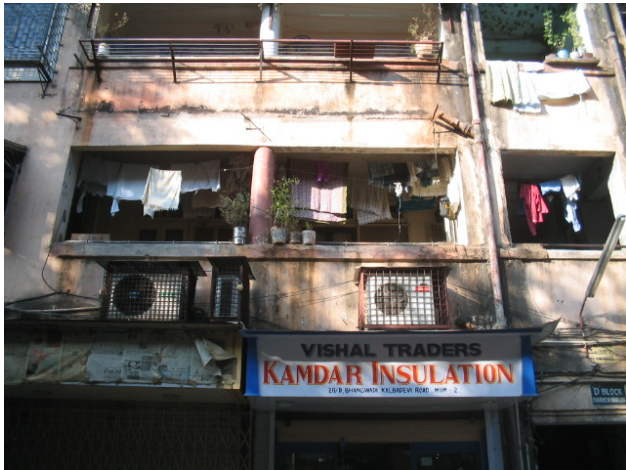
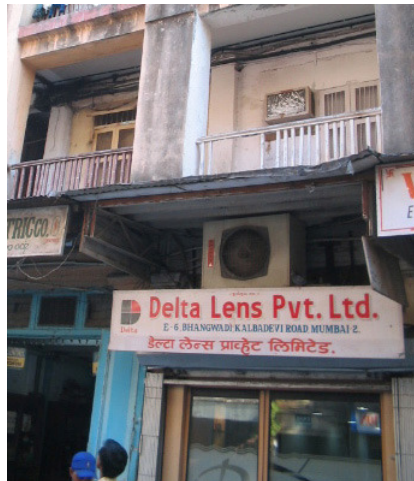
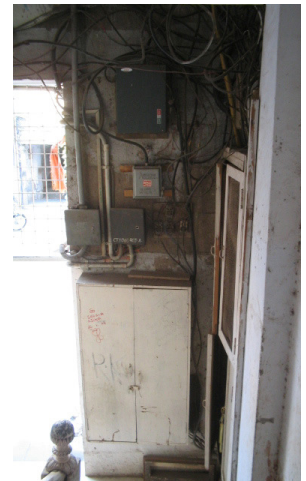
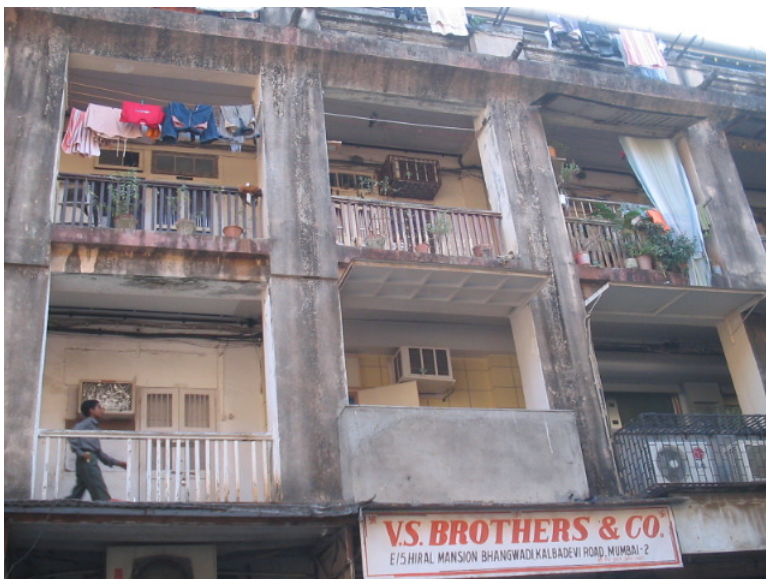
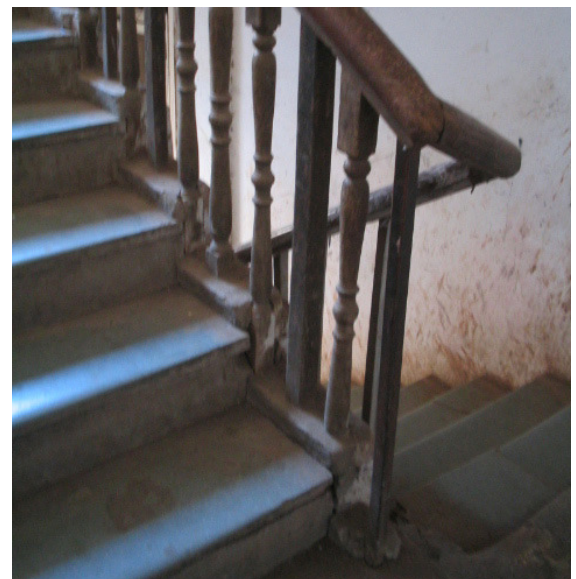
329	BHANGWADI	
		<p>extends outside the building line and alters its form. The verandah balusters are blocked either by brick walls or placing compressor units of split air conditioners in front of them. This reduces the transparency of the façade.</p> <p>Weather shades of tin sheets, acrylic sheets or asbestos corrugated sheets have been added above the open verandahs.</p>

10.2	Structure	<p>There have been major structural transformations to buildings within Bhangwadi. All structural members of the open verandahs are replaced by RCC columns (there is evidence of stone circular columns at few places). Also, timber roof structural members have been replaced by steel 'I' sections on the upper floors. The structures of the staircases in all buildings have been altered to RCC treads and risers and only timber balusters and railings remain.</p>

10.3	Articulation & Finishes	<p>Articulation like ornate timber balusters on the staircases have been replaced by timber pieces of square cross sections without any carving. The balusters of open verandahs on all floors have been blocked off by brick partition walls and also by compressor units of split air-conditioners. All ornate fascia boards and columns of the structure are now absent / missing. Floor finishes have changed from the original to Shahbad in most places and marble in some, ceramic tile dado up to 6' is introduced in many places.</p>

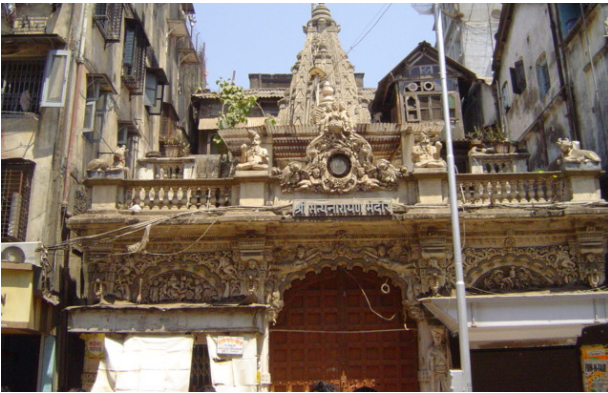
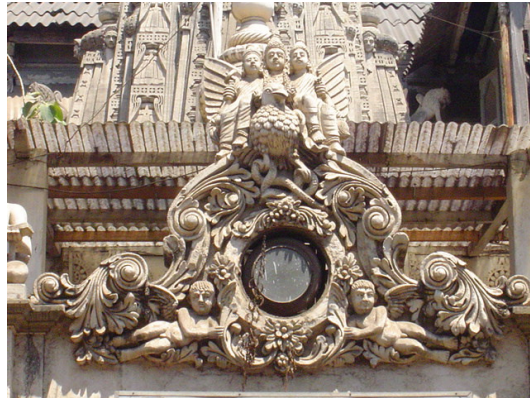
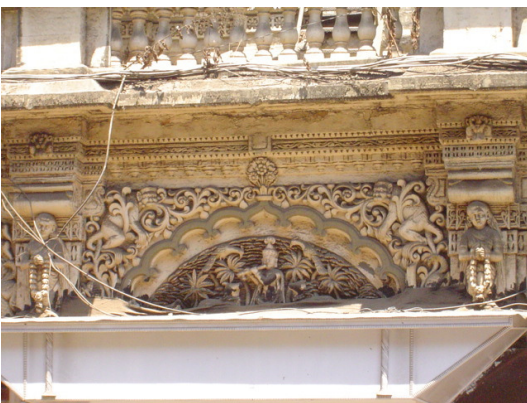
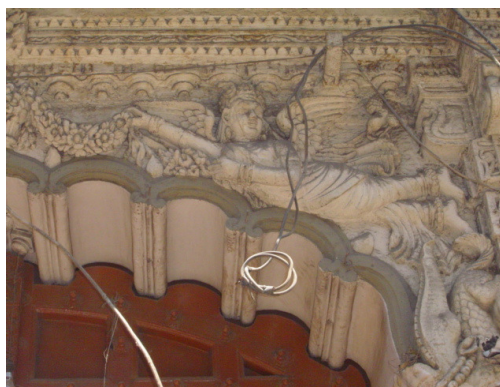
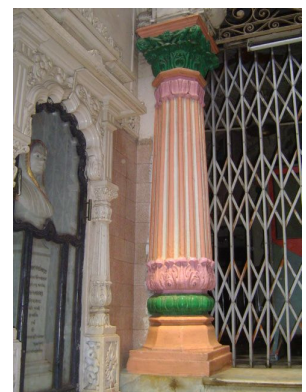
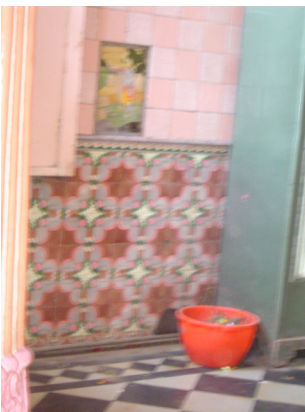
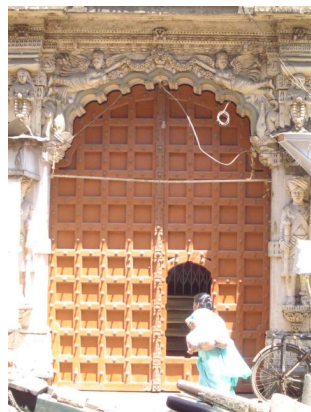
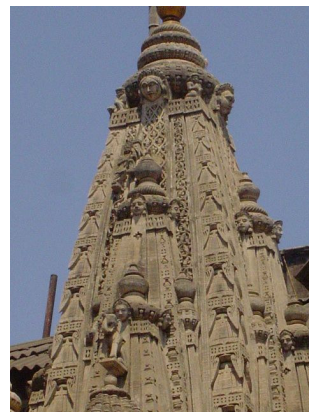
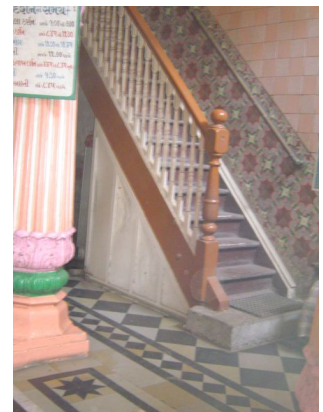
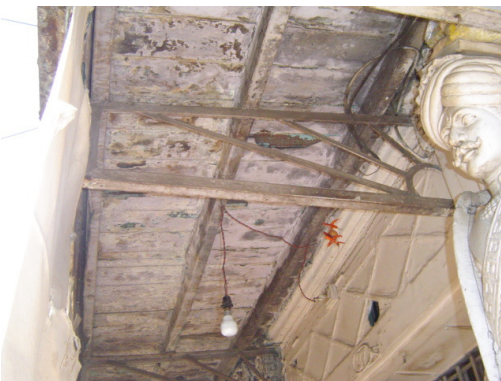
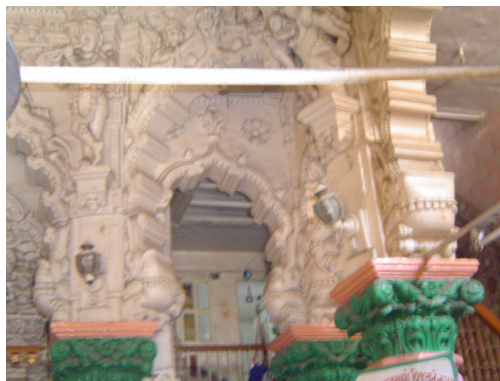
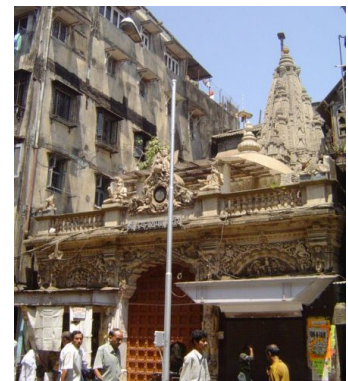
334

9.0		CONDITION
9.1	Plinth	Discoloration of plinth stones; dampness due to constant contact with water in the side yard
9.2	Walls	Discoloration due to pollution

9.3	Floor	No damage observed
9.4	Stairs	No damage observed
9.5	Openings	No damage observed
9.6	Roofing	No access to the roof
9.7	Articulation & Finishes	Discoloration due to pollution

9.8	Services	Breakage and leakage of pipes on the side facade
9.9	Outbuildings	None
9.10	Overall Condition	Good
10.0		TRANSFORMATION
10.1	Form	No transformation in form

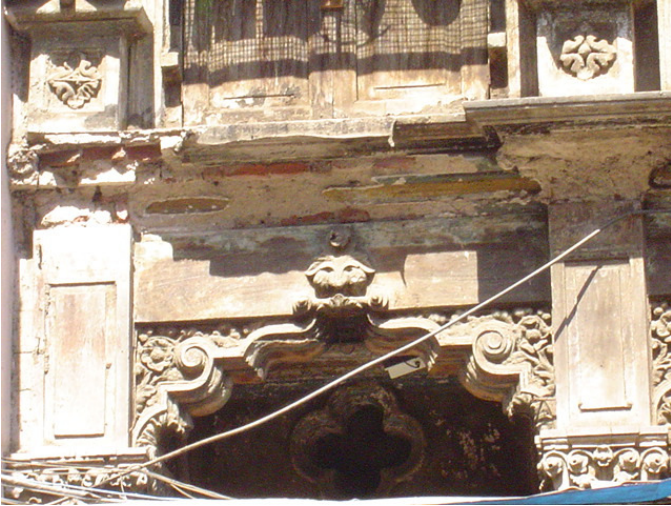
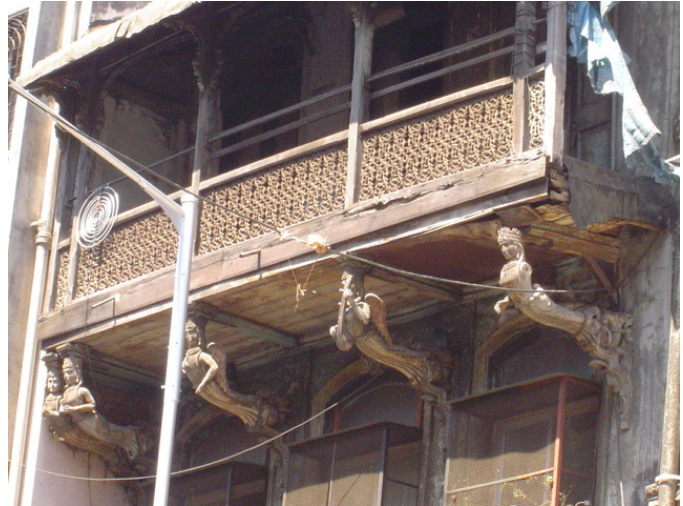
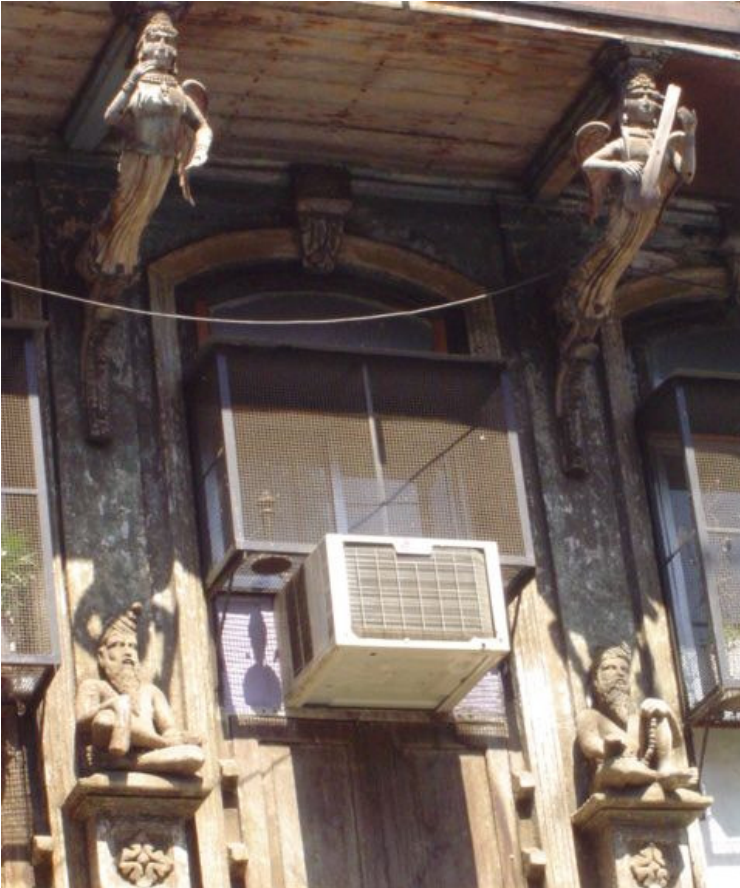
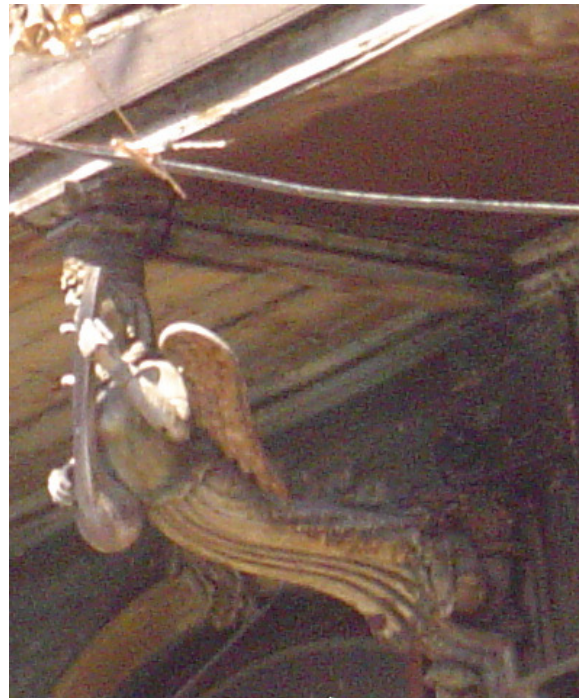
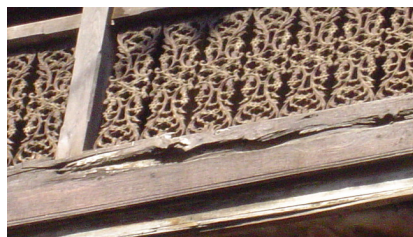
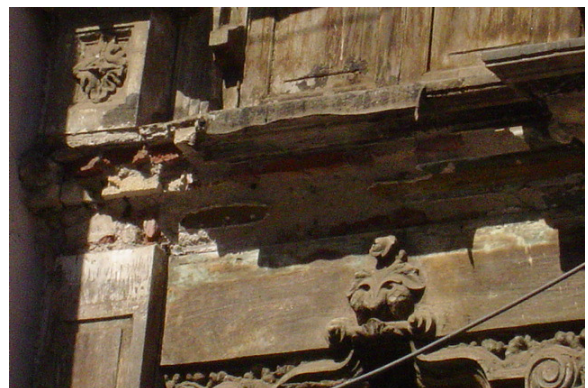
335 JAGDISH TEMPLE

8.7	Other (HVAC/BMC/Security Systems)	None
9.0		CONDITION
9.1	Plinth	Layers of stone coming off from the plinth; dry moss on plinth; breakage of stones at some parts

9.2	Walls	Dry moss on all facades; cracks at joints of column and wall; cracks in beams on the second floor; cracks on walls
9.3	Floor	No damage observed in the Cudappa and marble floor; floor of the second floor damaged due to wear and tear

9.4	Stairs	Stair moving away from the wall; breakage of treads and risers; treads and risers moving away; broken hand rails
9.5	Openings	Breakage of glass panels; damage of timber panels

9.6	Roofing	Wooden members have dry rot; rafters broken
9.7	Articulation & Finishes	Discoloration due to pollution; some portions are broken
9.8	Services	Water pipes going through the interior is broken; other service pipes are broken and there is leakage of pipes

9.9	Outbuildings	No outbuildings
9.10	Overall Condition	Poor
10.0		TRANSFORMATION
10.1	Form	The glass panels of windows replaced by new materials; entrance arches hidden by hoardings; windows covered by grills; air conditioners installed in windows

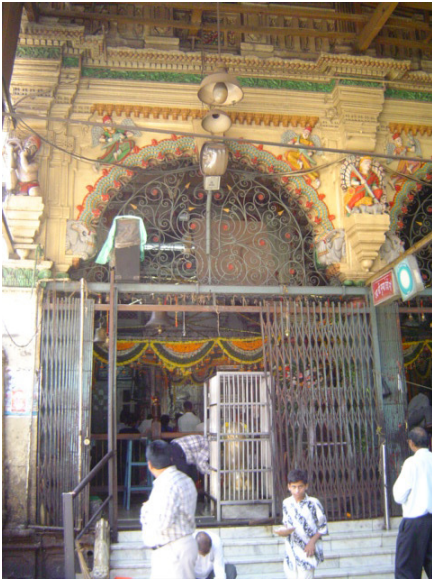
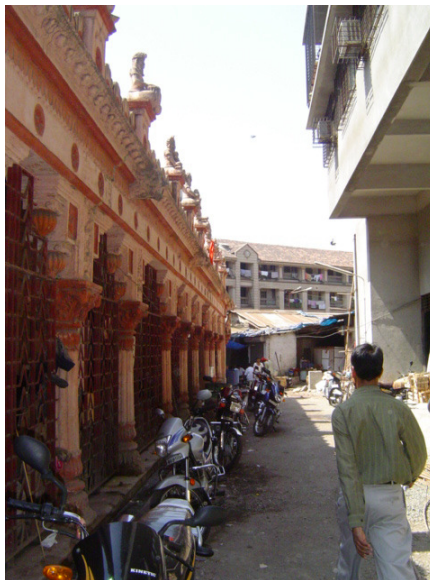
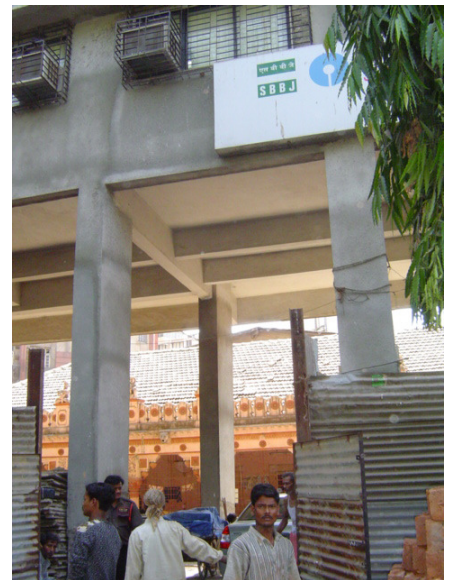
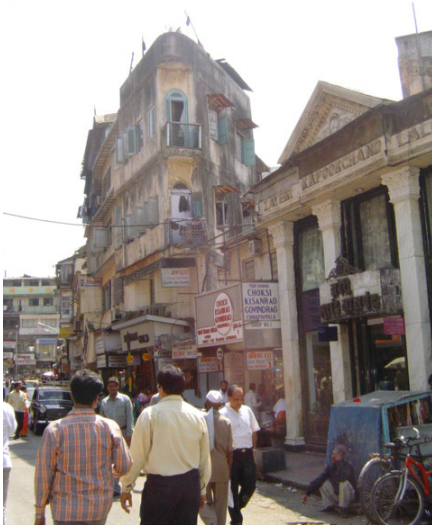
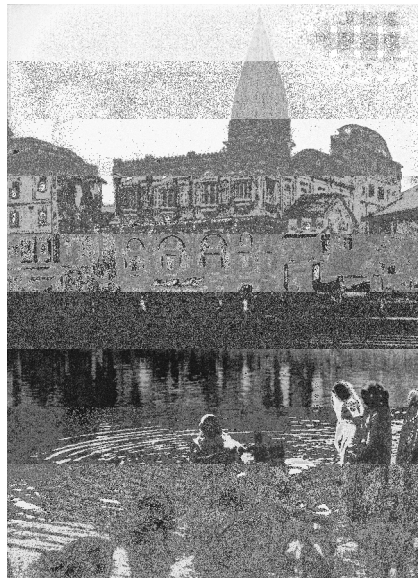
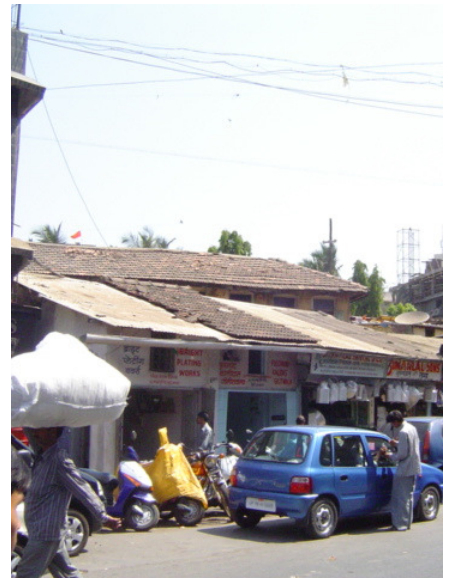
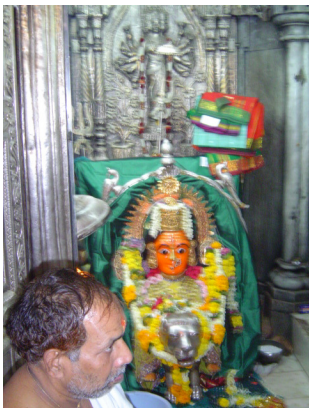
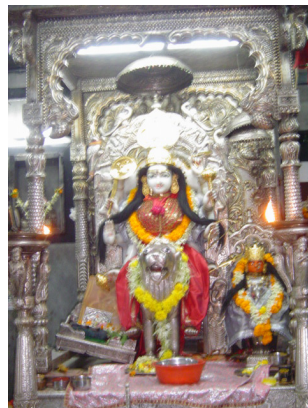
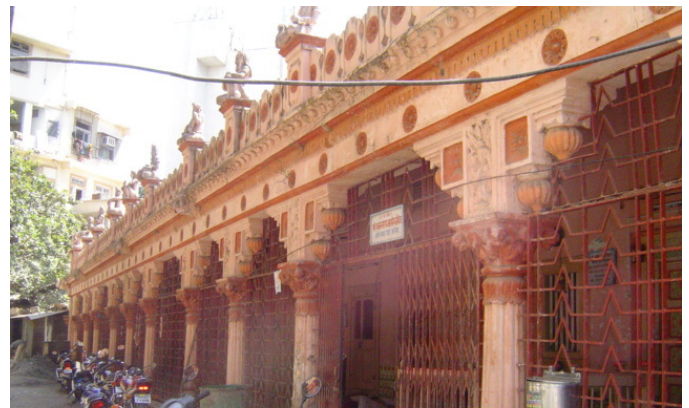
342	MUMBADEVI TEMPLE COMPLEX	
8.7	Other (HVAC/BMC/Security Systems)	Not applicable
9.0		CONDITION
9.1	Plinth	Not applicable
9.2	Walls	Evidence of rising damp and seepage

9.6	Roofing	Roof seepage due to lack of repair is a common problem compounded by redundant down take pipes and choked or non-existent gutters.
9.7	Articulation & Finishes	Not applicable

9.8	Services	Not applicable
9.9	Outbuildings	Not applicable
9.10	Overall Condition	Poor Maintenance level: Non-existent
10.0		TRANSFORMATION
10.1	Form	<p>Although the primary temple enclave of the two temples, the main Mumbadevi temple and the subsidiary Hanuman temple have been preserved in keeping with the religious sanctity of the site, the other Mahadev temple which is a short distance away from them has been affected due to the massive development around. The ground storey temple with a continuous verandah and religious bracket motifs initially consisted an open space in front.</p> <p>This temple falls on the secondary route to the main temple complex from Kalbadevi Road and the open space was situated between the Mahadev temple and the BMC garden. The new multi-storey construction within the open space has not only irrevocably disrupted the religiosity of the temple but has also completely altered the quality of the sacred site. This development is particularly serious considering the already eroding and lost fabric of the precinct.</p>

10.2	Structure	Timber frame structures have given way to steel stanchions.
10.3	Articulation & Finishes	Most of the original detailing has been replaced over time with modern incompatible materials.

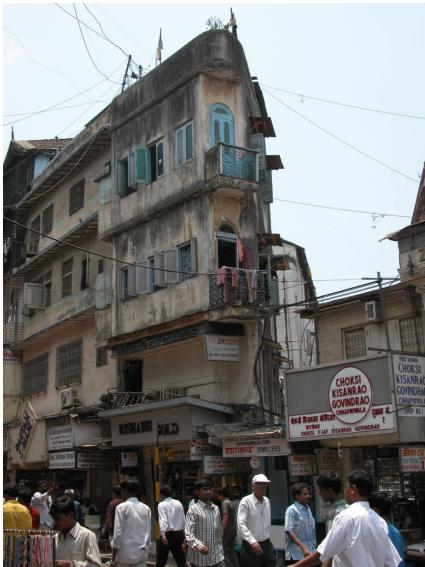
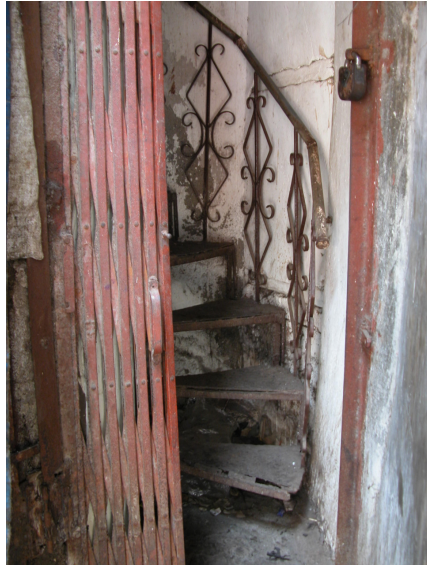
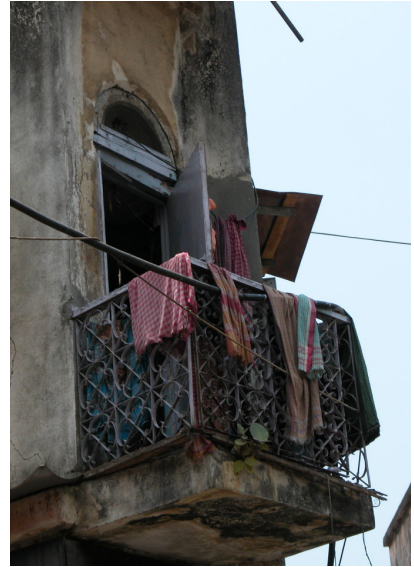
5.4	Value Classification	<p>Existing Grade: Deleted Recommended Grade: Deleted</p> <p>The building is fully tenanted and excessive reconstruction and insensitive repairs have stripped the building of its architectural character and hence it is proposed to be deleted from the list.</p>

7.6	Roofing	Flat RCC roof with terrace
7.7	Articulation	The building is devoid of any articulation and classical details and has undergone repairs in the past which is done badly.

343	BUILDING NO 136	
8.2	Ventilation	The building receives poor ventilation as most of the windows do not function while few windows are altered to acquire air conditioners

343	BUILDING NO 136	ADDITIONAL NOTES/REFERENCES/DOCUMENTS AVAILABLE/RECOMMENDATIONS & SUGGESTIONS FOR IMPLEMENTATION
12.0		The building has lost its value and hence there are no character defining elements attached to it and therefore should be deleted from the heritage list.

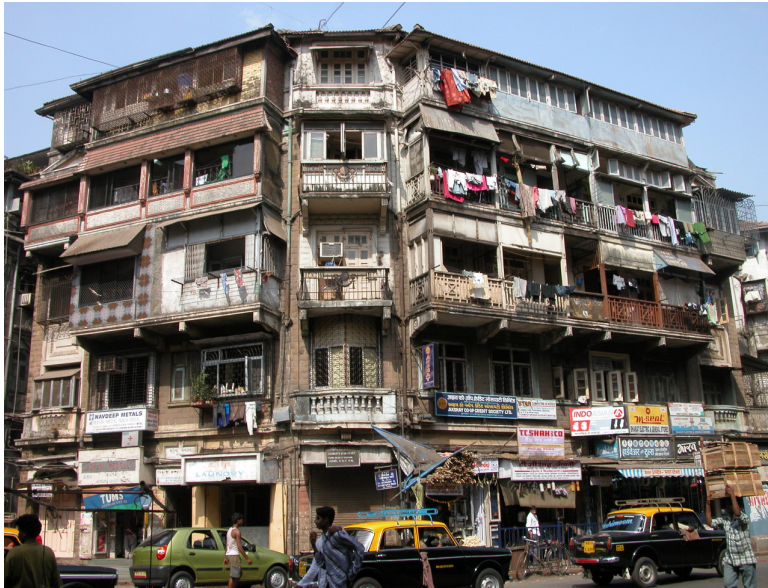
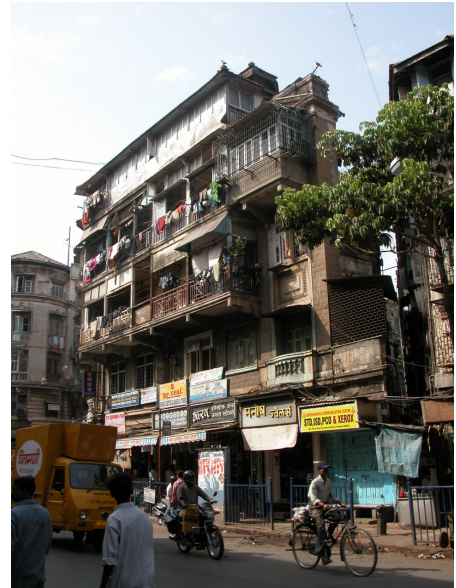
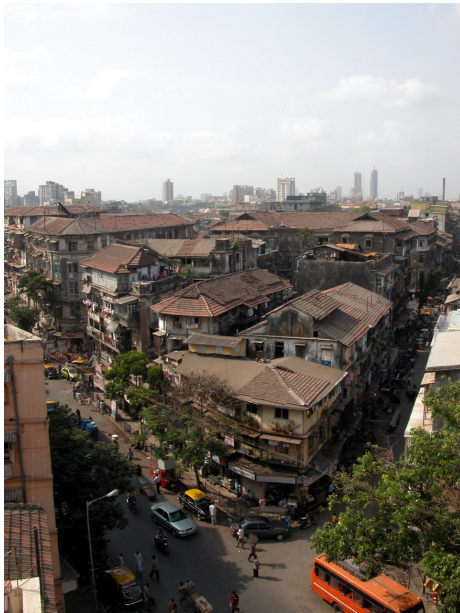
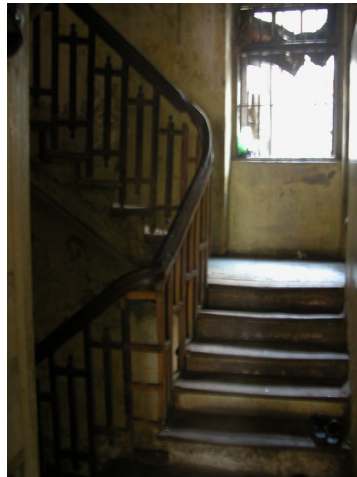
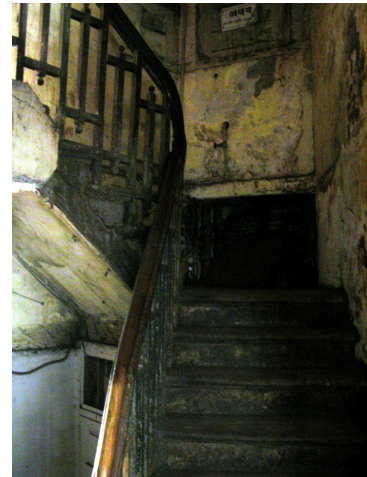
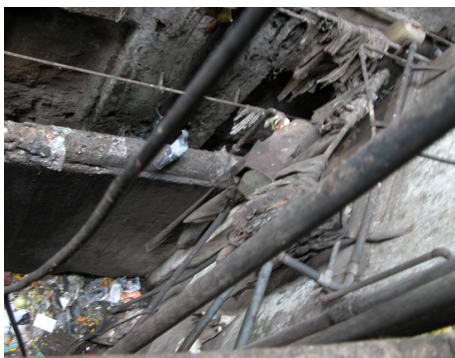
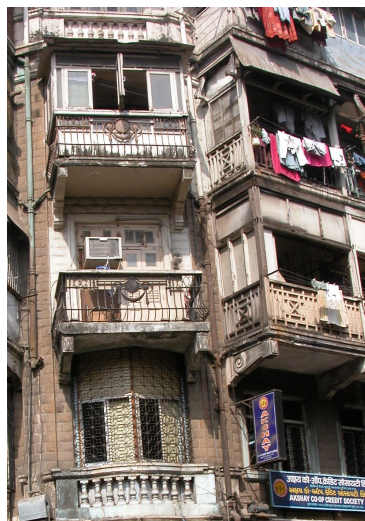
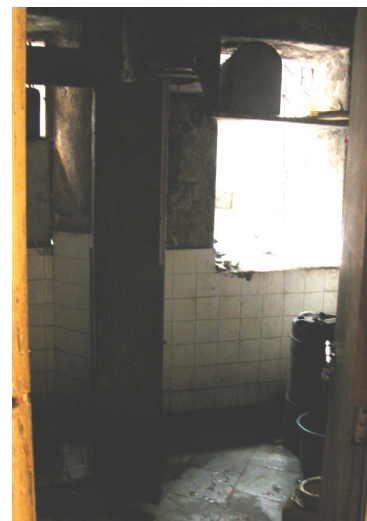
DINESH BHUVAN

9.0		CONDITION
9.1	Plinth	In some areas, the plinth has been covered with granite slabs and ceramic tiles.
9.2	Walls	Seepage and damp patches seen in the toilet block, peeling paint observed in the passage. Black muck all on the ceiling of the corridor and the entrance.

9.3	Floor	Rotten ends of timber beams of the balcony area.
9.4	Stairs	Treads and risers of the timber staircase are broken and loose at few places.
9.5	Openings	Some ventilators and windows have been blocked to accommodate AC units. Some balconies have been enclosed and sliding windows have been added.

9.6	Roofing	Main roof is in fair condition while the lean to roof over the balconies is changed to tin sheets at few places.
9.7	Articulation & Finishes	Poor condition of Shahbad floor passage. The Articulated railing and the gate not painted. The terrace balusters have been infilled.

9.8	Services	Leakages are seen in the pipes along the north east face of the building. Rear portion of the structure where all the drainage happens are in an extremely un maintained condition with garbage and food dumping in the courts. Toilets are very poorly maintained with leaking taps.

9.9	Outbuildings	None.
9.10	Overall Condition	Poor
10.0		TRANSFORMATION
10.1	Form	An entire floor has been added. All the projecting cantilevered balconies have been enclosed to create more room for the occupants.

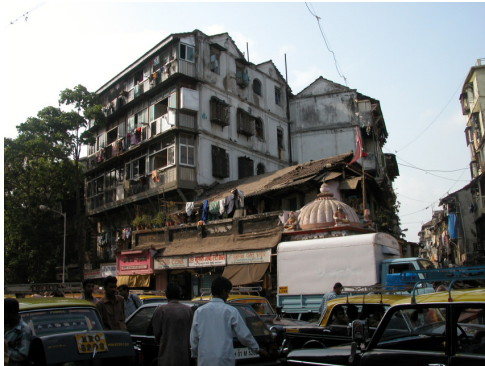
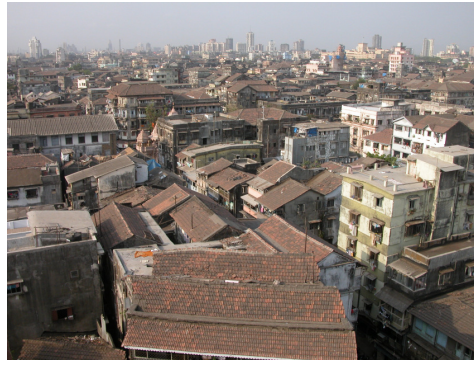
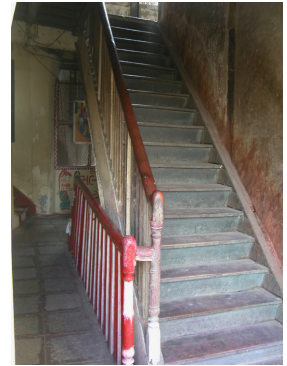
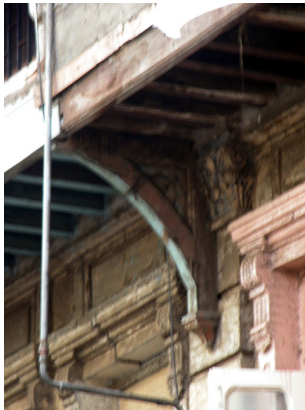
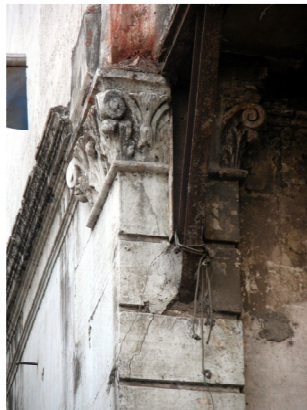
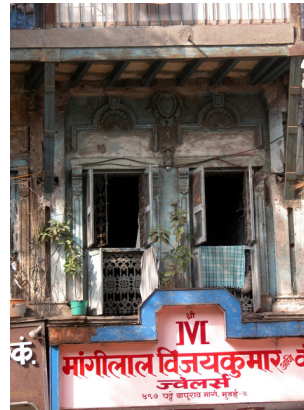
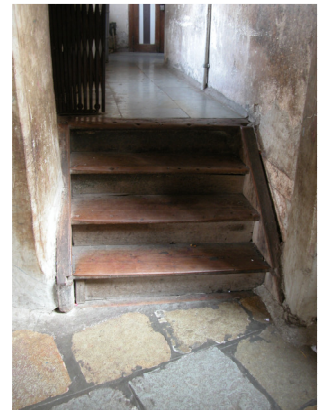
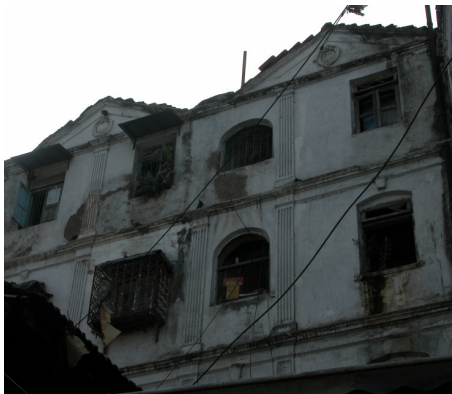
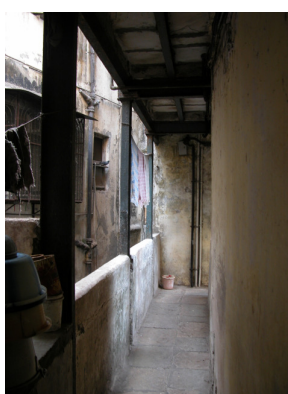
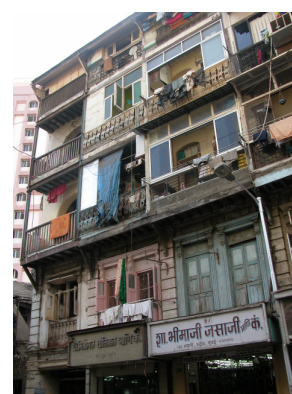
9.2	Walls	Rising damp and wet patches are observed in the inner chowk. Also fungus growth has been seen at few places. Plaster has fallen off in some portions. The exposed structural steel members have rusted. Cracks are seen in the stone lintels. The structural I Section members supporting the corridors have rusted.

9.3	Floor	Consolidated flooring in structural steel members. The Shahbad stone floor in passages is well maintained.
9.4	Stairs	Fair. The bottom part of the flight has been covered with tin sheets. The timber balusters are broken at some places. The treads are worn out at few places.

9.5	Openings	Some window shutters are broken and in poor condition. The openings on the internal side are poorly maintained and few are covered with MS box grills.

347	LOKHANDWALA BUILDING	
9.6	Roofing	Some portions of the Mangalore tiled roof have been tarred.
9.7	Articulation & Finishes	The structure is losing its articulation. The Corinthian capitals have been broken at many places to accommodate the steel brackets. The stucco work on the external façade has started falling off. The articulated wooden brackets have been replaced with I-sections.

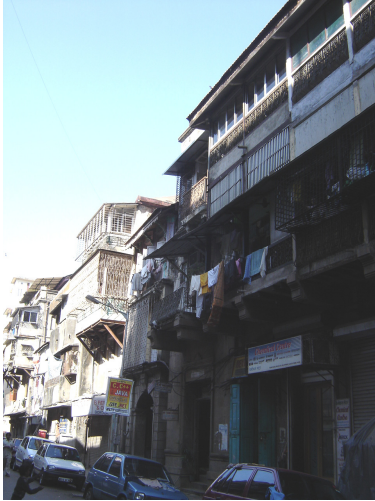
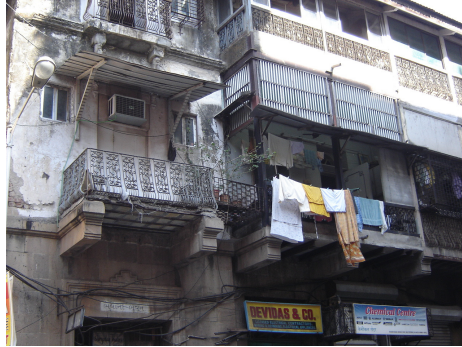
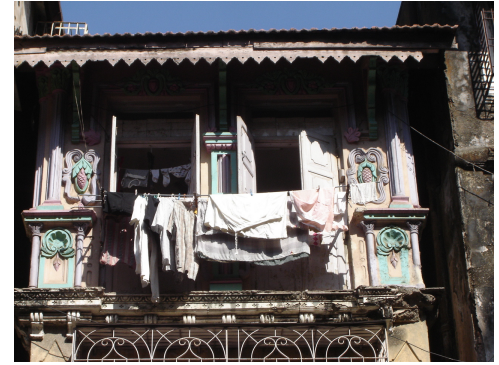
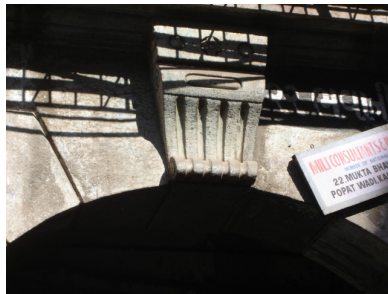
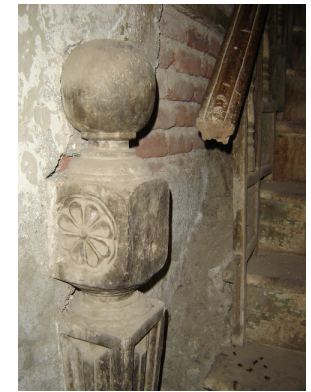
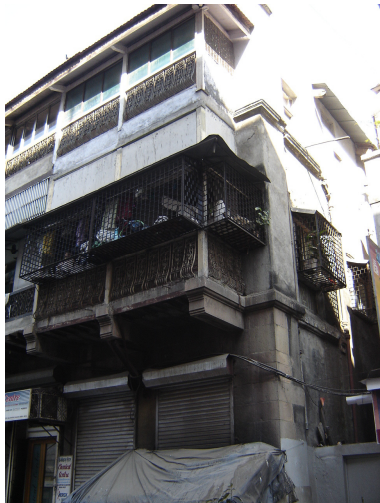
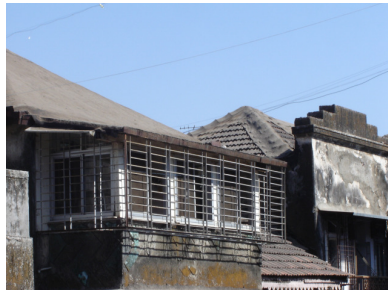
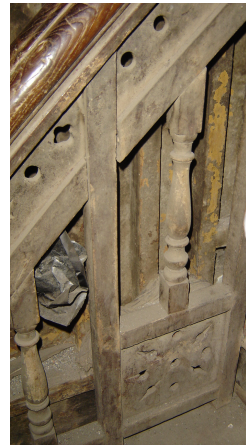
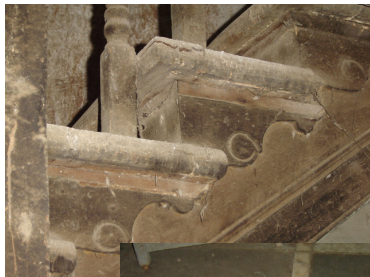
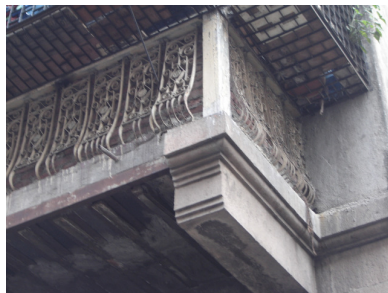
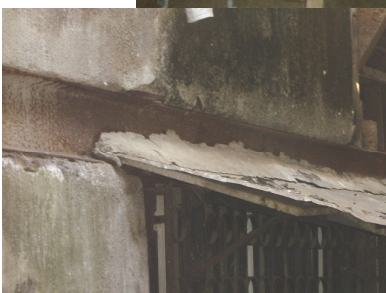
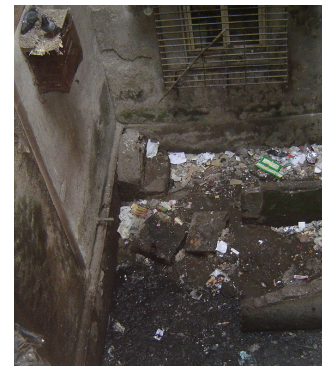
349	BHAVANI BHUVAN	
11.0		DP REMARKS/PERCEIVED THREATS
		NA
12.0		ADDITIONAL NOTES/REFERENCES/DOCUMENTS AVAILABLE/RECOMMENDATIONS & SUGGESTIONS FOR IMPLEMENTATION
		The structure has undergone many internal changes and is in a very poor and bad condition internally, externally and maintenance wise. Hence should be deleted.
