LISTING & GRADING OF HERITAGE BUILDINGS & PRECINCTS IN MUMBAI
TASK II: Review of Sr. No. 317 to 632 of the Heritage Regulations

317 ZAOBA HOUSE		
 	Common Ref no:	2005/GII/317
	Card No.:	1
	Ward (Part):	C Ward
	CS No.	1963
	Plot Area:	318.63 sq m
	Date:	7 th February 05
	Record by:	Sheetal Gandhi
	Review by:	Aishwarya Tipnis
	Int: SG Ext: SG	
	Photo Ref:	317a

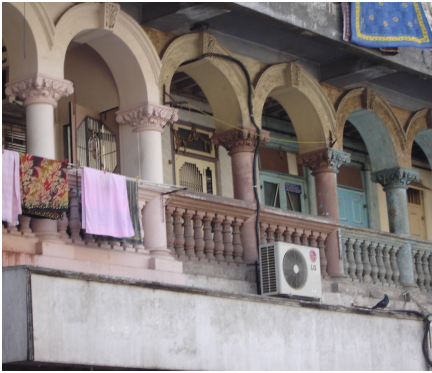
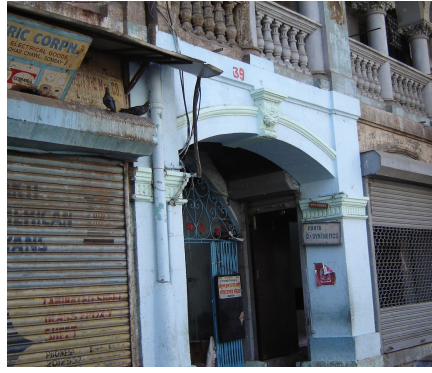
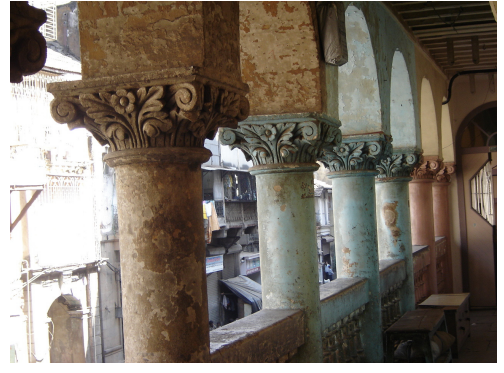
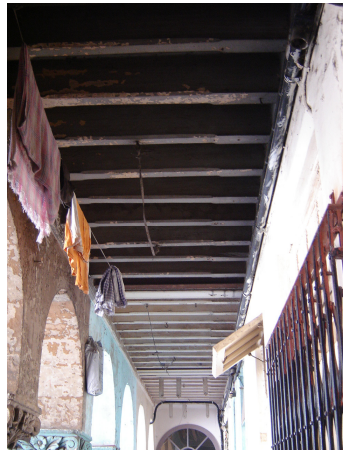
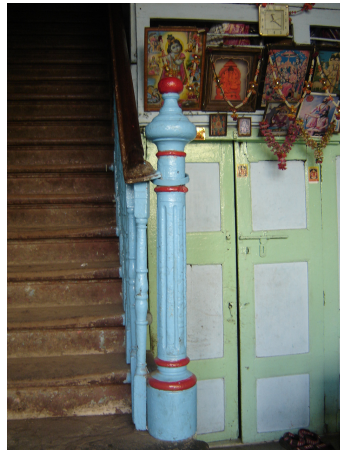
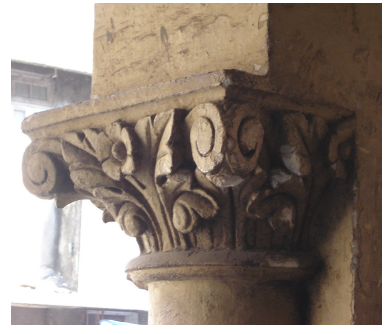
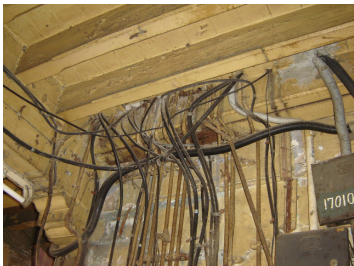
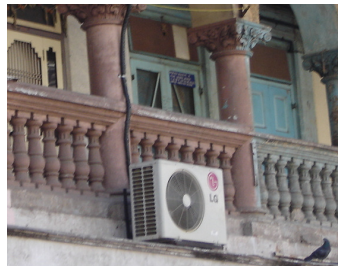
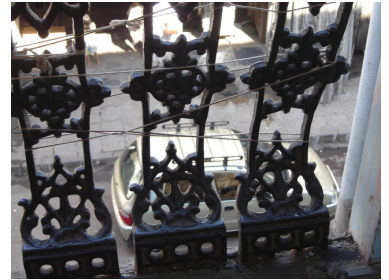
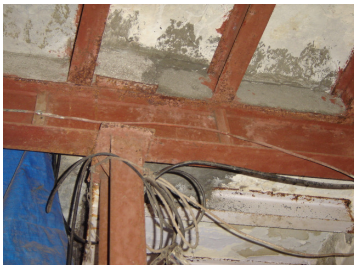
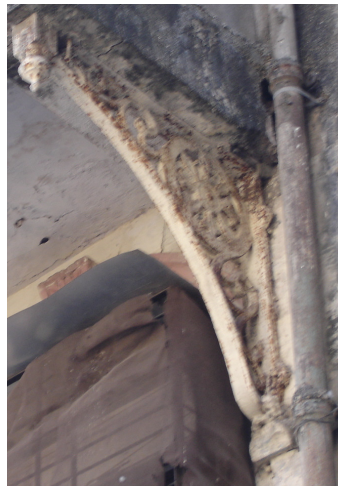
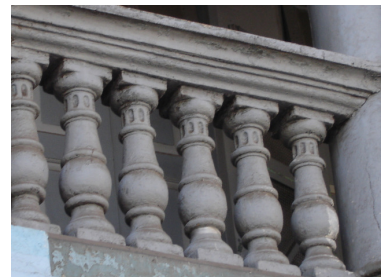
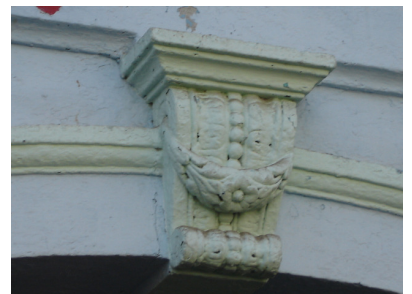
9.0		CONDITION
9.1	Plinth	Rising damp and discolouration is visible in some places
9.2	Walls	Paint flaking and plaster chipping off can be seen at many places. At few places the walls are covered completely from ceiling till floor level with ceramic tiles. Other stains are also visible.

9.3	Floor	I-sections have replaced the original timber joists at some places. Rusting of I-sections is clearly visible. The colour of the mosaic tiles have faded away. Internally each house has maintained their own property.

9.8	Services	The services are in a poor condition and need to be upgraded immediately
9.9	Outbuildings	No outbuildings found.
9.10	Overall Condition	Fair Maintenance level: Occasionally

10.0		TRANSFORMATION
10.1	Form	A floor has been added on the terrace, setback from the main façade.
10.2	Structure	The main building structurally is sound. The original timber joists have been replaced with I sections, on the rear façade (the toilet block area) freshly cemented areas are visible with exposed I-sections painted in red. Plastic sheets are used as covering area where there is no proper roofing.

11.0		DP REMARKS/PERCEIVED THREATS
		NA
12.0		ADDITIONAL NOTES/REFERENCES/DOCUMENTS AVAILABLE/RECOMMENDATIONS & SUGGESTIONS FOR IMPLEMENTATION
		The structural has lost its architectural value and is not maintained on regular bases.

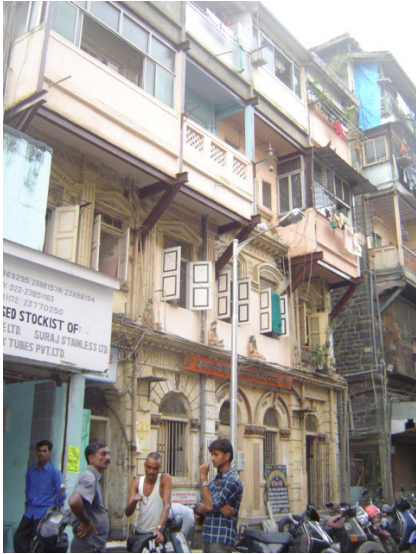
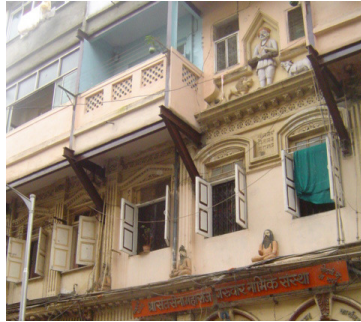
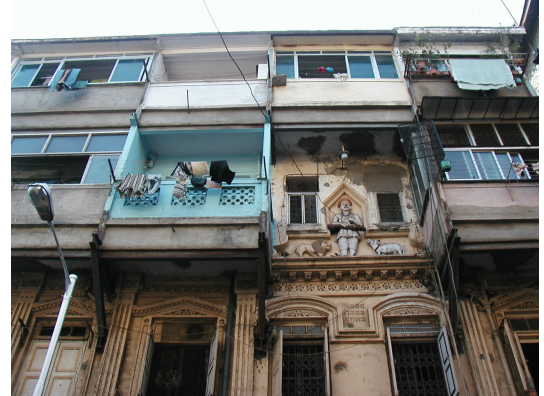
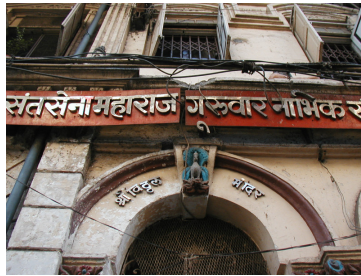
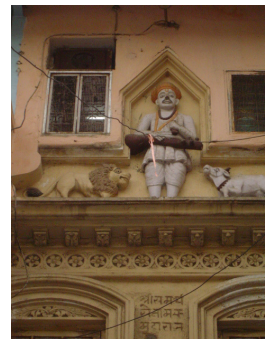
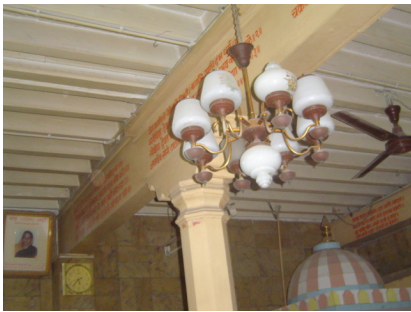
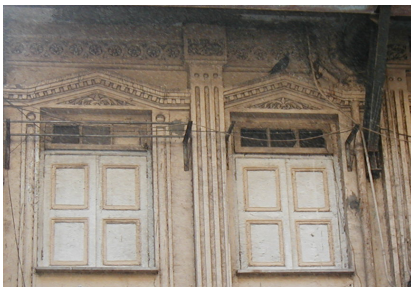
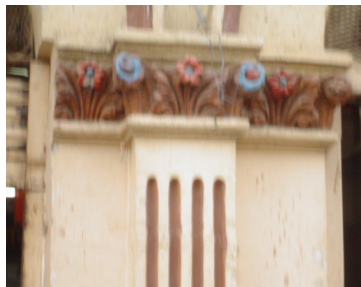
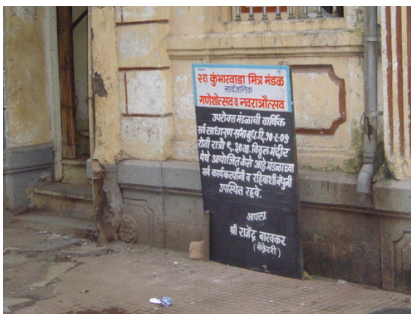
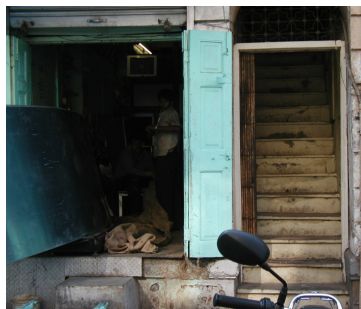
351 VITHAL MANDIR

9.0		CONDITION
9.1	Plinth	The stone plinth is in sound condition structurally with no major defects seen except for dampness due to the down take pipes. The plinth is covered by 2 to 3 inches from ground level due to the paver's block being added on the pavement which is incongruous.

9.2	Walls	The walls are structurally in fair condition with a few pilaster cracks at certain areas except for the extended floors, the external walls have been punctured in many places by the M.S. I-sections used as brackets to support the balcony slabs of the upper floors which is done insensitively and has completely defaced the structure badly.

9.3	Floor	The floor retains its structural integrity and is free from all defects. Internally the tenants have altered the flooring extensively.
9.4	Stairs	Cracks are observed in the stone risers. Also joints between the risers and Shahbad slabs on the treads have widened and weakened leading to uneven treads.

9.5	Openings	Most of the original arched openings are structurally in sound condition, but some of the original glass panes need to be repaired. One of the arches at the ground level has been completely dismantled and a completely incongruous larger opening with rolling shutters has been created by the commercial shop occupying the area inside. The modern continuous balconies on the upper two storeys with blank unpainted parapet walls are in complete contrast with the detailed fenestrations below.

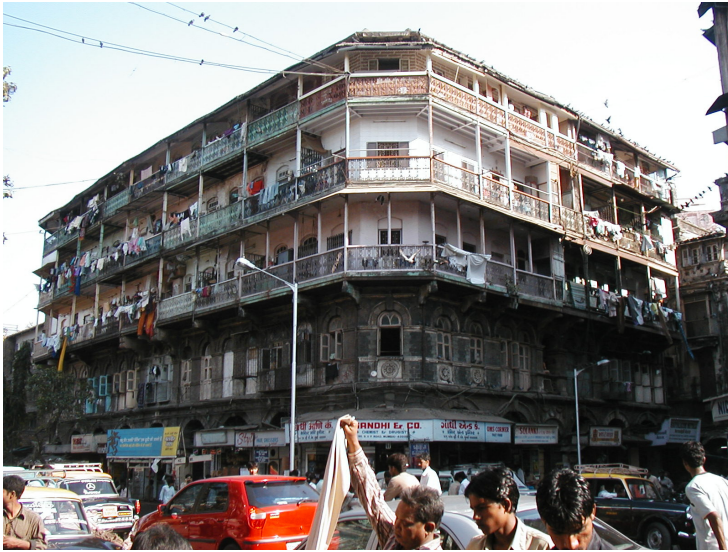
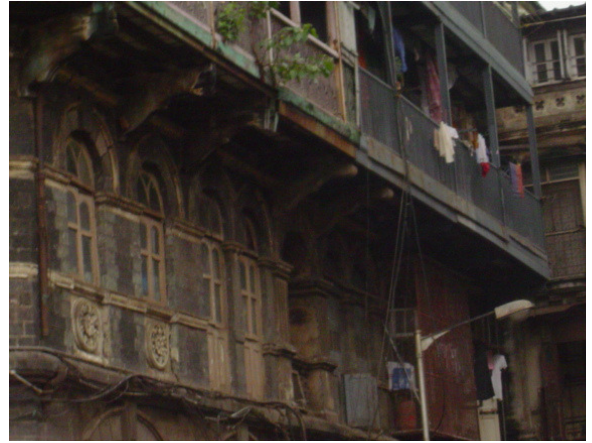
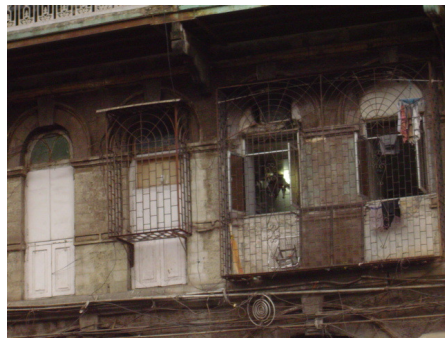
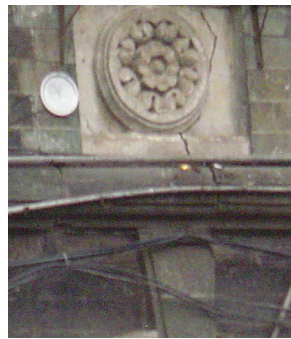
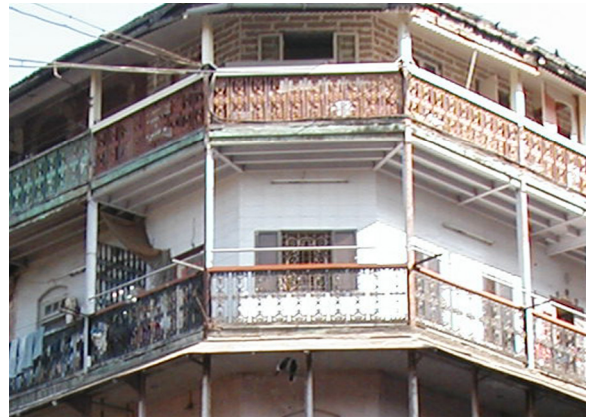
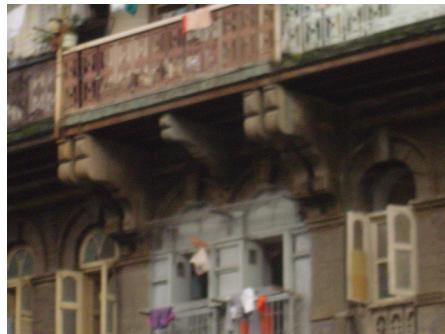
8.6	Fire Precaution	None
8.7	Other (HVAC/BMC/Security Systems)	None
9.0		CONDITION
9.1	Plinth	The stone plinth is mostly in sound structural condition.
9.2	Walls	Discoloration and damage due to the water seepage from the roof, and ficus growth is also seen. Widening of masonry joints is also seen.

9.5	Openings	Most of the arches at the ground level have been obliterated by signage and rolling shutters. The timber balconies are mainly in sound structural condition but sagging in a few places has been arrested using MS sections. At few places openings have been altered to accommodate air conditioners and metal box grills.

353	BLACKSTONE BUILDING	
10.3	Articulation & Finishes	The ground floor of the building is completely altered due to the presence of retail shops and commercial establishments. Incongruous additions like shop tin chajjas; signboards, shutters, counters, shelving etc. hide the details and mar the building façade.
11.0		DP REMARKS/PERCEIVED THREATS
		None
12.0		ADDITIONAL NOTES/REFERENCES/DOCUMENTS AVAILABLE/RECOMMENDATIONS & SUGGESTIONS FOR IMPLEMENTATION

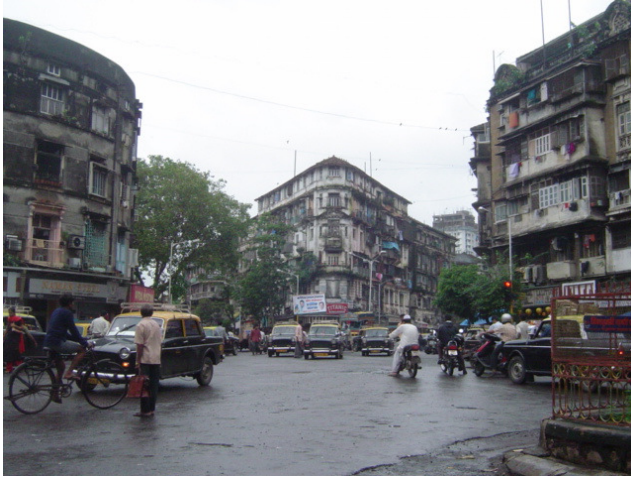
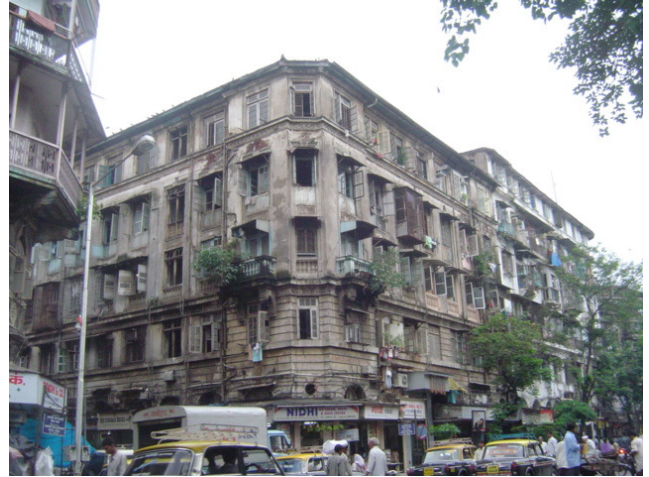
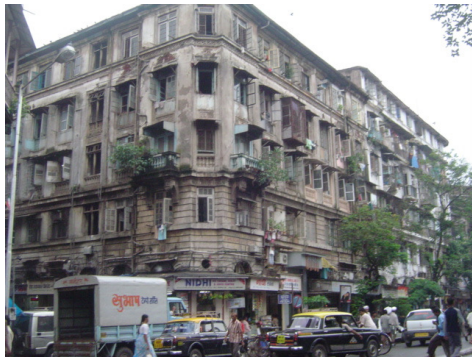
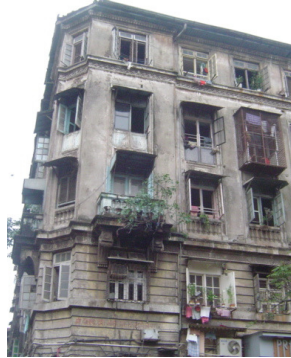
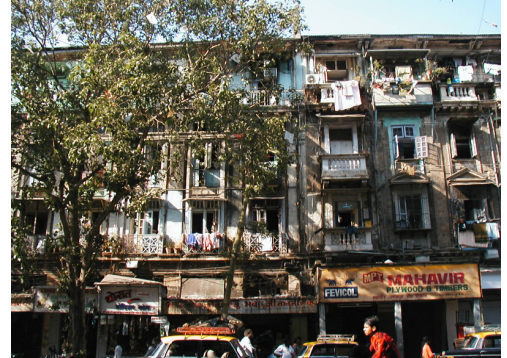
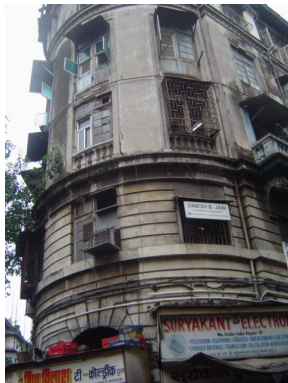
9.0		CONDITION
9.1	Plinth	The stone plinth is structurally in a sound condition but most of the plinth has been altered to make way to steps to enter the shops and are clad by new stone finishes like marble, granite etc.

9.2	Walls	Discoloration and damage to the water seepage from the roof, and ficus growth is also seen. Widening of masonry joints is also seen.
9.3	Floor	All floors are in sound structural condition or have been structurally consolidated using MS sections.

9.4	Stairs	Staircases have worn out timber treads.
9.5	Openings	Most of the arches at the ground level have been obliterated by signage's and rolling shutters. The timber balconies are mainly in sound structural condition but sagging in a few places has been arrested using MS sections. Few openings are altered to accommodate air conditioners and metal box grills.

9.6	Roofing	M.S. girders and I-sections have been used in few places to prop up the originally timber-framed roof.
9.7	Articulation & Finishes	Requires cleaning and repair work. In many cases, balconies been enclosed with the addition of modern Aluminium sliding windows. Sagging balconies in one building are provided extra support by means of MS sections. The ground floor of the building is completely altered due to the presence of retail shops and commercial establishments. Incongruous additions like shop tin chajjas; signboards, shutters, counters, shelving etc. hide the details and mar the building façade. Arches and other openings have been enclosed, metal jalis rolling shutters added. Other modern accretions on the facades include clothes lines and window A.C units. Exposed Electrical wiring has been running through the articulations unattended which can lead to dangerous situations.

354	BAULA BUILDING	
		the ground level. Fire safety and security are non-existent.
9.9	Outbuildings	Not applicable
9.10	Overall Condition	Though there does not seem to be any visible structural threat, the architectural quality of the building is somewhat compromised due to signage accretions, insufficient upkeep etc.

11.0		DP REMARKS/PERCEIVED THREATS
		Not applicable as building is deleted from Listing
12.0		ADDITIONAL NOTES/REFERENCES/DOCUMENTS AVAILABLE/RECOMMENDATIONS & SUGGESTIONS FOR IMPLEMENTATION
		Contrary to the remarks in the Heritage Conservation Regulations Report of Designated Officer Vol 1, that the building reflects no heritage value and is privately owned and tenanted, the building reflects great architectural value as elaborated in the description and in the supporting photographs. Currently, deleted from the list of demarcated heritage buildings, it is proposed to be re-inducted as a Grade III building, on account of its architectural value. The yellow stone façade along with the arcades on the ground level, which also forms an integral part of the line of heritage structures along Sardar Vallabhbhai Patel Road, is worthy of preservation.

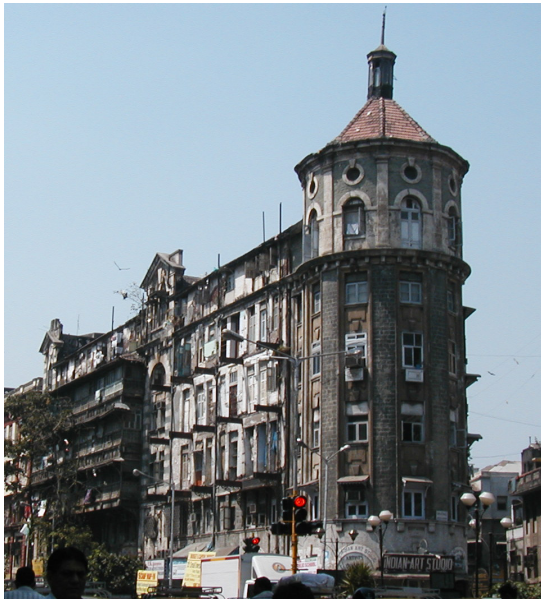
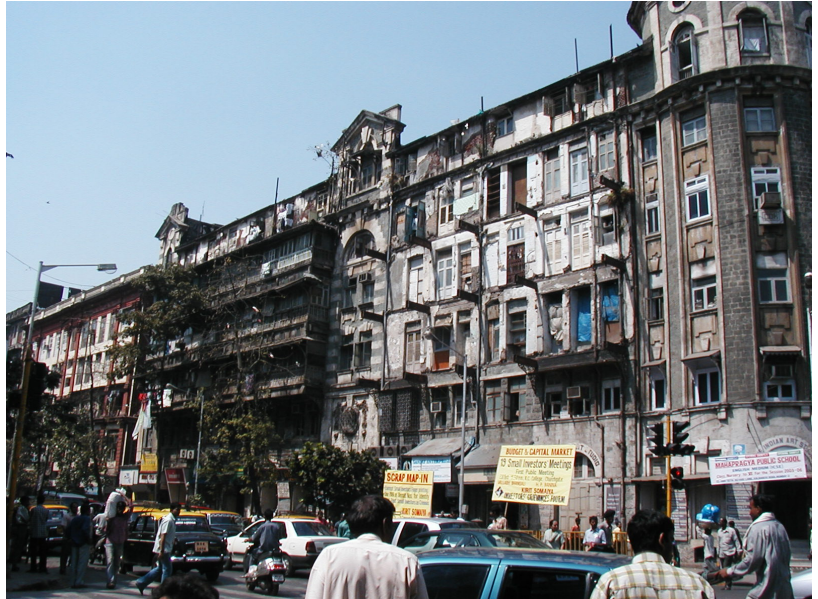
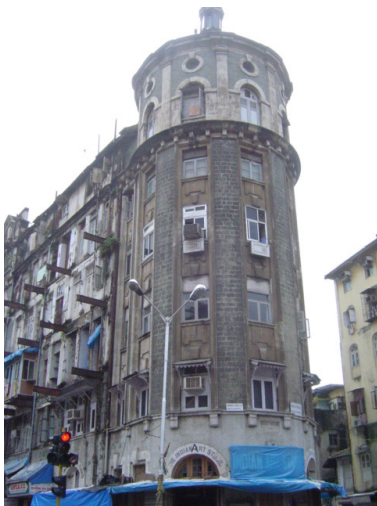
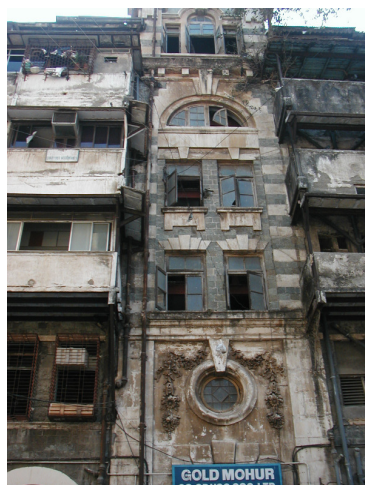
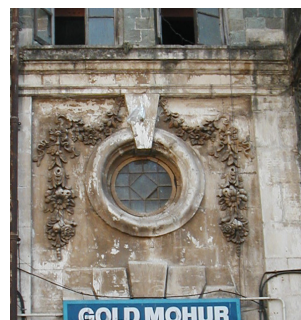
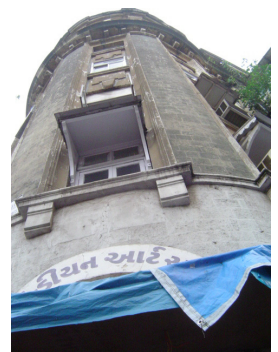
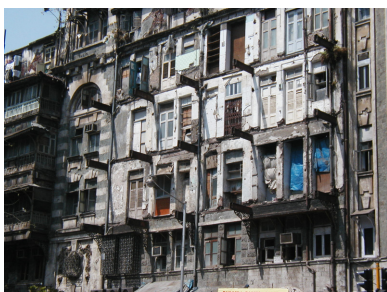
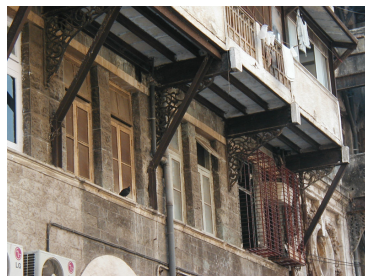
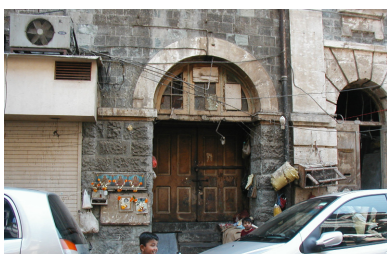
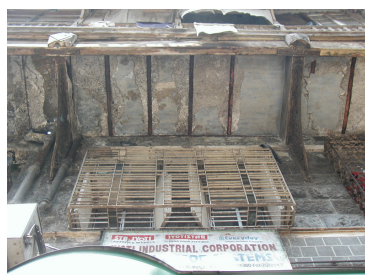
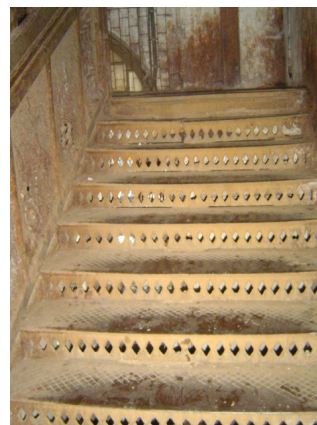
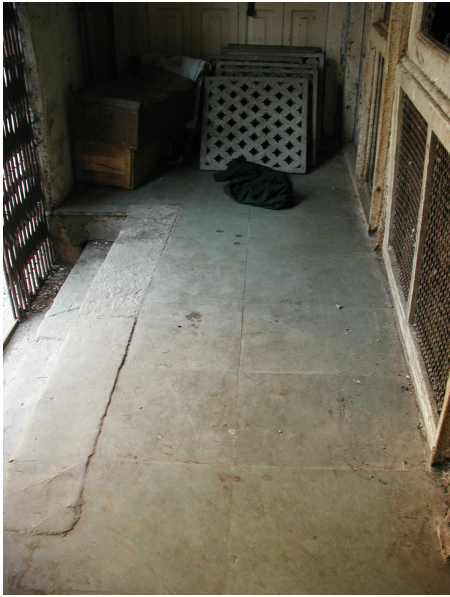
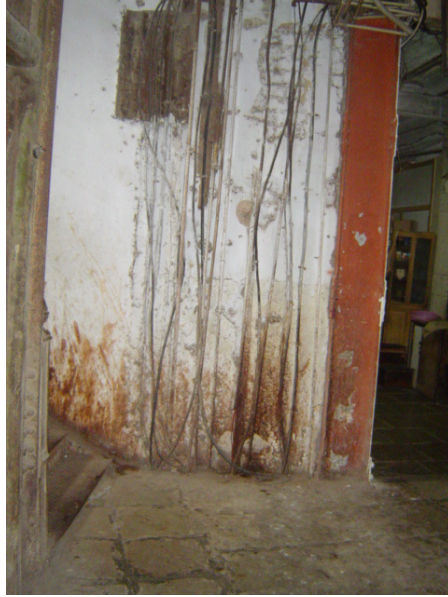
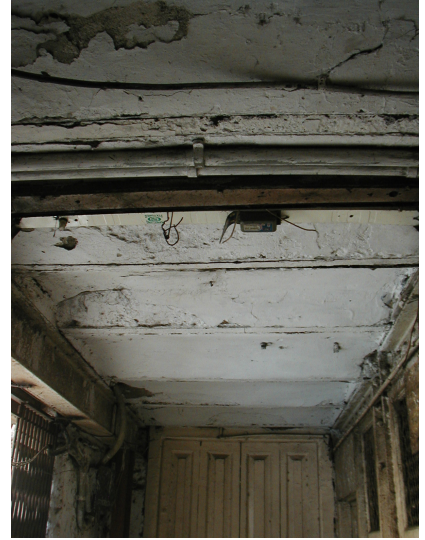
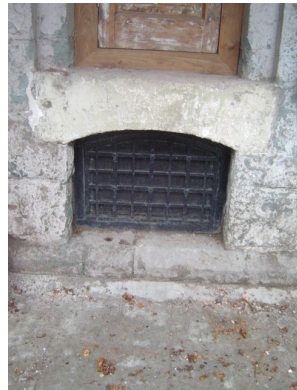
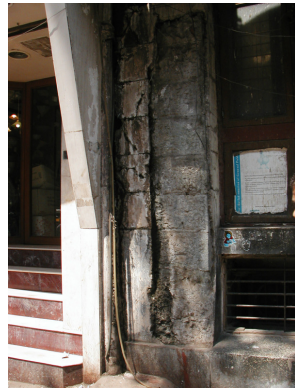
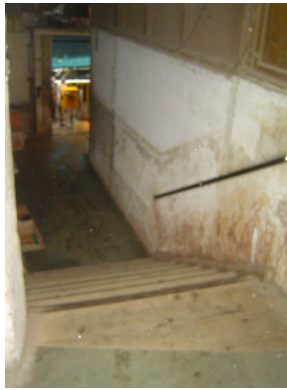
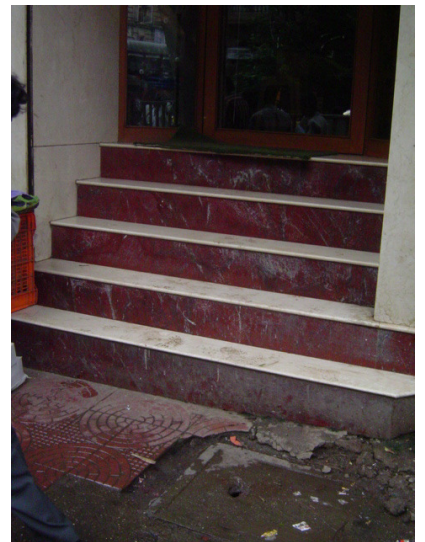
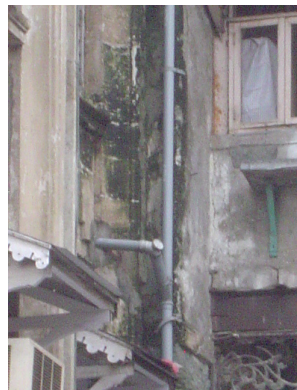
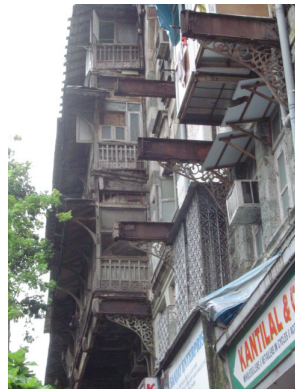
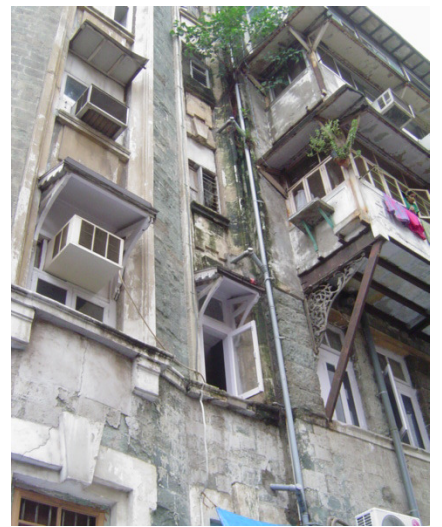
9.0		CONDITION
9.1	Plinth	The stone plinth is structurally in a sound condition. But at few areas the plinth has been modified using modern finishes.
9.2	Walls	Discoloration and damage to the water seepage from the roof, and ficus growth is also seen on the external walls. Widening of masonry joints is observed in a few places. Damage to the external masonry has caused vertical cracks on the façade to appear due to rampant insensitive construction and additions done on the building during the recent years.

9.3	Floor	All floors are in sound structural condition or have been structurally consolidated using MS sections. Few areas have been replastered with cement plaster.

9.4	Stairs	Staircases have worn out treads with the chequered pattern being almost obliterated. Balustrades are broken and require maintenance. The walls of the staircase well require be cleaning and re-plastering.

9.6	Roofing	The roof requires regular maintenance and water-proofing treatment, but is otherwise in a structurally sound condition.
9.7	Articulation & Finishes	Mostly hidden by signboards or shutters, have been broken or show cracks and damage. The ground floor of the building is completely altered due to the presence of retail shops and commercial establishments. Incongruous additions like shop tin chajjas, signboards, shutters, counters, shelving etc. mar the building façade. Arches and other openings have been enclosed, rolling shutters added. In some places, the external stone wall covered with a layer of chemical paint or other modern cladding materials. Other modern accretions on the facades

356	GOLD MOHUR	
		include clothes lines and window A.C units.
9.8	Services	Services are in a bad condition and need to be upgraded especially the wiring at the ground level. Fire safety is non-existent.

9.9	Outbuildings	There are no outbuildings within the premises.
9.10	Overall Condition	The architectural quality of the building is compromised due to incongruous accretions, irregular upkeep etc. The building is not satisfactorily maintained, though the north wing is better maintained than the south wing that faces the main road. Maintenance level is POOR

11.0		DP REMARKS/PERCEIVED THREATS
		None
12.0		ADDITIONAL NOTES/REFERENCES/DOCUMENTS AVAILABLE/RECOMMENDATIONS & SUGGESTIONS FOR IMPLEMENTATION
		With their distinctive tall corner towers and conical roofs, Gold Mohur along with its twin building, Gopal Nivas directly opposite occupies dominant positions at this key intersection of Vardhaman Chowk. Additionally, it forms a distinctive urban focal point on the sight line along Shamaldas Gandhi Marg. Hence it is recommended to upgrade its listing from Grade III to IIB.

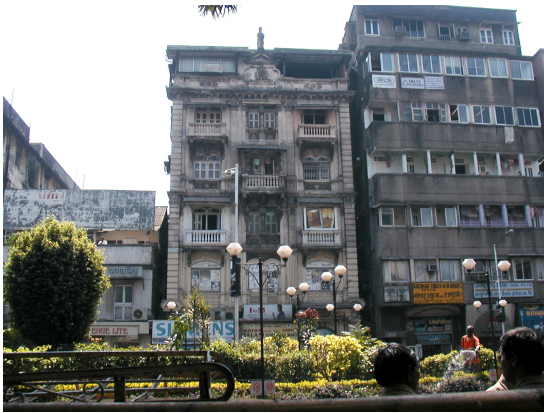
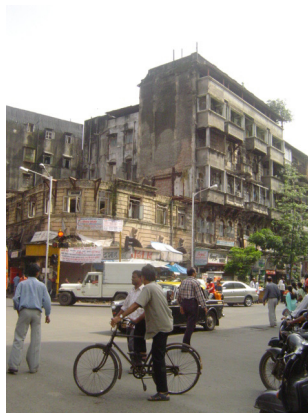
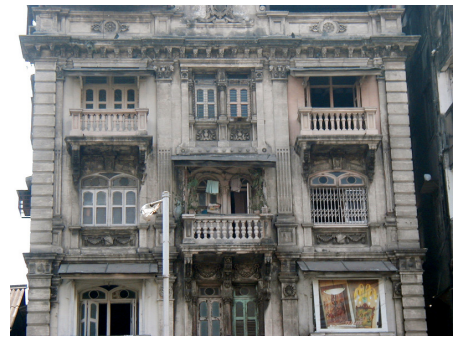
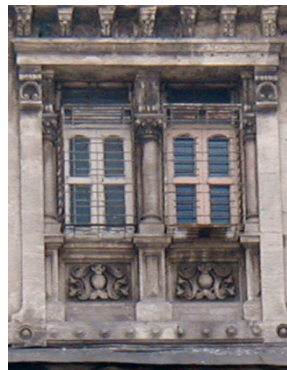
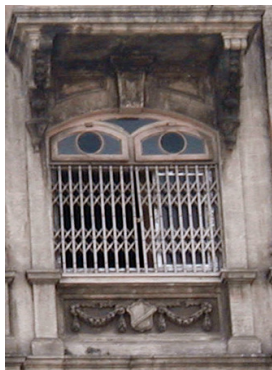
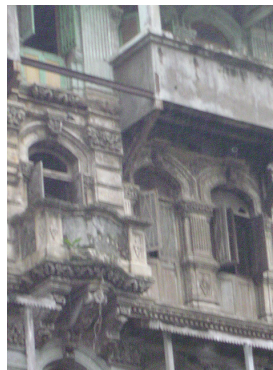
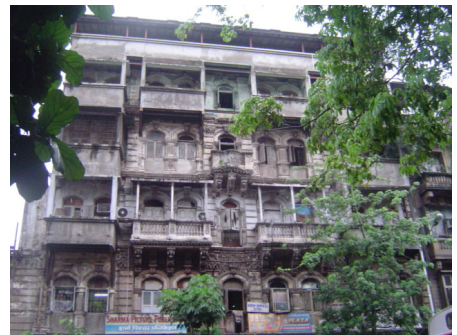
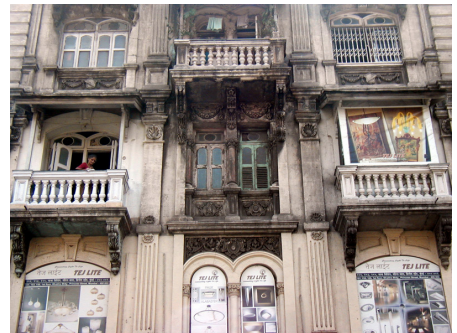
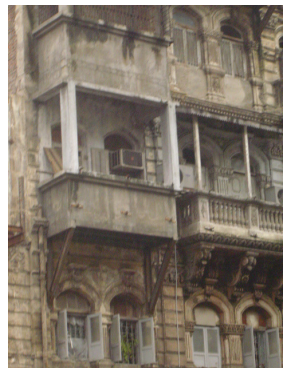
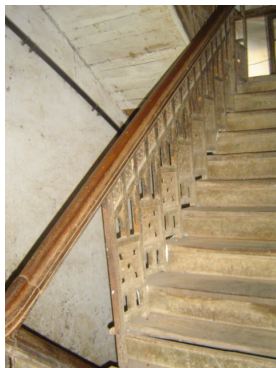
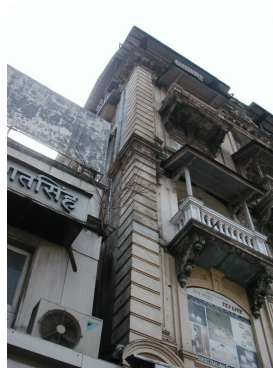
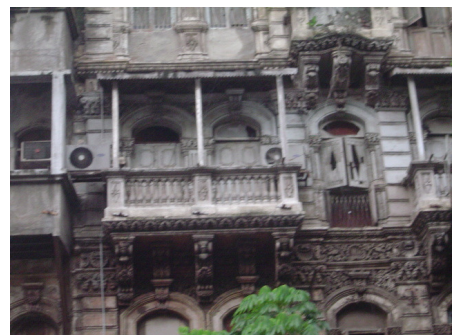
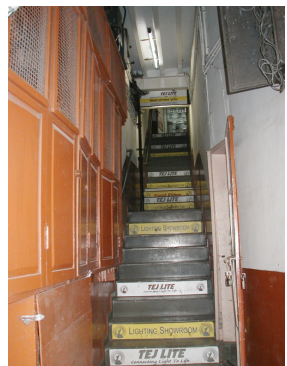
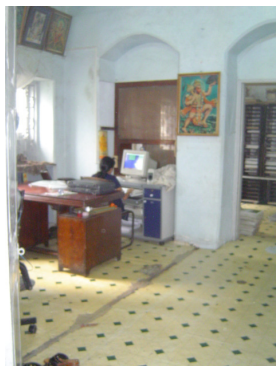
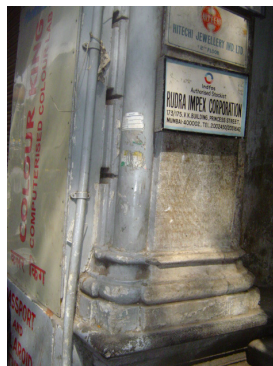
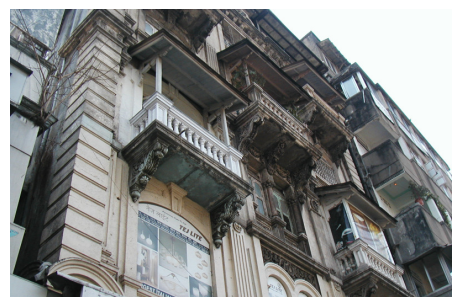
357 VALLABHDAS KANJI BUILDING

8.6	Fire Precaution	Fire extinguishers present installed by individual offices
8.7	Other (HVAC/BMC/Security Systems)	None
9.0		CONDITION
9.1	Plinth	The stone plinth is structurally in sound condition except there for dampness in some areas.

9.2	Walls	The walls are in fair condition devoid of any structural defects. Discoloration and damage to the water seepage from the roof, and ficus growth is also seen on the external walls. Widening of masonry joints is observed in a few places. The walls are punctured with structural steel interventions to support the buildings.

9.3	Floor	The floor is free from any structural defects.
9.4	Stairs	The staircase is in a structurally stable condition except for the timber handrail which needs to be cleaned. At few areas some portion of the handrail are missing.

9.5	Openings	All the arched openings are in poor condition with alterations done at few places like air conditioners and metal box grills. Certain windows have glass panes broken while few timber shutters have dismantled due to poor maintenance. Few openings are also been blocked.

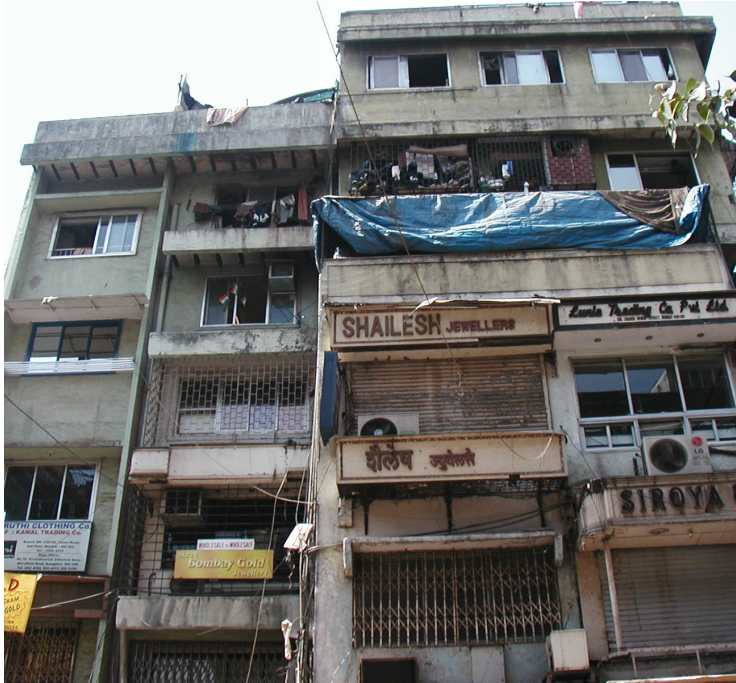
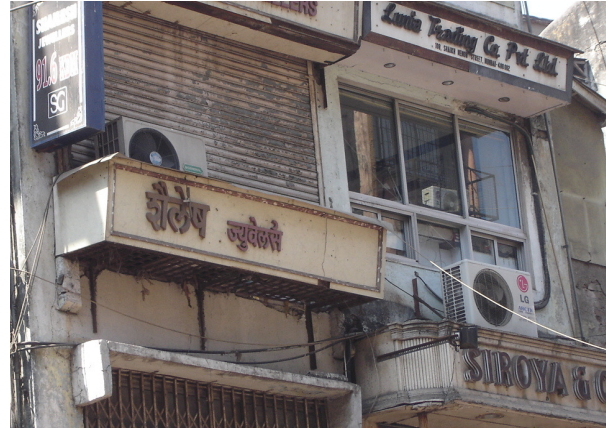
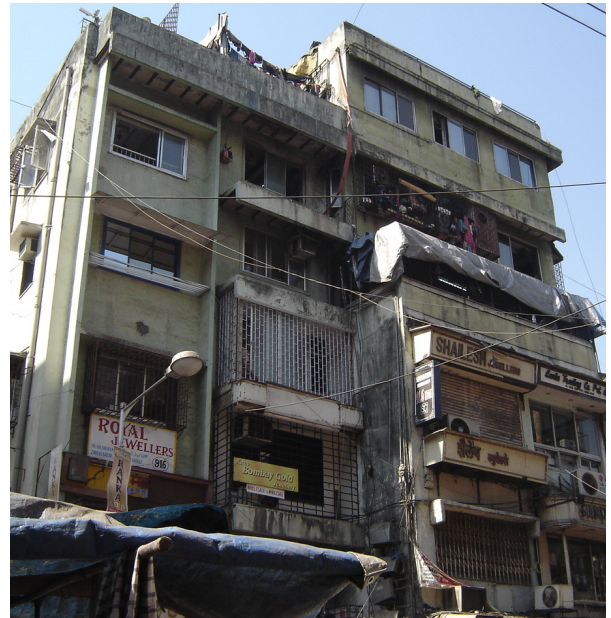
359	USTAD BUILDING	
		facades).
9.0		CONDITION
9.1	Plinth	The plinth does not show any signs of structural distress.
9.2	Walls	Walls needs proper maintenance, paints flaking and chipping off can be seen, <i>paan</i> stains can be seen on the staircase walls which is poorly maintained.

9.3	Floor	Broken Shahbad tiles and ceramic tiles are used.
9.4	Stairs	Has no proper ventilation and is poorly maintained, broken tiles can be seen
9.5	Openings	Openings are accommodated with aluminium framed sliding windows and grills.

9.7	Articulation & Finishes	Repeated insensitive repairs have led to the loss of all articulation.
9.8	Services	The services are cluttered and in severe need of maintainance.

9.9	Outbuildings	The surrounding areas are occupied by hawkers (<i>sandwich walas, fruit walas</i> etc.)
9.10	Overall Condition	Poor Maintenance level: Irregular

10.2	Structure	Structurally the building has been transformed completely. The original timber has been replaced with I Sections and RCC.
10.3	Articulation & Finishes	Repeated insensitive repairs have led to the loss of all articulation.

11.0		DP REMARKS/PERCEIVED THREATS
		Reservation for Public Housing
12.0		ADDITIONAL NOTES/REFERENCES/DOCUMENTS AVAILABLE/RECOMMENDATIONS & SUGGESTIONS FOR IMPLEMENTATION
		The building doesn't show any architectural character and has lost its value. With the urban development the building has undergone tremendous changes both internal and externally. It stands as any other building in the surrounding and can not be easily found out. Hence it should be deleted from the list.

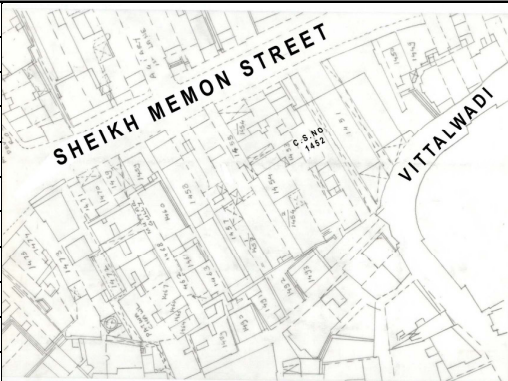
360		BUILDING NO.126- 134	
 	Common Ref No: 2005/GII/360

9.0		CONDITION
9.1	Plinth	The plinth does not display any signs of structural distress.
9.2	Walls	On part of the building the externally façade is not maintained on regular bases. It needs a fresh coat of paint. The staircase area also has paan stains and other stains all around.

9.3	Floor	The floor remains sound but tiling work is missing at many areas.
9.4	Stairs	The staircase is in a structurally stable condition.
9.5	Openings	The balconies are shut down with grills and aluminium framed windows

9.6	Roofing	The roof appears to be free from structural distress.
9.7	Articulation & Finishes	Decorative jali work on balcony railing and decorative column brackets with stain glass work, at one corner there could be a missing stain glass piece.

9.10	Overall Condition	Poor Maintenance level: Irregular
10.0		TRANSFORMATION
10.1	Form	All the projecting balconies have been enclosed to create more room.

10.2	Structure	MS angles and beam have replaced original timber members.
10.3	Articulation & Finishes	The articulation has been lost in re-plastering in some cases, the timber posts show warping and are in need of consolidation.

11.0		DP REMARKS/PERCEIVED THREATS
		Area is en-marked as Public Housing.
12.0		ADDITIONAL NOTES/REFERENCES/DOCUMENTS AVAILABLE/RECOMMENDATIONS & SUGGESTIONS FOR IMPLEMENTATION
		The building doesn't show any architectural character and has lost its value, still at the third floor level articulation work remains without been hampered. In whole the building doesn't posses any value to be restore other than the articulation work. Hence should be deleted from the list.

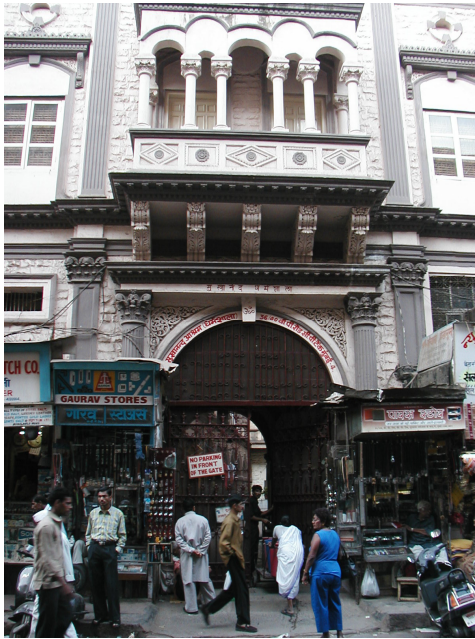
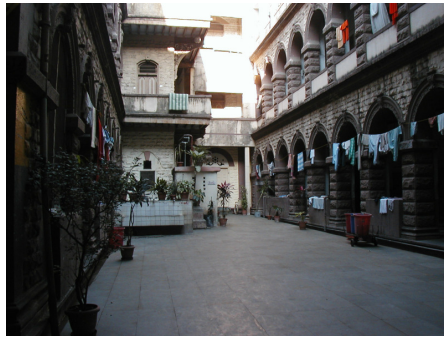
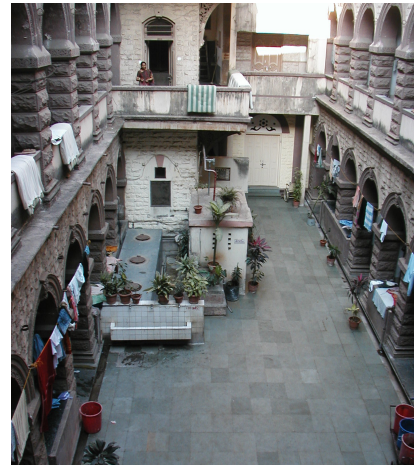
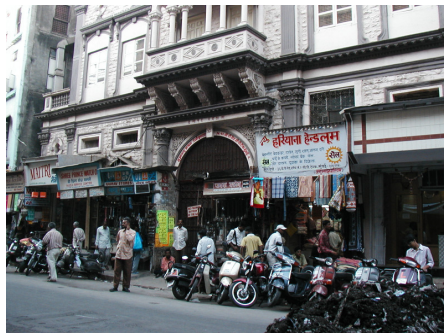
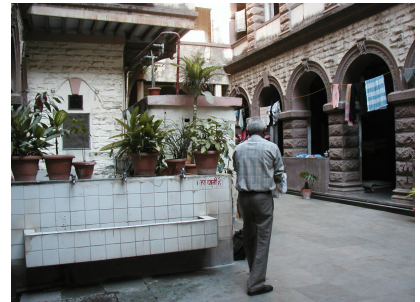
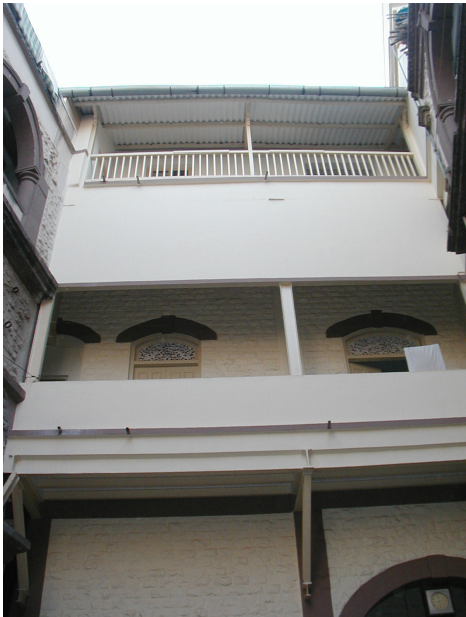
362

9.2	Walls	The walls do not any signs of structural distress or defects. condition in the renovated wing. In the older wings, water seepage can be seen on the surface as well as a few cracks in the stone masonry.

9.6	Roofing	The roof is does not show any signs of structural interventions but requires water-proofing treatment.
9.7	Articulation & Finishes	All the details and carvings in limestone on the façade are painted grey and do not display any signs of deterioration. In the older wings, the stone floor surface seems a little worn out. In the newly renovated wing, the colonnade in the verandah has been removed and replaced by I-sections and blank brick parapet walls painted white.

10.3	Articulation & Finishes	In the newly renovated wing, the colonnade in the verandah has been removed and replaced by I-sections and blank brick parapet walls painted white.

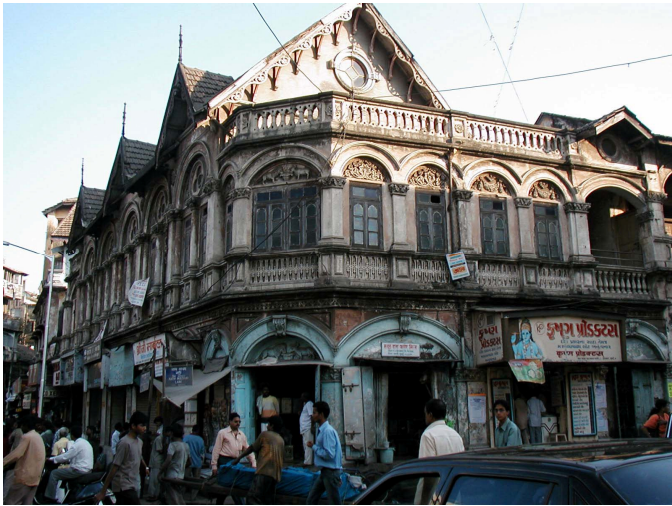
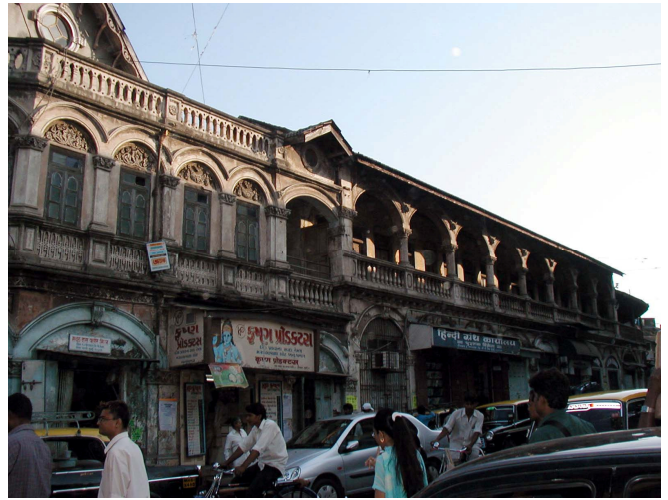
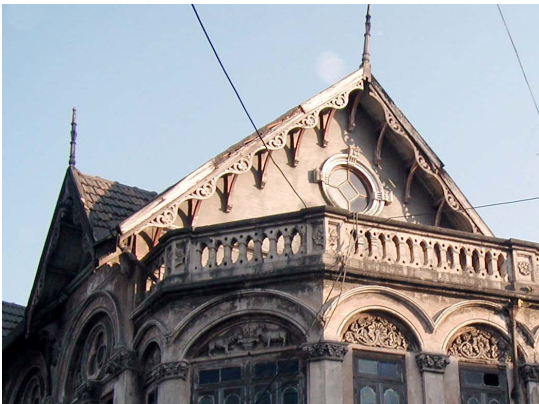
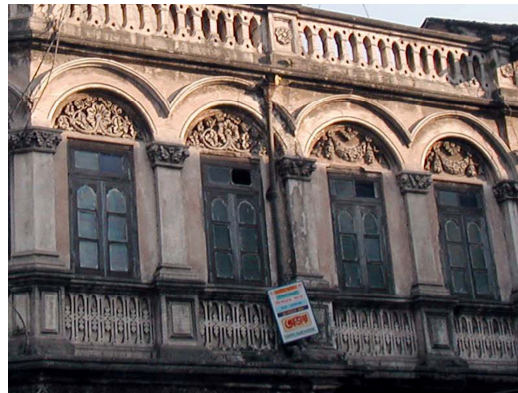
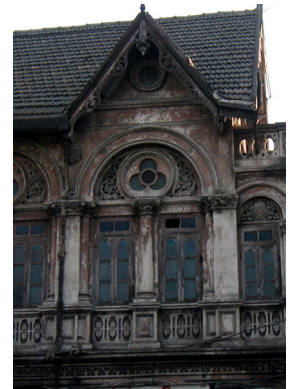
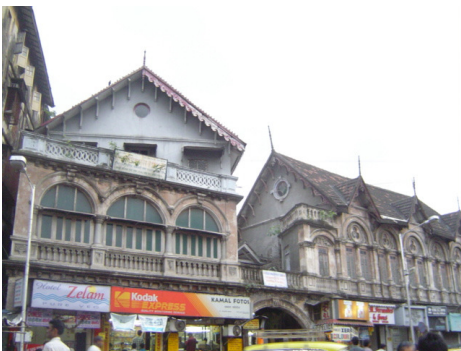
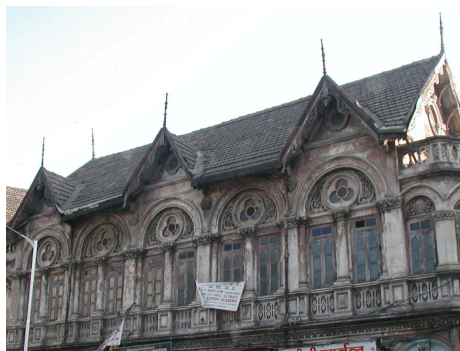
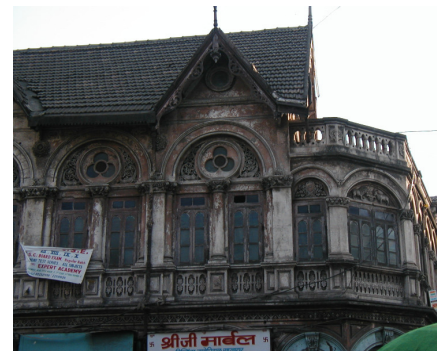
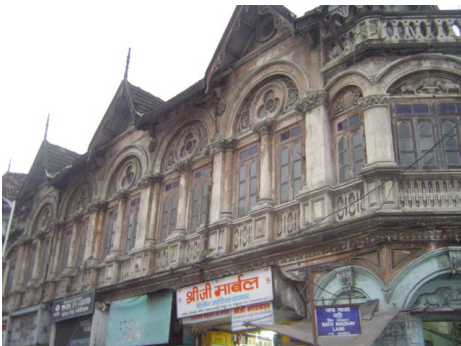
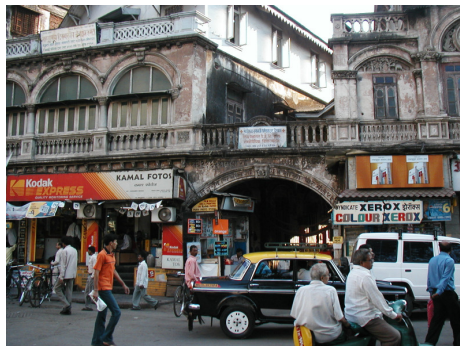
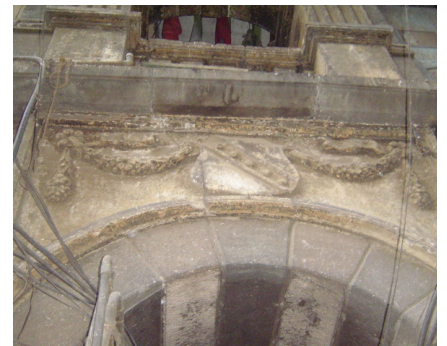
9.2	Walls	The walls are in a sound condition with no major structural defects observed except for a few areas where flaking of paint due to dampness is seen in many places, plaster flaking is also observed and some areas exposed brick work is also observed. Ficus growth is also observed at certain areas.

9.3	Floor	The structural steel members used in the flooring have rusted due to wear and tear and need to be replaced and haphazard electrical wiring is seen running unattended which also need to be replaced. The flooring has been altered extensively by the tenants and none of the original finishes have remained.

9.4	Stairs	The timber staircase is in fair condition but requires maintenance.
9.5	Openings	All the arched openings are in sound structural condition but paint layers on the exterior have flaked off exposing the stone masonry joints in a few places. Window frames and glass panels need to be regularly cleaned and some broken ones also require to be replaced. At the ground level, incongruous additions like tin chajjas, shop signboards, rolling shutters, counters, shelving etc. hide the arches and other openings.

9.6	Roofing	The roof requires regular maintenance work including tile replacements and water-proofing work but is otherwise is in a fair structural condition. The eaves boards have broken off in some places on the south façade and need to be repaired.

363	HIRA BAUG	
		have been given a fresh coat of white paint. All the details and carvings in limestone on the façade that were painted over are now covered in a layer of efflorescence which has turned a dusty grey colour. The original flooring is a little worn out and requires maintenance.

9.8	Services	Lighting and all other electric fixtures are periodically maintained. The wiring and cabling within the building needs to be regulated as it is currently quite haphazardly done. There is no problem with the electricity and water supply from the authorities. Drainage pipes have been replaced by PVC pipes but adequate moss and Ficus growth are observed which needs to be cleaned.

9.9	Outbuildings	None
9.10	Overall Condition	There seems to be no visible structural threat and apart from the some modern accretions on the façade, the architectural quality is not lost and more or less been fairly well maintained. Maintenance level is Fair

10.0		TRANSFORMATION
10.1	Form	No changes have been observed in the form of the building.
10.2	Structure	At the ground level, incongruous additions like tin chajjas, shop signboards, rolling shutters, counters, shelving etc. hide the arches and other openings.
	Articulation & Finishes	The first floor of the south wing of the building has been renovated – window frames have been changed and the walls have been given a fresh coat of white paint. The ground floor of the building is completed altered due to the presence of retail shops and commercial establishments. Incongruous additions like shop tin chajjas; signboards, shutters, counters, shelving etc. hide the details and mar the building façade. Arches and other openings have been enclosed, rolling shutters added. In some places, the external stone wall covered with a layer of chemical paint. Other modern accretions on the facades include clothes lines and window A.C units.

11.0		DP REMARKS/PERCEIVED THREATS
		The building has been marked wrongly on the D.P and hence this anomaly needs to be corrected.
12.0		ADDITIONAL NOTES/REFERENCES/DOCUMENTS AVAILABLE/RECOMMENDATIONS & SUGGESTIONS FOR IMPLEMENTATION
		This hybrid Colonial style building has unique architectural value with an amalgamation of neo-Classic and vernacular style elements. Its main façade makes a very strong presence on the streetscape especially the elegant pitched roof with dormer windows and its line of arched fenestrations. Additionally, it is archetypal of the early 20 th century period that it was built in and is worthy of preservation. Hence it is recommended to upgrade its listing from Grade III to IIB.
