LISTING & GRADING OF HERITAGE BUILDINGS & PRECINCTS IN MUMBAI
TASK II: Review of Sr. No. 317 to 632 of the Heritage Regulations

317 ZAOBA HOUSE		
 	Common Ref no:	2005/GII/317
	Card No.:	1
	Ward (Part):	C Ward
	CS No.	1963
	Plot Area:	318.63 sq m
	Date:	7 th February 05
	Record by:	Sheetal Gandhi
	Review by:	Aishwarya Tipnis
	Int: SG Ext: SG	
	Photo Ref:	317a

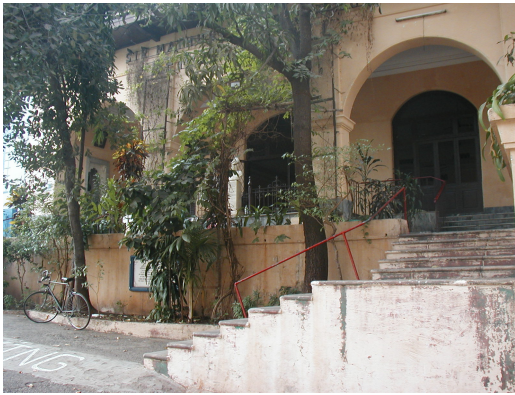
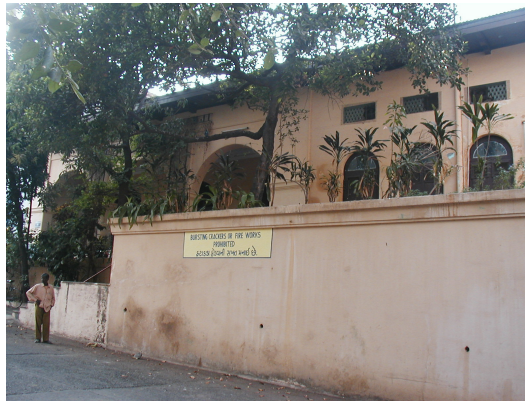
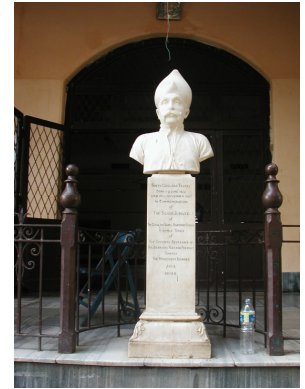
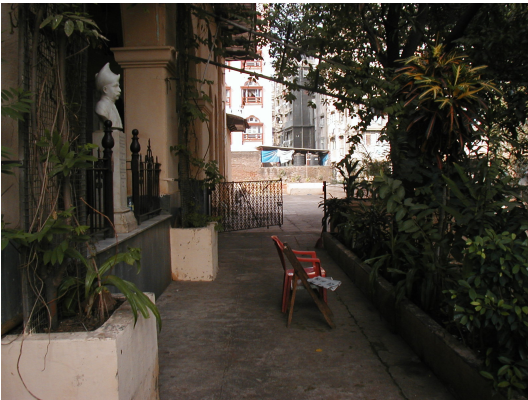
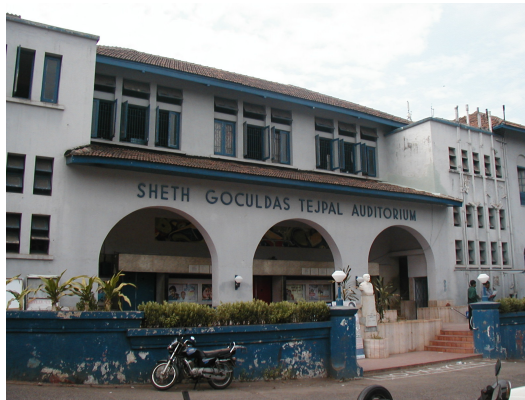
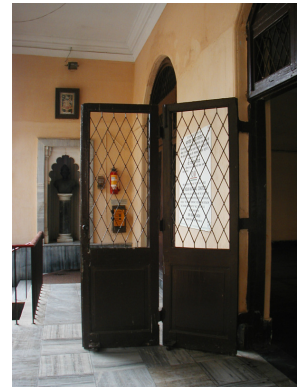
8.6	Fire Precaution	Fire extinguisher present
8.7	Other (HVAC/BMC/Security Systems)	Manned by private security guards.
9.0		CONDITION
9.1	Plinth	The stone plinth is plastered and painted, and is in sound structural condition.

9.5	Openings	All the openings are in sound condition with wooden frames and glass shutters intact and in operational condition.
9.6	Roofing	The roof is regularly maintained and is in a sound structural condition.

9.7	Articulation & Finishes	The walls and floor tiles are regularly cleaned and show no signs of intervention. The cast iron railings, roof brackets, marble plaques and statues do not show any signs of deterioration.

9.9	Outbuildings	The Auditorium building and temple structures are in a structurally stable condition.
9.10	Overall Condition	Fair Maintenance Level : Regular

367	TEJPAL AUDITORIUM	
10.3	Articulation & Finishes	None
11.0		DP REMARKS/PERCEIVED THREATS
		None
12.0		ADDITIONAL NOTES/REFERENCES/DOCUMENTS AVAILABLE/RECOMMENDATIONS & SUGGESTIONS FOR IMPLEMENTATION
		This building is a crucial historical and cultural landmark where the Indian National Congress party was founded in 1885. It is an important marker during the period of India's freedom struggle with great significance attached to the social history of Mumbai at the time. Hence it is recommended to upgrade its listing from Grade III to II B
