LISTING & GRADING OF HERITAGE BUILDINGS & PRECINCTS IN MUMBAI  
 TASK II: Review of Sr. No. 317 to 632 of the Heritage Regulations

470 SWAMI PREMPURI ASHRAM TRUST BUILDING

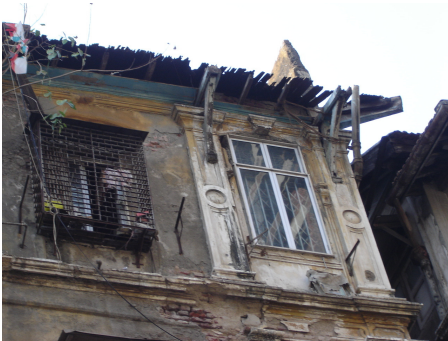
CONDITION OF OPENINGS

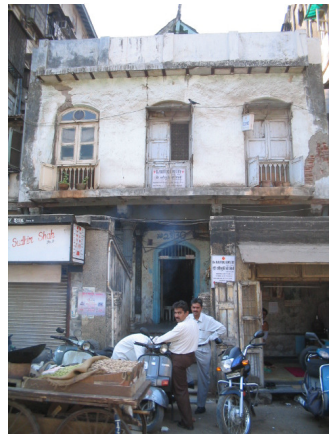
BRICK MASONRY STRUCTURE

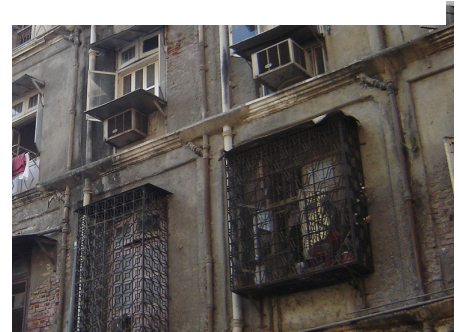
SERVICES IN BAD CONDITION
