HERITAGE SITES IDENTIFIED IN THE STUDY AREA

MUMBAI METROPOLITAN REGION HERITAGE CONSERVATION SOCIETY

Record Details for Hazrat Alishah Darbar

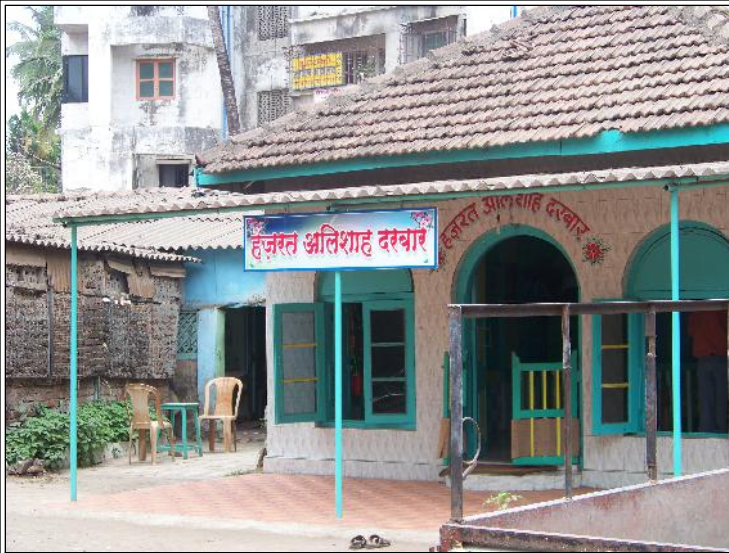
3.20	Other(Fire protection, HVAC, Security etc)	NA	NA	-
3.21	Incongruent Transformation	Verandah added in the front. Tile cladding to the walls. Hoardings / Sign Boards.		
3.22	Overall Maintenance Status	Average		
3.23	Overall Condition	Minor Repair

Image Title: Hazrat Alishah Darbar
Image Type: Front-View
Reference: View of the dargah from the road showing the added verandah

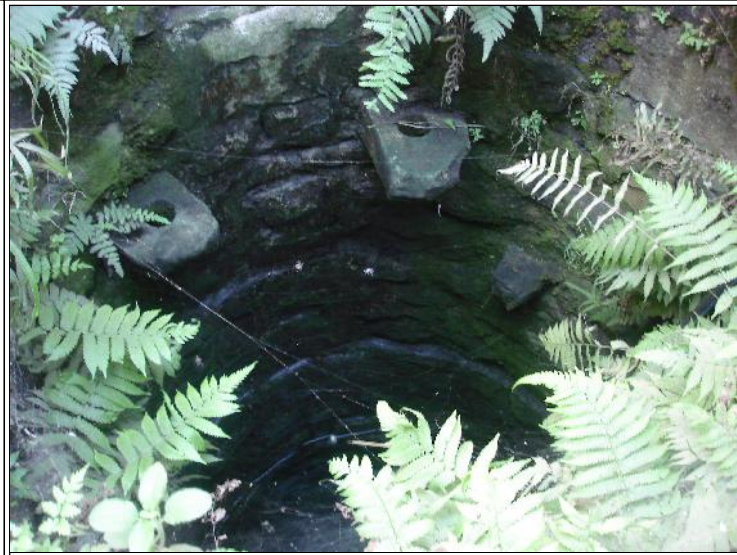
3.01	Height	The water is at 4M depth		
3.02	No. of Floors	None		
		Description	Problem/Threat	Condition
3.03	Structural System	The well has been dug into the ground and lined with stone masonry.	There is some vegetation growth on the side wall	Minor Repair

3.04	Plinth	NA	NA	-
3.05	Walls	NA	NA	-
3.06	Floors	NA	NA	-
3.07	Stairs	NA	NA	-
3.08	Openings	NA	NA	-
3.09	Roof	NA	NA	-
3.10	Articulation	Two stones near surface with holes to erect the traditional rahat for fetching water. The termination of the well at ground level is marked with a course of vertical stones.	Minor damage is seen.	Minor Repair

Image Title: Well Near Hazarat Alishah Dargha
Image Type: Front-View
Reference: View of well showing remains of Rahat or water lifting structure along with growth of vegetation

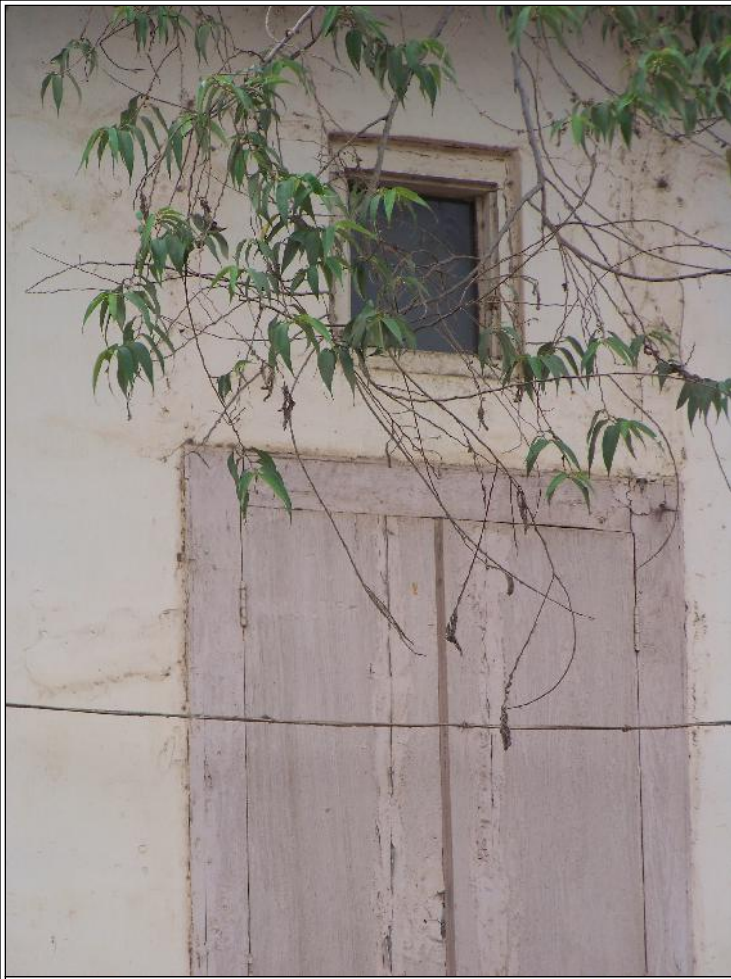
3.07	Stairs	Timber	NA	Good
3.08	Openings	Wooden frame shutters with glass infill panels and wooden louvers.	Rusting of hinges, cracking of wood, damaged louvers	Minor Repair

Image Title: Angre Wada
Image Type: Front-View
Reference: Window First Floor

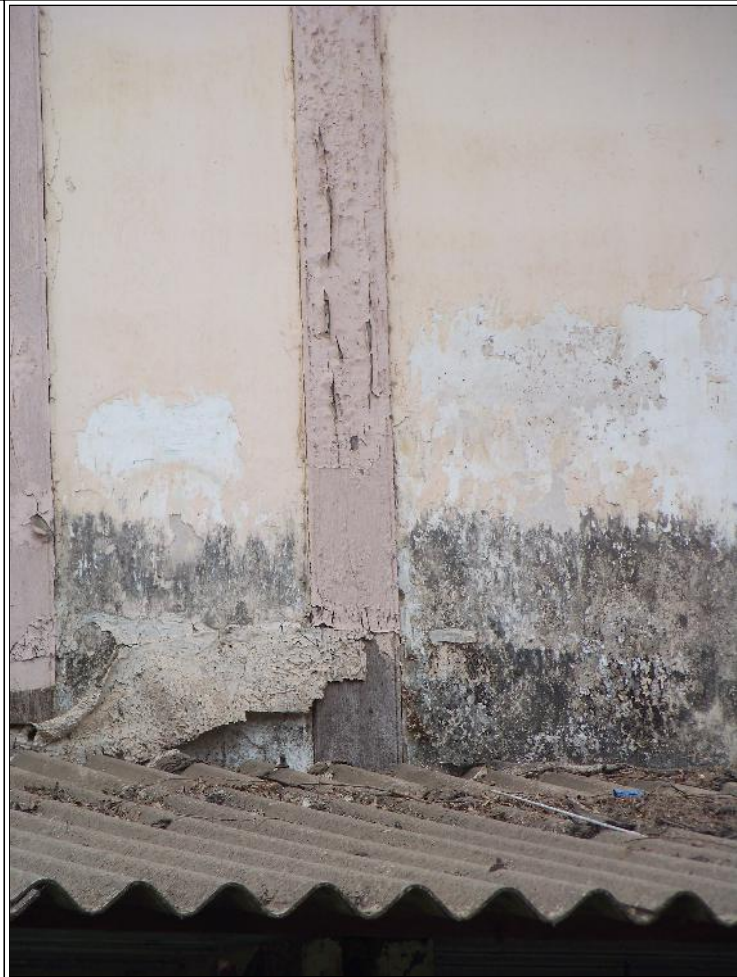
3.20	Other(Fire protection, HVAC, Security etc)	None	NA	-
3.21	Incongruent Transformation	Compound wall in the front. Roofing material changed to GI sheets.		
3.22	Overall Maintenance Status	The place is maintained but the modifications are in-congruent		
3.23	Overall Condition	Minor Repair

Image Title: Angre Wada
 Image Type: Front-View
 Reference: Junction of new verandah with old structure

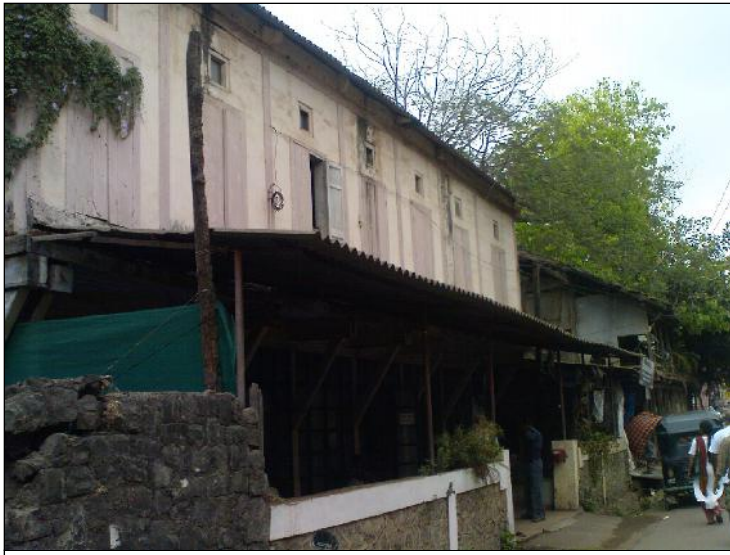
Image Title: Angre Wada
Image Type: Front-View
Reference: Front View Showing addition of verandah and Ground Floor

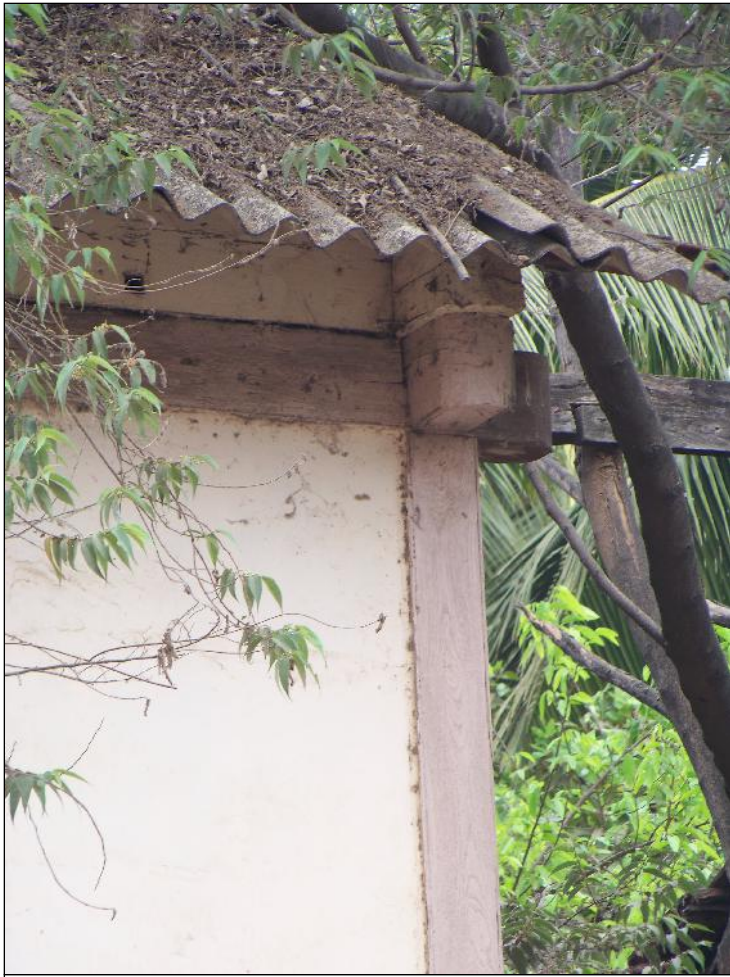
3.09	Roof	GI sheets on timber truss	Needs to be covered in country tiles.	Minor Repair
3.10	Articulation	The residence is essentially well built but unadorned. The column brackets and window lintels show some articulation of colonial influence.	The plaster is damaged in places	Minor Repair

Image Title: Angre Wada
Image Type: Front-View
Reference: Roof Detail

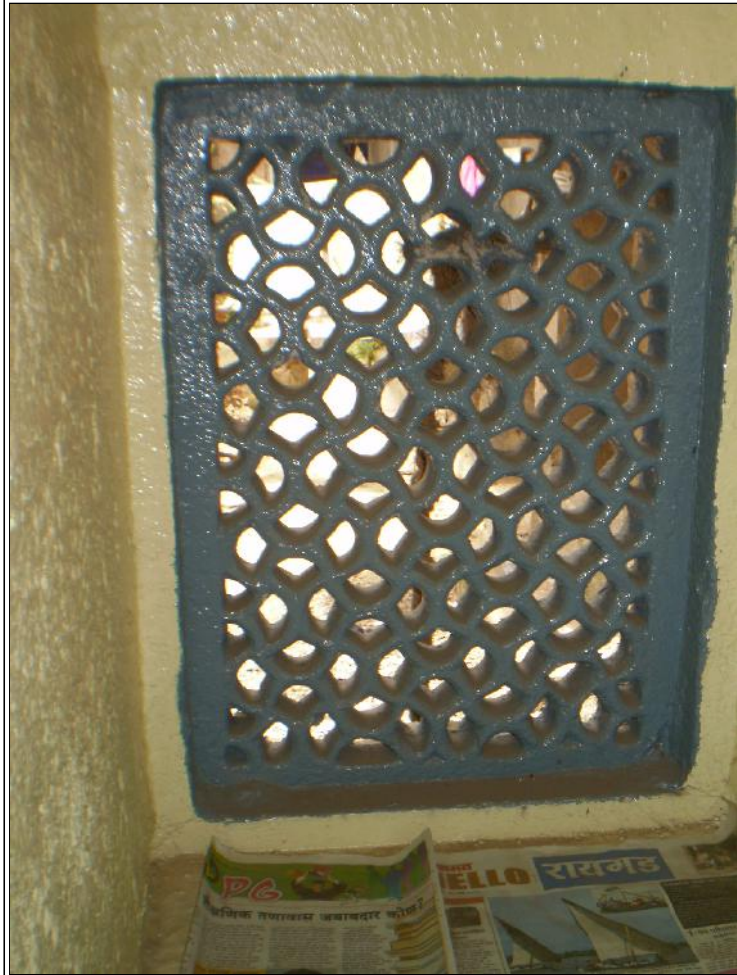
3.07	Stairs	NA	NA	-
3.08	Openings	Timber framed shutters with cast iron rods. windows infilled with stone jali work	The paint needs to be removed	Minor Repair

Image Title: Balaji Mandir
 Image Type: Front-View
 Reference: Jali window from outside

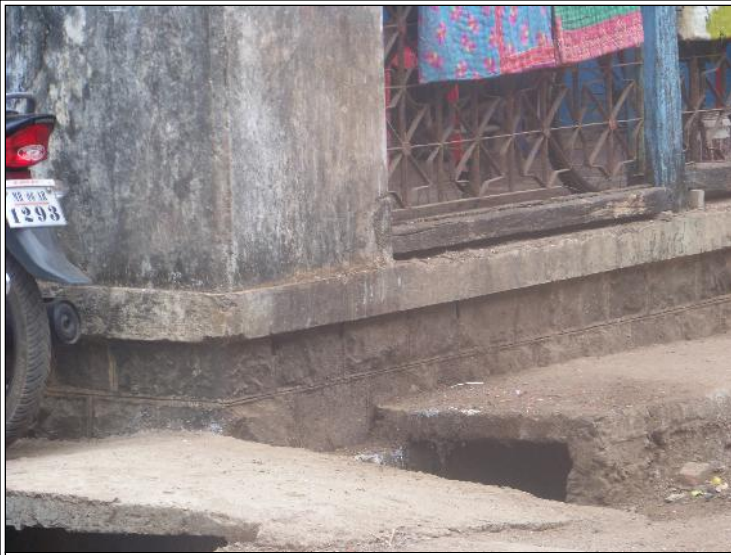
Image Title: Dabri House

Image Type: Front-View

Reference: View of plinth showing condition of junction with gutter

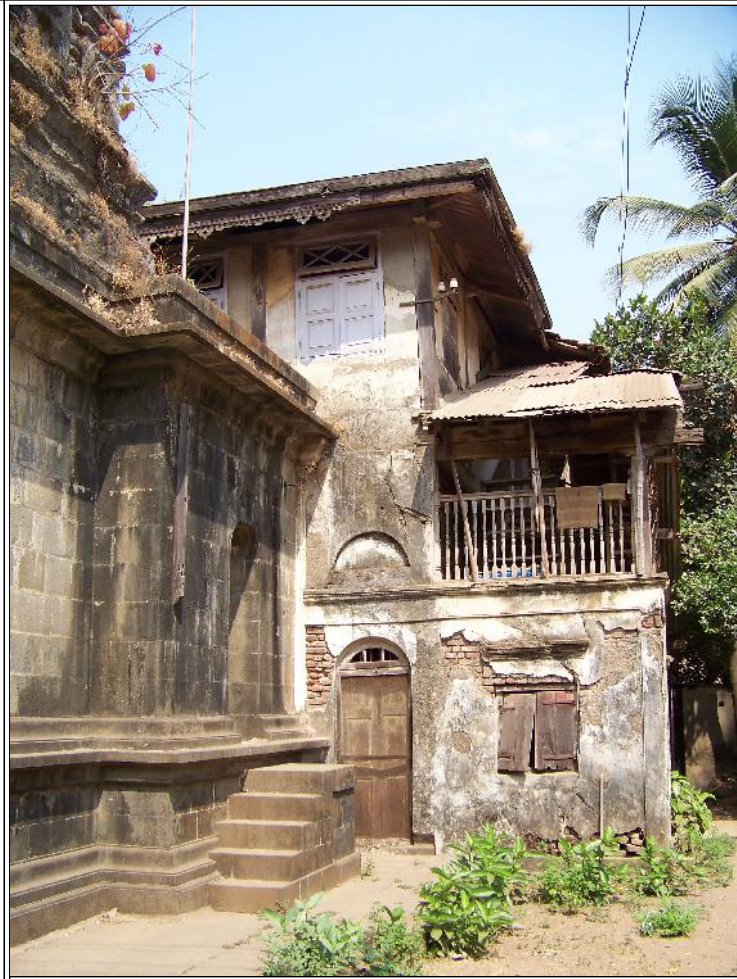
Image Title: Biwalkar Shiv Mandir
 Image Type: Front-View
 Reference: External view showing the uneasy junction between a traditional temple and Europe inspired Sabhamandapa

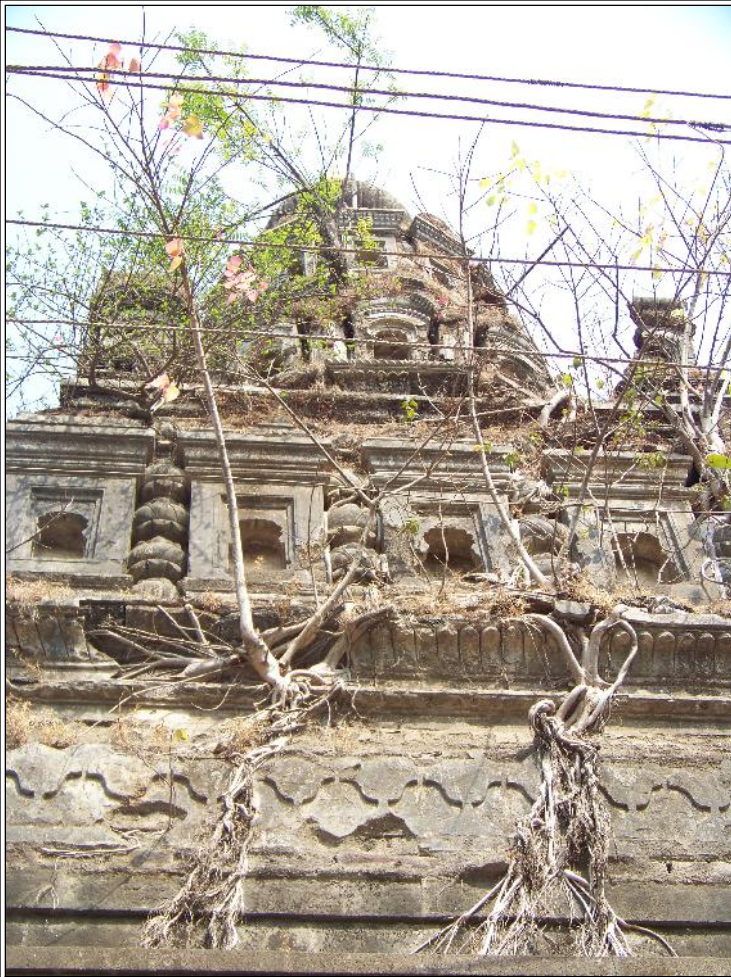
Image Title: Biwalkar Shiv Mandir
 Image Type: Front-View
 Reference: Dilapidated condition of the Shikhara Evidences of good craftsmanship still clearly evident

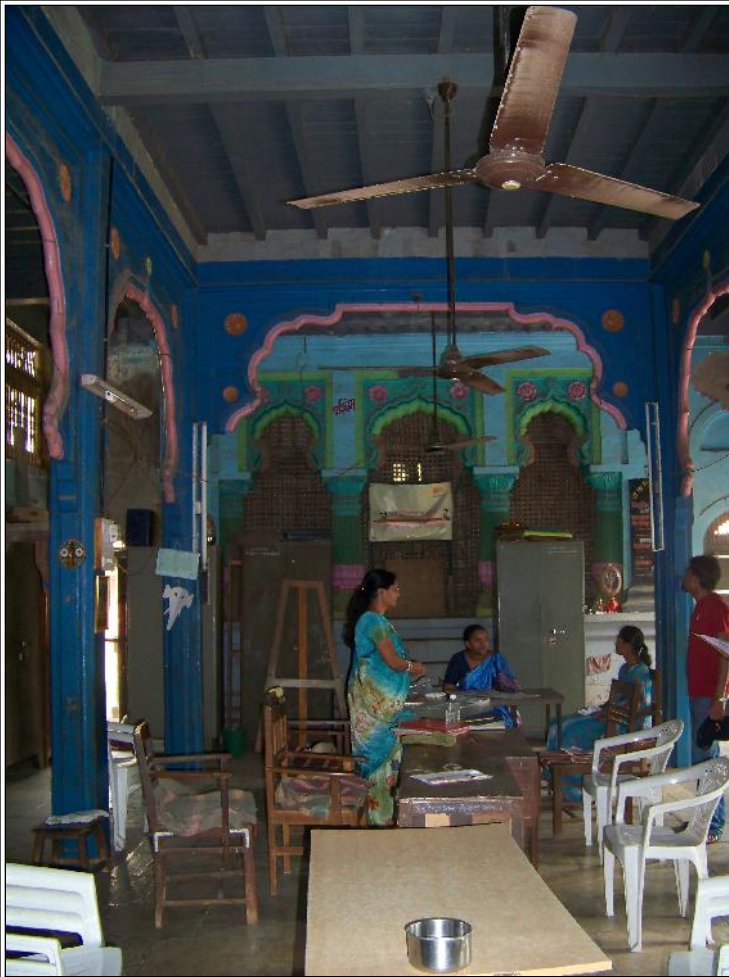
Image Title: Biwalkar Shiv Mandir
 Image Type: Front-View
 Reference: Internal view of the temple showing adhoc interventions

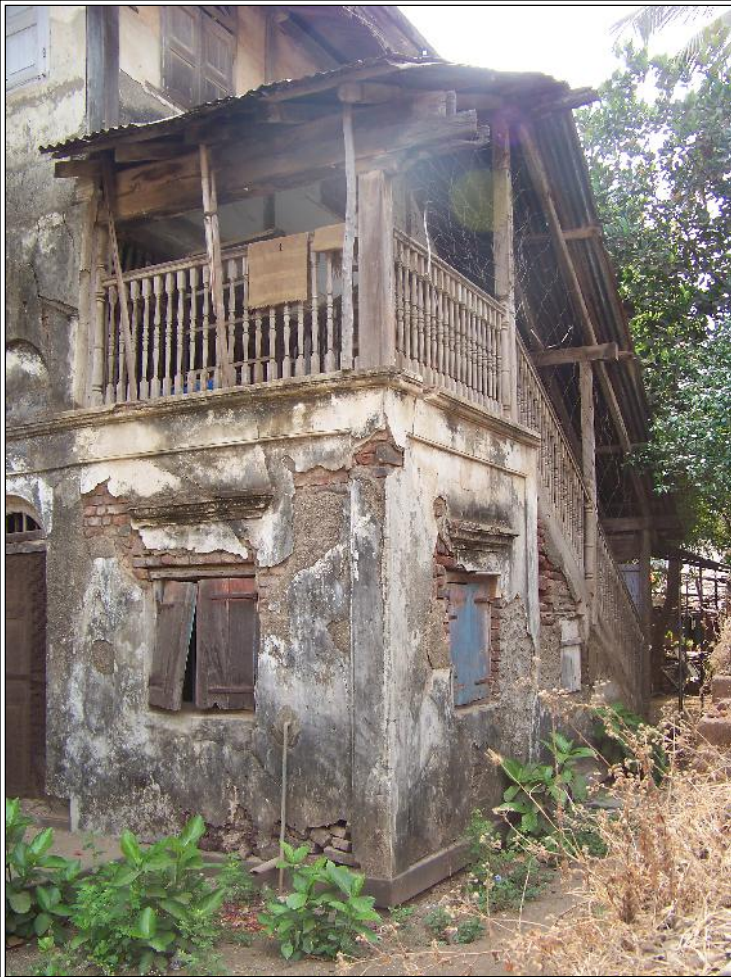
Image Title: Biwalkar Shiv Mandir
 Image Type: Rear-View
 Reference: Dilapidated rear side of the sabhamandap

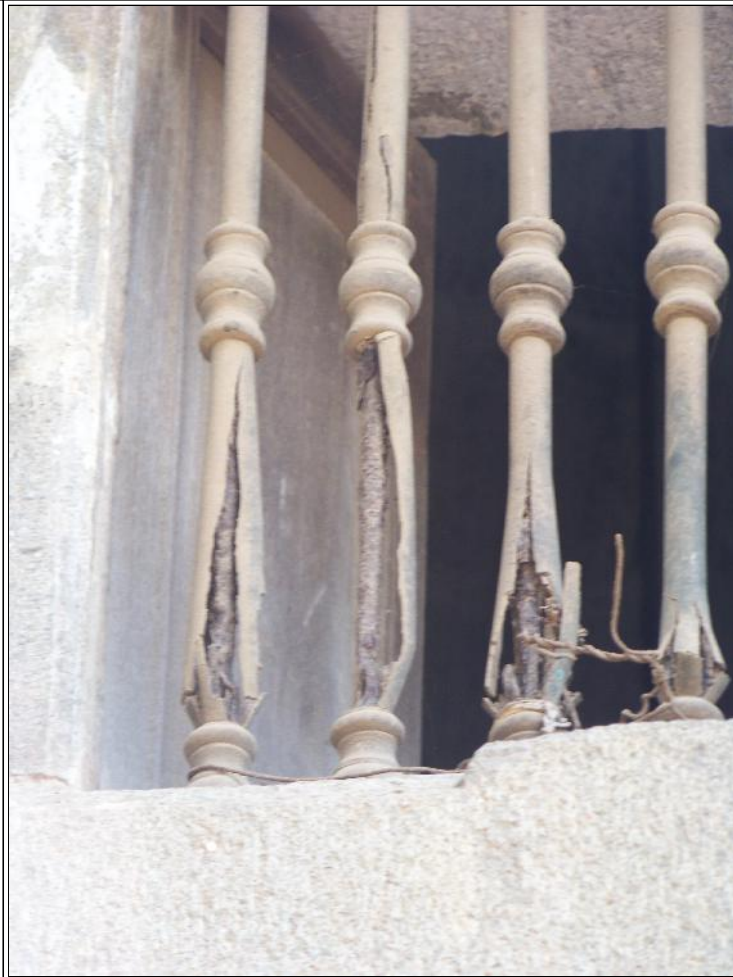
4.03	Additional Notes	Mandir is generally closed except in morning at time of Pooja, window grill of brass members with iron core.
4.04	References	
	Books/Documents	Amrut Mahotsav smaranika, shri vithal sansthan, Dahivali, 1990. Apte B.K. A history of the Marathi Navy and Merchantships, State Board for literature and culture, Bombay, 1973. Avalaskar Shantaram, Angrekalin Ashtagar, BISM, Pune, 1947. Dabu D G Kulabkar Angre Sarkhel. Datar Shridhar Hari. Datar Kulvrittanta, Pune 1974. Gupta Rupa Raje, The wada of Maharashtra an Indian courtyard house form. Unpublished Ph.D. thesis, Welsh school of Architecture, Cardiff. Harvande Geeta, Pen, Granthali Dn
	WebSites	NA
	Persons	NA

Image Title: Biwalkar Shiv Mandir
 Image Type: Front-View
 Reference: Broken Brass Grill with corroded iron core

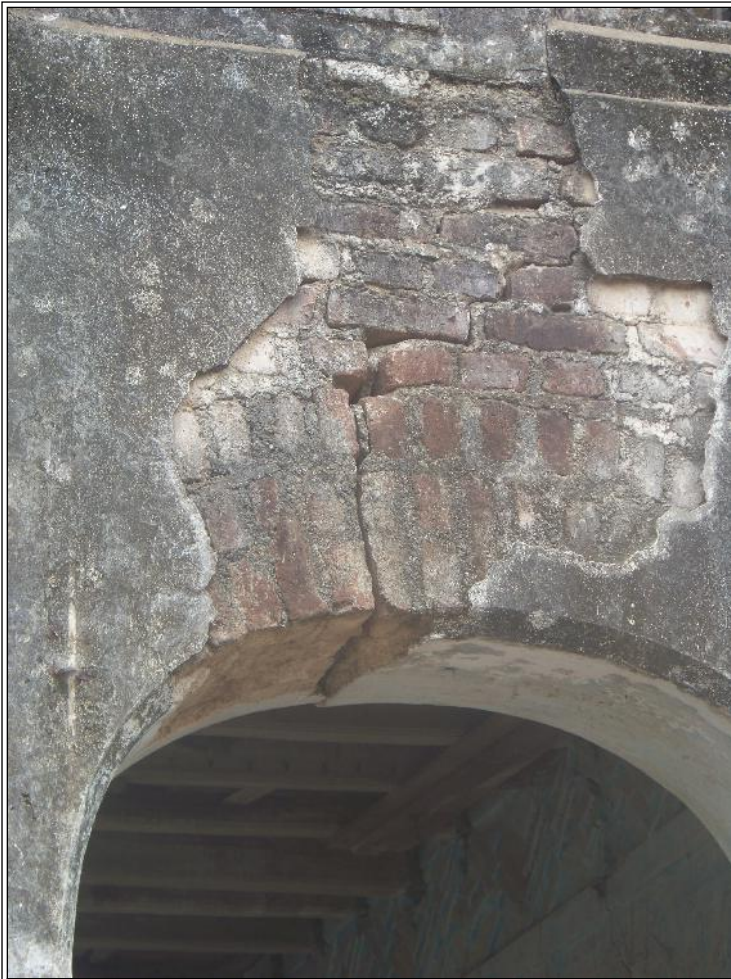
3.01	Height	4.0 meters		
3.02	No. of Floors	Ground		
		Description	Problem/Threat	Condition
3.03	Structural System	Load bearing masonry walls with an arcaded front porch	Some arches show major structural cracks	Major Repair

4.01	D P Remarks	Landuse - Residential. The street abuts the Raigad Jilha Macchimar Madhyavarti Sahakari Sangha Limited premises on the West.
4.02	Overall Problems & Threats	Incongruent addition of top floor resulting in overloading and hence structural deterioration. The building is neglected without any maintenance

4.03	Additional Notes	Willfully ornamented facade needs to be specially mentioned as an important characteristic of the structure. Some of the cracks are significant and run throughout the facade. They could be indicative of uneven settlement of part of the building.

Image Title: Raigad Jilha Macchimar Sangha Ltd.
Image Type: Top-View
Reference: Cracked arches in need of structural repairs

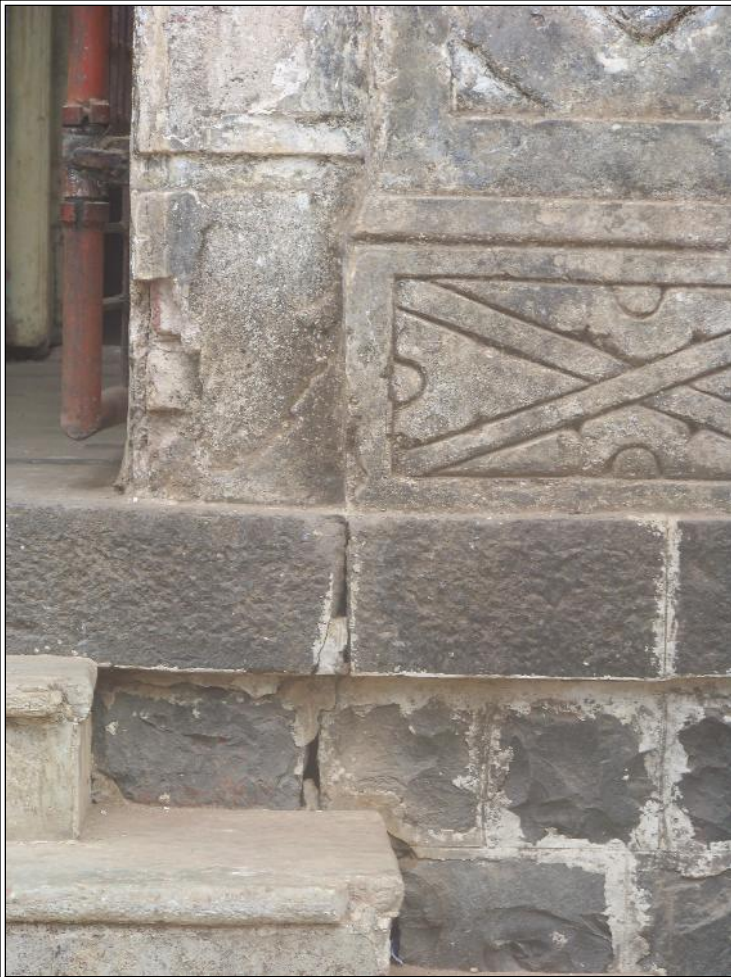
3.04	Plinth	Dressed stone masonry with rubble infill	Plinth protection is required	Minor Repair
3.05	Walls	Plastered Brick	Plaster has fallen off in many areas though the brickwork seems to be in order.	Minor Repair

Image Title: Raigad Jilha Macchimar Sangha Ltd.
 Image Type: Front-View
 Reference: Detail view of plinth crack indicating possible differential brittleness

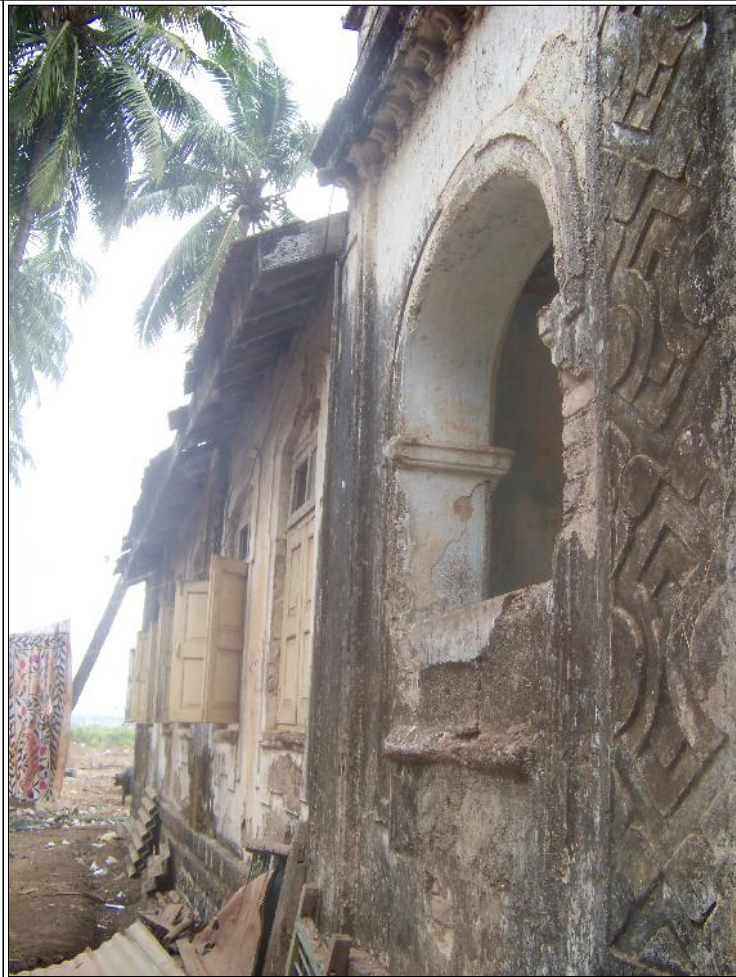
3.09	Roof	Flat roof with wooden framework underneath	NA	Minor Repair
3.10	Articulation	The entire front facade is filled with plaster stucco work.	Plaster peeling off, cracks	Major Repair

Image Title: Raigad Jilha Macchimar Sangha Ltd.
Image Type: Side-View1
Reference: Ornamental plaster work around arches

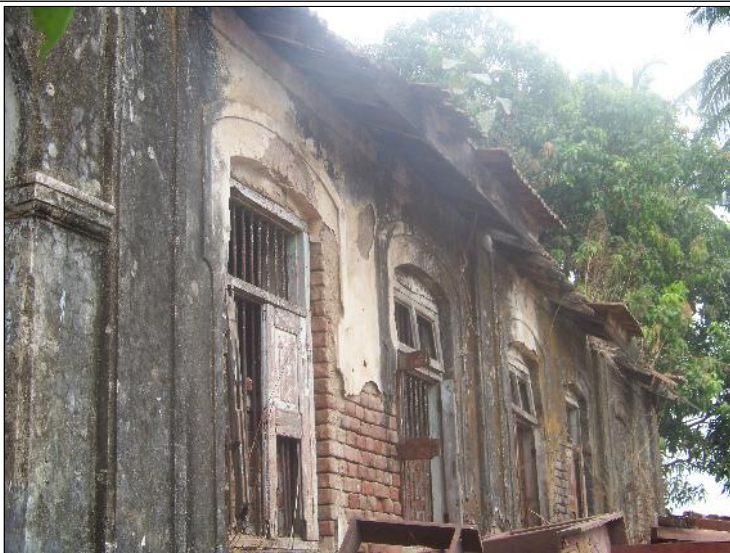
3.07	Stairs	NA	NA	-
3.08	Openings	Wooden framed shutters with timber panel infill and round cast iron bar grill	Damaged shutters, rusted grill, some infill panels missing	Major Repair

Image Title: Raigad Jilha Macchimar Sangha Ltd.
Image Type: Front-View
Reference: Dilapidated side openings

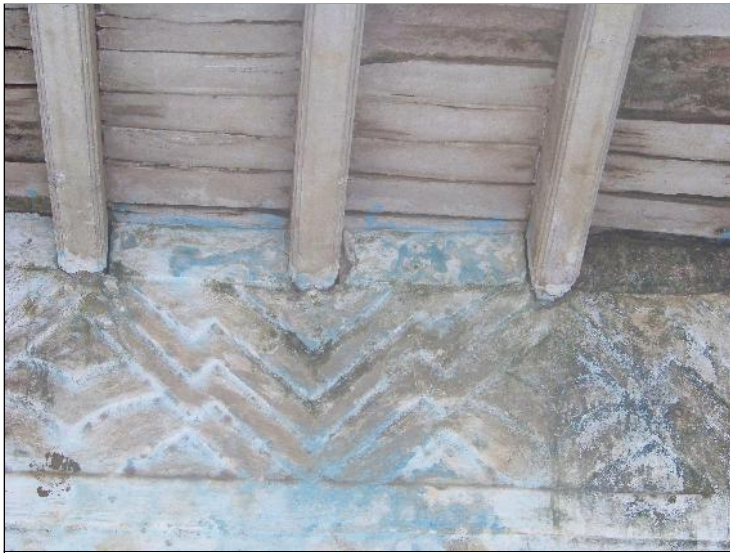
Image Title: Raigad Jilha Macchimar Sangha Ltd.
Image Type: Top-View
Reference: Substructure of the roof with missing planks

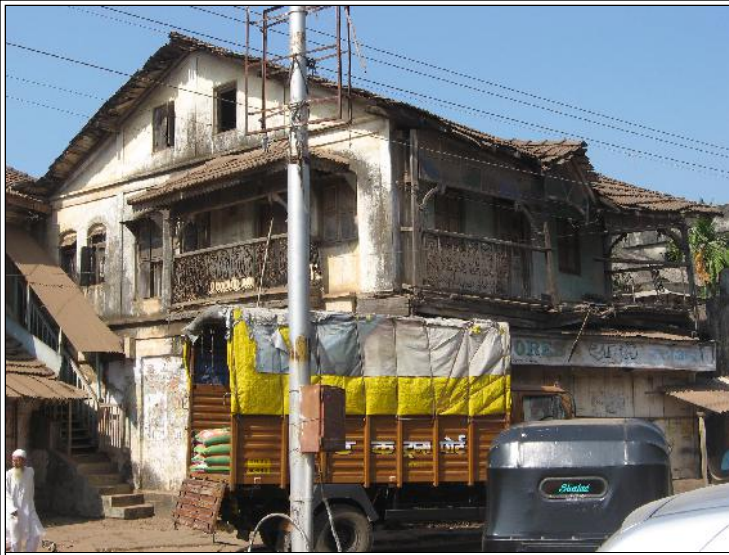
Image Title: Dia Sheth House
Image Type: Front-View
Reference: Front view of the house

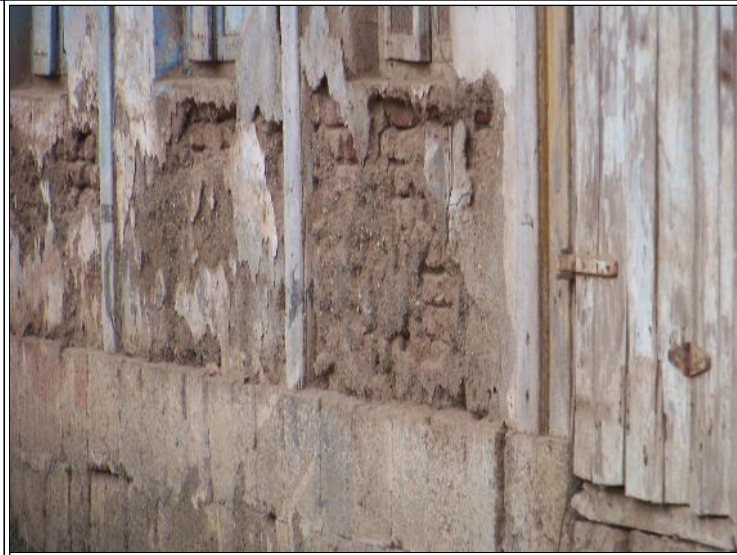
Image Title: Dia Sheth House
Image Type: Front-View
Reference: Condition of the wall

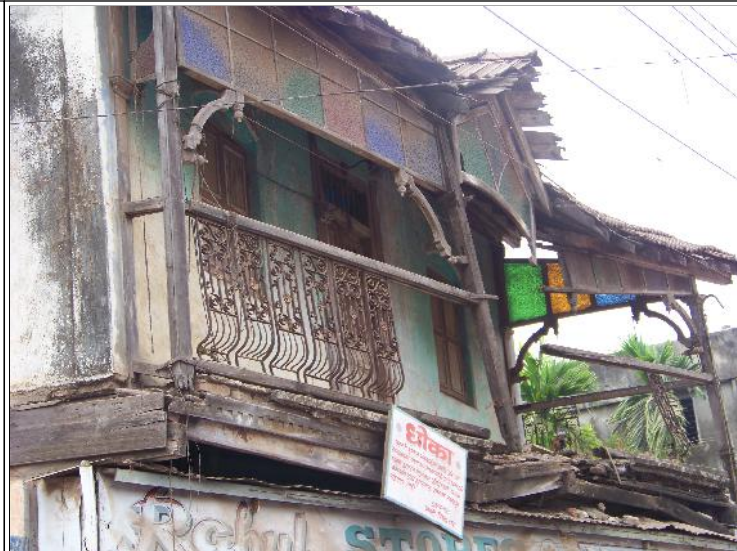
4.01	D P Remarks	Landuse -Commercial. The street abuts the Dia Sheth House premises on the East.
4.02	Overall Problems & Threats	Not maintained and not occupied.
4.03	Additional Notes	Extremely dilapidated and vacant building, could be acquired by Alibag municipal council.
4.04	References	
	Books/Documents	Amrut Mahotsav smaranika, shri vithal sansthan, Dahivali, 1990. Apte B.K. A history of the Marathi Navy and Merchantships, State Board for literature and culture, Bombay, 1973. Avalaskar Shantaram, Angrekalin Ashtagar, BISM, Pune, 1947. Dabu D G Kulabkar Angre Sarkhel. Datar Shridhar Hari. Datar Kulvrittanta, Pune 1974. Gupta Rupa Raje, The wada of Maharashtra an Indian courtyard house form. Unpublished Ph.D. thesis, Welsh school of Architecture, Cardiff. Harvande Geeta, Pen, Granthali Dn
	WebSites	NA
	Persons	NA

Image Title: Dia Sheth House
Image Type: Front-View
Reference: Dilapidated first floor

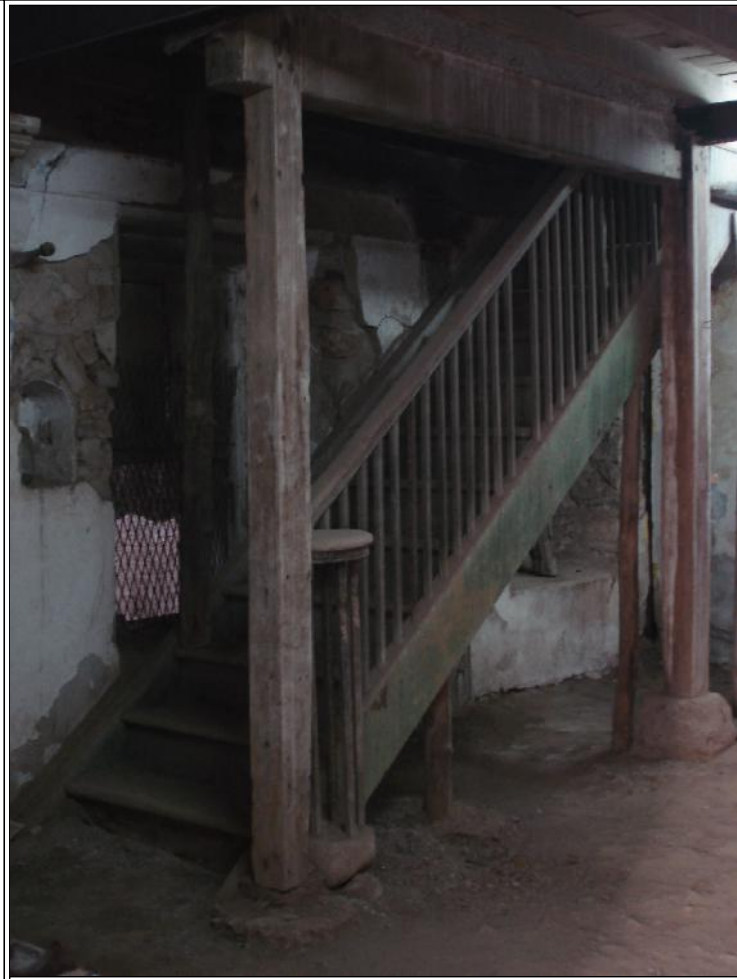
Reference: Internal staircase connecting to first floor (Now Demolished) the

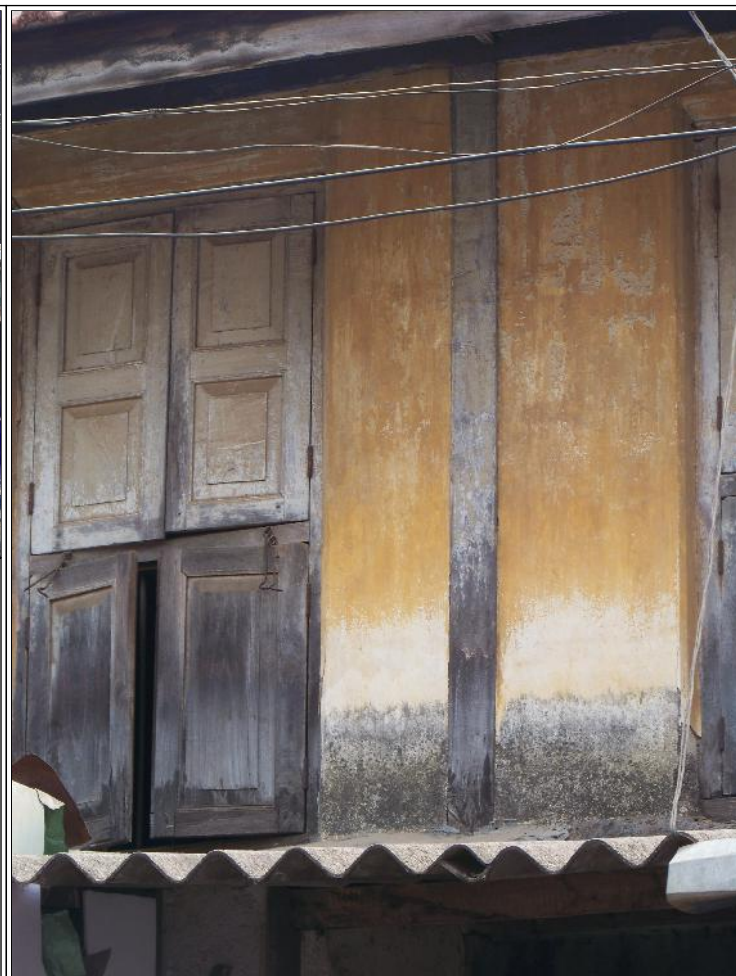
Image Title: Gujrati Mahajan House
Image Type: Front-View
Reference: Double shuttered windows on first floor walls show evidence of water seepage

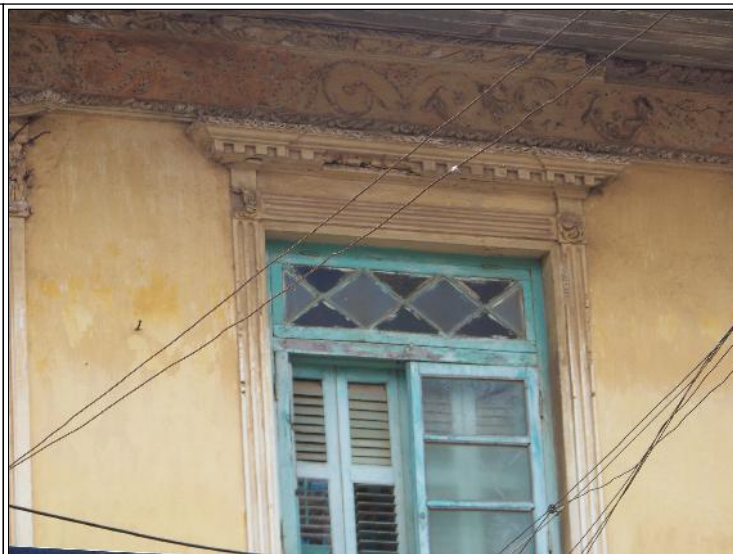
Image Title: Gurjar House
Image Type: Front-View
Reference: Detail view of window on first floor

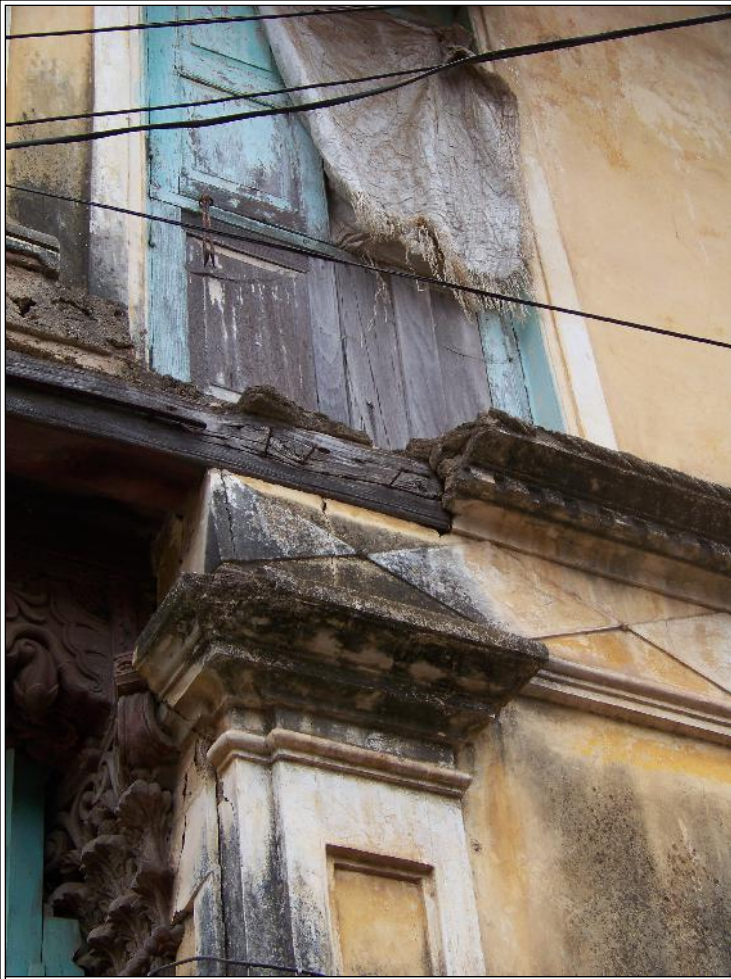
Reference: Damaged broken plaster work and growth of moss

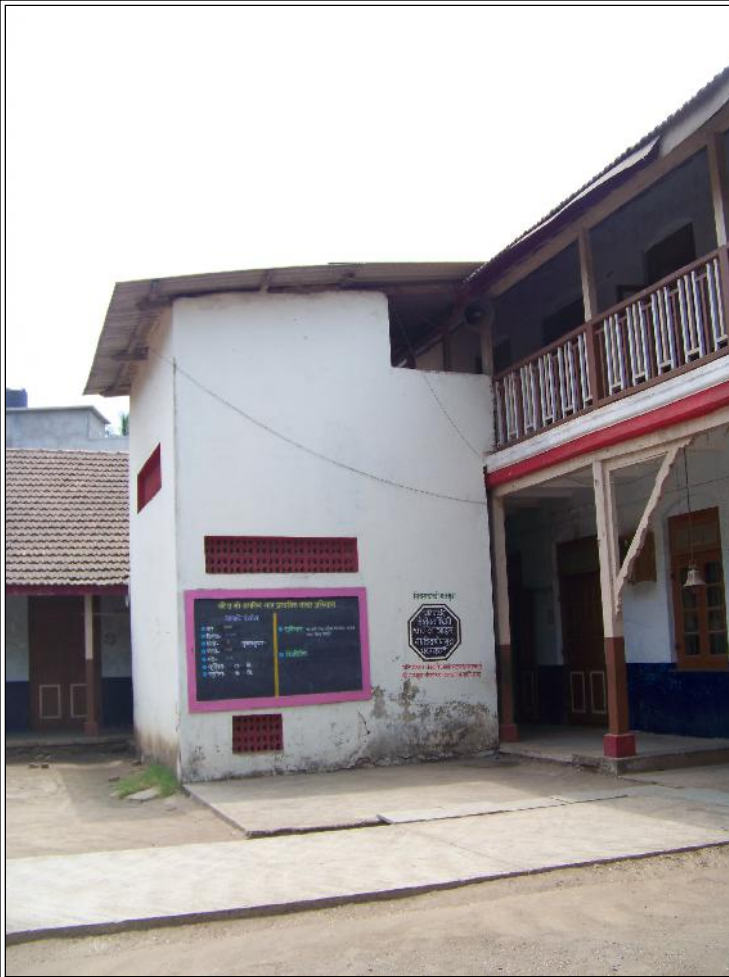
Image Title: Haldavanekar School
Image Type: Front-View
Reference: Staircase block added later

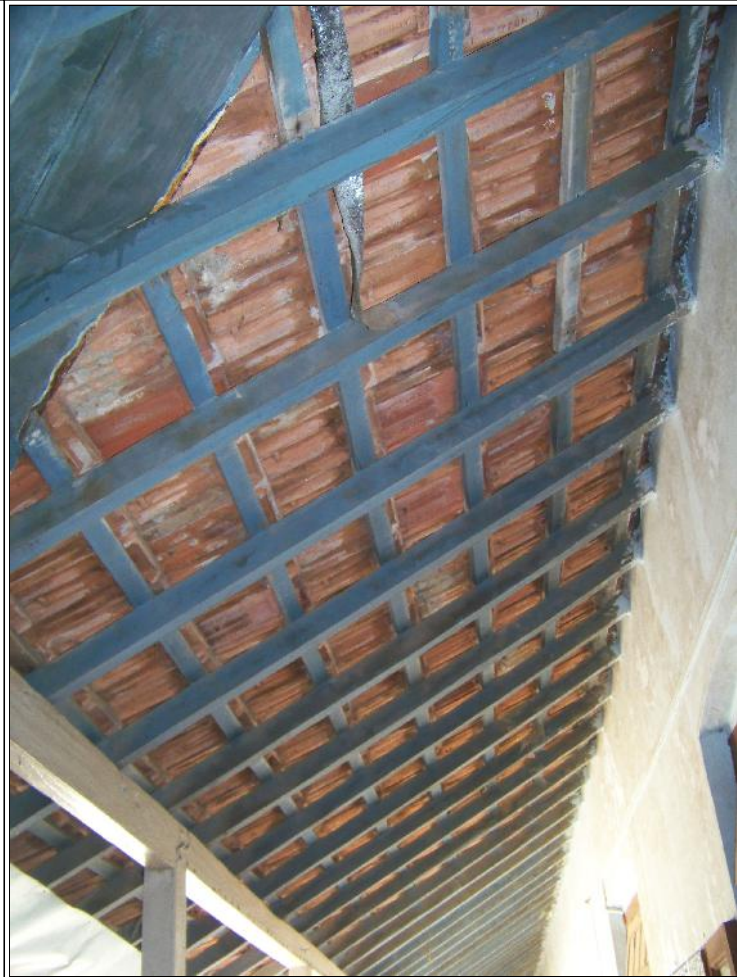
Image Title: Haldavanekar School
Image Type: Top-View
Reference: Lean to roof of verandah

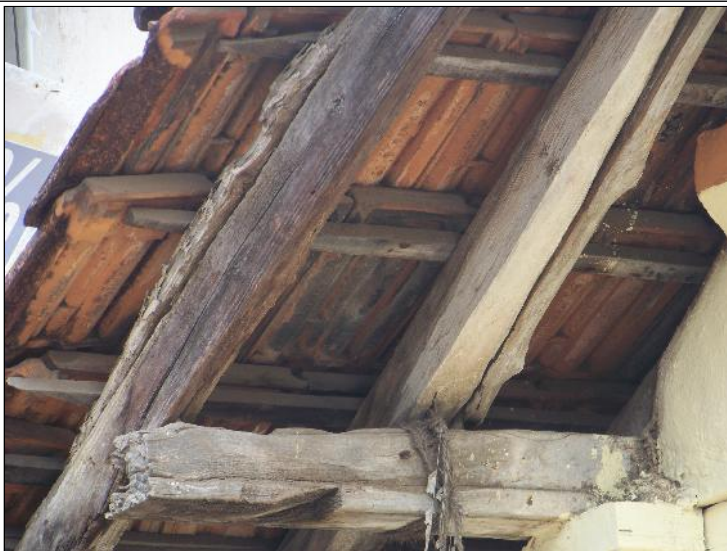
Image Title: Hanuman Mandir
Image Type: Top-View
Reference: Mangalore tile roofing over undressed timber members

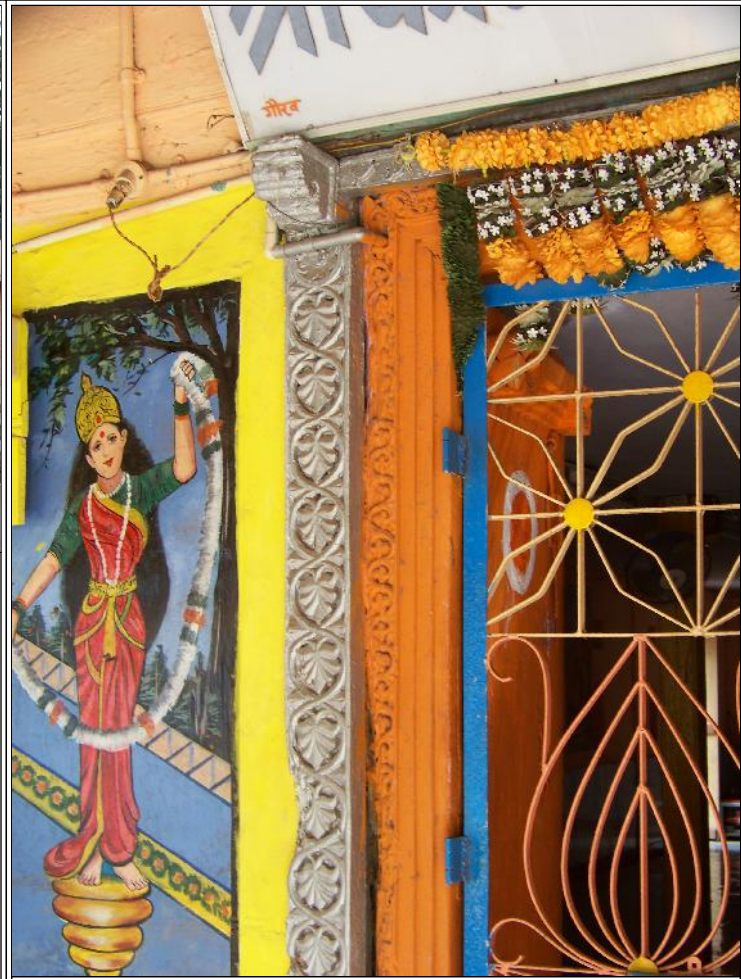
Image Title: Kalambika Mandir
Image Type: Front-View
Reference: Recent additions of grill and oil painting on the side

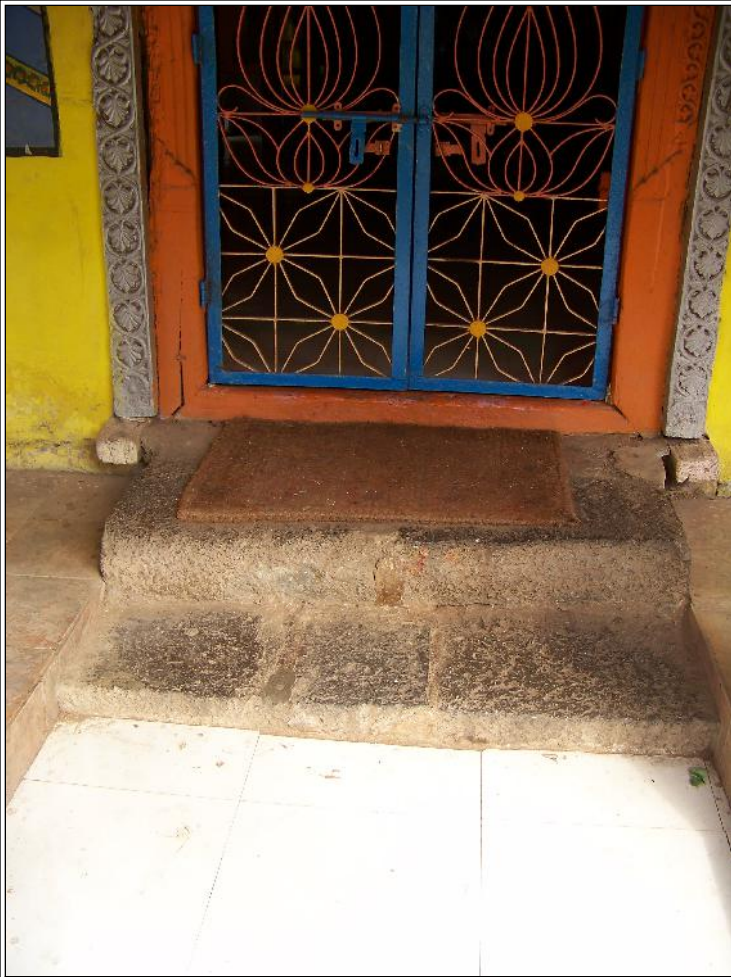
Image Title: Kalambika Mandir
 Image Type: Front-View
 Reference: Old stone steps with recently added the flooring

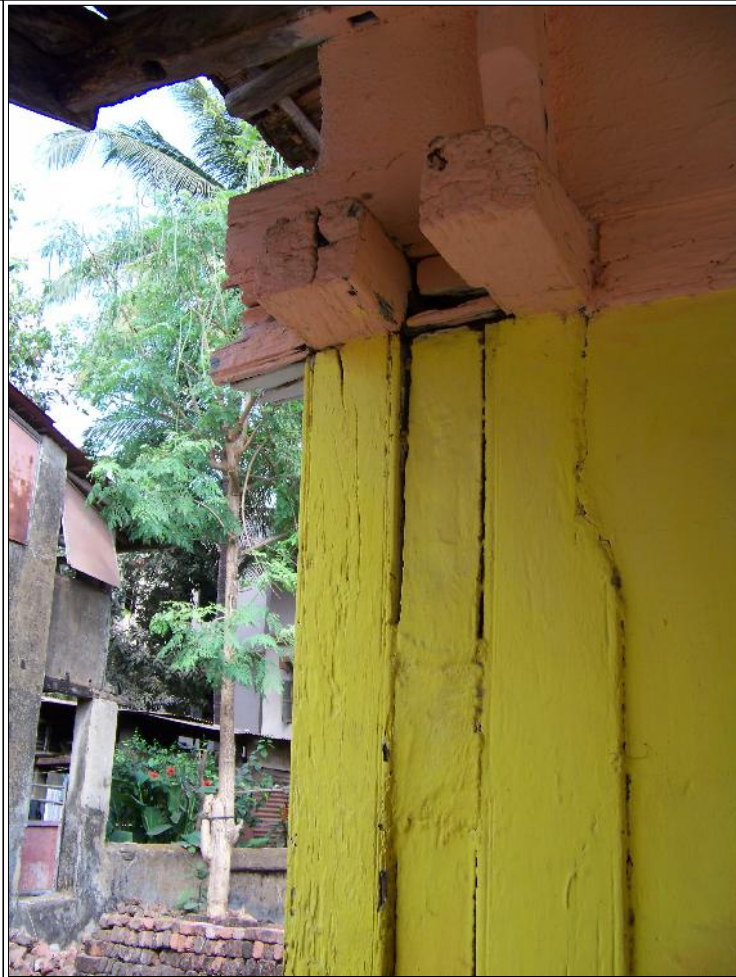
3.01	Height	6.0 meters		
3.02	No. of Floors	Ground + Attic		
		Description	Problem/Threat	Condition
3.03	Structural System	Timber frame structure with brick infill walls	The wood has cracked in some places. the joinery needs to be checked	Minor Repair

3.07	Stairs	Timber	NA	Minor Repair
3.08	Openings	Wooden frame windows with infill wooden panels	Paint flaking and cracking of wood	Minor Repair
3.09	Roof	Mangalore tiles on timber framing	NA	Minor Repair

3.10	Articulation	The main door frame is carved. otherwise it is a very plain structure	The carving needs to be cleaned and re polished.	Minor Repair
3.11	Finishes	Plastered painted	NA	Good

Image Title: Kalambika Mandir
 Image Type: Top-View
 Reference: Woodwork of the temple in need of repairs

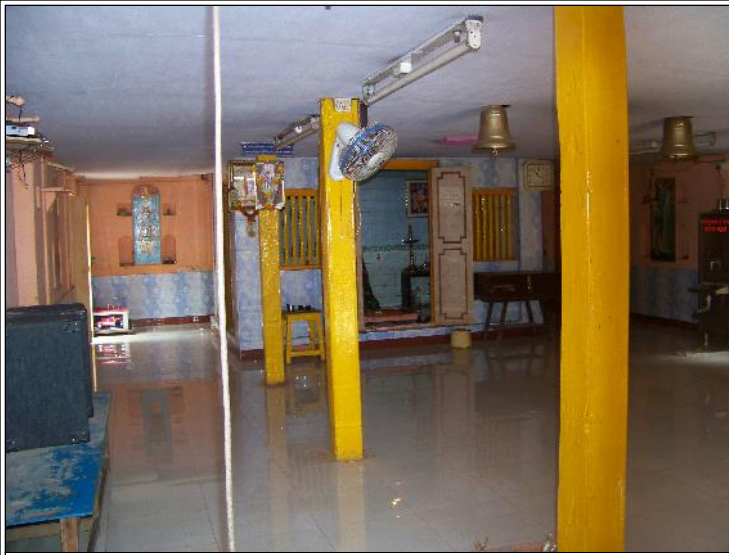
Image Title: Kalambika Mandir
Image Type: Top-View
Reference: Internal view of the temple showing oil paintings and vitrified tile flooring

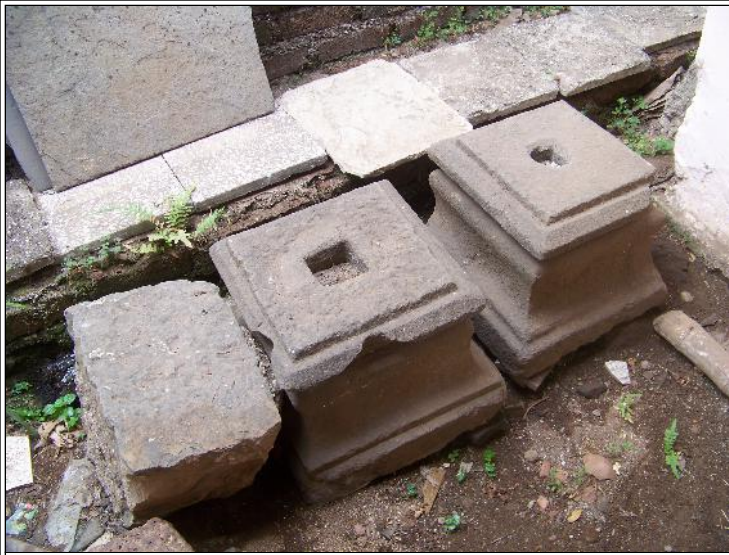
Image Title: Shree Kashivishweshwar Mandir
Image Type: Front-View
Reference: Column bases lying outside the temple

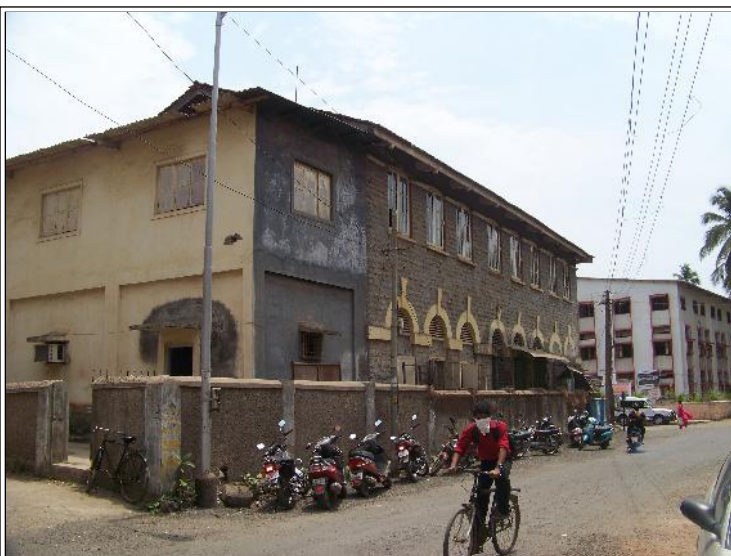
Image Title: Keluskar College
Image Type: Side-View1
Reference: Corner view showing adhoc changes / repairs to the facade

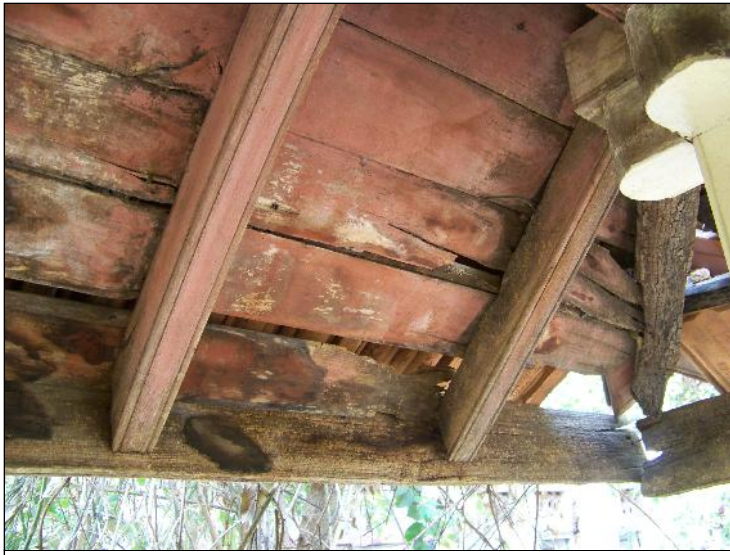
Image Title: Laxmi Narayan Mandir
 Image Type: Top-View
 Reference: Neglected part of the roof in need of repairs
