HERITAGE SITES IDENTIFIED IN THE STUDY AREA

MUMBAI METROPOLITAN REGION HERITAGE CONSERVATION SOCIETY

Record Details for Hazrat Alishah Darbar

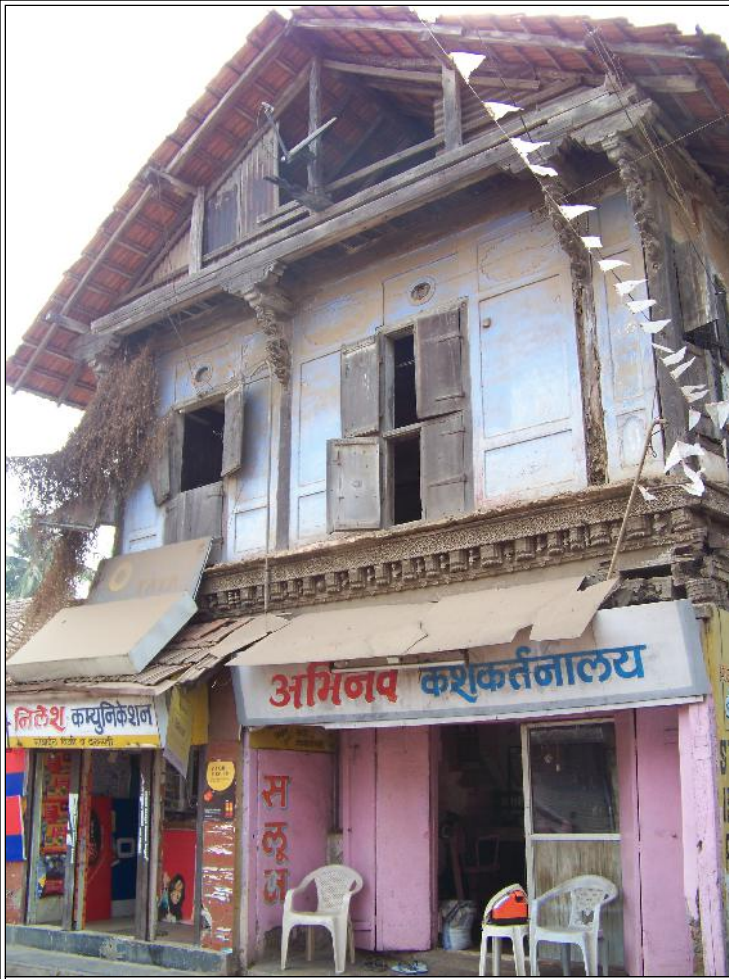
3.20	Other(Fire protection, HVAC, Security etc)	None	NA	Minor Repair
3.21	Incongruent Transformation	Adhoc additions at ground level. Signboards in various forms and style and incongruous adhoc addition on ground floor consisting of extensions of plinths, awnings in G.I. Sheet. etc.		
3.22	Overall Maintenance Status	Poor Maintenance		
3.23	Overall Condition	Major Repair

Image Title: Modi Wada
Image Type: Front-View
Reference: Front view showing dilapidated attic and ground level with incongruent additions

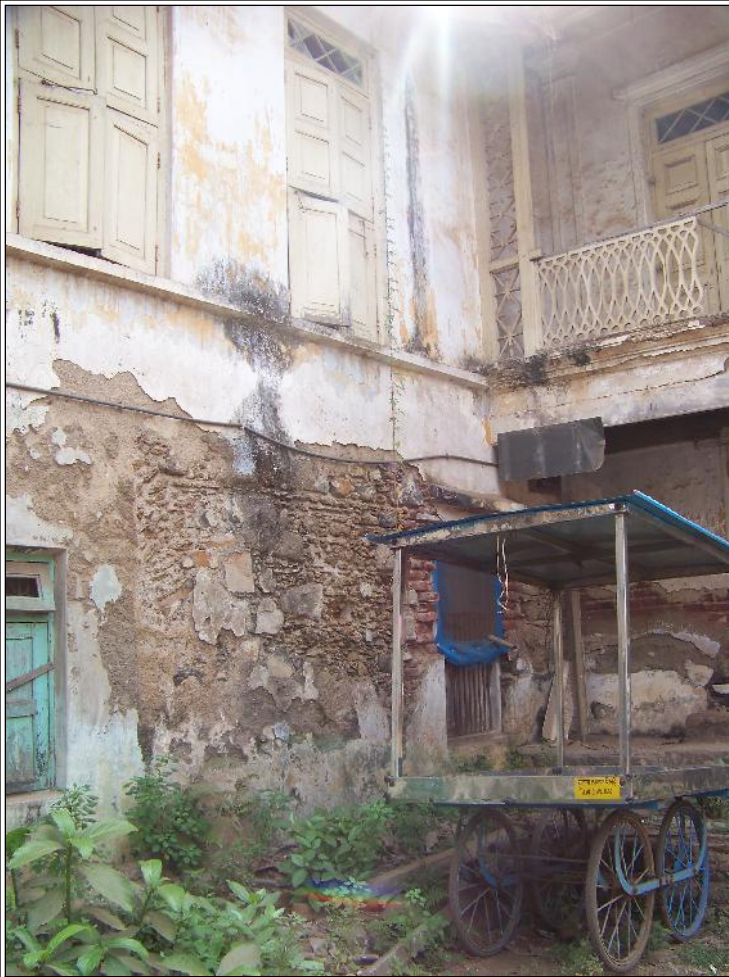
3.04	Plinth	Dressed stone plinth with rubble infill.	NA	Minor Repair
3.05	Walls	Brick walls with plaster. Exposed wooden columns on the surface	Plaster has fallen at many places and has cracks at many other. Vegetation growth was observed in the front facade	Major Repair

3.11	Finishes	Plastered painted	Plaster has fallen in many parts, cracks in number of locations	Major Repair
3.12	Furniture	No lose furniture of note	NA	-

Image Title: Modi Wada
 Image Type: Rear-View
 Reference: Rear elevation showing damage to facade

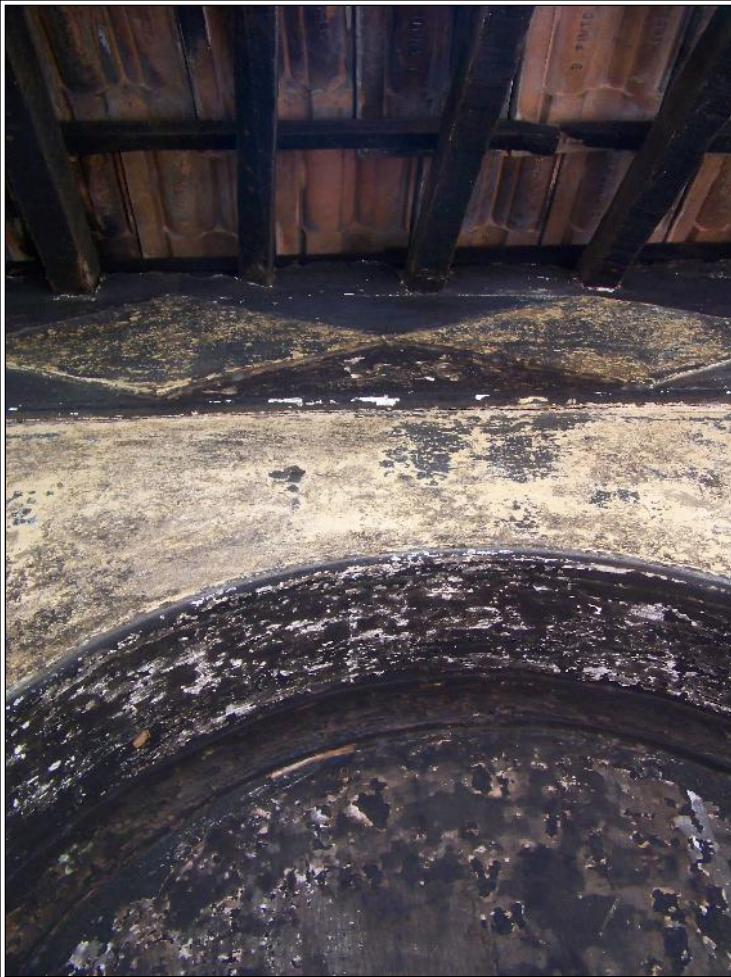
Image Title: Modi Wada
Image Type: Top-View
Reference: Part of wall damaged due to water

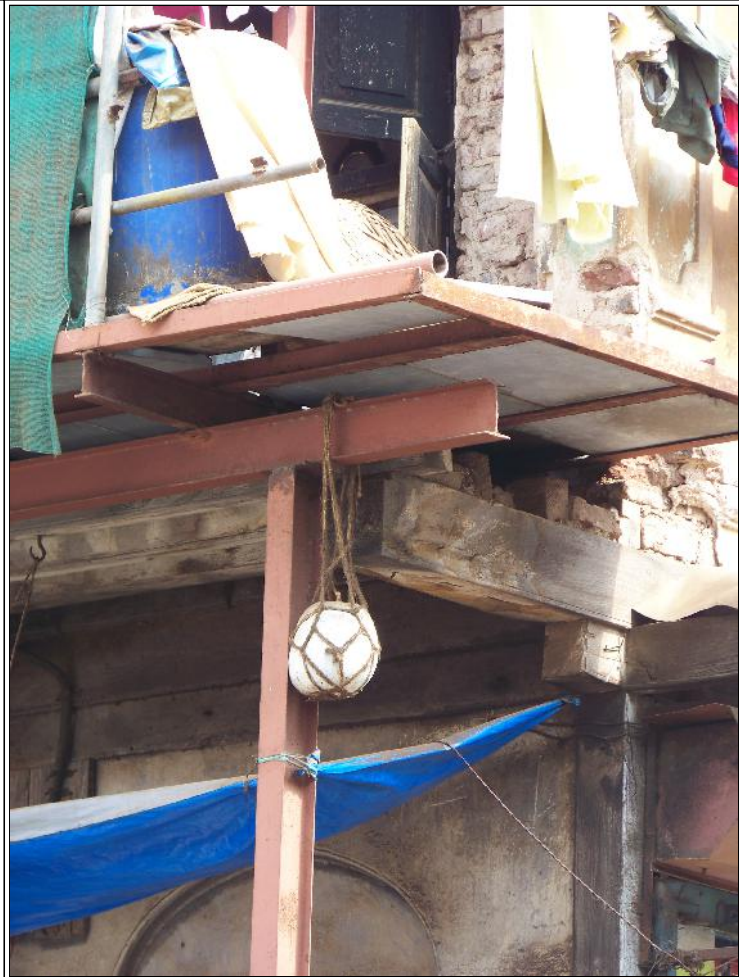
3.01	Height	6.0 meters		
3.02	No. of Floors	Ground + 1 Upper		
		Description	Problem/Threat	Condition
3.03	Structural System	Masonry building with timber columns	One wall on the first floor has been removed and a balcony added.	Major Repair

Image Title: Modi Wada
Image Type: Top-View
Reference: Incongruent MS Supports added to Balcony

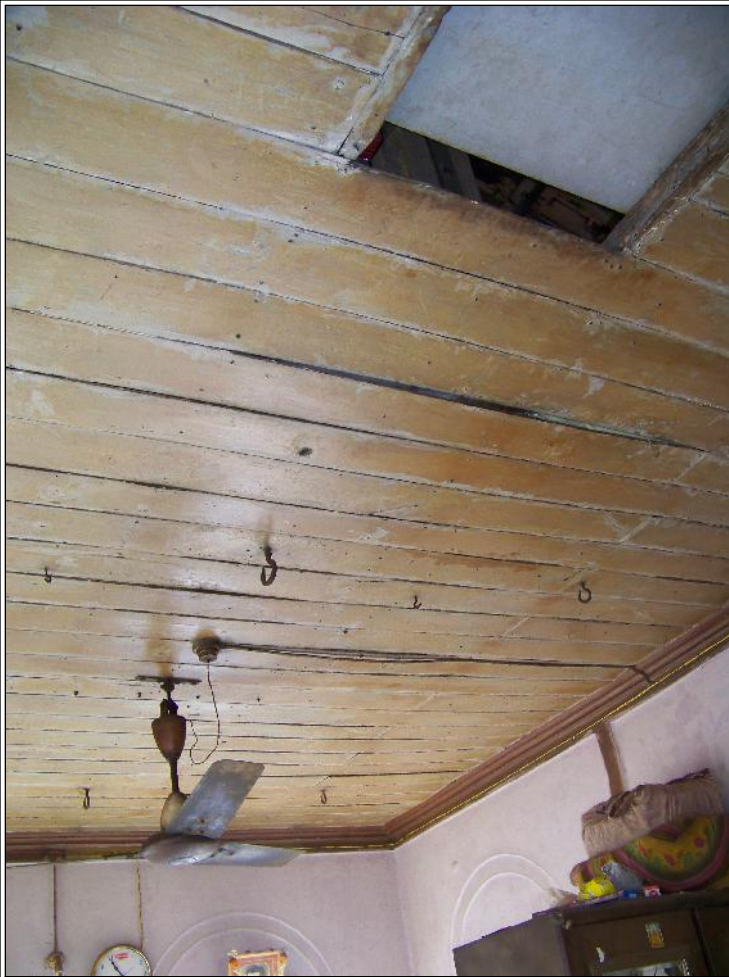
3.09	Roof	Mangalore tiles on timber framing concealed by wooden plank false ceiling.	The wooden planks need to be reset	Major Repair
3.10	Articulation	Stucco work on walls and around openings is the main area of articulation and has obvious colonial influences.	Flaking and aeging	Major Repair

Image Title: Modi Wada
Image Type: Top-View
Reference: Wooden False Ceiling on First Floor

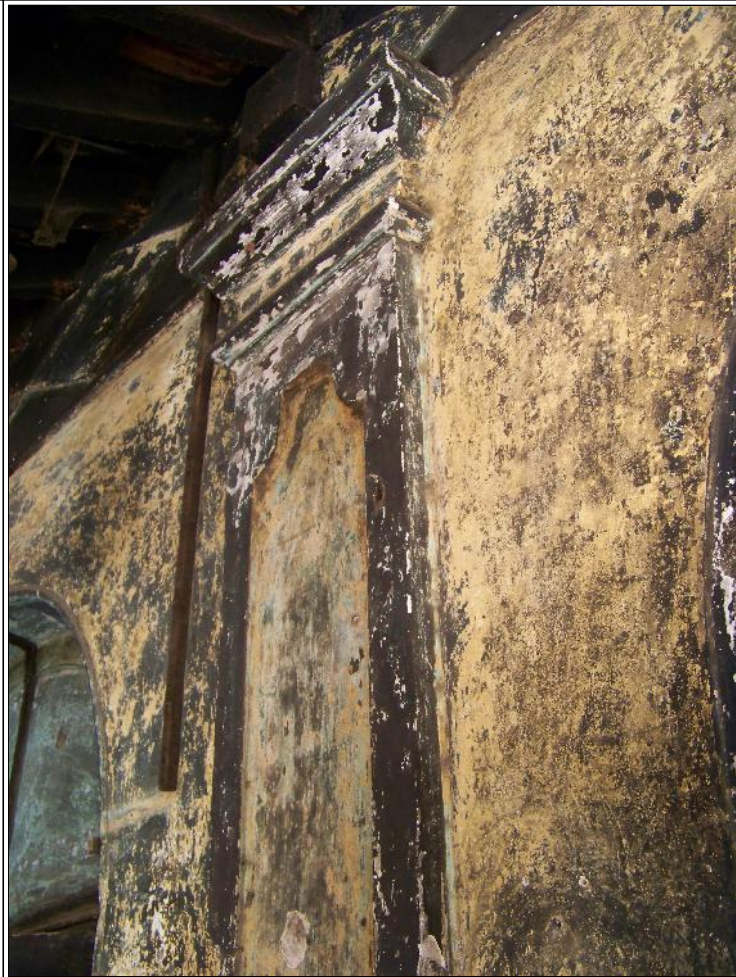
Image Title: Modi Wada
Image Type: Front-View
Reference: Part of wall damaged due to water

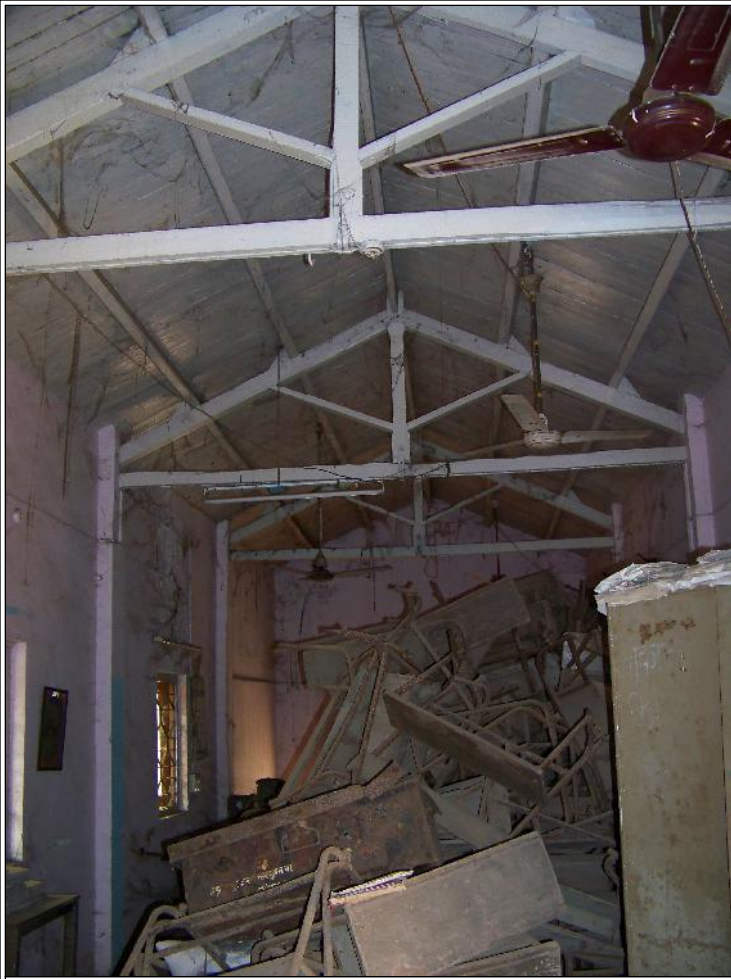
Image Title: Old Nagar Parishad
Image Type: Top-View
Reference: Neglected First Floor

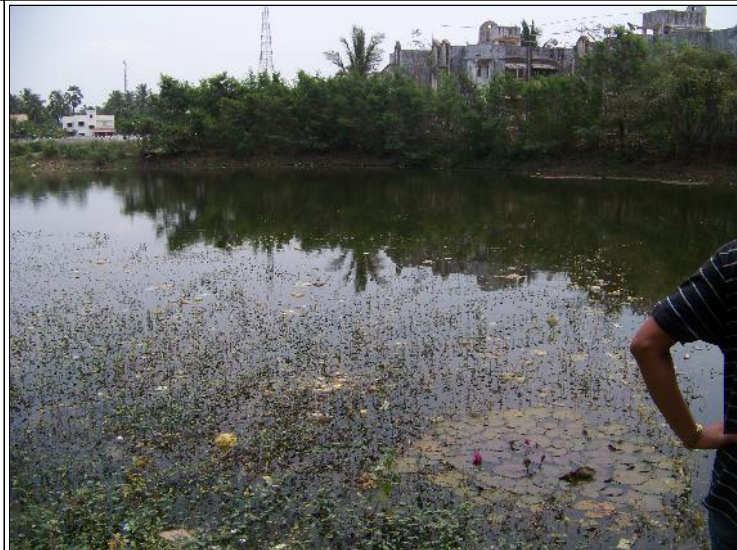
4.01	D P Remarks	Landuse - Gardens / Play Ground. It is marked as a recreation ground on the DP. The non recognition as a water body is a cause of serious concern.

Image Title: Ramwadi Tale
Image Type: Front-View
Reference: Lake getting surrounded with residences

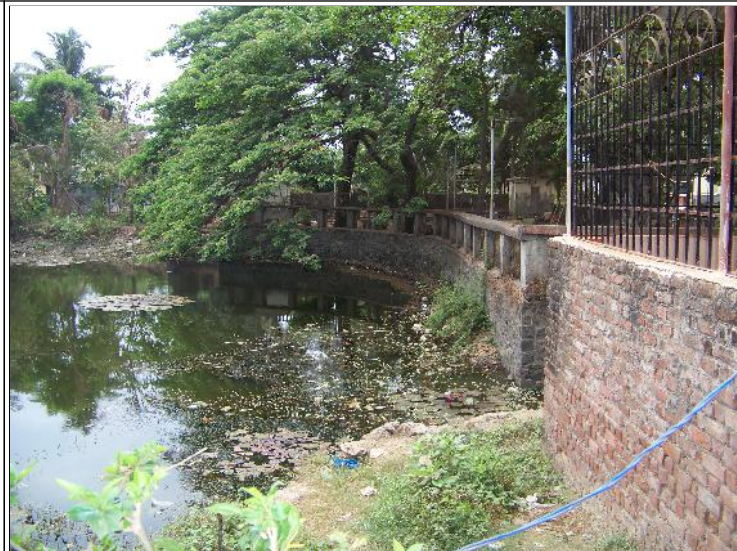
3.17	Electricity	NA	NA	-
3.18	Water Supply	NA	NA	-
3.19	Plumbing & Drainage	Some surface drainage inlets were observed on the edges	Need to be treated before opening into the lake	Major Repair

Image Title: Ramwadi Tale
Image Type: Front-View
Reference: Built Edge of the Lake with some Drainage inlets

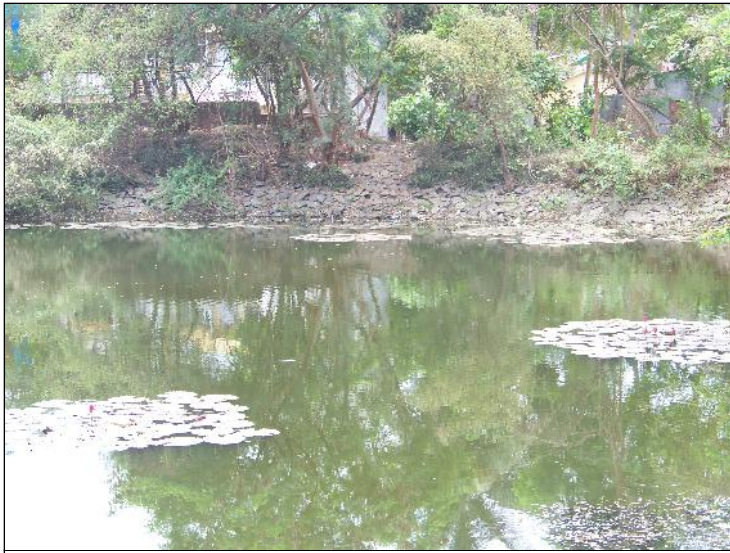
3.06	Floors	NA	NA	-
3.07	Stairs	NA	NA	-
3.08	Openings	NA	NA	-
3.09	Roof	NA	NA	-
3.10	Articulation	NA	NA	-
3.11	Finishes	NA	NA	-
3.12	Furniture	NA	NA	-
3.13	Compound/Fence/Gate	The lake has a pitched stone embankment along half of its perimeter. The other half has a very loose edge fringed with occasional trees	NA	Minor Repair

Image Title: Ramwadi Tale
Image Type: Front-View
Reference: Unbuilt Edge, Needs protection

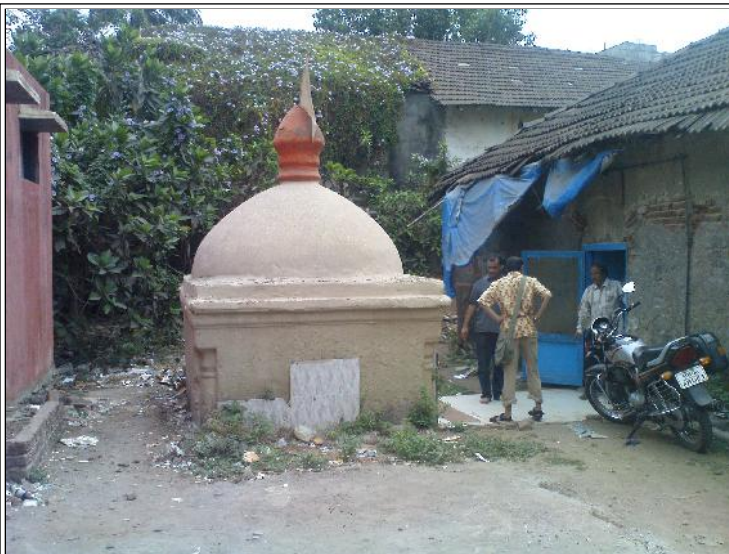
3.11	Finishes	Stone walls and masonry dome oil painted, tile cladding inside	The tiles and the paint are recent additions and need to be removed	Minor Repair

3.22	Overall Maintenance Status	The surrounds need to be cleared and the level lowered to expose the plinth		
3.23	Overall Condition	Major Repair

Image Title: Sati Asara Mandir
Image Type: Side-View1
Reference: Small Shrine of the Asaras (Water Deities) seen from the Road

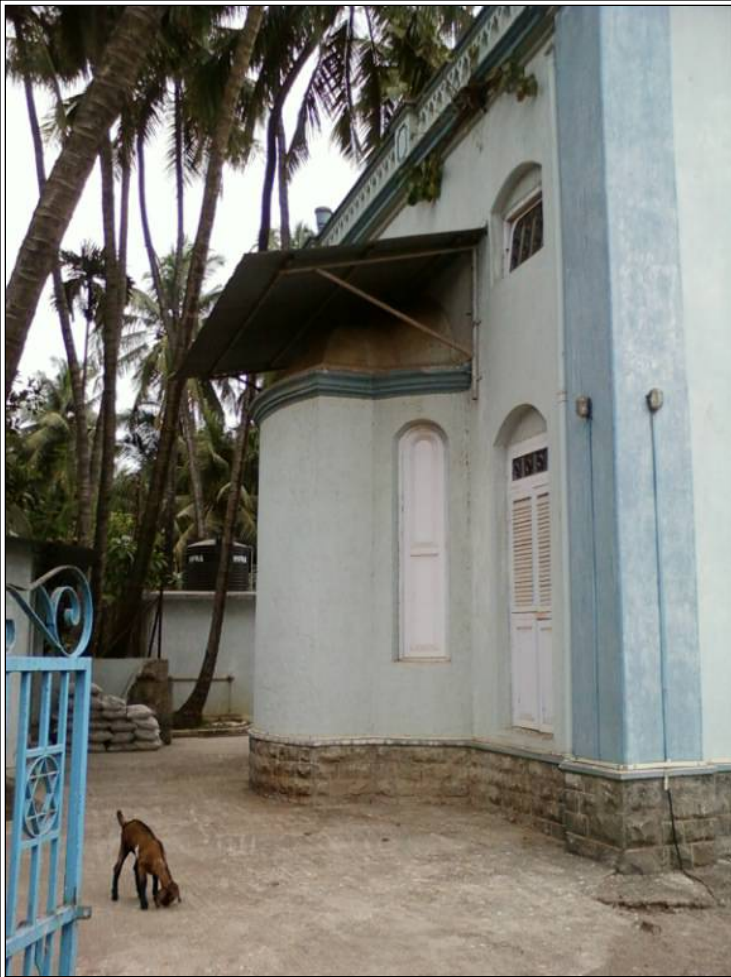
3.09	Roof	Flat	NA	Good
3.10	Articulation	Motifs in plaster, stained glass panes in windows	NA	Good
3.11	Finishes	The apse was earlier finished in mosaic tile work.	Mosaic tile work has been painted over	-

Image Title: Megan Aboth Synagogue
Image Type: Front-View
Reference: Apsidal End

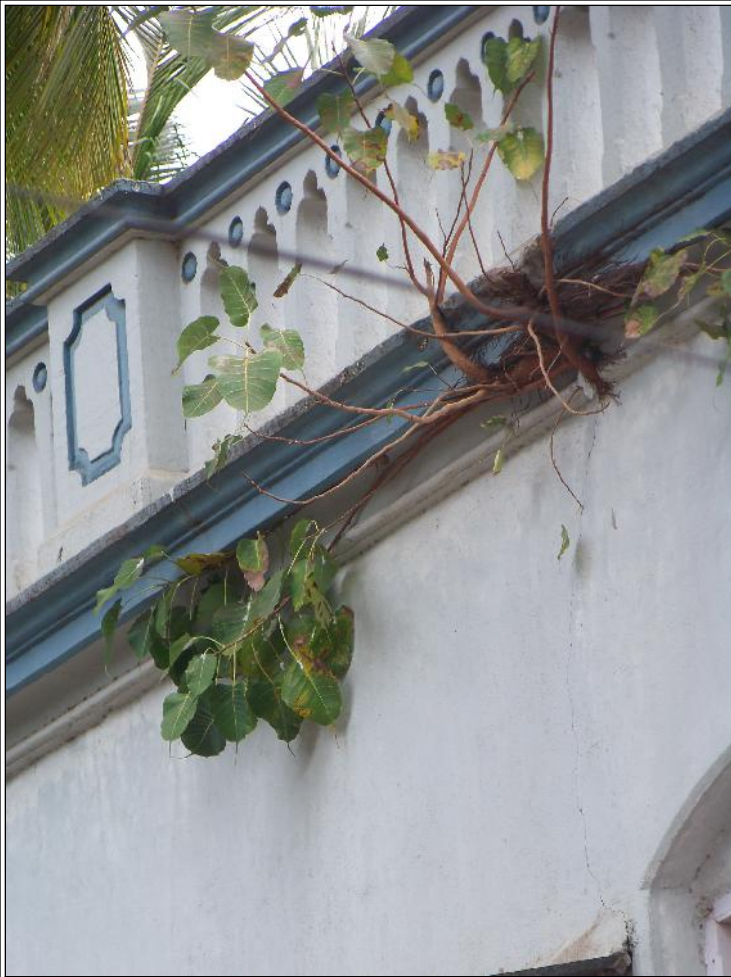
Image Title: Megan Aboth Synagogue
Image Type: Front-View
Reference: Vegetation Growth

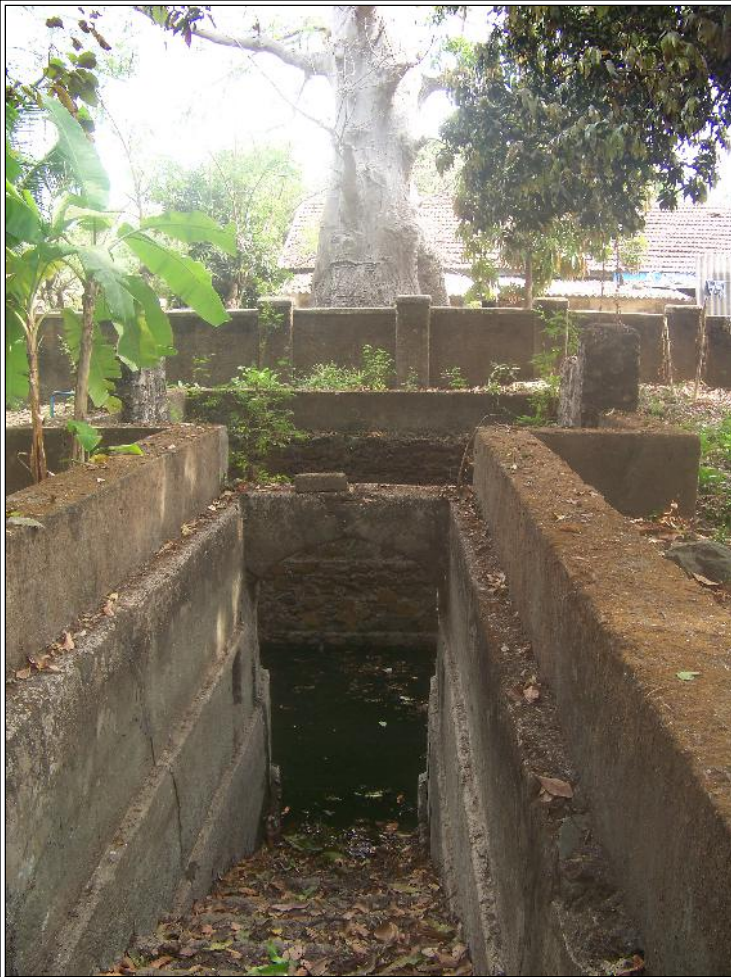
3.12	Furniture	The Mandir does not have any loose furniture to speak of.	NA	-
3.13	Compound/Fence/Gate	The compound wall has broken in many places. One gate of the possible four is still standing giving an idea of the articulation.	The plaster has fallen off and some bricks are loose. Needs immediate attention.	Major Repair

Image Title: Shriram Mandir
Image Type: Front-View
Reference: Dilapidated side entrance in threat of extinction due to neglect

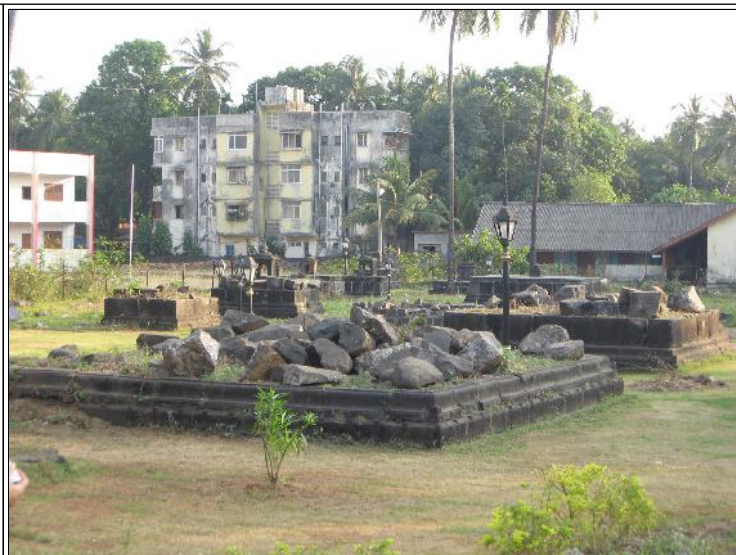
3.22	Overall Maintenance Status	A lot of loose stones and carved stones are scattered in the surroundings. The site is prone to thefts of stone artefacts and other vandalism.

Image Title: Angre Smarak
Image Type: Front-View
Reference: A View of the ruins

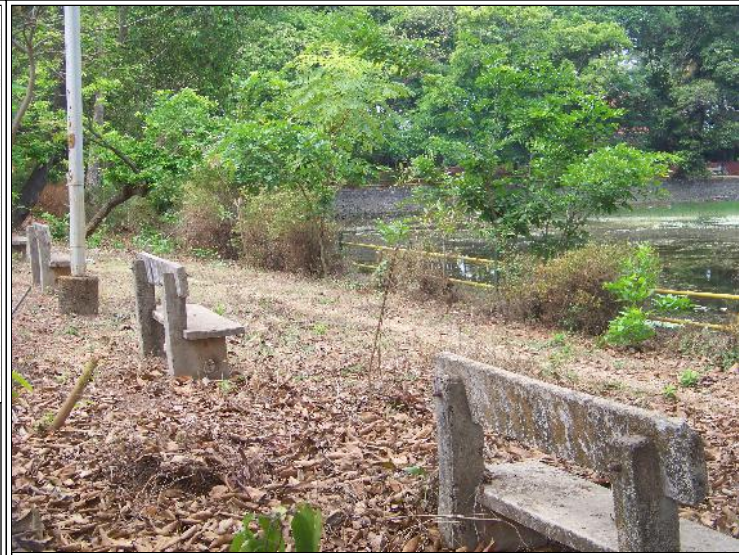
3.15	Lighting	Pole lights	Pedestals need minor repairs	Minor Repair
3.16	Ventilation	NA	NA	-
3.17	Electricity	Added later	NA	-
3.18	Water Supply	NA	NA	-
3.19	Plumbing & Drainage	Drainage inlet was observed	NA	Major Repair

Image Title: Hirakot Tale
Image Type: Front-View
Reference: Illmaintained lake surroundings

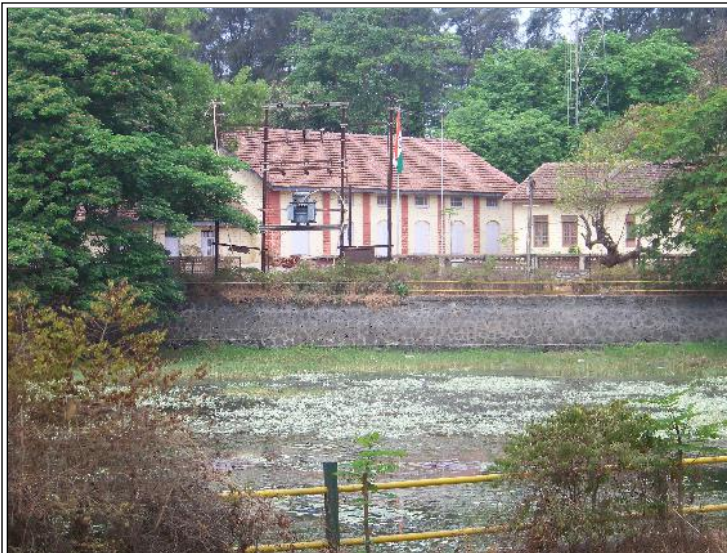
Image Title: Hirakot Tale
Image Type: Front-View
Reference: Illmaintained lake surroundings

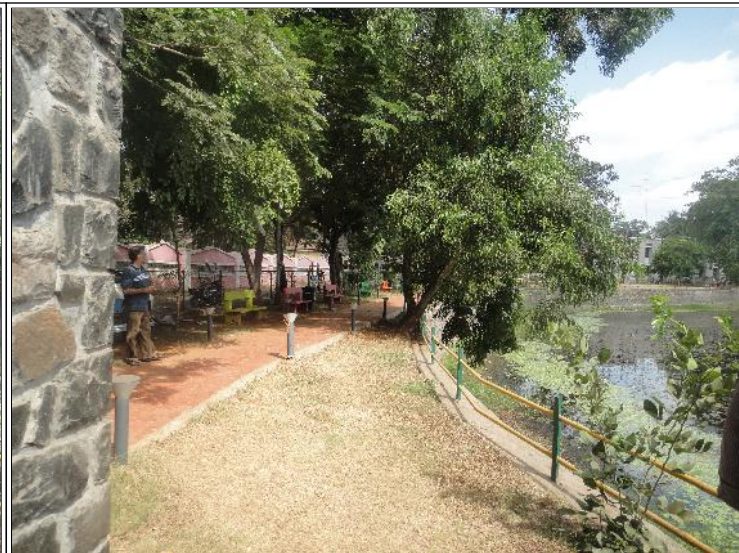
Image Title: Hirakot Tale
Image Type: Front-View
Reference: Newly constructed pathway around tale

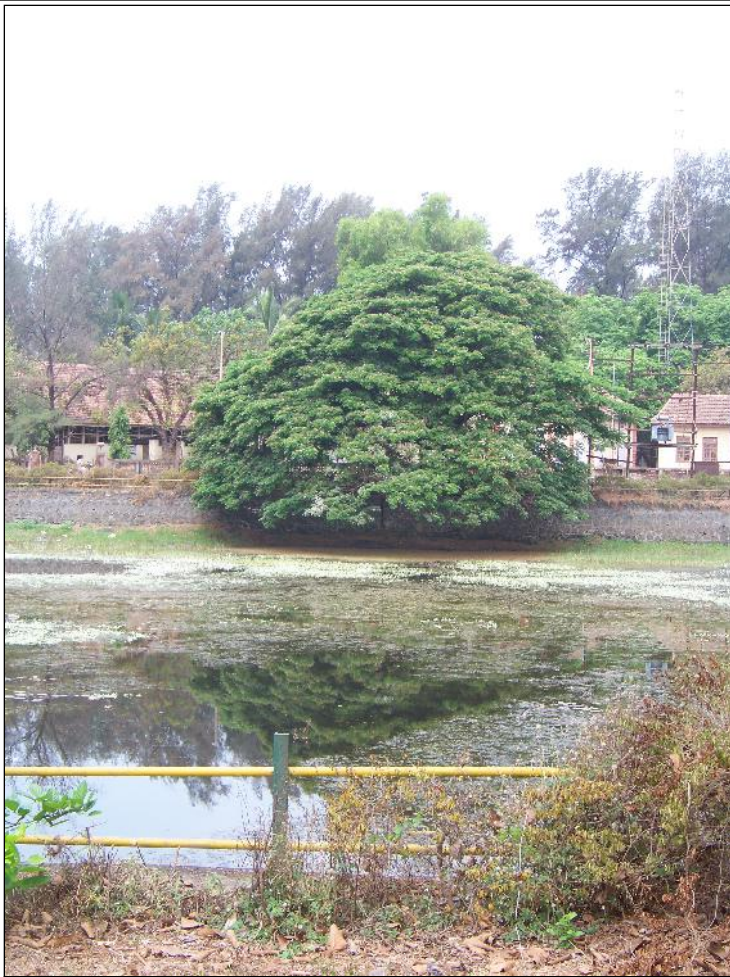
Image Title: Hirakot Tale
Image Type: Front-View
Reference: Water covered with weeds

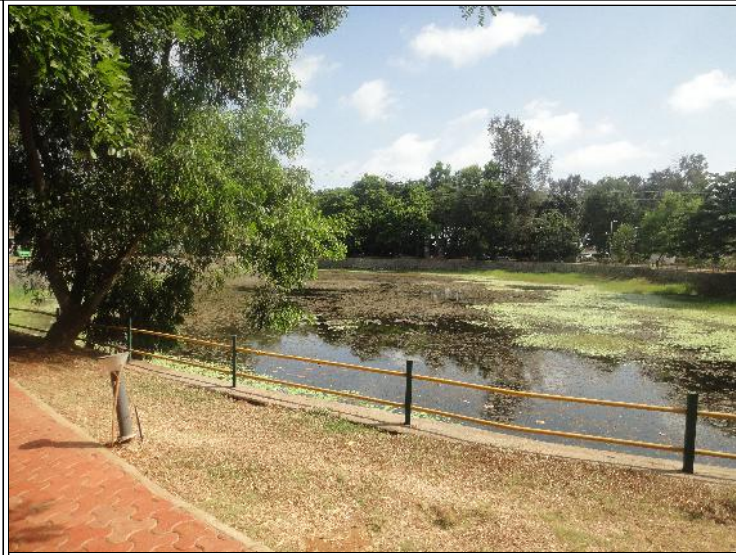
3.12	Furniture	NA	NA	-
3.13	Compound/Fence/ Gate	Chain link fencing with gate	NA	Minor Repair
3.14	Curtilage / unbuilt / space /out buildings / landscape	A strip of land around 8 to 10 m wide along the periphery	Needs cleaning and regular maintenance	Minor Repair

Image Title: Hirakot Tale
Image Type: Front-View
Reference: Fencing around tale

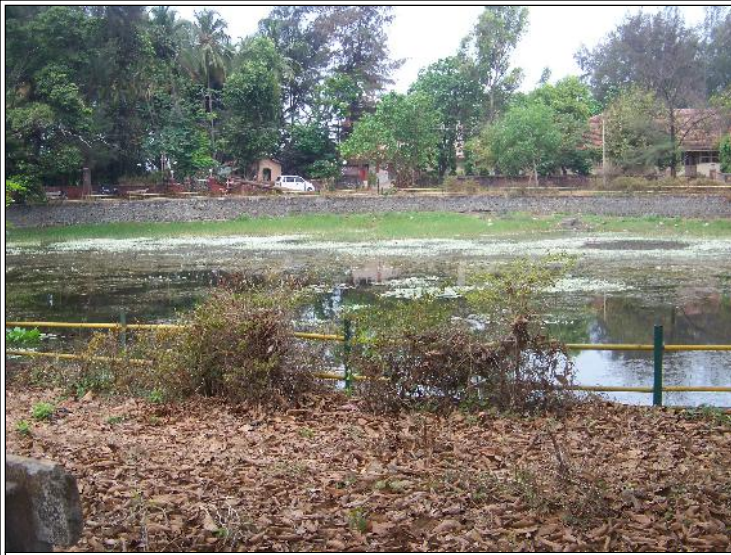
Image Title: Hirakot Tale
Image Type: Front-View
Reference: Illmaintained lake surroundings

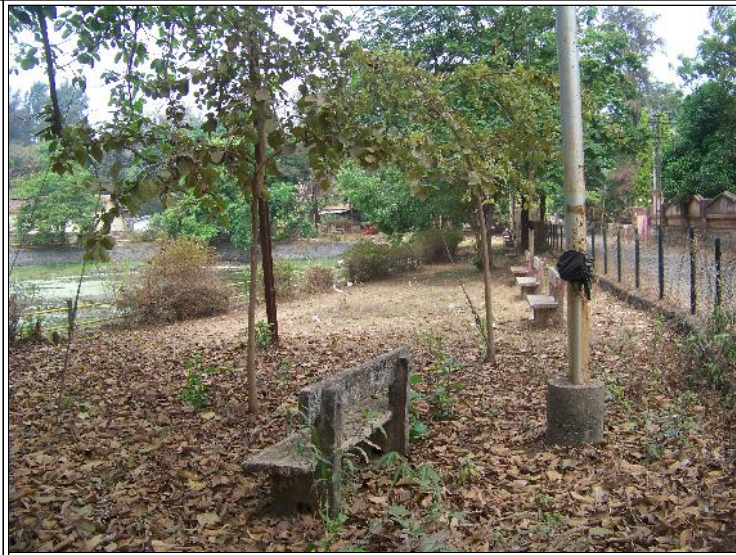
Image Title: Hirakot Tale
Image Type: Front-View
Reference: Illmaintained lake surroundings

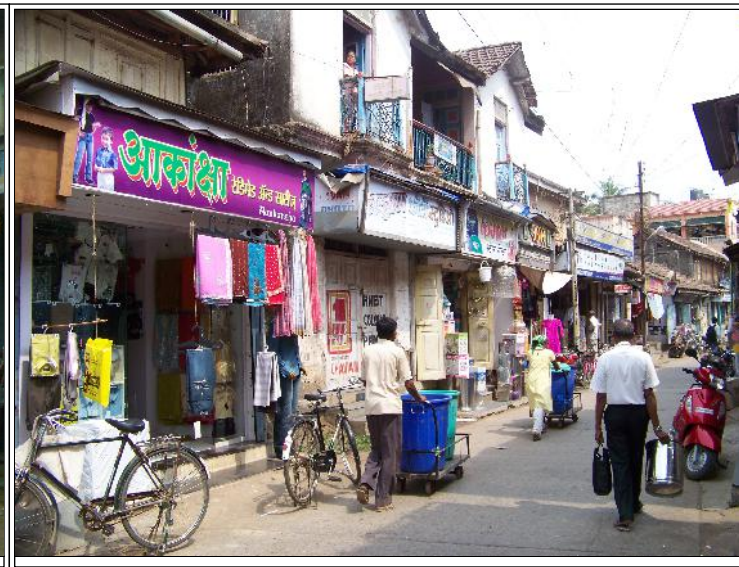
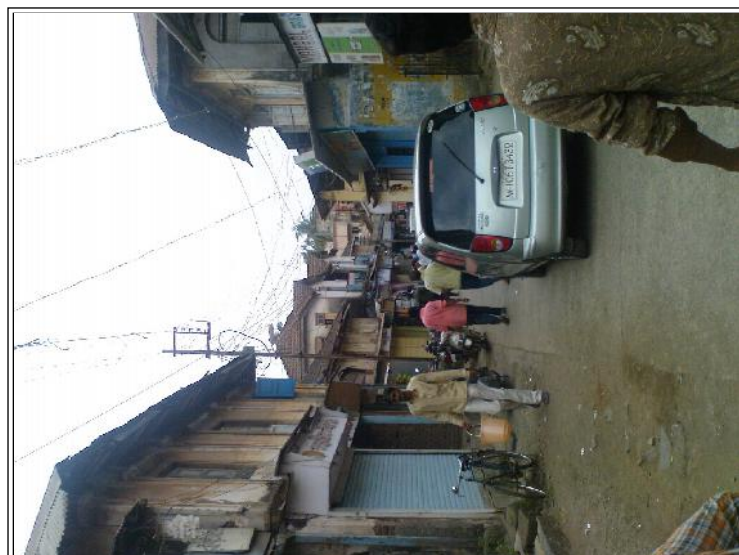
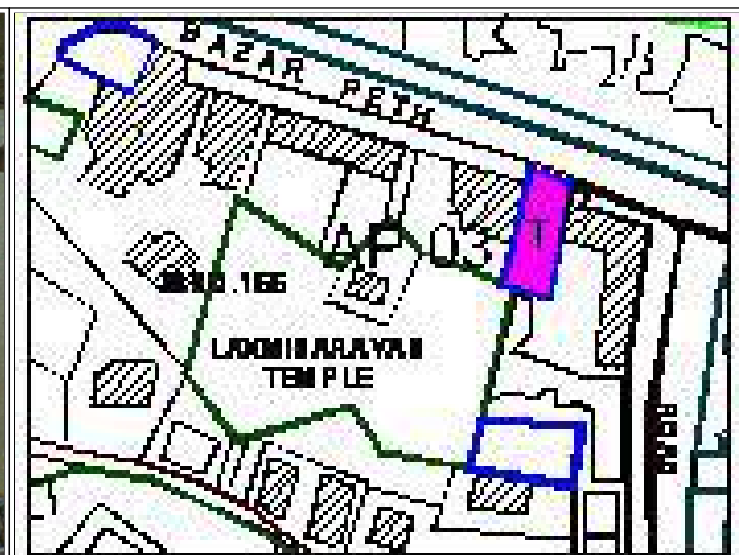
3.01	Height	Average height around 6.0 M.		
3.02	No. of Floors	Ground + 1 Upper		
		Description	Problem/Threat	Condition
3.03	Structural System	Load-bearing brick masonry walls with pilasters	NA	-
3.04	Plinth	Dressed stone masonry plinths with rubble infill	NA	-
3.05	Walls	Barck masonry walls	NA	-
3.06	Floors	Wooden framework with wooden planks covered with tiles	NA	-
3.07	Stairs	NA	NA	-
3.08	Openings	Rectangular openings with semicircular arches or flat lintels, infilled with wooden framed shutters.	NA	-
3.09	Roof	NA	NA	-
3.10	Articulation	NA	NA	-
3.11	Finishes	NA	NA	-
3.12	Furniture	NA	NA	-
3.13	Compound/Fence/Gate	NA	NA	-
3.14	Curtilage / unbuilt / space /out buildings / landscape	NA	NA	-
3.15	Lighting	NA	NA	-
3.16	Ventilation	NA	NA	-
3.17	Electricity	NA	NA	-
3.18	Water Supply	NA	NA	-
3.19	Plumbing & Drainage	NA	NA	-
3.20	Other(Fire protection, HVAC, Security etc)	NA	NA	-

3.21	Incongruent Transformation	NA
3.22	Overall Maintenance Status	NA
3.23	Overall Condition	Minor Repair

4.01	D P Remarks	Landuse - Shopping Line The street abuts the Bazar Peth Precinct premises on the South.
4.02	Overall Problems & Threats	'development' as per 'byelaws' is a big threat
4.03	Additional Notes	Needs form based codes to be drafted as per the character
4.04	References	
	Books/Documents	Amrut Mahotsav smaranika, shri vithal sansthan, Dahivali, 1990. Apte B.K. A history of the Marathi Navy and Merchantships, State Board for literature and culture, Bombay, 1973. Avalaskar Shantaram, Angrekalin Ashtagar, BISM, Pune, 1947. Dabu D G Kulabkar Angre Sarkhel. Datar Shridhar Hari. Datar Kulvrittanta, Pune 1974. Gupta Rupa Raje, The wada of Maharashtra an Indian courtyard house form. Unpublished Ph.D. thesis, Welsh school of Architecture, Cardiff. Harvande Geeta, Pen, Granthali Dn
	WebSites	NA
	Persons	NA

Image Title: Bazar Peth Precinct
Image Type: Front-View
Reference: Streetscape
