RESTORATION WORKS AT CHHATRAPATI SHIVAJI MAHARAJ VASTU SANGRAHALAYA Completion Report for Phase I Exterior Restoration Works

> Architects Abha Narain Lambah Associates: Conservation Architects & Historic Building Consultants Structural Rehab Consultant Mr. Arup Sarbadhikary Contractors

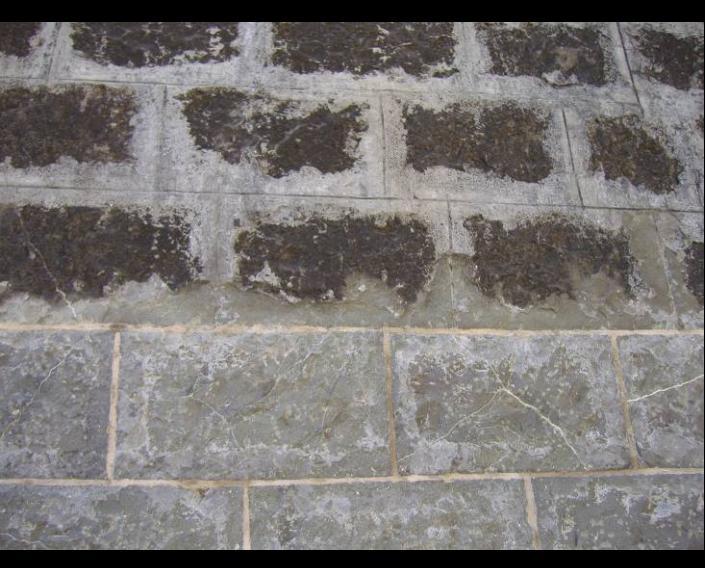
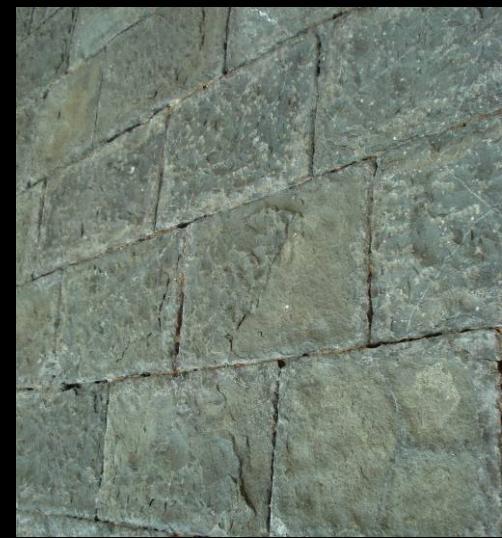
REMOVAL OF HARD CEMENT POINTING AND REPOINTING IN LIME

This pointing exercise was undertaken in the 1970's and the pointing mix was not compatible with the original softer lime pointing. Almost the entire façade of the North West and the south east protruding block has been re-pointed in cement. Ribbon pointing juts out from the surface of the masonry, is much wider than the original joint and different from the original texture of pointing, therefore altering the visual aesthetics of the stone. The careful removal of this hard ribbon pointing was undertaken as a first step in the restoration process.

The original stone joints were very fine joints and ensured the breathability of the masonry, allowing trapped moisture to evaporate. Hard pointing in cement introduced at a later stage in the building, in fact competed with the strength of the stone masonry. As a result, it caused the moisture to evaporate from the stone surface, stressing the stone masonry and causing deposition of salts and consequently stone delamination. Removal of Hard pointing and re doing the same in fine lime pointing.

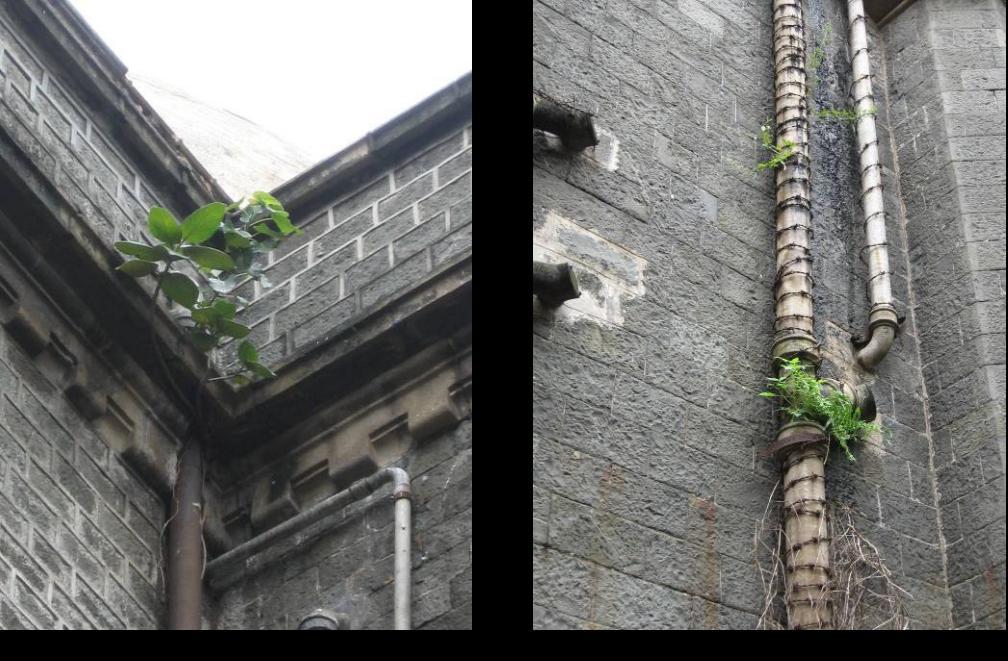
Areas along rainwater down takes were prone to ficus growth as the constantly wet masonry harboured such plant growth. In the case of smaller ficus (peepal /banyan) plants growing out of the stone joints, the methodology adopted was that of pulling out the plant and using a syringe to inject the ammoniacal biocide into the root system. In case of larger plants, a length of the main stem was cut out at a convenient height above the stone surface. The plant was then sprayed over with biocides and the parent stem, after cutting was cut into a frill girdle, and coated with a paste made from Ammonium sulphamate crystals. This is a better system than using acids, but in cases of extremely stubborn growth, when the above measures are not effective, and the masonry is not a soft limestone, only then can the option of injecting acid be adopted, and that too after ensuring that no surface overflowing of the solution takes place.

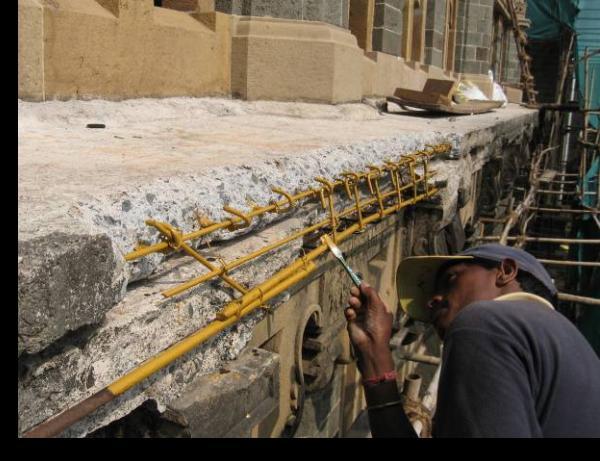
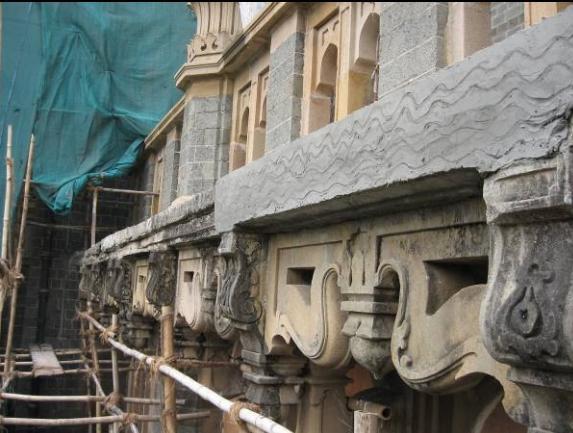
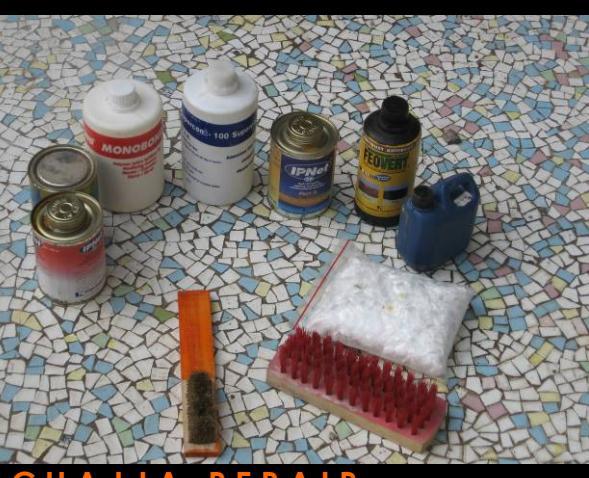
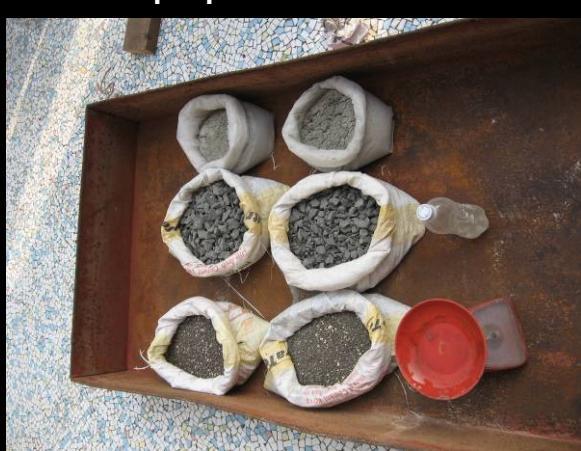
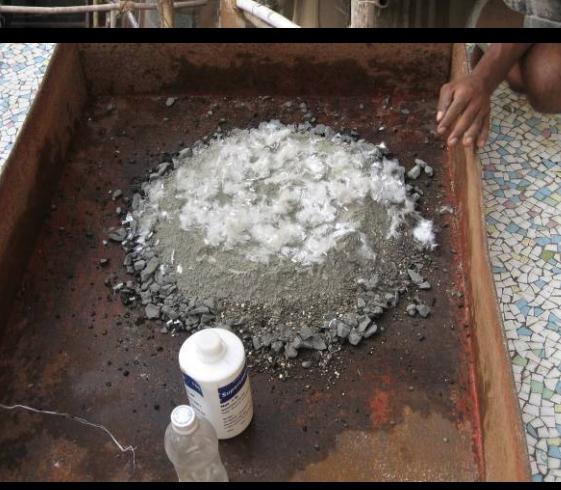
Structural Consultant Mr. The Arup Sarbadhikary inspected the samples undertaken for chajja repair and recommended the procedure for undertaking polymer aided repair for the concrete chajjas. The spoiled cement was removed from the chajja's exposing the reinforcement which was treated by adding stirrups for support and strength. Anti corrosive paint was applied for protection. Then the chajja's were plastered with cement with proper admixtures.

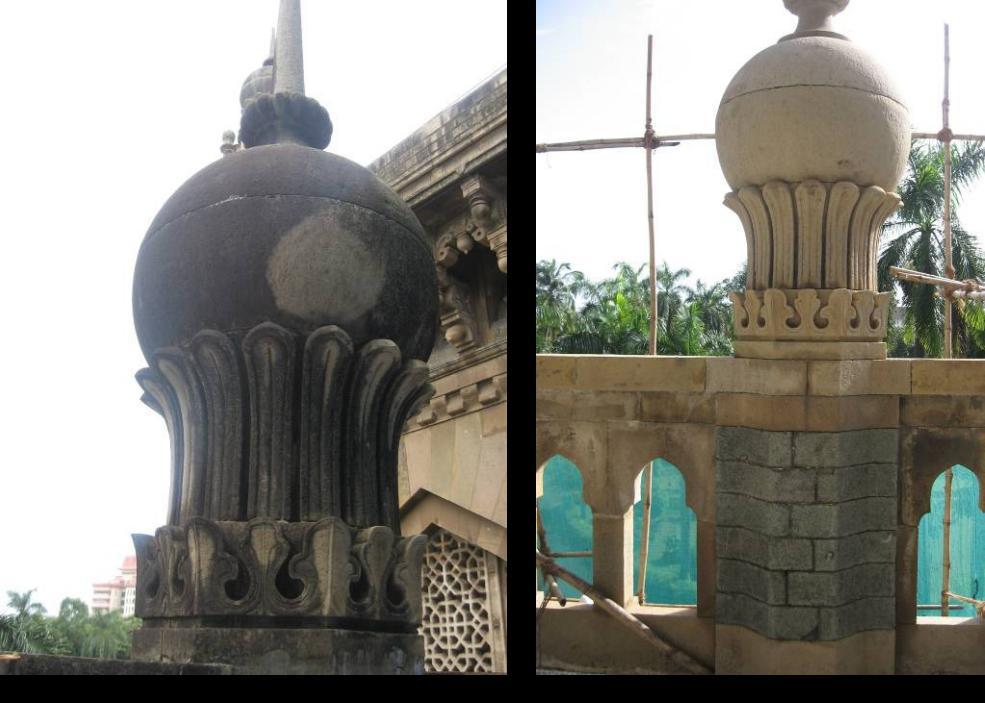
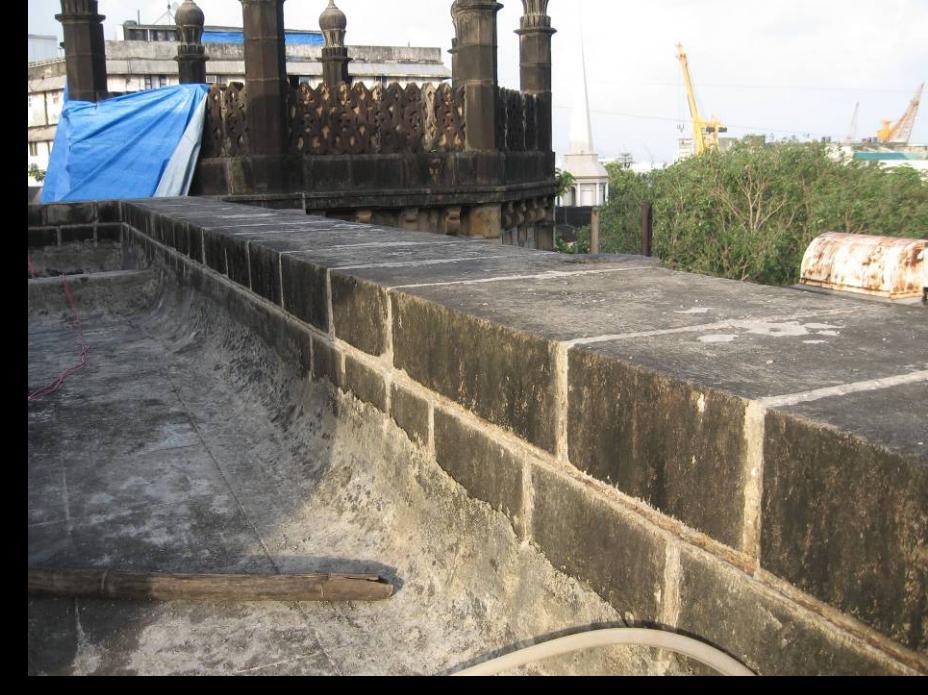
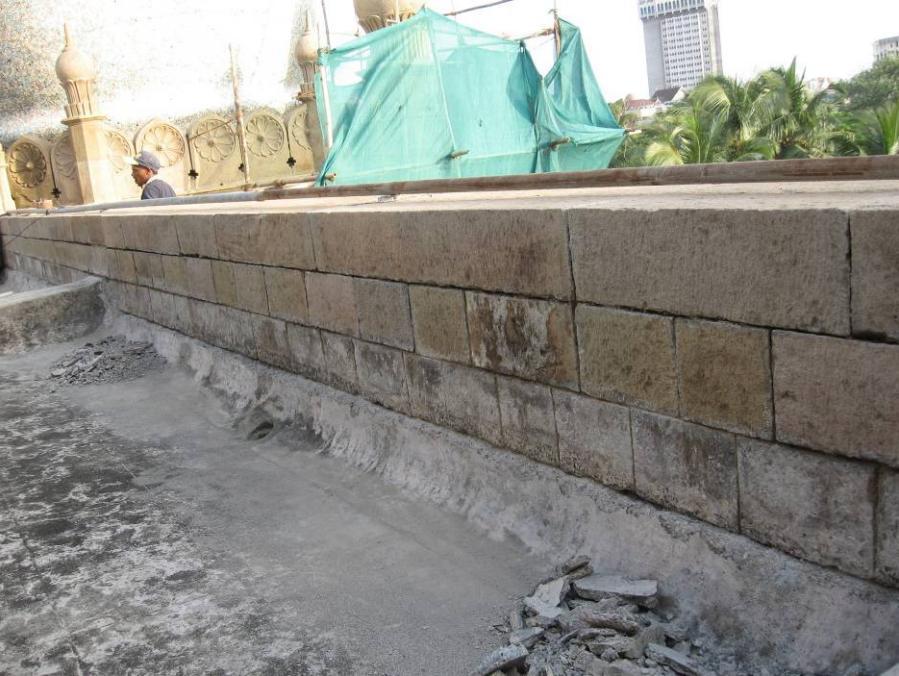
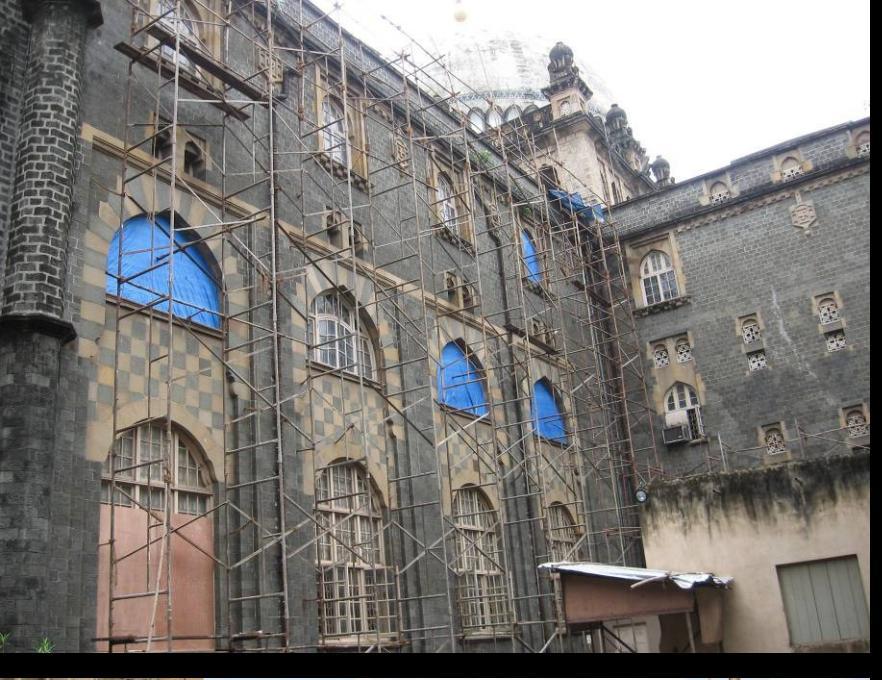
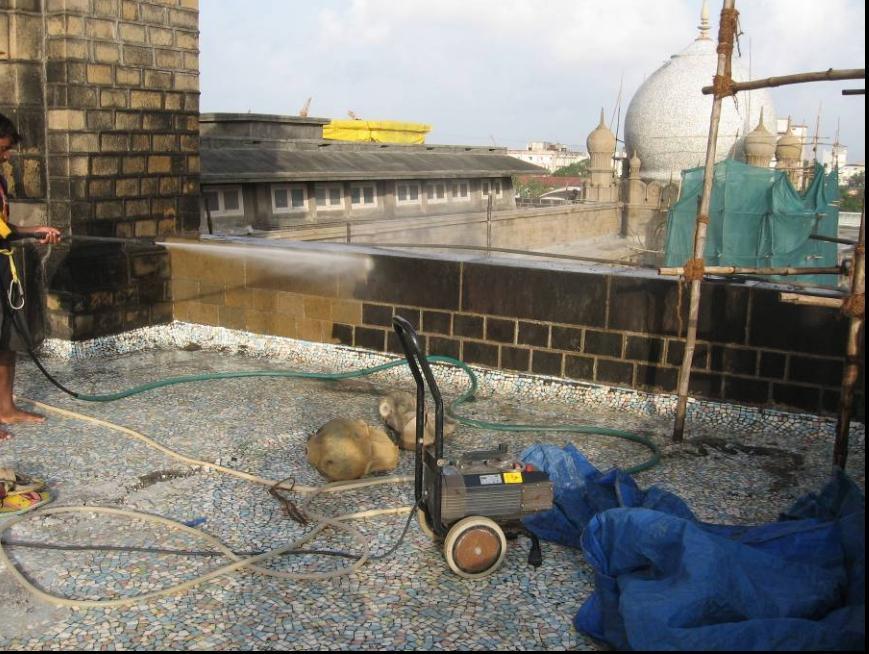
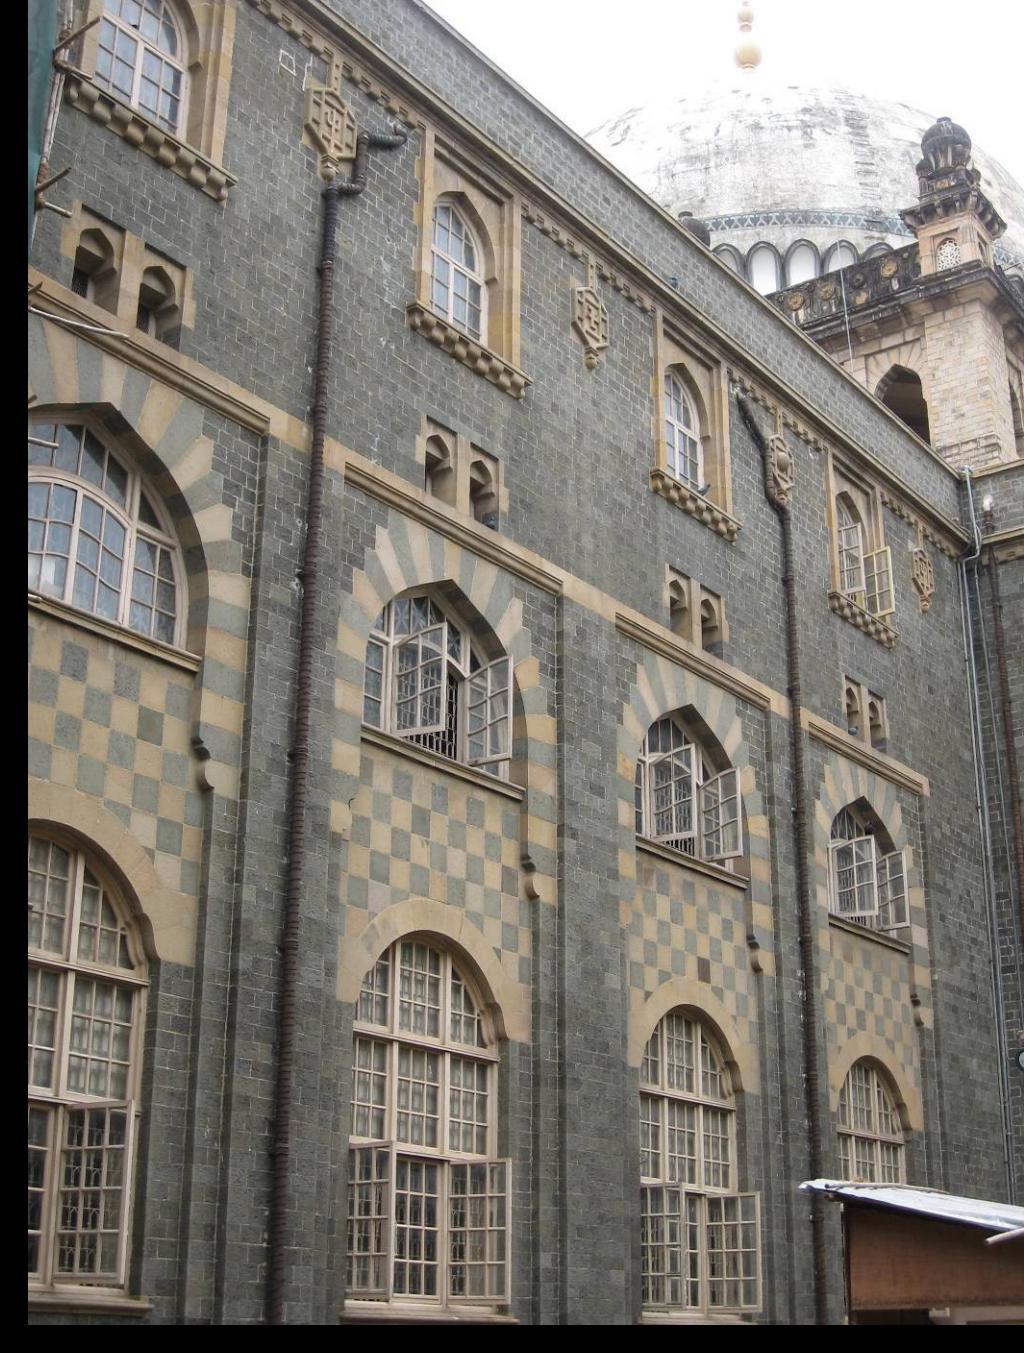
WATER MISTING AND SPECIALISED STONE CLEANING

The building has an external stone facing of grey Kurla Basalt stone, combined with buff coloured stone brackets and decorative bands in Malad stone that is a variety of trachyte. The masonry however, exhibits some amount of stone staining and stone surfaces on the external facades exhibit surface deposits, general staining and accretion of pollutants. The turrets and domes dotting the skyline were especially exposed to surface deposits and dark staining, while the patches of masonry near water spouts showed salt deposits and sulphate growth. Stone Cleaning with carefully calibrated water misting was employed and the sample areas were approved by the Architects.

The entire stone cleaning systems adopted have employed non abrasive, sensitive methods, without any use of harsh chemicals.

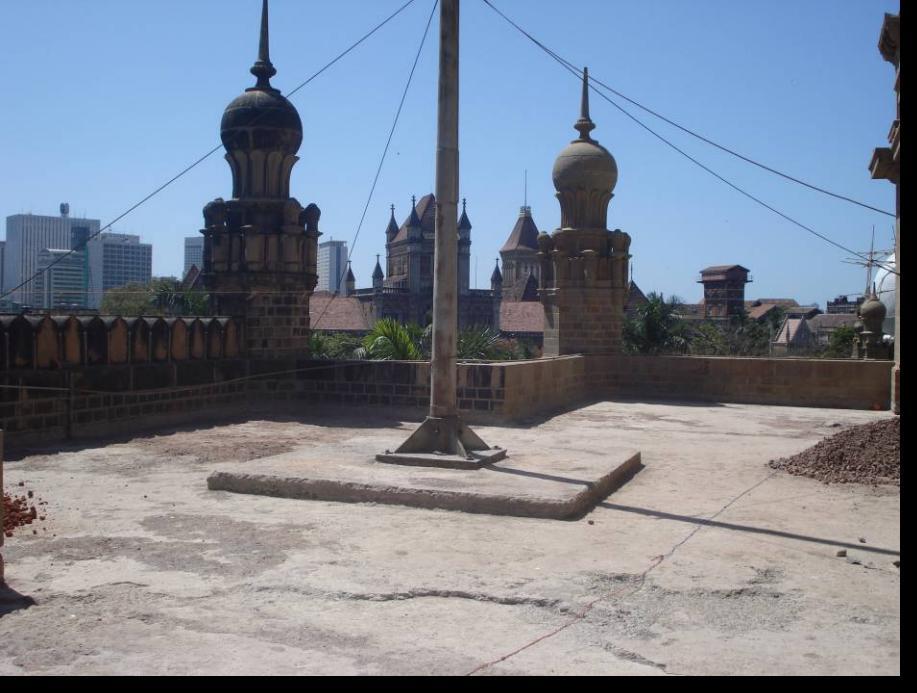
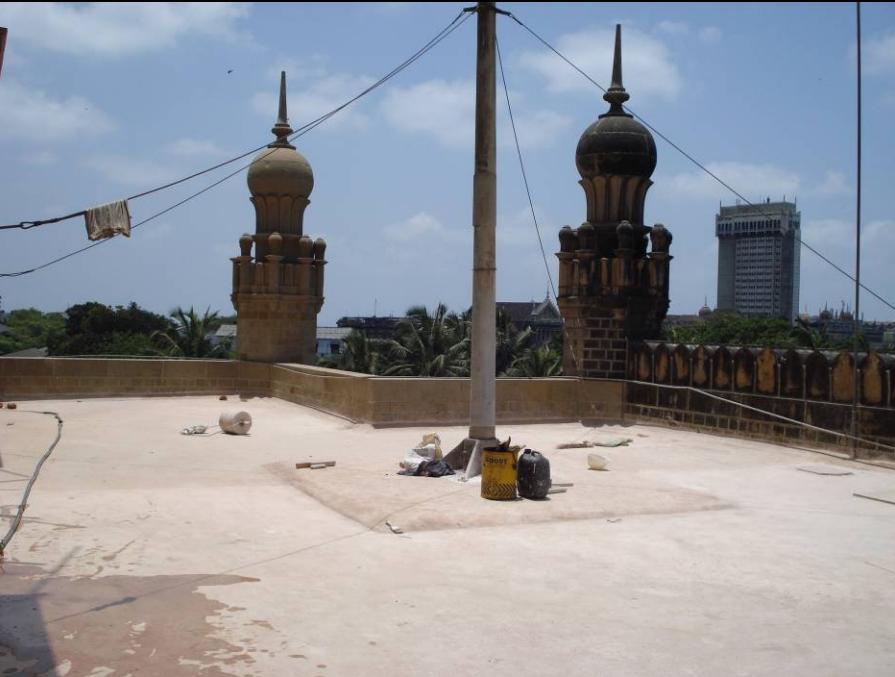
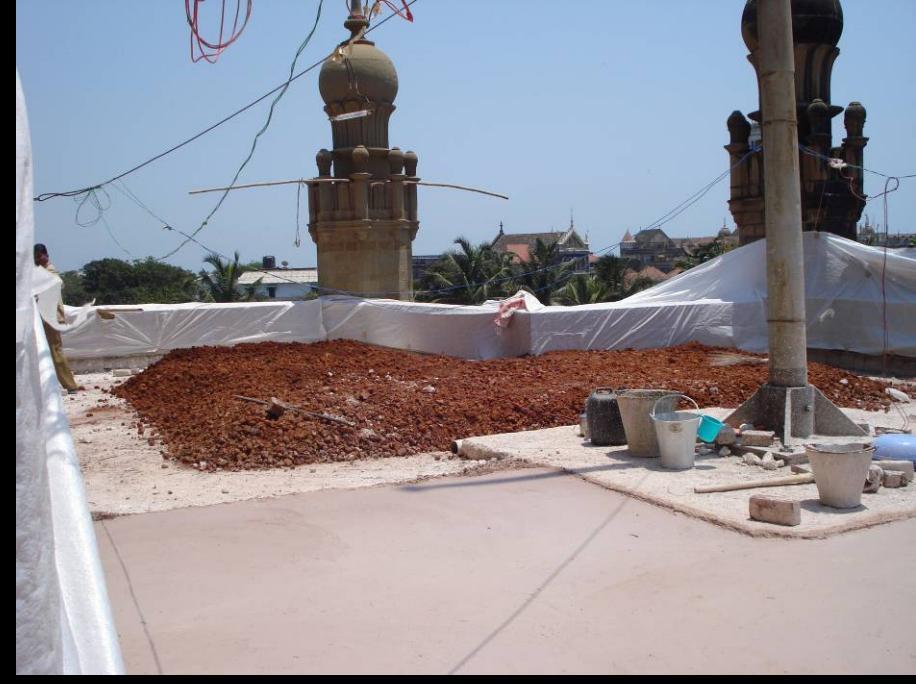
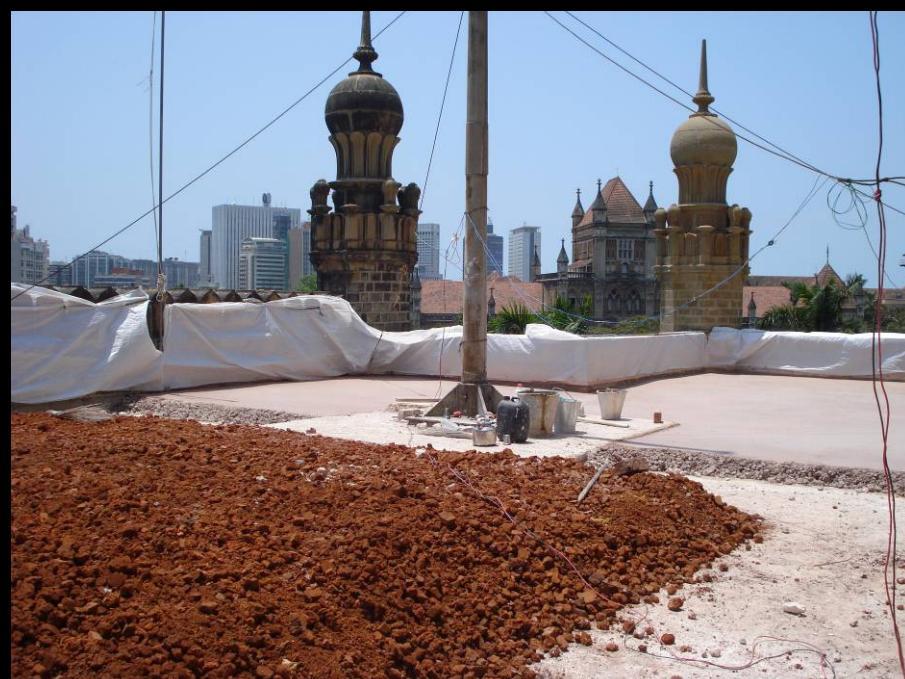
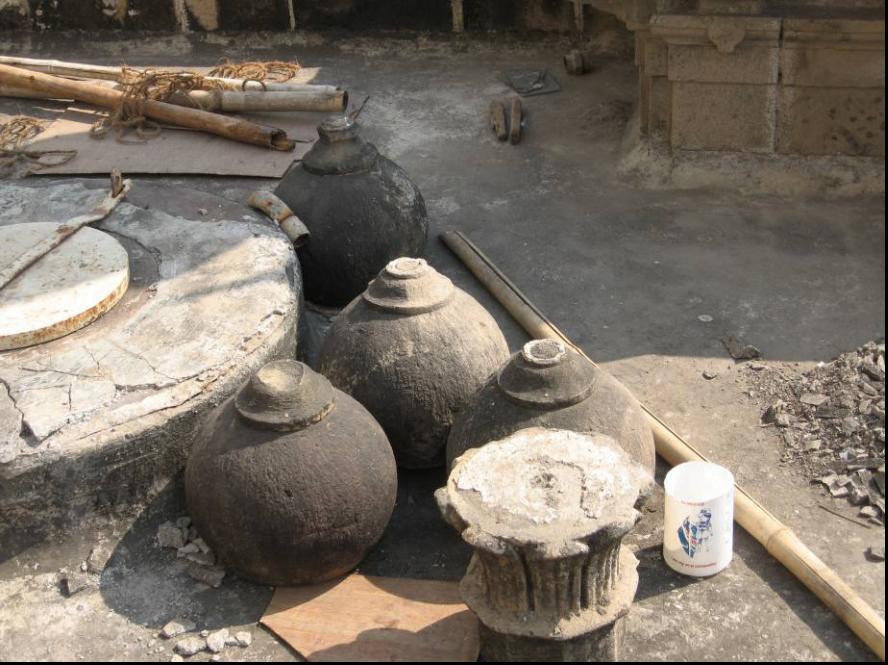
TERRACE WATER PROOFING IN LIME CONCRETE AND CHINA MOSAIC

The Consultants have inspected sections of the terrace waterproofing that had been cracked and after opening out sections of hollow and cracked terrace waterproofing the team jointly decided that redoing the China Mosaic waterproofing would be a more effective treatment for addressing the waterproofing as the underlying layer of screed was very friable and had an extremely low cement content.
